**ALBERTA TRANSPORTATION  
GEOHAZARD ASSESSMENT PROGRAM  
NORTH CENTRAL REGION – ATHABASCA &  
FORT MCMURRAY DISTRICTS  
2022 INSPECTION**

Site Number	Location	Name	km
NC084	To the south of the King Street Interchange in Fort McMurray	Hwy 63:11 Beacon Hill Erosion	9.1
Legal Description		UTM Co-ordinates	
5-10-089-09 W4M		12U E 478509	N 6284231

Date	PF	CF	Total
<b>Previous Inspection:</b>	June 24, 2021	16	4	64 (Ditch Erosion)
<b>Current Inspection:</b>	June 8, 2021	16	4	64 (Ditch Erosion)
<b>Road AADT:</b>	28,690	<b>Year:</b>	2022	
<b>Inspected By:</b>	José Pineda, Tarek Abdelaziz (Thurber) Arthur Kavulok, Rishi Adhikari, Amy Driessen (Alberta Transportation)			
<b>Report Attachments:</b>	<input checked="" type="checkbox"/> Photographs <input checked="" type="checkbox"/> Plans <input type="checkbox"/> Maintenance Items

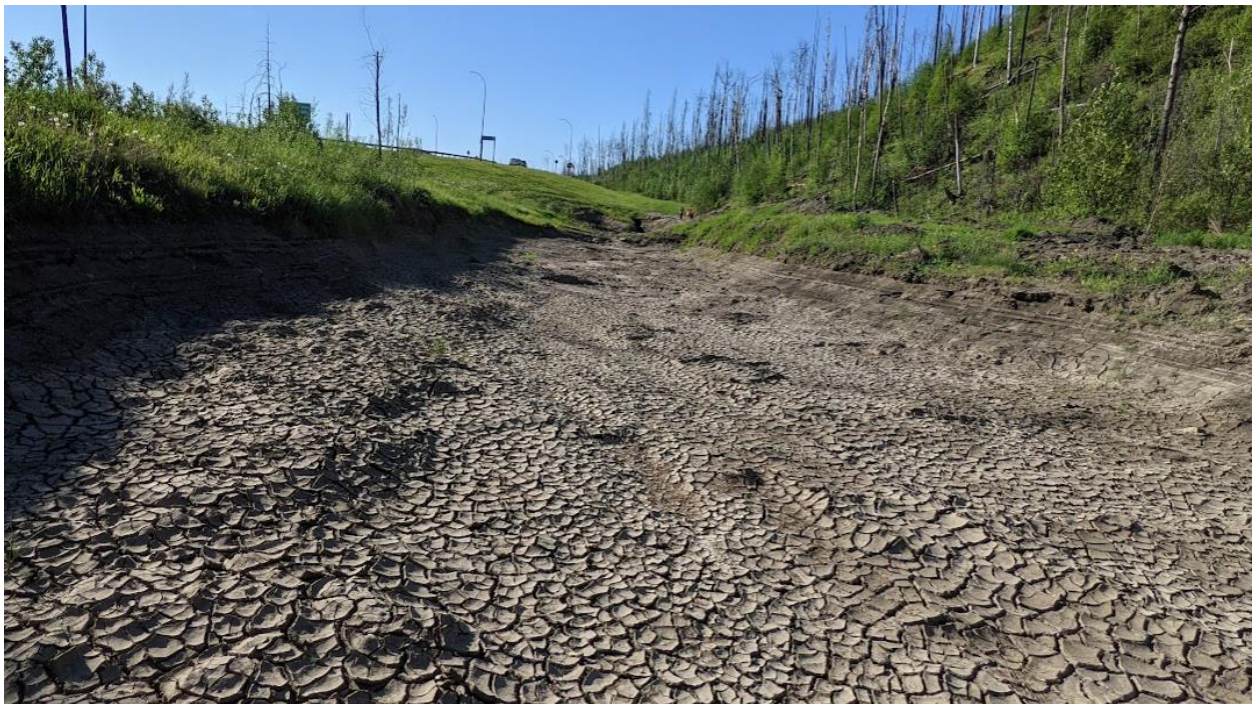
Photo 12 – Looking south from the north end of the pond. Note dry conditions in 2022.

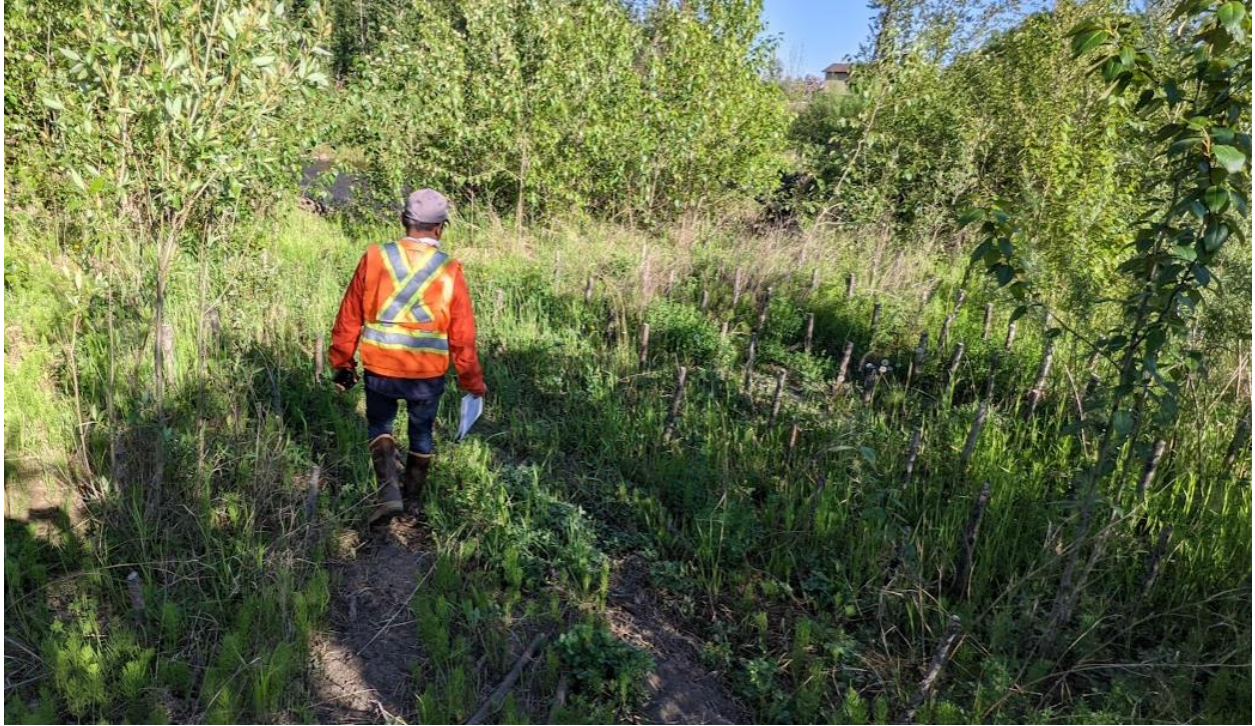
Photo 13 – Willow staking within the vegetation buffer zone between the pond and the river.
