**ALBERTA TRANSPORTATION AND  
ECONOMIC CORRIDORS GRMP  
NORTH CENTRAL (ATHABASCA AND FORT  
MCMURRAY DISTRICTS)  
2024 SITE INSPECTION**

Site Number	Location	Name	km
NC084	To the south of the King Street Interchange in Fort McMurray	Hwy 63:11 Beacon Hill Erosion	9.1
Legal Description		UTM Co-ordinates	
5-10-089-09 W4M		12U E 478509	N 6284231

**NORTH CENTRAL REGION  
 (ATHABASCA AND FORT MCMURRAY DISTRICTS)  
 2024 GEOHAZARD ASSESSMENT  
 NC084: HWY 63:11 BEACON HILL EROSION ISSUES  
 (km 9.1)  
 LIDAR IMAGE SHOWING SITE FEATURES**

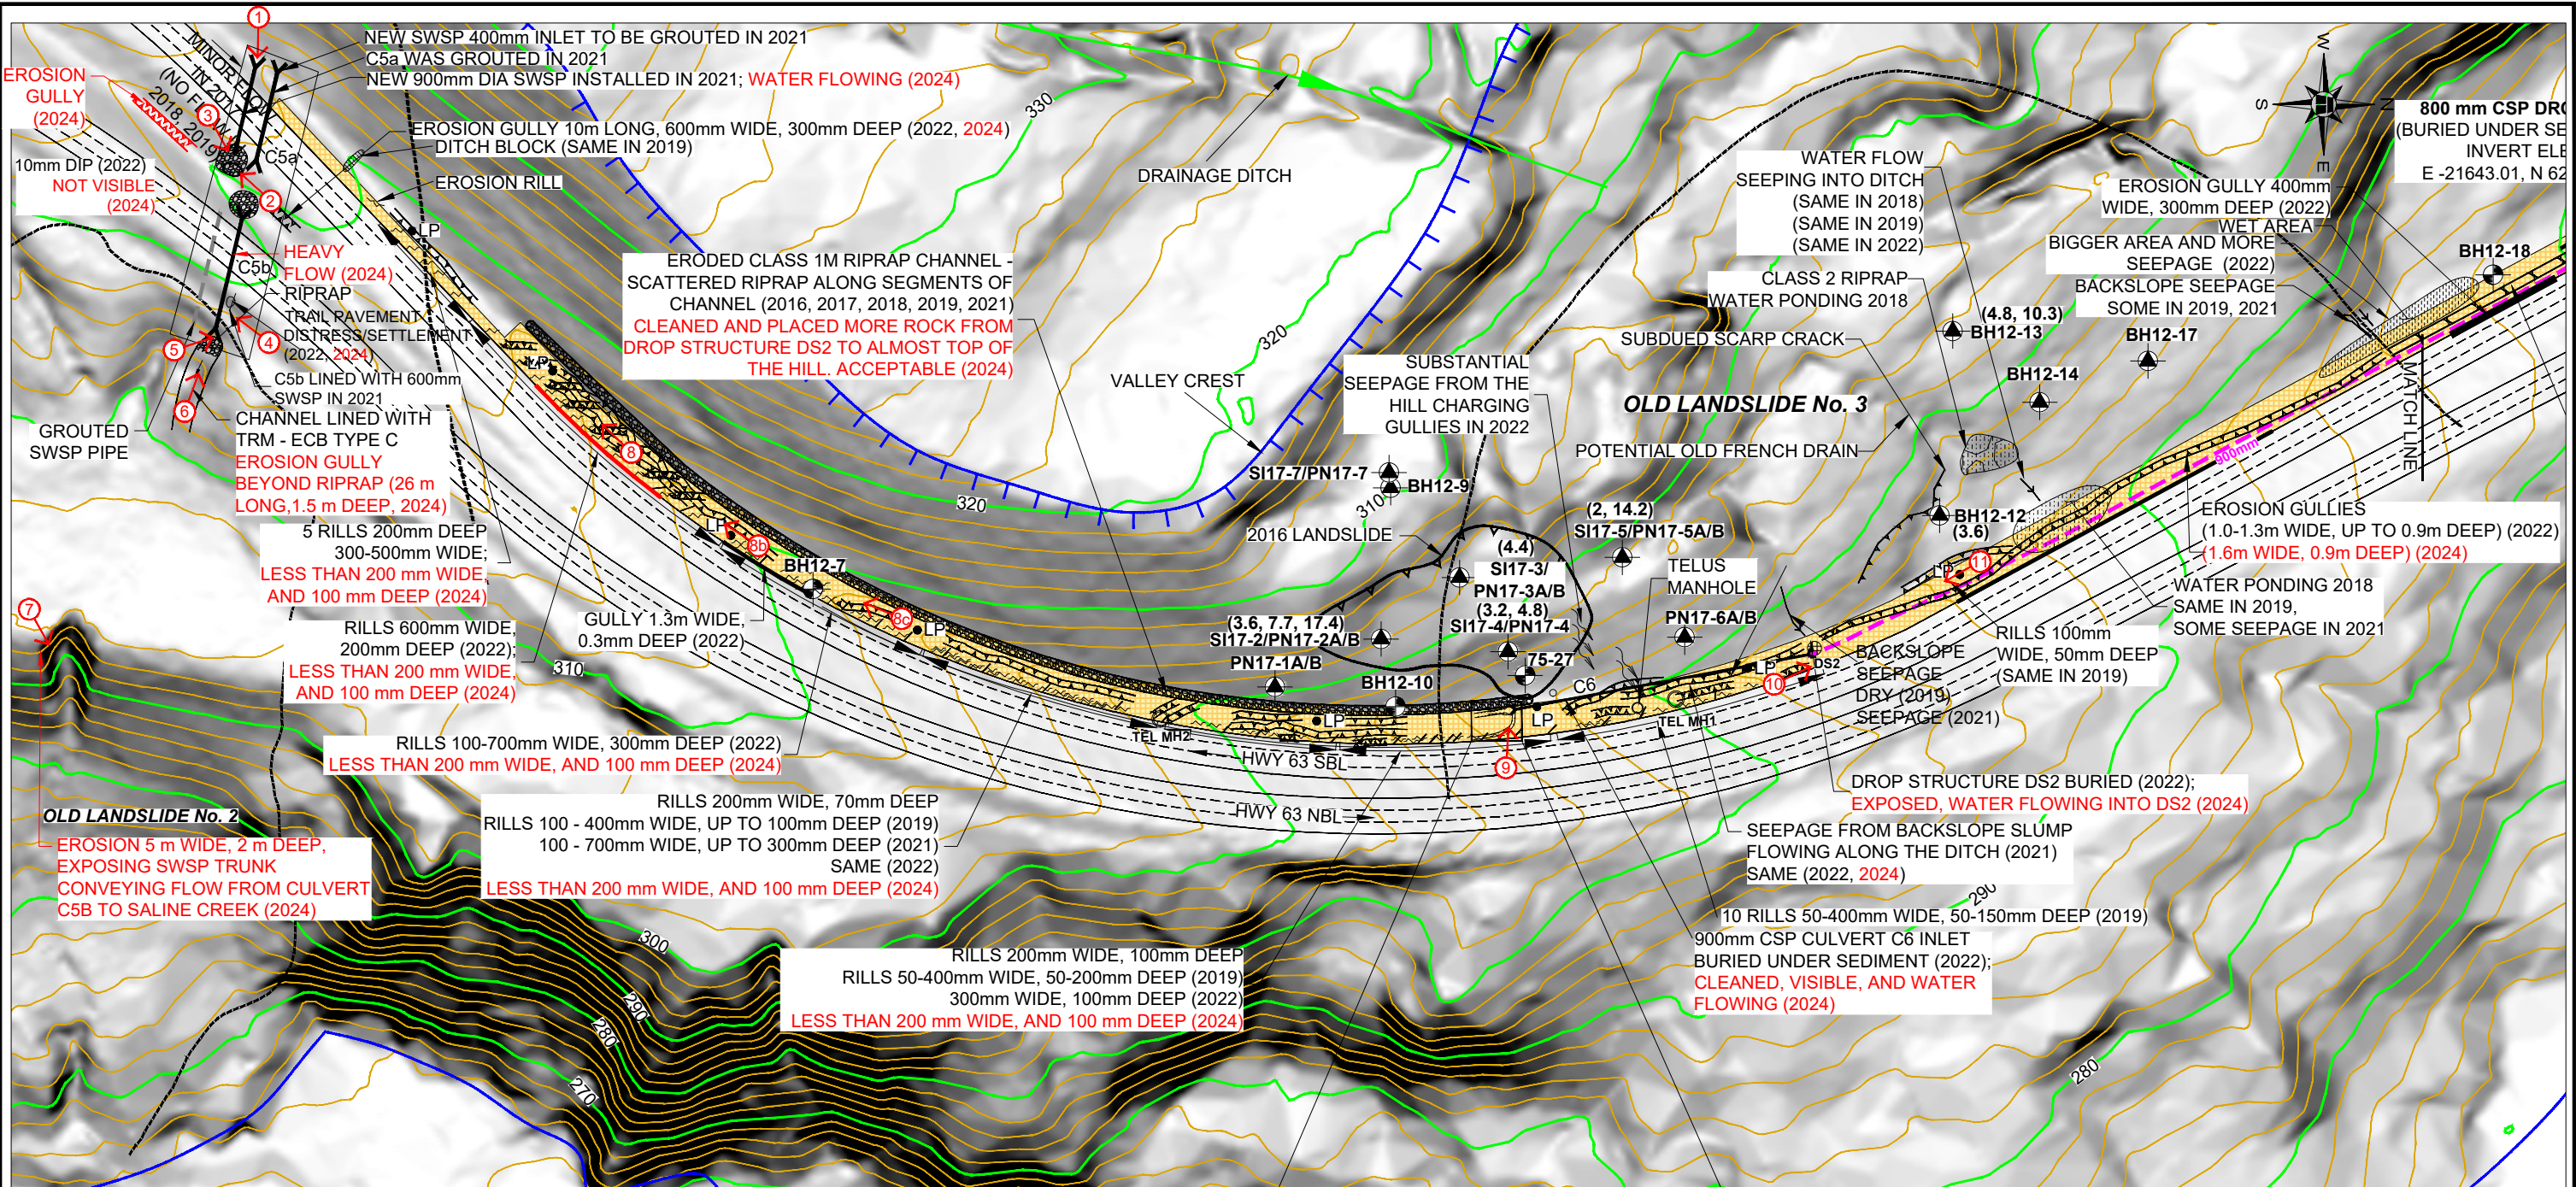
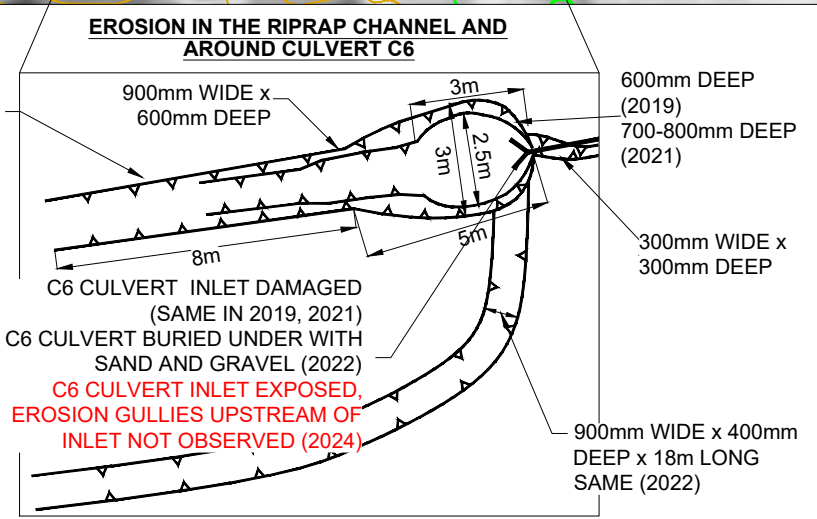
**FIGURE 2**

**NOTES:**  
 1. JUNE 4, 2024 OBSERVATIONS SHOWN IN RED.  
 2. INLINE CONTRACTING WAS WORKING ON THE REPLACEMENT OF CULVERT C5a AND C5b; TETRA TECH WAS THE CONSULTANT OVERSEEING THE CULVERT REPLACEMENT WORK. TETRA TECH INDICATED THAT THE CONTRACTOR HAD MULTIPLE UNSUCCESSFUL ATTEMPTS TO REPLACE THE C5b CULVERT.

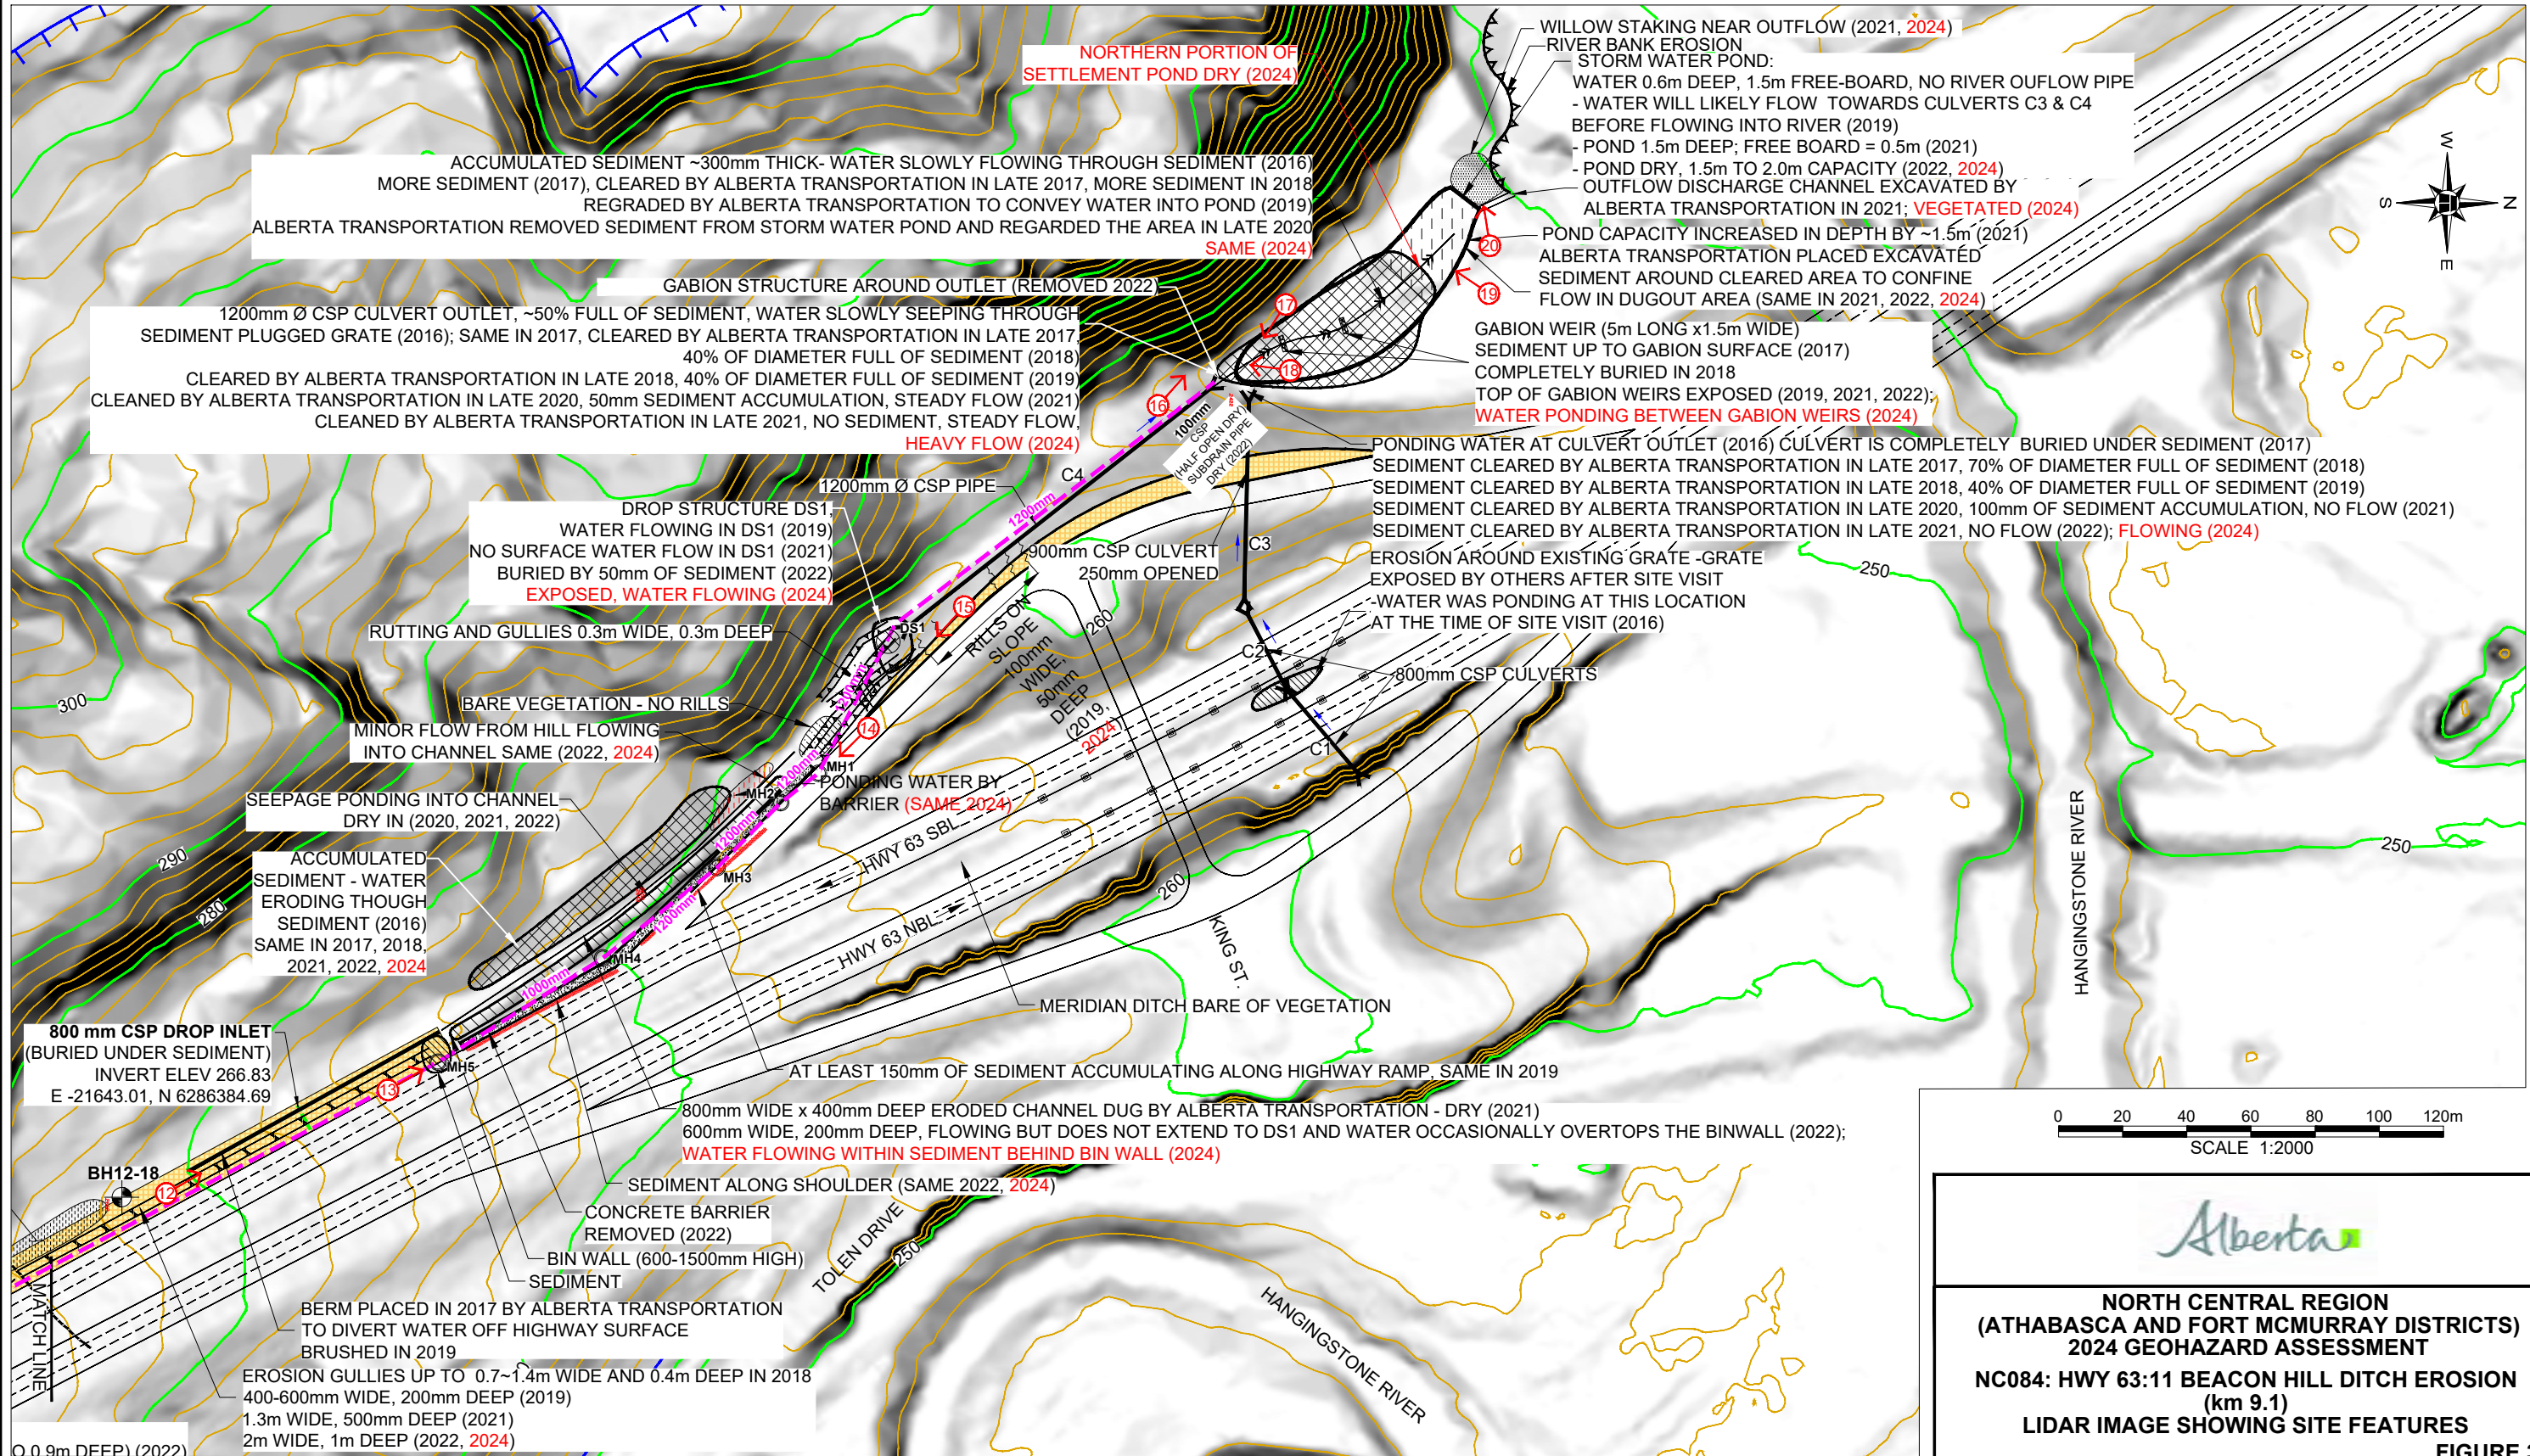
**FIGURE 3**

1. MH2 TO MH5 ARE BURIED UNDER SEDIMENT.
2. JUNE 4, 2024 OBSERVATIONS SHOWN IN RED.

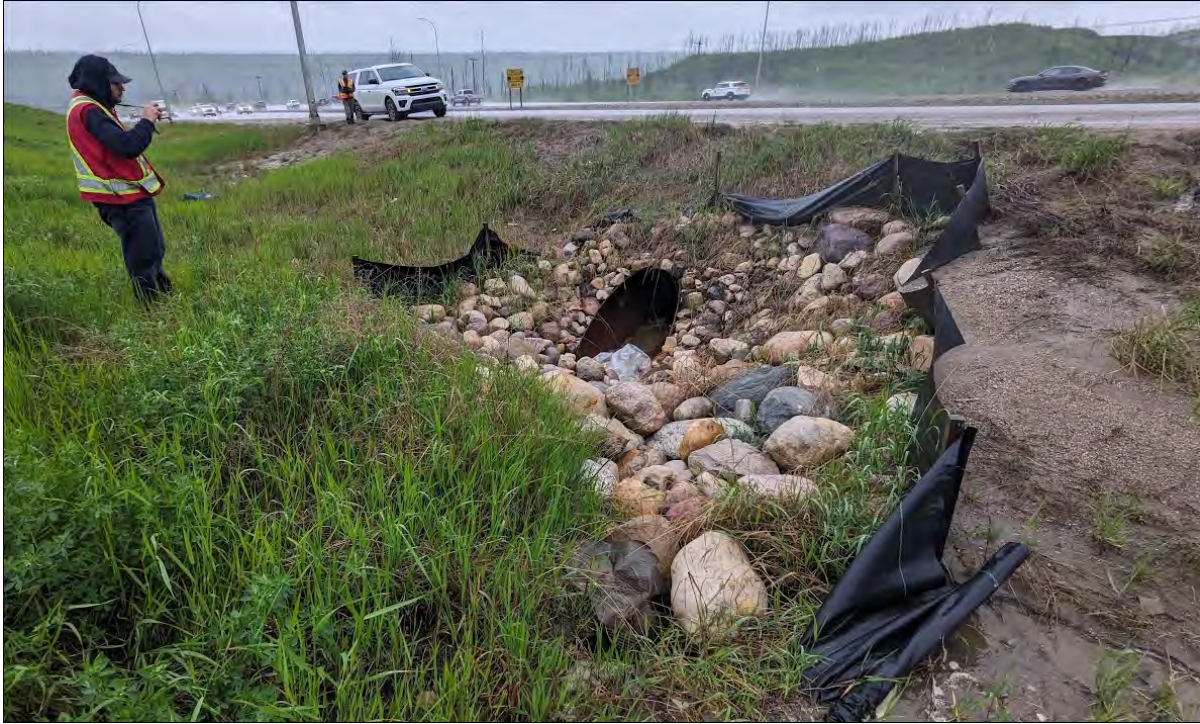
Photo 1 – Looking at the inlet of the 900 mm diameter SWSP culvert (C5a replacement).

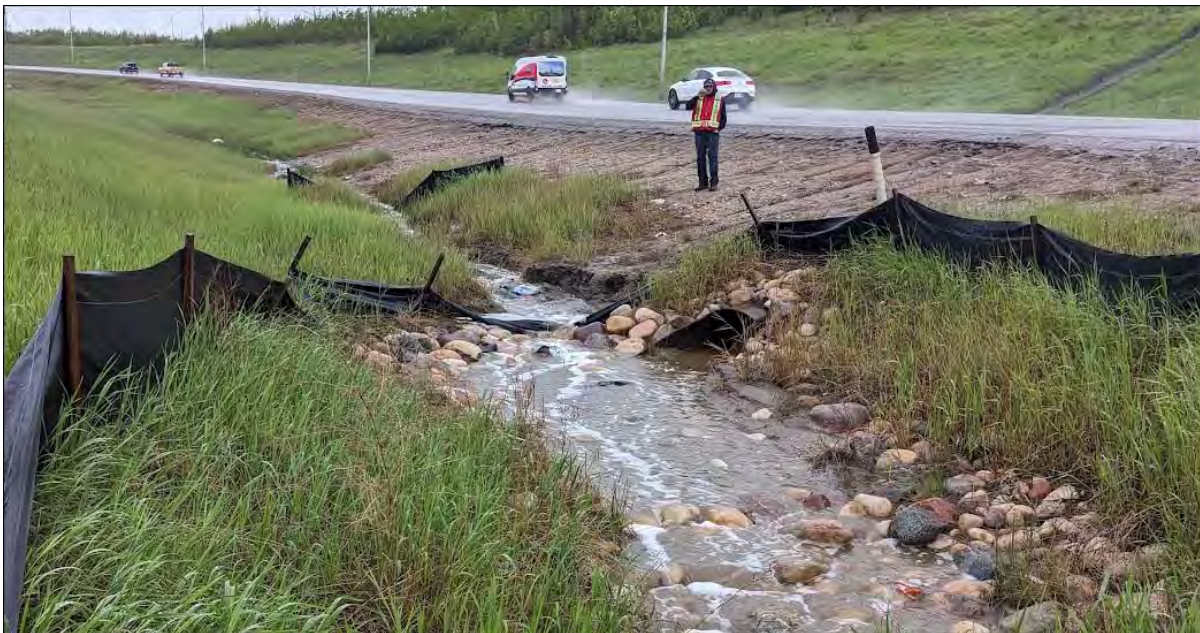
Photo 2 – Looking at the outlet of the 900 mm diameter SWSP culvert (C5a replacement);

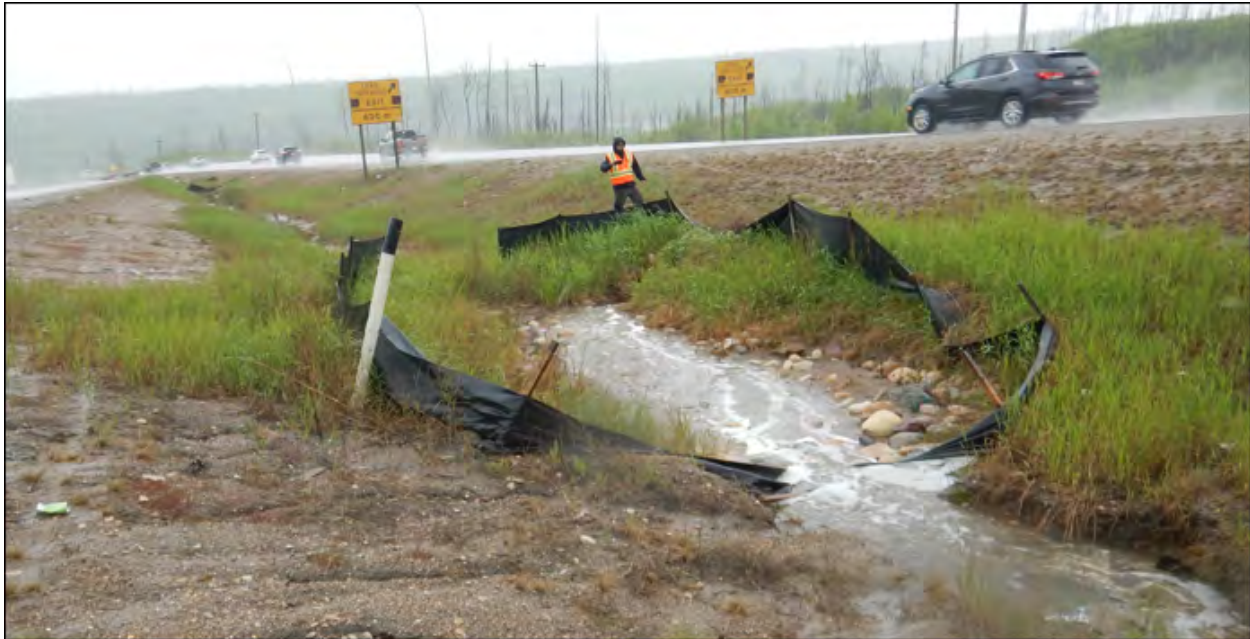
C5b culvert is currently undersized, and this may result in future flooding of the highway and additional erosion of the median ditch. The existing erosion gullies within the highway median ditch and downslope of the outlet of the C5b pipe is due to inadequate erosion protection. The erosion gullies are anticipated to grow bigger in size unless additional measures are designed and implemented to deal with the current issue.

Photo 3 - 600 mm diameter SWSP culvert inlet (C5b; liner installed within the original C5b pipe).

- A hydrotechnical study should be conducted to assess the impact of the reduced capacity of C6b on the storm water management system in this area. The median ditch and the highway surface should be monitored by the local MCI after a prolonged heavy rainfall event.

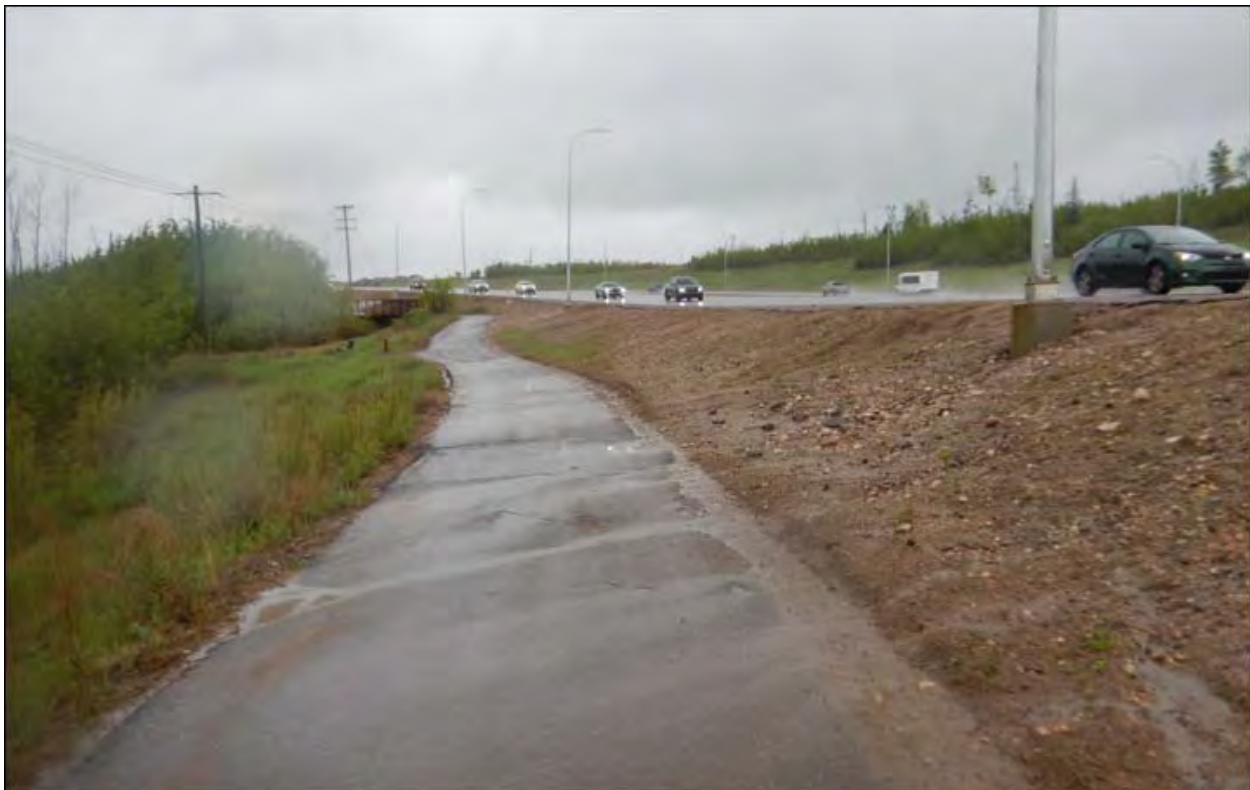
Photo 4 – Asphalt walking trail settlement/distress in response to the failed attempts to replace C5b.

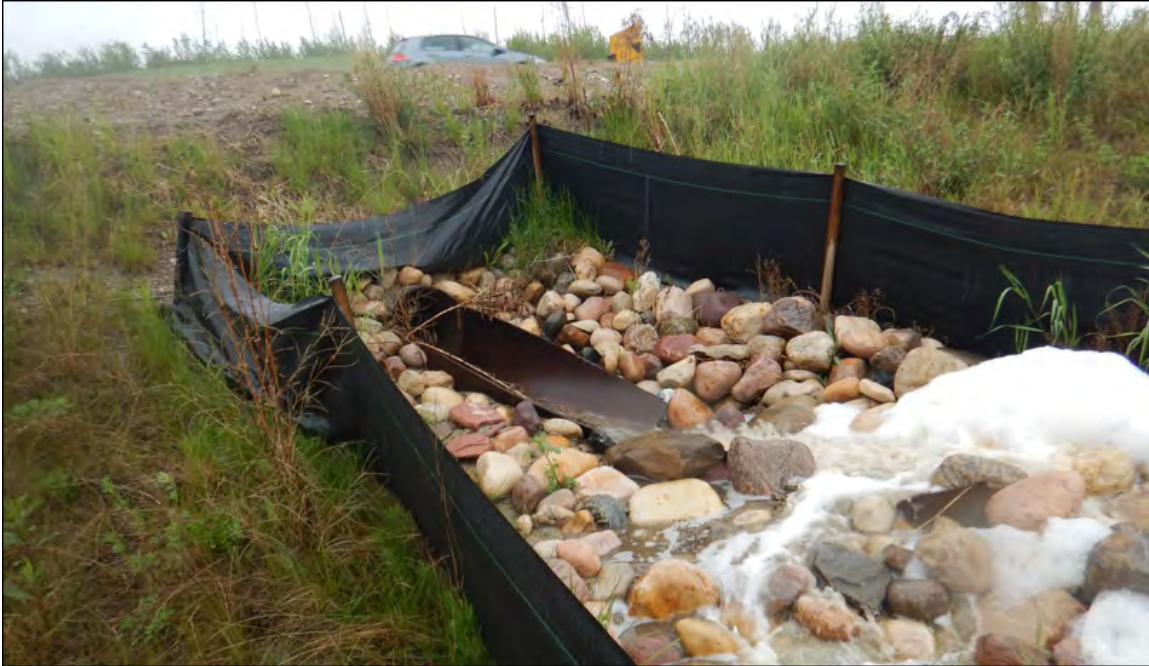
Photo 5 – Looking at the outlet of the C5b liner.

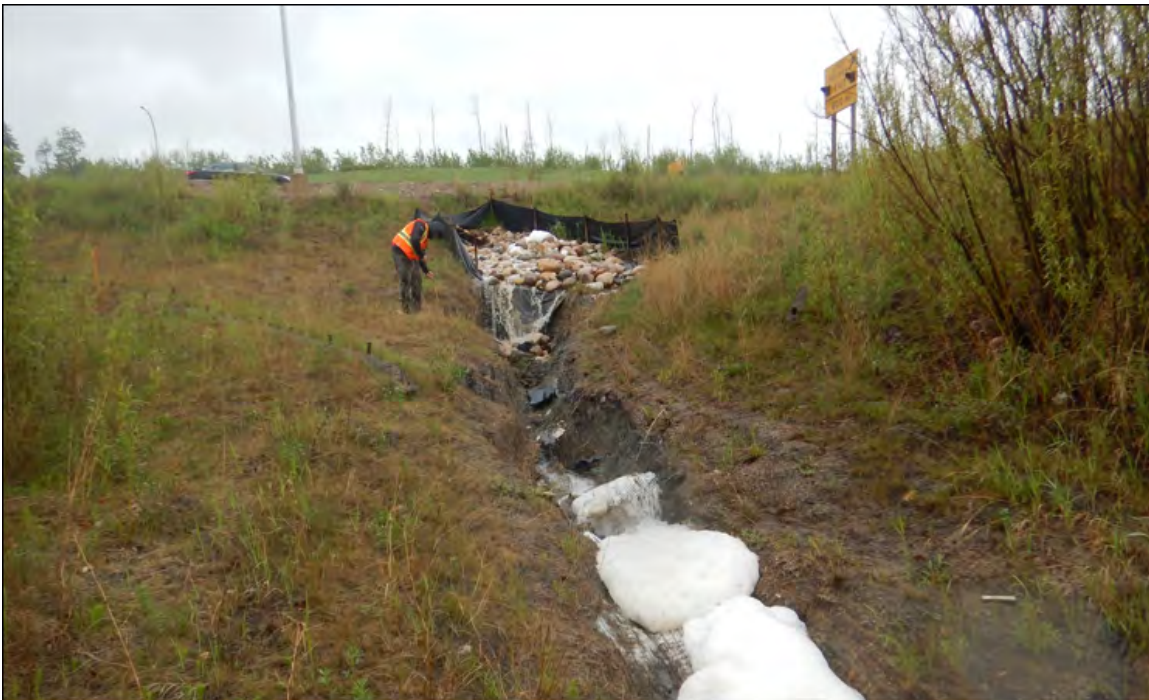
<b>Observations:</b>	<b>Description</b>	<b>Worsened?</b>
<input type="checkbox"/> Pavement Distress		<input type="checkbox"/>
<input type="checkbox"/> Slope Movement		<input type="checkbox"/>
<input checked="" type="checkbox"/> Erosion	Erosion rills (less than 200 mm wide and 100 mm deep) were noted on the highway west side slopes; severe erosion gullies up to 1.6 m wide and 0.9 m deep in the ditch	<input type="checkbox"/>
<input checked="" type="checkbox"/> Seepage	Seepage from the backslope at multiple locations above the ditch alignment	<input type="checkbox"/>
<input checked="" type="checkbox"/> Bridge/Culvert Distress	CSP Culvert C6 inlet is damaged and partially buried with sand and gravel sediment; CSP culverts C3 and C4 outlets are almost free of sediment; DS1 and DS2 were exposed, and water was flowing into the drop structures	<input type="checkbox"/>
<input checked="" type="checkbox"/> Other	Accumulated sediment on the highway shoulder along the bin wall was covering Manholes MH2 to MH5. MH1 was still exposed at the time visit; erosion in the median ditch upstream and downstream of C5b; distress of the paved trail in the vicinity of C5b alignment; severe erosion noted downslope of Culvert C5B outlet location and halfway down the colluvial valley slope exposing a buried SWSP trunk (refer to Photos 6 and 7).	<input checked="" type="checkbox"/>

Photo 6 – Looking at a severe erosion gully downslope of the culvert C5b outlet location.

- The erosion gullies developed in the highway median ditch and within the channel at the outlet of C5b should be repaired before they get bigger in size. All debris and loose material in the gullies should be removed; and the ditch/channel should be reshaped (use clay as needed to re-build the ditch/channel), sized appropriately, and the sides and the bottom of the ditch/channel should be armored with riprap (Class 1 (min.) over non-woven geotextile Type (C)).

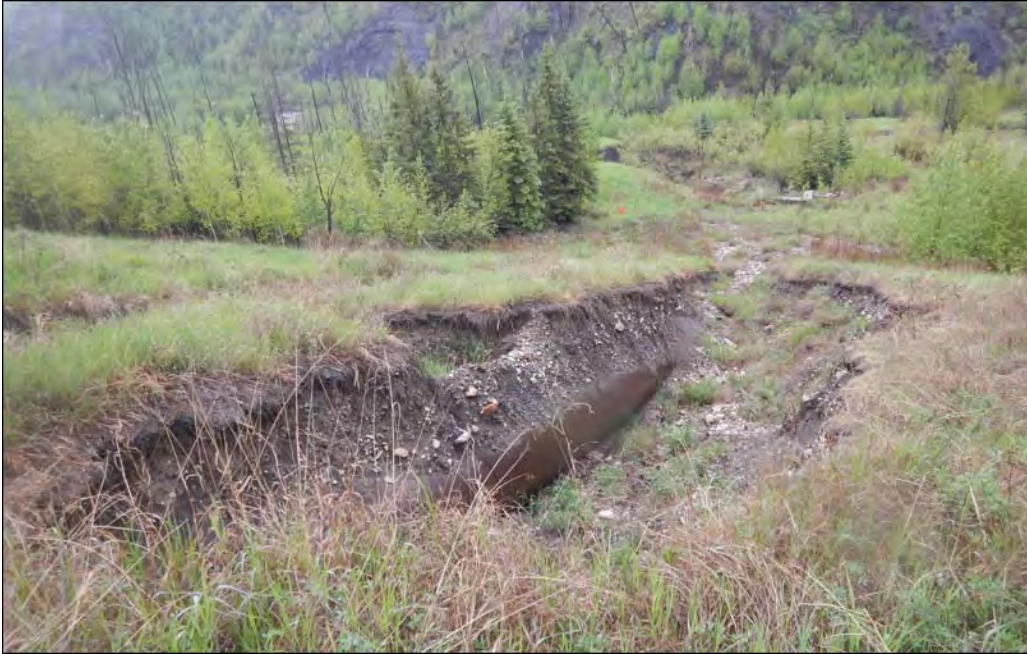
Photo 7 – Looking at erosion halfway down the hill exposing a buried SWSP trunk conveying the flow from the Culvert C5b to Saline Creek at the base of the valley

- The Regional Municipality of Wood Buffalo should be made aware of the severe erosion gully that exposed the storm sewer pipe descending the valley slope of Saline Creek.

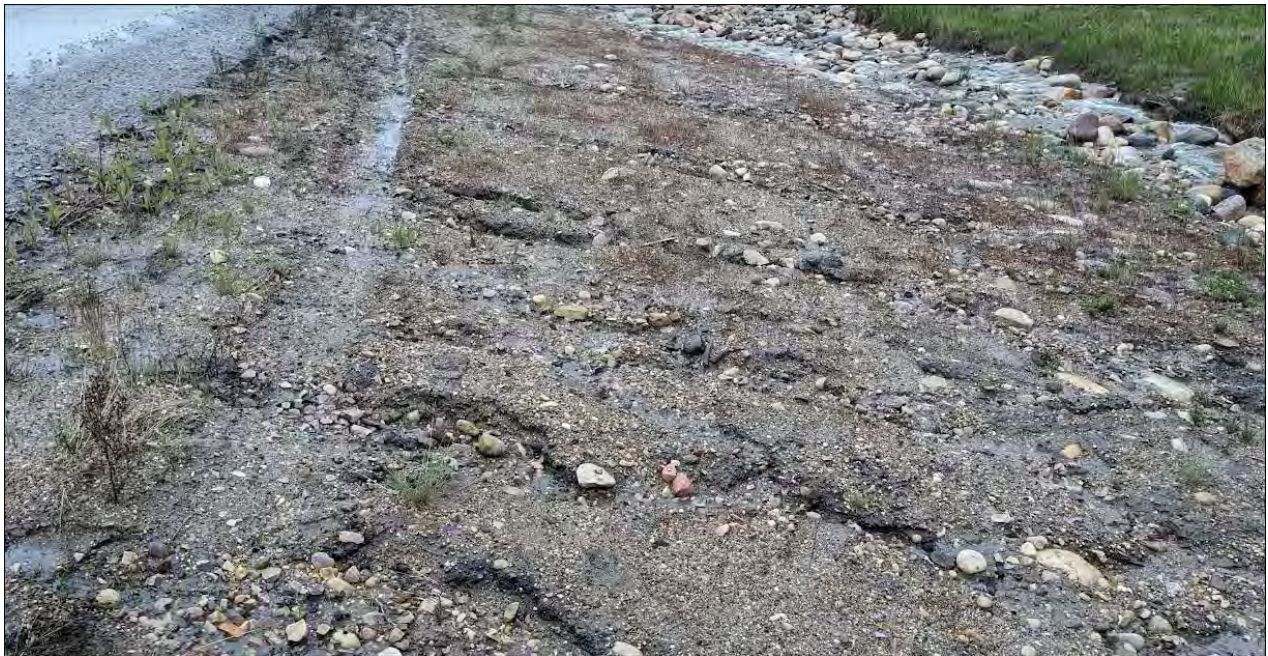
Photo 8 – Bare side slopes with minor erosion rills (looking south)

- Consideration should be given to blading and track packing rilled and bare side slopes of the highway and interchange ramp in a direction perpendicular to the flow direction (i.e., up and down the side slope surface to deal with side slope rills). Minor contouring should be undertaken to re-establish ditch grade and profile. The ditch should have at least 1 m wide flat bottom, 4H:1V side slopes and provided with a minimum height of 300 mm. Grading work should be carefully undertaken particularly where the toe of the valley slope is abutting the highway surface to avoid slope instability issues. The re-constructed ditch should be connected to the inlet drop structure located to the north of the interchange west ramp bin wall through the construction of a narrow/shallow channel by the tree line behind the bin wall.

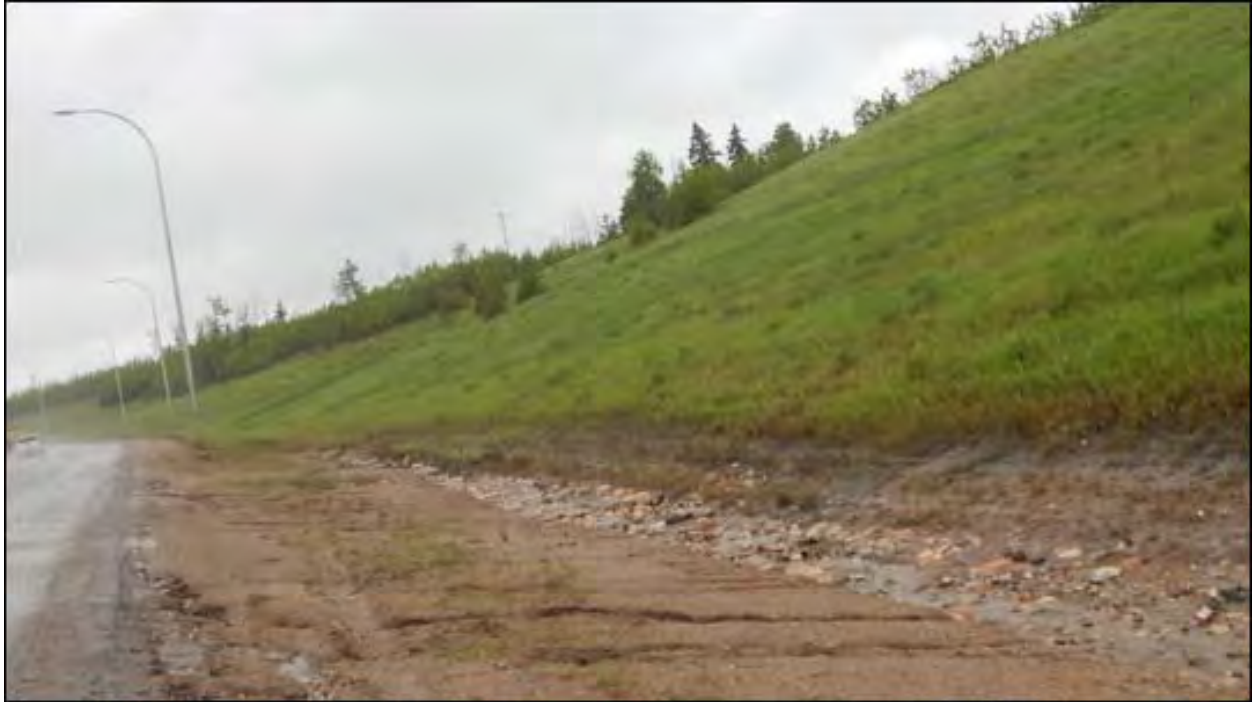
Photo 8b – Bare side slopes and minor erosion rills

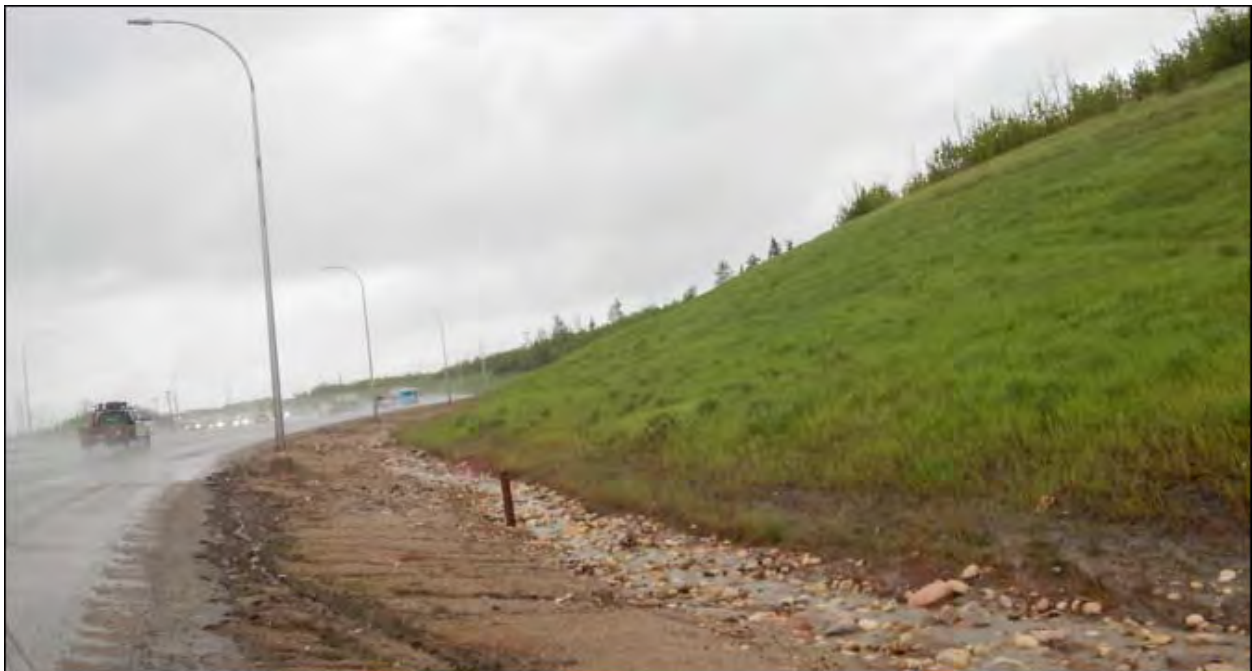
Photo 8c – Bare side slopes and minor erosion rills

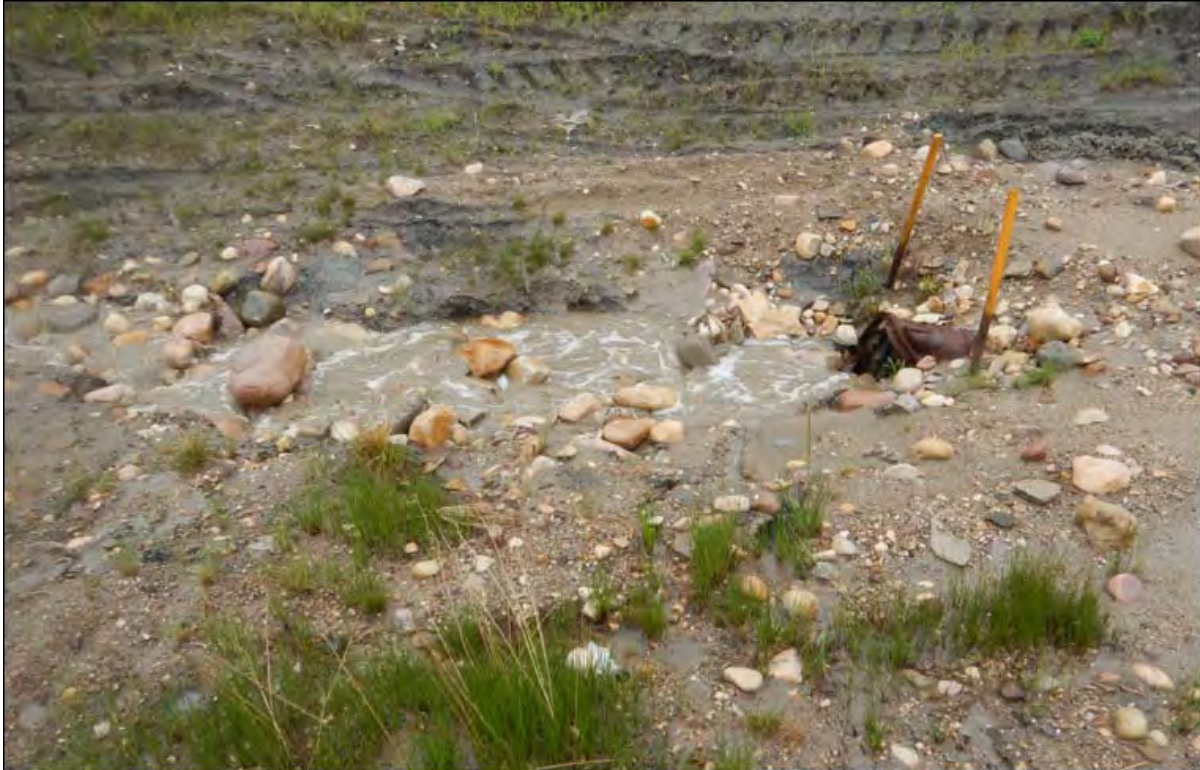
Photo 9 – Culvert C6 inlet previously buried under sediment was exposed in 2024

- Expose and remove potential sediments within MHs 1 to 5.
- Any accumulated sediment around Culvert C6 inlet and the drop structures DS1 and DS2 should be cleared.

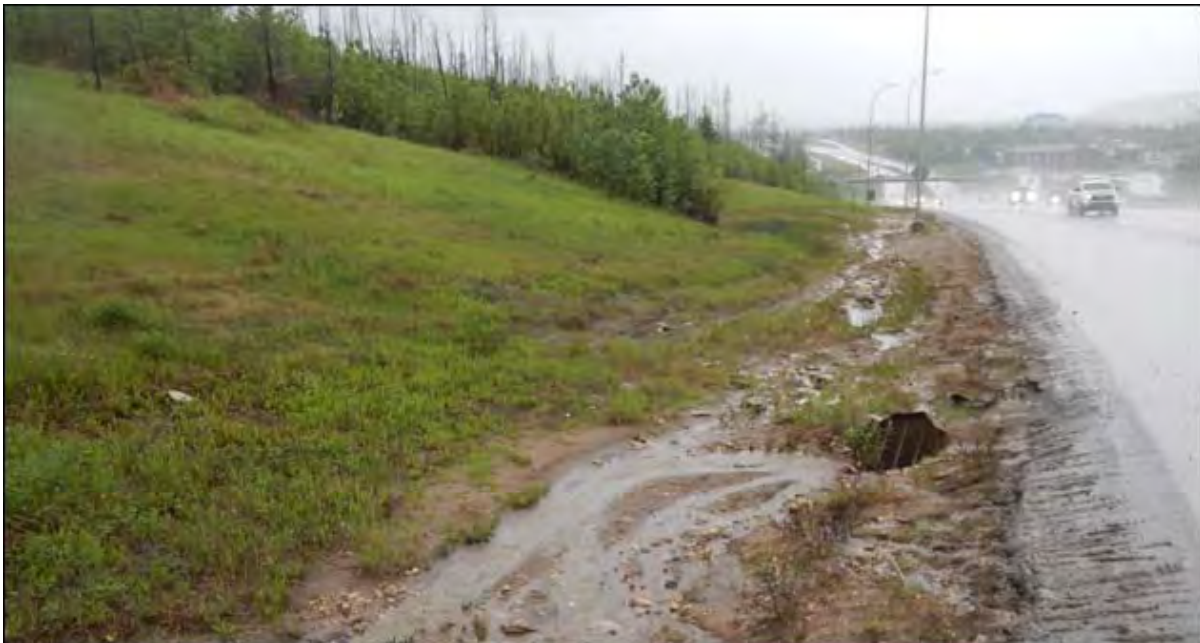
Photo 10 – Drop structure DS2 exposed in 2024

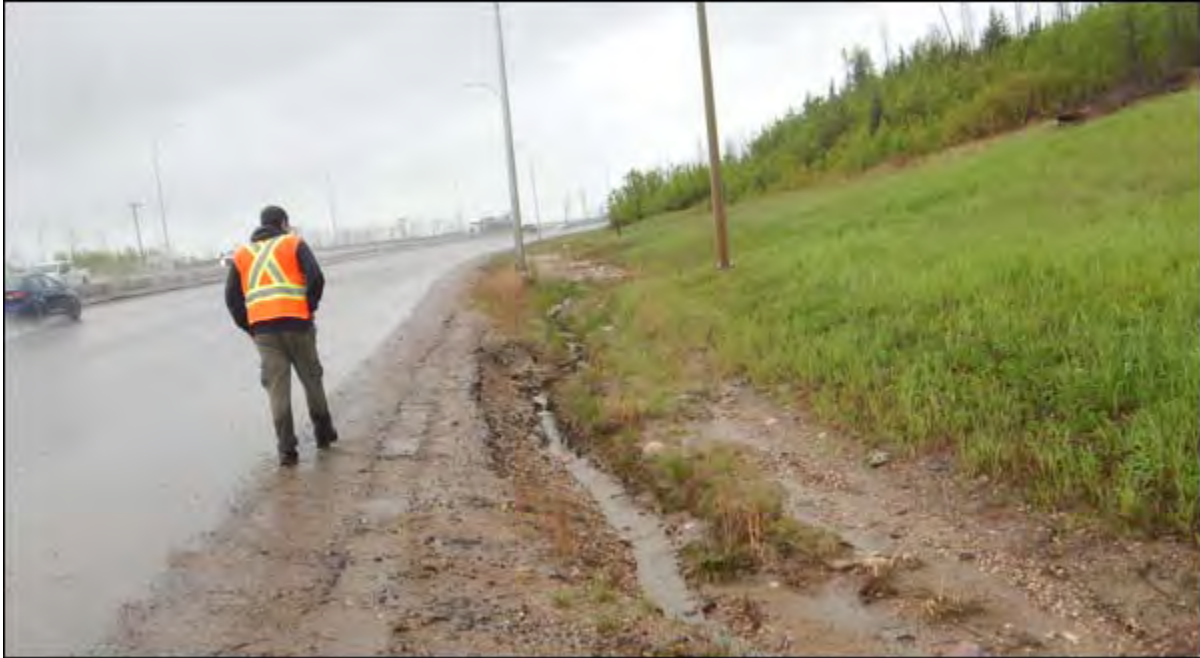
Photo 11 – Erosion gully less than 1.6 m wide by 0.9 m deep

- As a minimum, and where severe erosion gullies developed in the highway side slope and the ditch, the gullies should be backfilled with well compacted crushed gravel or riprap (away from the edge of the road). Backfilling gullies near the edge of the road should be the priority to eliminate existing safety hazard to motorists.

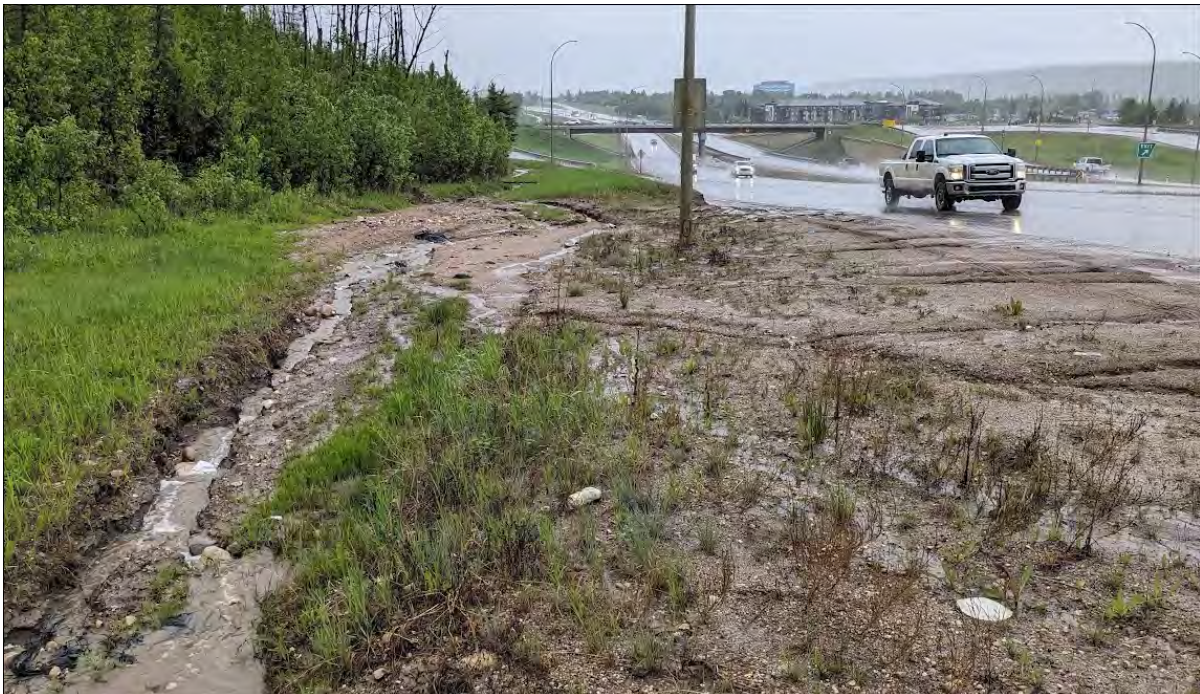
Photo 12 – Eroded ditch upstream of Jersey Wall

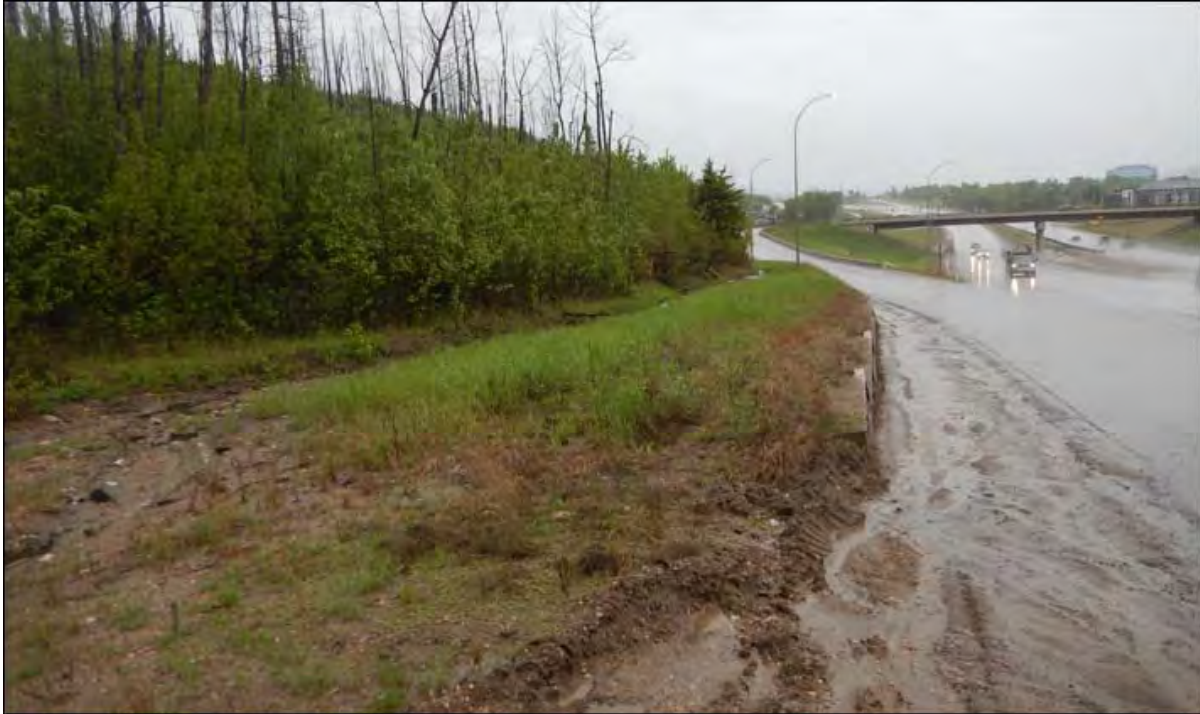
Photo No 13 – Manhole 5 is buried under sediment

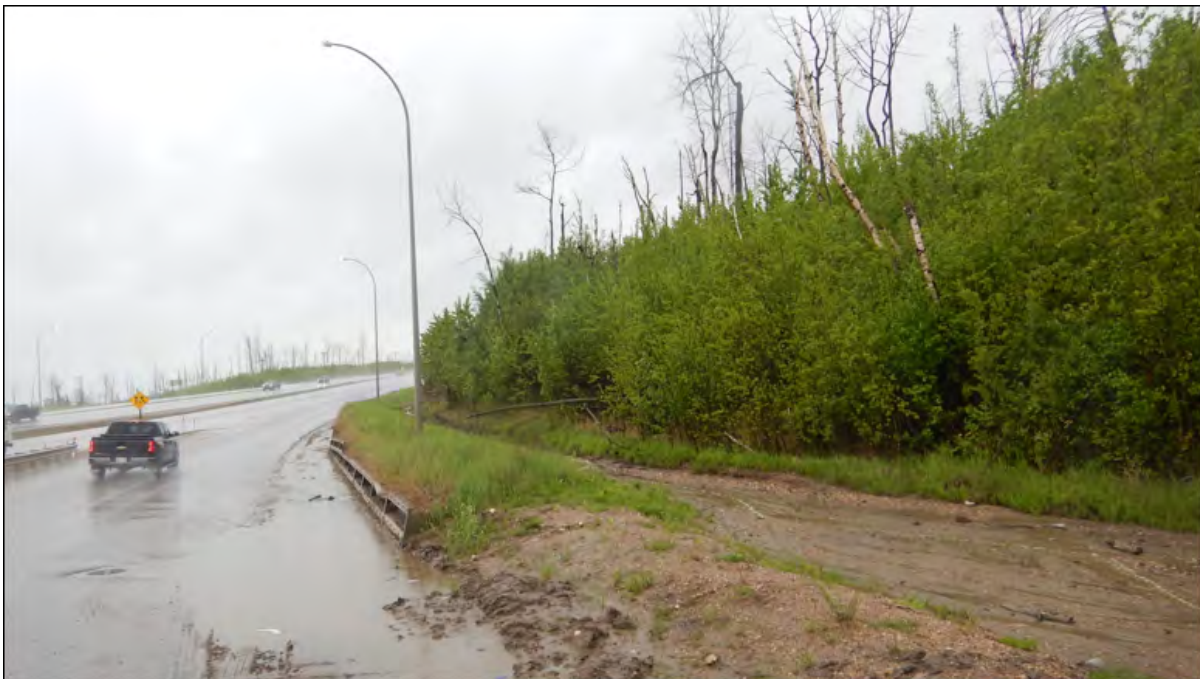
Sediment accumulation along the bin wall between Manholes MH#1 and MH#5 will continue to provide poor driving conditions at the King Street Interchange west ramp. This may also result in flooding of the highway. Sediment accumulation to the north of C4 pipe and within the pond may result in further loss of the pond's storage capacity and backing up of water towards the C3 and C4 culverts and the king street embankment. Ponding of water, if occurs, at the King Street Interchange west ramp may impact the integrity of the ramp.

Photo 14 –Surface water from the road is ponding against the bin wall; roadway MHs 2 to 4 by the bin wall may have also been partially filled with sediment; sand and salt piles near the north end of the wall may have also dammed the water at this location.

- A temporary small berm should be constructed to the south of the bin wall to divert the ditch flow towards the small channel by the tree line and prevent sediment from spilling on the highway surface, and accordingly plugging of existing manholes.

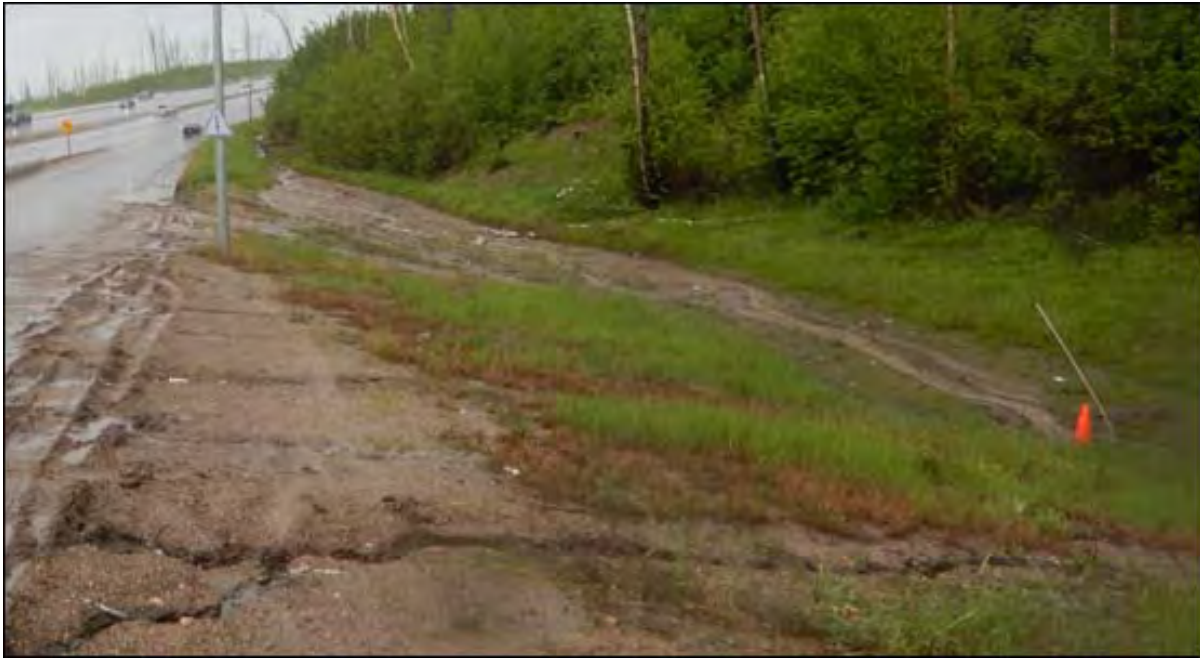
Photo 15 – Drop Structure DS1 exposed in 2024
