**ALBERTA TRANSPORTATION AND  
ECONOMIC CORRIDORS GRMP  
NORTH CENTRAL (ATHABASCA AND FORT  
MCMURRAY DISTRICTS)  
2024 SITE INSPECTION**

Site Number	Location	Name	km
NC084	To the south of the King Street Interchange in Fort McMurray	Hwy 63:11 Beacon Hill Erosion	9.1
Legal Description		UTM Co-ordinates	
5-10-089-09 W4M		12U E 478509	N 6284231

**NORTH CENTRAL REGION  
 (ATHABASCA AND FORT MCMURRAY DISTRICTS)  
 2024 GEOHAZARD ASSESSMENT  
 NC084: HWY 63:11 BEACON HILL EROSION ISSUES  
 (km 9.1)  
 LIDAR IMAGE SHOWING SITE FEATURES**

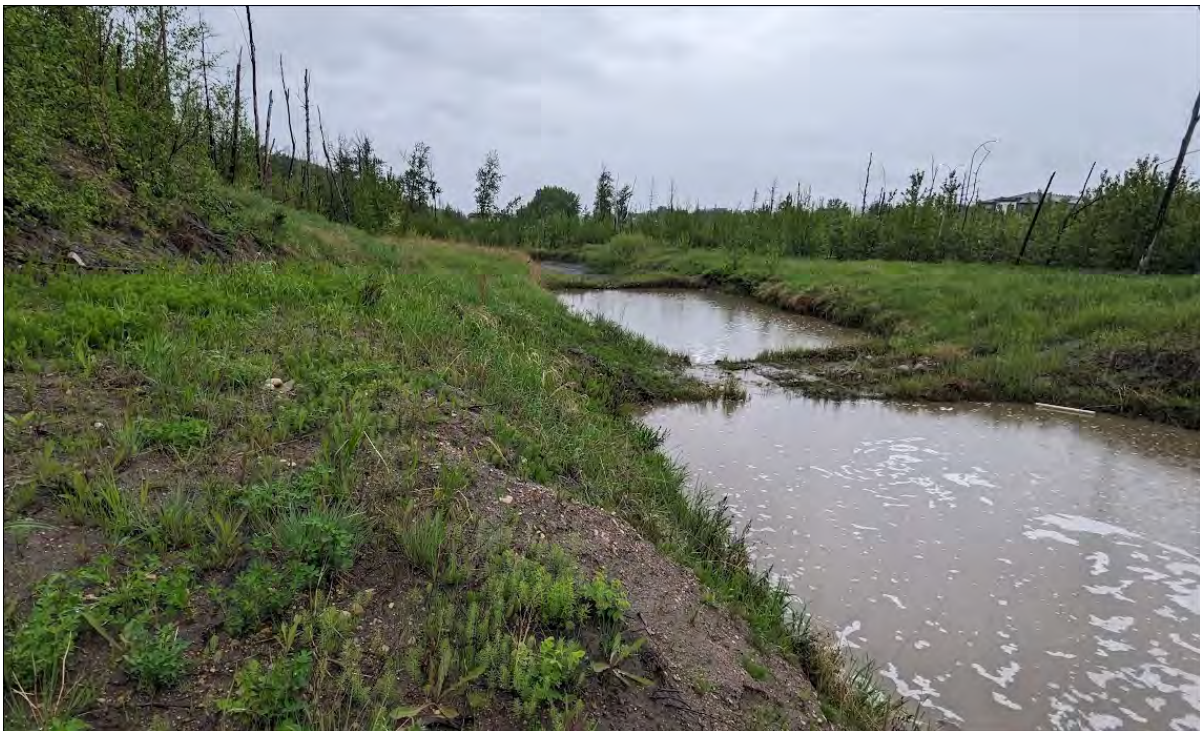
Photo 16 – TEC cleaned the pond in the fall of 2021; substantial sediment removed at that time to increase pond capacity.

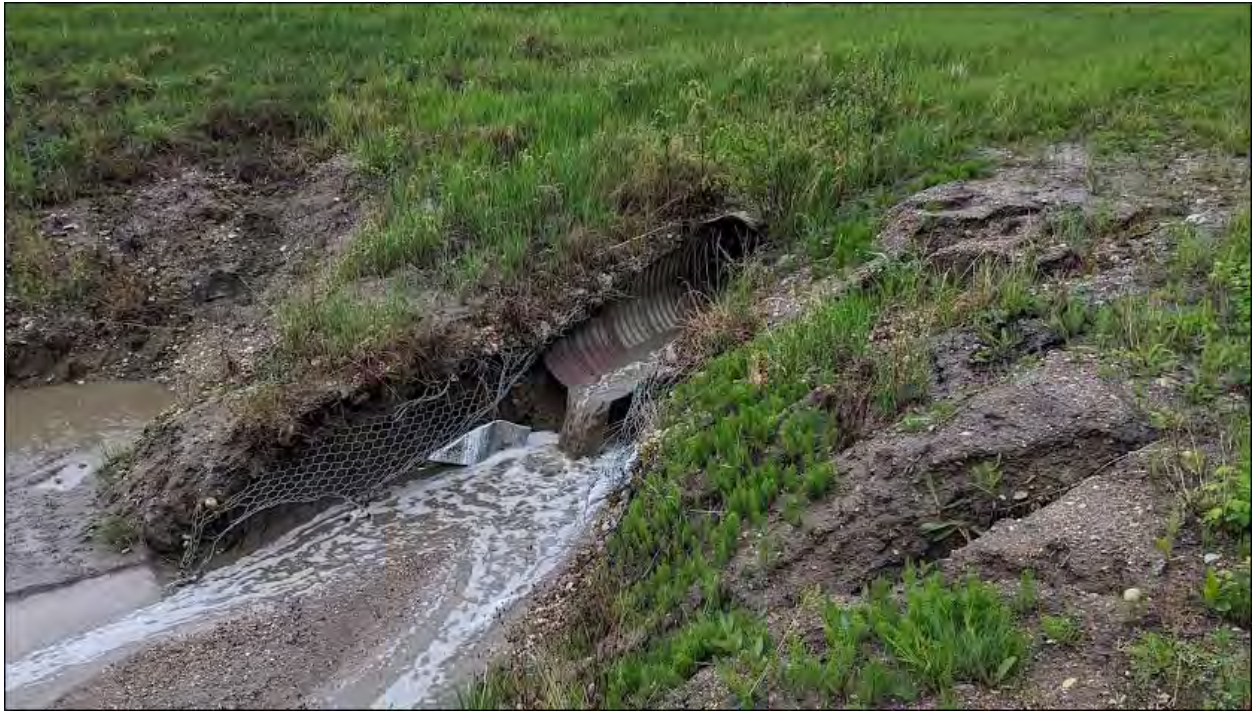
Photo 17 – Culvert C4 (1200 mm outlet); scour under the culvert; steady flow from the outlet.

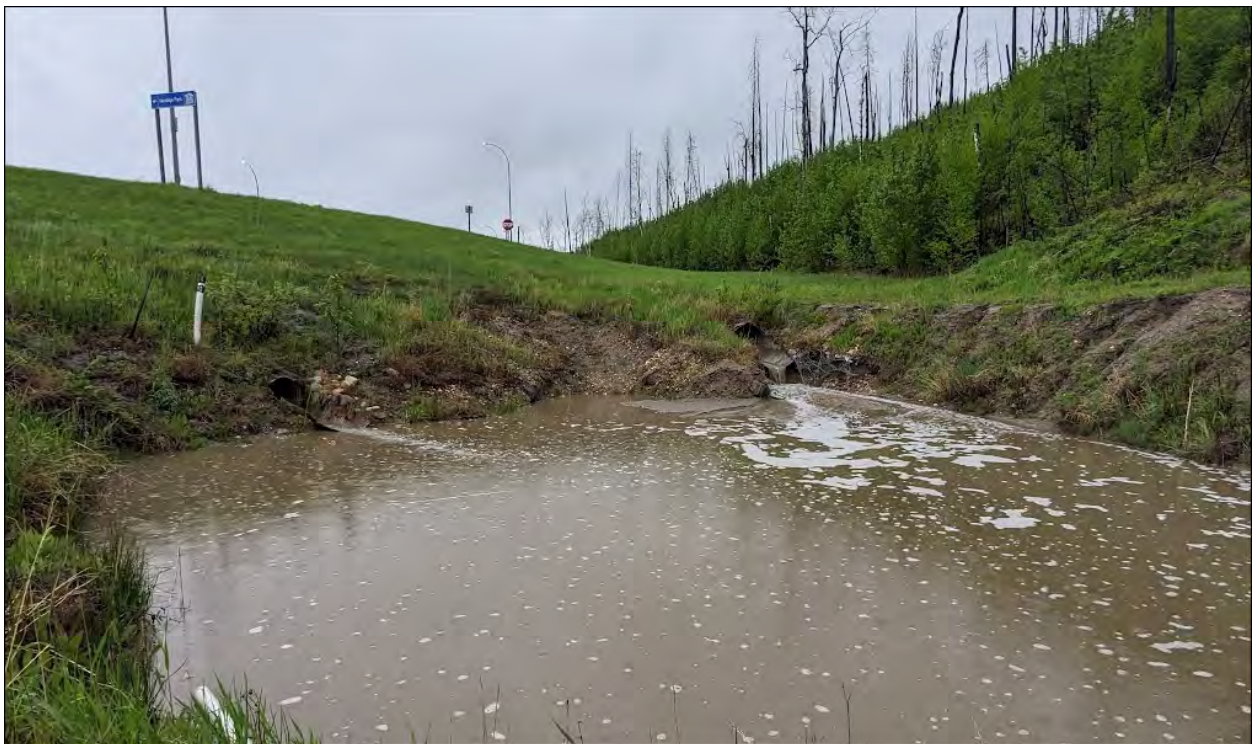
Photo 18 – Culvert C3 and C4 outlets

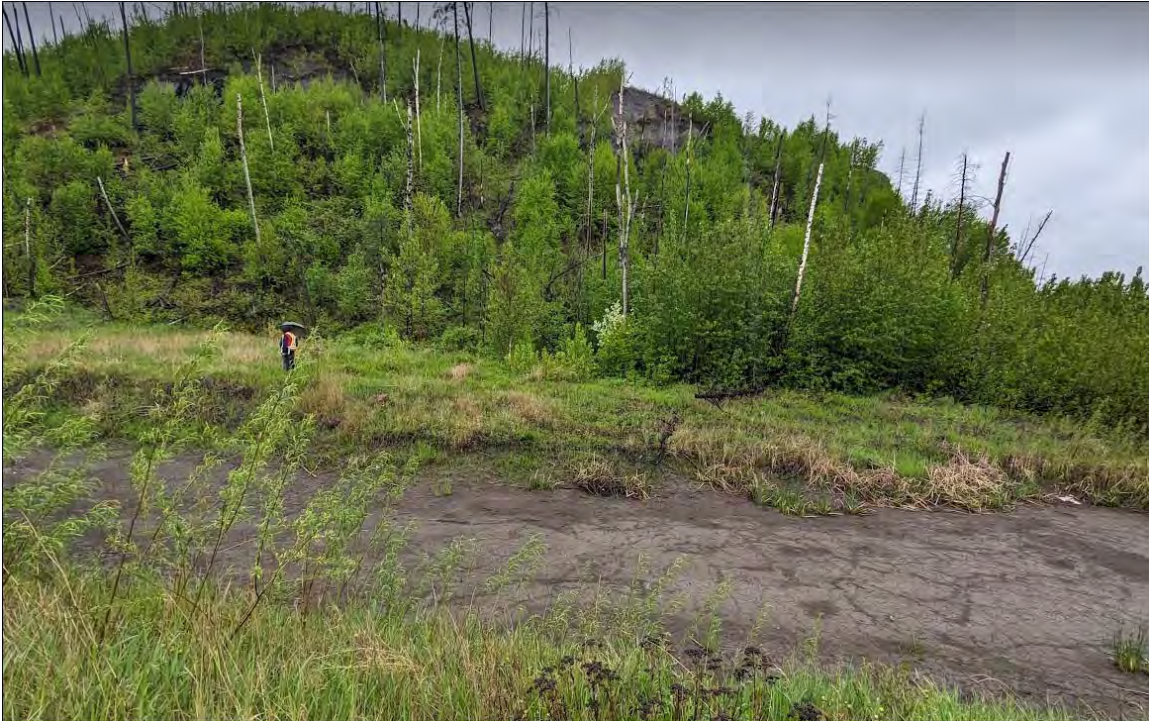
Photo 19 – Looking west at the north end of the pond. Note dry conditions in this section of the pond.

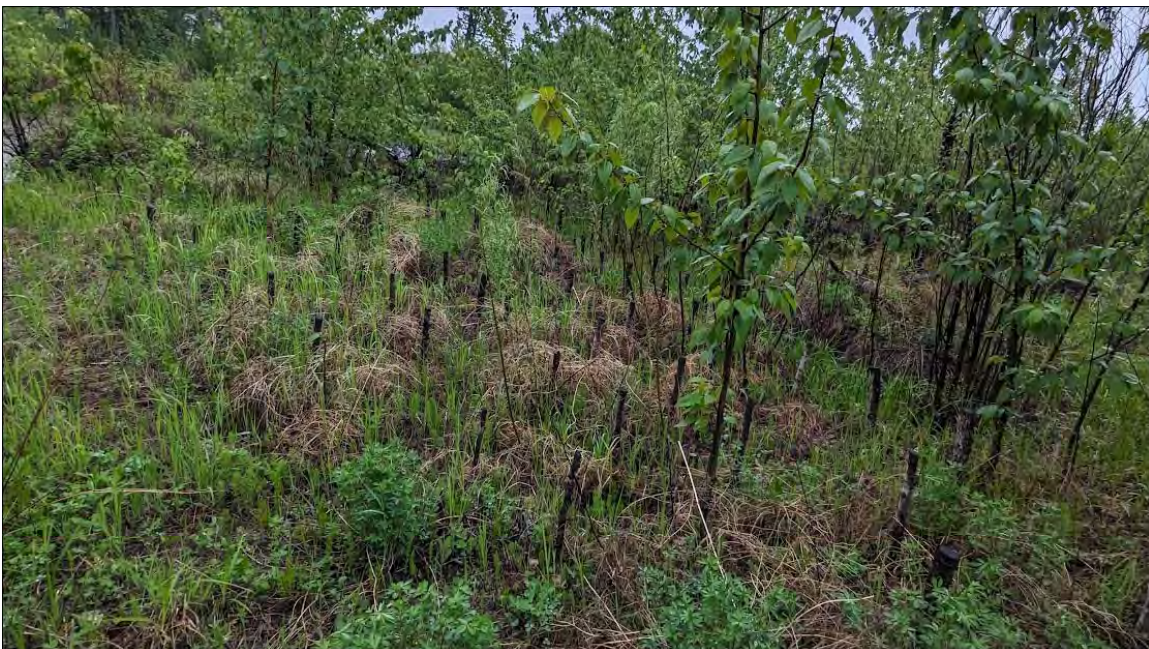
Photo 20 – Willow staking within the vegetation buffer zone between the pond and the river.
