**GEOHAZARD ASSESSMENT PROGRAM
NORTH CENTRAL REGION – ATHABASCA
2020 INSPECTION REPORT**

Site Number	Location	Name	Hwy	km
NC089	On the backslope of Hwy 63 to the south of King Street Interchange in Fort McMurray	Beacon Hill Backslope Slide	63:11	8.7
Legal Description		UTM Co-ordinates (NAD 83)		
SW-10-89-09-W4M		12 N 6284132.65	E	478495.60

**NC089-1: HWY 63:11 BEACON HILL
BACKSLOPE SLIDE (km 8.7)
SITE INSPECTION PLAN**

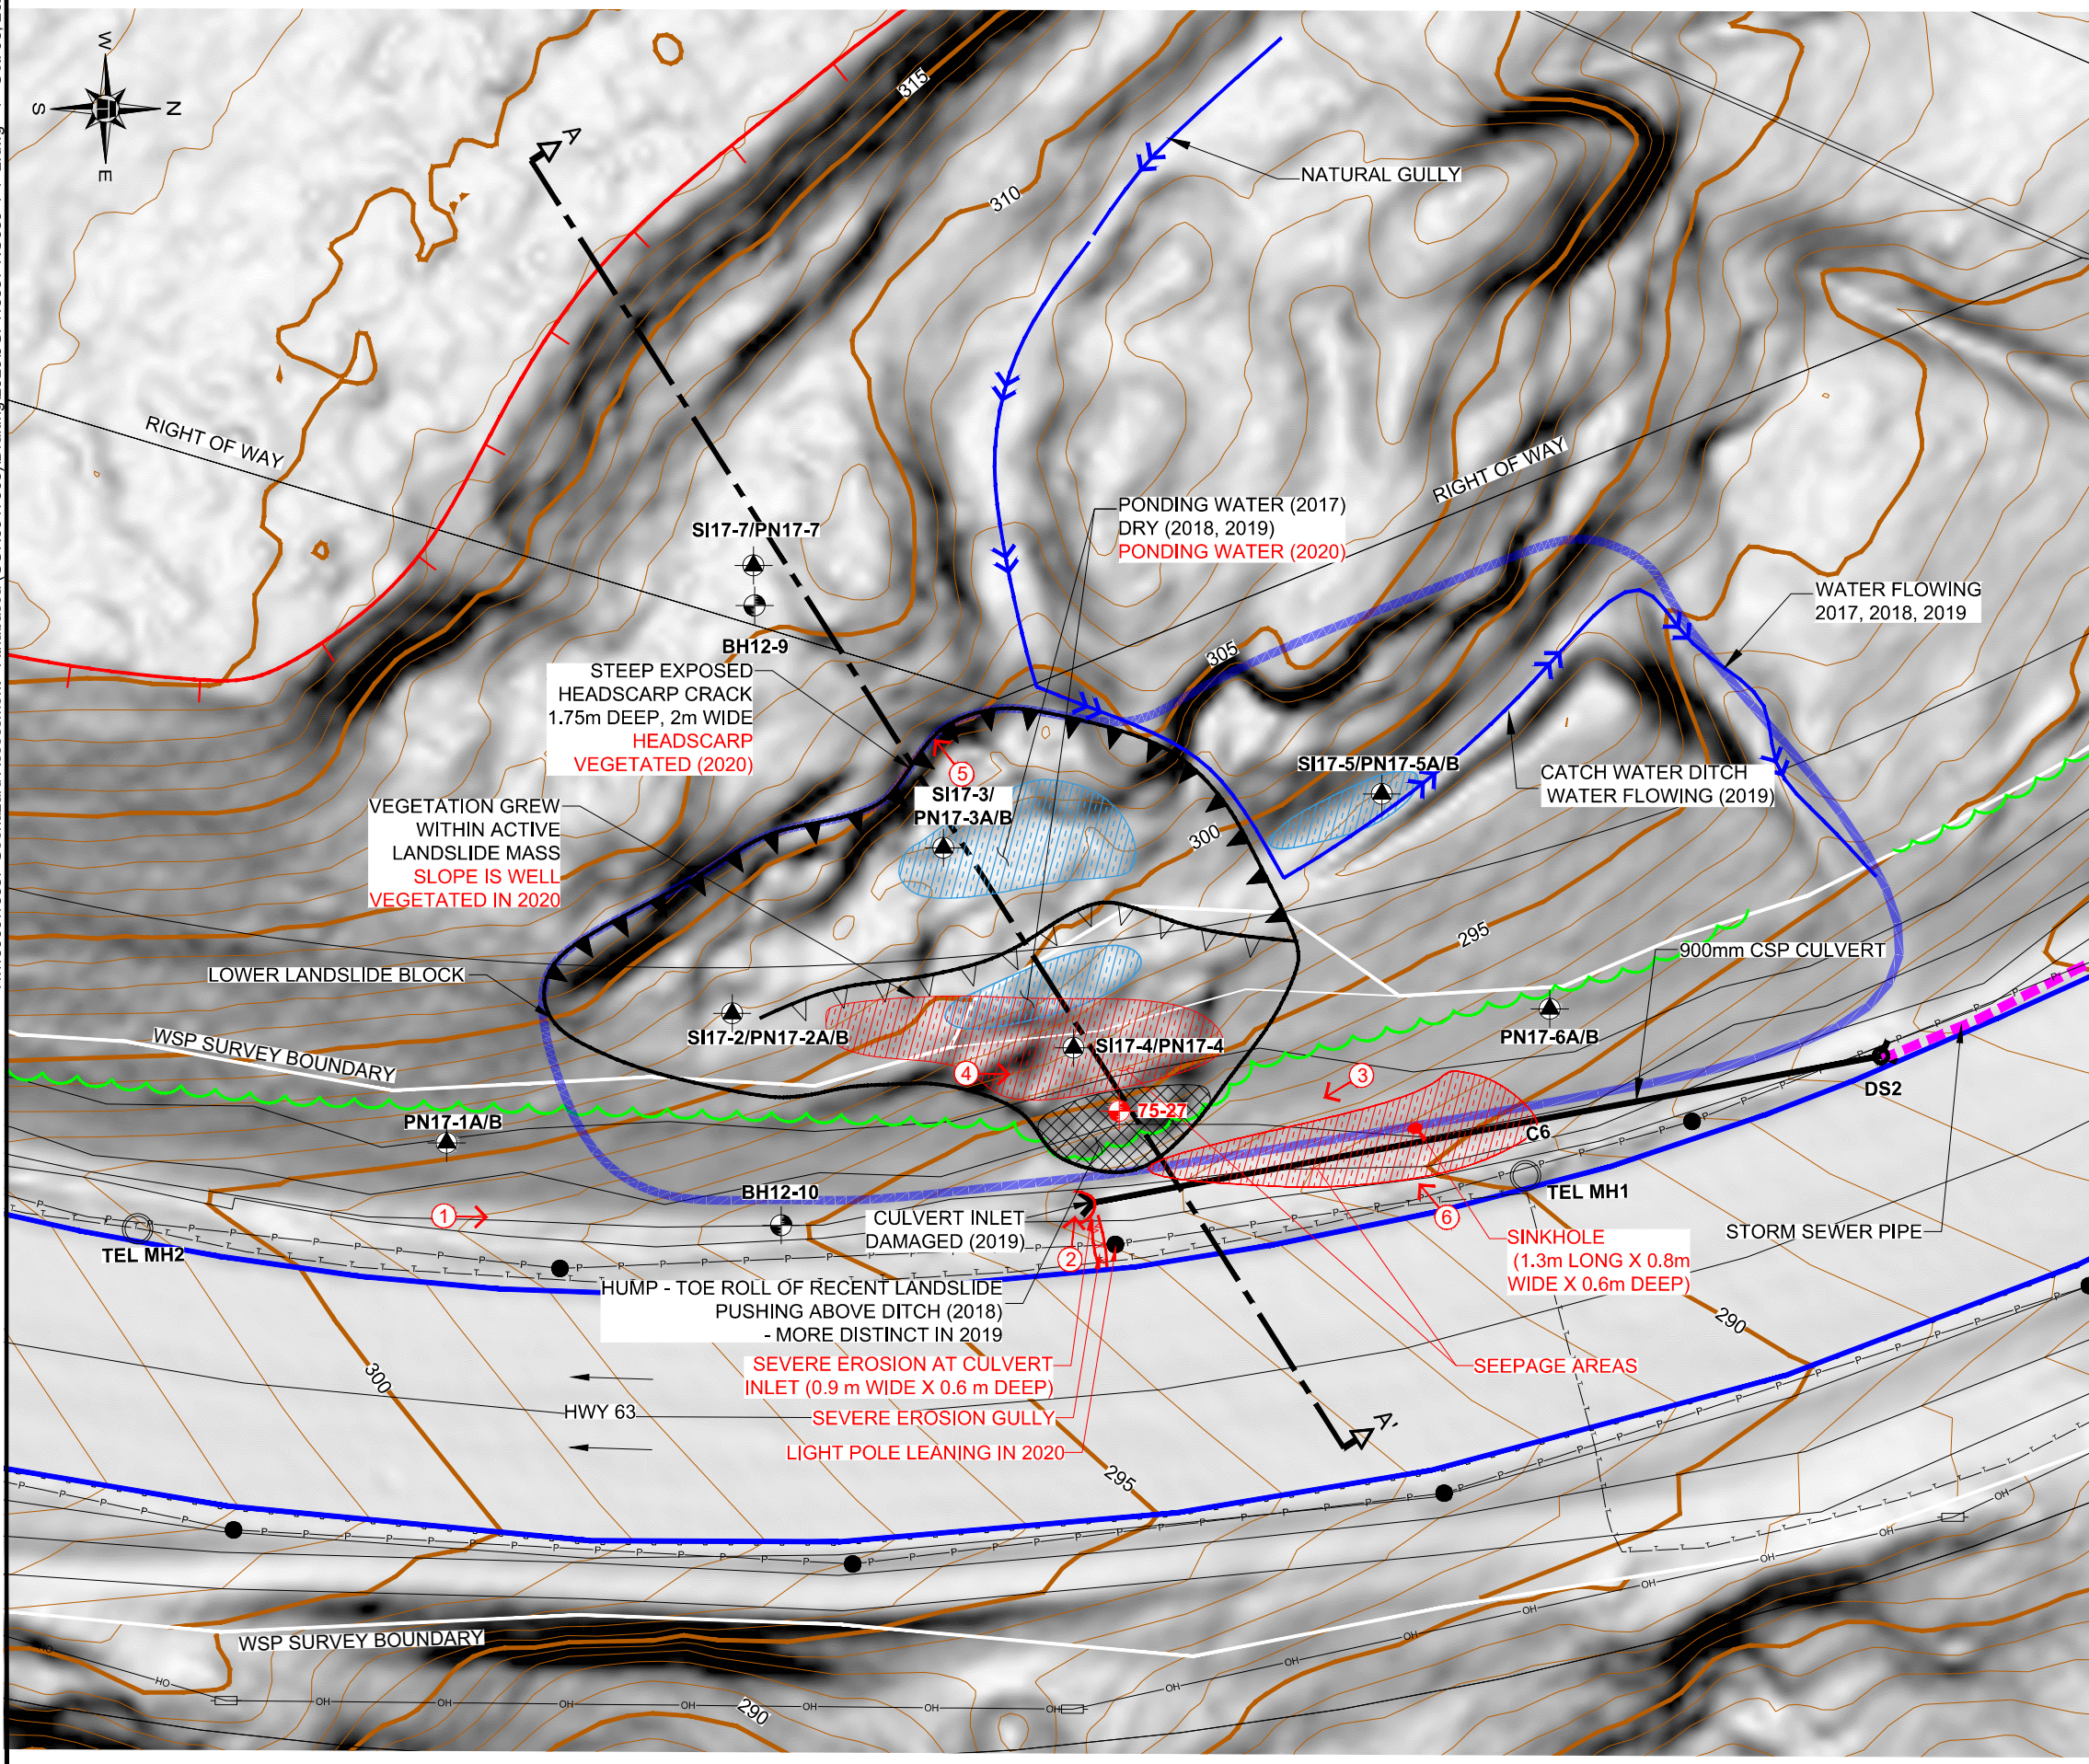
DWG No. 13357-NC089-1-1

The 2016 lower landslide block (i.e. southern half of the ancient landslide block), toeing above the highway ditch, is about 7 m deep, 75 m wide, 55 long and extends midway up the hill side. The landslide is visible on recent and previous LiDAR images and constitutes the southern portion an ancient landslide block, which is about 140 m wide (parallel to the highway).

The site observations and instrumentation readings indicate that the 2016 landslide block is still moving but at relatively slow rates. Although signs of slope movement have not yet been detected within the northern half of the ancient block, abrupt movement may take place as previously occurred within the southern half of the block.

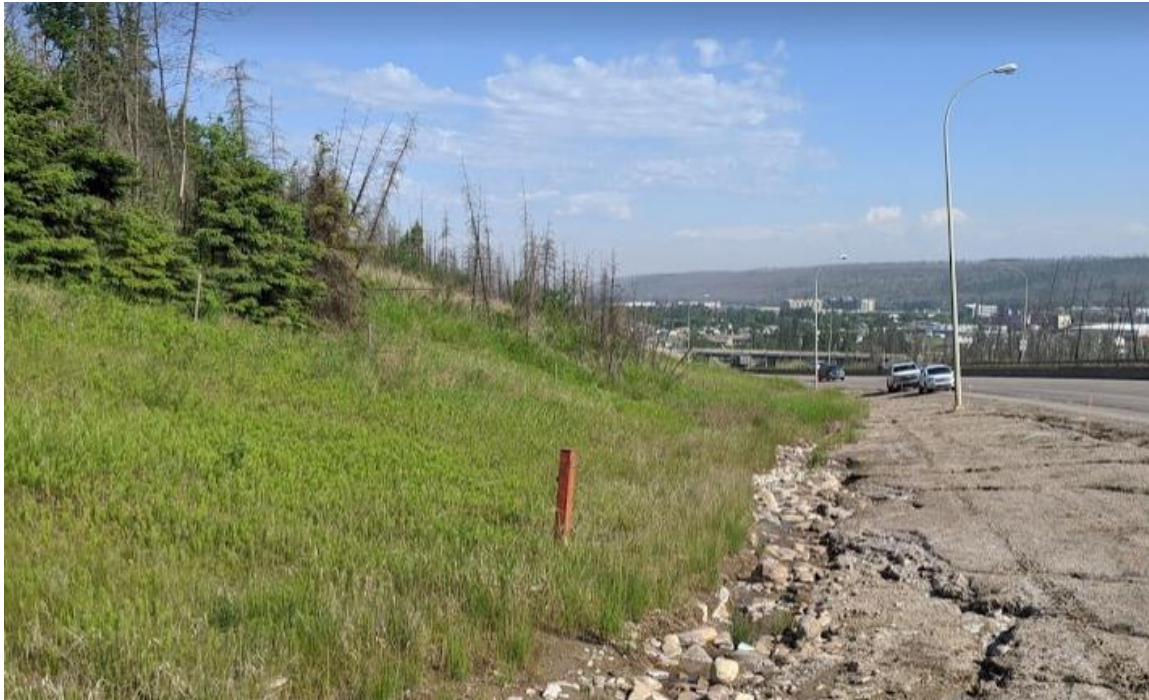
Although the 2016 landslide does not currently appear to affect the highway ditch, landslide debris may quickly spill over the existing shallow ditch and possibly spread over the highway shoulder/lanes in response to an accelerated movement. Similar risk should be expected if the northern half of the ancient landslide block fails in the future.

Photo No.1 – Looking north at the toe of the landslide; the landslide is toeing out above the ditch near culvert C6

In the short term, the landslide should be regularly monitored, and the ditch bottom should be touched to be cleared of the landslide debris as needed (without significantly changing grades) to improve surface water drainage. Excavated landslide debris (if any) from the highway ditch should be pushed back into the toe of the slope.

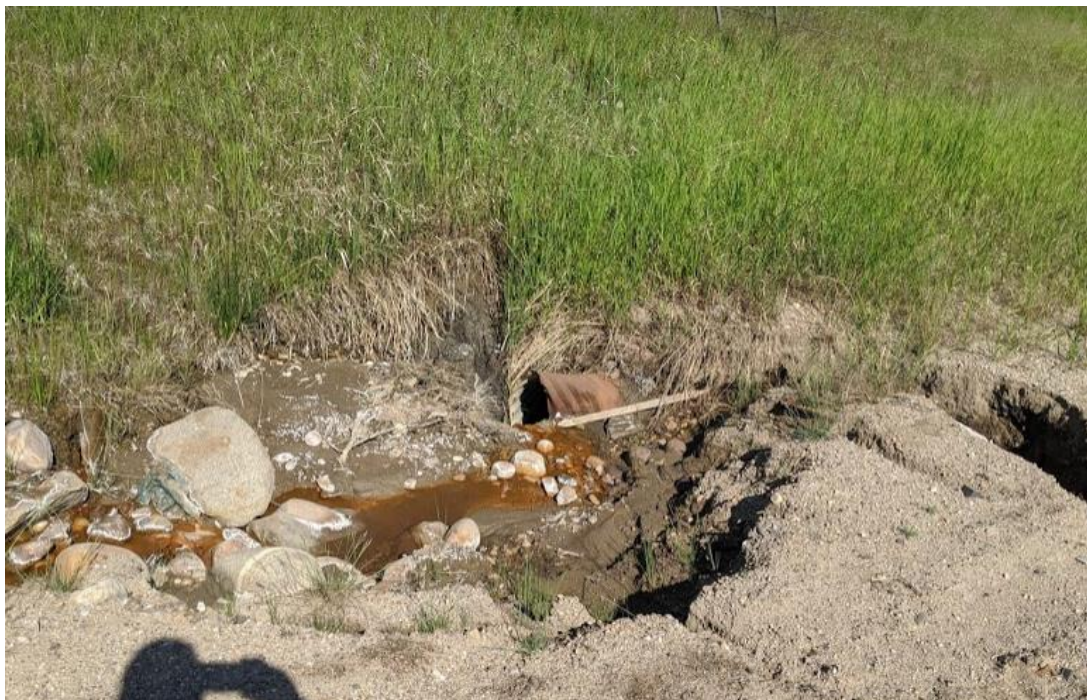
The ditch erosion will need to be addressed to reduce the risk of local instability which could trigger accelerated movement of the landslide block.

Photo No.2 – Erosion gully downslope of the toe of the landslide at culvert inlet location (Looking West)

The severe erosion noted at the C6 culvert inlet location should be repaired as part of the ditch maintenance work to prevent further loss of support at the toe of the landslide. In addition, the sinkhole noted about 20 north of the landslide should be filled with gravel. If the sinkhole develops again, consideration should be given to undertaking a CCTV inspection of the C6 culvert to confirm whether it is separated/ruptured.

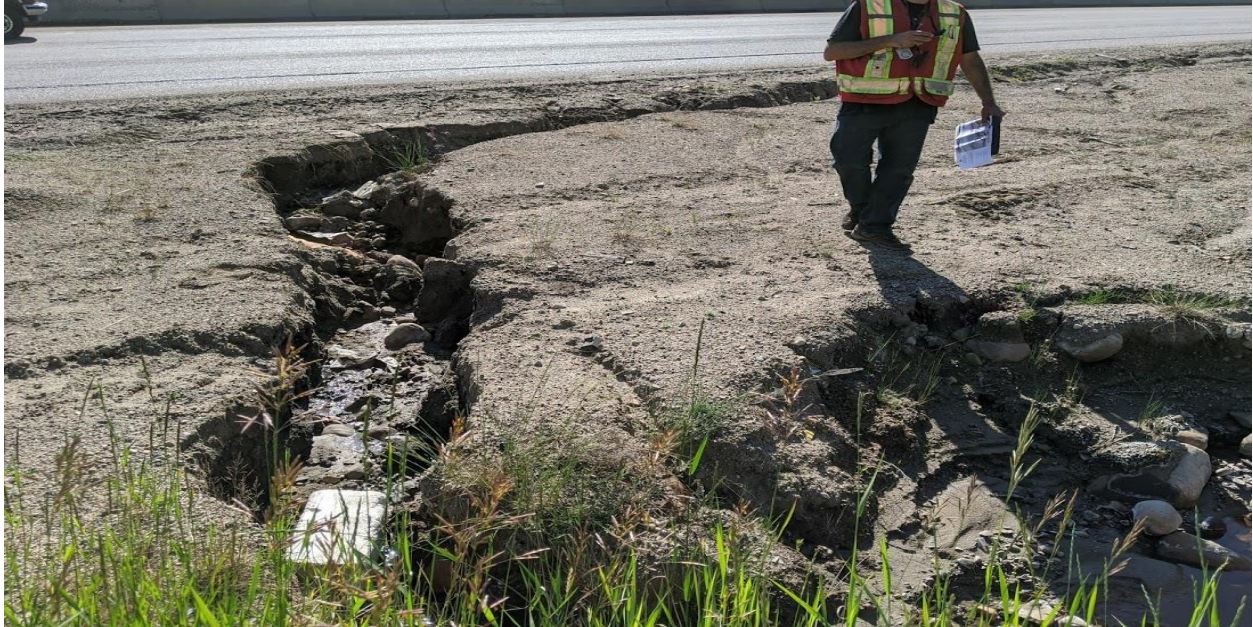
Photo No.2a – Severe erosion gully on the highway side slope to the east of the culvert inlet location (Looking east)

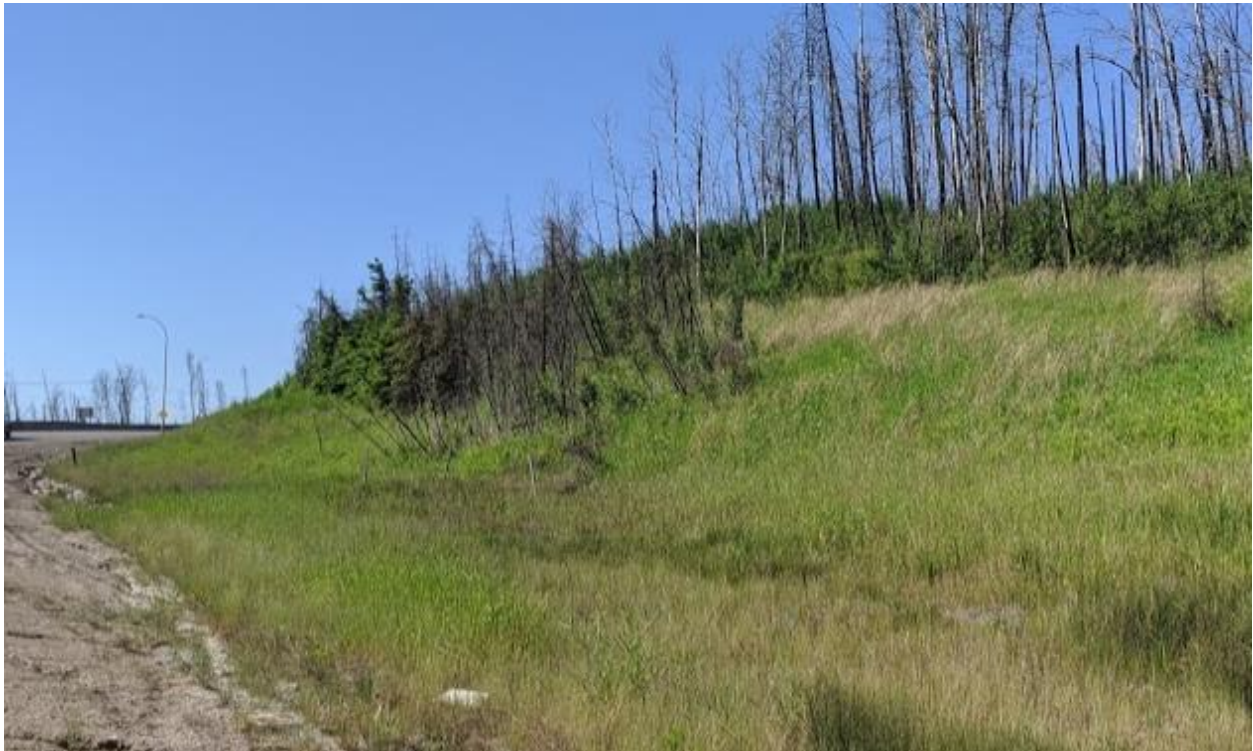
Photo No.3 –Looking south at the toe of the landslide; note tilting trees within the landslide mass

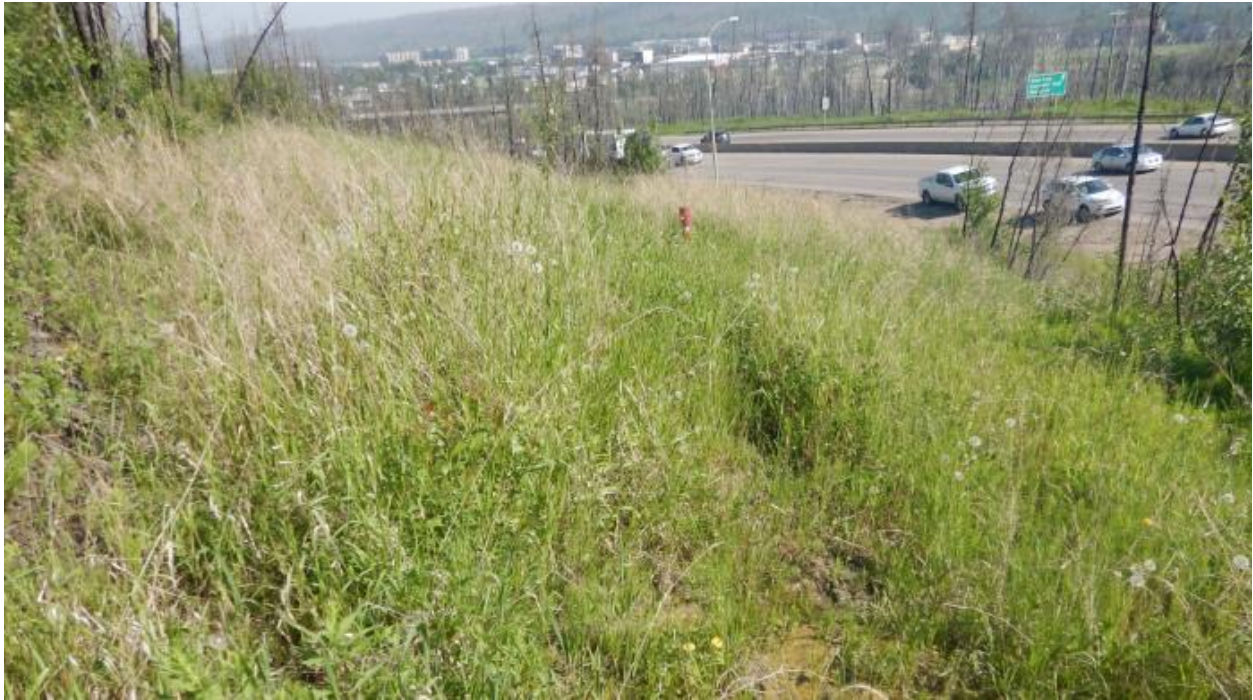
Photo No.4 –Looking north at S117-4; landslide mass is well vegetated

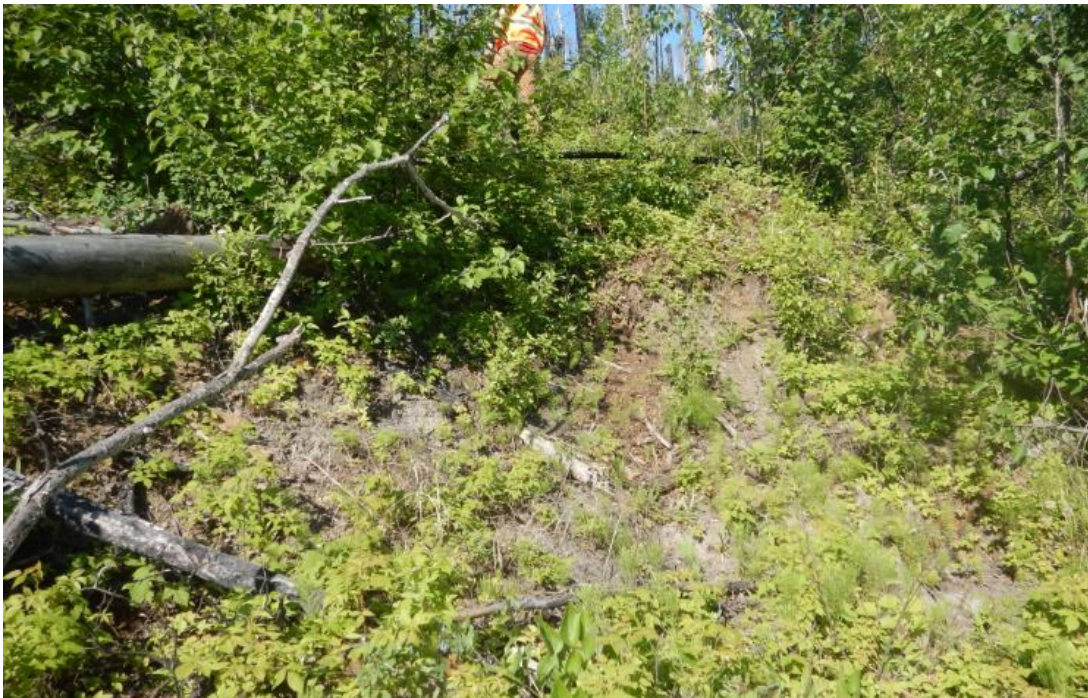
Photo No.5 – Looking west at 1.75 m deep and 2 m wide vegetated backscarp crack

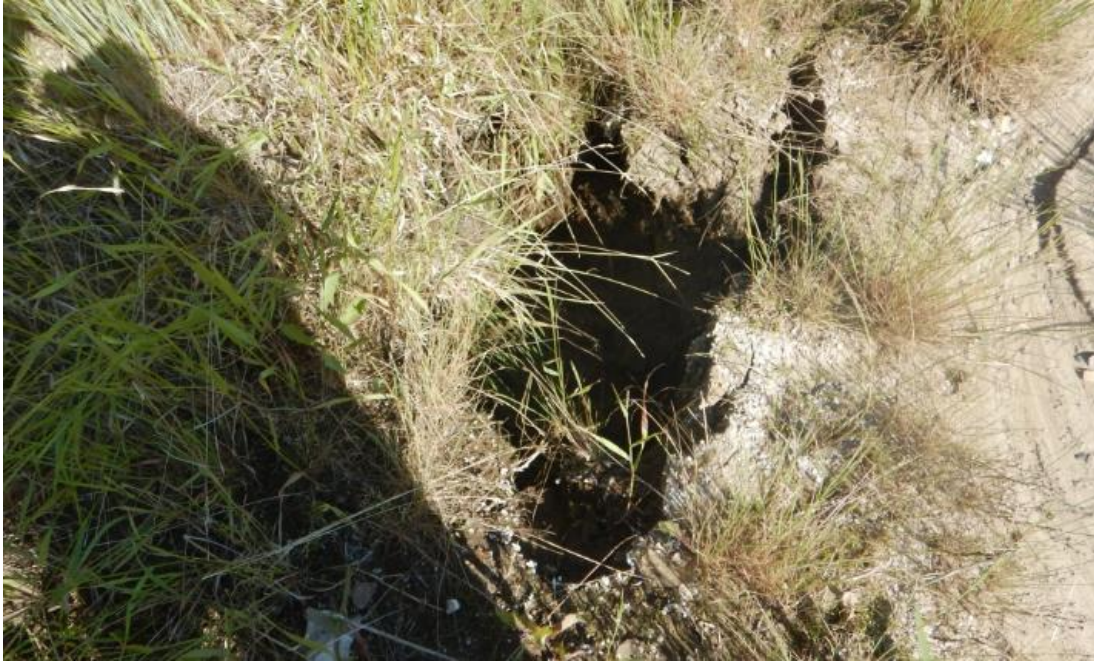
It is possible that the sinkhole developed 20 m north of the landslide toe is the result of the C6 culvert rupture or separation.

Photo No.6 –Sinkhole (1.3 m long x 0.8 m wide x 0.6 m deep) developed at the base of the
backslope
