**GEOHAZARD ASSESSMENT PROGRAM
NORTH CENTRAL REGION – ATHABASCA &
FORT MCMURRAY DISTRICTS
2021 SITE INSPECTION**

Site Number	Location	Name	Hwy	km
NC089	On the backslope of Hwy 63 to the south of King Street Interchange in Fort McMurray	Beacon Hill Backslope Slide	63:11	8.7
Legal Description		UTM Co-ordinates (NAD 83)		
SW-10-89-09-W4M		12 N 6284132.65	E	478495.60

**NC089: HWY 63:11 BEACON HILL
BACKSLOPE SLIDE (km 8.7)
SITE INSPECTION PLAN**

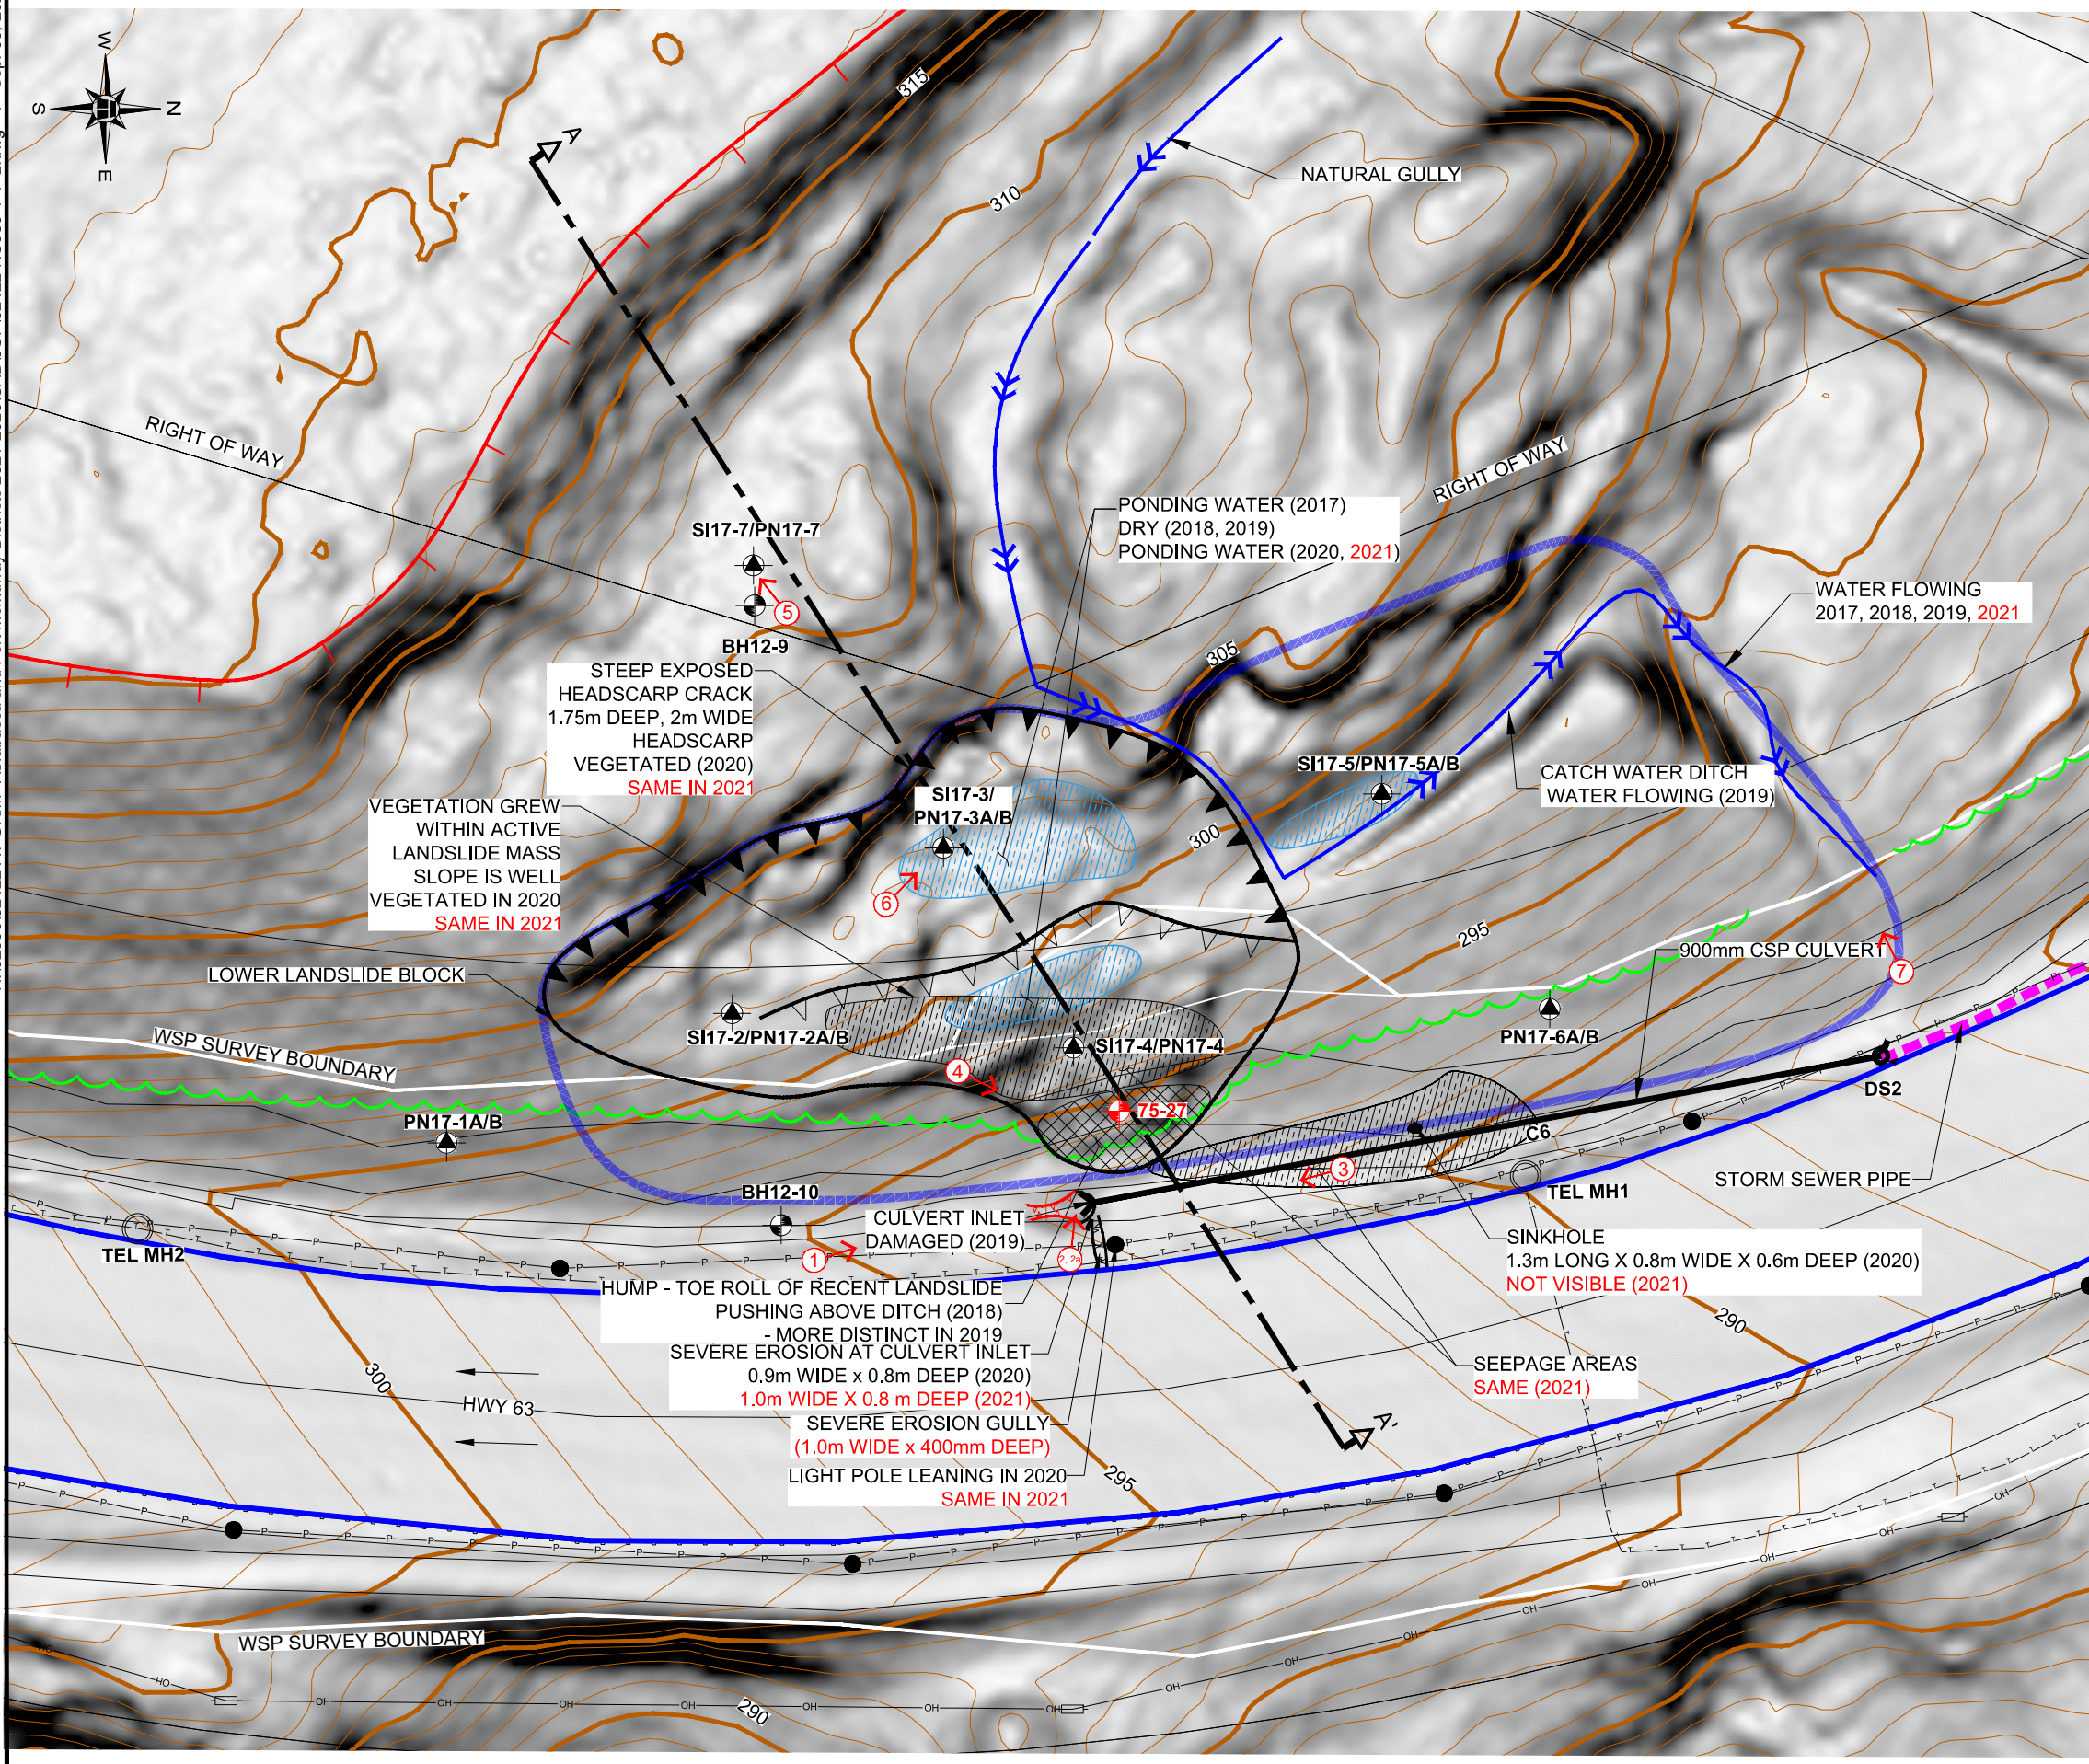
FIGURE 1

The 2016 lower landslide block (i.e., southern half of the ancient landslide block), toeing above the highway ditch, is about 7 m deep, 75 m wide, 55 long and extends midway up the hill side. The landslide is visible on recent and previous LiDAR images and constitutes the southern portion an ancient landslide block, which is about 140 m wide (parallel to the highway).

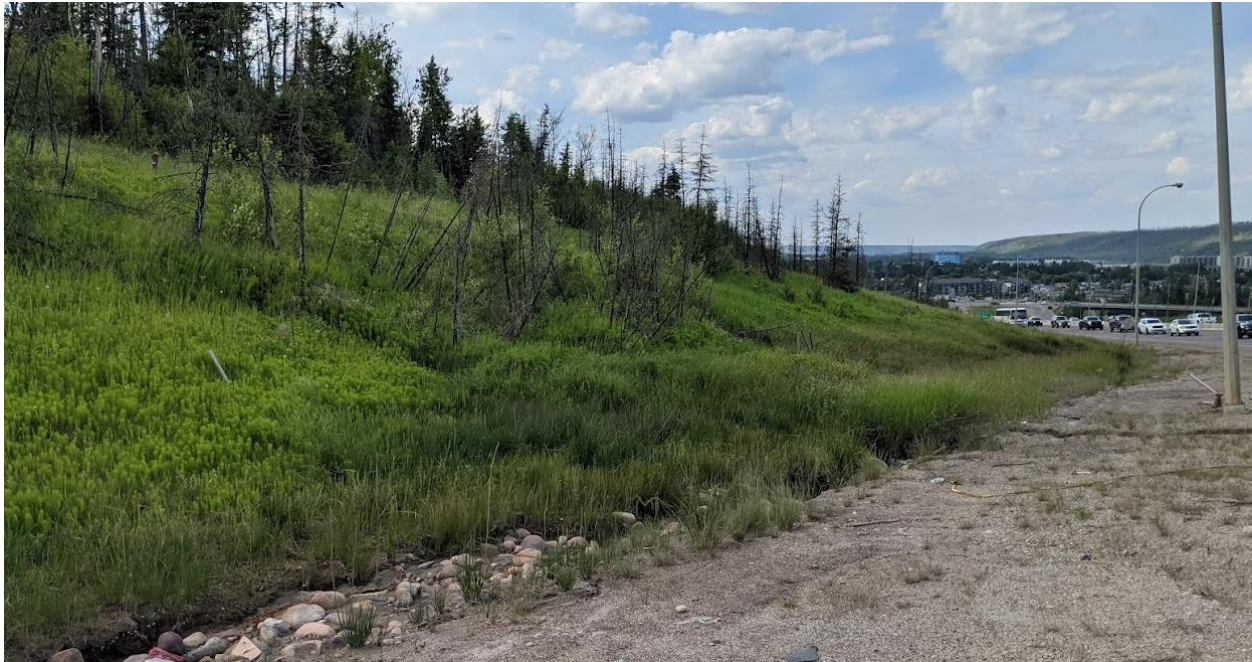
Although the local backslope landslide does not currently appear to affect the highway ditch, landslide debris may quickly spill over the existing shallow ditch and possibly spread over the highway shoulder/lanes in response to an accelerated seasonal movement.

Photo No.1 – Looking north at the toe of the landslide; the landslide is toeing out above the ditch near culvert C6

In the short term, the landslide should be regularly monitored, particularly after a prolonged rainfall event, and the ditch bottom should be touched to be cleared of the landslide debris as needed (without significantly changing grades) to improve surface water drainage. Excavated landslide debris (if any due to future movement) from the highway ditch should be pushed back into the toe of the slope.

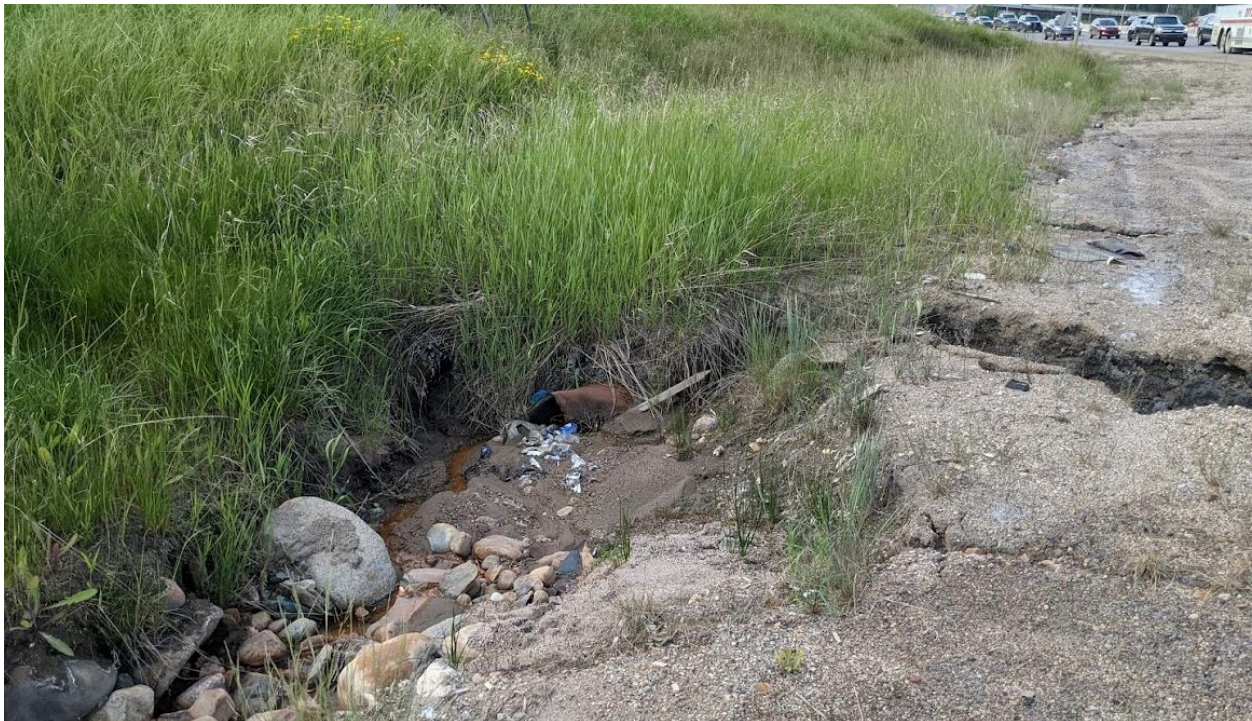
The ditch erosion will need to be addressed to reduce the risk of local instability which could trigger accelerated movement of the landslide block.

Photo No.2 – Erosion gully downslope of the toe of the landslide at culvert inlet location (Looking West)

The severe erosion noted at the C6 culvert inlet location should be repaired as part of the ditch maintenance work to prevent further loss of support at the toe of the landslide. It appears that the sinkhole developed 20 m north of the landslide toe was repaired.

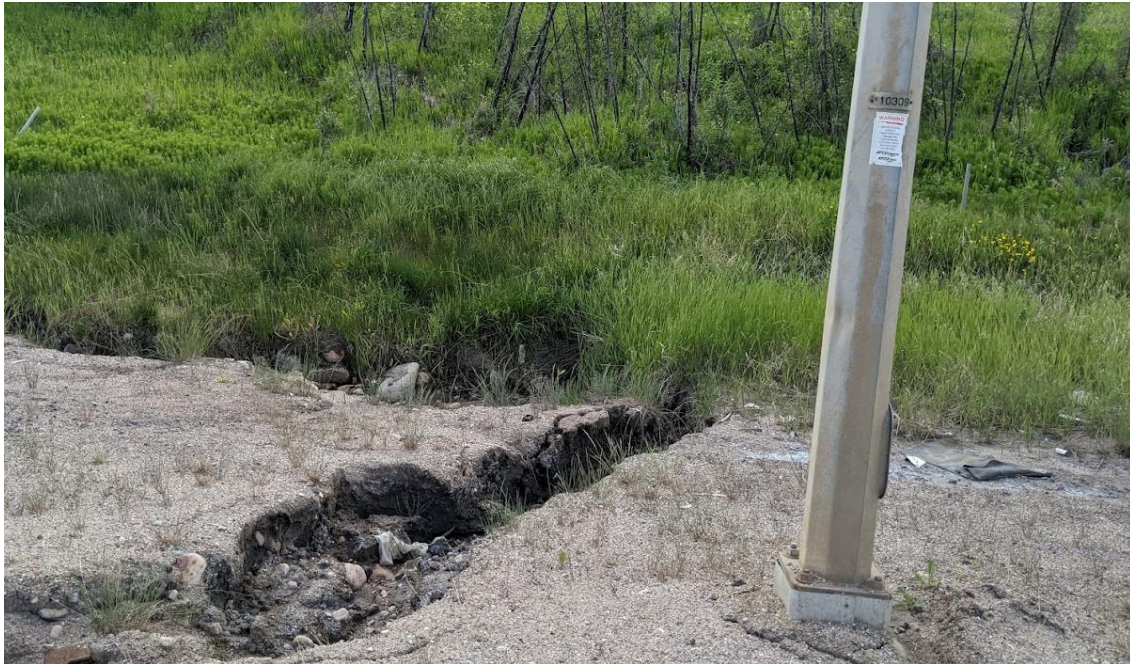
Photo No.2a – Severe erosion gully on the highway side slope to the east of the culvert inlet location (Looking east)

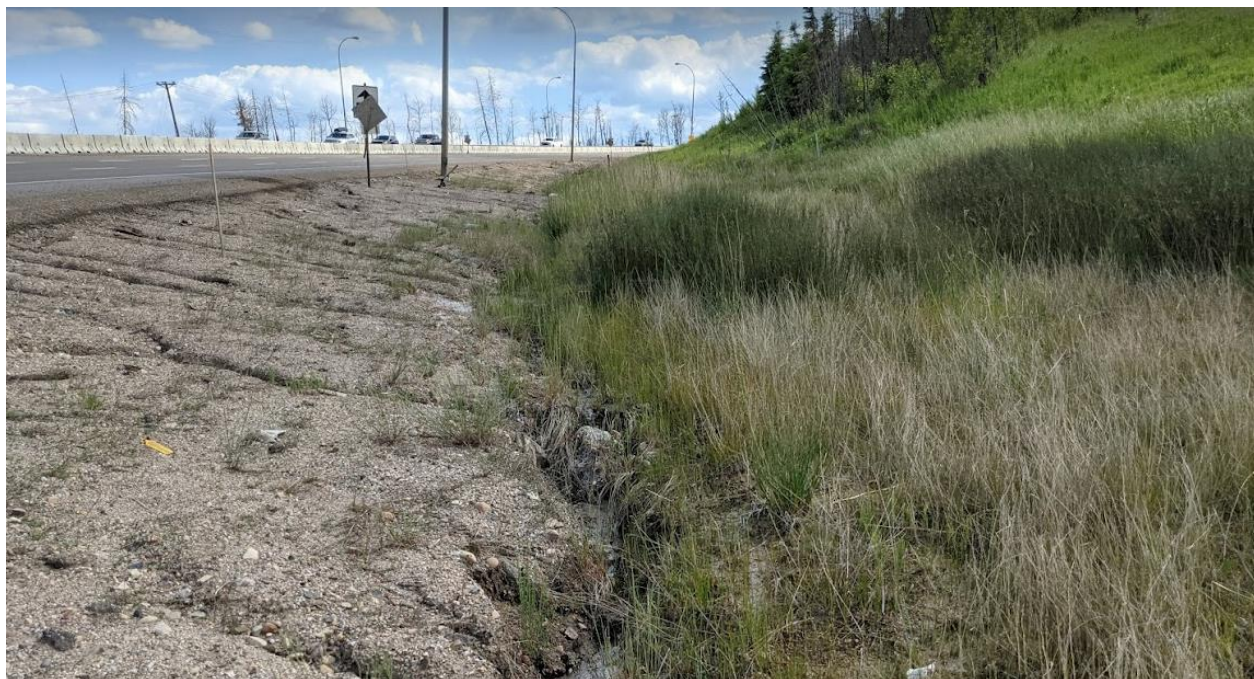
Photo No.3 –Looking south at the toe of the landslide; note tilting trees within the landslide mass

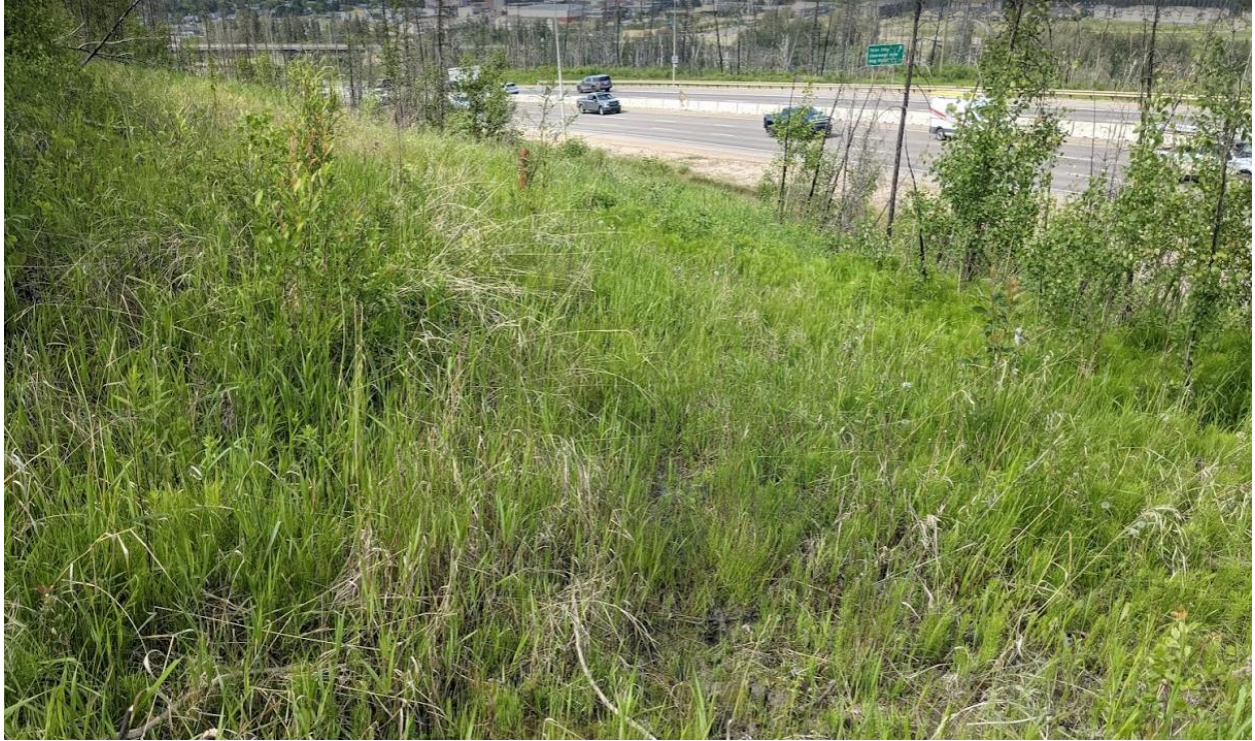
Photo No.4 –Looking north at S117-4; landslide mass is well vegetated

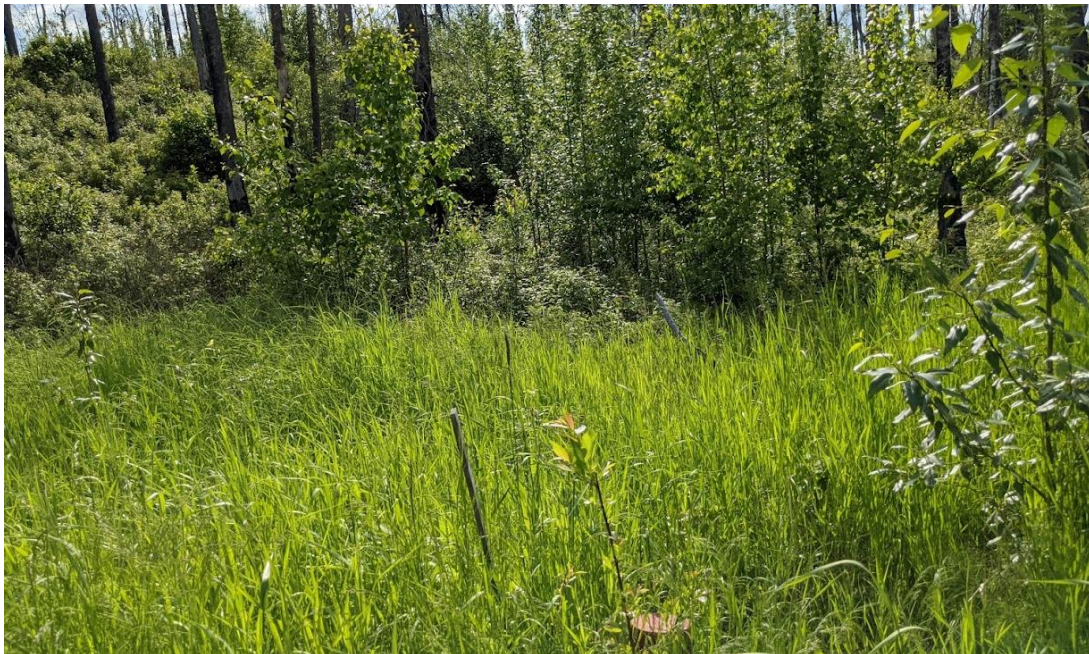
Photo No.5 – Looking west at the valley crest near S117-7

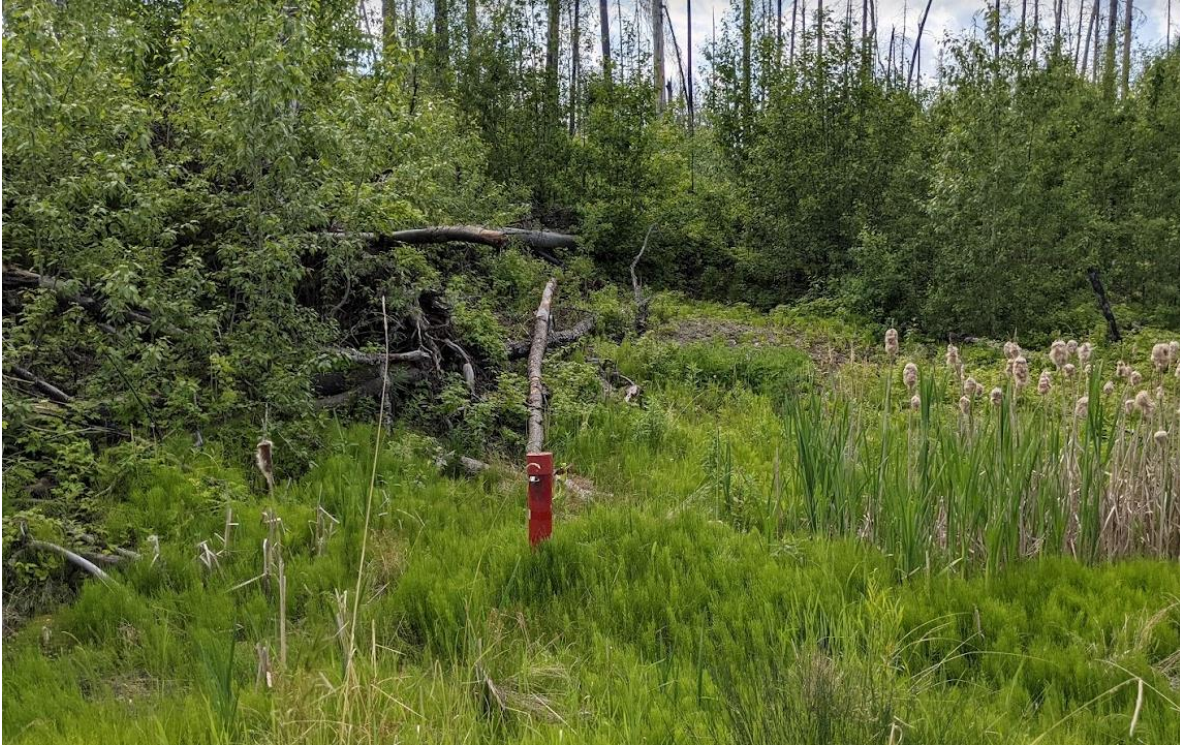
Photo No.6 –Looking northwest at backscarp; note cattails and lush vegetation due to seepage near SI17-3

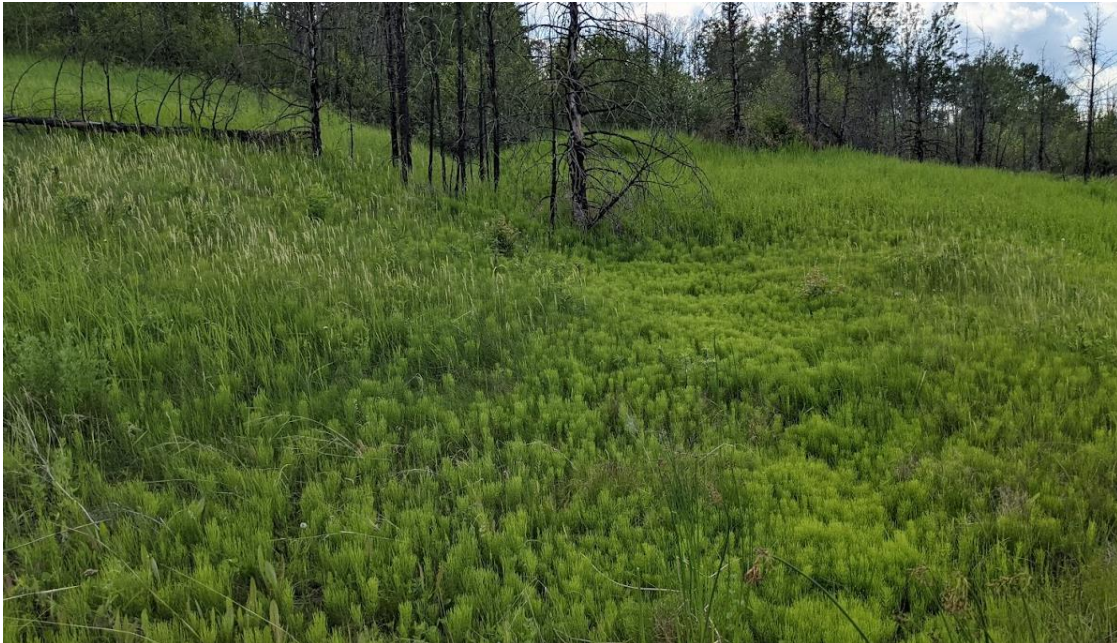
Photo No.7 –Looking west at the north flank of the lower ancient landslide block; note lush vegetation due to seepage and minor water flow
