File No.: 32122

**ALBERTA TRANSPORTATION GRMP (CON0022163)
NORTH CENTRAL (ATHABASCA AND FORT McMURRAY DISTRICTS)
INSTRUMENTATION MONITORING RESULTS – SPRING 2022**

SITE NC089: HWY 63:12 BEACON HILL BACKSLOPE SLIDE (km 8.7)

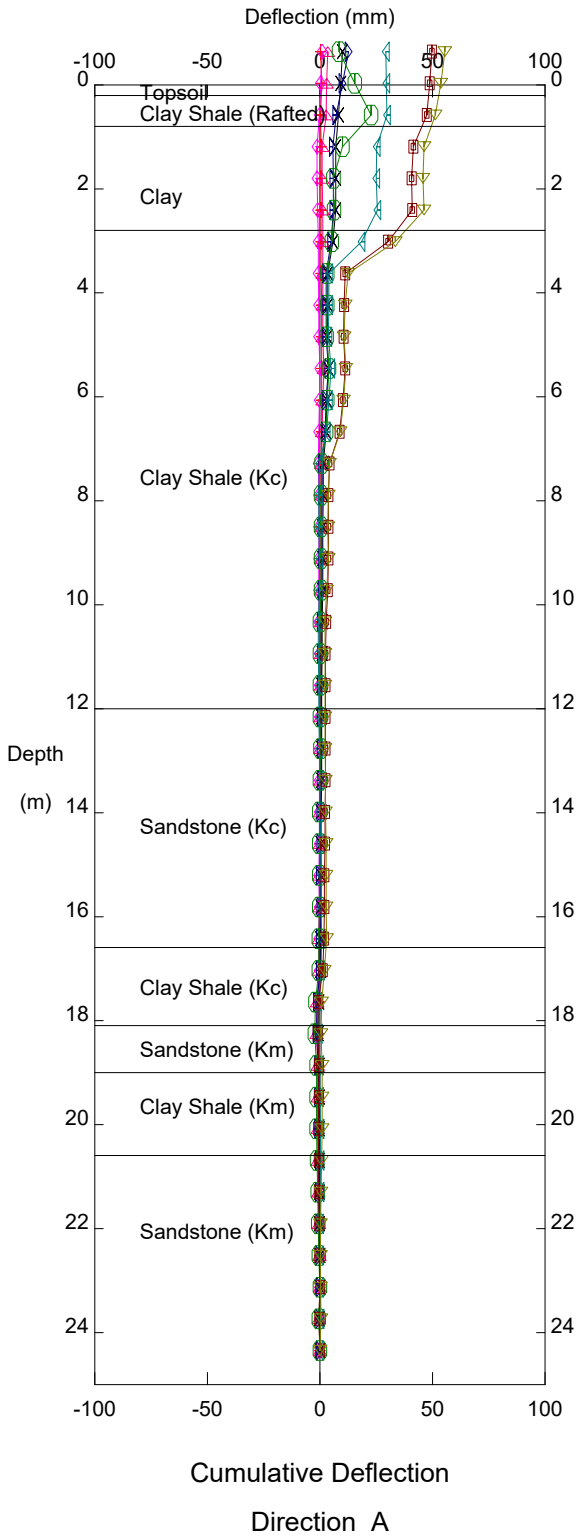
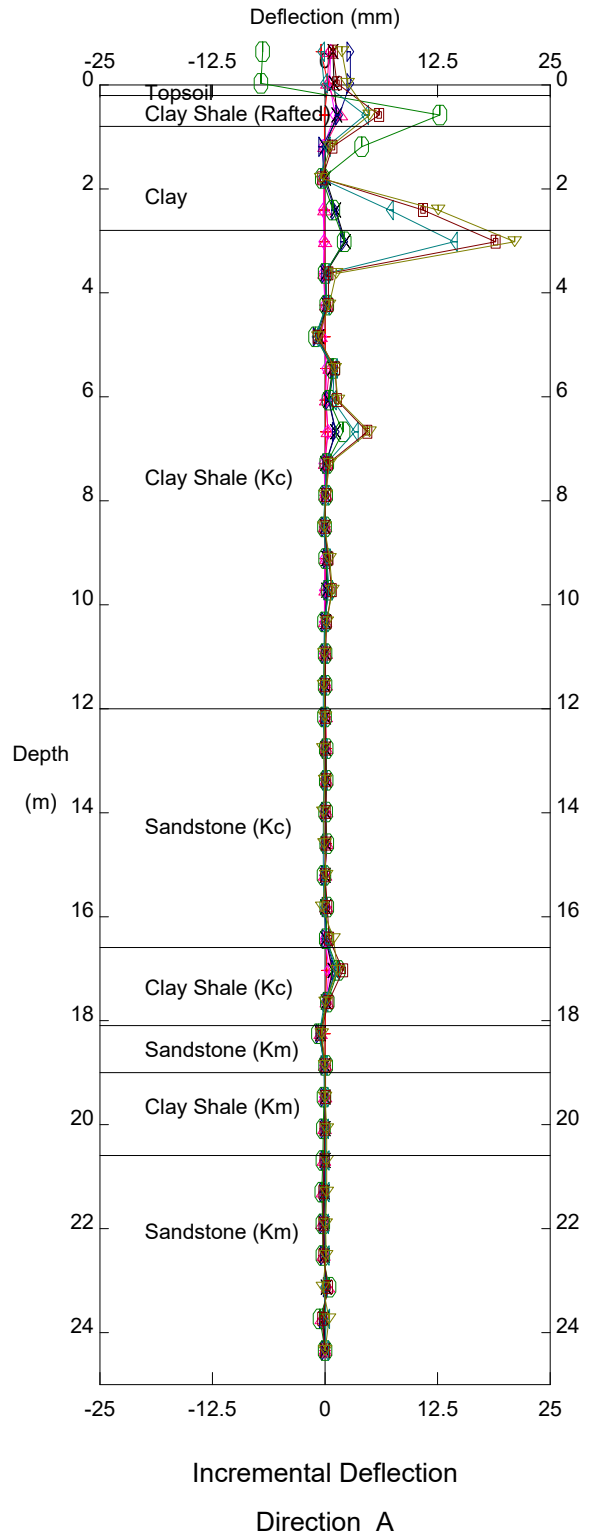
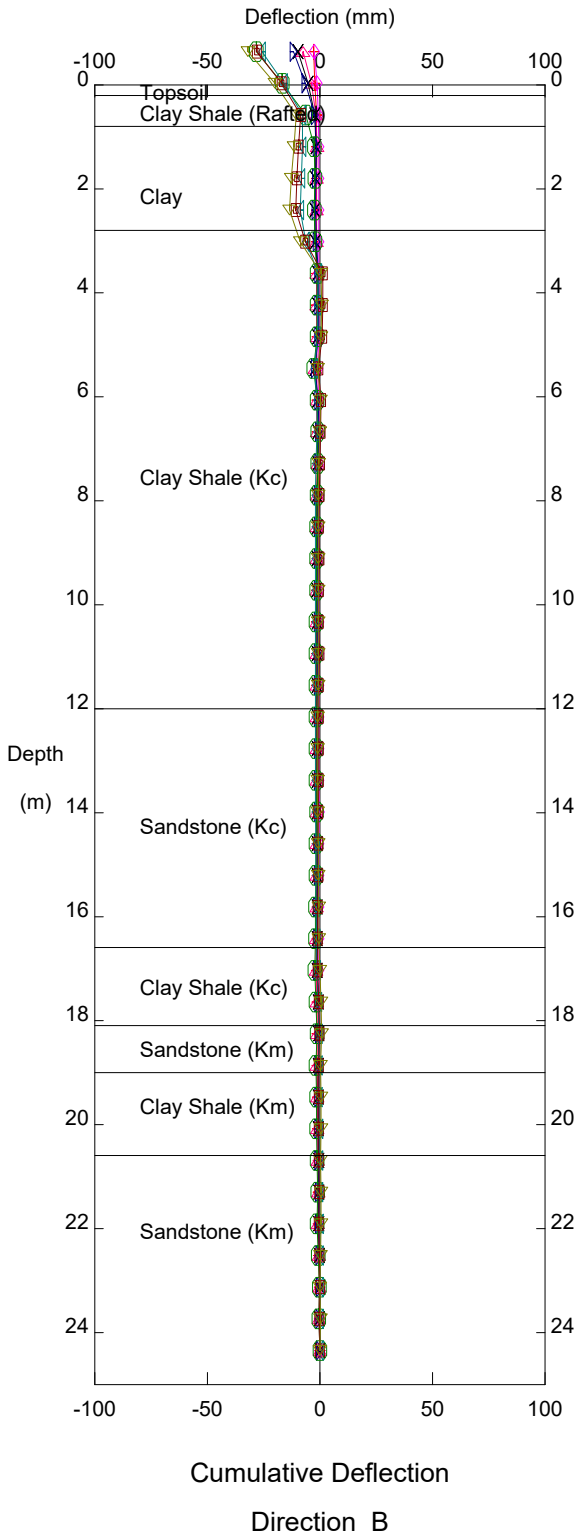
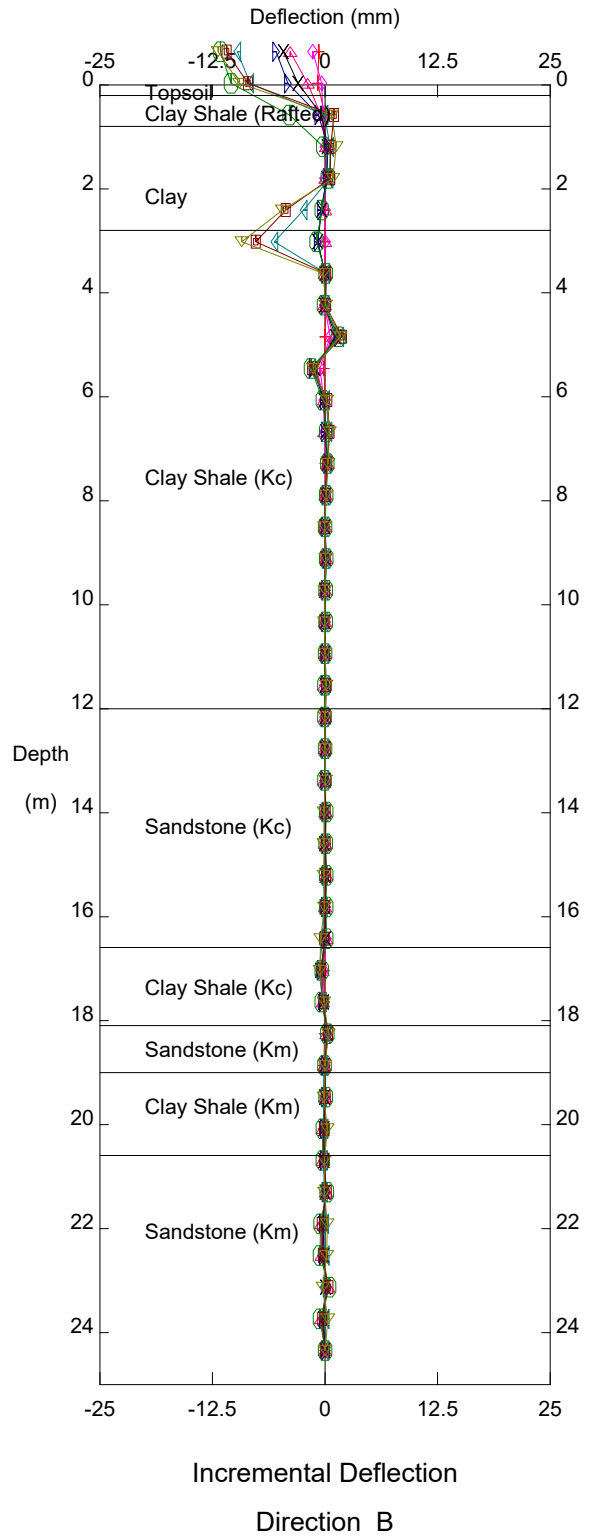
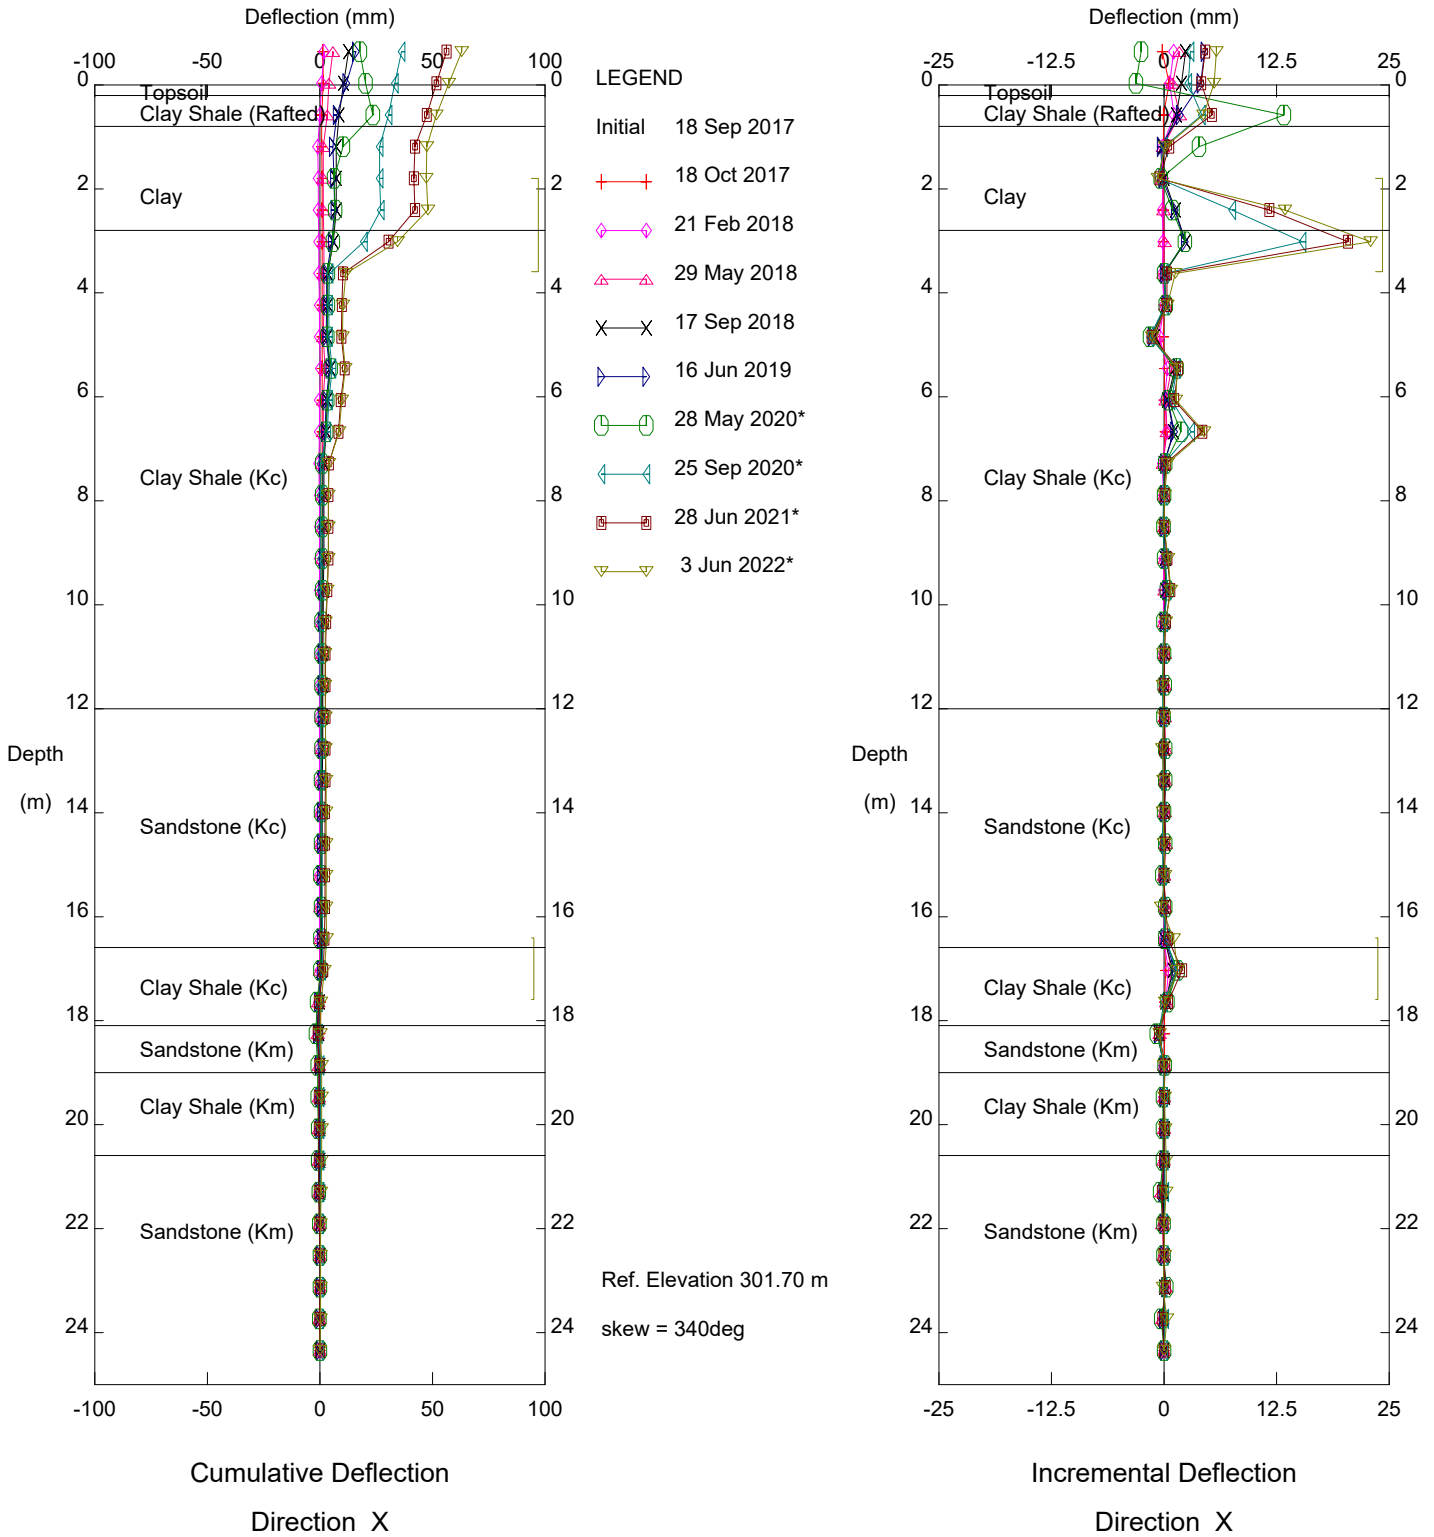
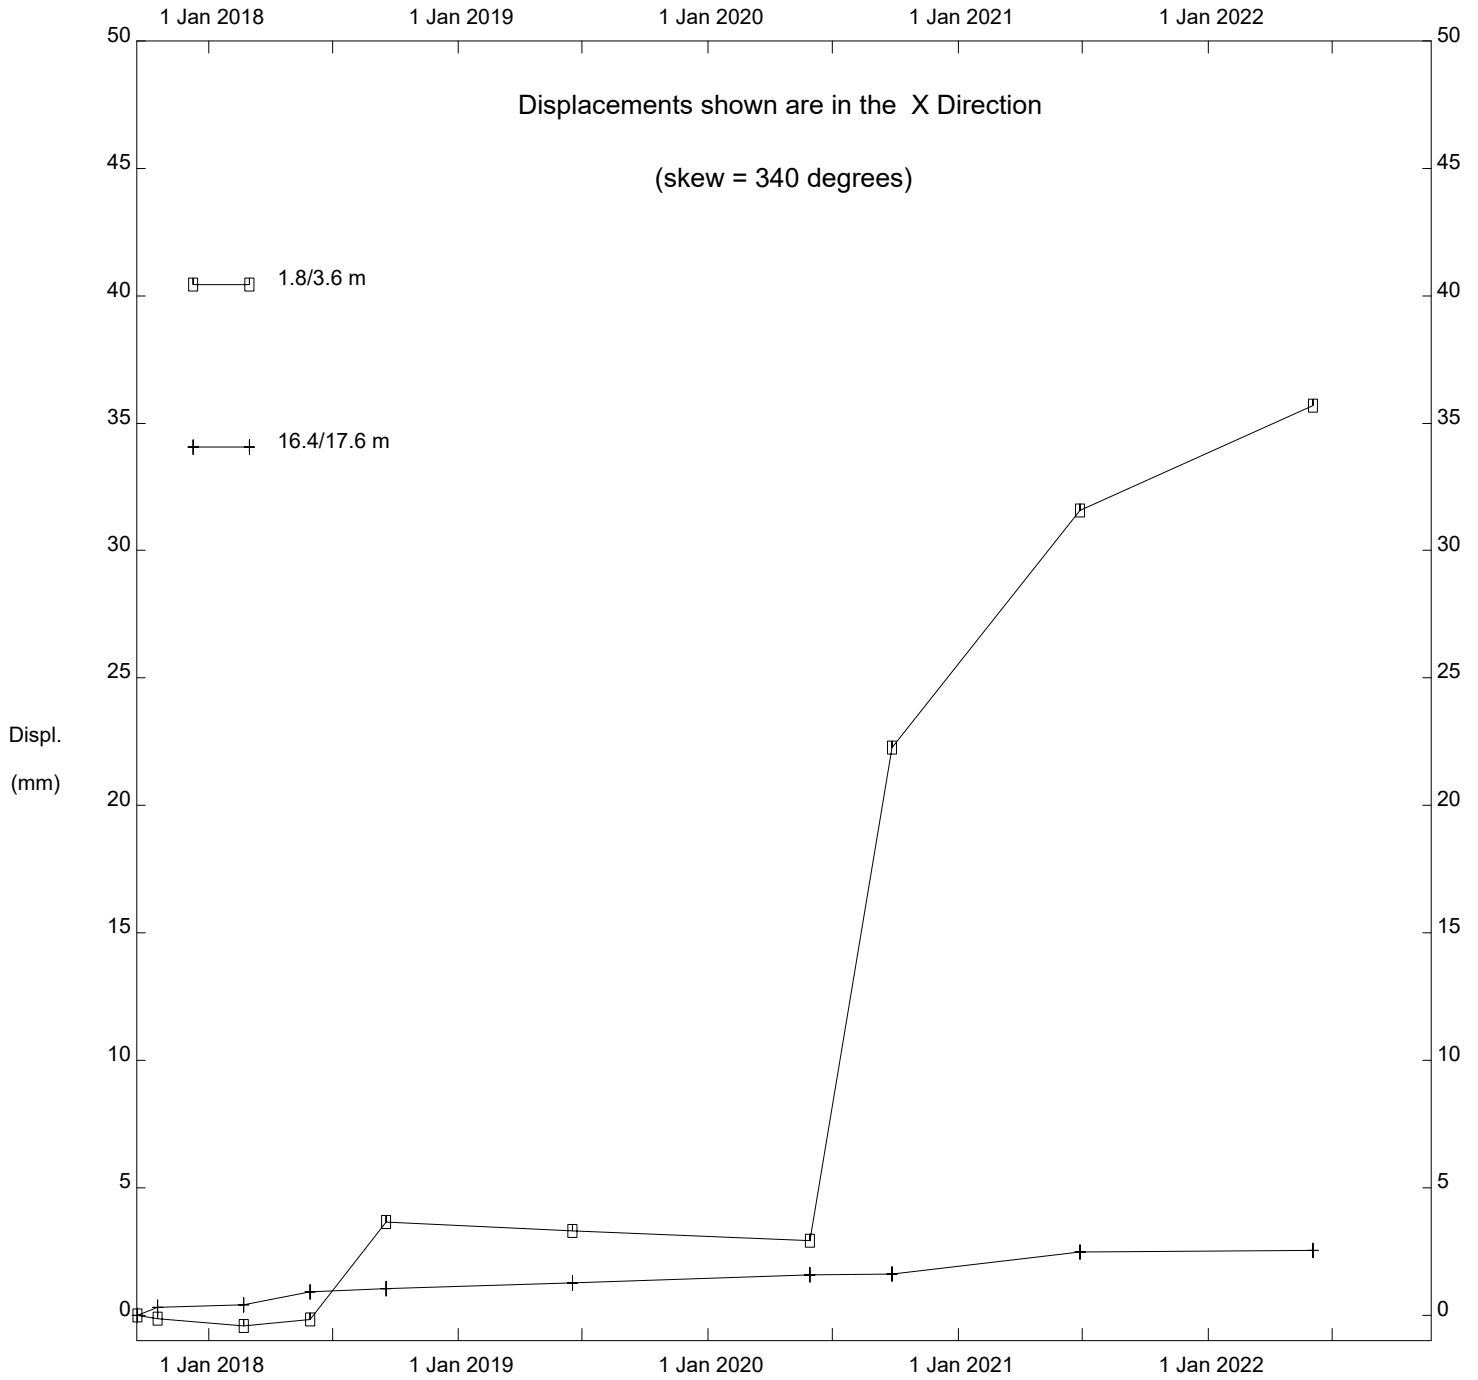
NC089 - Beacon Hill Backslope Slide, Inclinometer SI17-2

SI17-2 showed rates of movement of 4.4 mm/yr over 1.8 m to 3.6 m depth, 0.4 mm/yr over 4.8 m to 7.3 m depth, and less than 0.1 mm/yr over 16.4 to 17.6 m of depth. The rate of movement decreased in SI17-2 by 7.9 mm/yr over 1.8 m to 3.6 m depth since the spring of 2021 reading event. SI17-7 showed rates of movement of 1.3 mm/yr and 0.7 mm/yr, over 1.6 m to 3.4 m depth and 22.9 m to 24.1 m depth, respectively. The rate of movement decreased in SI17-7 by 0.9 mm/yr over 1.6 m to 3.4 m since the spring of 2021 reading event.

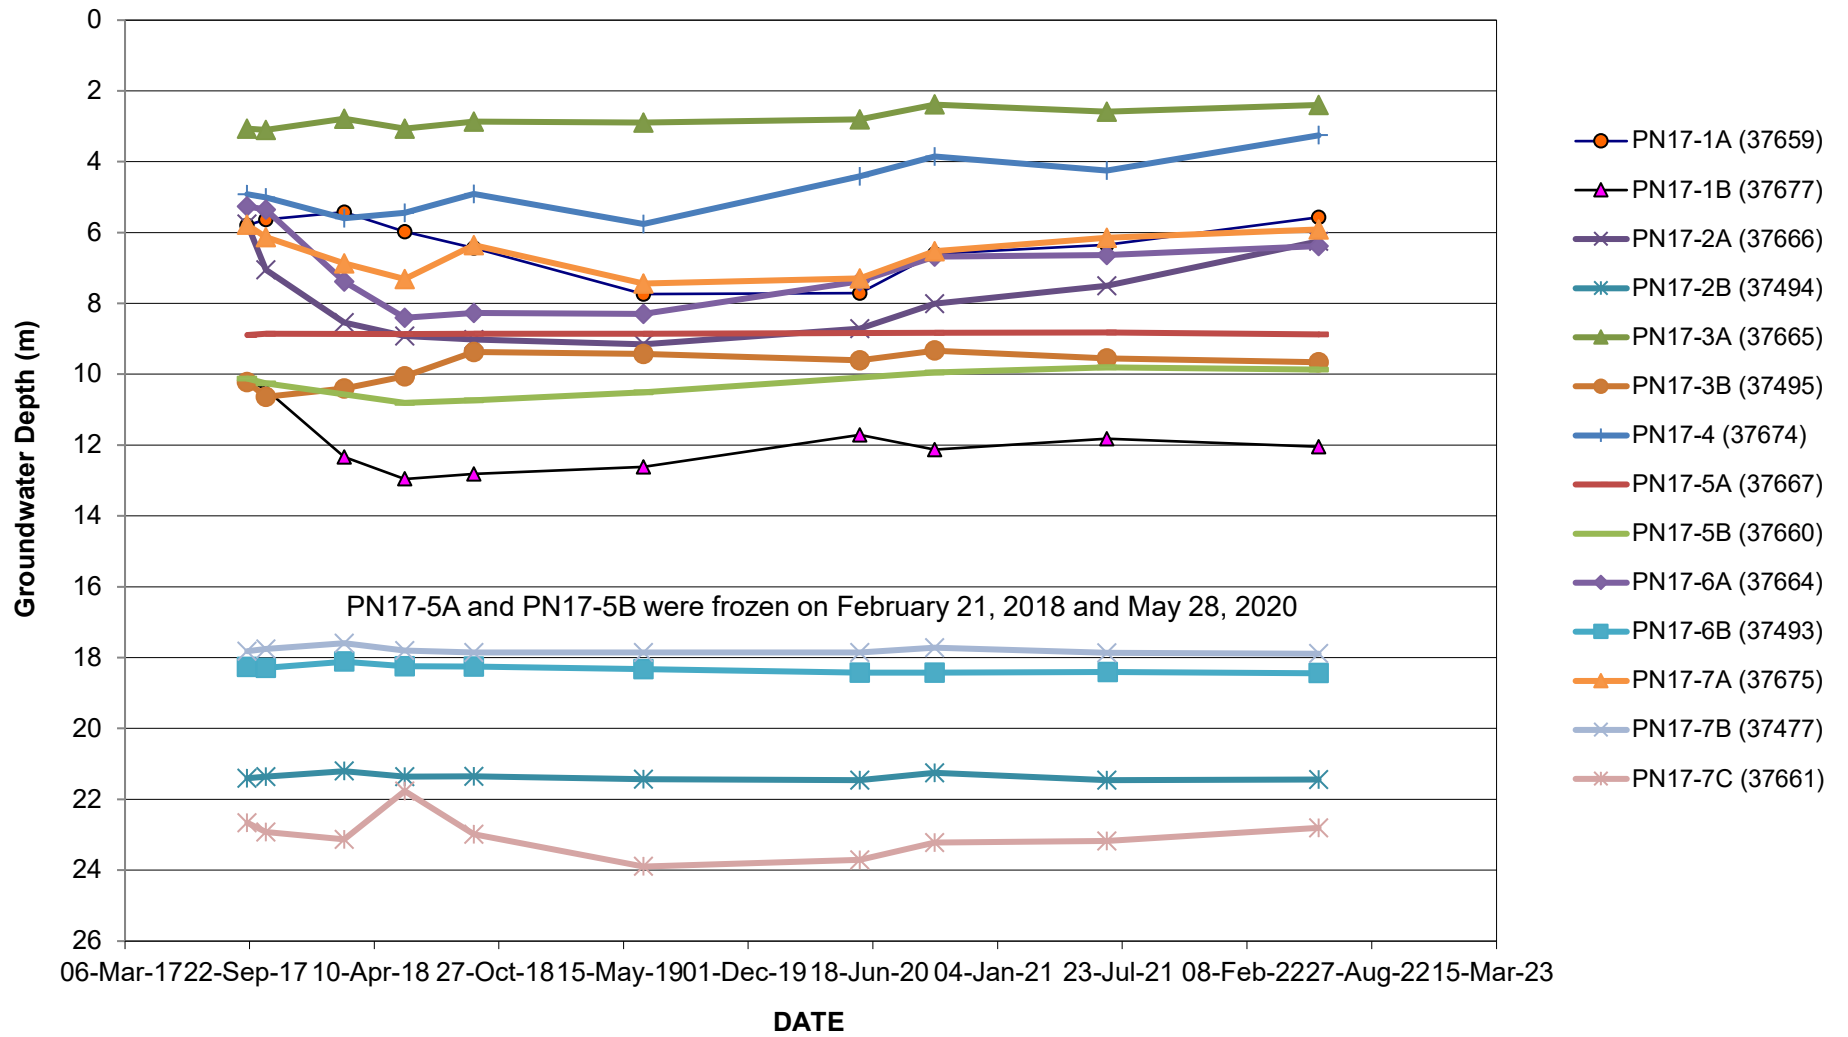
**FIGURE NC089-1
PIEZOMETER DATA FOR HWY 63:12 BEACON HILL**

Pneumatic piezometers PN17-1A, PN 17-2A, PN17-2B, PN17-3A, PN17-4, PN17-6A, PN17-7A, and PN17-7C showed increases in groundwater levels of 0.78 m, 1.26 m, 0.01 m, 0.19 m, 1.00 m, 0.24 m, 0.23 m, and 0.37 m, respectively, since the spring of 2021. Pneumatic piezometers PN17-1B, PN17-3B, PN17-5A, PN17-5B, PN17-6B, and PN17-7B showed decreases in groundwater of 0.22 m, 0.12 m, 0.06 m, 0.06 m, 0.03 m, and 0.02 m, respectively since the spring of 2021. The pneumatic piezometer readings are summarized in Table NC089-2 and are plotted in Figure NC089-1 in Appendix A.
