**ALBERTA TRANSPORTATION AND ECONOMIC CORRIDORS  
GEOHAZARD ASSESSMENT PROGRAM  
NORTH CENTRAL REGION – ATHABASCA &  
FORT MCMURRAY DISTRICTS  
2023 SITE INSPECTION**

Site Number	Location	Name	Hwy	km
NC089	On the backslope of Hwy 63 to the south of King Street Interchange in Fort McMurray	Beacon Hill Backslope Slide	63:11	8.7
Legal Description		UTM Co-ordinates (NAD 83)		
SW-10-89-09-W4M		12 N 6284132.65	E	478495.60

Date	PF	CF	Total
<b>Previous Inspection:</b>	June 24, 2021	11	3	33
<b>Current Inspection:</b>	May 17, 2023	11	3	33
<b>Road WAADT:</b>	27,390	<b>Year:</b>	2022	
<b>Inspected By:</b>	José Pineda, Tarek Abdelaziz (Thurber) Kristen Tappenden, Arthur Kavulok (TEC)			
<b>Report Attachments:</b>	<input checked="" type="checkbox"/> Photographs <input checked="" type="checkbox"/> Plans <input type="checkbox"/> Maintenance Items			
<b>Primary Site Issue</b>	An active landslide toeing out immediately above the highway west ditch but not currently impacting the highway (2016 lower landslide block)			
<b>Dimensions:</b>	About 75 m wide along the highway alignment and 55 m long perpendicular to the highway alignment (southern half of a 140 m wide ancient lower landslide block)			
<

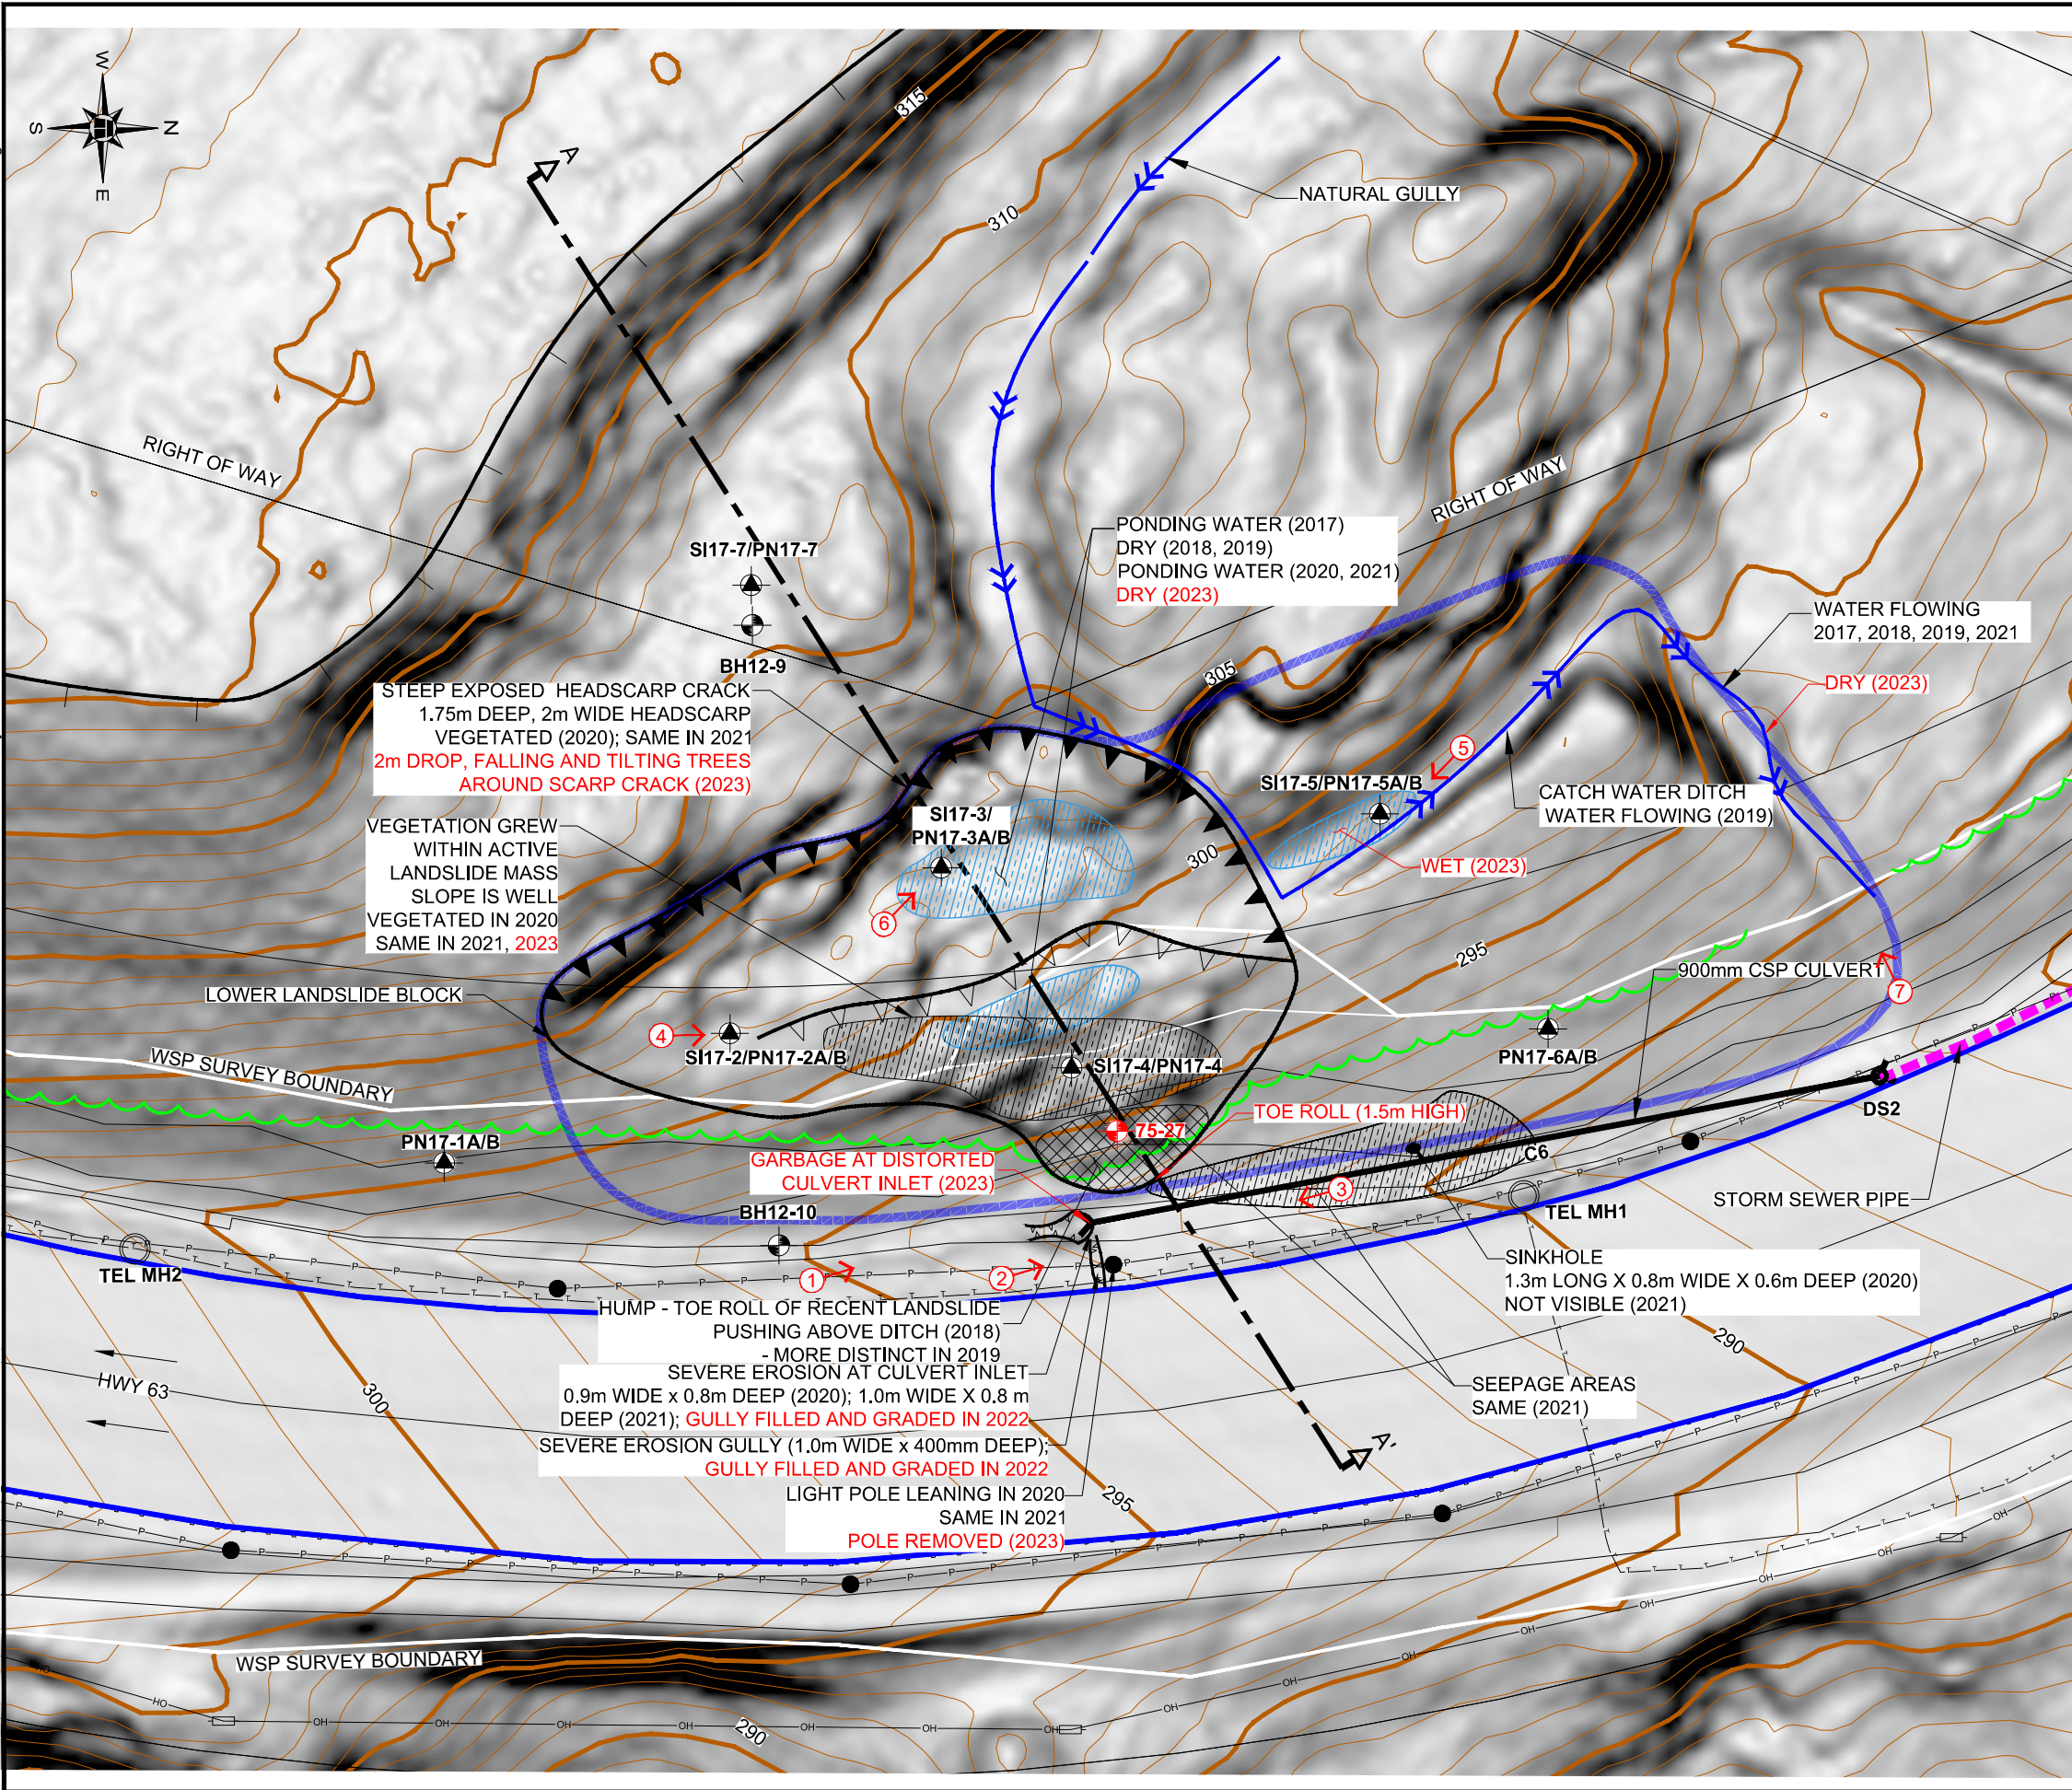
**FIGURE 1**

<b>Observations:</b>	<b>Description</b>			<b>Worse?</b>
<input checked="" type="checkbox"/> Slope Movement	2016 landslide block: 2 m deep and 2.0 m wide exposed head scarp crack; tilting trees; distinct toe roll (1.5 m high) located 9.5 m away from the edge of the highway			<input type="checkbox"/>
<input checked="" type="checkbox"/> Seepage	Typical zones of standing water and seepage areas were dry during the current inspection			<input type="checkbox"/>
<input checked="" type="checkbox"/> Other	Vegetation grew within the landslide mass; sink hole developed in 2020 approximately 20 m north of the landslide toe was not visible; severe erosion developed at the inlet of the C6 pipe was not visible; garbage was noted at the inlet of culvert C6			<input type="checkbox"/>

The site condition remained relatively unchanged since the 2021 site inspection visit.

Based on current site observations and instrumentation readings, the landslide appears to have generally become more stable over the past few years likely due to progressive growth of vegetation and reduction of groundwater levels over time. However, previous readings of instrumentation within the landslide mass (including sheared off/blocked slope inclinometers) indicated that the 2016 landslide block was moving at high rates between the spring and the fall seasons due to the increase in groundwater level during this period. Hence, an abrupt movement could still take place as previously occurred in response to loss of vegetation and/or elevated groundwater levels within the colluvium deposits.

If an abrupt movement of the landslide takes place, the landslide debris will likely accumulate in the highway ditch and impede surface drainage.

The site condition remained relatively unchanged for a few years, and therefore this site can be temporarily removed from the geohazard inspection program.

The operational instruments should however be read at least once a year.

The landslide should be regularly monitored by the local MCI, particularly after a prolonged rainfall event, and the ditch bottom should be touched to be cleared of the landslide debris as needed (without significantly changing grades) to improve surface water drainage. Excavated landslide debris (if any due to future movement) from the highway ditch should be pushed back into the toe of the slope.

Permanent repairs are not anticipated at this site unless the landslide becomes very active, and starts impacting the highway.

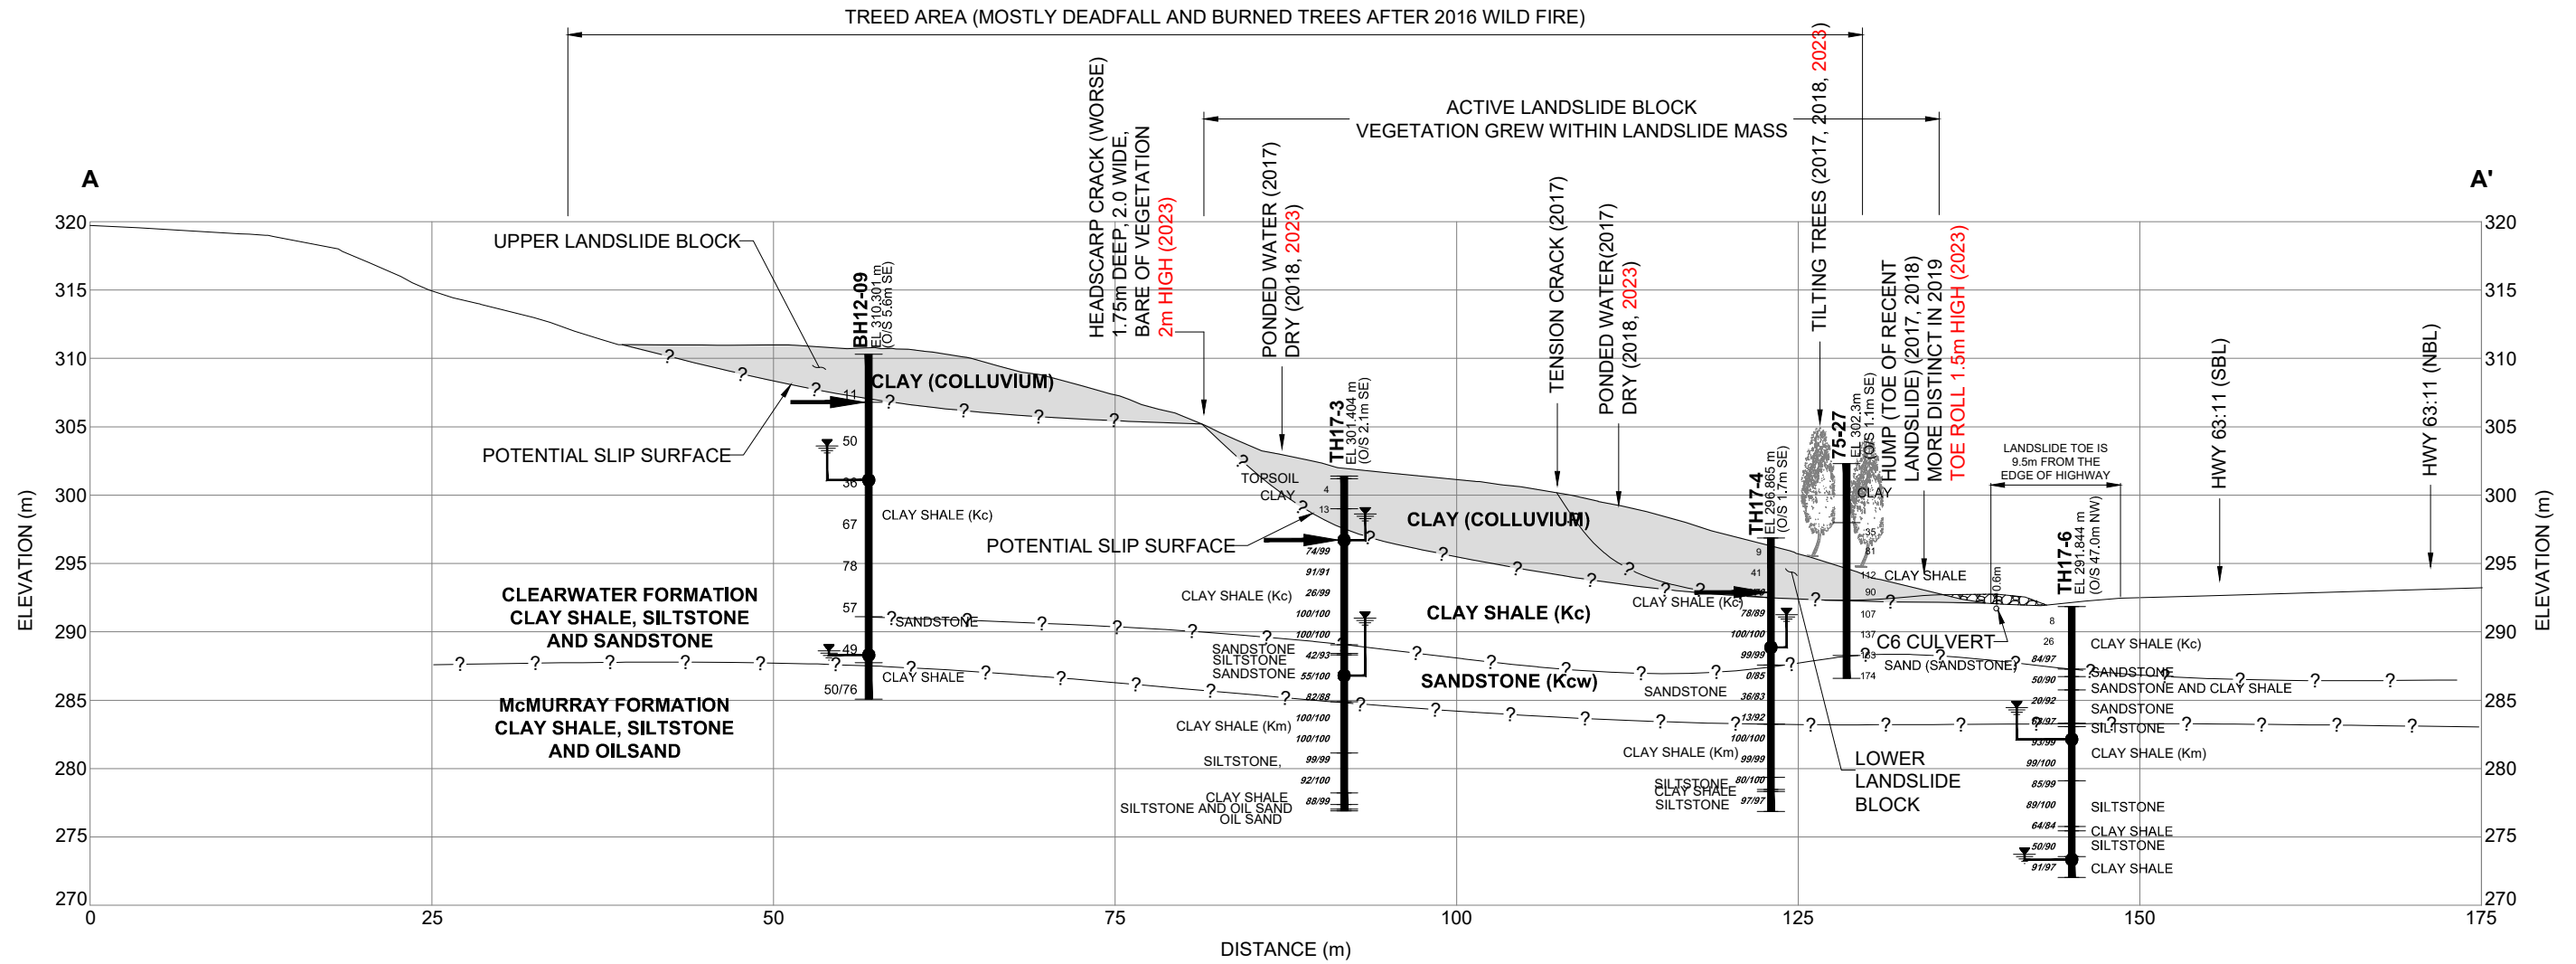
**FIGURE 2**

SI17-2, located within the local landslide block, showed a rate of movement of 0.3 mm/yr over 4.8 m to 7.3 m depth between the spring of 2022 and the spring of 2023. SI17-7, located in the upper landslide block, also showed a rate of movement up to 0.2 mm/yr at a depth of 22.9 m to 24.1 m since the previous readings.

Pneumatic piezometers PN17-1A, PN17-2B, PN17-3A, PN17-5A, PN17-7C showed increases in groundwater levels of ranging between 0.05 m to 1.26 m since the piezometers were last read in the spring of 2022. Pneumatic piezometers PN17-1B, PN17-2A, PN17-3B, PN17-4, PN17-5B, PN17-6A, PN17-6B, PN17-7A, and PN17-7B showed decreases in groundwater ranging from 0.1 to 2.76 m since they were last read in the spring of 2022.

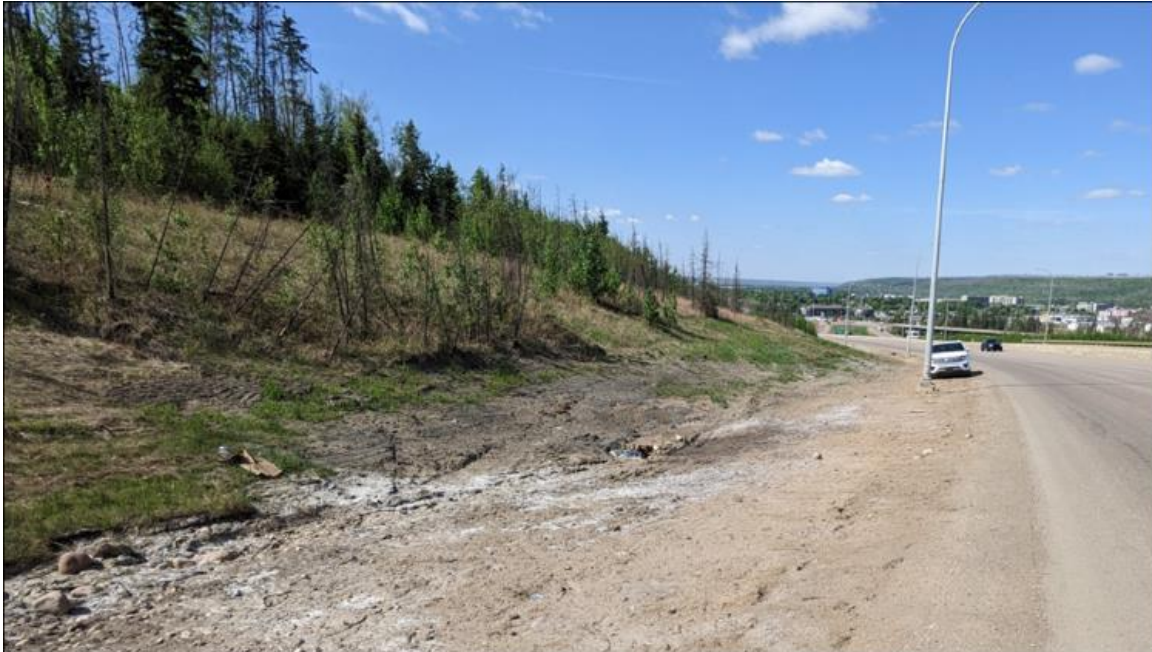
**Photo 1. Looking north at the toe of the landslide; the landslide is toeing out above the ditch near culvert C6**

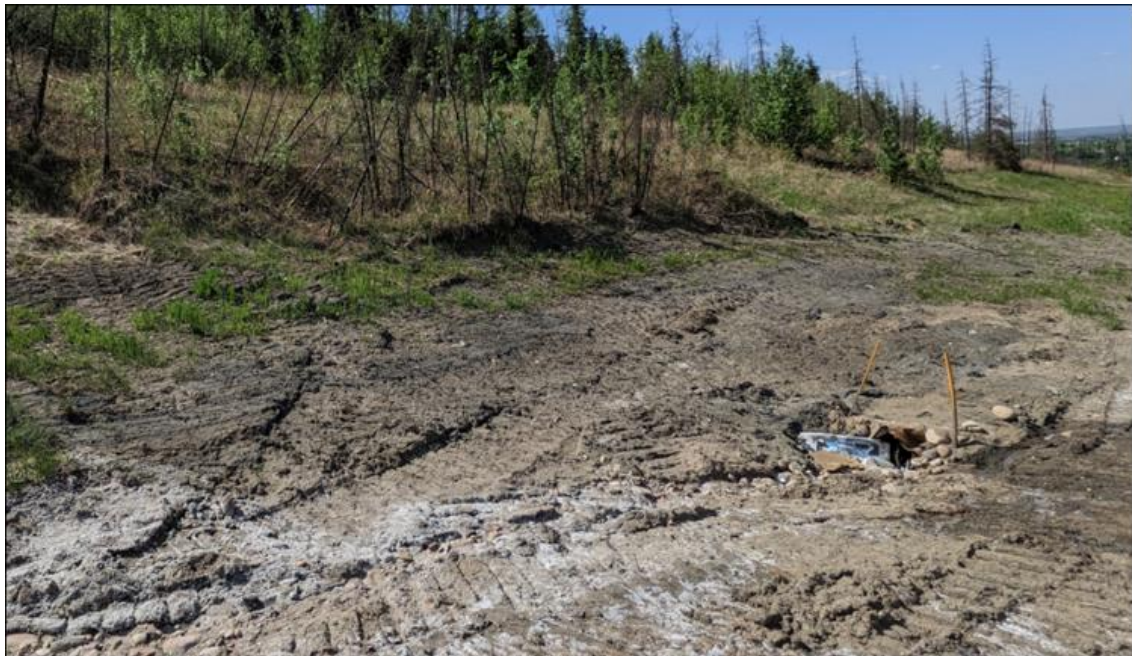
**Photo 2. Previously noted erosion gully, downslope of the toe of the landslide at culvert inlet location, was filled and graded. Note garbage accumulation at the culvert inlet**

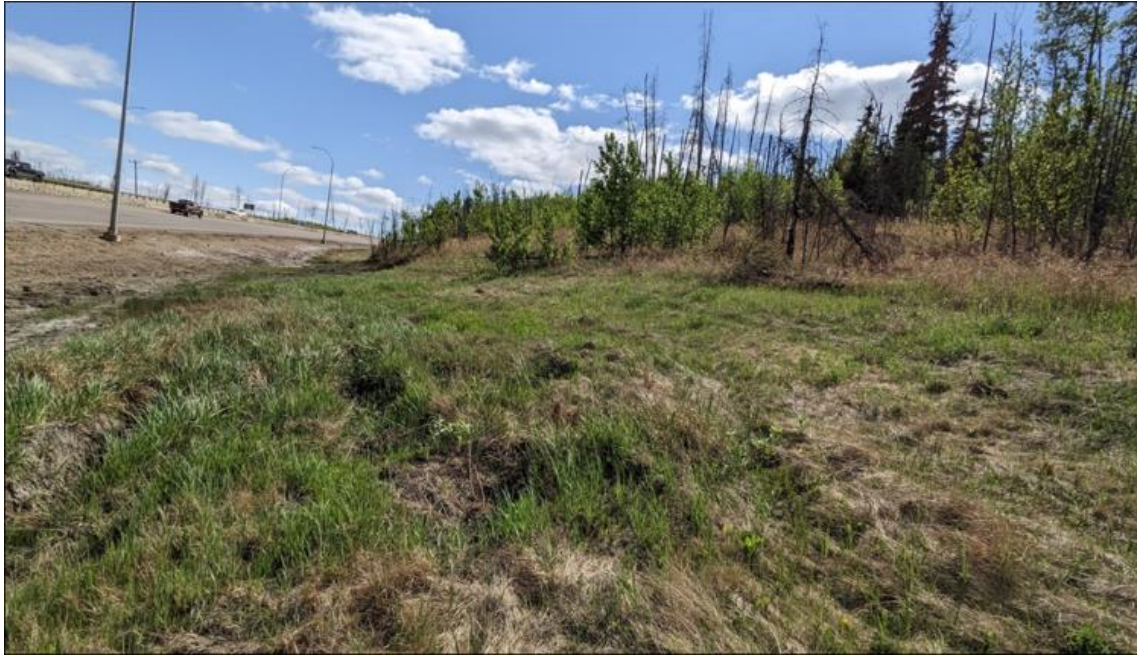
**Photo 3. Looking south at the toe of the landslide; note tilting trees within the landslide mass**

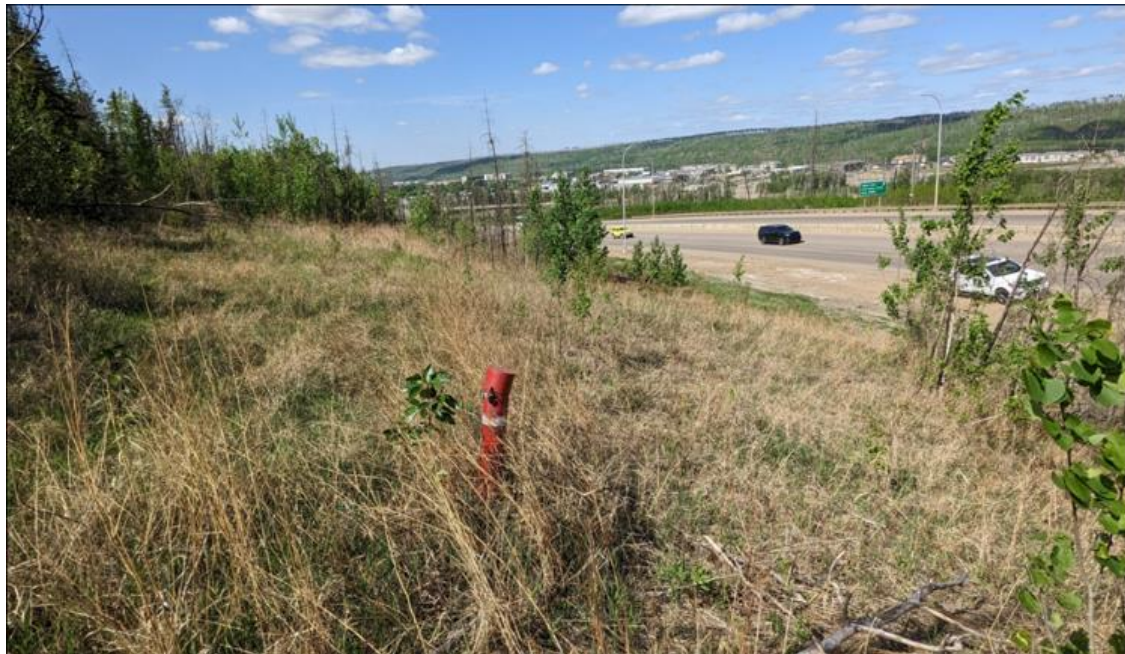
**Photo 4. Looking south at the toe of the landslide; note tilting trees within the landslide mass.**

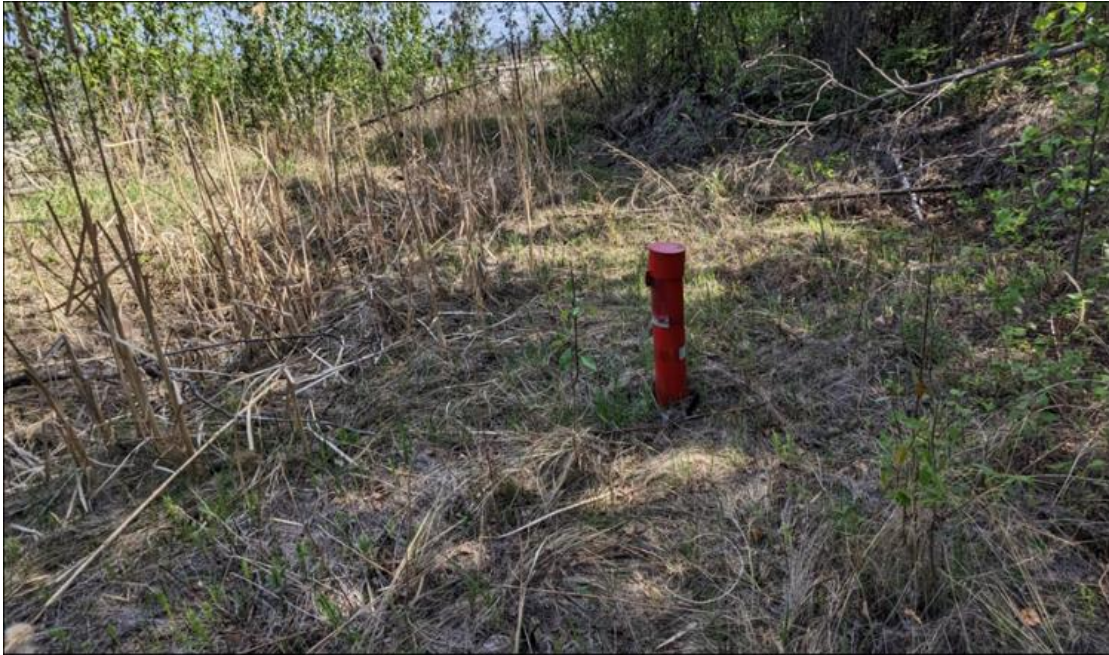
**Photo 5. Looking south at catch water ditch near SI17-5. Ground was wet but no water ponding in 2023.**

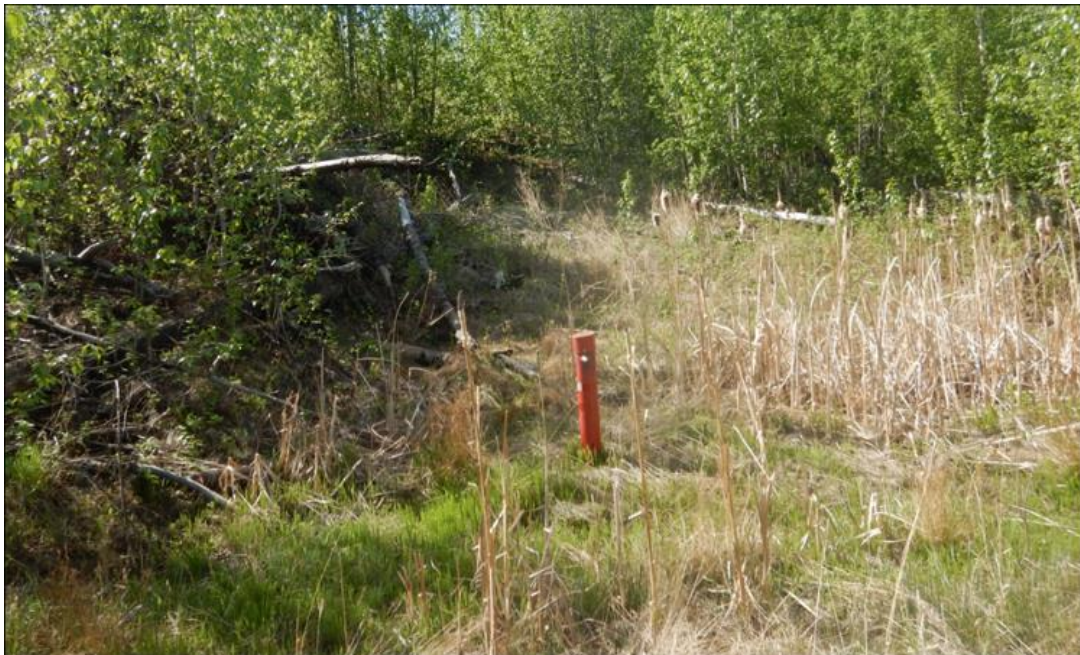
**Photo 6. Looking northwest at backscarp; note cattails and lush vegetation due to seepage near SI17-3.**

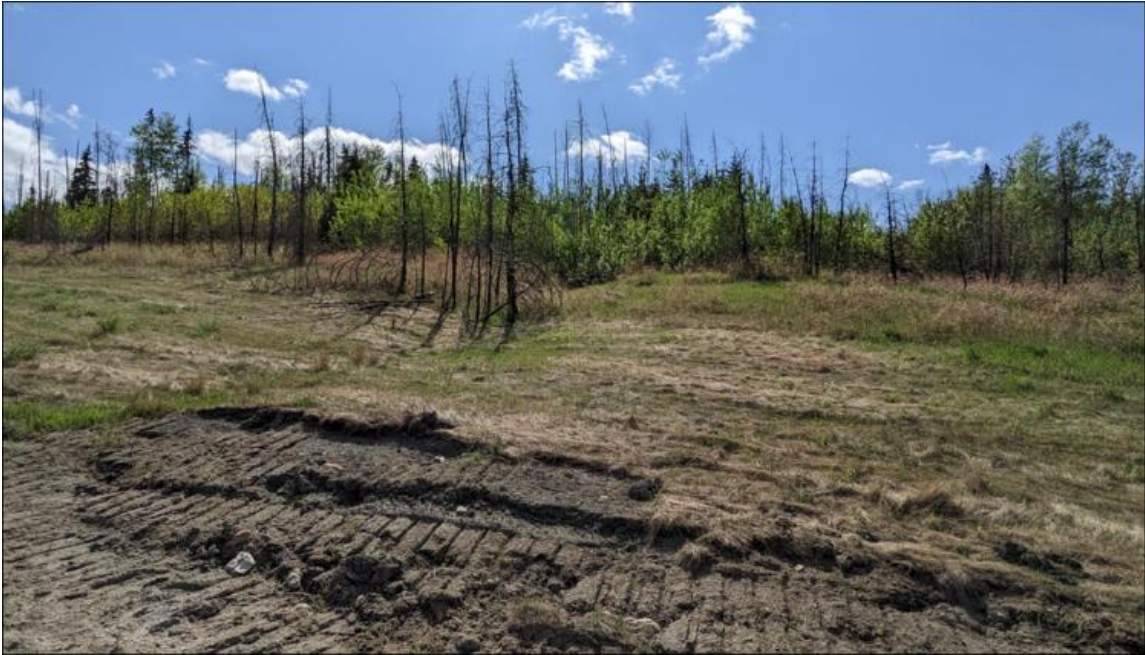
**Photo 7. Looking west at the northern flank of the lower ancient landslide block |**
