ALBERTA TRANSPORTATION AND
ECONOMIC CORRIDORS GRMP
NORTH CENTRAL (ATHABASCA AND FORT
McMURRAY DISTRICTS)
INSTRUMENTATION MONITORING- SPRING 2024

Site Number	Location	Name	Hwy	km
NC089	HWY 63:12	Beacon Hill Backslope Slide	63:12	Km 8.7
Legal Description: 3-10-89-9 W4		UTM Co-ordinates		
		12U E 478503	N	6284103

Current Monitoring:	11-June-2024	Previous Monitoring	30-May-2023
Instruments Read By:	Mr. Niraj Regmi, G.I.T and Mr. Nixson Mationg, of Thurber

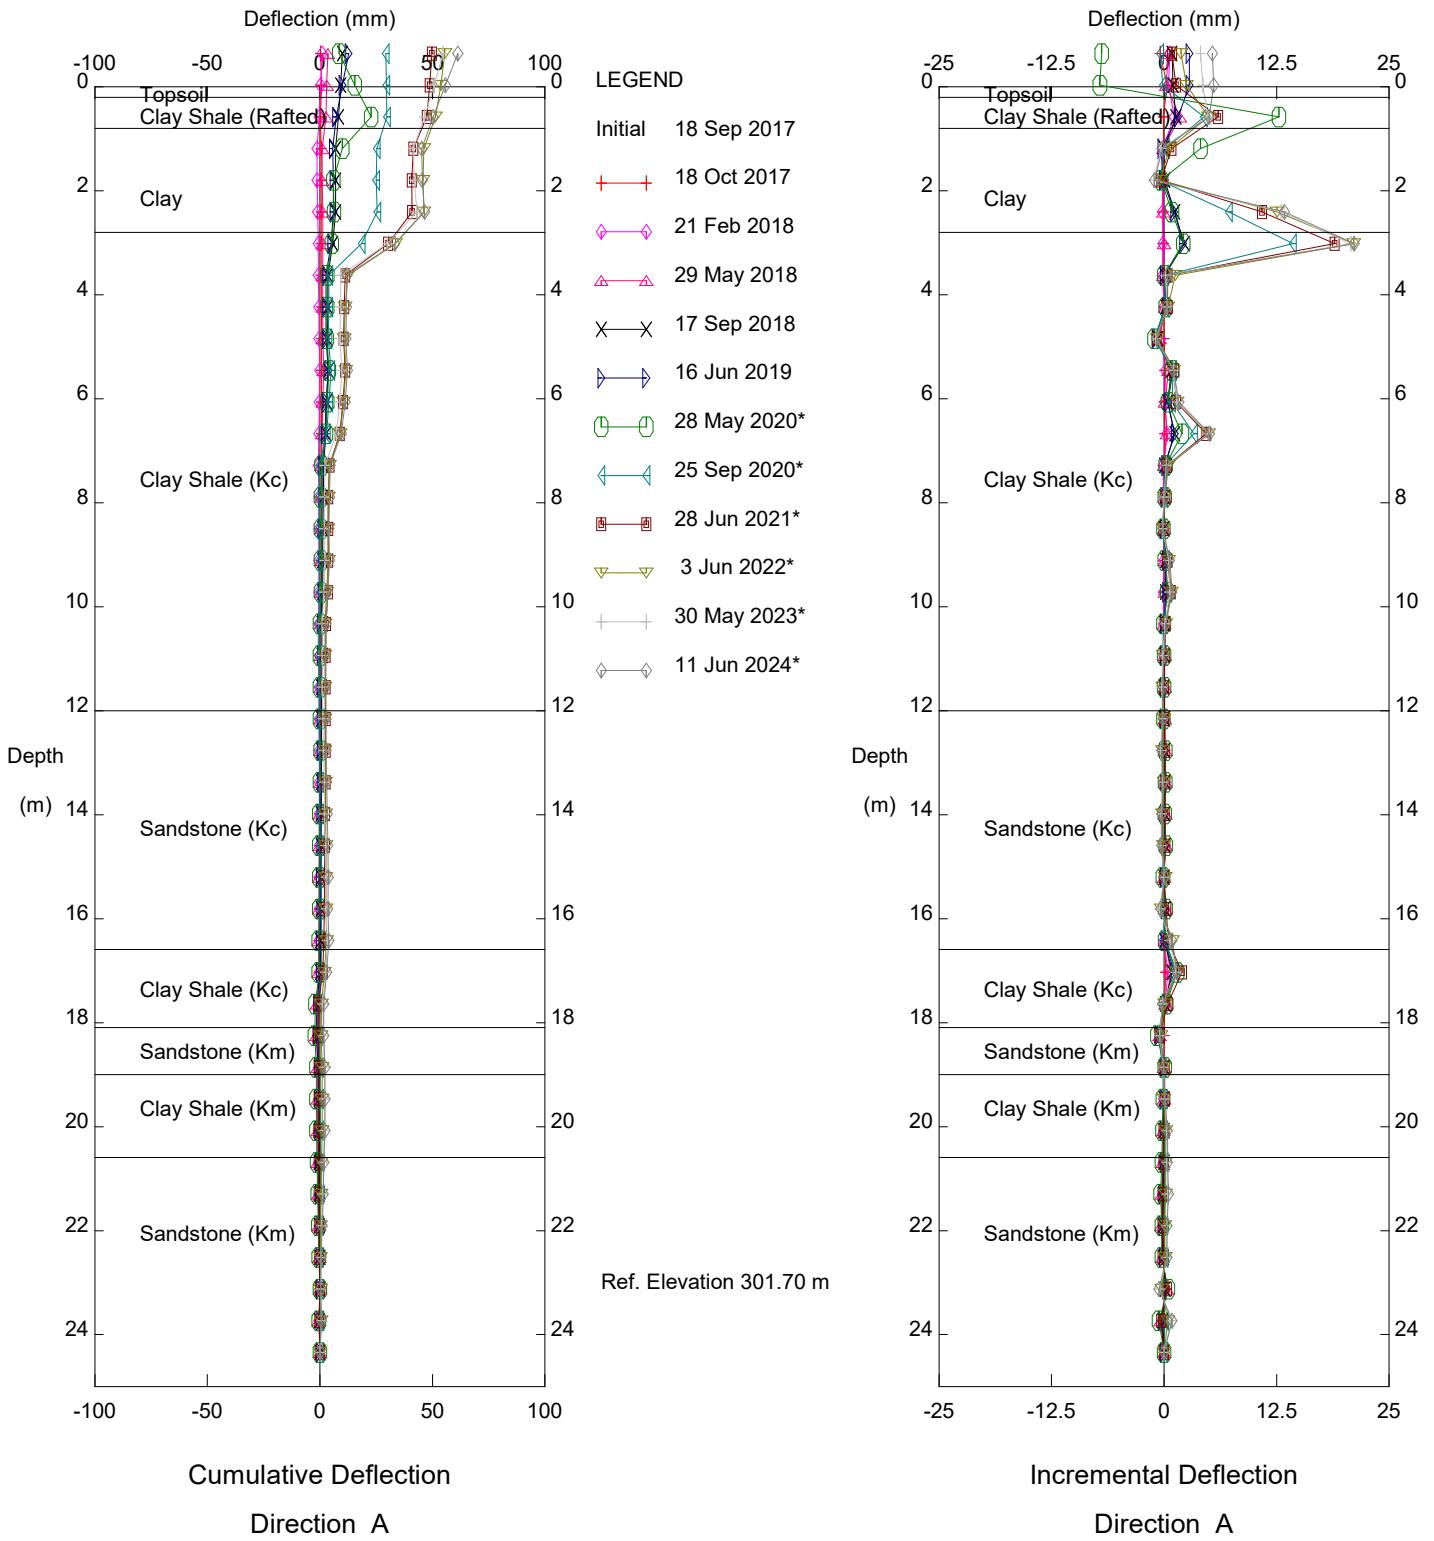
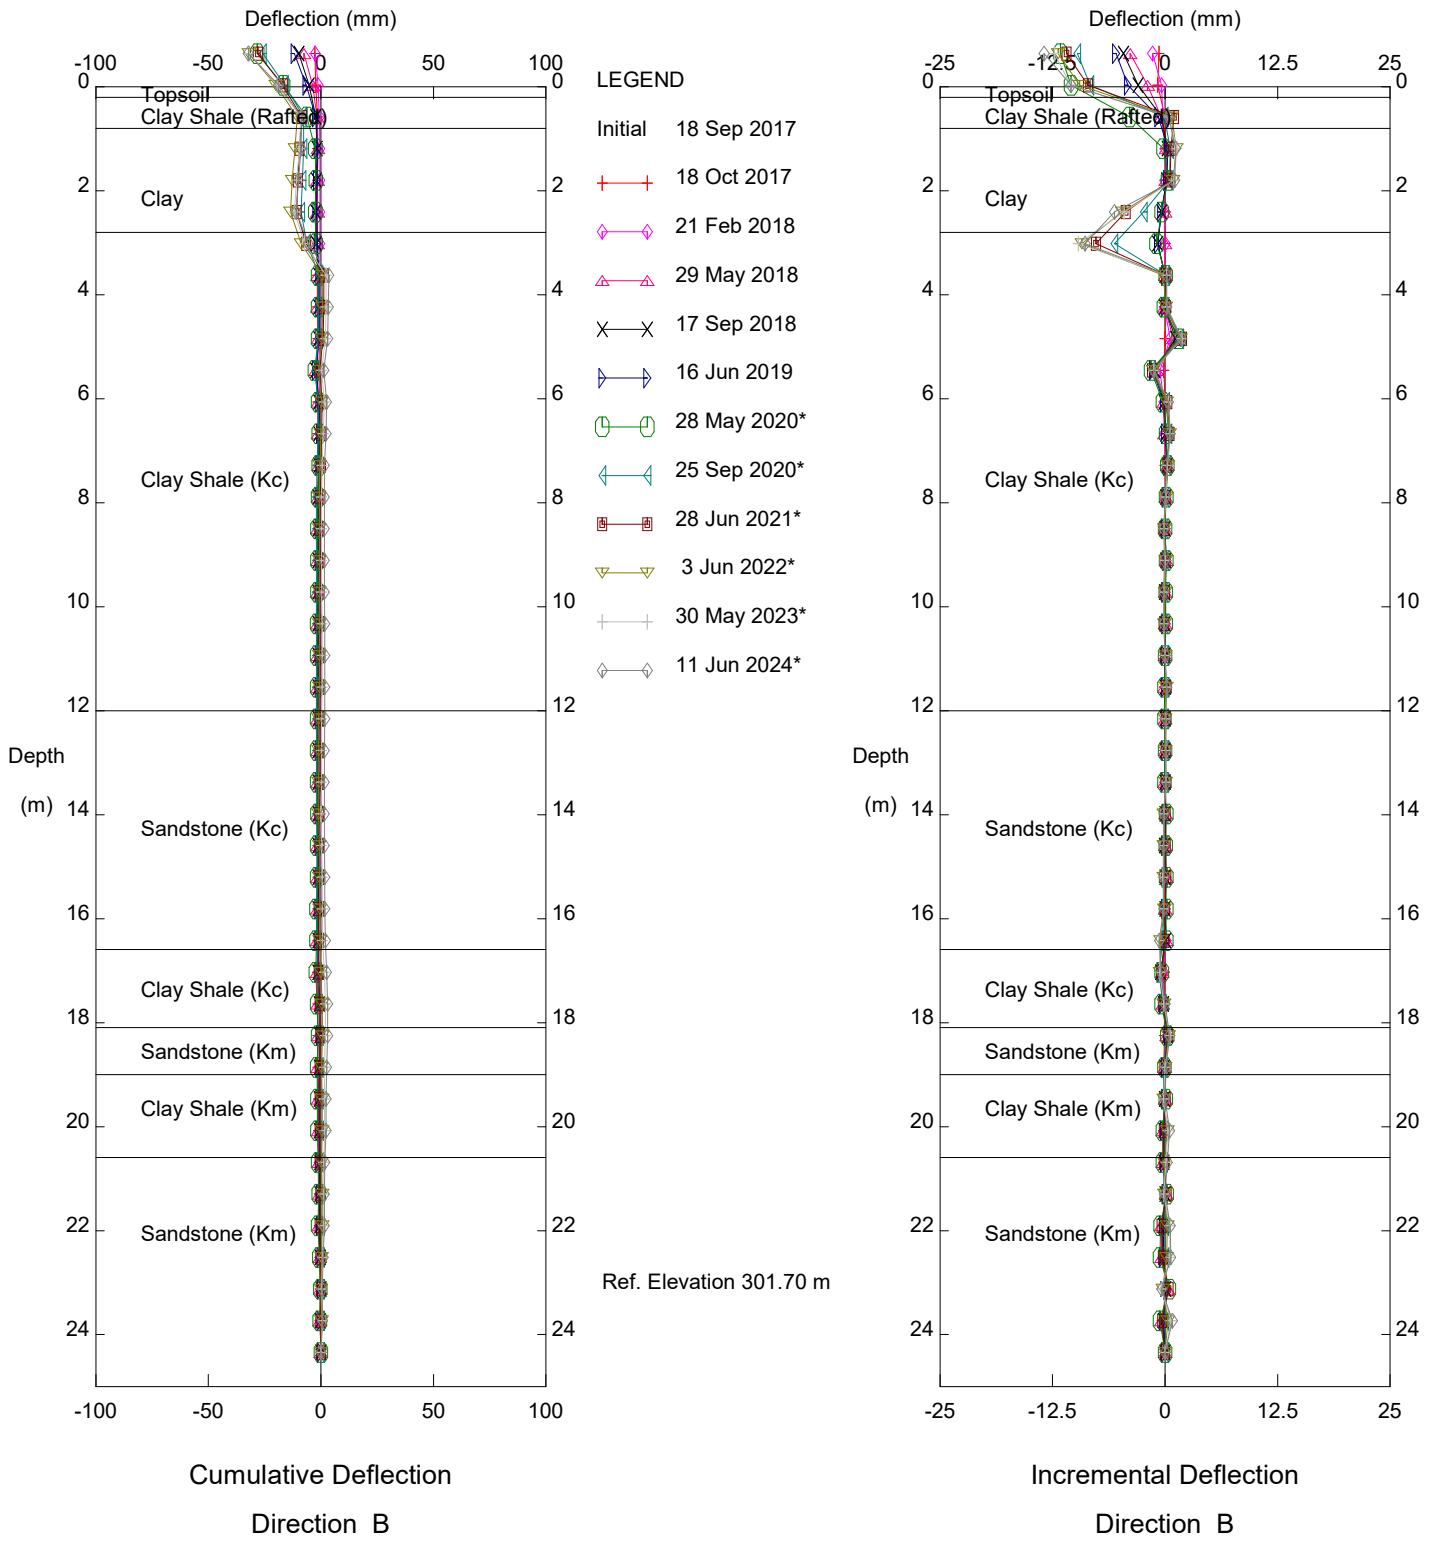
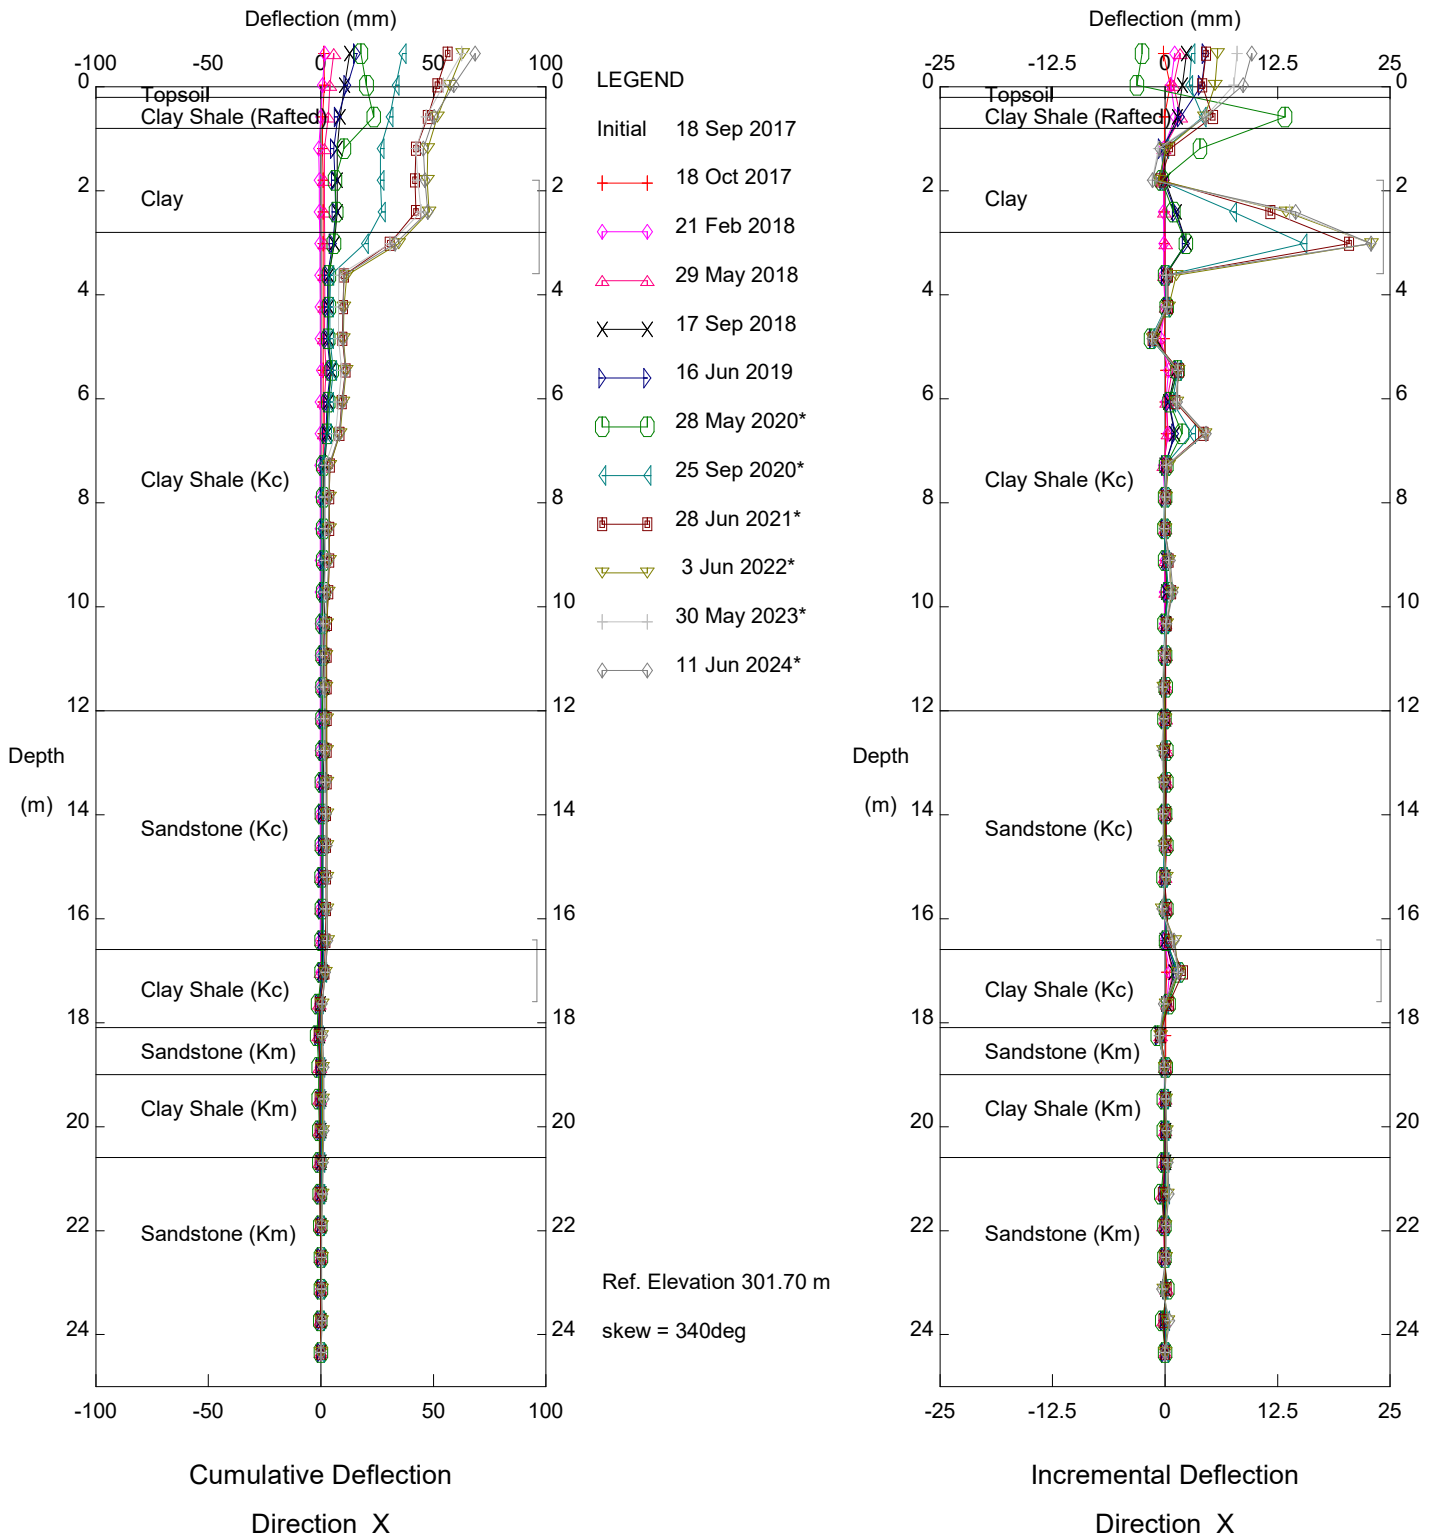
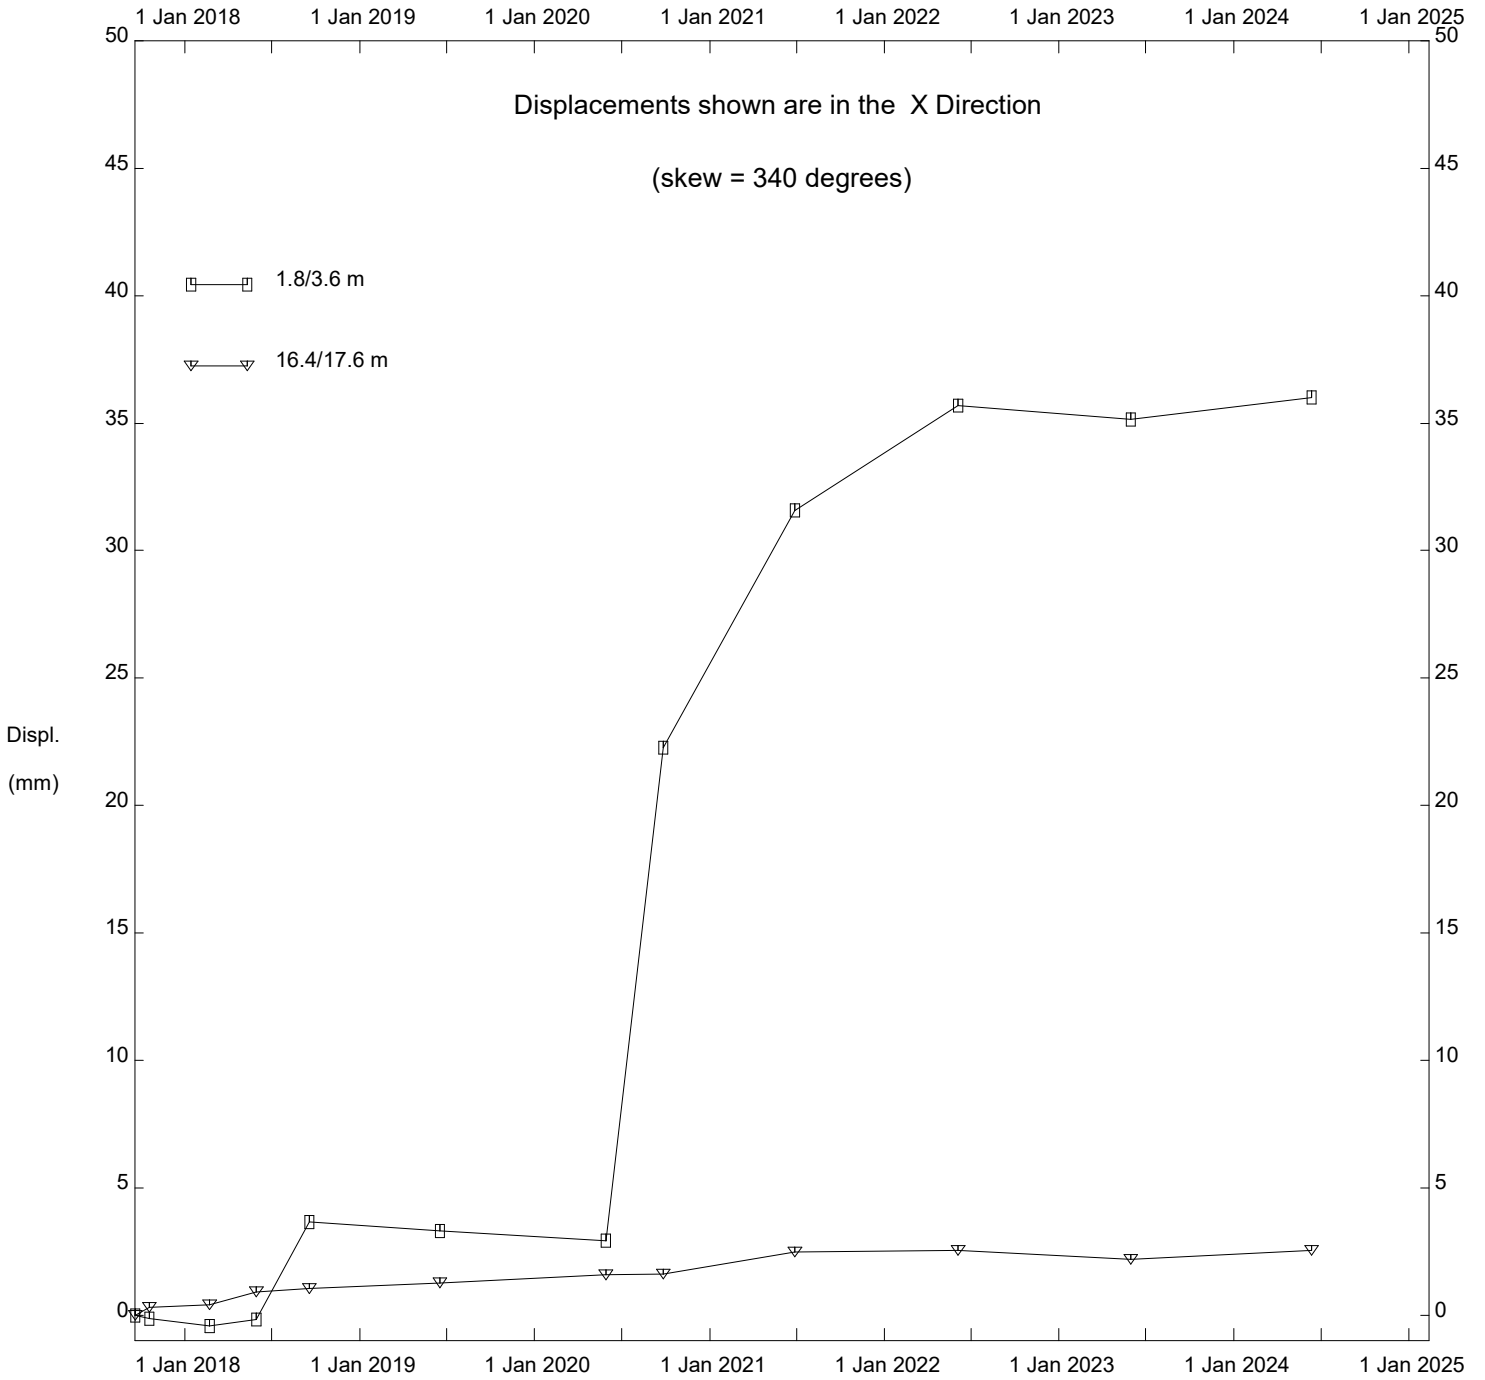
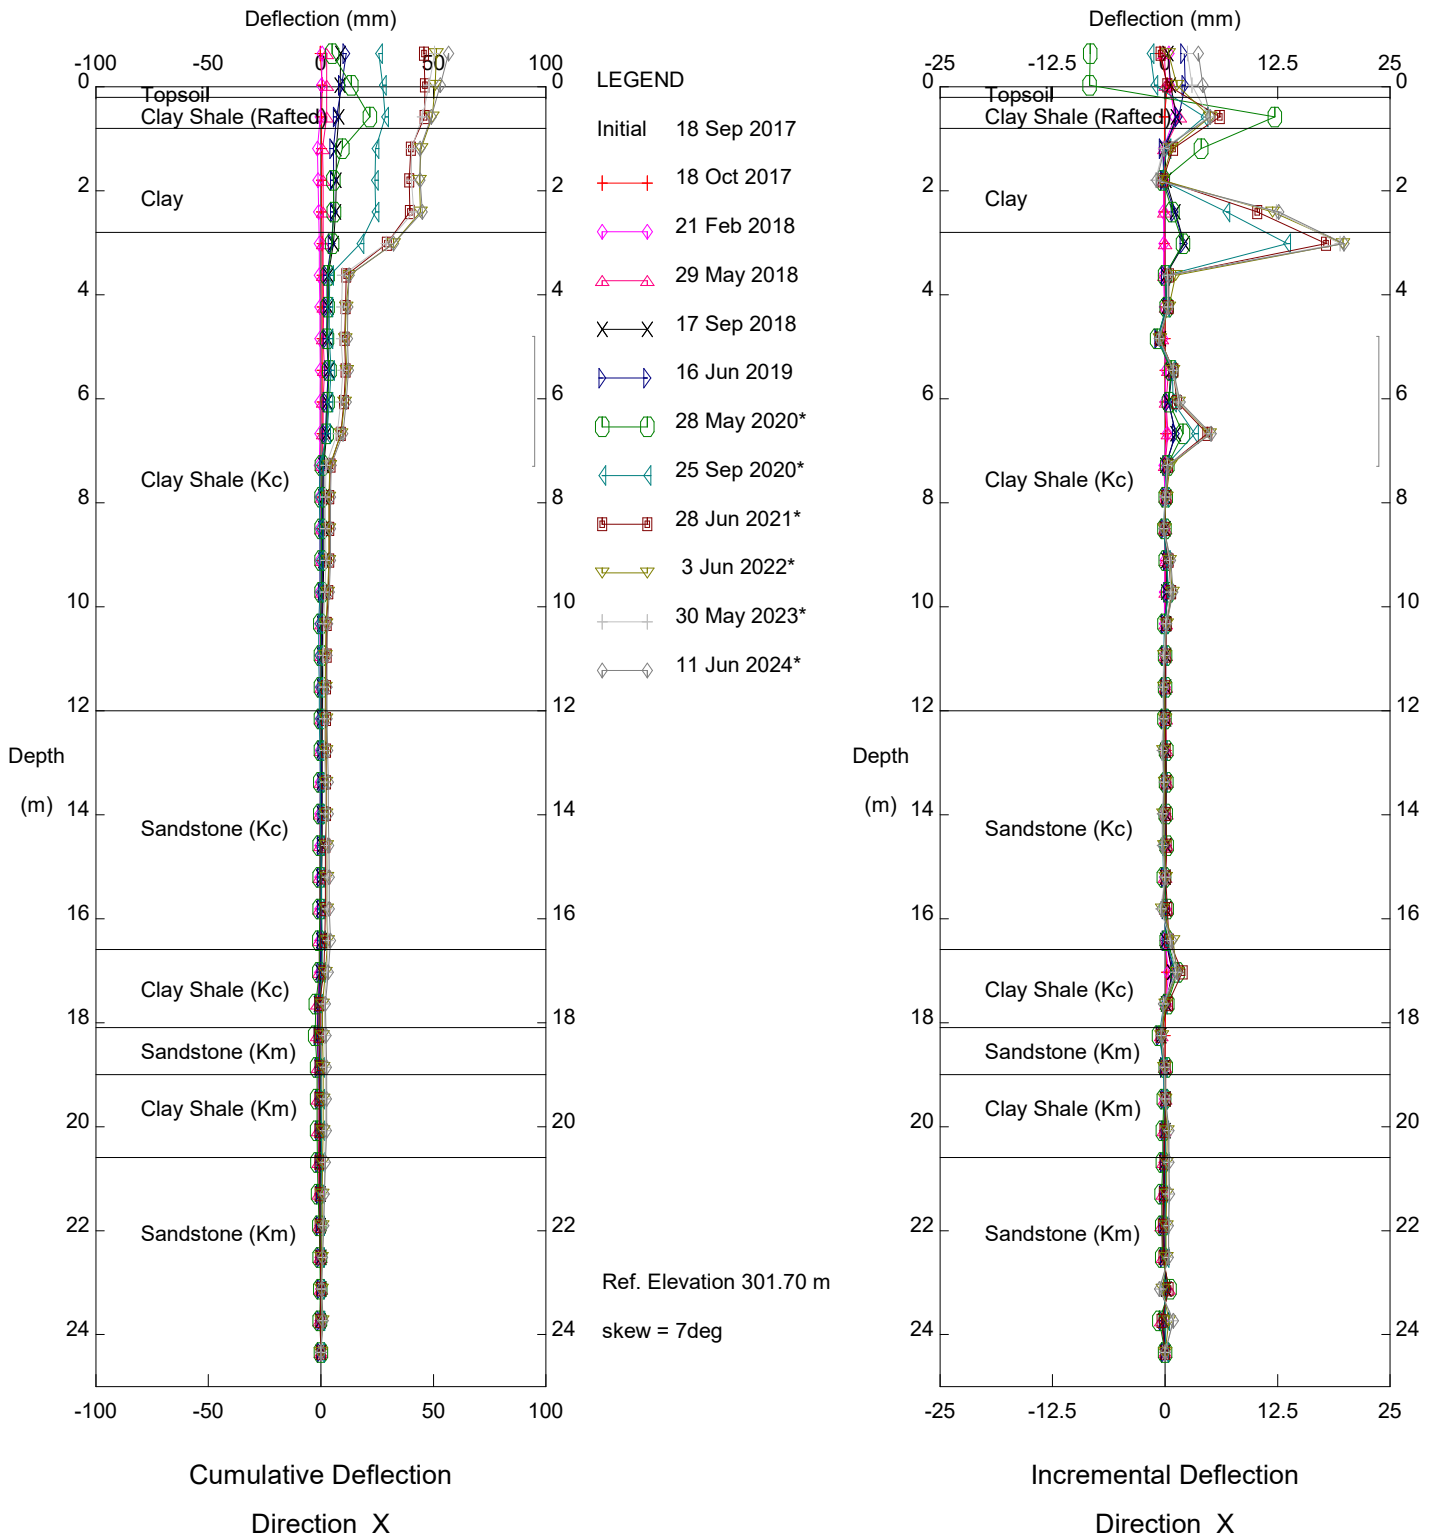
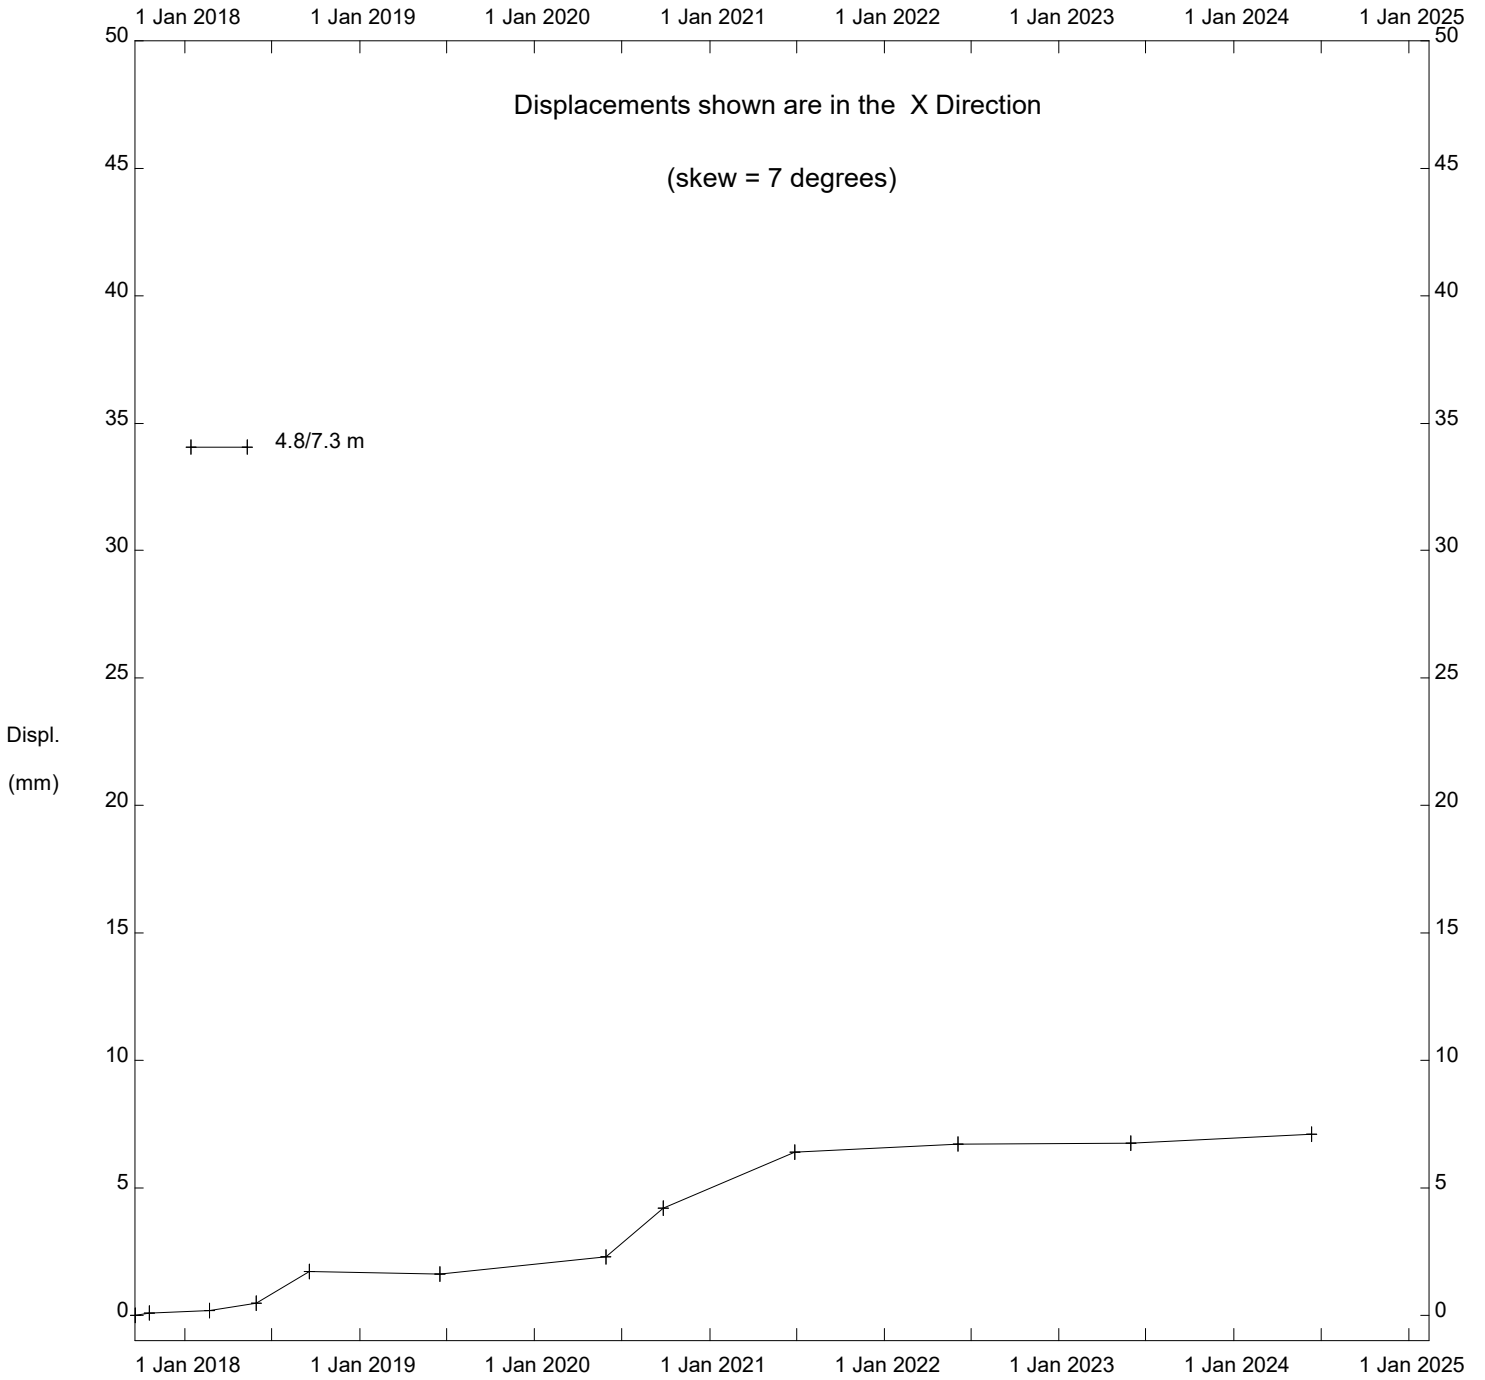
NC089 - Beacon Hill Backslope Slide, Inclinometer SI17-2

Discussion	
Zones of New Movement:	None
Interpretation of Monitoring Results:	SI17-2 showed a rate of movement of 0.8 mm/yr movement over 1.8 m to 3.6 m depth, a rate of movement of 0.3 mm/yr over 4.8 m to 7.3 m depth, and a rate of movement of 0.3 mm/yr over 16.4 to 17.6 m of depth. The rate of movement increased in SI17-2 by 1.4 mm/yr over 1.8 m to 3.6 m depth since the spring of 2023 reading event. SI17-7 showed a rate of movement of 0.7 mm/yr over 1.6 m to 3.4 m depth and a rate of movement of 0.3 mm/yr over 22.9 m to 24.1 m depth.

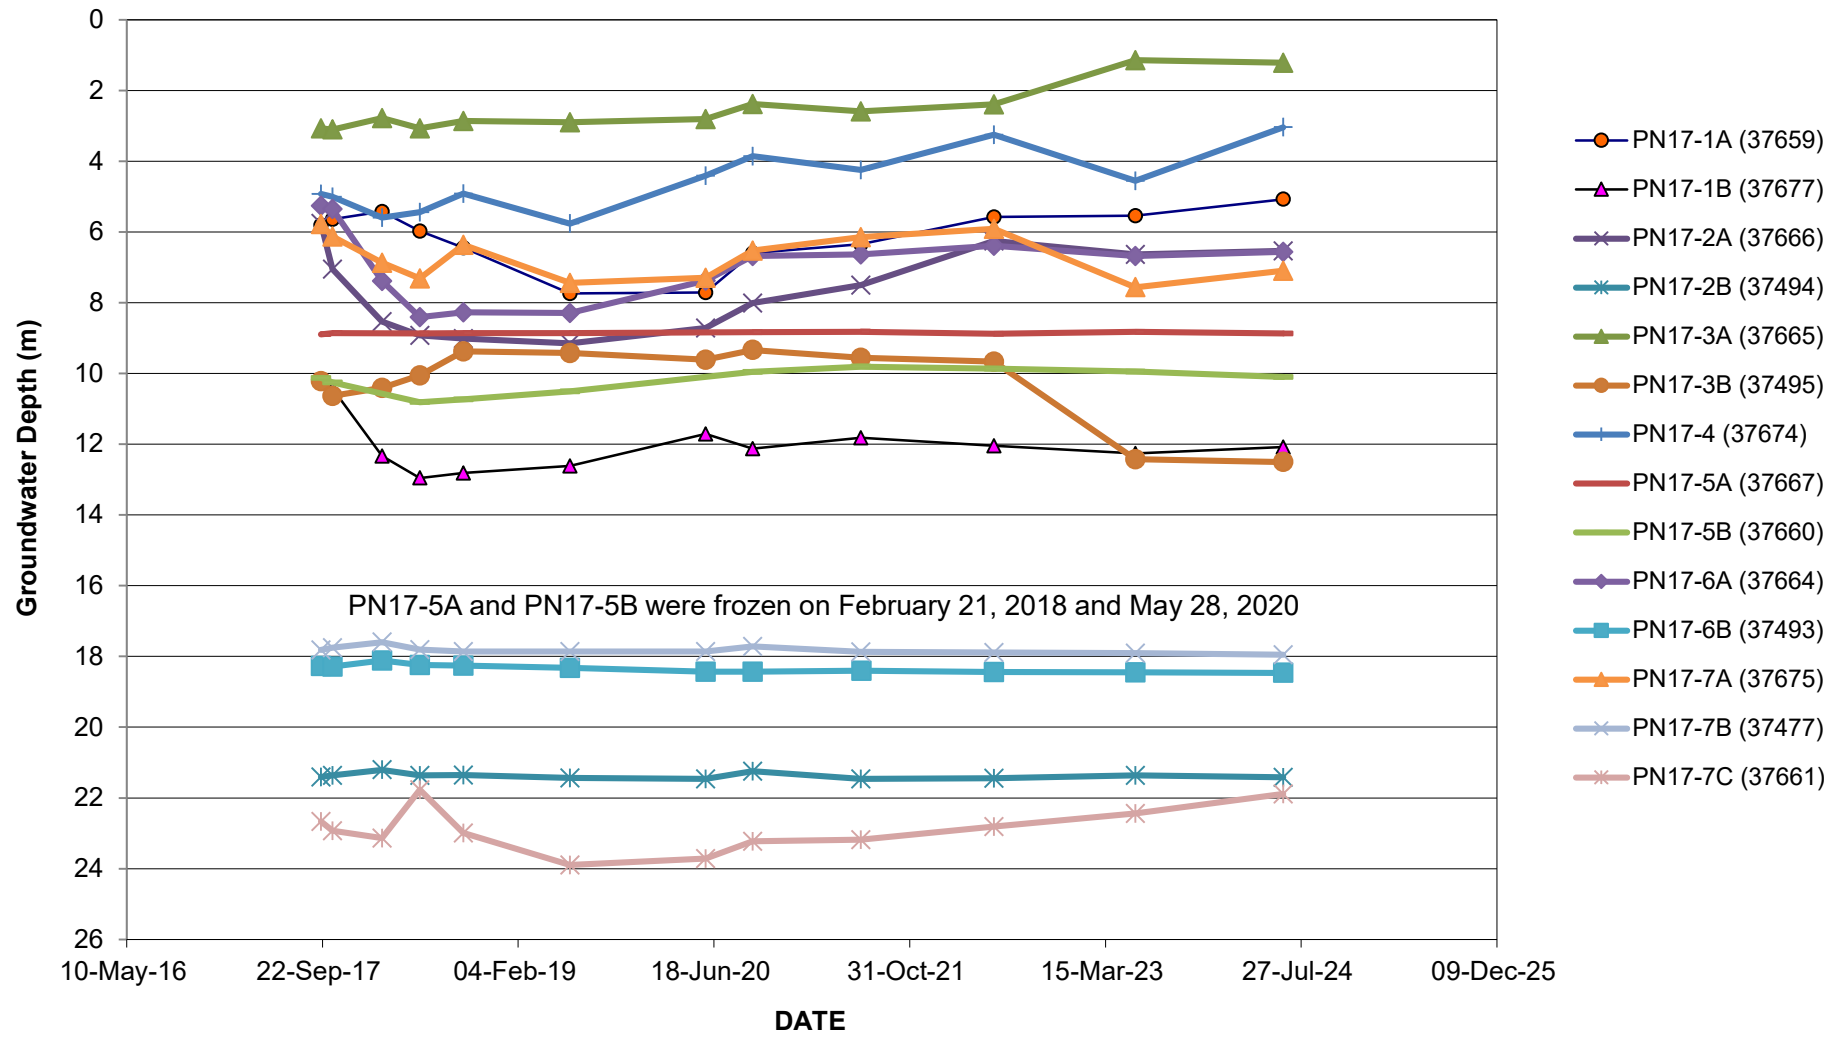
**FIGURE NC089-1
PIEZOMETER DATA FOR HWY 63:12 BEACON HILL**

<p>Pneumatic piezometers PN17-1A, PN17-1B, PN17-2A, PN17-4, PN17-6A, PN17-7A and PN17-7C showed increases in groundwater levels of 0.47 m, 0.17 m, 0.10 m, 1.51 m, 0.12 m, 0.47 m, and 0.55 m, respectively, since the spring of 2023. PN17-1A and PN17-4 showed a groundwater level of 5.07 m and 3.04 m below ground surface, respectively, which is the highest recorded reading in each of the instruments since initialization.</p> <p>Pneumatic piezometers PN17-2B, PN17-3A, PN17-3B, PN17-5A, PN17-5B, PN17-6B, and PN17-7B showed decreases in groundwater of 0.05 m, 0.07 m, 0.07 m, 0.04 m, 0.15 m, 0.01 m, and 0.04 m, respectively since the spring of 2023.</p>
Future Work:	The instruments should be read again in the spring of 2025.
Instrumentation Repairs:	No instrument repairs are required at this time.
Additional Comments:
