**GEOHAZARD ASSESSMENT PROGRAM
NORTH CENTRAL REGION – ATHABASCA
2017 INSPECTION**

Site Number	Location	Name	Hwy	km
NC017A	North of Fort McMurray	Hwy 63 Backslope Failures	63:12	2.2 to 2.9
Legal Description		UTM Co-ordinates (NAD 83)		
NW7 and SW18-90-09-W4M		12 N 6295275	E 473365

**NORTH CENTRAL REGION (ATHABASCA AREA)
- 2017 GEOHAZARD ASSESSMENT**

**NC017A: HWY 63:12 BACKSLOPE FAILURES
(km 2.4 AND km 2.7)
SITE PLAN**

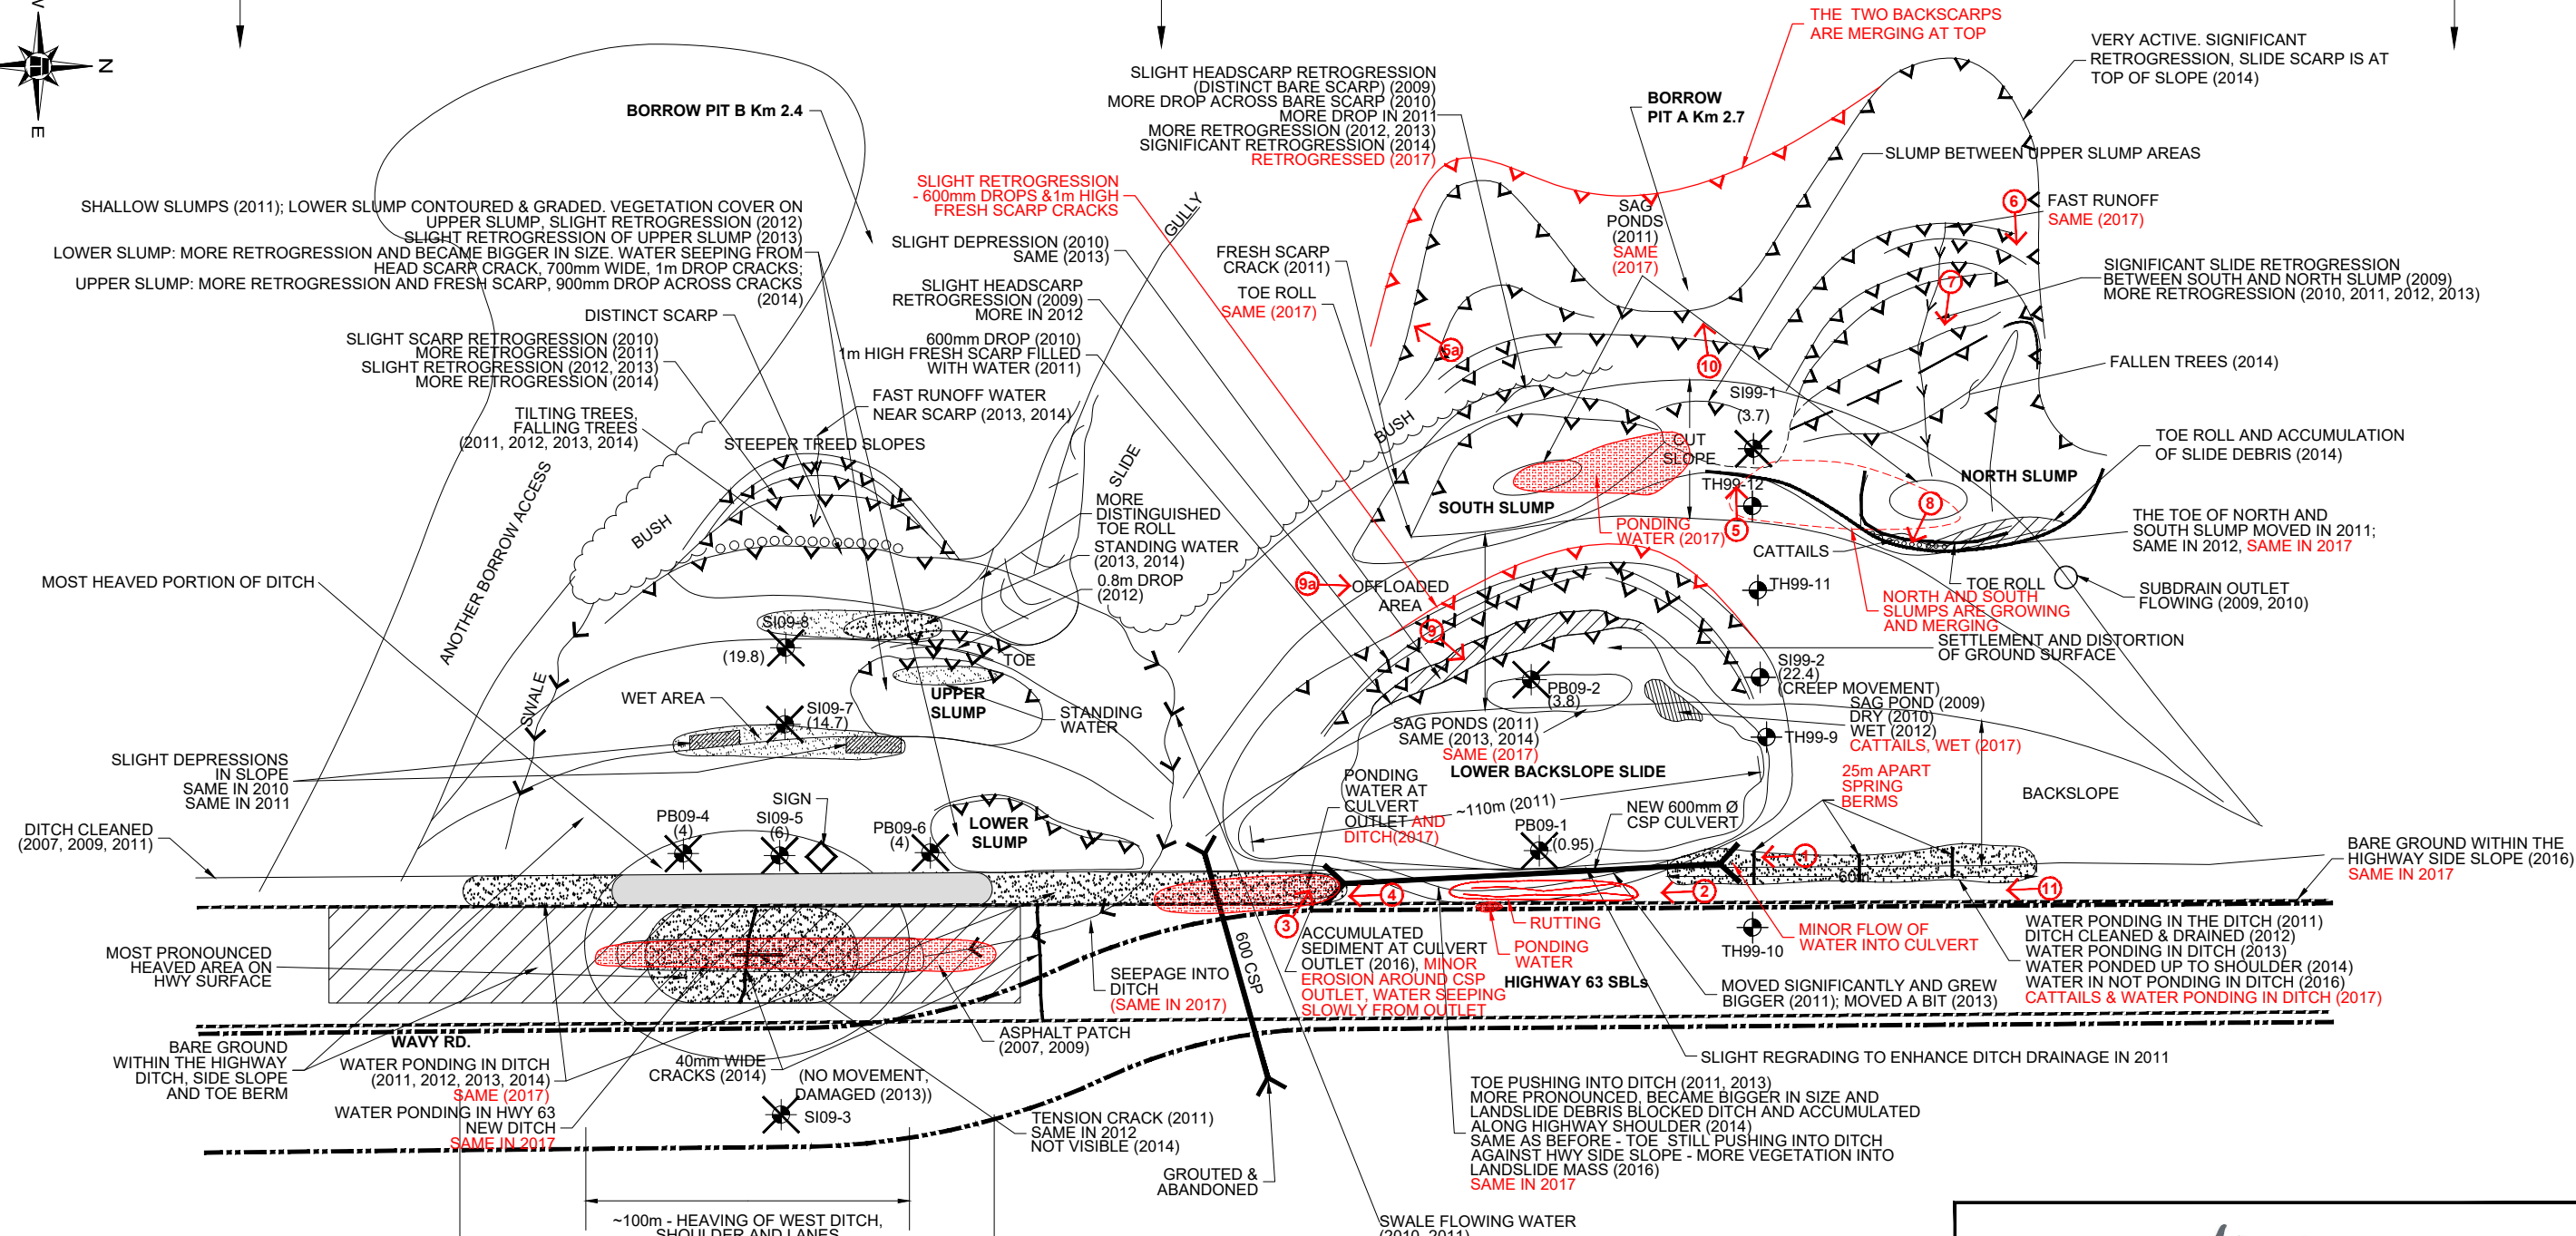
FIGURE NC017A-1

The existing lower landslide and upper backslope slumps occurred due to the progressive failure of the steep back slope cuts in the weak colluvium deposits.

Km 2.4: The highway was shifted away from the toe of the landslide and hence it is not currently impacted by the landslide movement.

Km 2.7: The upper back slope slumps and lower landslide are still active and will continue to move over time. It is likely that the lower landslide debris will keep pushing against the culvert and the highway shoulder. Although the landslide is not currently affecting the highway condition, the landslide debris are within the highway clear zone, which constitutes a safety hazard to motorists. In addition, the landslide debris may encroach into the highway surface in response to future accelerated movements.

Km 2.7: In the short-term, the lower landslide should be visually monitored by the local MCI, particularly after heavy rainfall events, to check if the landslide debris encroaches into the highway lanes in response to an accelerated movement. The ditch to the north and the south of the culvert will need to be slightly contoured to enhance surface drainage and additional riprap protection should be provided at the outlet of the culvert. The area located between the highway and the toe of the lower backslope landslide should also be touched, without significantly changing grades, to drain ponded water into the existing ditch.

The long-term remedial measure may include the installation of a gravity wall in the highway ditch to retain the toe of the landslide.

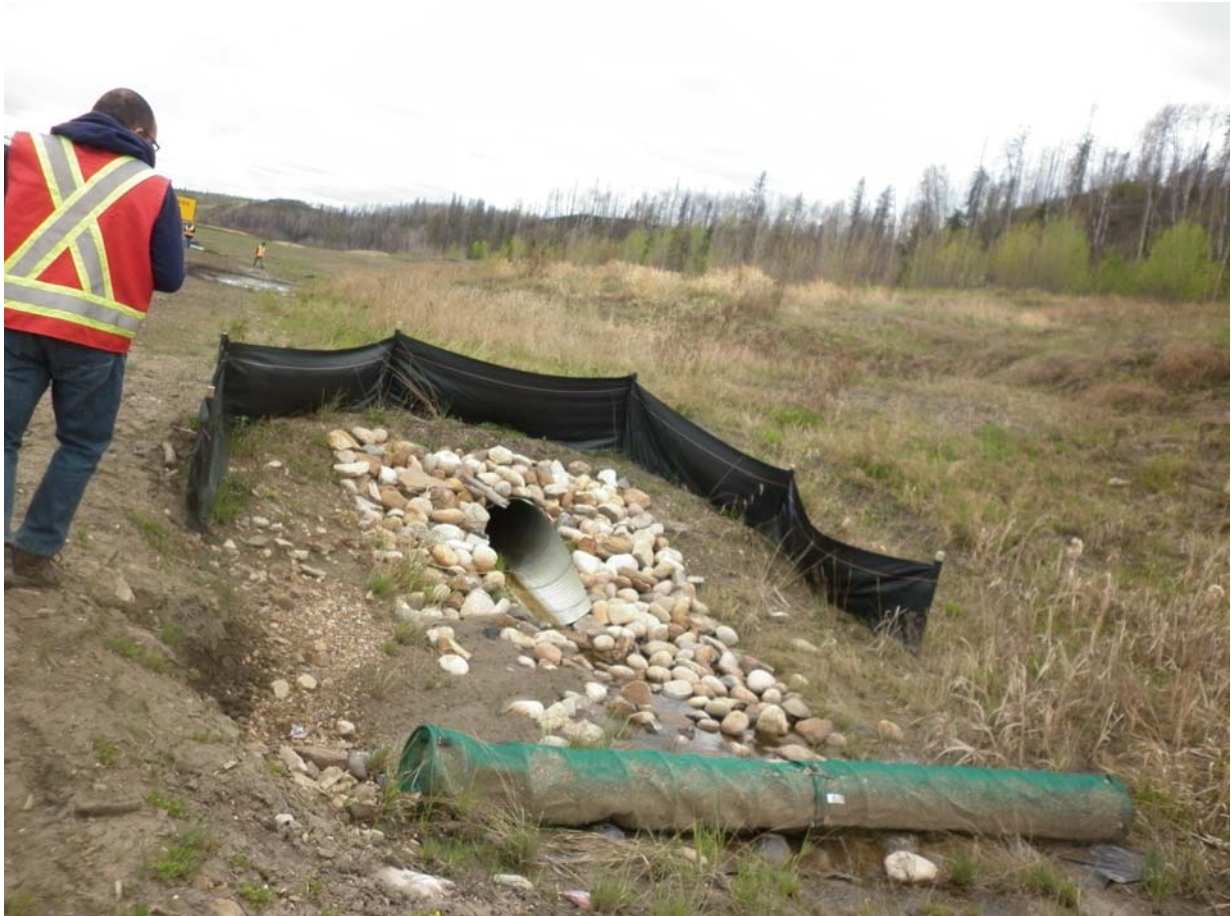
The ditch culvert is not currently damaged but appears to be sagging as it is not draining properly and the water continues ponding inside and beyond the outlet of the culvert. Impedance of surface drainage in the ditch could result in accelerated landslide movement and instability of the highway embankment side slopes. In addition, the culvert may get damaged/distorted in response to future accelerated movements.

Photo 1 – Looking at the inlet of the culvert installed in the highway ditch below the lower landslide toe roll

In addition, the local MCI should periodically inspect the culvert to ensure it is not damaged or separated. Consideration should be given for replacing or lining the existing culvert with a more robust pipe (e.g. a smooth wall steel pipe) to sustain ongoing landslide movements.

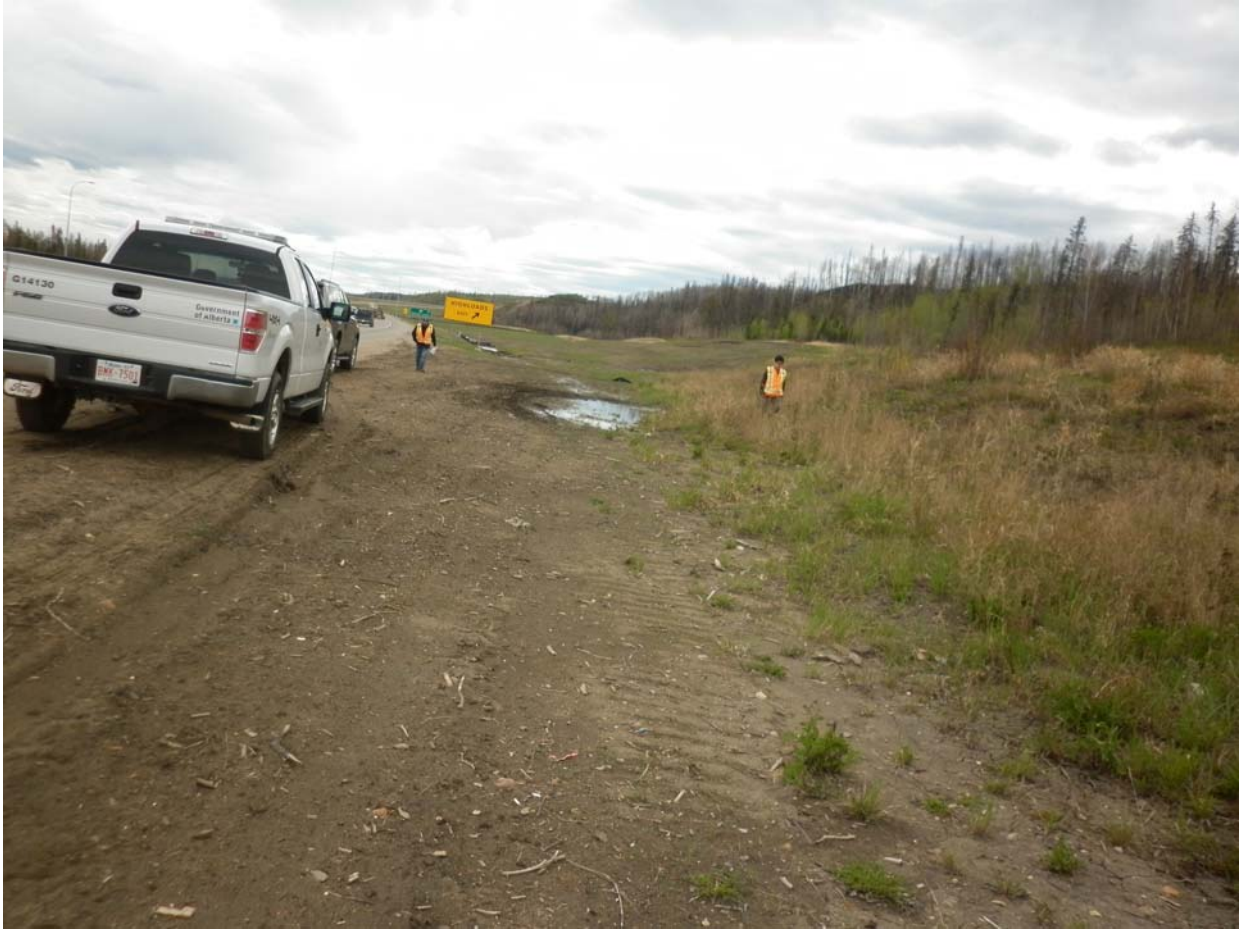
Erosion issues may develop in the highway side slopes and ditches due to the absence of vegetation.

Photo 2 – Ponding water between the highway and the toe of the landslide (Looking South); note that the highway side slopes are bare of vegetation

The highway side slopes and ditches should be topsoiled and seeded, as needed, to promote vegetation and reduce erosion potential.

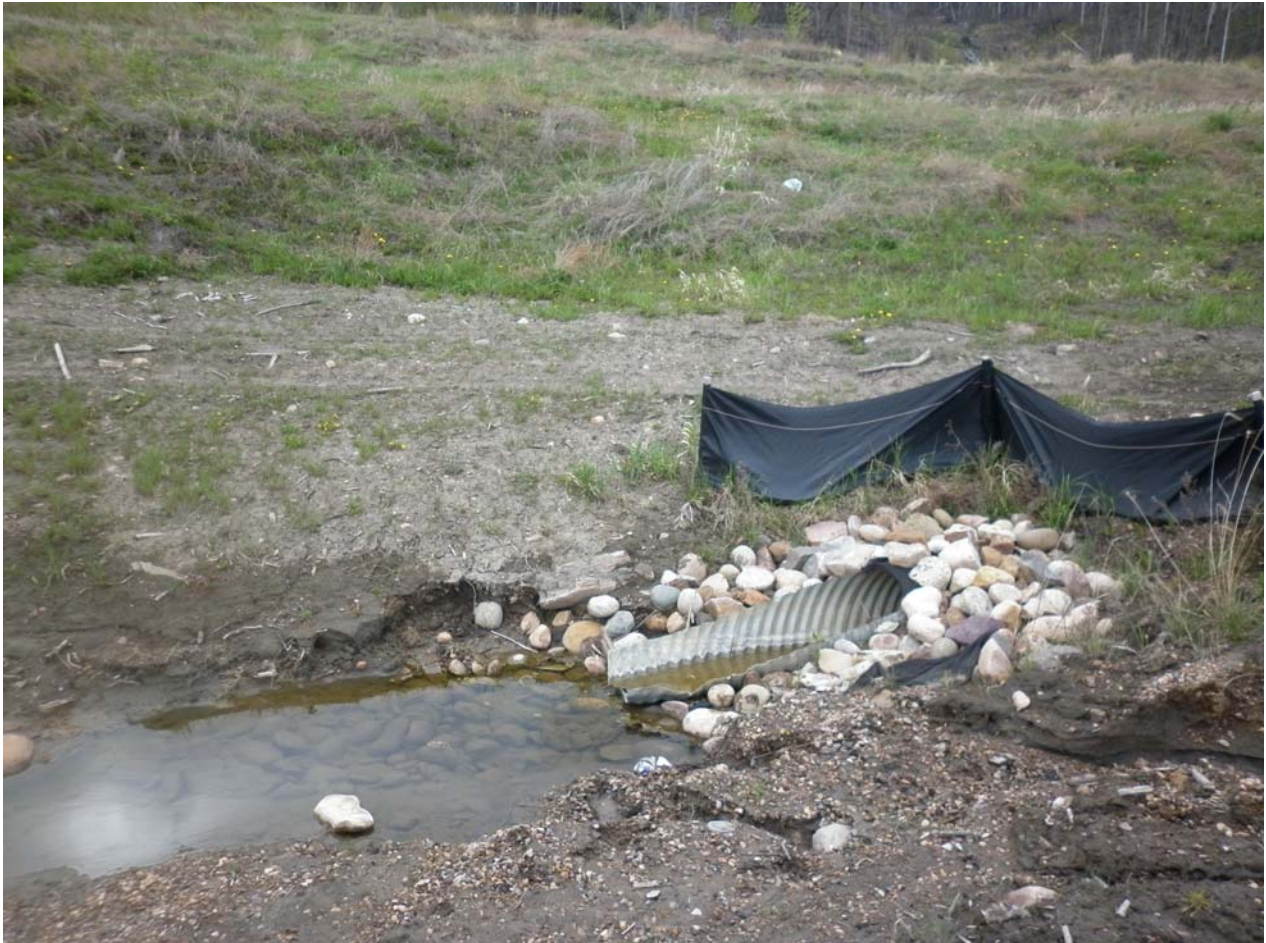
Photo 3 – Minor erosion and standing water around culvert outlet

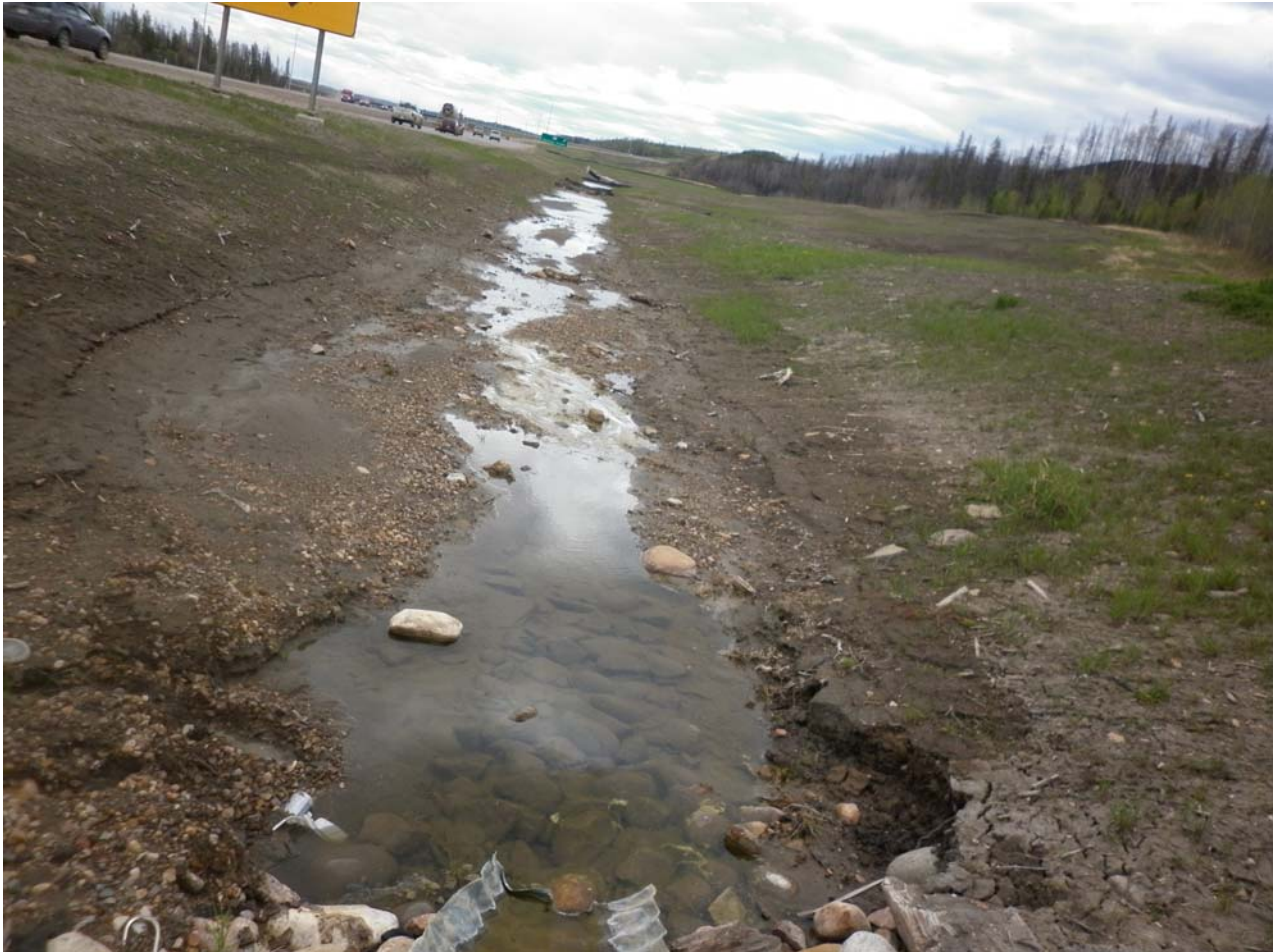
The ditch does not appear to have enough gradient to the north and the south of the culvert location to handle surface runoff.

Photo 4 – Water ponding at the culvert outlet and along the ditch (Looking South)

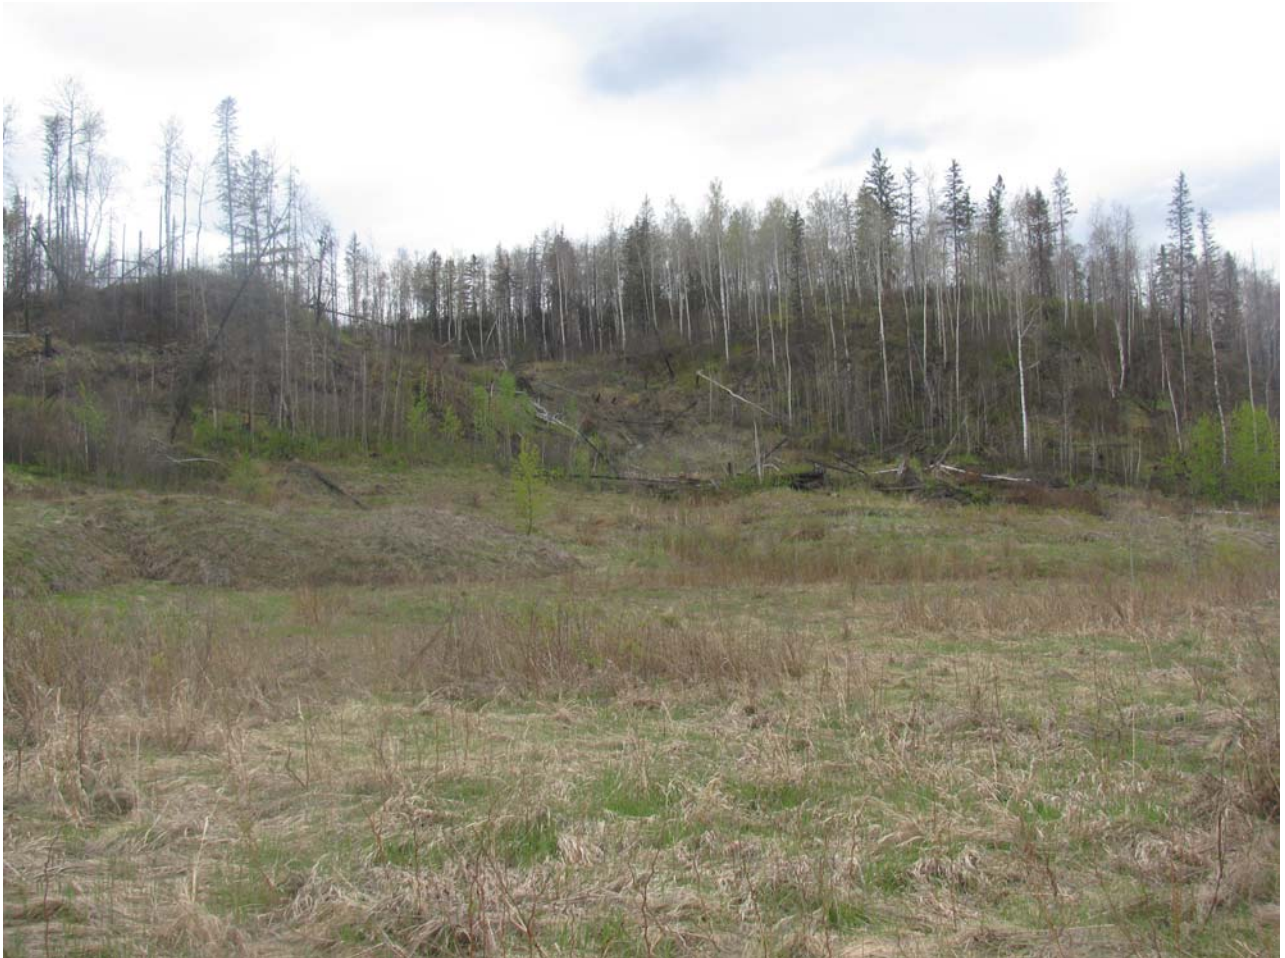
Photo 5 – Looking at the upper backslope slump areas and toe rolls

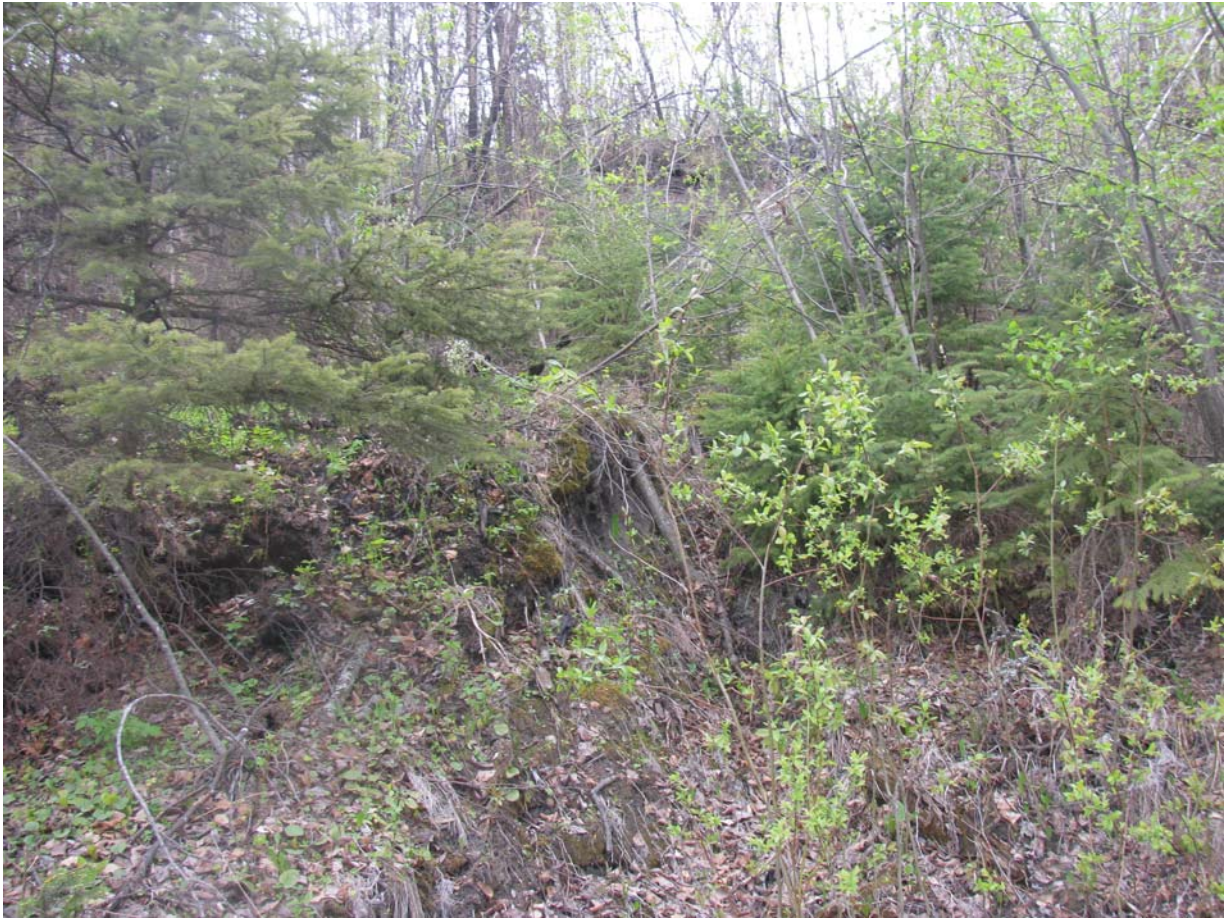
Photo 5a – Looking at the flank of the upper backslope south slump

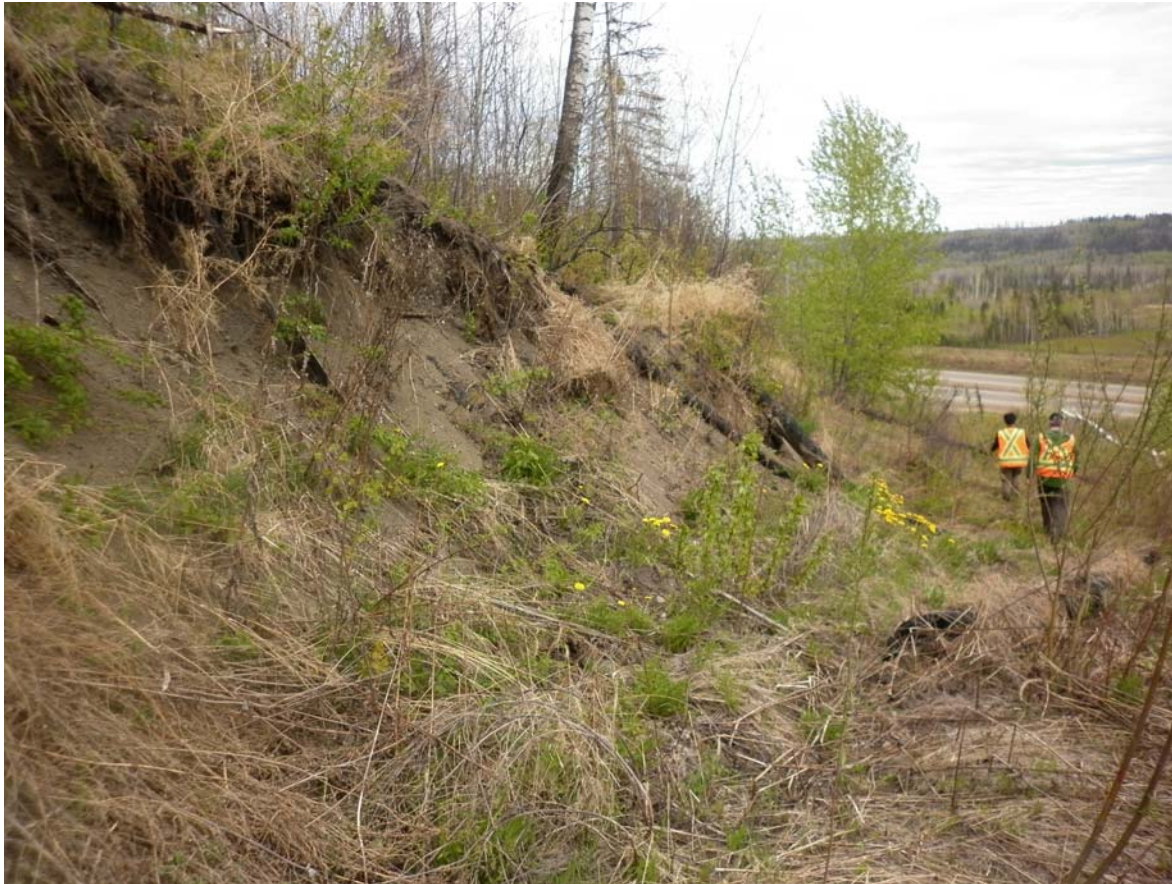
Photo 6 – Looking at the flank of the upper backslope north slump

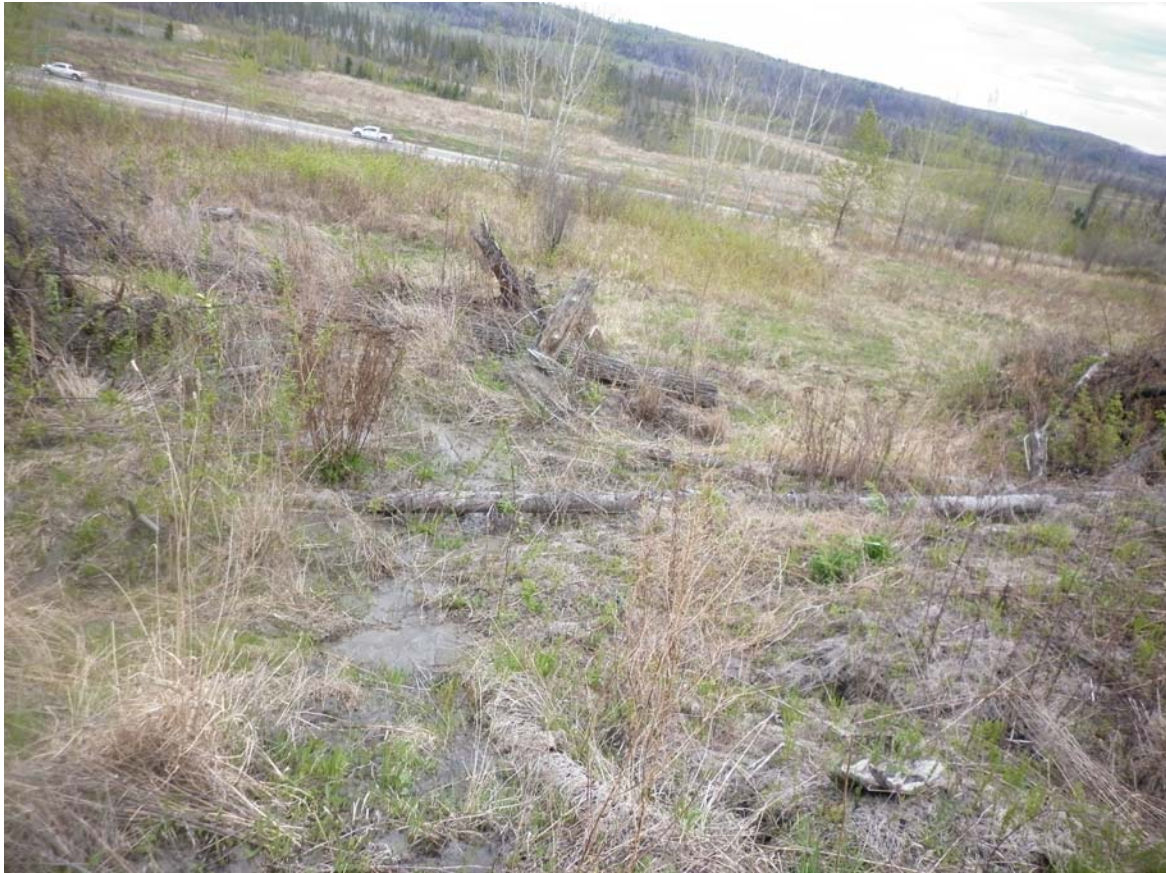
Photo 7 – Fast seepage near the northern flank of the upper backslope north slump (Looking East)

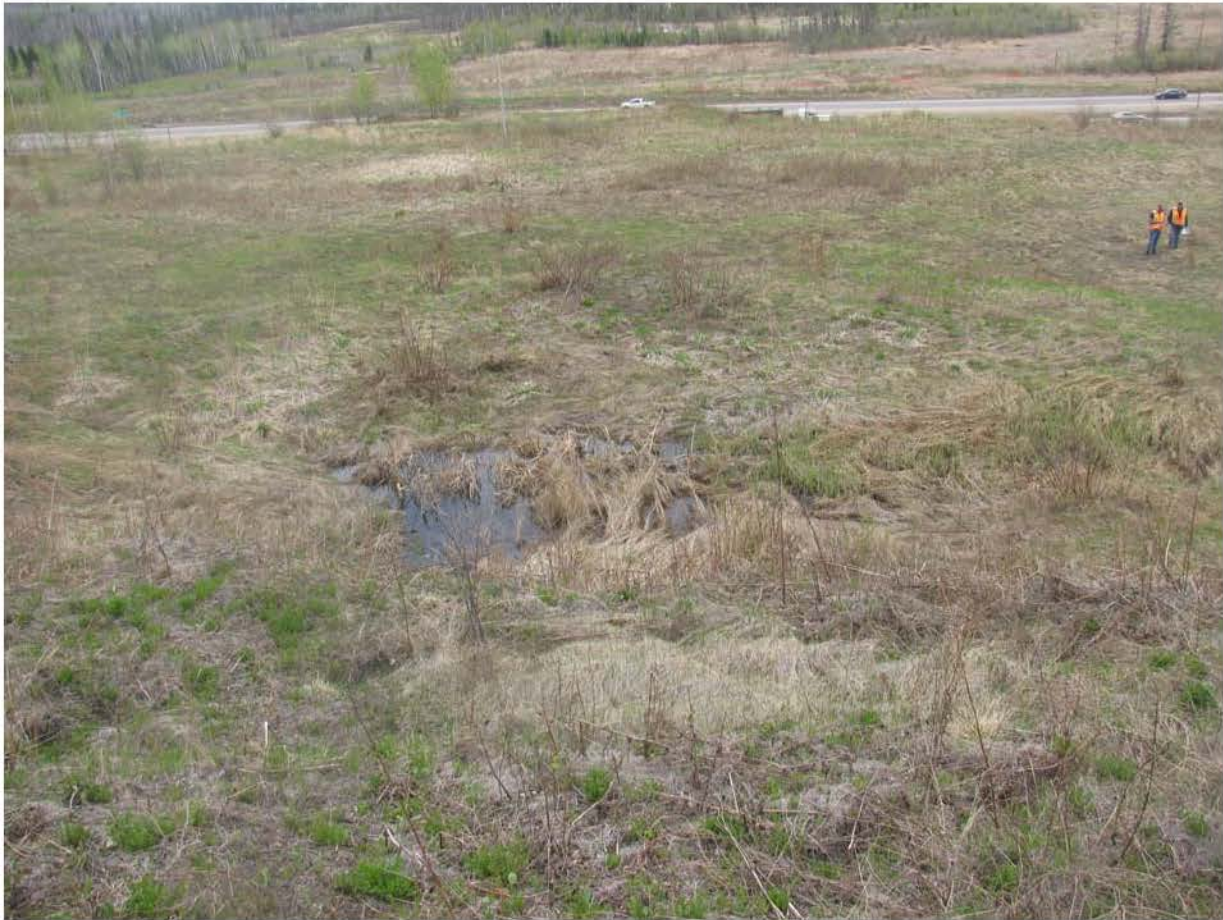
Photo 8 – Ponding water near the toe of the north slump (Looking East)

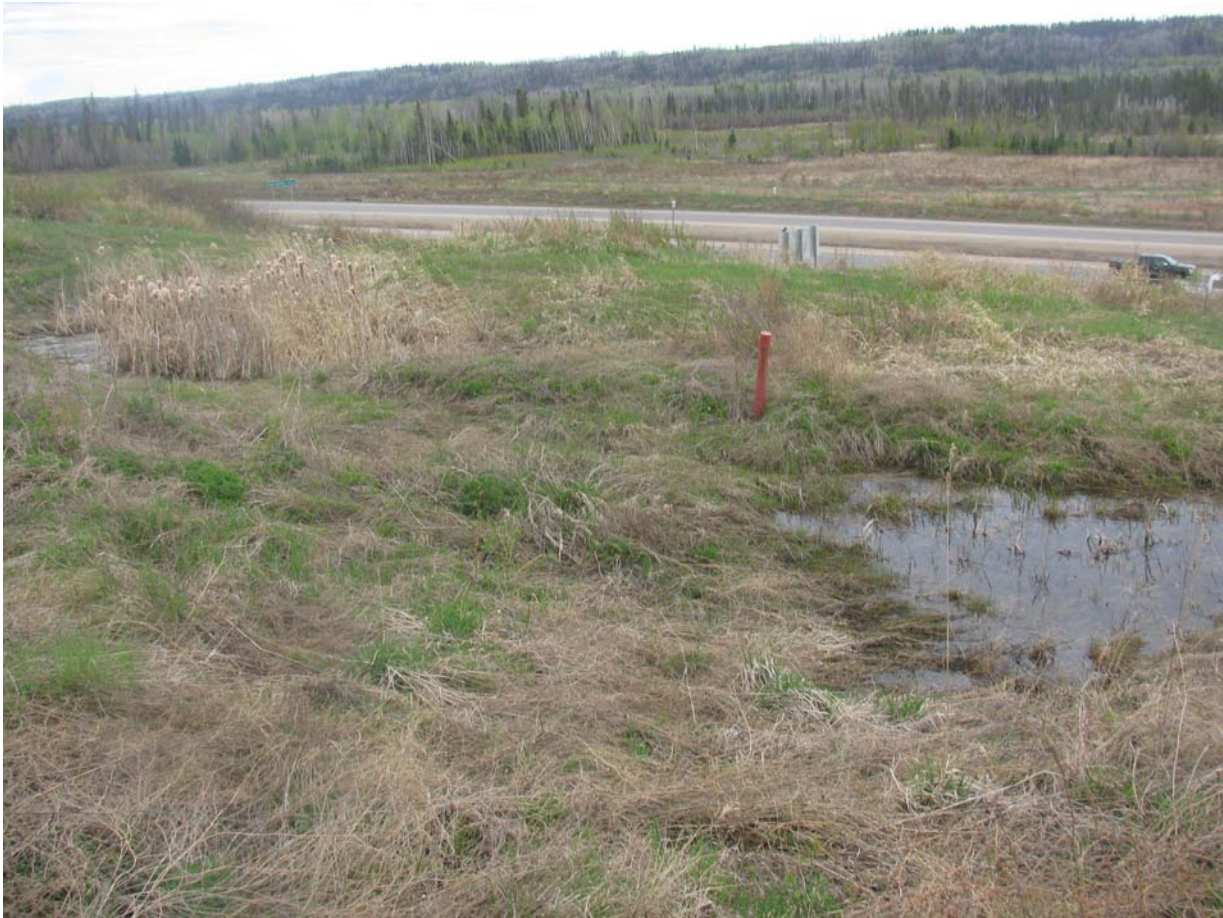
Photo 9 – Sag Ponds around PB09-2 within the lower backslope landslide mass (looking north); note that cattail vegetation has grown in one of the sag ponds

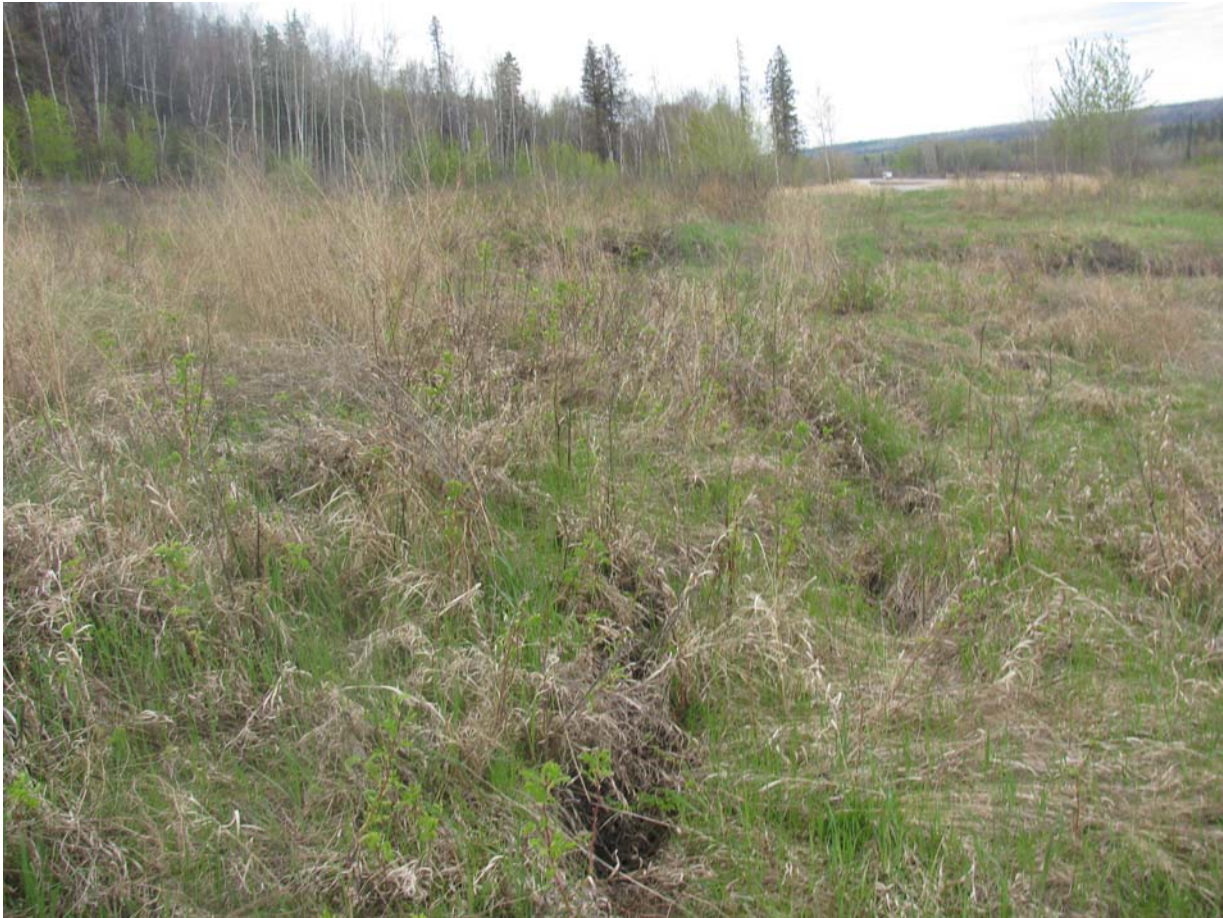
Photo 9a – Looking north at a relatively fresh head scarp crack of the lower backslope landslide

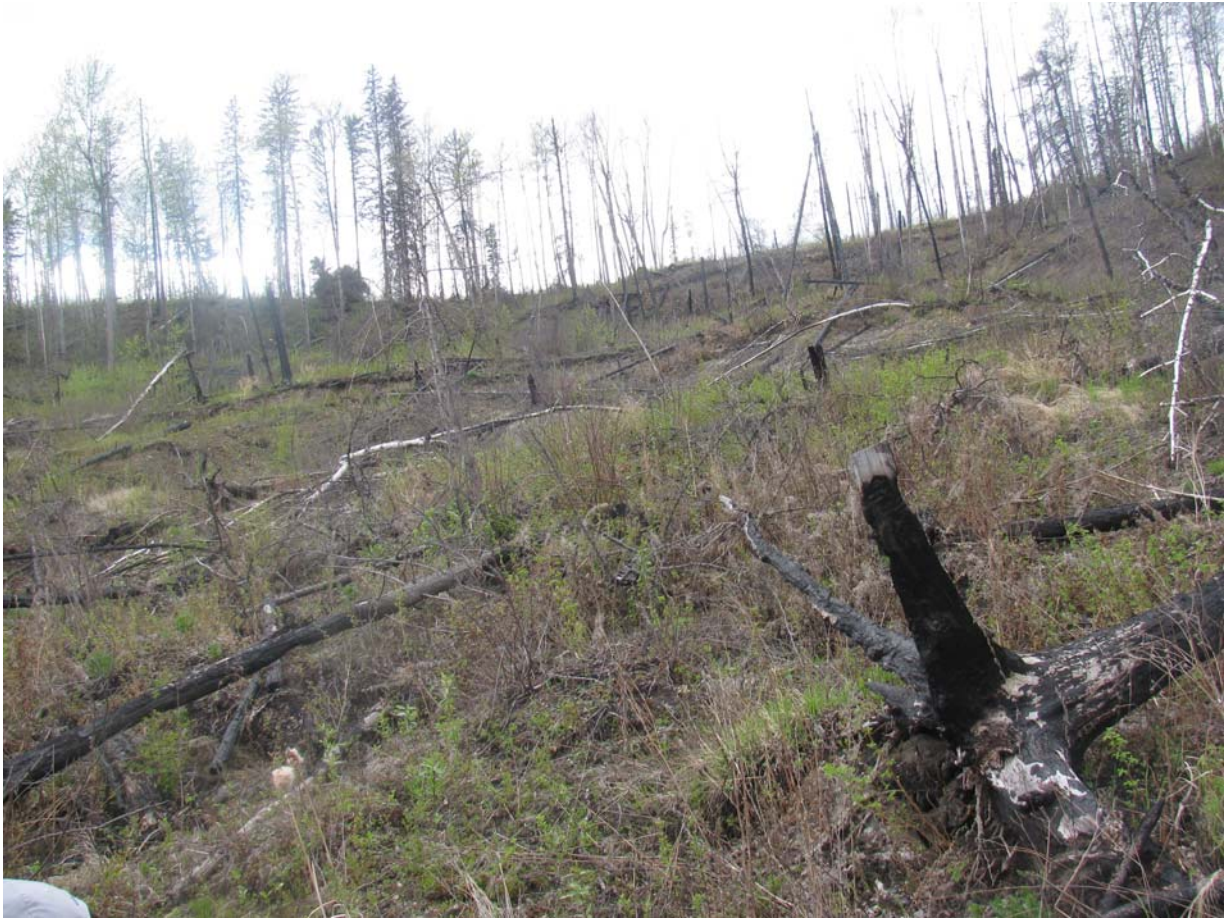
Photo 10 – Looking at a scarp crack connecting the head scarps of the upper backslope north and south slumps

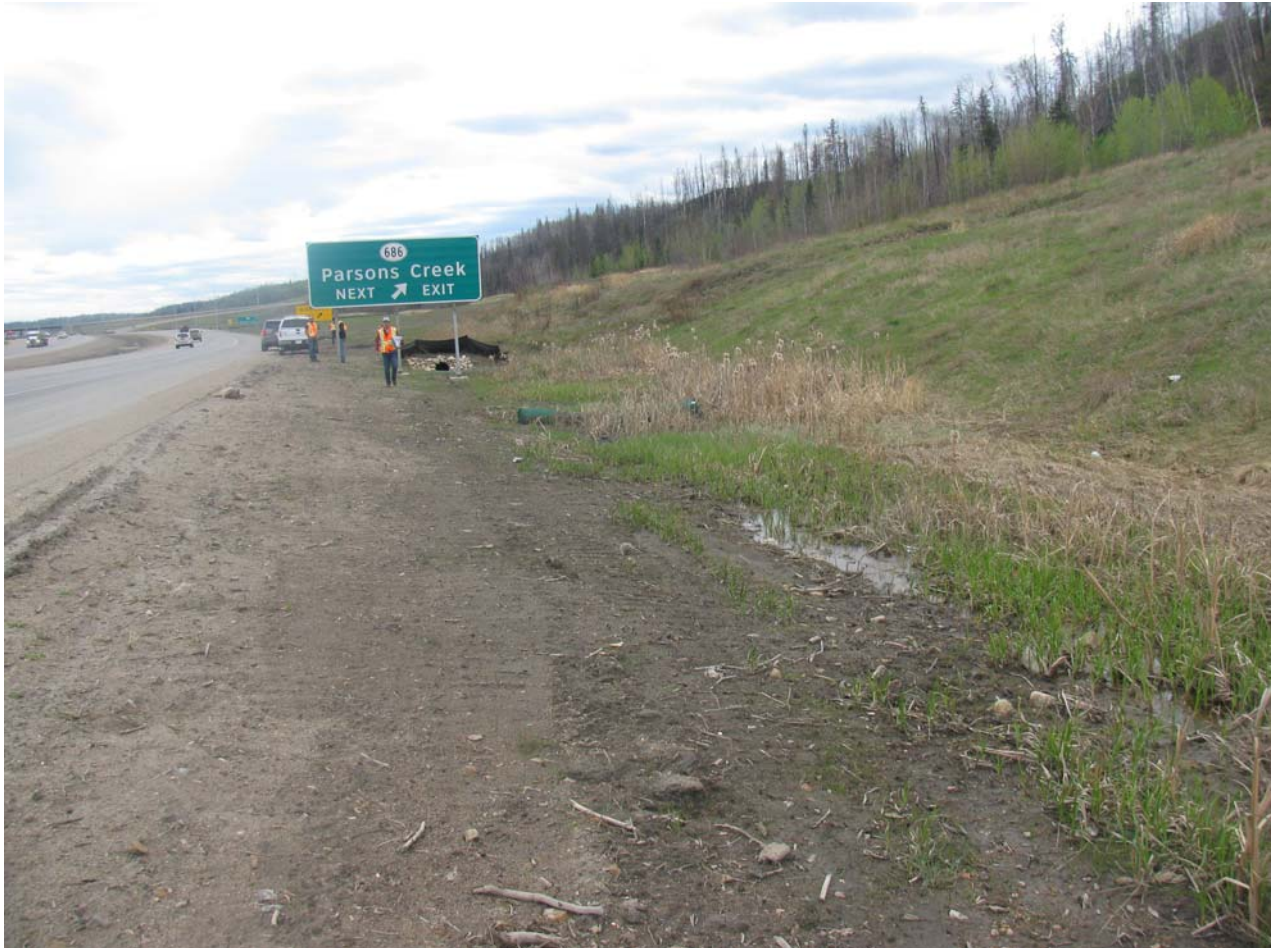
Photo 11 – Water ponding in the ditch (Looking South)
