**ALBERTA TRANSPORTATION
GEOHAZARD ASSESSMENT PROGRAM
NORTH CENTRAL REGION – ATHABASCA &
FORT MCMURRAY DISTRICTS)
2022 SITE INSPECTION**

| Site Number | Location | Name | Hwy | km |
|---|---|---|---|---|
| NC017A | North of Fort McMurray | Hwy 63 Backslope Failures | 63:12 | 2.7 |

**NORTH CENTRAL REGION
(ATHABASCA AND FORT MCMURRAY DISTRICTS)
2022 GEOHAZARD ASSESSMENT
NC017A: HWY 63:12 BACKSLOPE FAILURES
(km 2.4 AND km 2.7)
SITE PLAN**

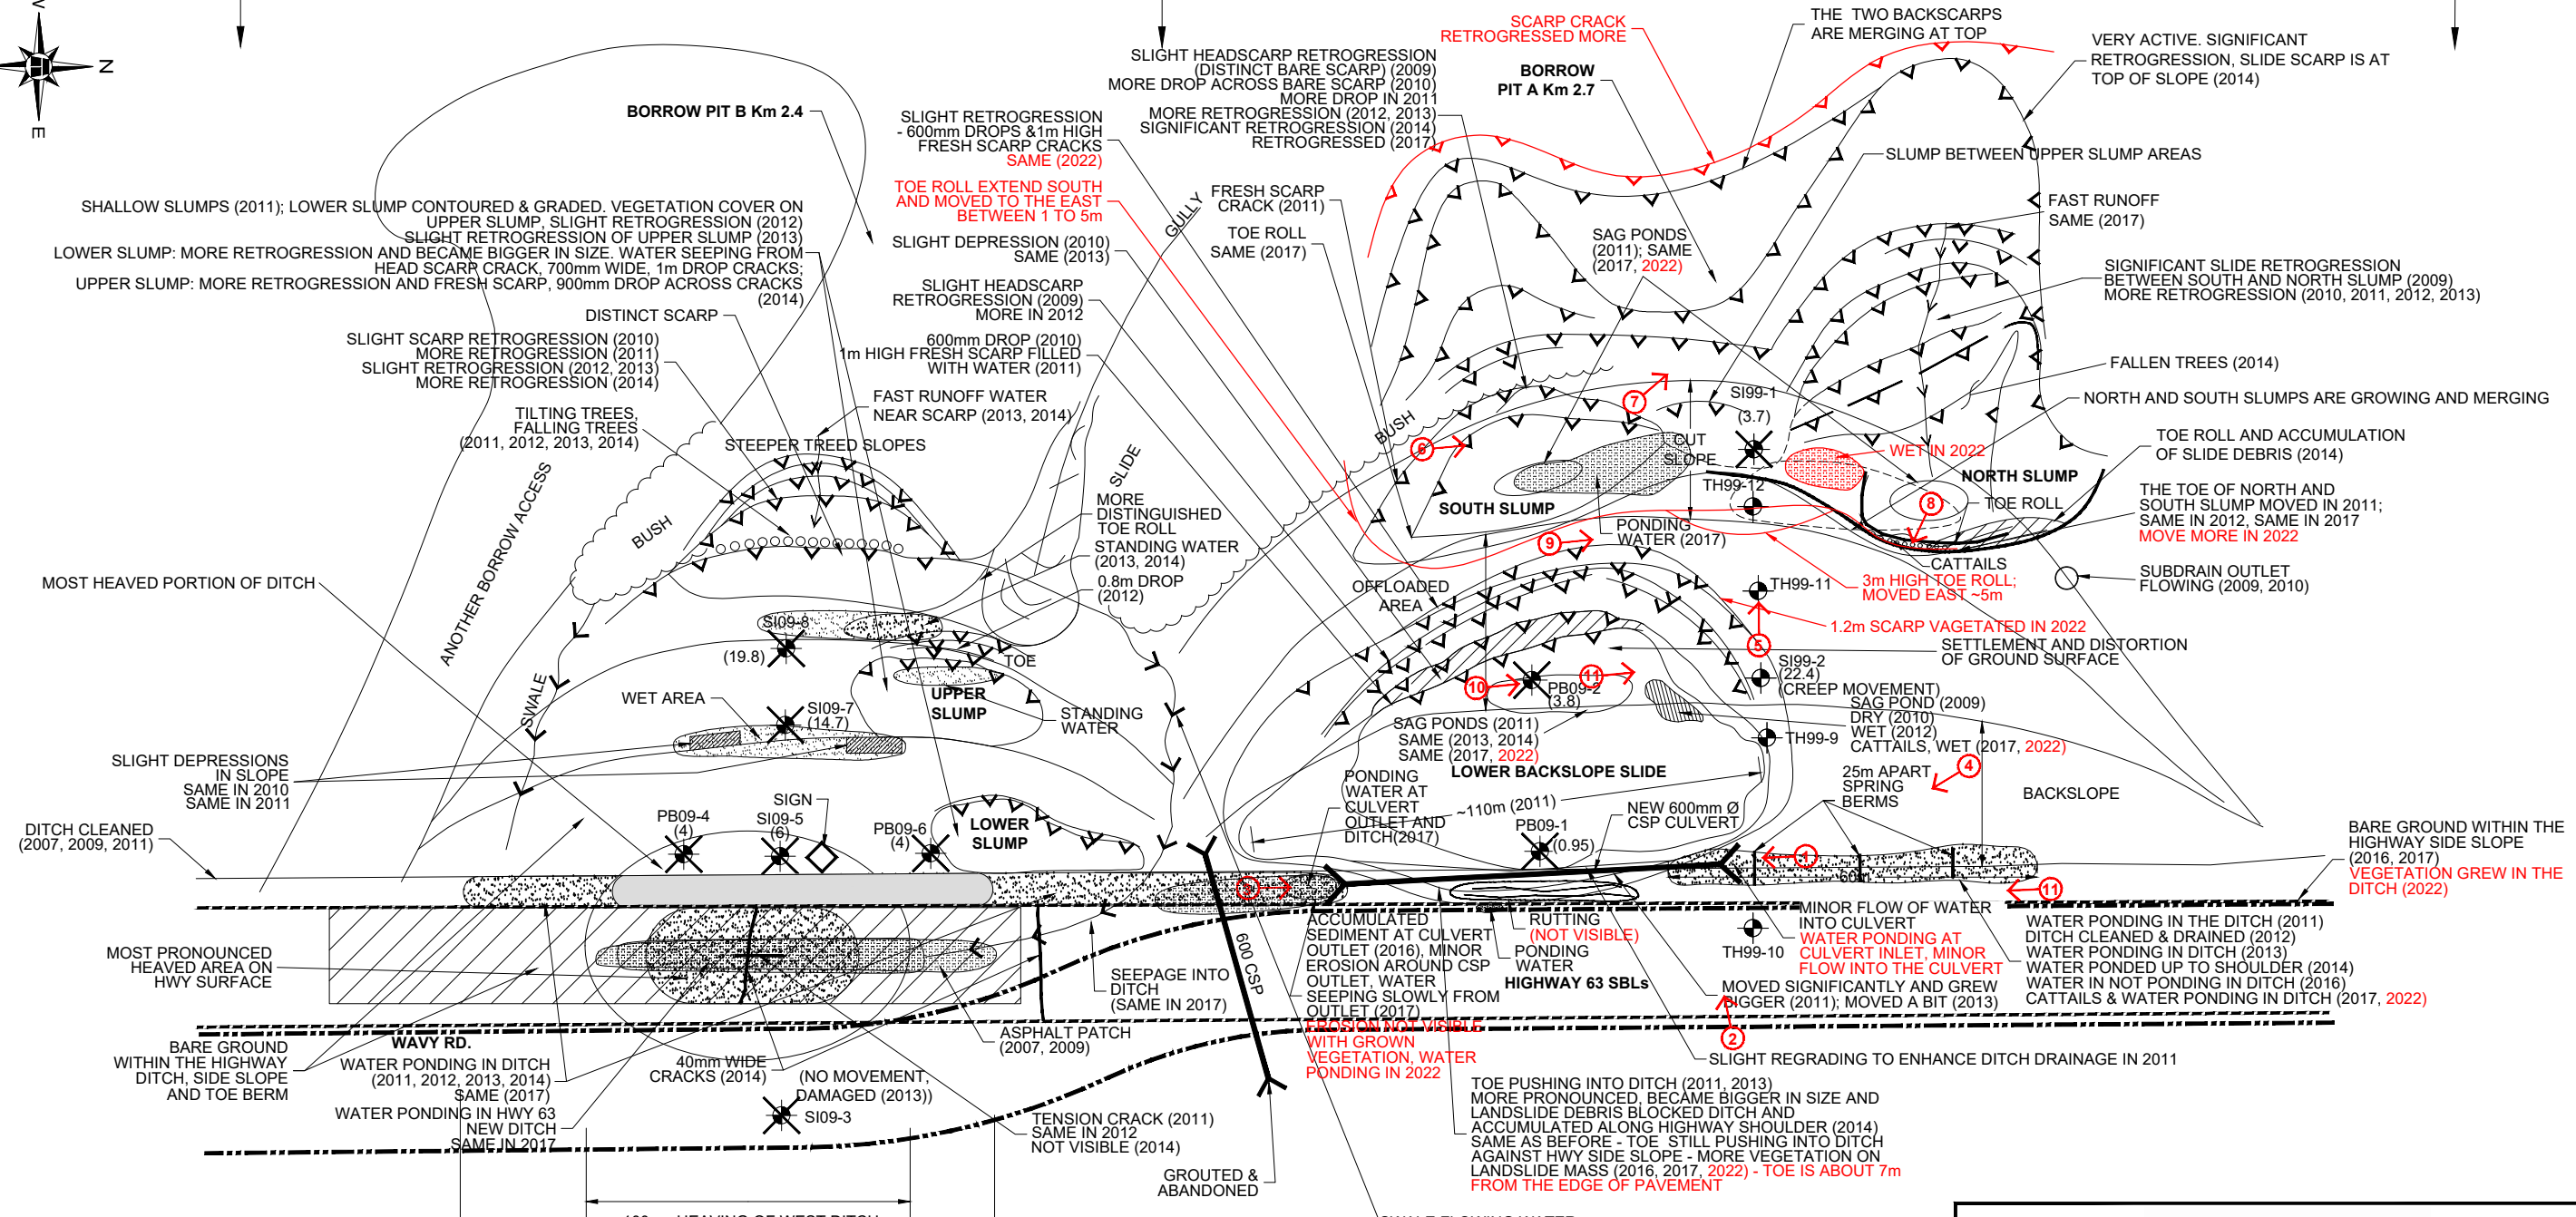
FIGURE NC017A-1

| Previously installed instruments as shown on the attached Figure NC017A-1 are either sheared off or damaged and unreparable. | | |
| <p>The existing lower landslide and upper backslope slumps occurred due to the progressive failure of the steep back slope cuts in the weak colluvium deposits.</p> <p>The ditch does not appear to have enough gradient to the north and the south of the culvert location to handle surface runoff.</p> <p>Km 2.4: The highway was shifted away from the toe of the landslide and hence it is not currently impacted by the landslide movement.</p> <p>Km 2.7: The upper back slope slumps and lower landslide are still active and will continue to move over time. However, the upper back slope slumps appear to have moved more than the lower landslide. It is likely that the lower landslide debris will keep pushing against the culvert and the highway shoulder. Although the landslide is not currently affecting the highway condition, the landslide debris are within the highway clear zone, which constitutes a safety hazard to motorists. In addition, the landslide debris may encroach into the highway surface in response to future accelerated movements.</p> <p>The ditch culvert appears to be sagging as it is not draining properly, and the water continues ponding inside and beyond the ends of the culvert. Impedance of surface drainage in the ditch could result in accelerated landslide movement and instability of the highway embankment side slopes. In addition, the culvert may get damaged/distorted in response to future accelerated movements.</p> | | |

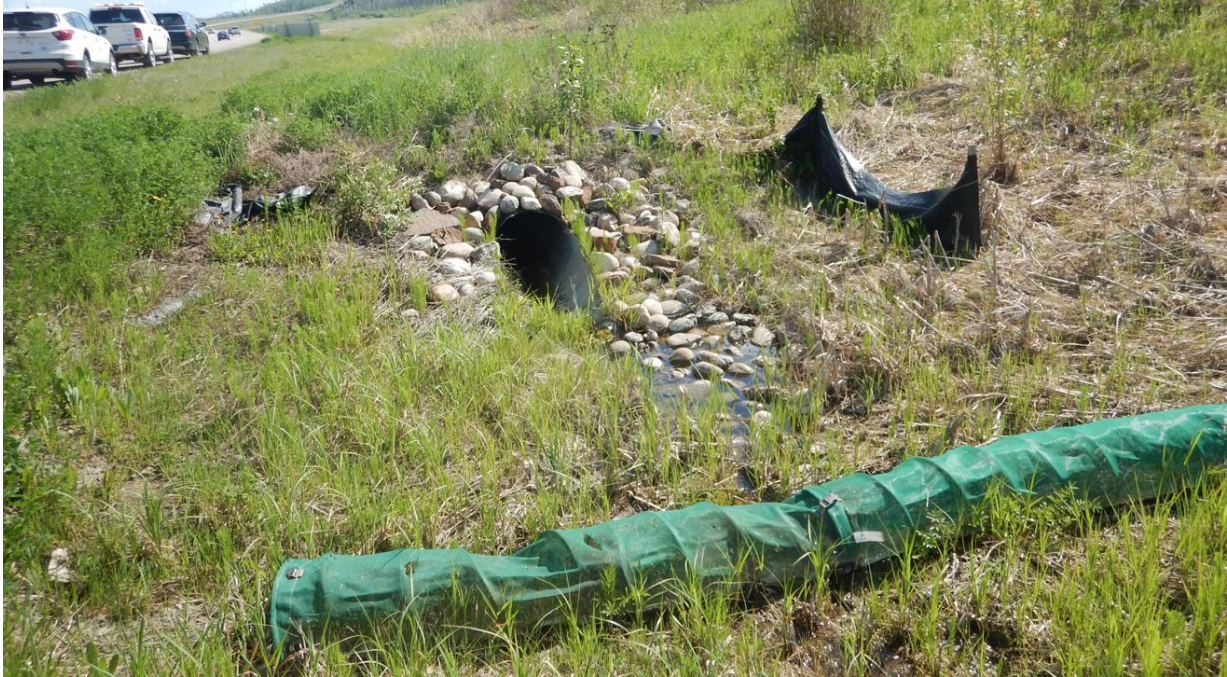
| <input checked="" type="checkbox"/> Bridge/Culvert Distress | Km 2.7: Water slowly flowing from the culvert outlet; ponding water inside the culvert | <input type="checkbox"/> |

Photo No. 1 – Looking at the inlet of the culvert installed in the highway ditch below the lower landslide toe roll; water is slightly ponding at the culvert inlet location

In addition, the local MCI should periodically inspect the culvert to ensure it is not damaged or separated. Consideration should be given to lining the existing culvert with a more robust pipe (e.g., a smooth wall steel pipe) to sustain ongoing landslide movements. If the culvert is damaged or separated in response to the landslide movement, a new SWSP pipe will have to be auger bored below the toll roll debris to enhance surface water drainage in the highway ditch.

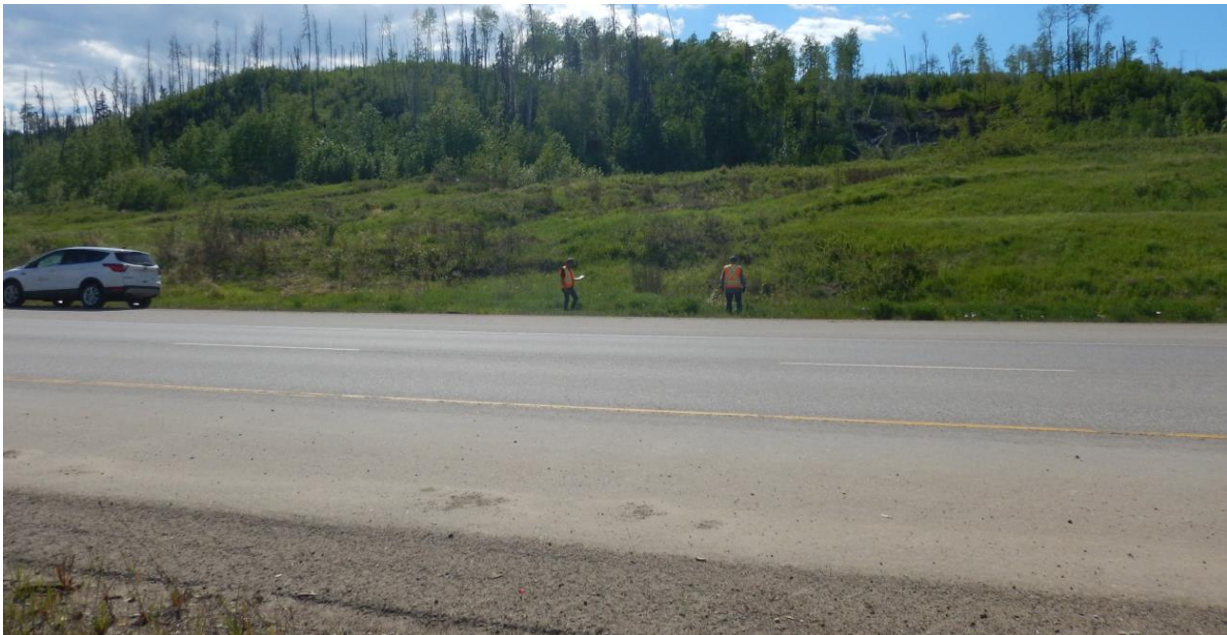
Photo No. 2 – Looking west at NC017A-2 landslide area

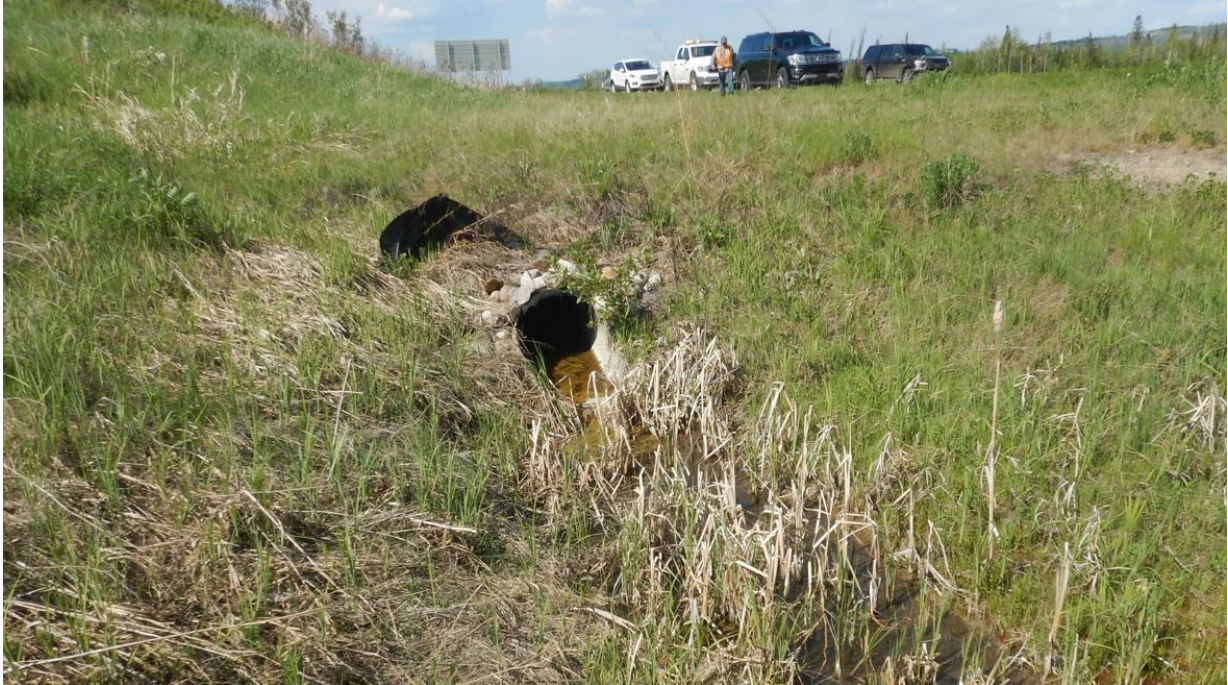
| <input checked="" type="checkbox"/> Erosion | Km 2.7: Minor erosion previously noted at the outlet of the of the existing 600 mm diameter CSP culvert in the ditch was not visible during the 2022 inspection as this area was covered with vegetation | <input type="checkbox"/> |

Photo No. 3 – Looking north at culvert outlet; more vegetation grew in ditch and water ponding at outlet in 2022

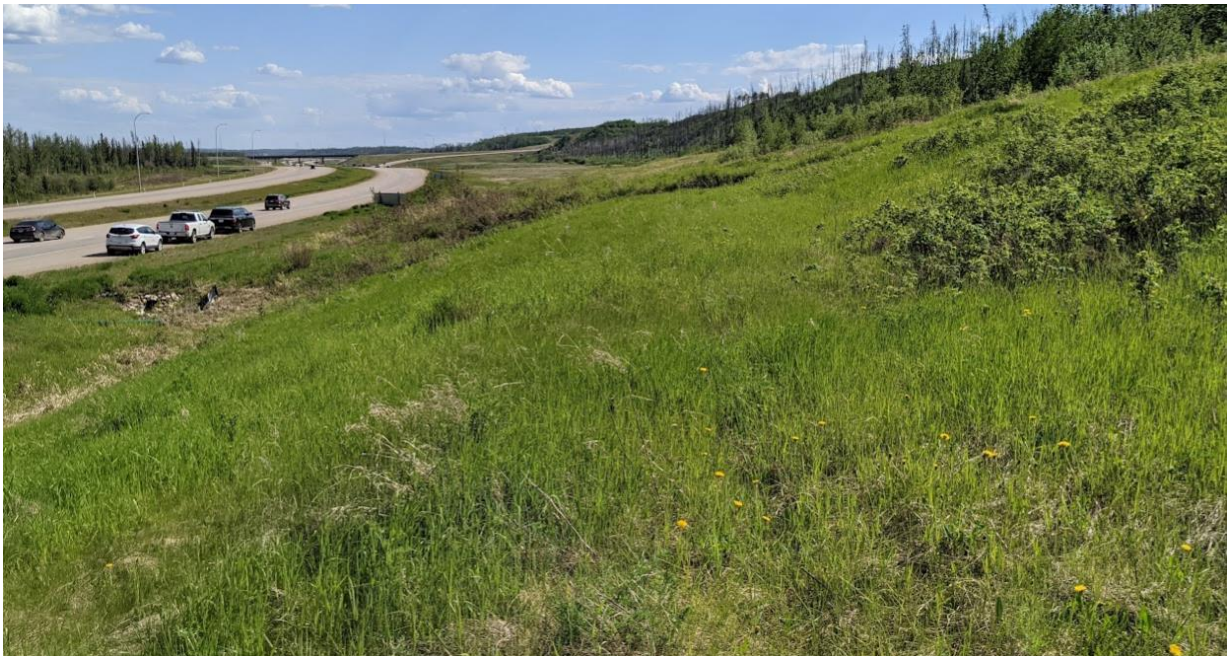
Photo No. 4 – Looking southeast at a scarp cack of the lower backslope slide

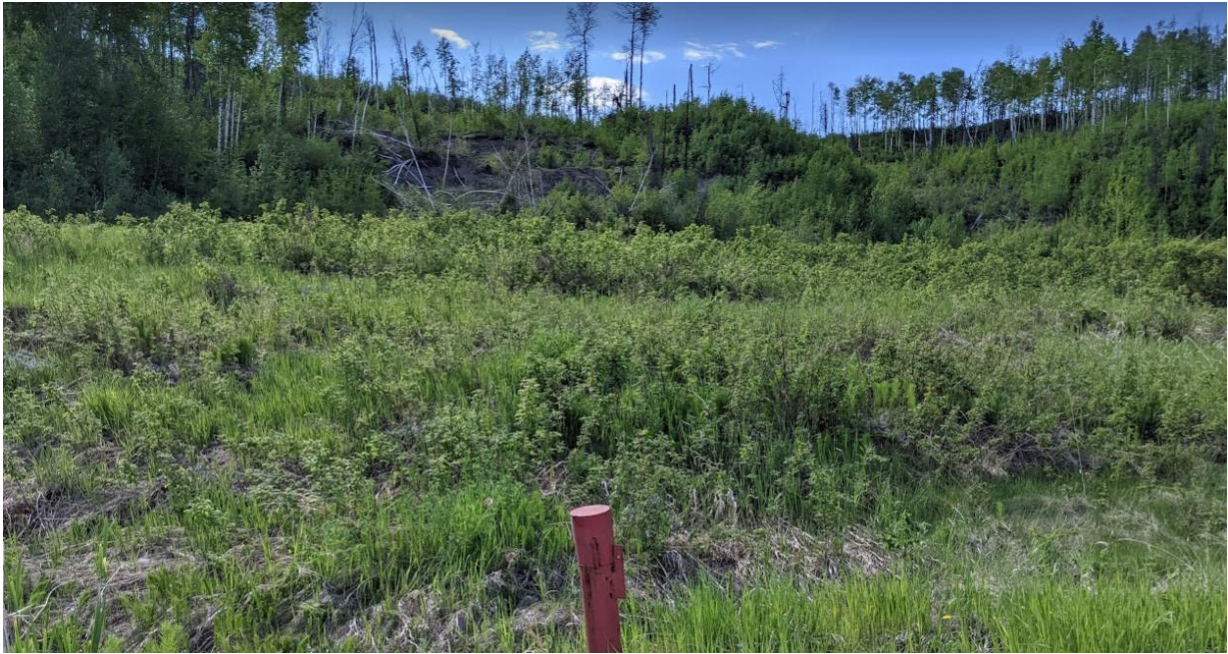
Photo No. 5 – Looking at the upper backslope slump areas and toe rolls

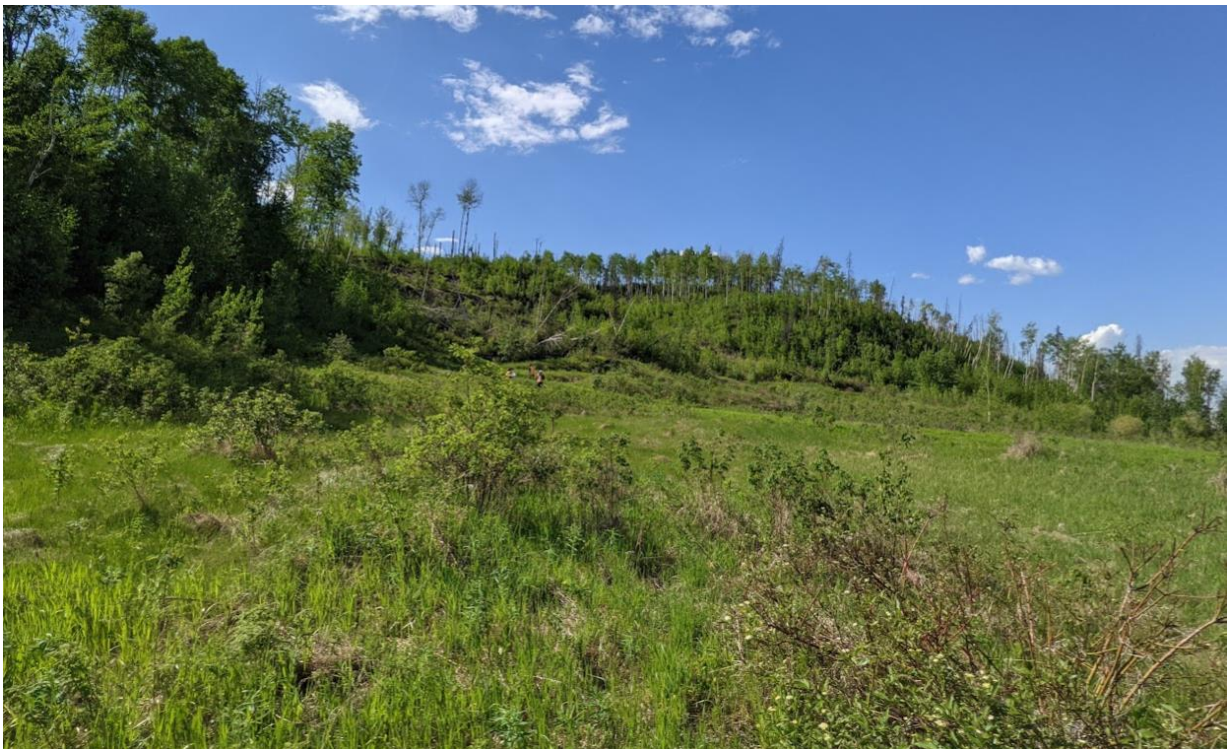
Photo No. 6 – Looking at the southern flank of the upper backslope slump

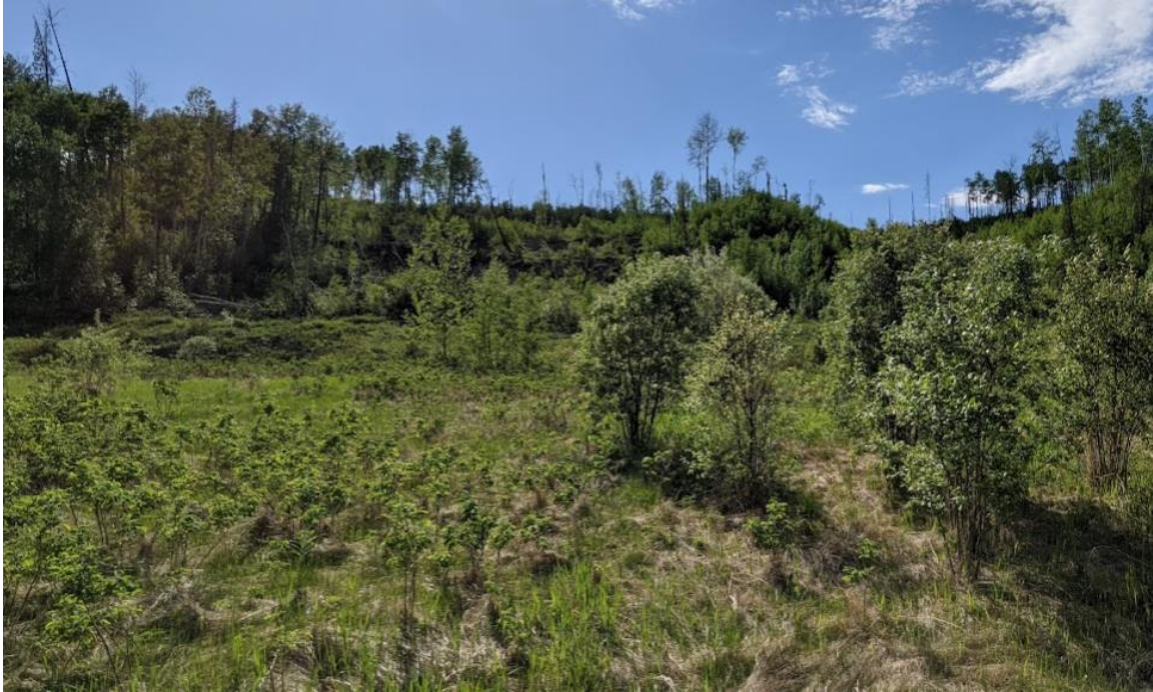
Photo No. 7 – Looking northwest at the head scarp cracks of the upper backslope slump

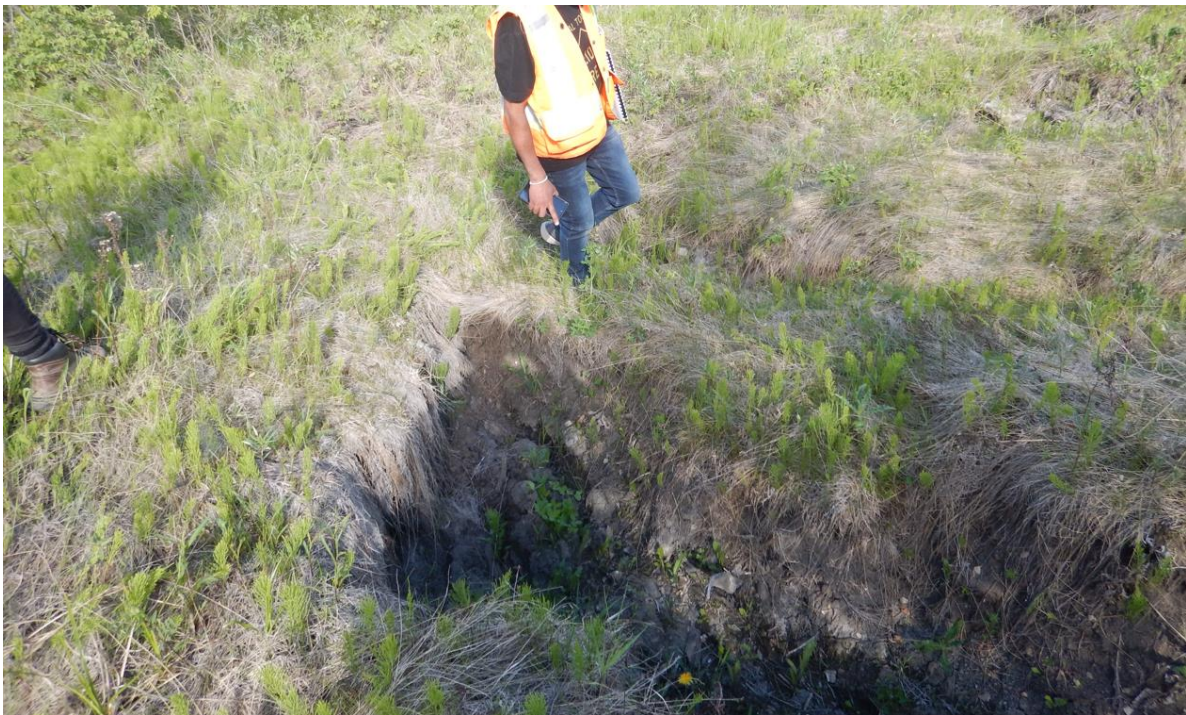
Photo No. 8 – Looking at a tension crack within the toe of the upper north slump; the tension crack is 1 m wide x 1 m deep; note seepage at depth of 0.5 m

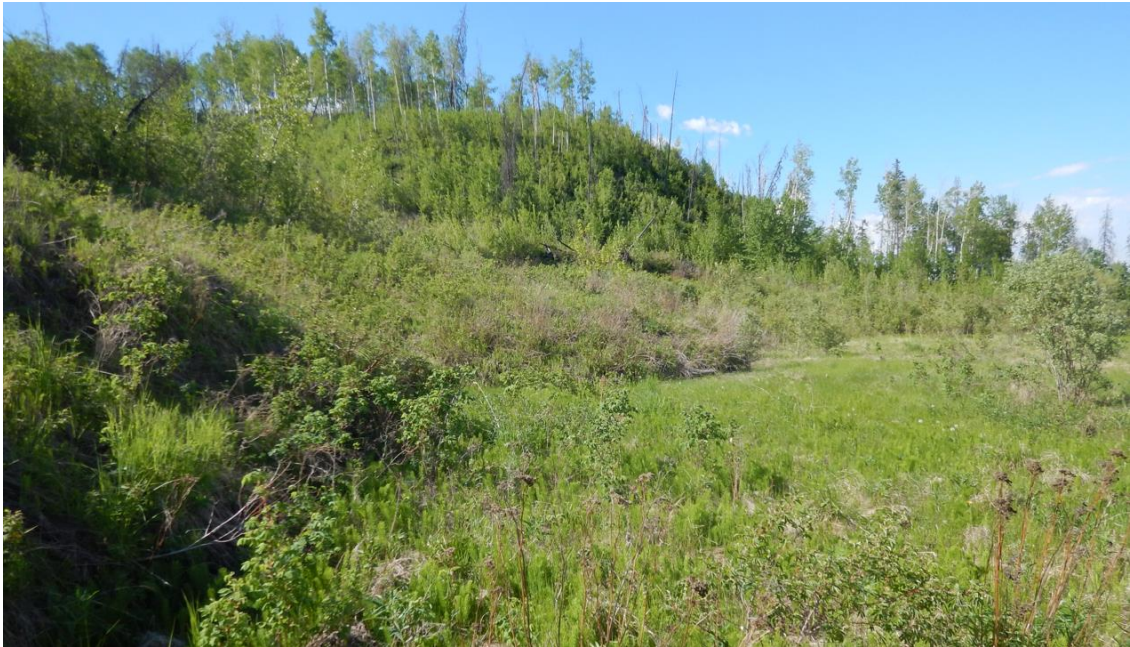
Photo No. 9 – Looking north at a 3 m high toe roll; the toe roll moved about 5 m to the east and buried TH99-12

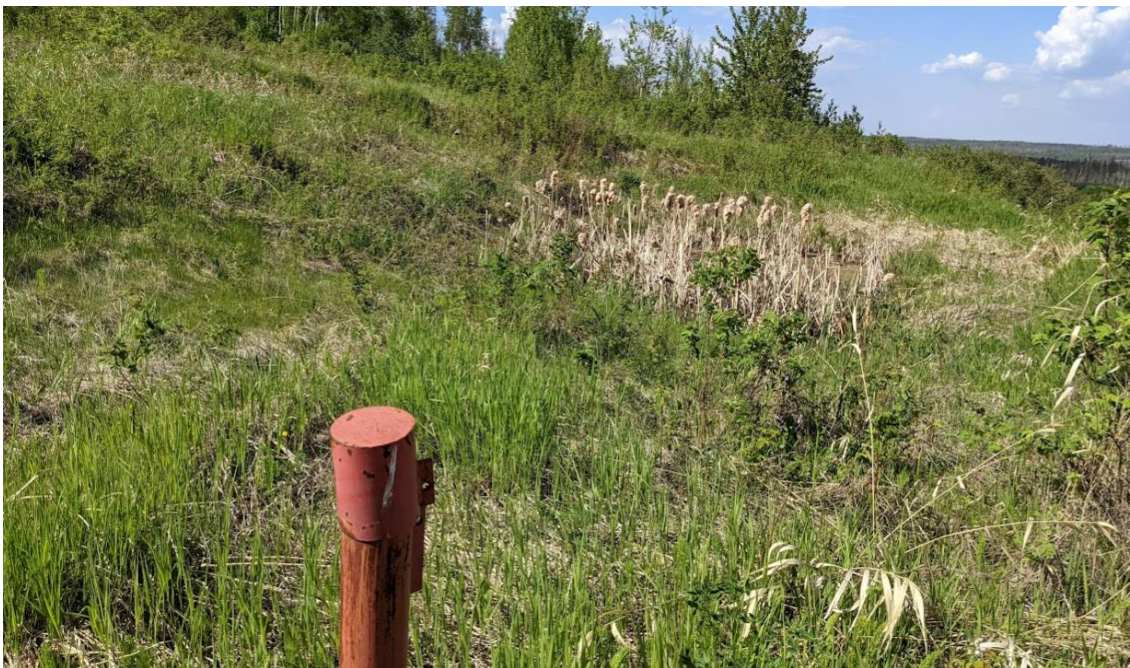
Photo No. 10 – Looking north at head scarp crack of the lower backslope landslide; more vegetation grew within the landslide mass

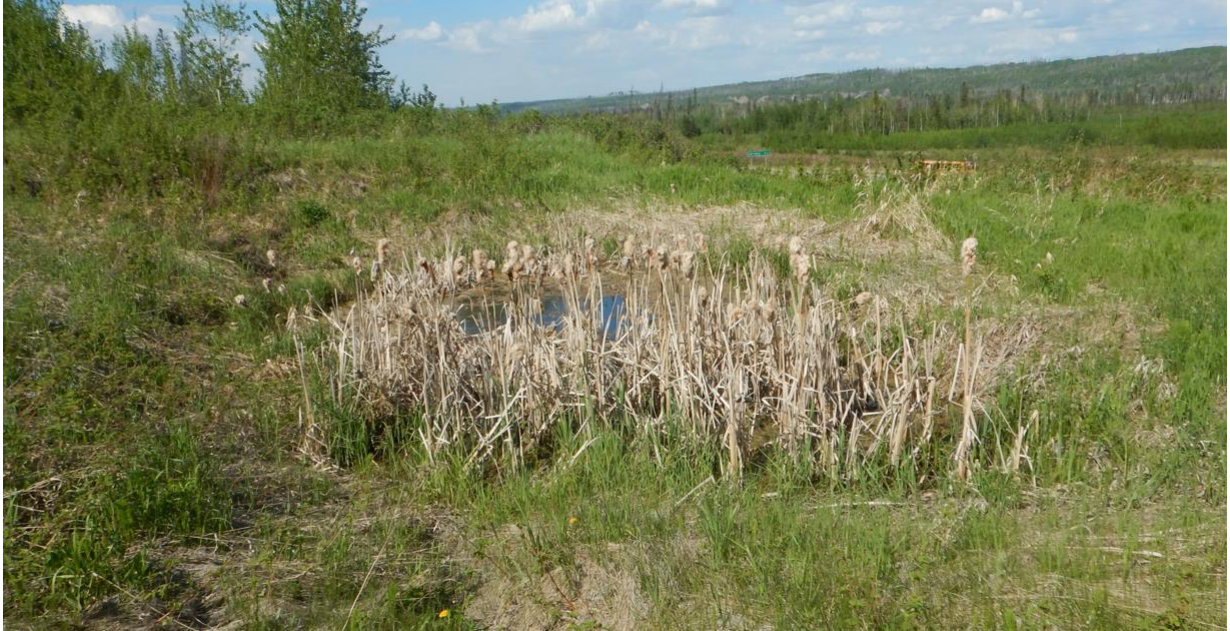
| <input checked="" type="checkbox"/> Seepage | Km 2.7: Water ponding within the sag ponds in the lower backslope landslide mass near PB09-2; seepage noted within the toe rolls of the upper backslope slumps | <input type="checkbox"/> |

Photo No. 11 – Looking north at sag pond with cattails and noted wet in 2022
