ALBERTA TRANSPORTATION AND
ECONOMIC CORRIDORS GRMP
NORTH CENTRAL (ATHABASCA AND FORT
MCMURRAY DISTRICTS)
2024 SITE INSPECTION

Site Number	Location	Name	Hwy	km
NC017A	North of Fort McMurray	Hwy 63 Backslope Failures	63:12	2.7
Legal Description		UTM Co-ordinates (NAD 83)		
NW7 and SW18-90-09-W4M		12	N 6295275	E 473365

**NC017A: HWY 63:12 BACKSLOPE FAILURES
(km 2.4 AND km 2.7)
SITE PLAN**

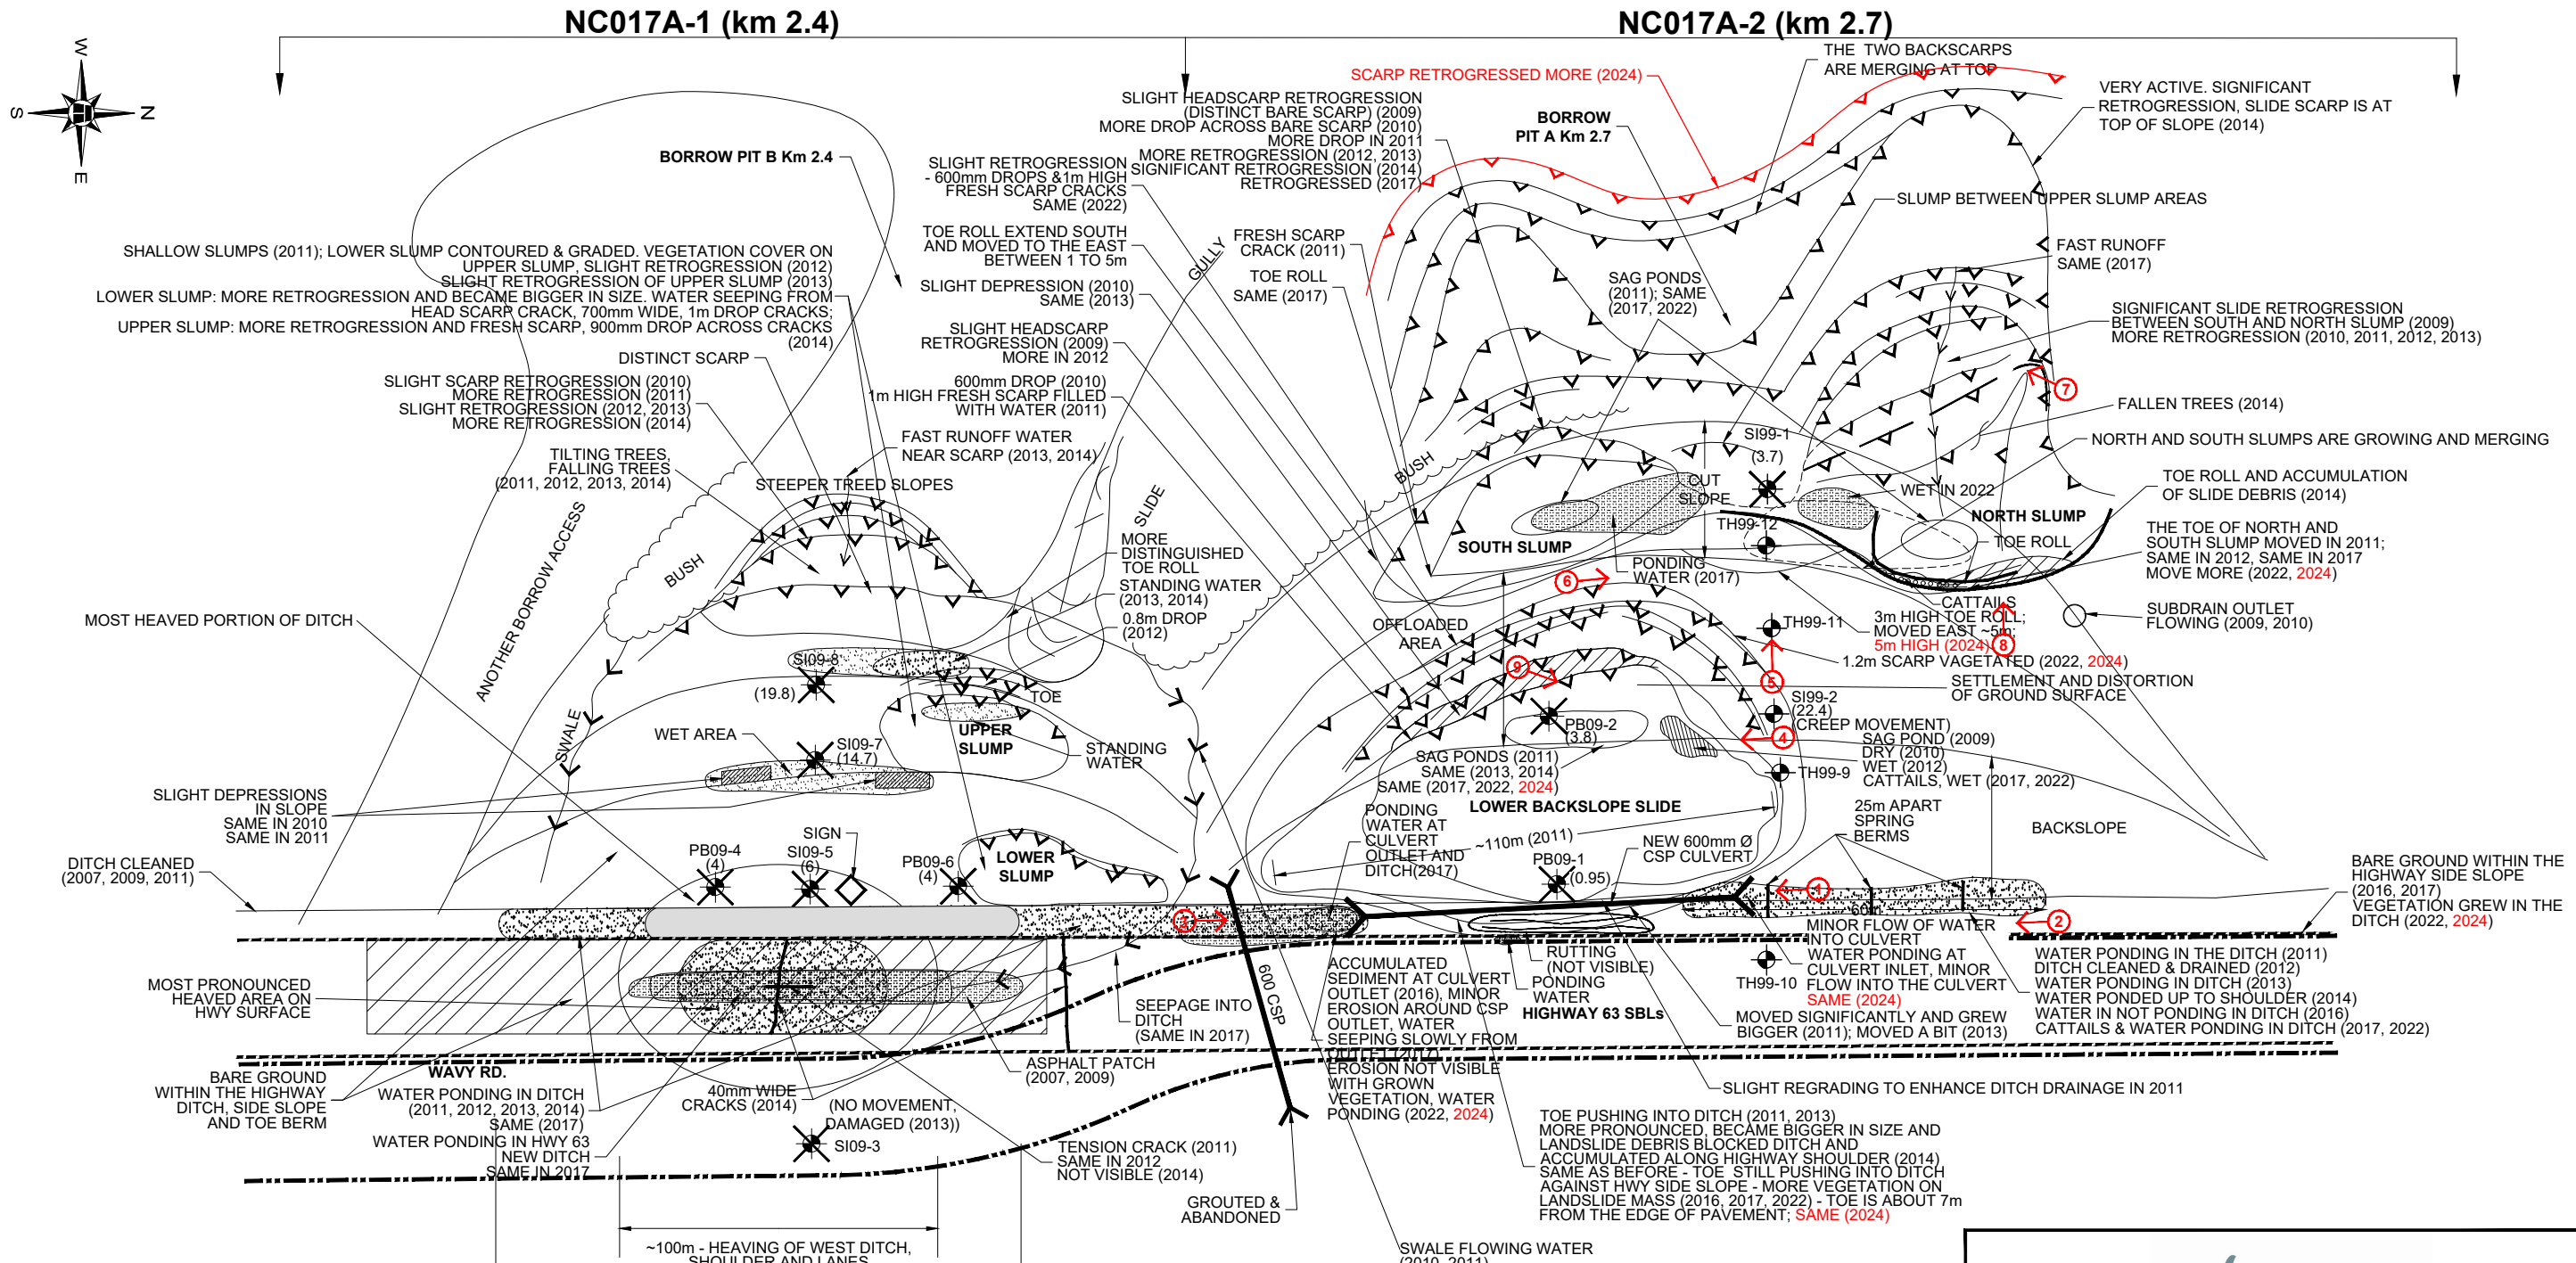
FIGURE NC017A-1

<input checked="" type="checkbox"/> Erosion	Km 2.7: Minor erosion previously noted at the outlet of the of the existing 600 mm diameter CSP culvert in the ditch was not visible during the 2024 inspection as this area was covered with vegetation	<input type="checkbox"/>
<input checked="" type="checkbox"/> Seepage	Km 2.7: Water ponding within the sag ponds in the lower backslope landslide mass near PB09-2; seepage noted within the toe rolls of the upper backslope slumps	<input type="checkbox"/>
<input checked="" type="checkbox"/> Bridge/Culvert Distress	Km 2.7: Water slowly flowing from the culvert outlet; ponding water inside the culvert	<input type="checkbox"/>
<input type="checkbox"/> Other	More vegetation within the lower backslope landslide	<input type="checkbox"/>
Instrumentation: (Non-Operational)		
Previously installed instruments as shown on the attached Figure NC017A-1 are either sheared off or damaged and unrepairable.

Assessment (Refer to attached Figure):		
<p>The existing lower landslide and upper backslope slumps occurred due to the progressive failure of the steep back slope cuts in the weak colluvium deposits.</p> <p>The ditch does not appear to have enough gradient to the north and the south of the culvert location to handle surface runoff.</p> <p>Km 2.4: The highway was shifted away from the toe of the landslide and hence it is not currently impacted by the landslide movement.</p> <p>Km 2.7: The upper back slope slumps and lower landslide are still active and will continue to move over time. However, the upper back slope slumps appear to have moved more than the lower landslide. It is likely that the lower landslide debris will keep pushing against the culvert and the highway shoulder. Although the landslide is not currently affecting the highway condition, the landslide debris is within the highway clear zone, which constitutes a safety hazard to motorists. In addition, the landslide debris may encroach into the highway surface in response to potential accelerated movements.</p> <p>The ditch culvert seems to be sagging and causing inadequate drainage. Water accumulates inside and beyond the culvert ends. This obstruction of surface drainage in the ditch could lead to accelerated landslide movement and instability of the highway embankment side slopes. In addition, the culvert may sustain damage or distortion in response to potential accelerated landslide movements.</p>

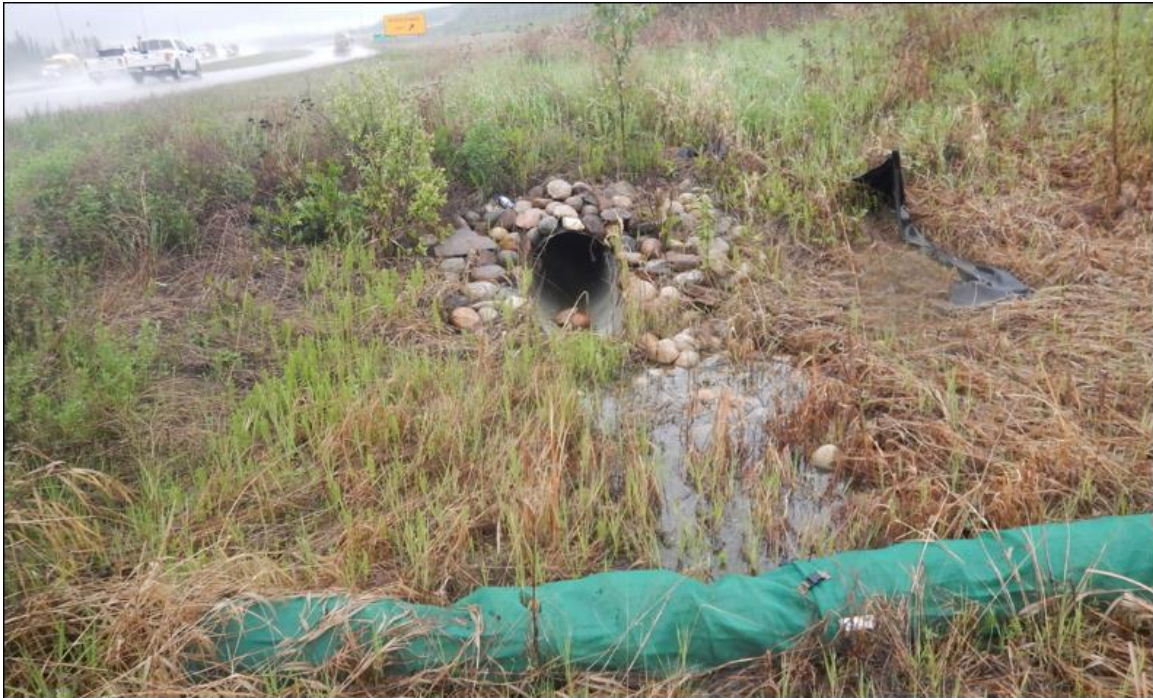
Photo No. 1 – Looking at the inlet of the culvert installed in the highway ditch below the lower landslide toe roll; water is slightly ponding at the culvert inlet location

Km 2.7: In the short-term, the local MCI should visually monitor the lower landslide, particularly after heavy rainfall events, to check if the landslide debris encroaches into the highway lanes in response to an accelerated movement. The ditch to the north and the south of the culvert should be slightly contoured to enhance surface drainage. The area located between the highway and the toe of the lower backslope landslide should also be touched, without significantly changing grades, to drain ponded water into the existing ditch.

In addition, the local MCI should periodically inspect the culvert to ensure it is not damaged or separated. Consideration should be given to lining the existing culvert with a more robust pipe (e.g., a smooth wall steel pipe) to sustain ongoing landslide movements. If the culvert is damaged or separated in response to the landslide movement, a new SWSP pipe will have to be auger bored below the toll roll debris to enhance surface water drainage in the highway ditch.

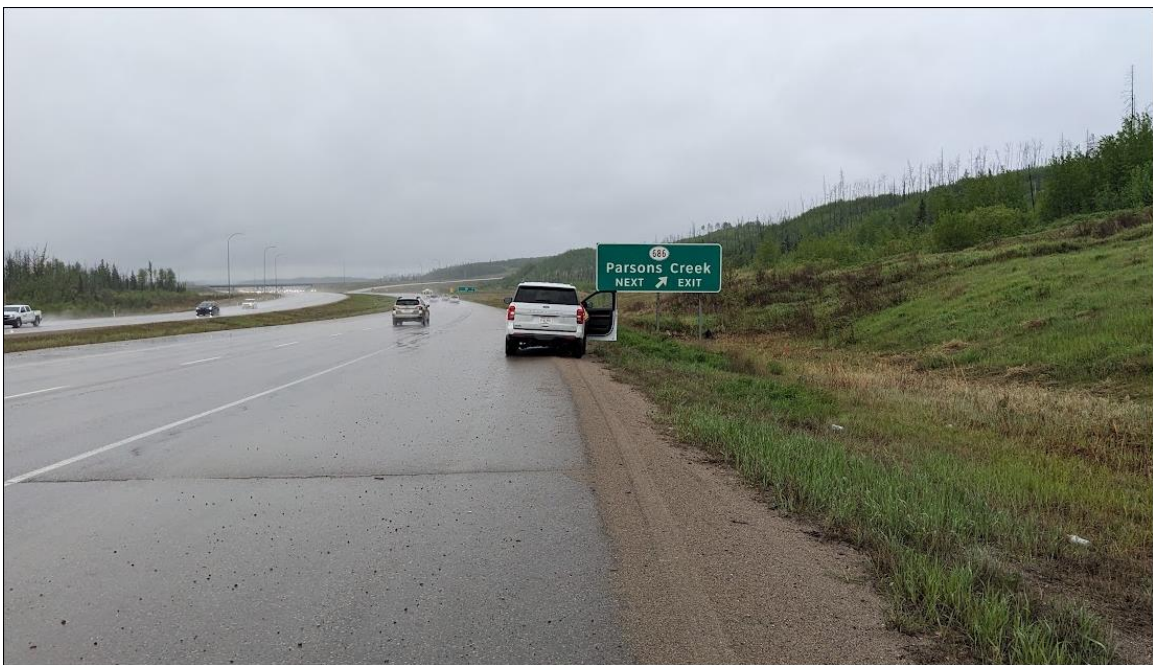
Photo No. 2 – Looking south at NC017A-2 landslide mass toppling over culvert in the ditch

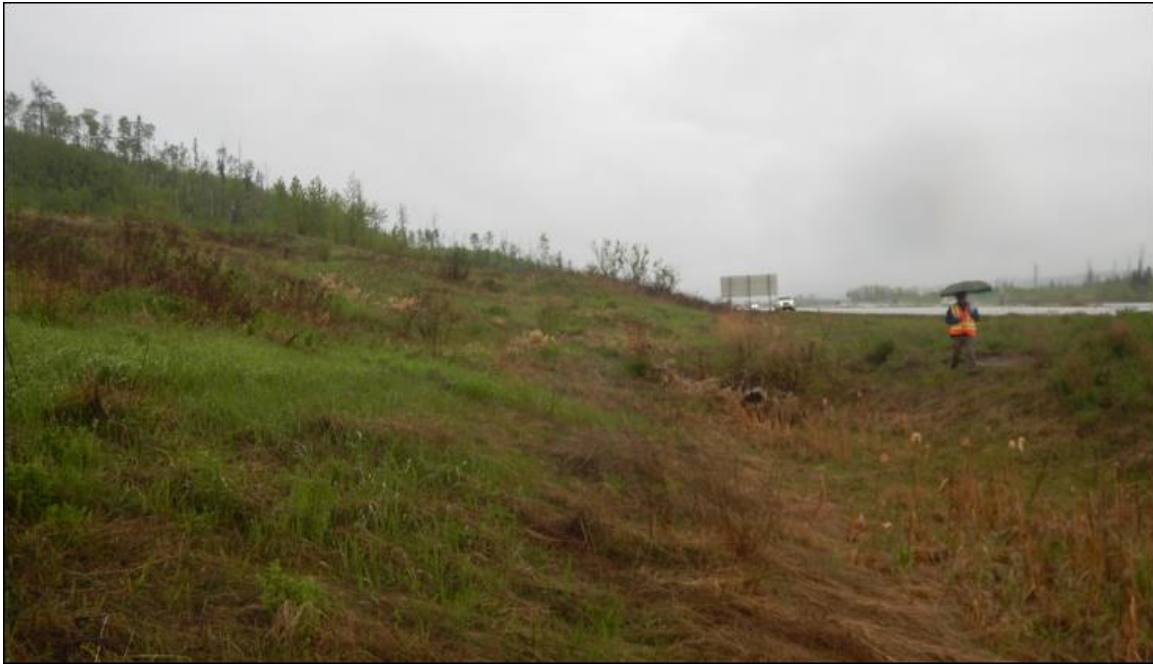
Photo No. 3 – Looking north at culvert outlet; Cattails and water ponding beyond the culvert outlet

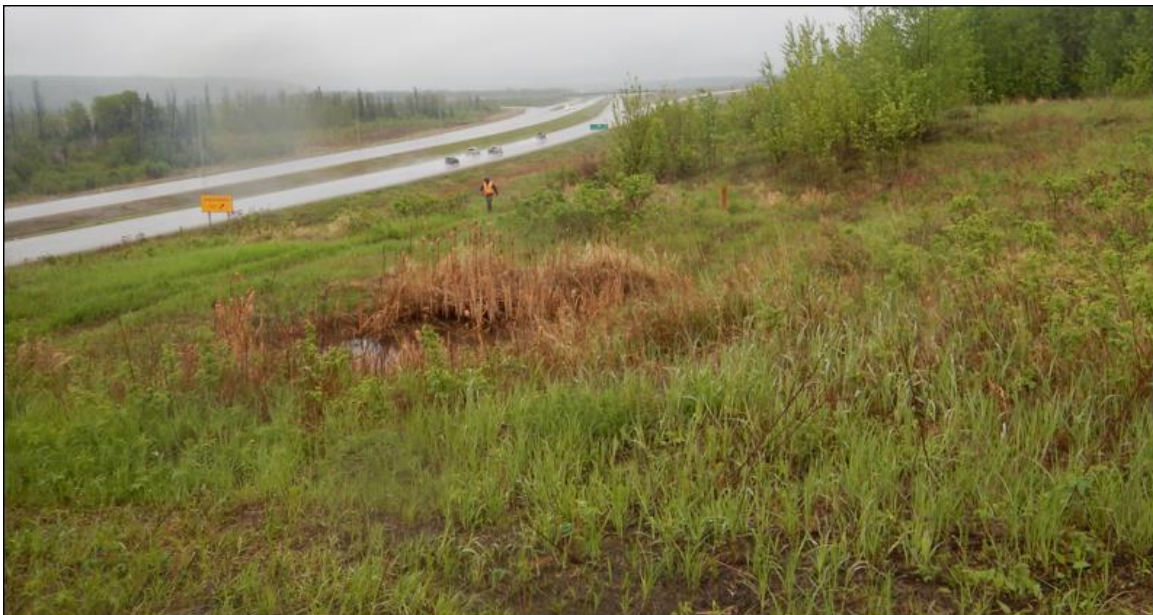
Photo No. 4 – Looking south at a vegetated scarp cack of the lower backslope slide

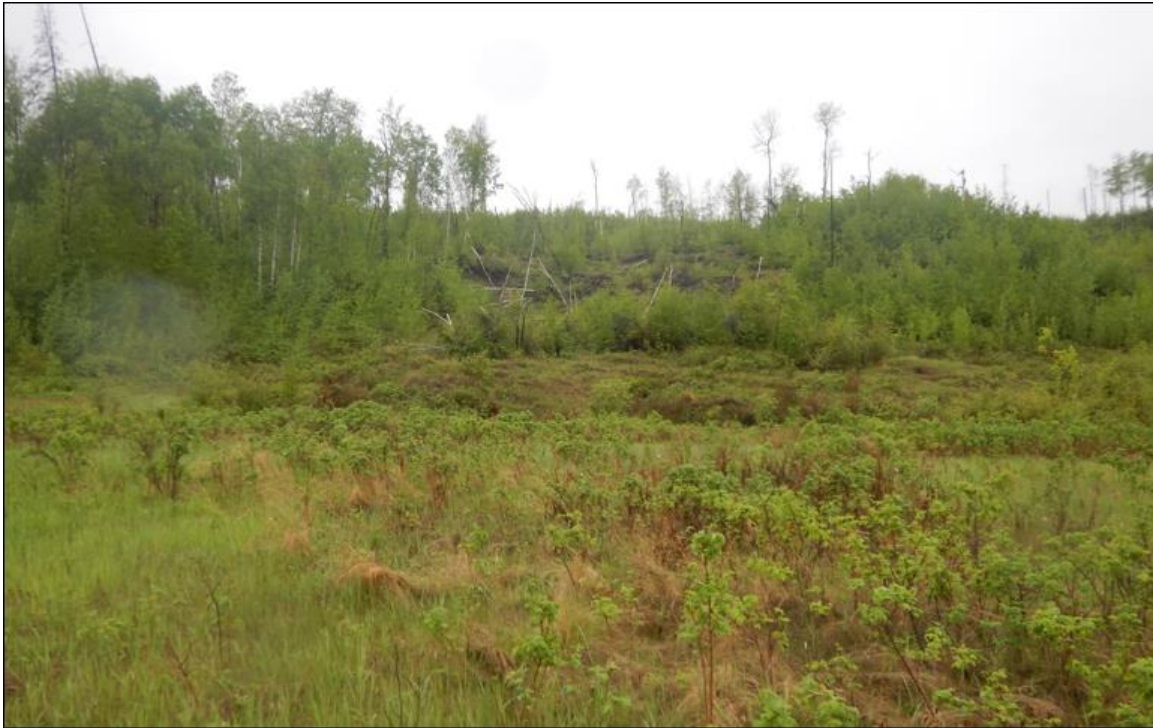
Photo No. 5 – Looking west at the upper backslope slump areas and toe rolls

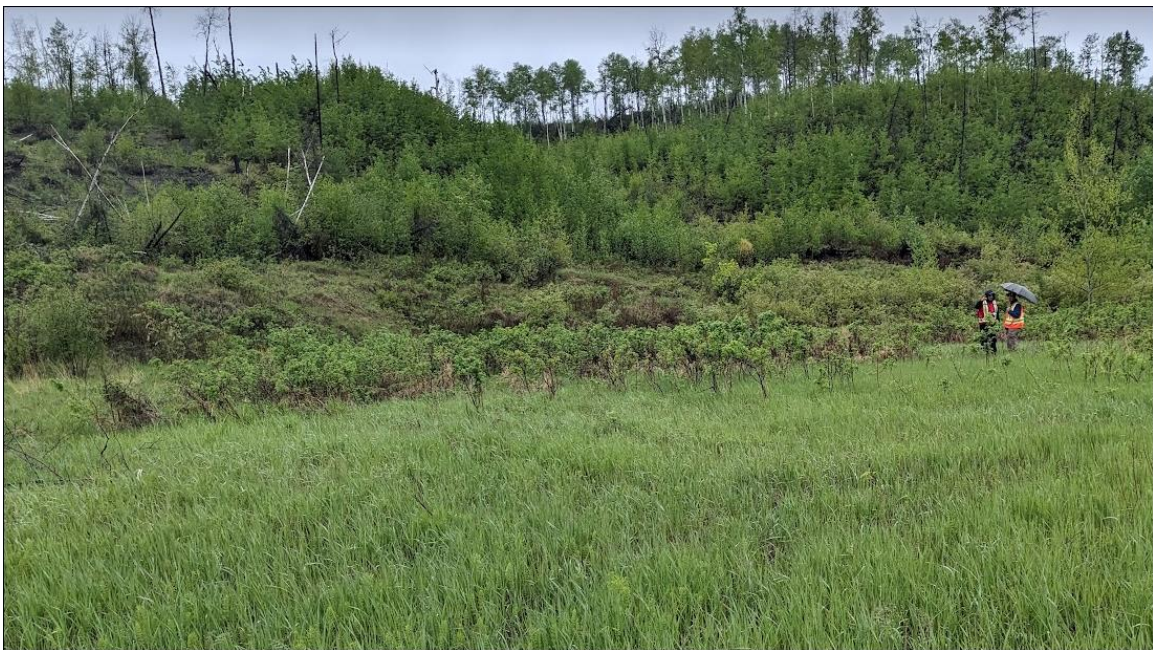
Photo No. 6 – Looking at the southern flank of the upper backslope slump

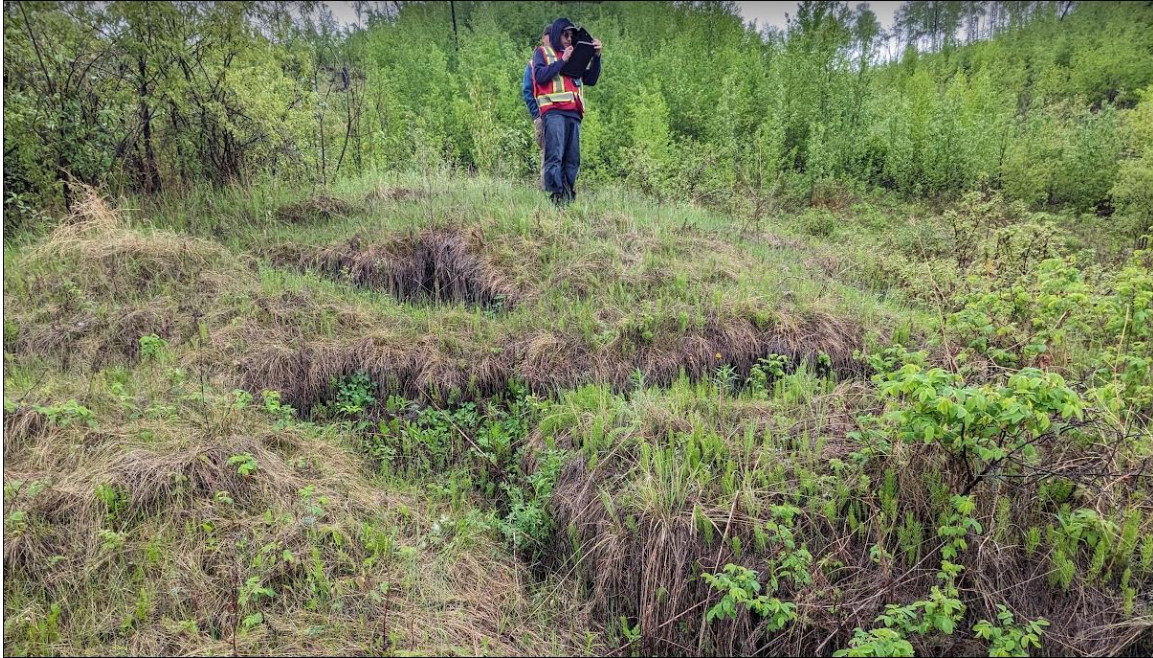
Photo No. 7 – Multiple tension cracks within the toe of the upper north slump

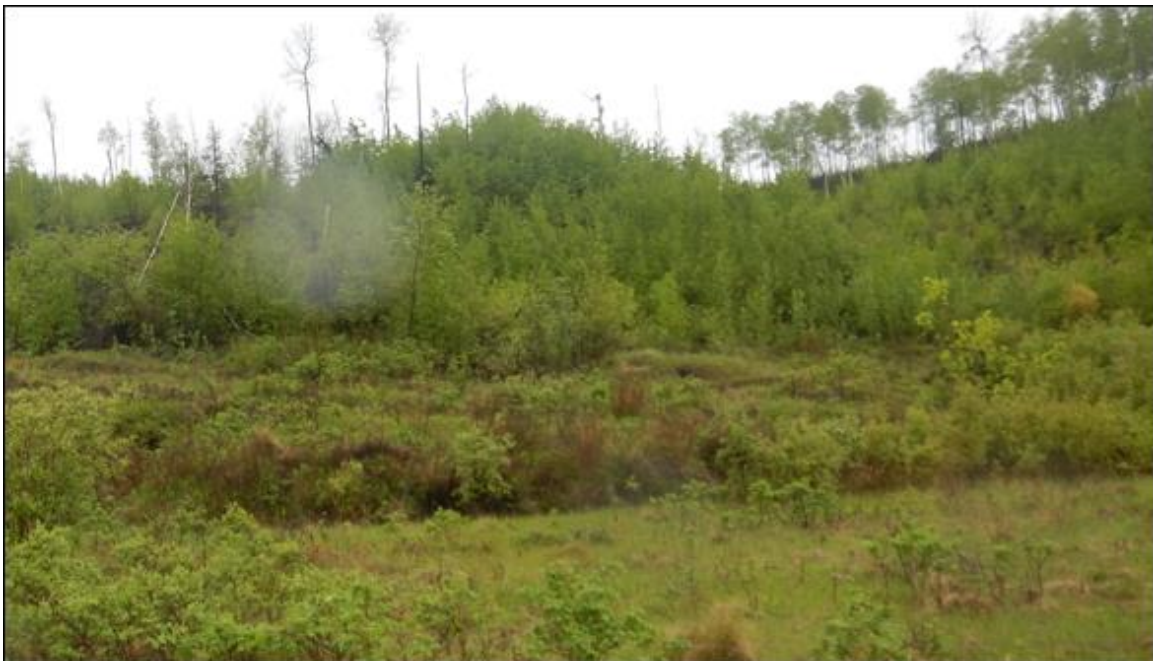
Photo No. 8 – Looking north at a 5 to 6 m high toe roll

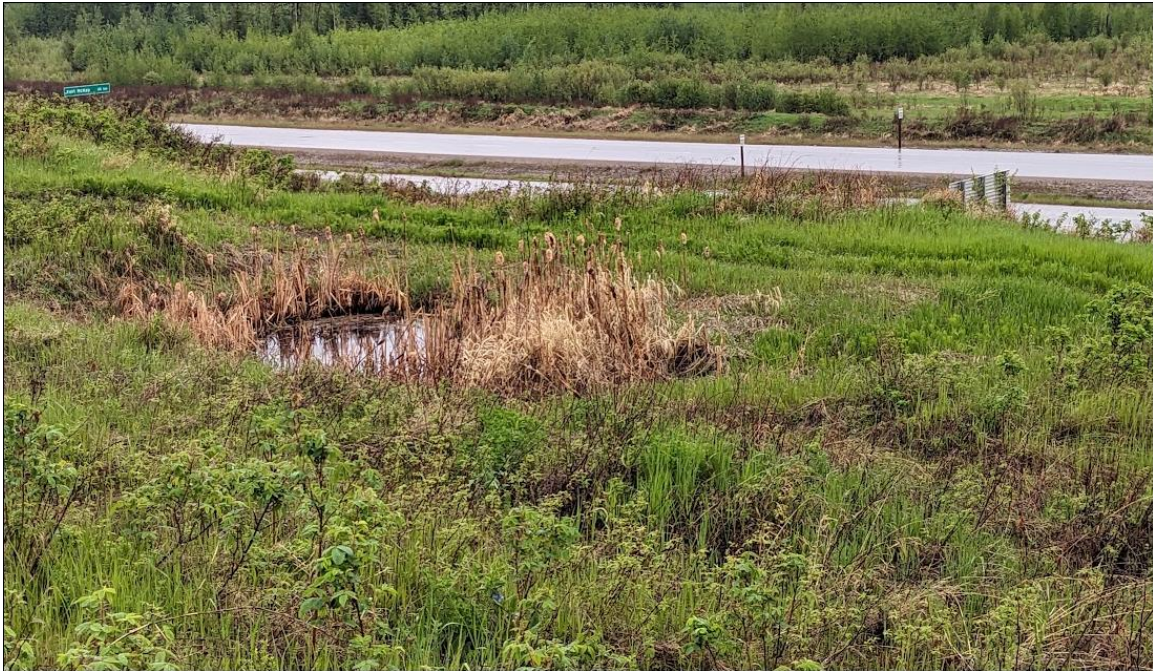
Photo No. 9 – Looking north at a sag pond within the lower landslide mass
