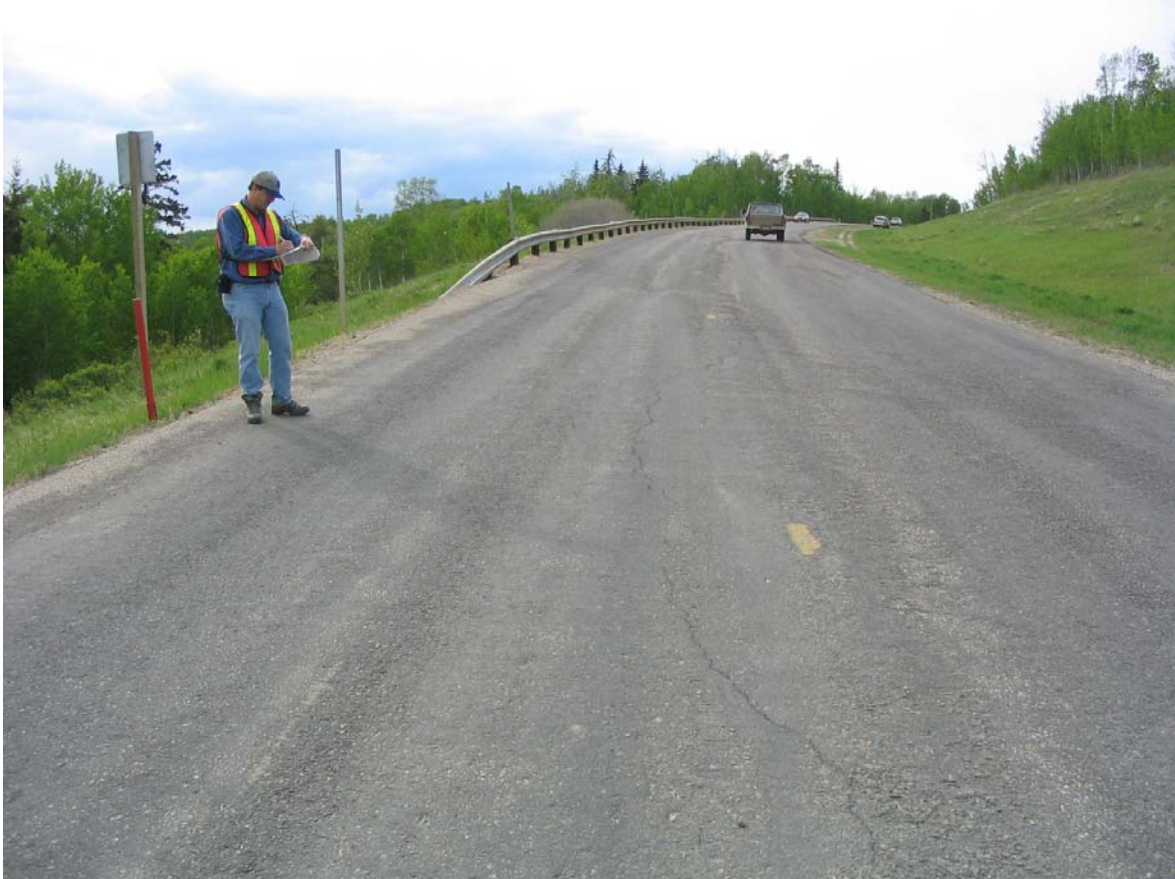
Mid-Hill - Faint crack re-appearing through the new path

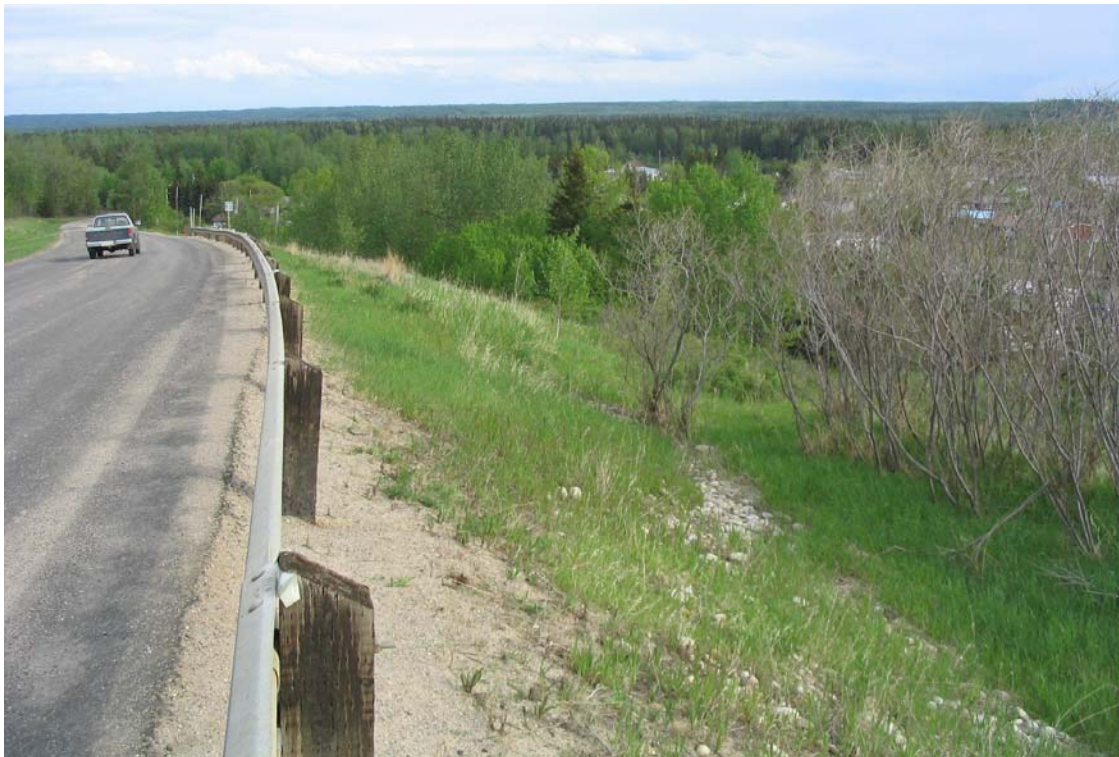
Up Hill – Side slope scarp.

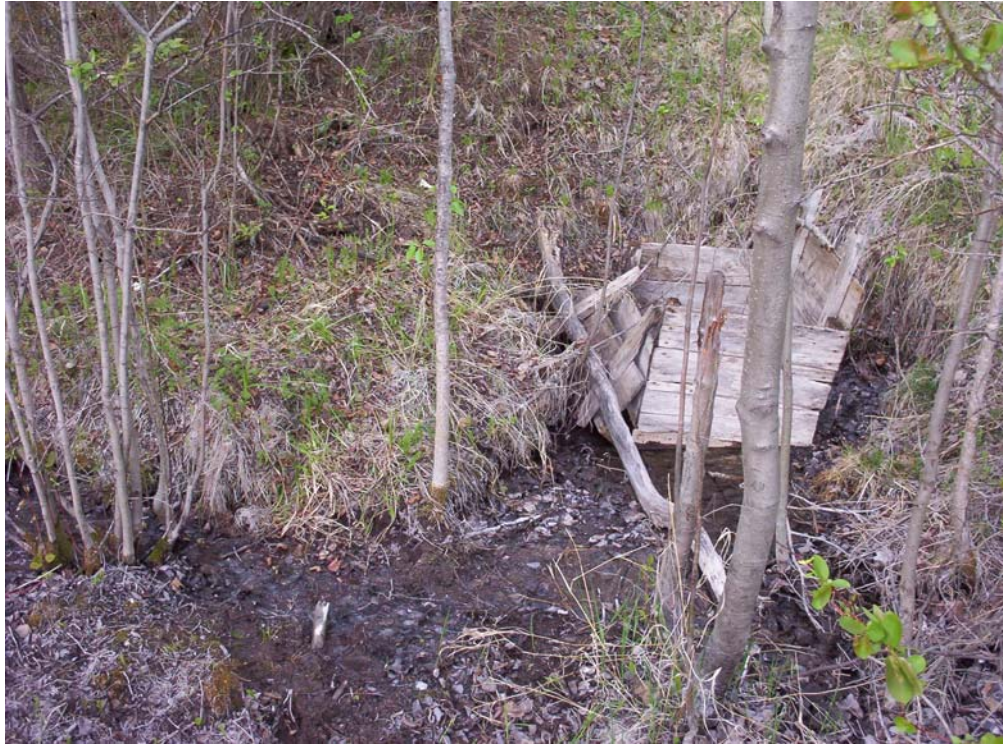
Spring at old wood casing well.

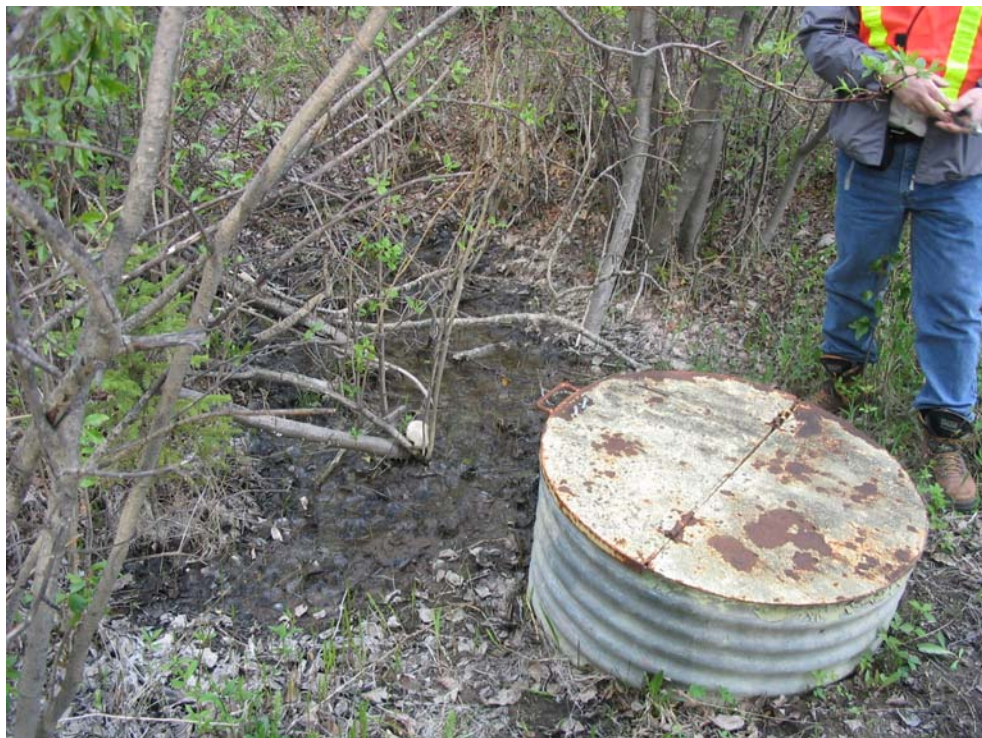
Spring flowing into vertical CSP well.
