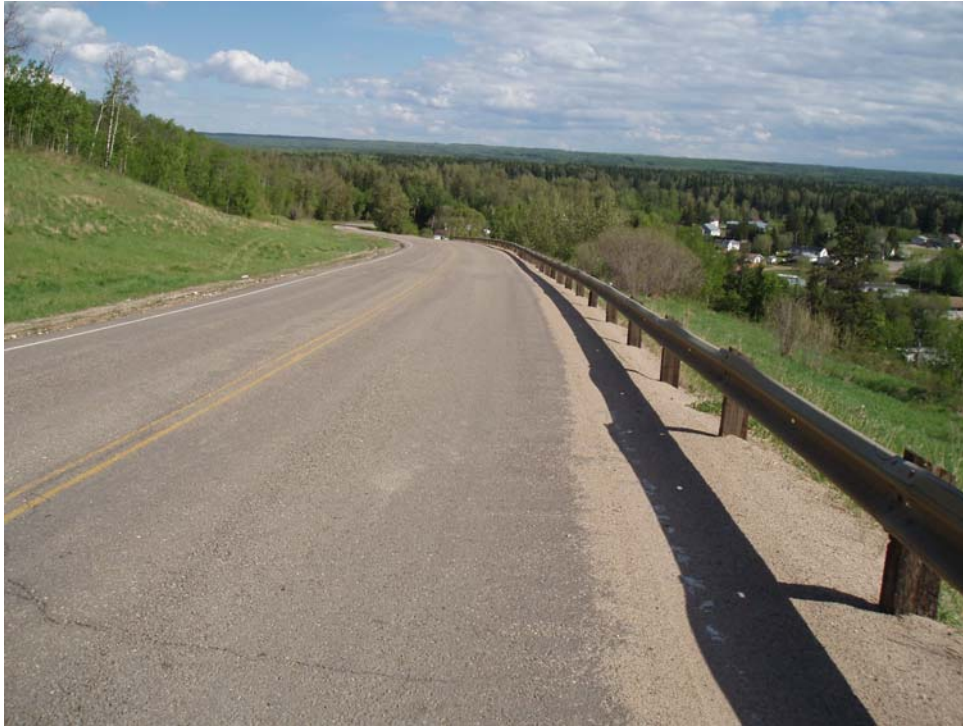
Photo 1. Up hill general view. Note on the foreground the cracking reappearing on the pavement patched in 2003.

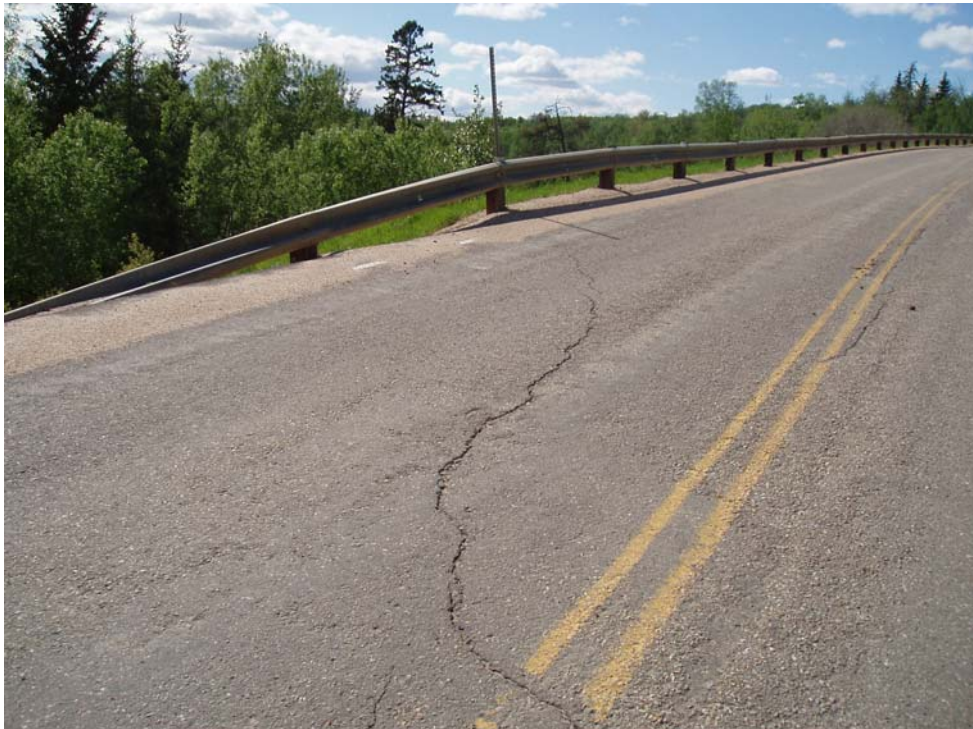
Photo 2. Mid-hill pavement distress.

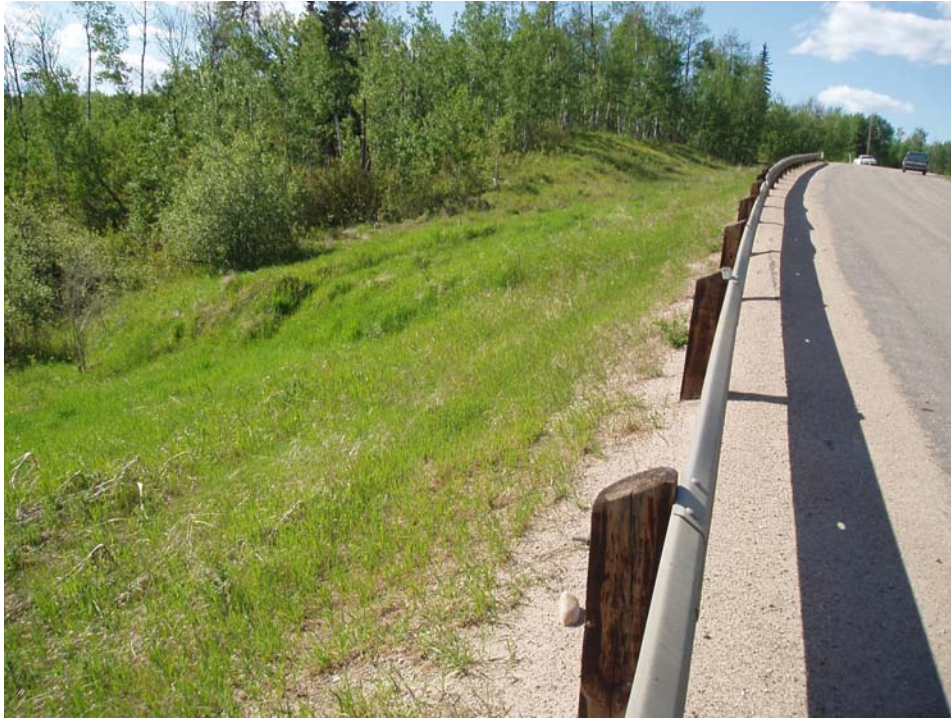
Photo 3 Scarp and graben feature on the sideslope unchanged.

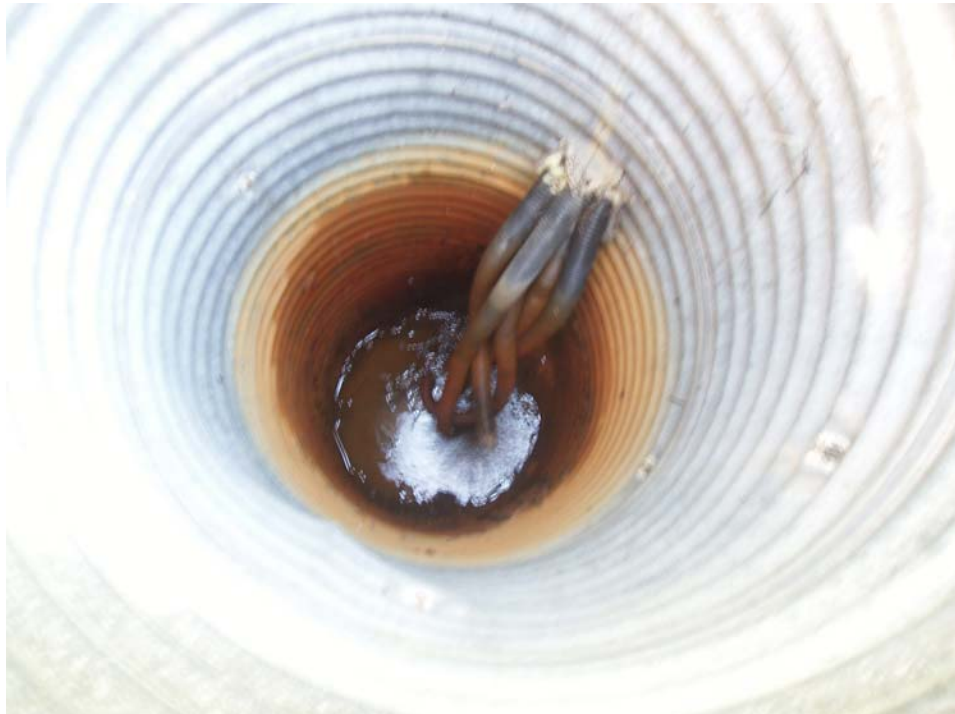
Photo 4 Collection point at the toe of the slope.
Note the oxidation stain elevation

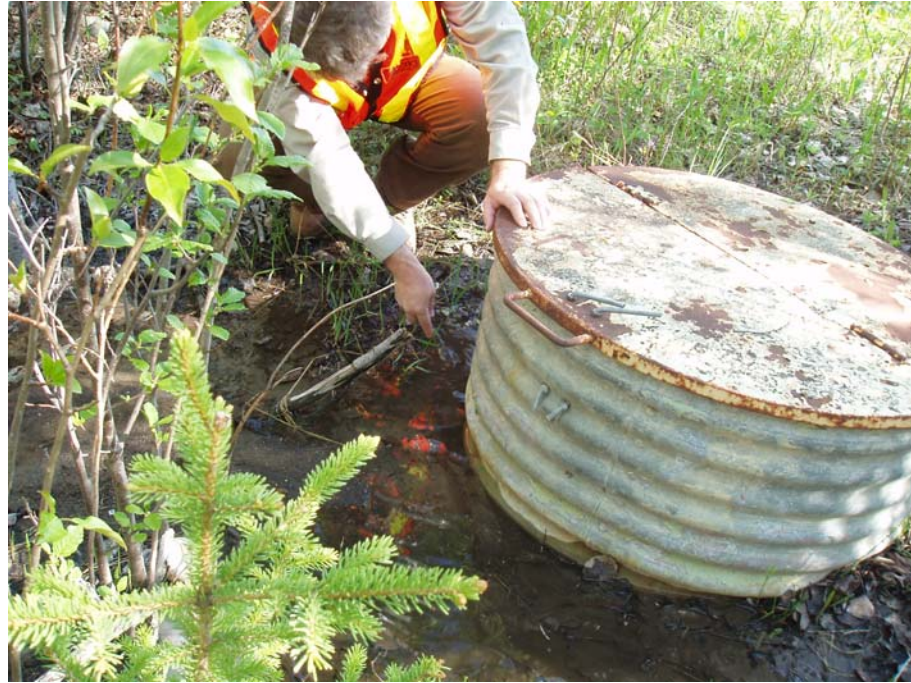
Photo 5 Backslope collection point, Cleaning the surface drainage holes
