August 23, 2006

File: 15-85-32

**NORTH CENTRAL REGION GEOHAZARD ASSESSMENT  
HWY 661:02 NEAR THE NORTHEAST BOUNDARY OF  
THE TOWN OF FORT ASSINIBOINE (NC14)  
2006 ANNUAL INSPECTION REPORT**

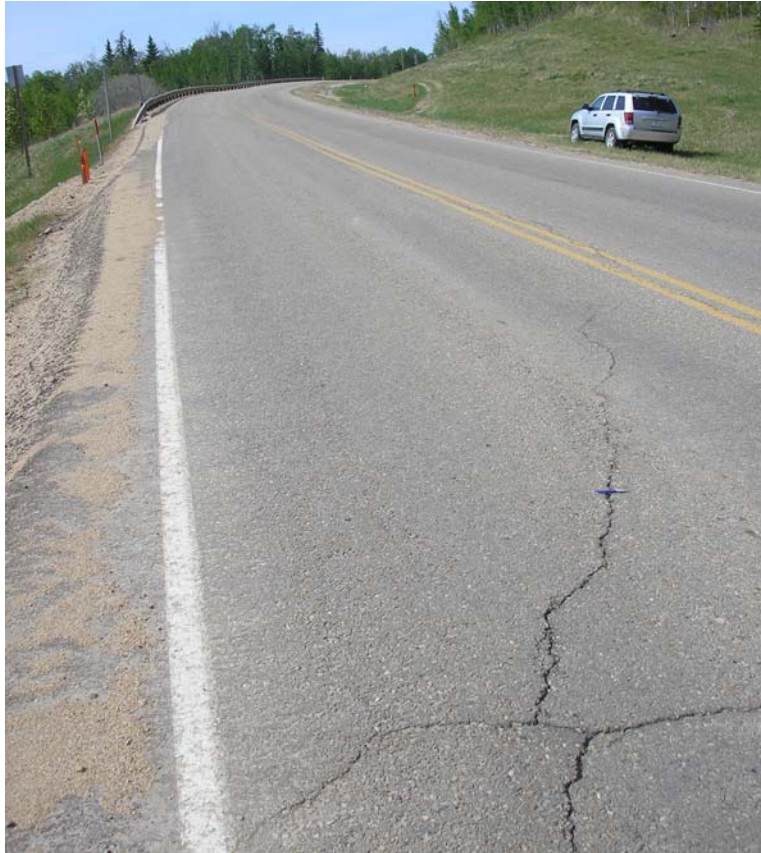
The previous cracks that were partially re-appearing through the pavement patch performed last year have now fully formed in a similar pattern as observed before the patch. No differential drop was observed across the cracks. A slight depression on pavement at the east end of the mid-hill slide area was also noted.

Photo 1. Up hill general pavement cracks, May 19, 2006.

In the short term the site should be regularly inspected by the MCI especially after heavy and long precipitation events. Cracks in the surface of the road that open up should be sealed to reduce the inflow of water into the slide mass.

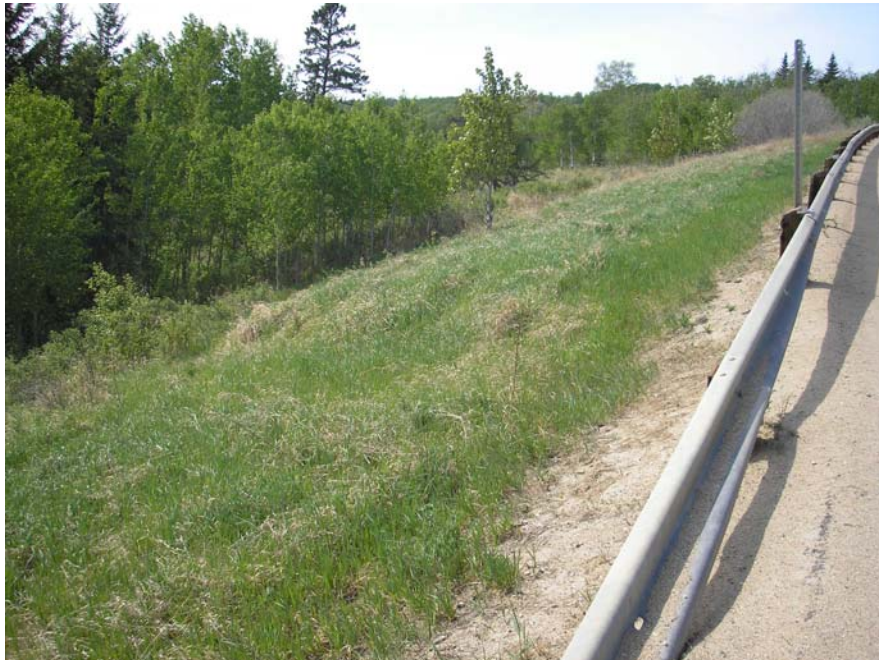
Other slide features, i.e., scarps and graben, existing on the sideslope were inspected and no noticeable changes were observed from that observed last year.

Photo 2. Scarp and graben feature on the sideslope unchanged, May 19, 2006.

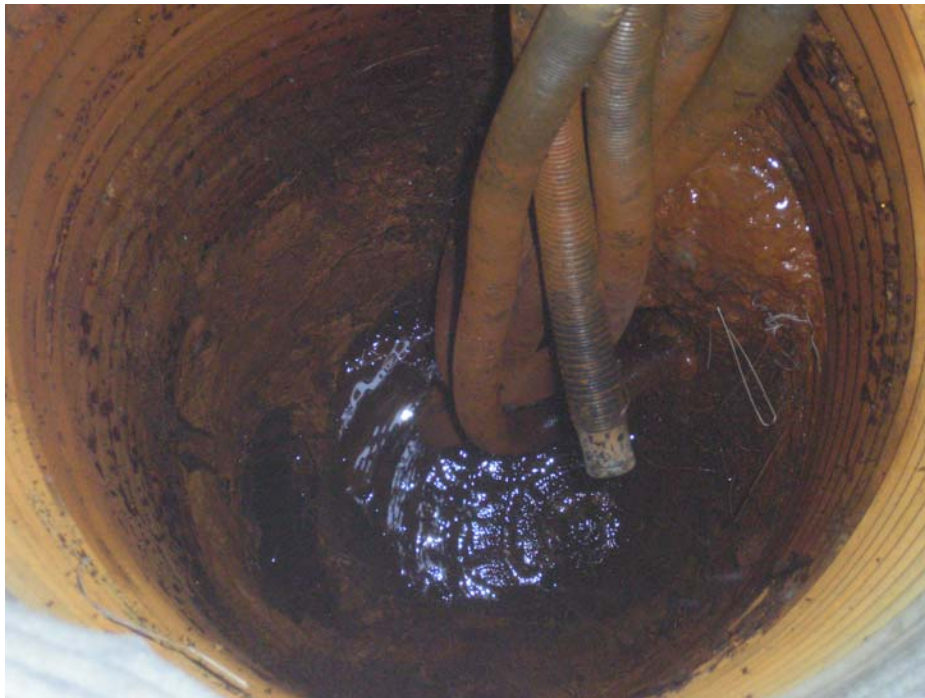
The collection well (CSP) located at the toe of the mid-hill slope was inspected and the existing pipes were trickling with a steady drip of water at the time of the inspection.

Photo 3. Collection point at the toe of the slope, May 19, 2006.

As a maintenance item for short term improvement of the slope stability it is recommended to inspect and clean the existing collection points to improve groundwater discharge that seems to be decreasing over the years possibly due to siltation in the collection points.

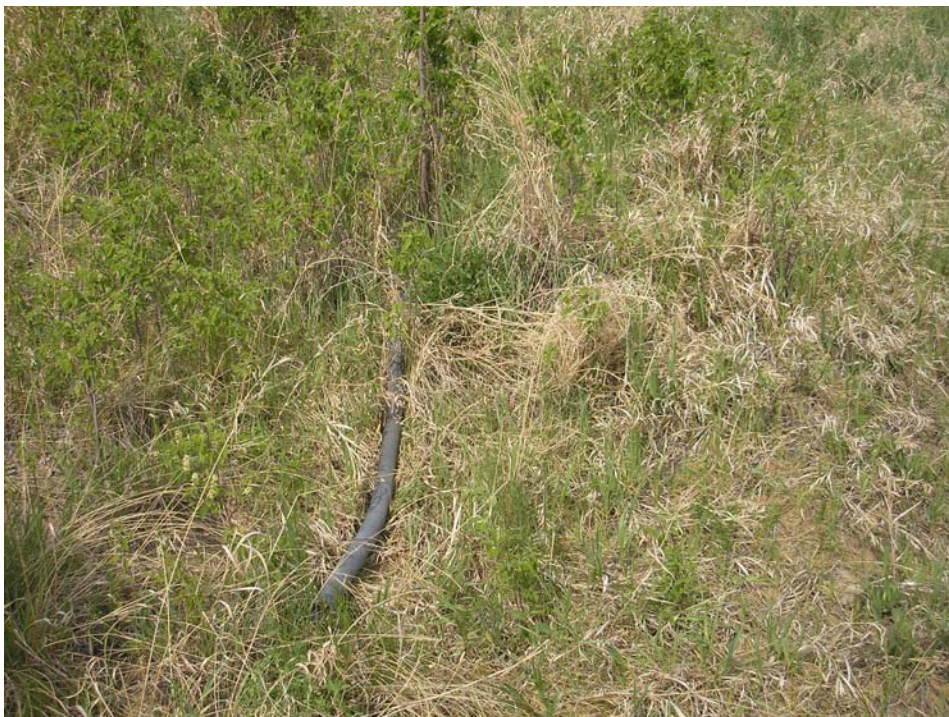
A 38 mm diameter subhorizontal drain pipe outlet was found in the side slope, located approximately as shown in Figure NC14-1. The drain was not flowing.

Photo 4. Subhorizontal drain outlet found in the side slope, May 19, 2006.

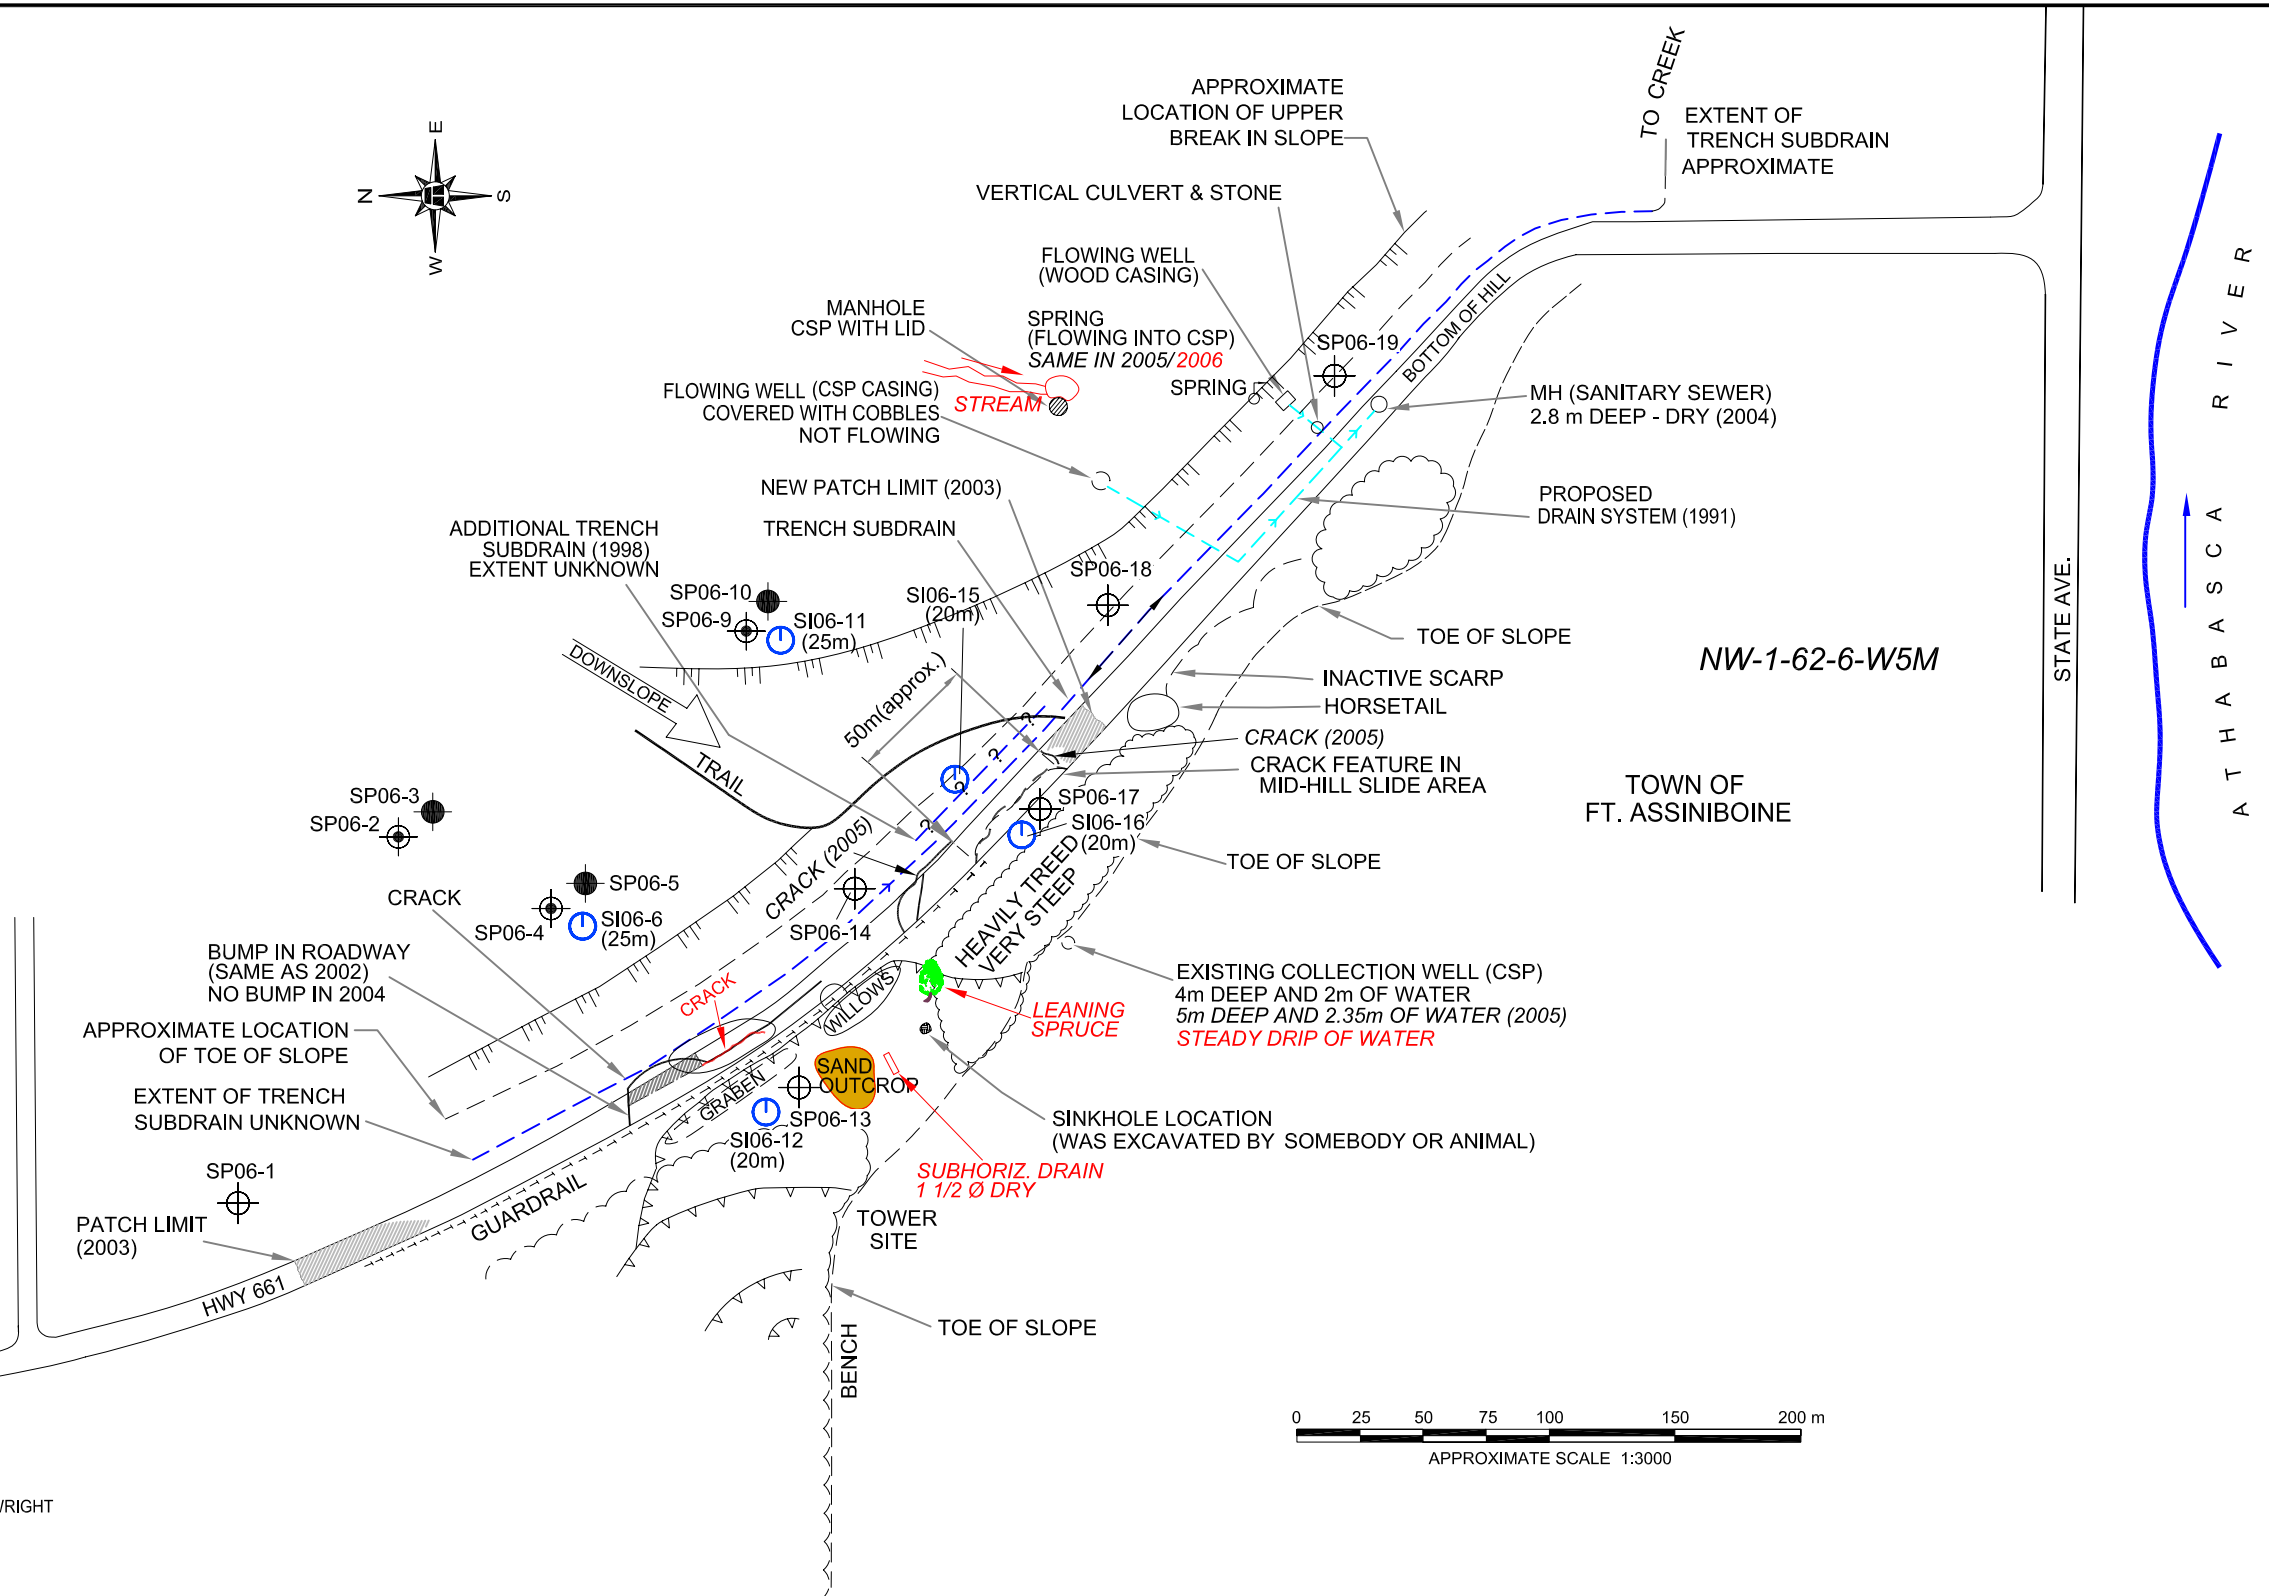
This letter documents the 2006 annual site inspection of an area of slope instability located along Hwy 661:02 on the northeast boundary of the Town of Fort Assiniboine, Alberta (refer to Figure NC14-1 attached for inclusion in Section F of the binder).

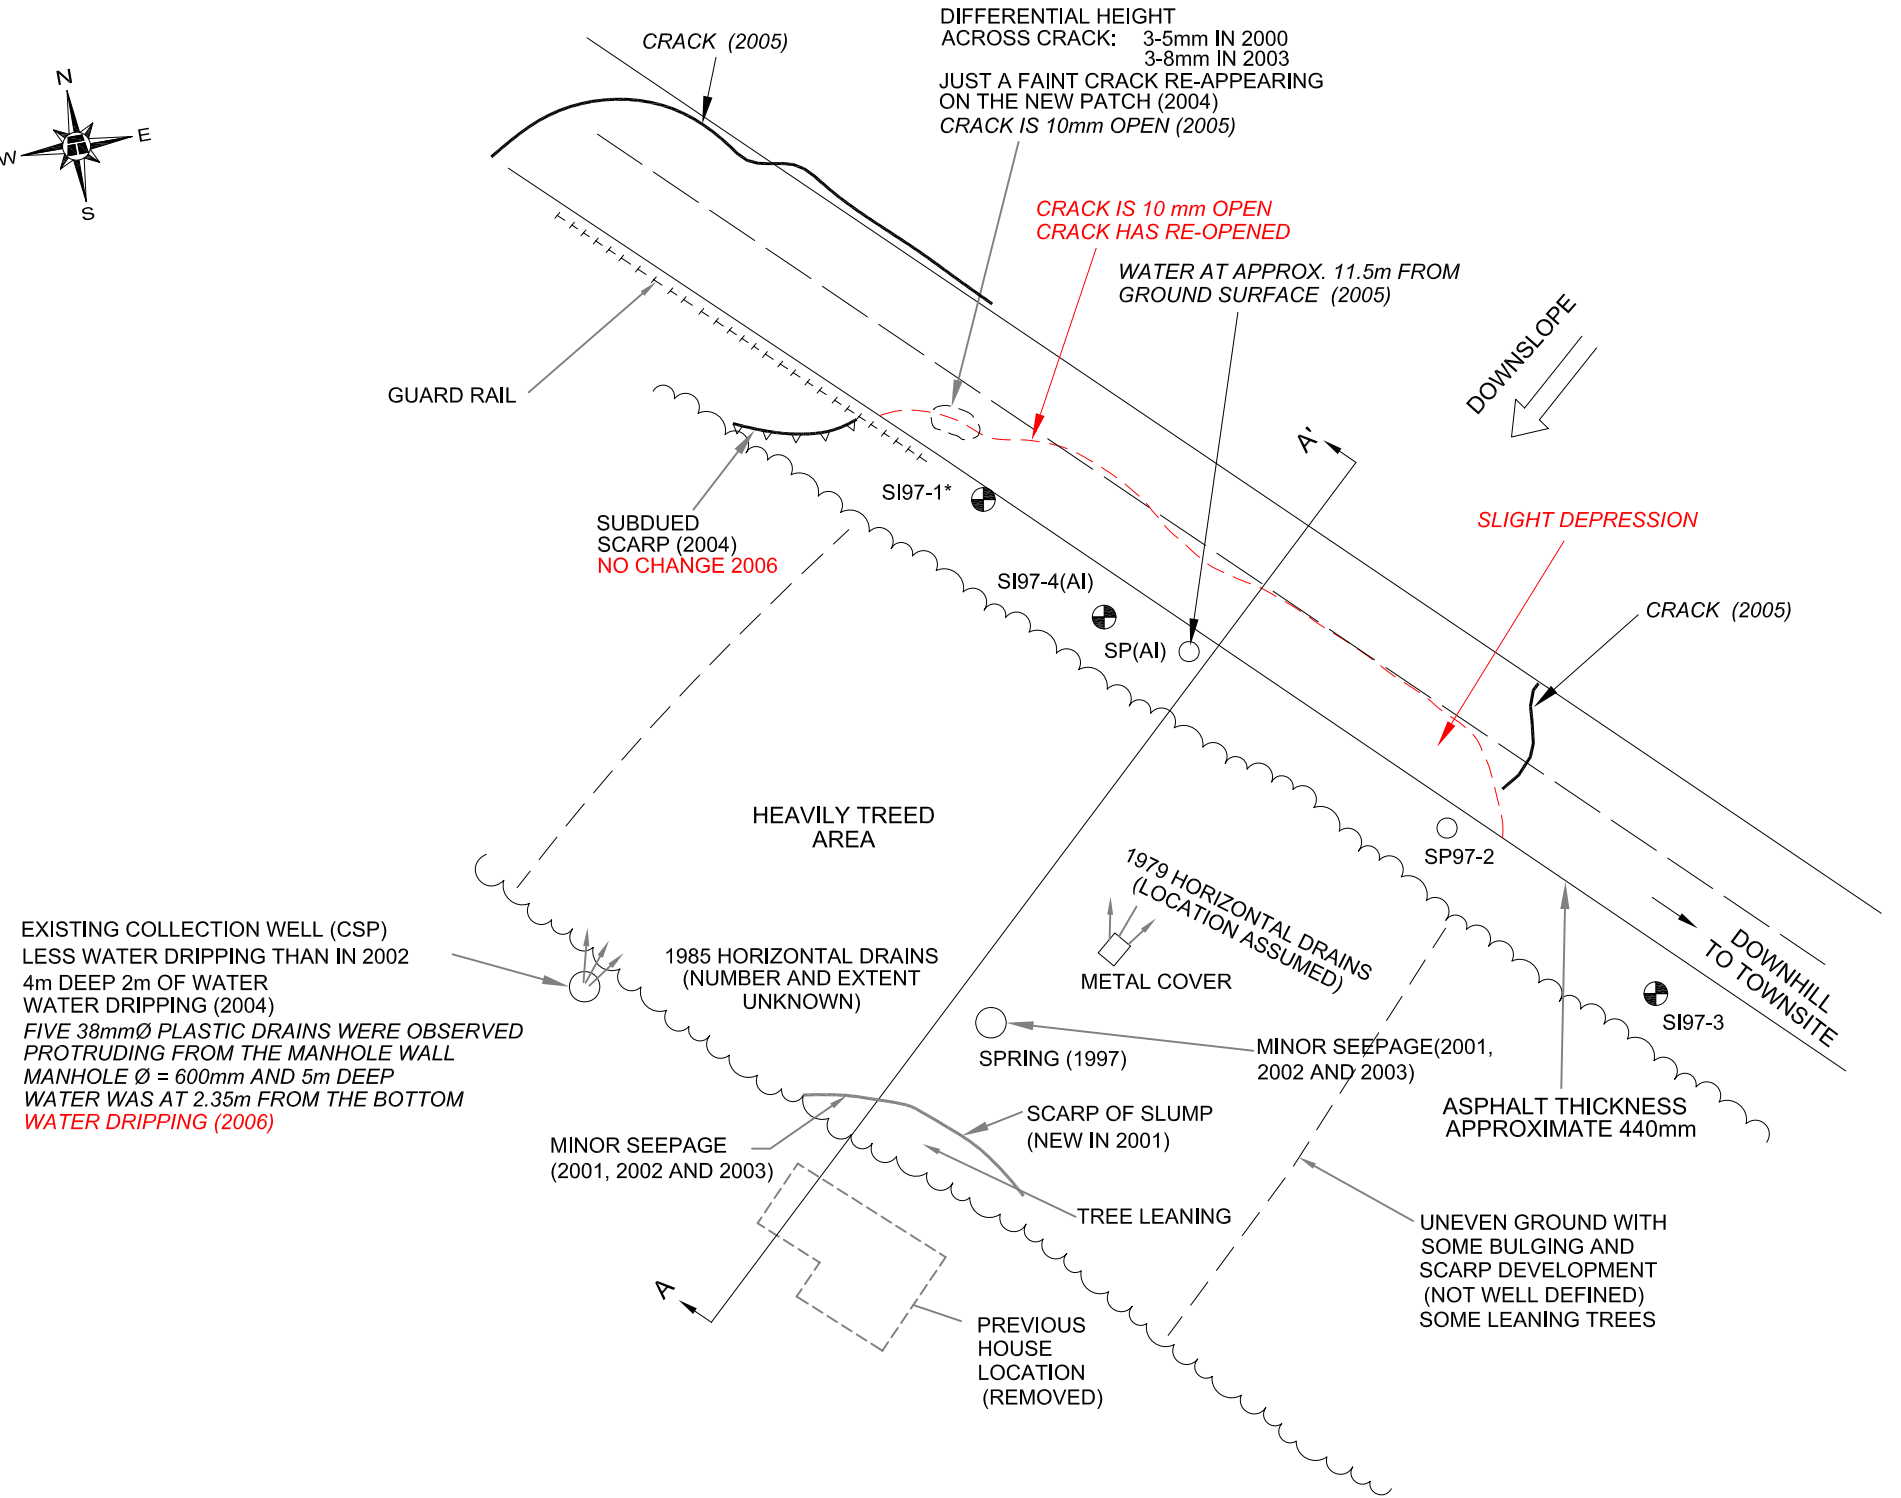
The CSP manhole with lid located in the back slope near the bottom of the hill was also inspected, but the lid could not be removed. The CSP is perforated just above the ground level to collect surface water, however these holes were mainly clogged and water was ponding at surface to the east of the manhole. The source of the water appears to be from a natural surface drainage course that comes from the north side of the manhole. The holes were cleaned with a stick and water started to flow into the manhole.

EXISTING COLLECTION WELL (CSP)  
 LESS WATER DRIPPING THAN IN 2002  
 4m DEEP 2m OF WATER  
 WATER DRIPPING (2004)  
 FIVE 38mmØ PLASTIC DRAINS WERE OBSERVED  
 PROTRUDING FROM THE MANHOLE WALL  
 MANHOLE Ø = 600mm AND 5m DEEP  
 WATER WAS AT 2.35m FROM THE BOTTOM  
**WATER DRIPPING (2006)**

Consideration should be given to installing a surface drainage treatment around the collection point located at the south end of the backslope to reduce the potential of having the existing holes clogged. This treatment may consist of excavating around the perimeter of the manhole to expose the holes, cover the exposed perimeter and holes with non-woven geotextile and backfill with washed rock. This should allow the surface water to enter the manhole while reducing the potential for clogging of the holes.
