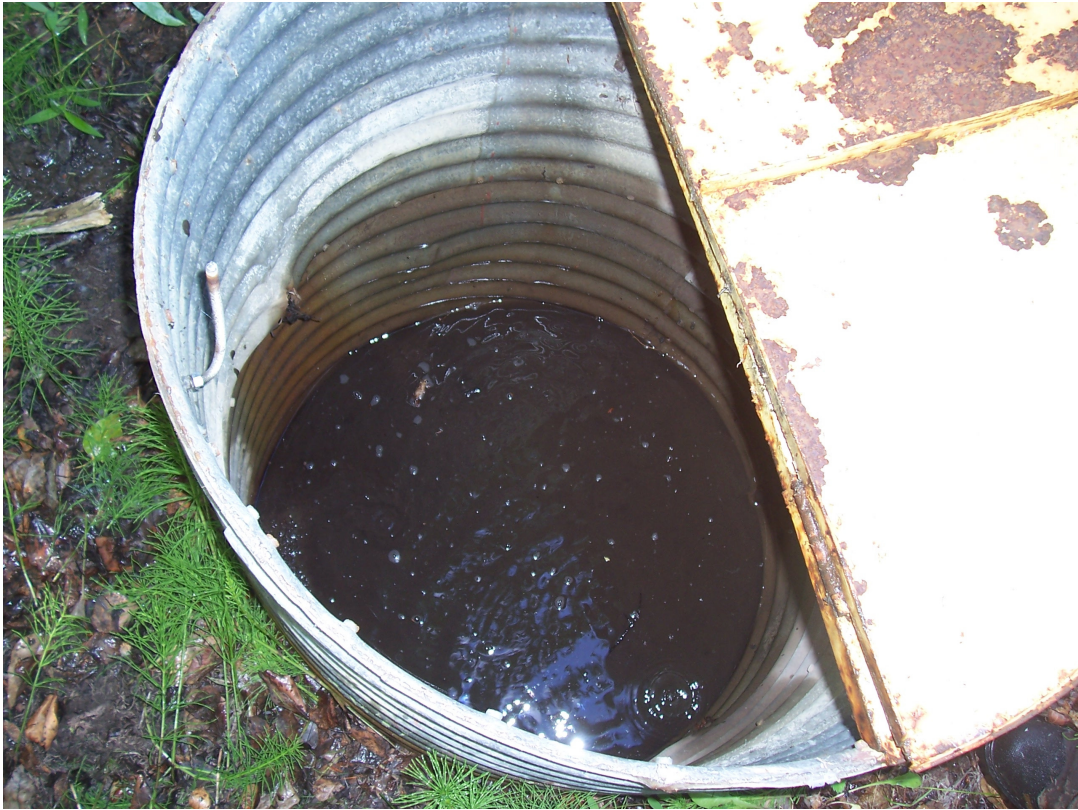
**Photo #1** Water standing inside the Uphill CSP drainage collection manhole (MH#1)

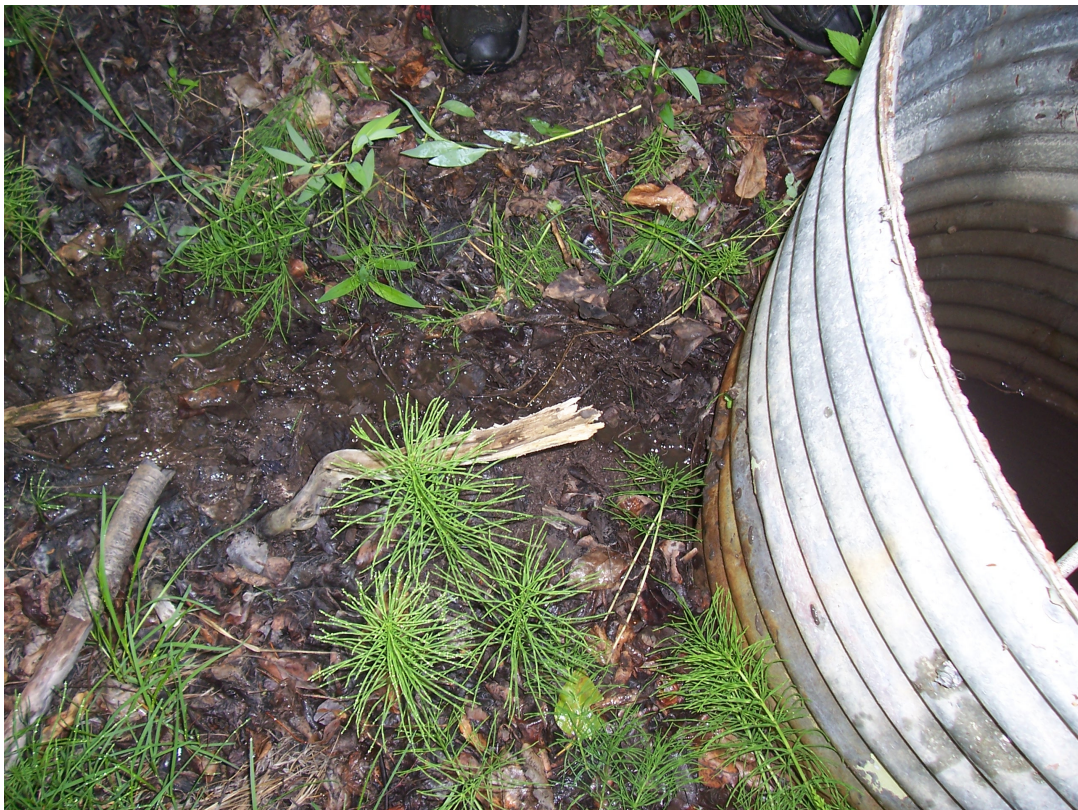
**Photo #2** Water ponding around MH#1

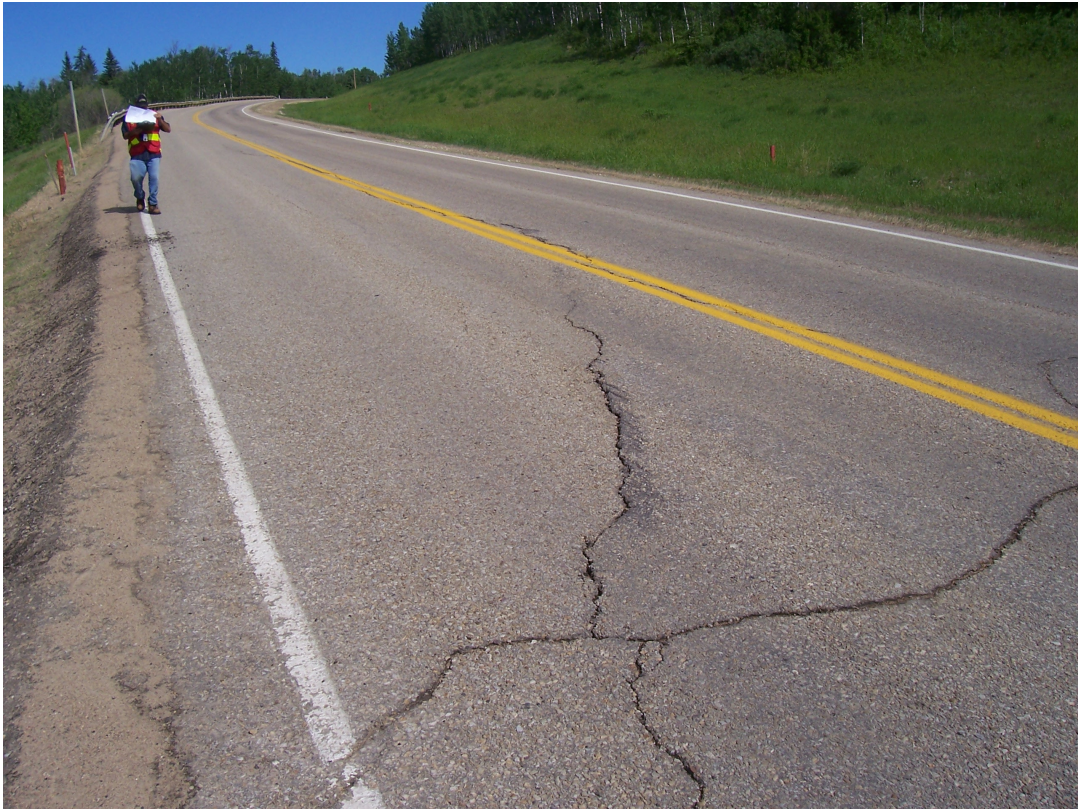
**Photo #3** Open arc-shaped crack at the southern limit of Mid-Hill slope section, looking north

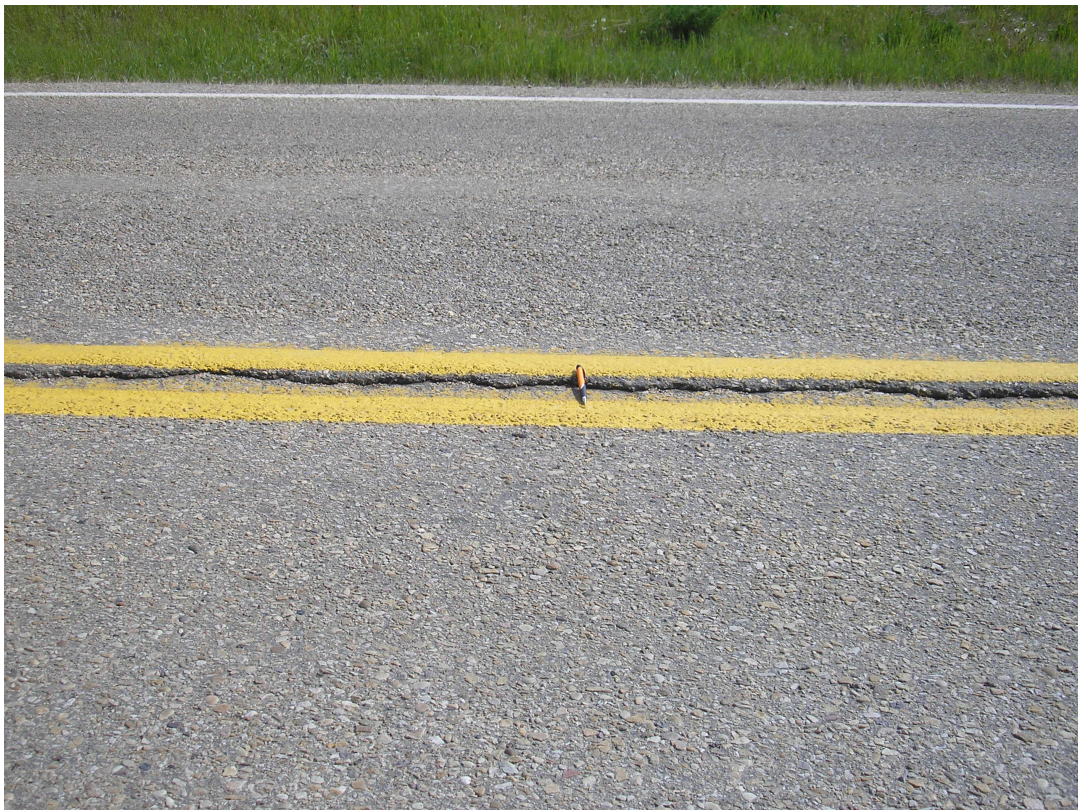
**Photo #4** Dip on the highway SBL bounded by a centerline crack along the Mid-Hill slope section, looking east

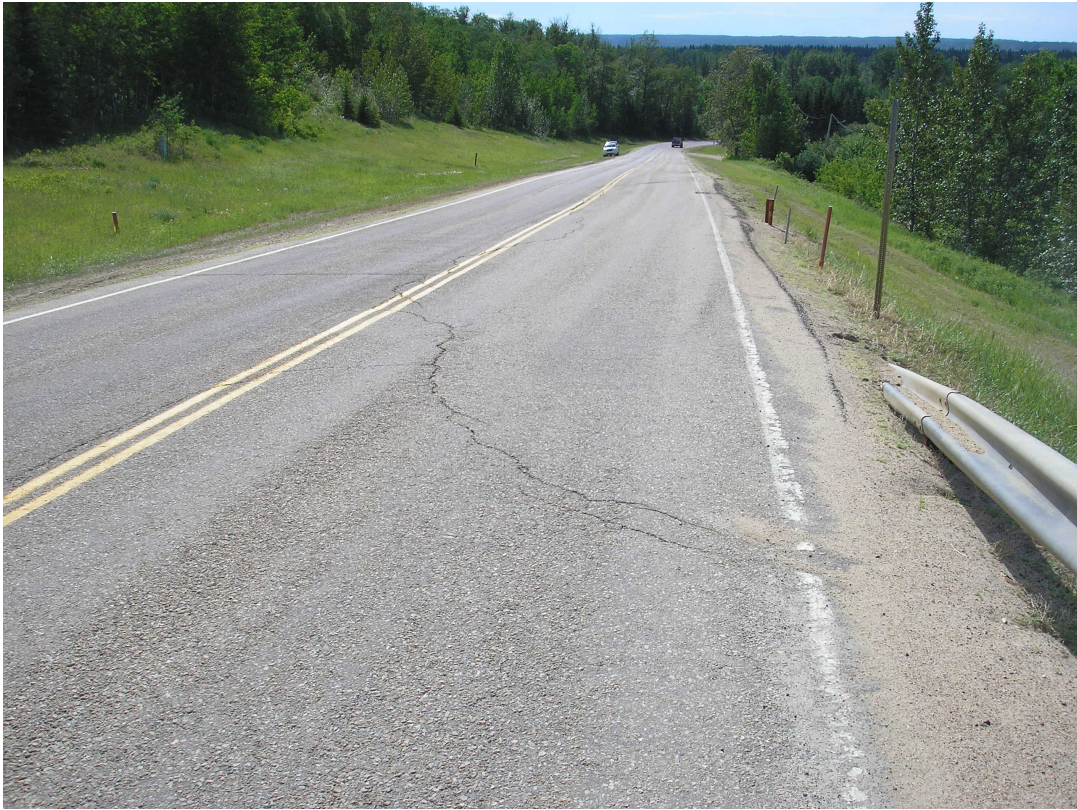
**Photo #5** Open arc-shaped crack at the northern limit of Mid-Hill slope section, note dip on highway SBL (looking south)

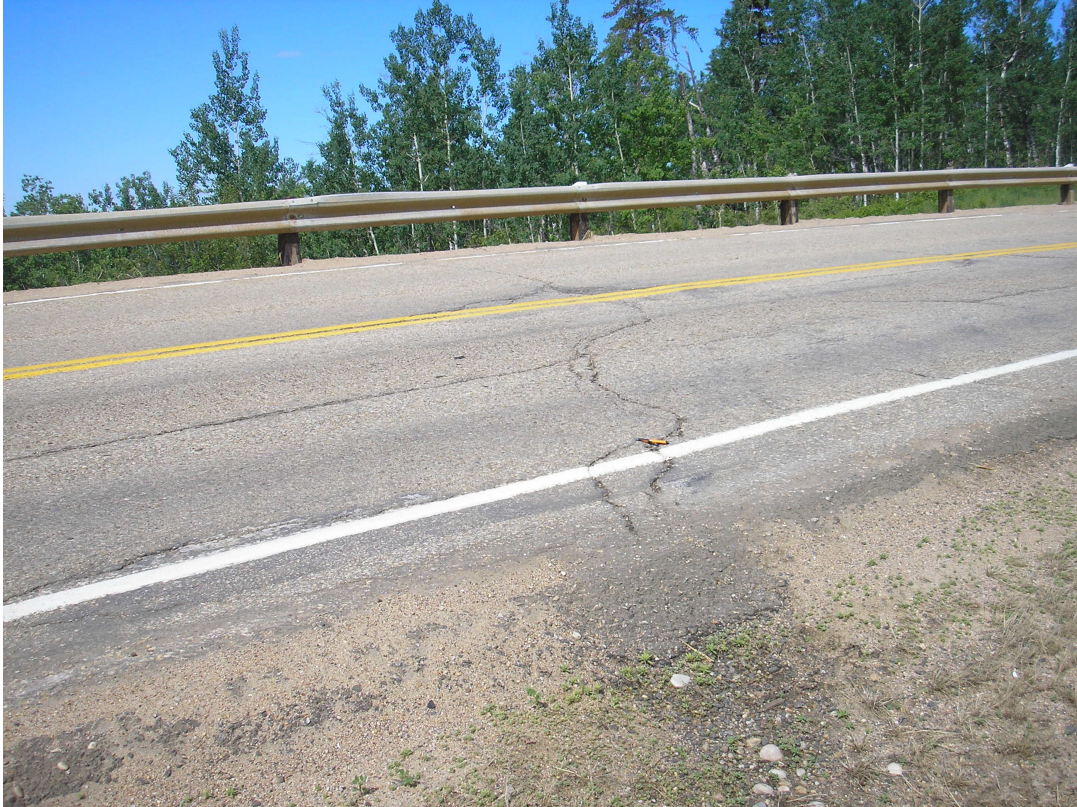
**Photo #6** Diagonal open crack on the northern limit of highway uphill section, looking west

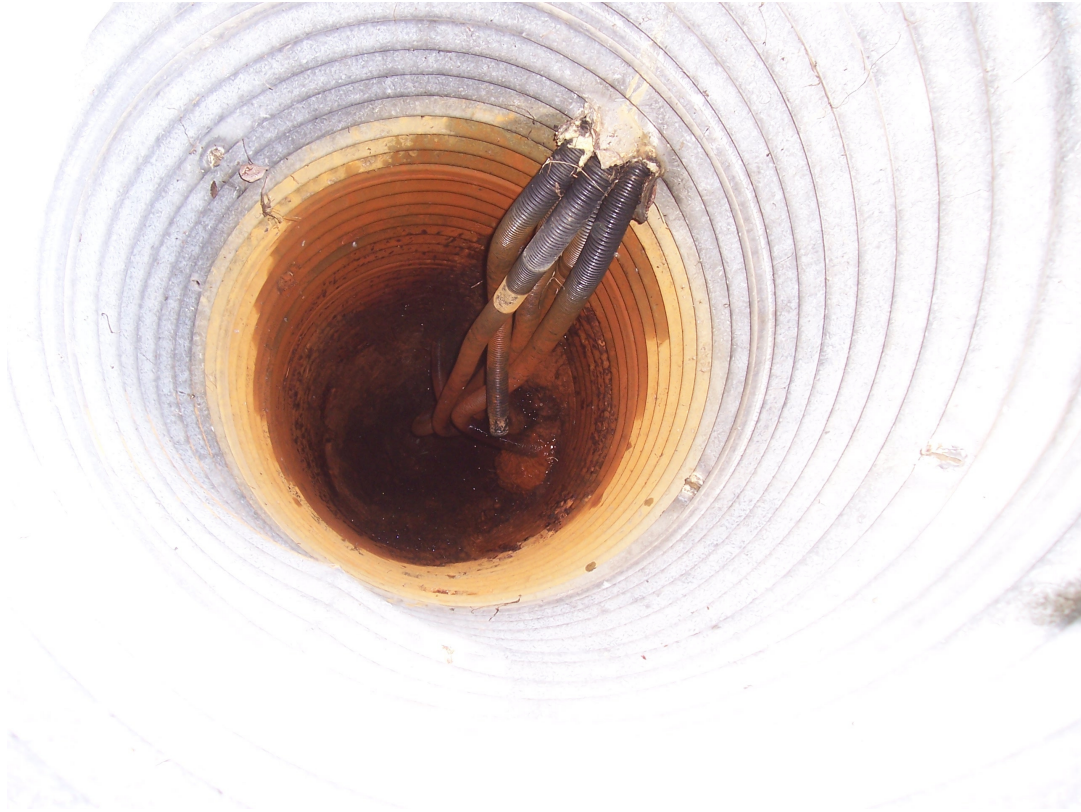
**Photo #7** Looking inside the downhill drainage collection manhole (MH#2)
