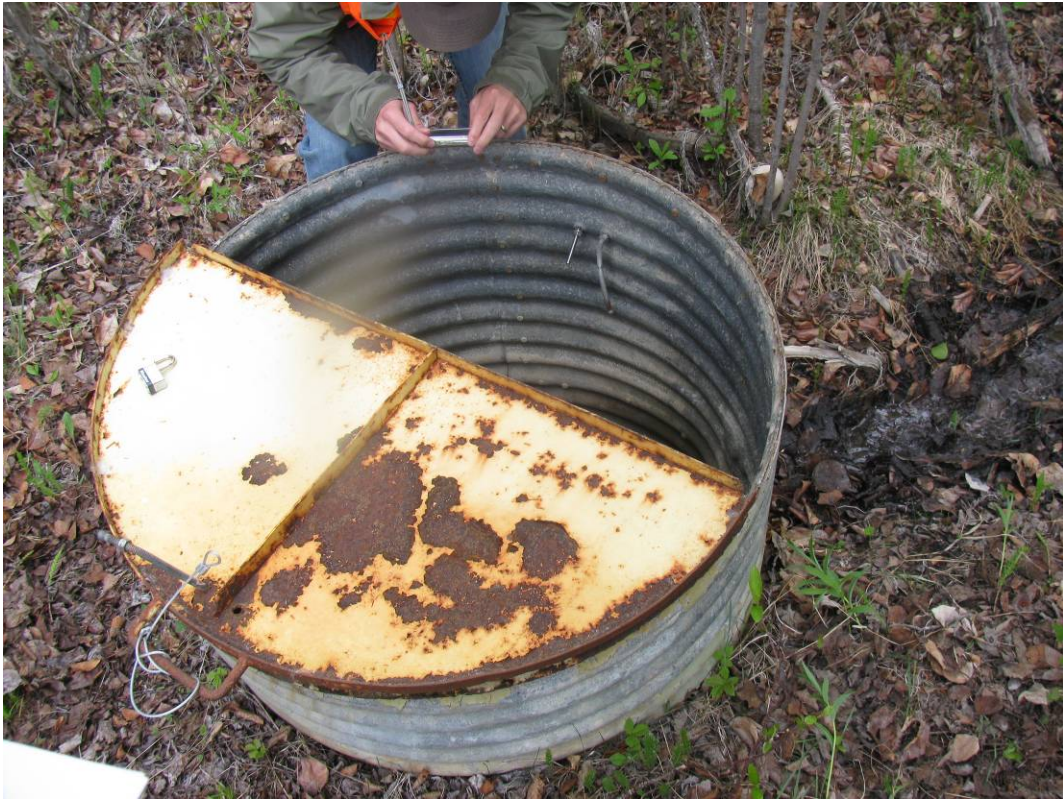
**Photo #1** Trace of water around the Uphill CSP drainage collection manhole (MH#1)

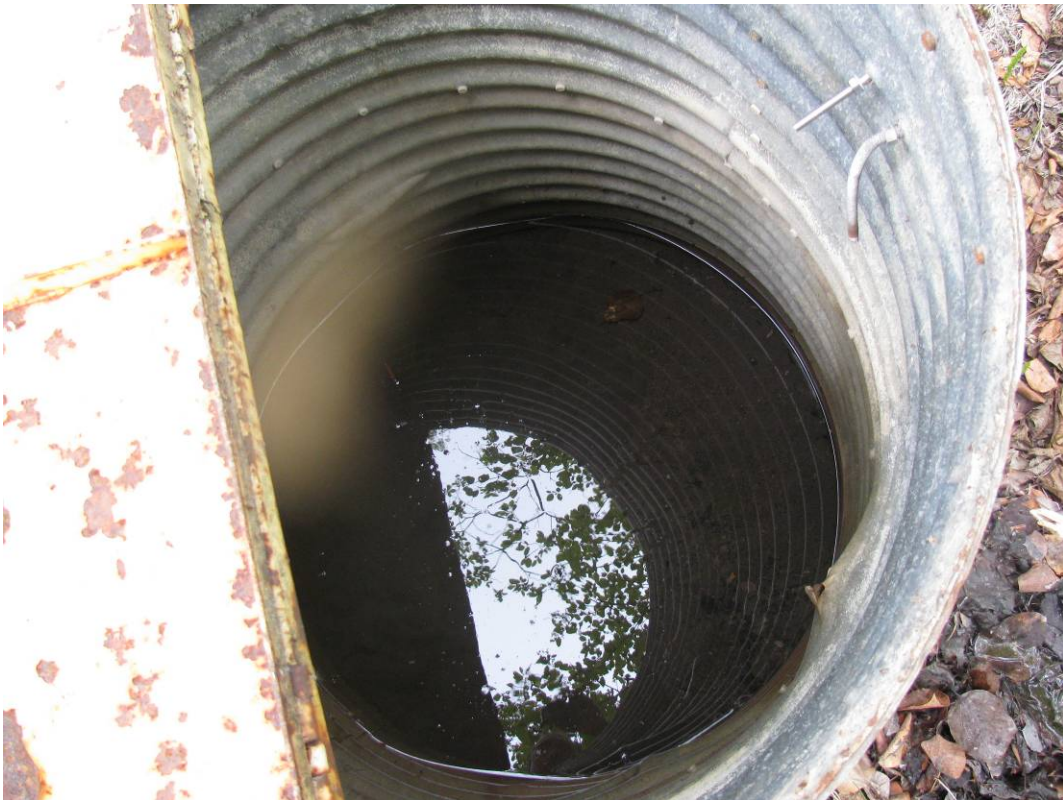
**Photo #2** Standing water inside MH#1; note that the drain outlets are completely submerged under water

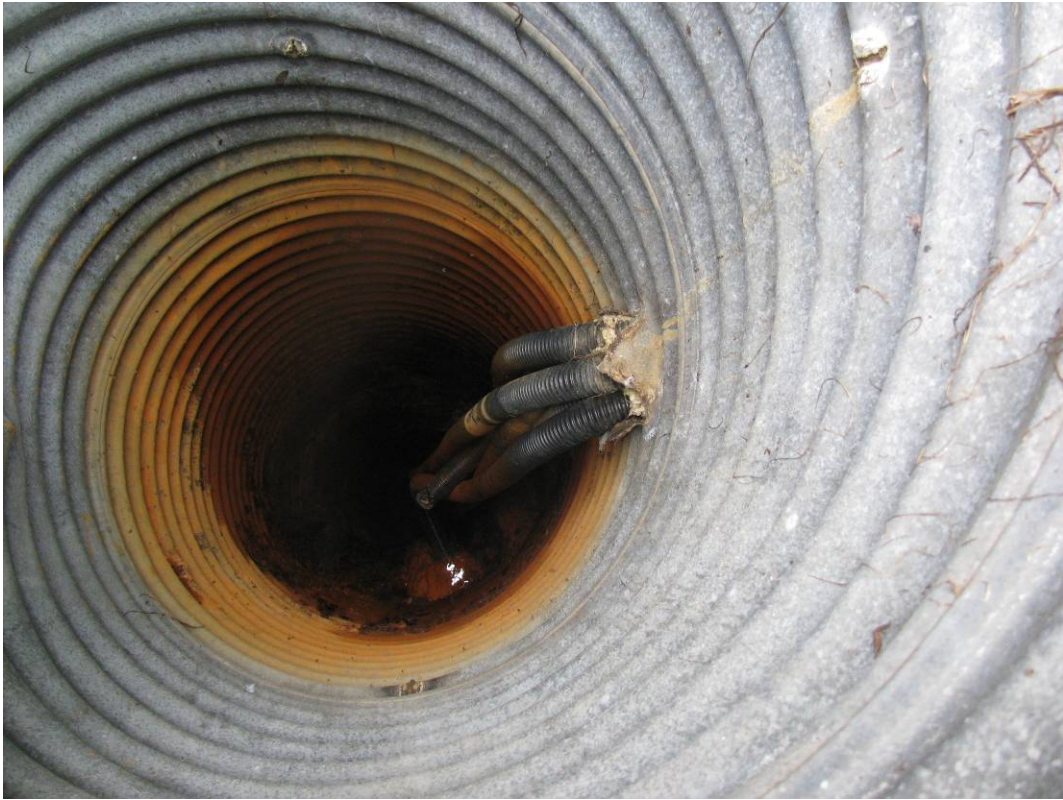
**Photo #3** Looking inside MH#2; note the dry conditions and the rust inside the manhole. The manhole is about 0.6 m in diameter and 4.5 m deep below ground surface.

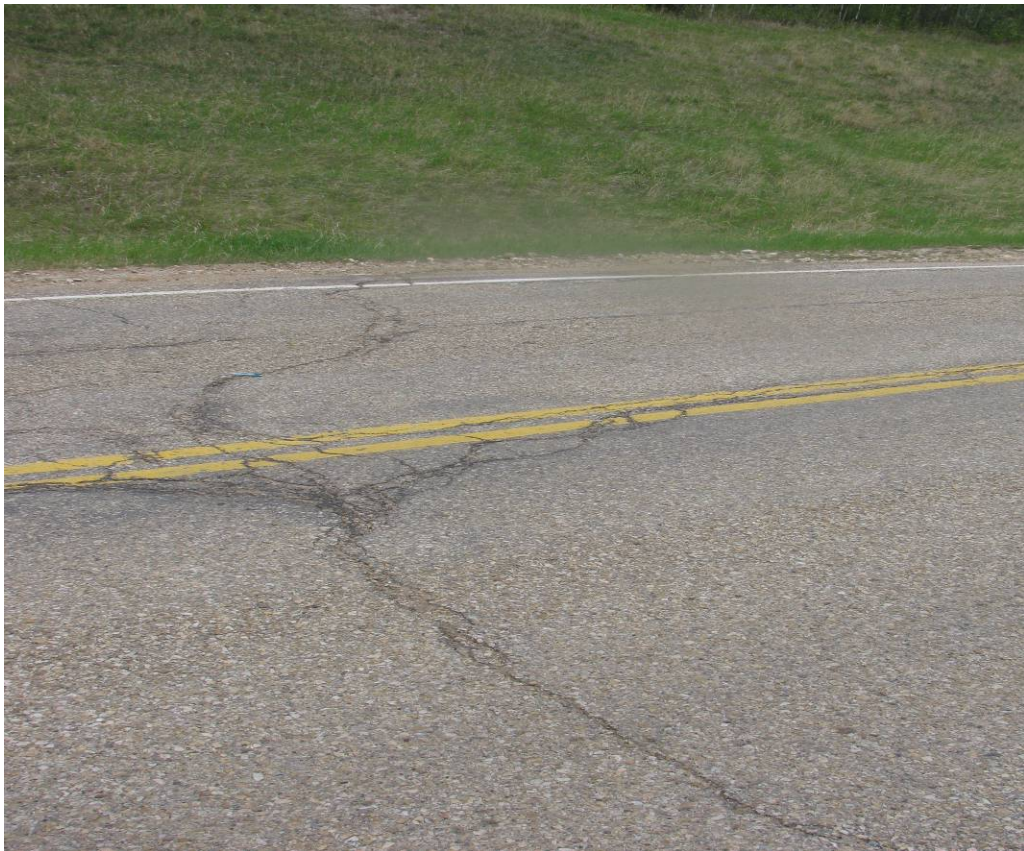
**Photo #4** Diagonal open crack on the northern limit of highway uphill section, looking east

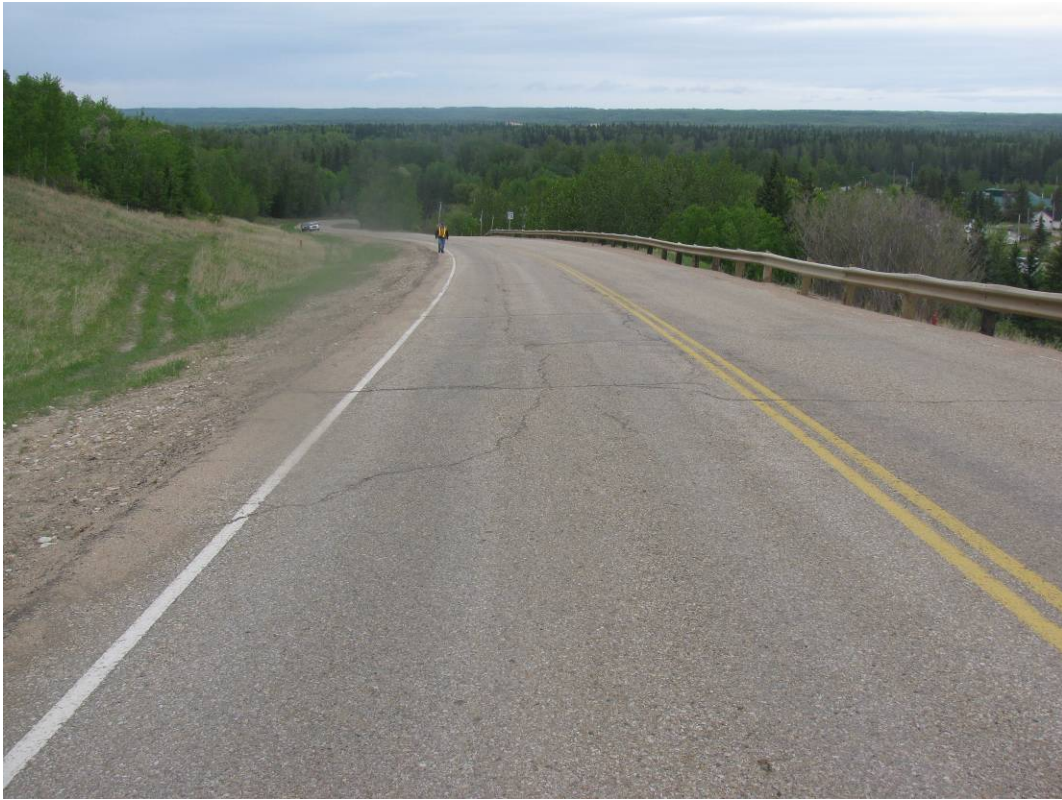
**Photo #5** Diagonal and longitudinal open crack in the NBL of the highway within the highway uphill section, looking south

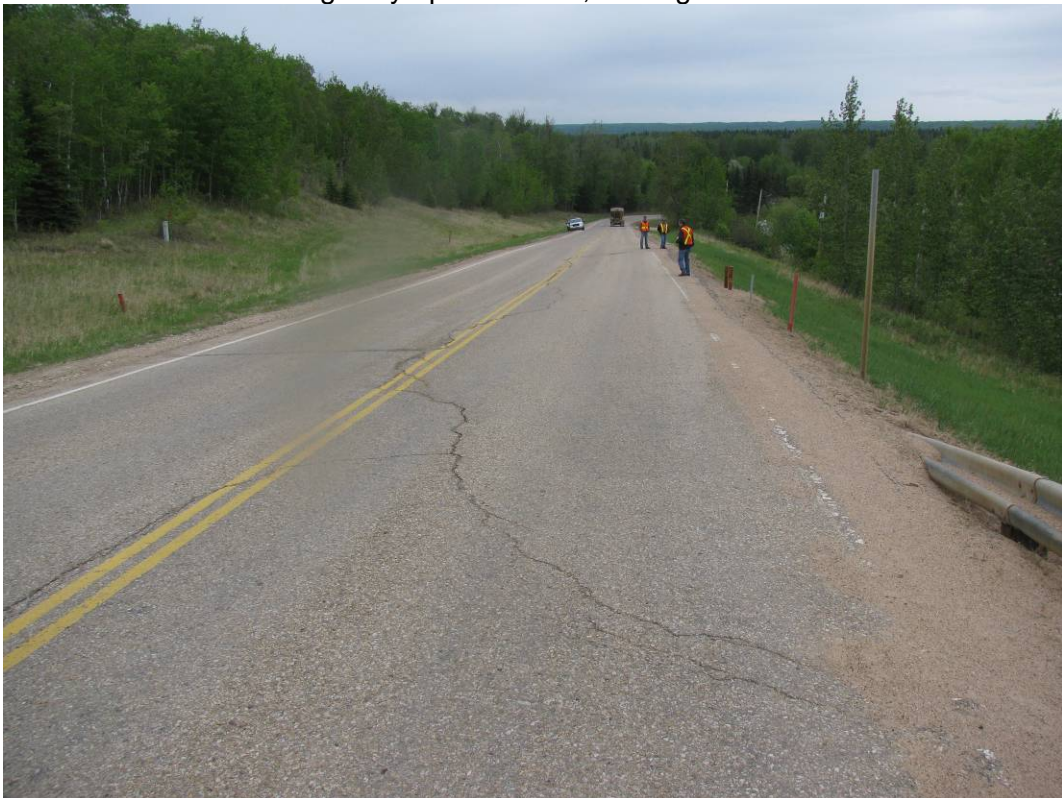
**Photo #6** Open arc-shaped crack at the northern limit of Mid-Hill slope section, note dip in highway SBL (looking south)

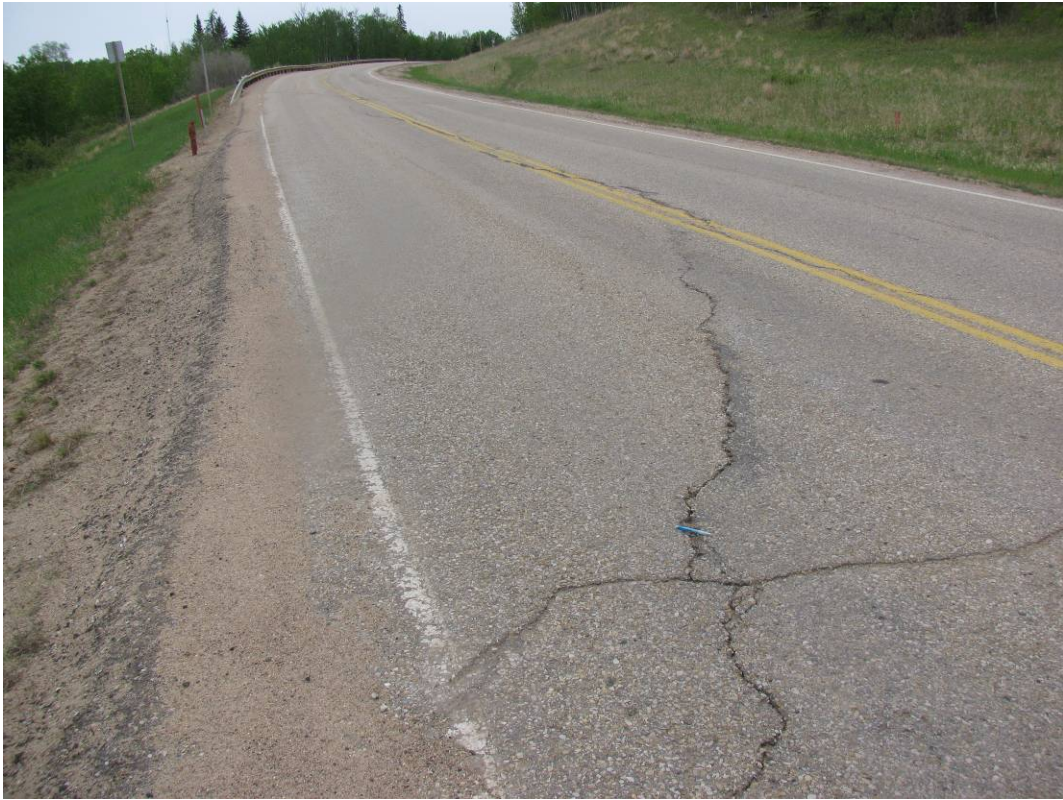
**Photo #7** Open diagonal crack at the southern limit of Mid-Hill slope section, looking north
