**SITE PLAN  
 MID-HILL SLIDE AREA**

NORTH CENTRAL (ATHABASCA) 2011  
 GEOHAZARD ASSESSMENTS  
 NW-1-62-6-W5M  
 NC14 - HWY 661:02 km1.8  
 N. OF FT. ASSINIBOINE, AB

ENGINEER:	TSA	DRAWN:	HH	APPROVED:	DWP
DATE:	MAY 2011	SCALE:	NOT TO SCALE	DRAWING No.:	<b>FIGURE NC14-2</b>

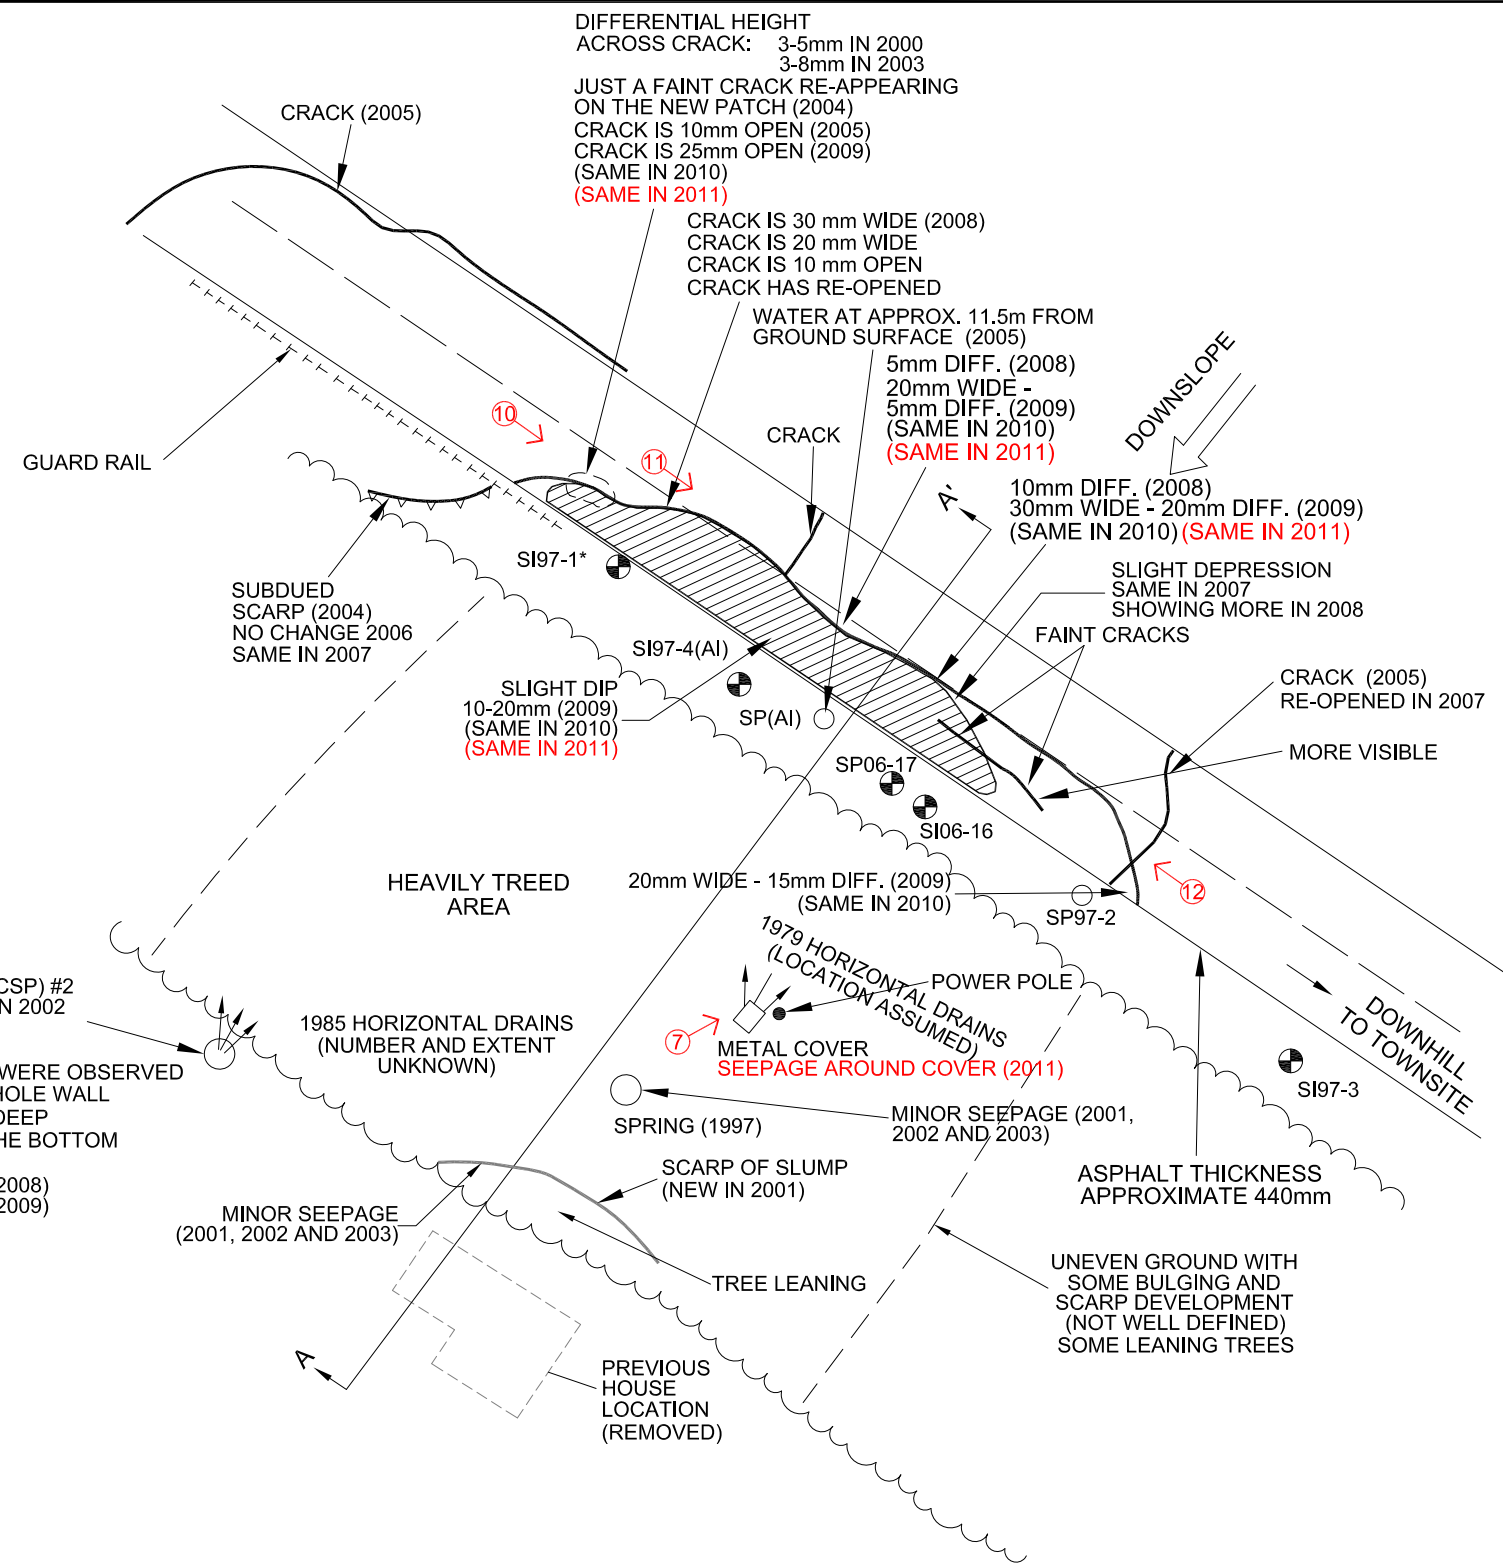
1. FEATURE LOCATIONS ARE APPROXIMATE.
2. PREVIOUS OBSERVATIONS SHOWN IN BLACK
3. PREVIOUS CRACK PATTERN WAS COVERED BY NEW (2004) ASPHALT PATCH
4. **MAY 4, 2011 OBSERVATIONS ARE SHOWN IN RED**

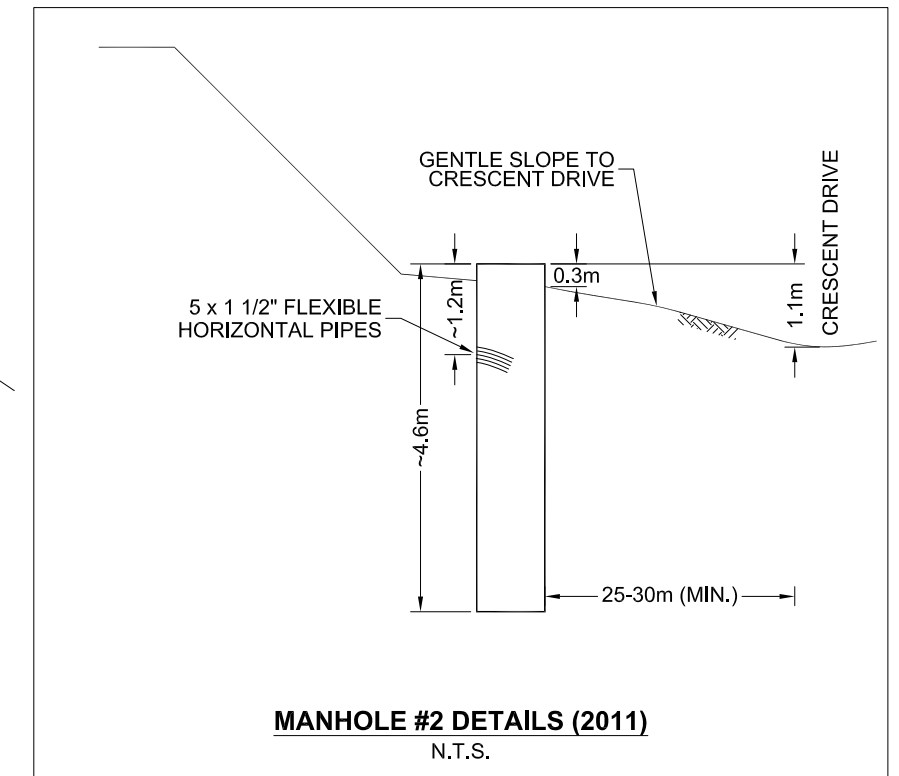
**MANHOLE #2 DETAILS (2011)**  
 N.T.S.

EXISTING COLLECTION WELL (CSP) #2  
 LESS WATER DRIPPING THAN IN 2002  
 4m DEEP 2m OF WATER  
 WATER DRIPPING (2004)  
 FIVE 38mm Ø PLASTIC DRAINS WERE OBSERVED  
 PROTRUDING FROM THE MANHOLE WALL  
 MANHOLE Ø = 600mm AND 5m DEEP  
 WATER WAS AT 2.35m FROM THE BOTTOM  
 WATER DRIPPING (2006)  
 WATER AT BOTTOM OF WELL (2008)  
 WATER AT BOTTOM OF WELL (2009)  
 DRY (2010)  
 (SAME IN 2011)
