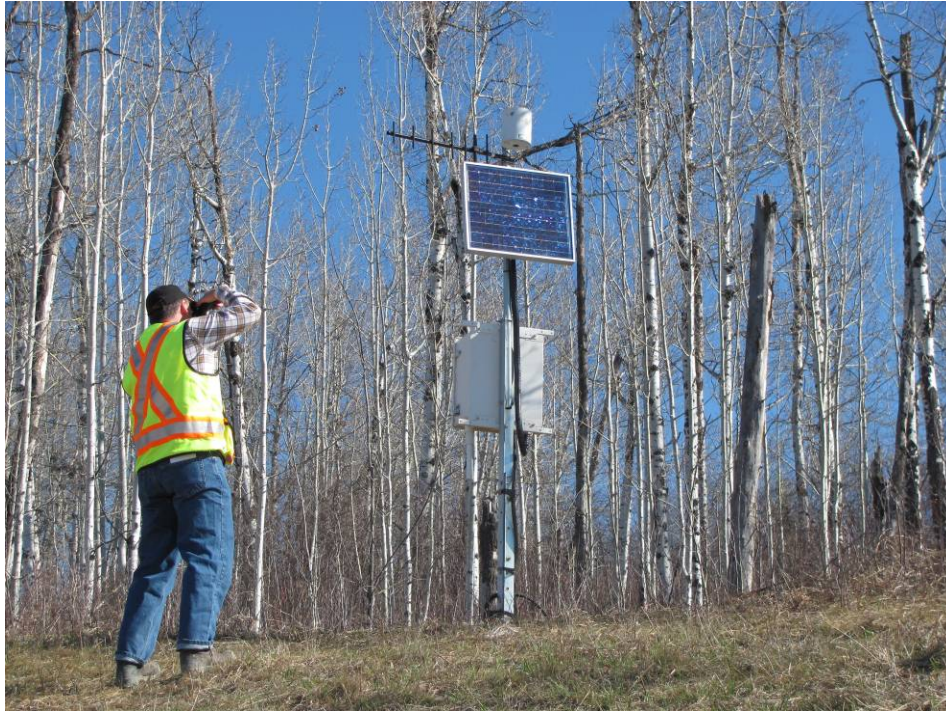
Photo #1 Looking at the weather station installed at NC 14

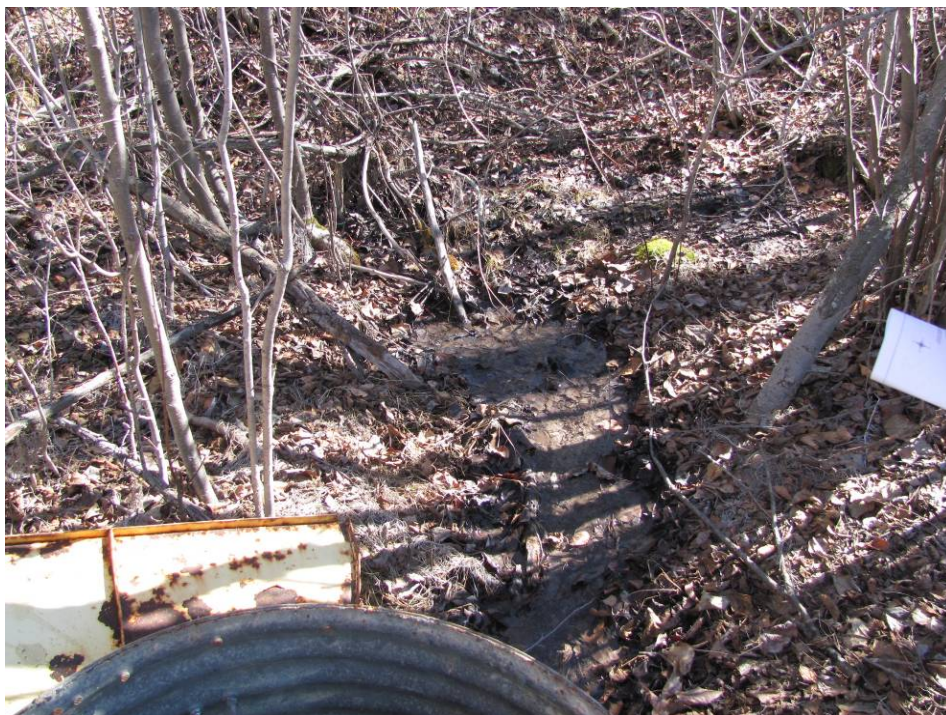
Photo #2 Trace of water around the Uphill CSP drainage collection manhole (MH#1)

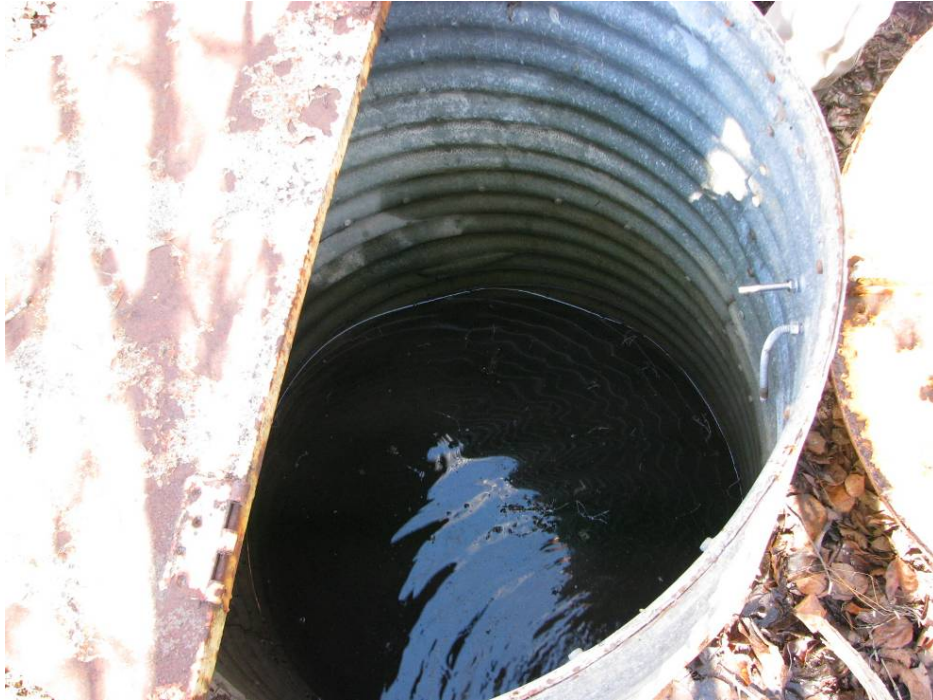
Photo #3 Standing water inside MH#1; note that the drain outlets are completely submerged under water

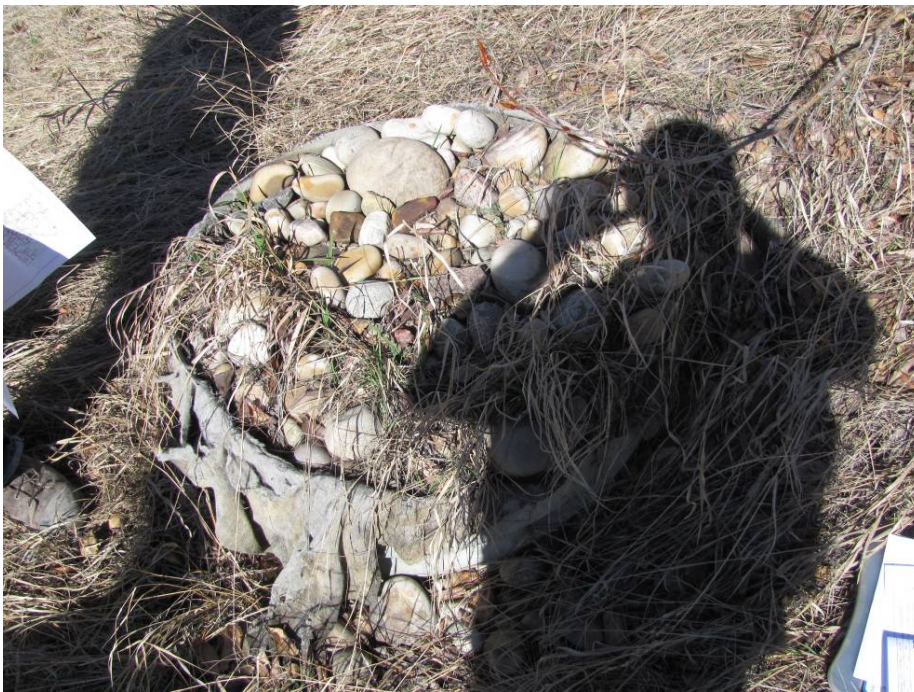
Photo #4 Looking at the manhole covered with cobbles located immediately downslope of MH#1.

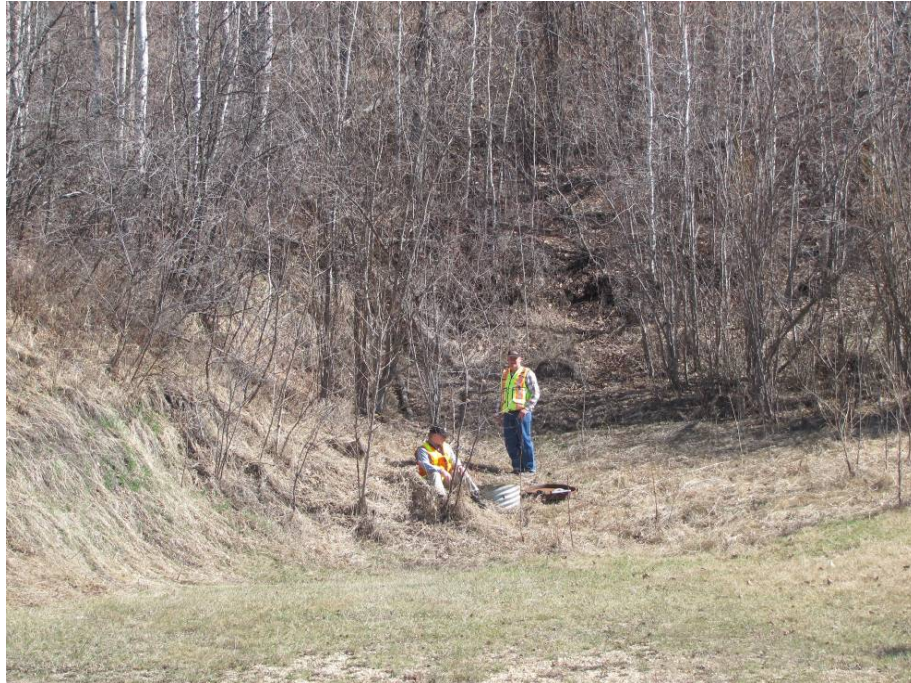
Photo #5 Looking east at MH#2 from the bottom of the slope; note the presence of a local old slump above the manhole location

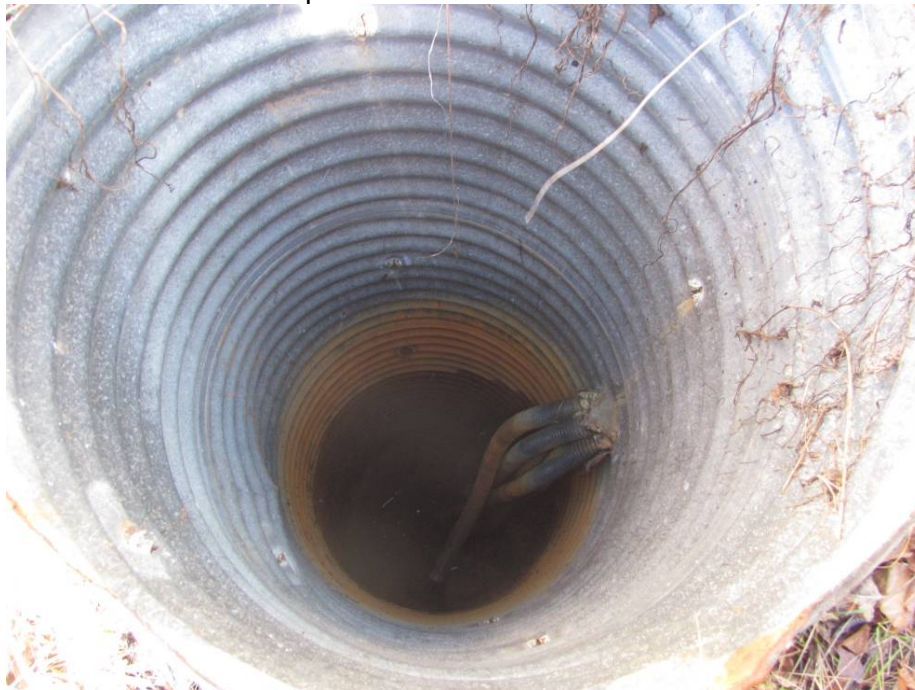
Photo #6 Looking inside MH#2; note the dry conditions and the rust inside the manhole. The manhole is about 0.6 m in diameter and 4.6 m deep below ground surface.

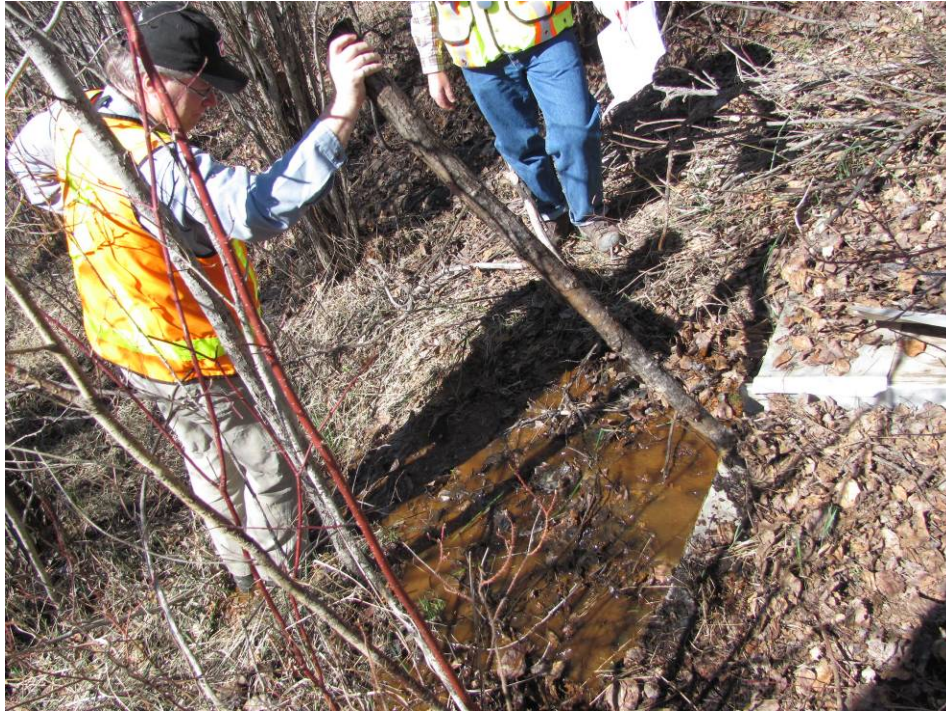
Photo #7 Existing metal cover in the top of the slope above MH#2; seepage came out when the cover was disturbed

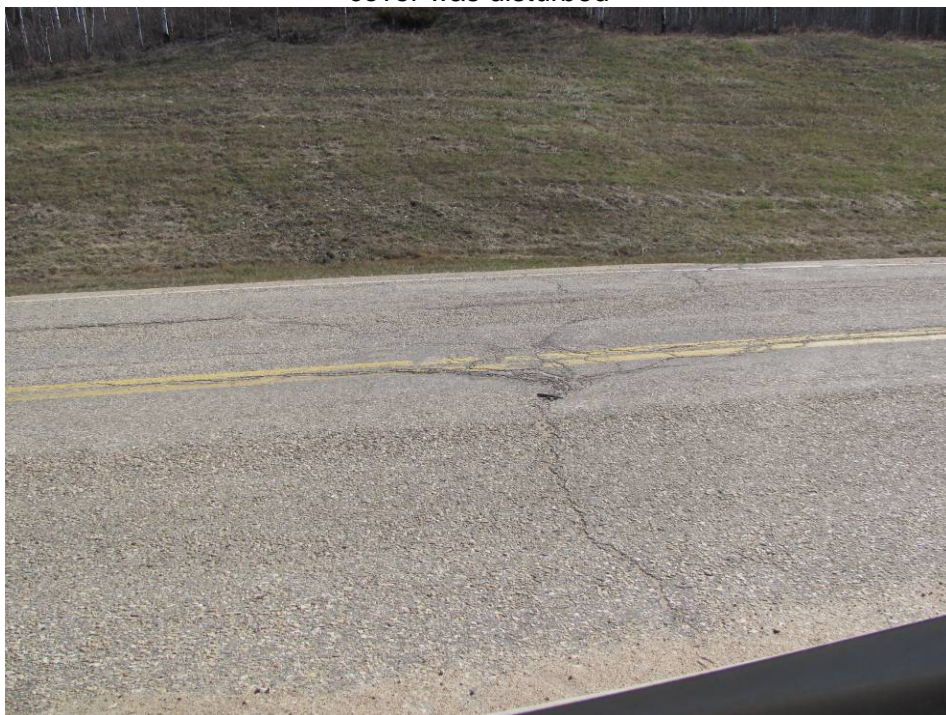
Photo #8 Diagonal open crack on the northern limit of highway uphill section, looking east

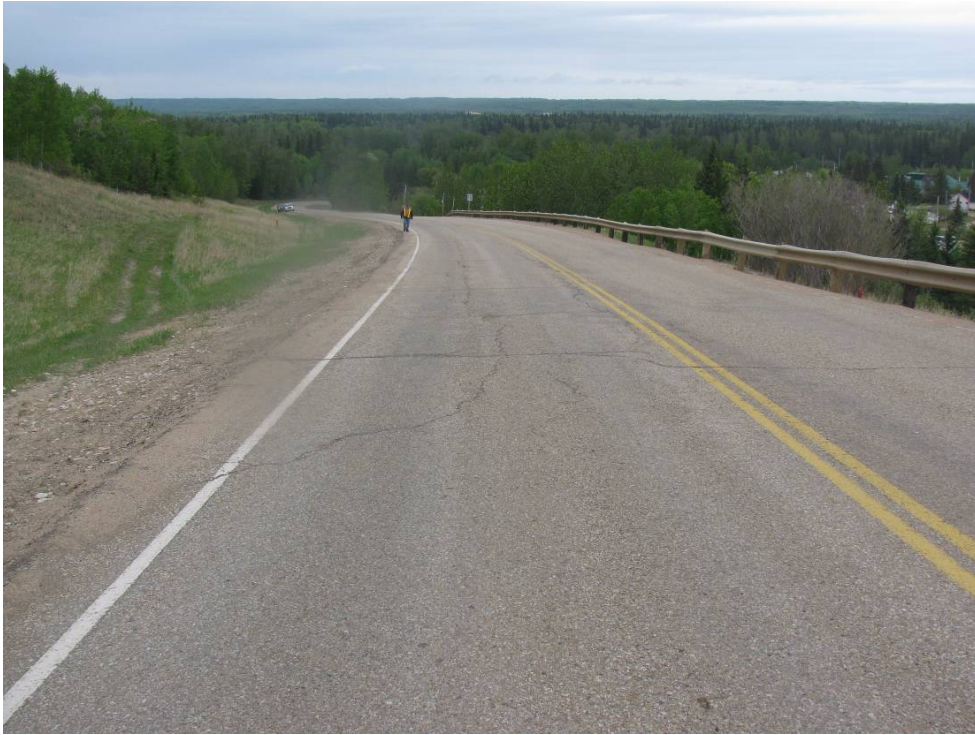
Photo #9 Diagonal and longitudinal open crack in the NBL of the highway within the highway uphill section (looking south)

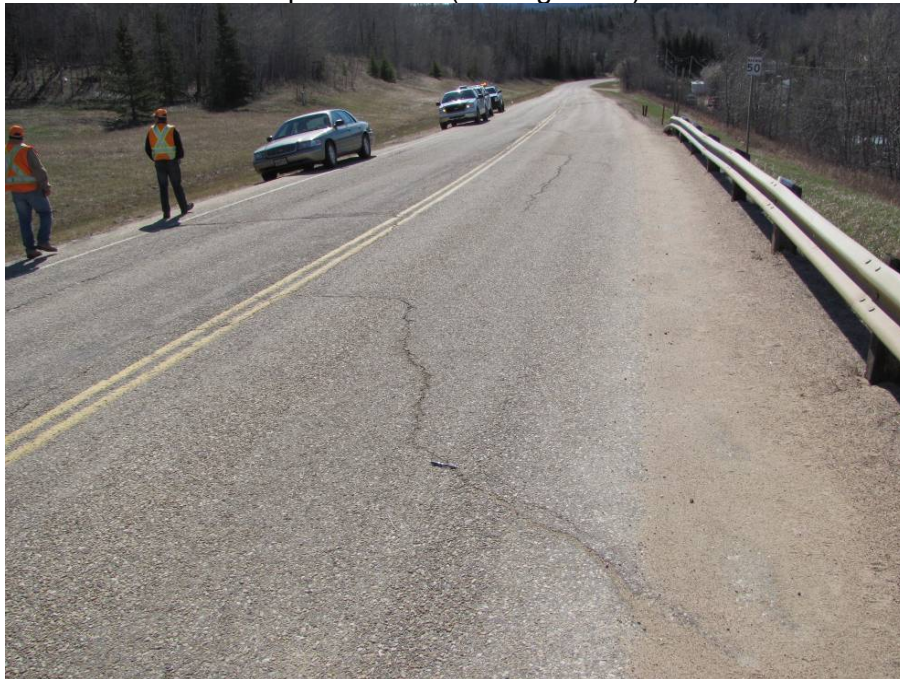
Photo #10 Open arc-shaped crack at the northern limit of Mid-Hill slope section, note dip in highway SBL (looking south)

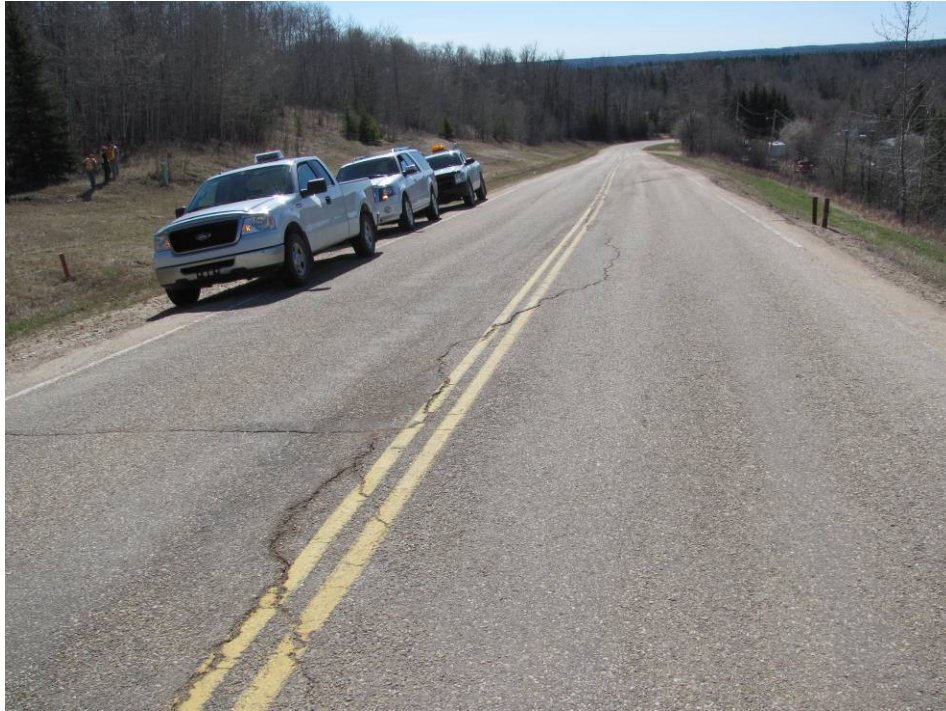
Photo #11 Cracks on the NBL and SBL surfaces within the Mid-Hill slope section (looking south)

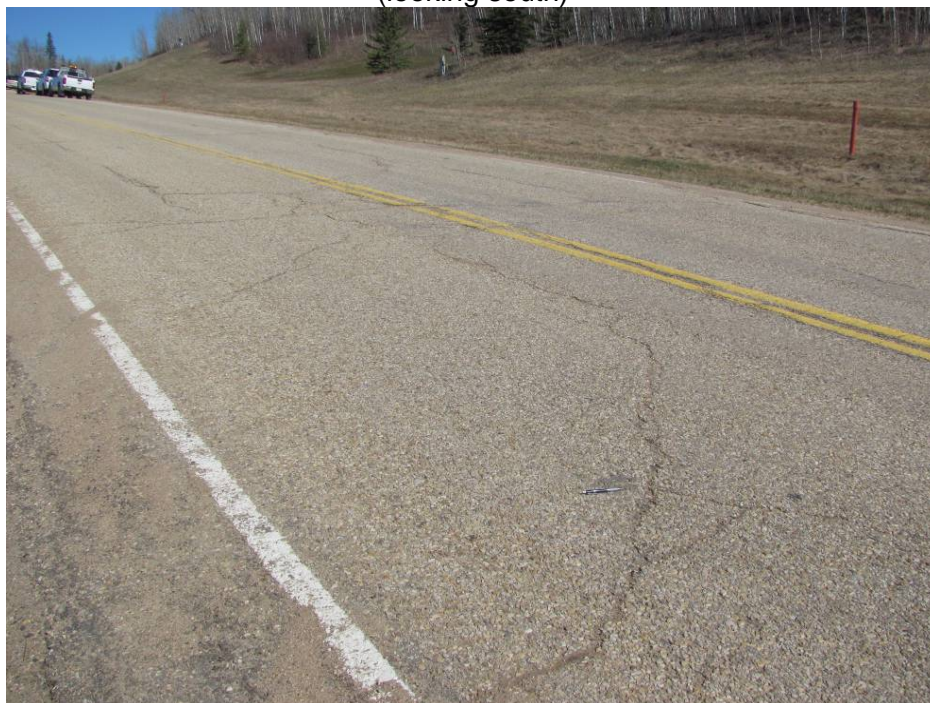
Photo #12 Open diagonal crack at the southern limit of Mid-Hill slope section (looking north)

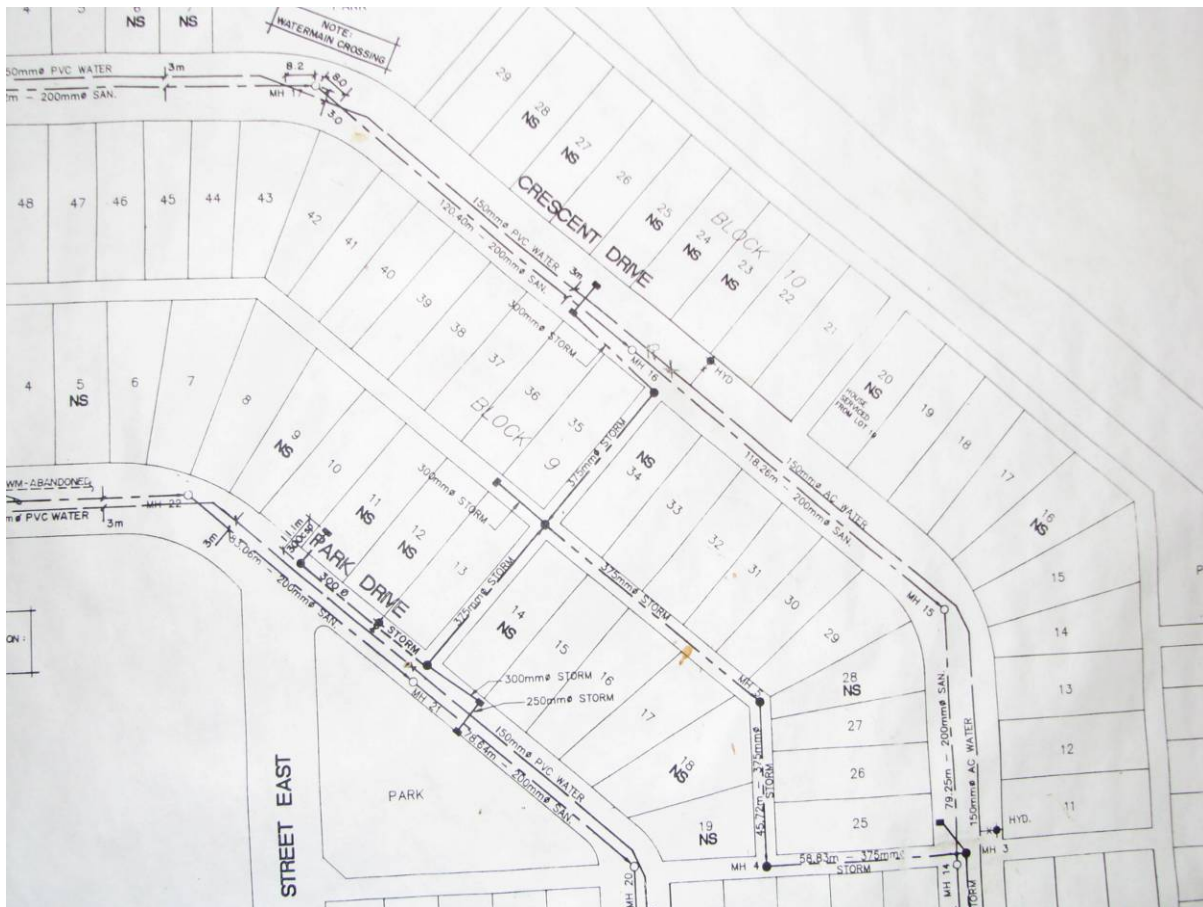
Photo #13 M.D. Woodlands No. 15- Existing Overall Utility Plan along Crescent Drive in the vicinity of MH#2 (Photo taken from Fort Assiniboine Water Plant Facility)
