NORTH CENTRAL REGION (ATHABASCA AREA) - 2012 GEOHAZARD ASSESSMENT

NC14: HWY 661: 02 FORT ASSINIBOINE (km 1.8) SITE PLAN SHOWING MID-HILL SLIDE AREA

FIGURE NC14-2

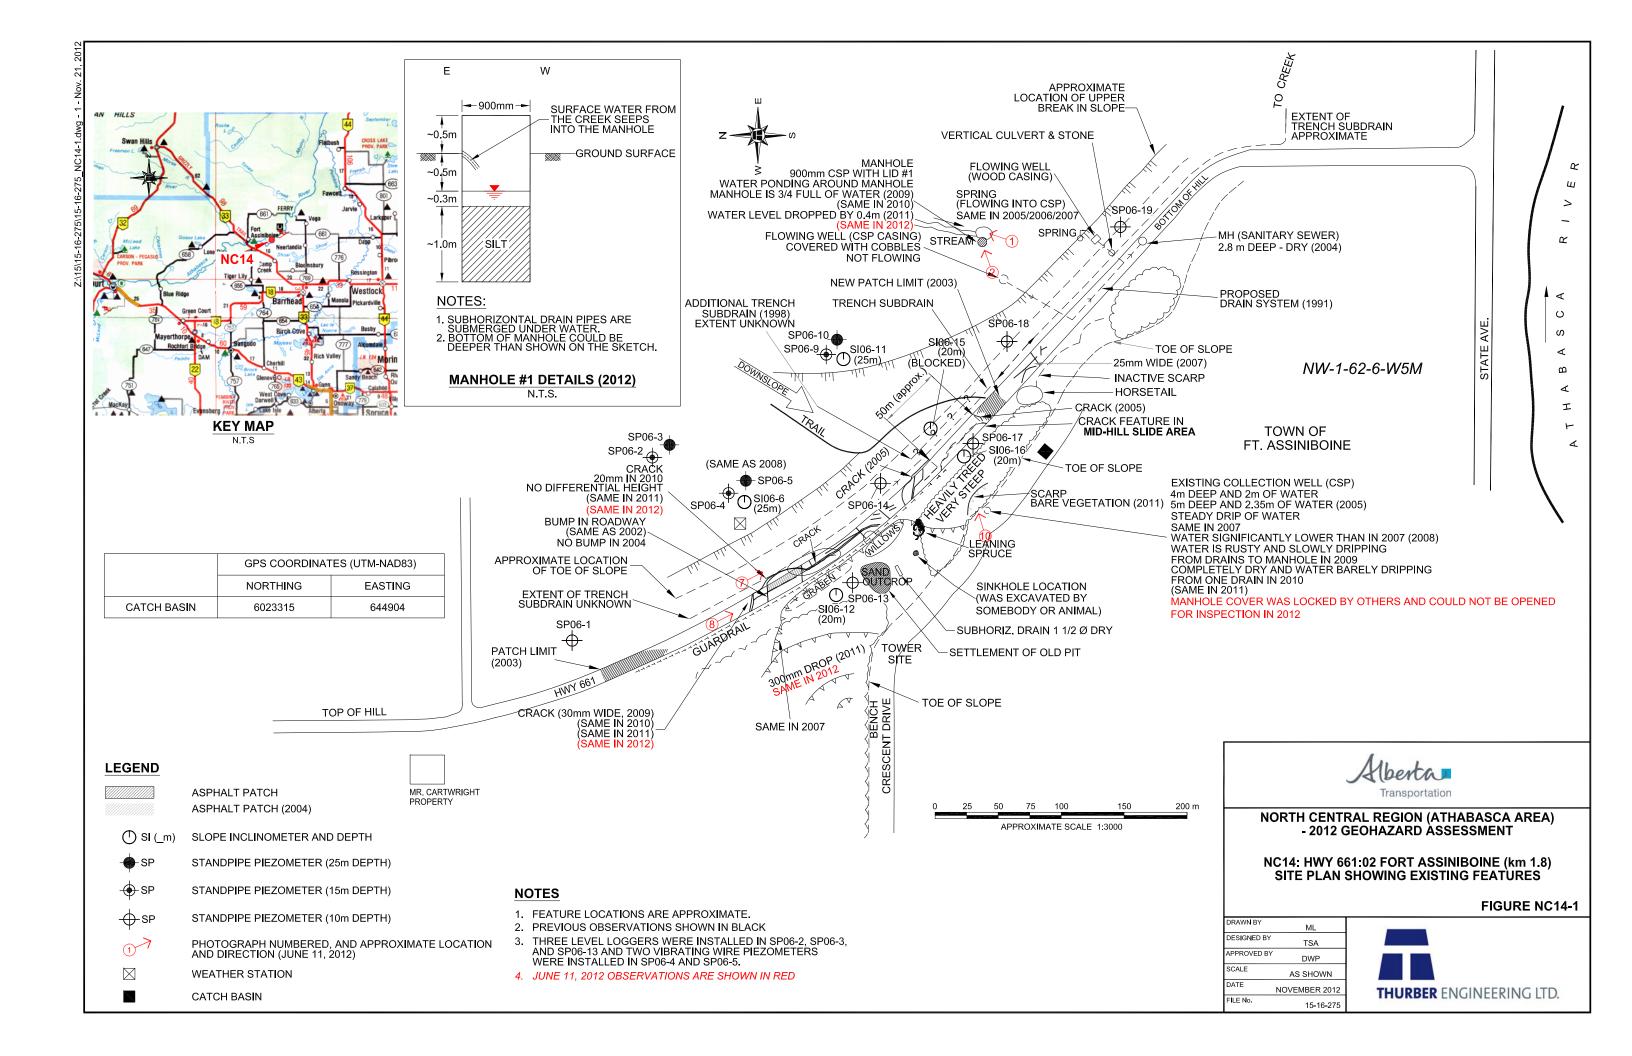
DIFFERENTIAL HEIGHT ACROSS CRACK: 3-5mm IN 2000 3-8mm IN 2003 JUST A FAINT CRACK RE-APPEARING ON THE NEW PATCH (2004) CRACK IS 10mm OPEN (2005) CRACK IS 25mm OPEN (2009) CRACK (2005) (SAME IN 2010) (SAME IN 2011) 25mm WIDE - 10mm DIFF. CRACK IS 30 mm WIDE (2008) CRACK IS 20 mm WIDE CRACK IS 10 mm OPEN CRACK HAS RE-OPENED WATER AT APPROX. 11.5m FROM GROUND SURFACE (2005) 5mm DIFF. (2008) 20mm WIDE -5mm DIFF. (2009) (SAME IN 2010) CRACK (SAME IN 2011) (SAME IN 2012) 10mm DIFF. (2008) 30mm WIDE - 20mm DIFF. (2009) **GUARD RAIL** (SAME IN 2010) (SAME IN 2011) 35mm WIDE - 30mm DIFF. SI97-1* SLIGHT DEPRESSION SAME IN 2007 SHOWING MORE IN 2008 SUBDUED SCARP (2004) NO CHANGE 2006 FAINT CRACKS SI97-4(AI) **SAME IN 2007** CRACK (2005) SLIGHT DIP 10-20mm (2009) (SAME IN 2010) (SAME IN 2011) RE-OPENED IN 2007 SP(AI) MORE VISIBLE SP06-17 15mm WIDE - NO DIFF. 20mm WIDE - 15mm DIFF. (2009) \$106-16 (SAME IN 2010) **HEAVILY TREED** NIDE - 25mm DIFF. AREA 1979 (LOCATION POWER POLE) AND POWER POLE) ASSUMEDINS SP97-2 EXISTING COLLECTION WELL (CSP) #2 LESS WATER DRIPPING THAN IN 2002 1985 HORIZONTAL DRAINS 4m DEEP 2m OF WATER (NUMBER AND EXTENT METAL COVER WATER DRIPPING (2004) SEEPAGE AROUND COVER (2011) SAME IN 2012 FIVE 38mm Ø PLASTIC DRAINS WERE OBSERVED PROTRUDING FROM THE MANHOLE WALL UNKNOWN) SI97-3 -MINOR SEEPAGE (2001, MANHOLE \emptyset = 600mm AND 5m DEEP **SPRING** (1997) 2002 AND 2003) WATER WAS AT 2.35m FROM THE BOTTOM WATER DRIPPING (2006) WATER AT BOTTOM OF WELL (2008) WATER AT BOTTOM OF WELL (2009) SCARP OF SLUMP ASPHALT THICKNESS (NEW IN 2001) APPROXIMATE 440mm MINOR SEEPAGE (2001, 2002 AND 2003) DRY (2010) (SAME IN 2011) UNEVEN GROUND WITH SOME BULGING AND SCARP DEVELOPMENT TREE LEANING (NOT WELL DEFINED) SOME LEANING TREES PREVIOUS HOUSE LOCATION (REMOVED) **LEGEND** SI - SLOPE INCLINOMETER SP - STANDPIPE PIEZOMETER GPS COORDINATES (UTM-NAD83) MANHOLE NUMBER NORTHING **EASTING**
