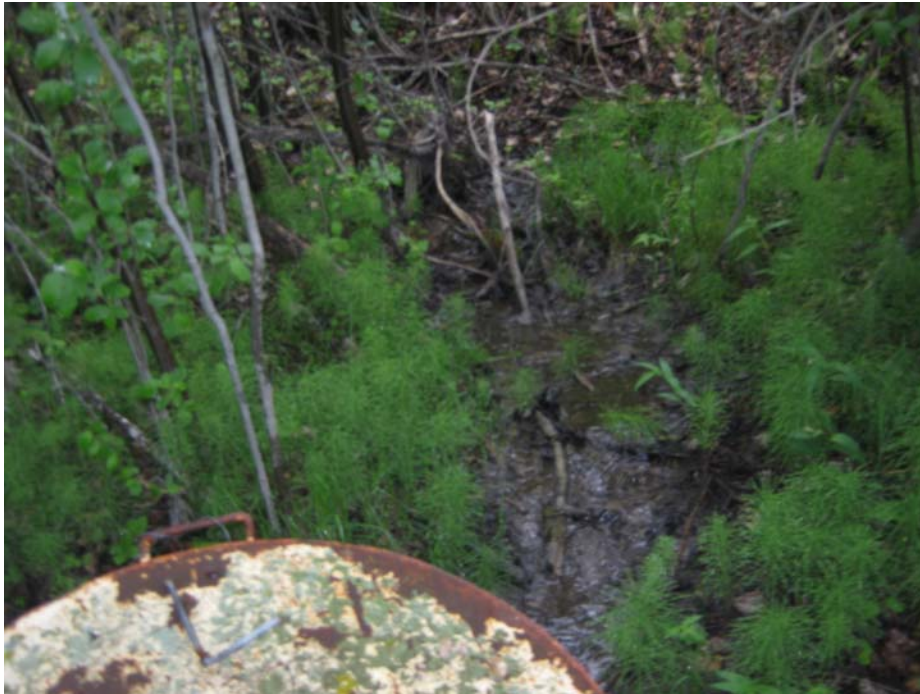
Photo #1 Some water around the Uphill CSP drainage collection manhole (MH#1)

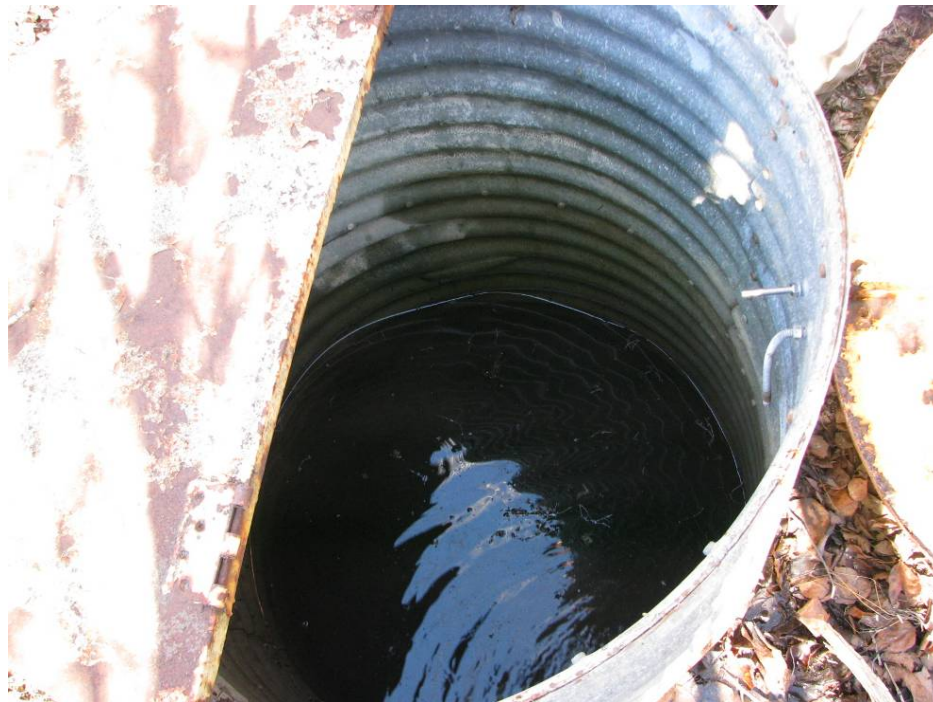
Photo #2 Standing water inside MH#1; note that the drain outlets are completely submerged under water

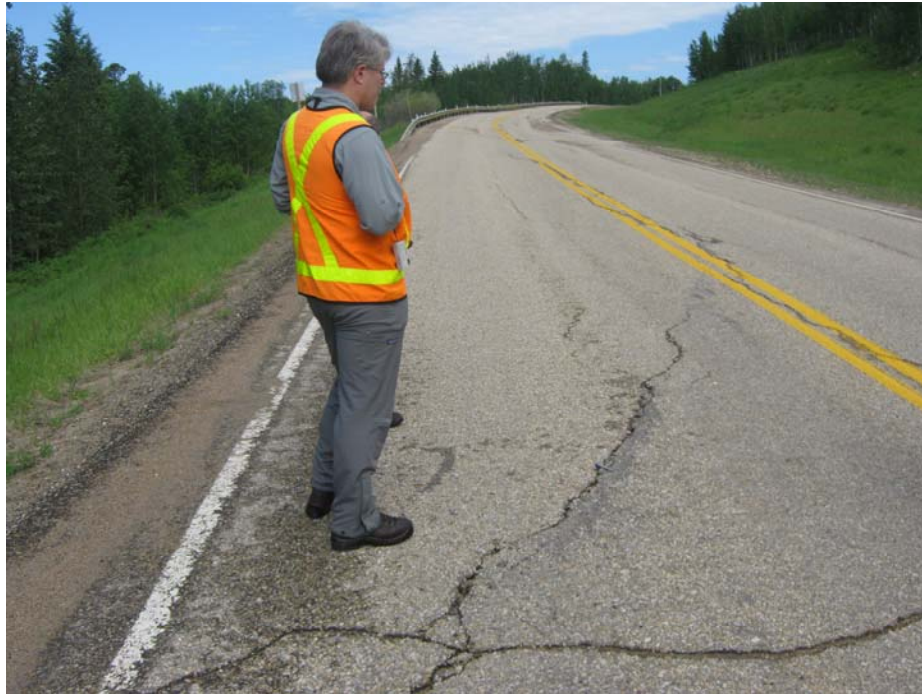
Photo #3 Open diagonal crack at the southern limit of Mid-Hill slope section (looking north)

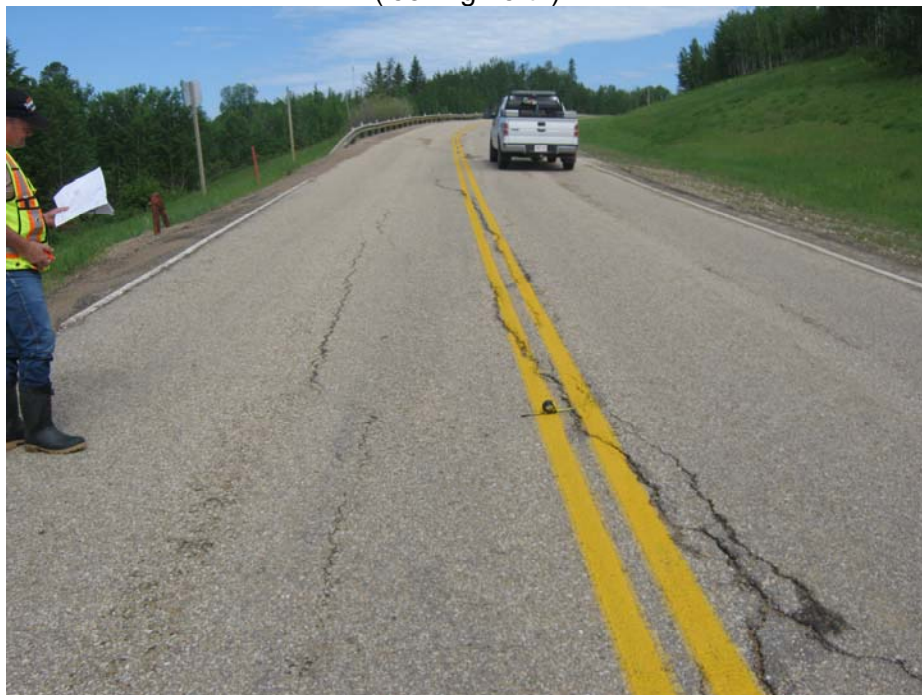
Photo #4 Open longitudinal crack within the Mid-Hill slope section (looking north)

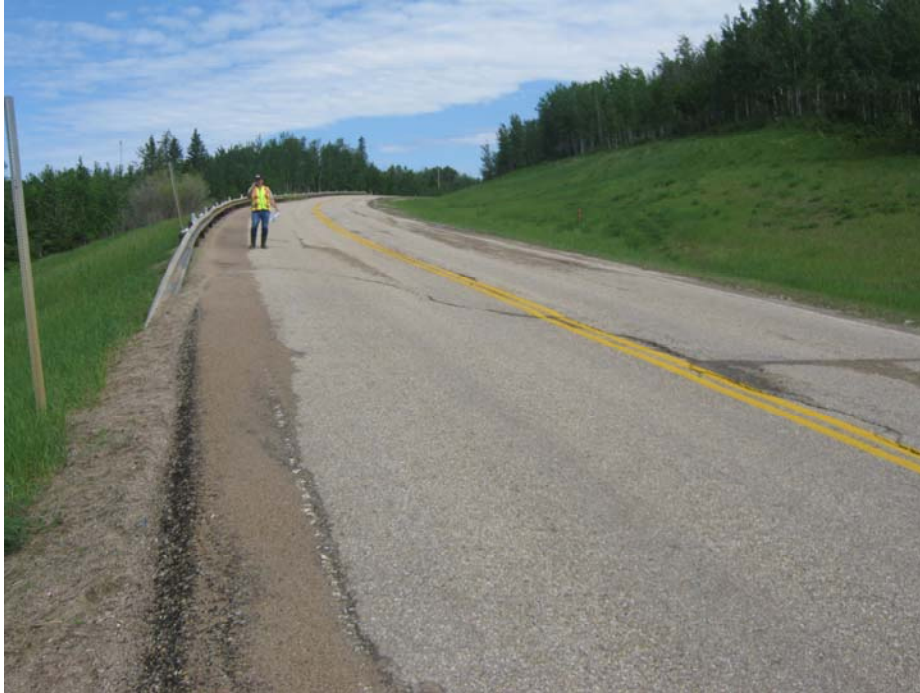
Photo #5 Open arc-shaped crack at the northern limit of Mid-Hill slope section (looking north)

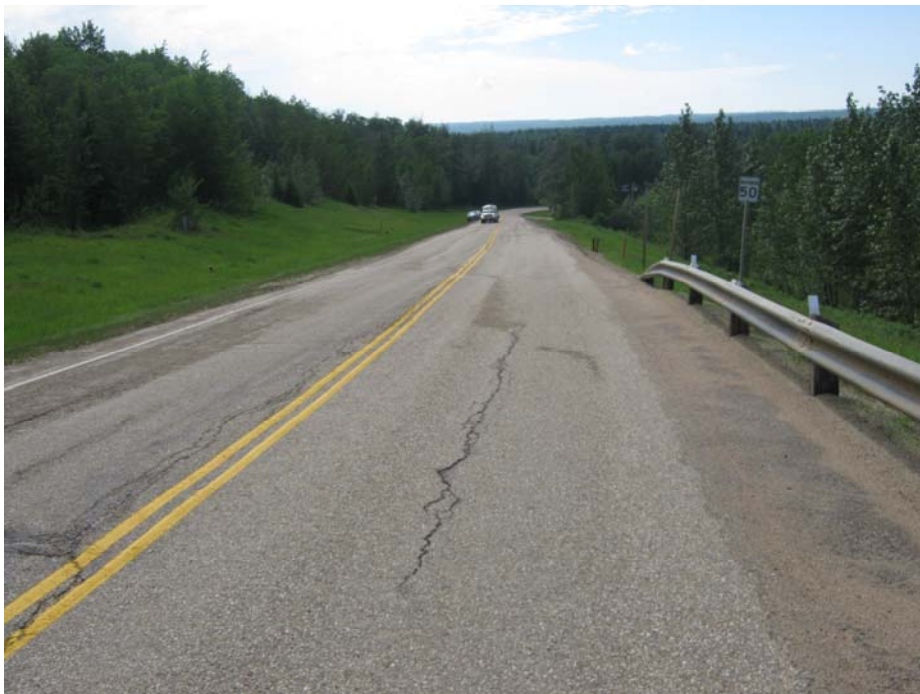
Photo #6 Looking south at the dip bounded by the cracks to the south of the speed sign on the highway Mid-Hill slope section

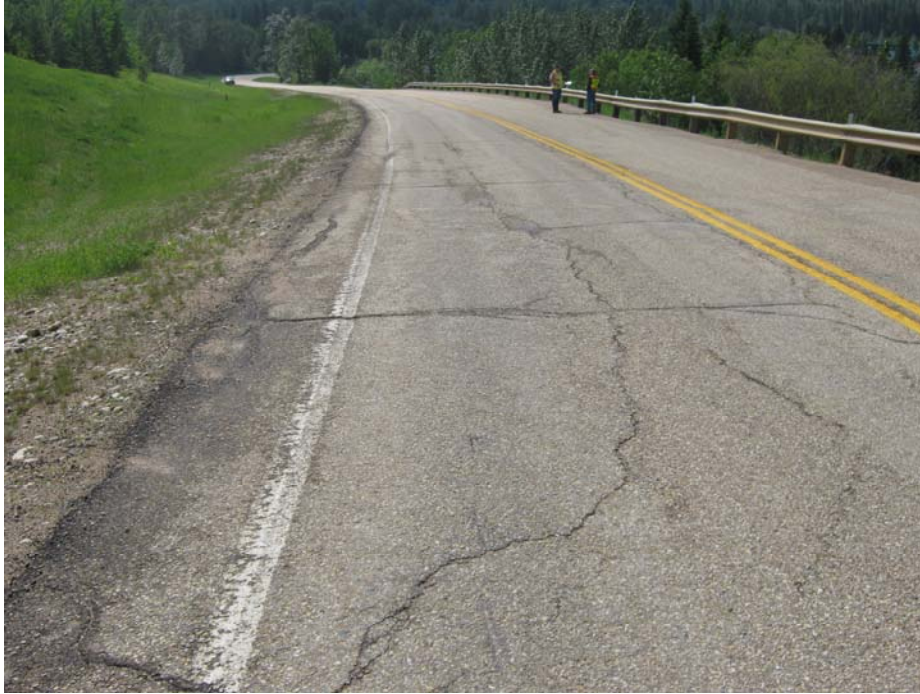
Photo #7 Diagonal and longitudinal open crack in the NBL of the highway within the highway uphill section (looking south)

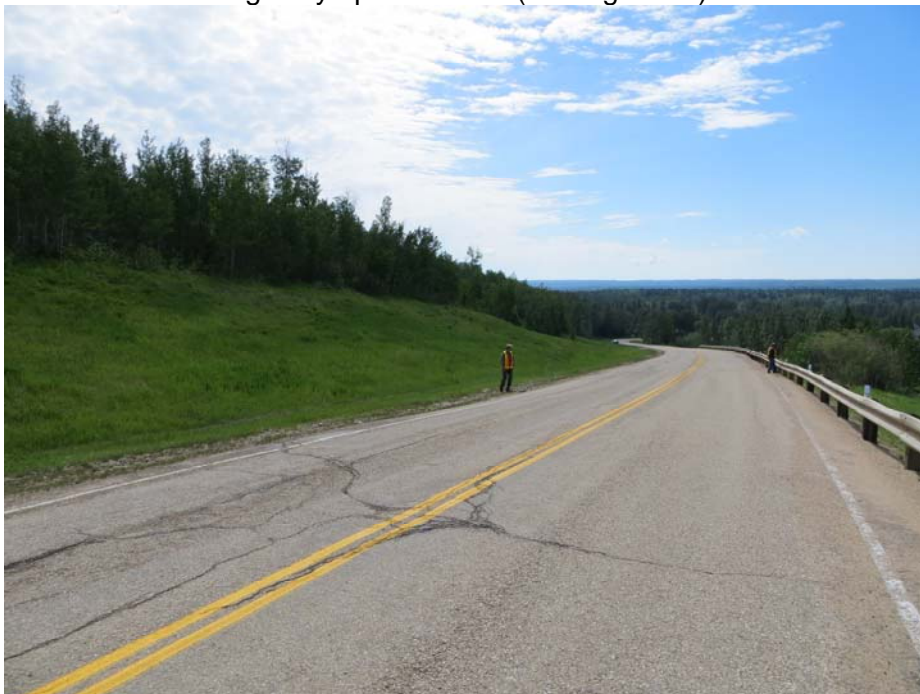
Photo #8 Diagonal open crack on the northern limit of highway uphill section, looking south

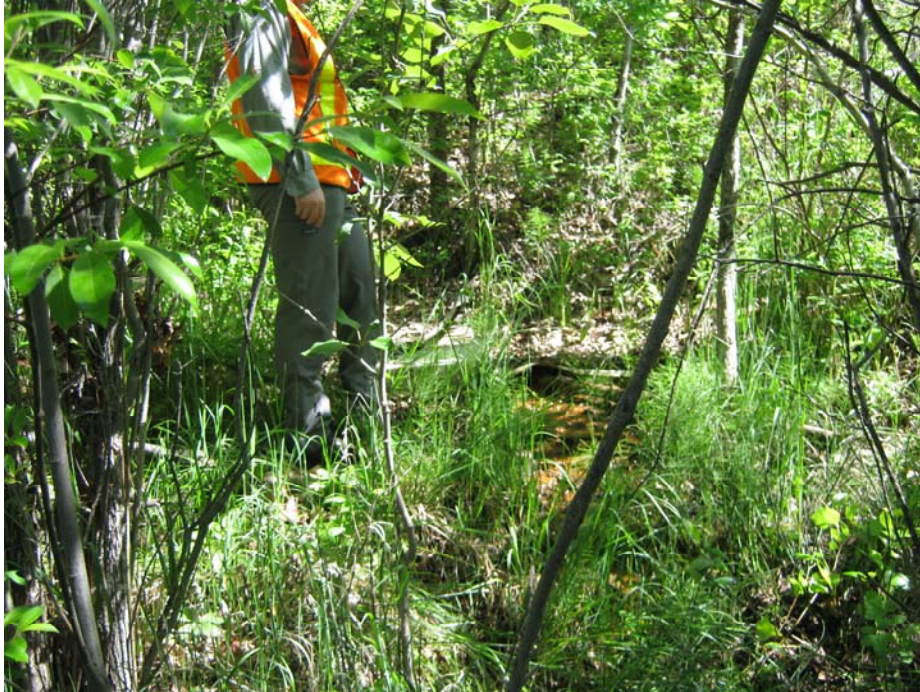
Photo #9 Looking at the metal cover above MH#2 location; note seeping water from below the cover

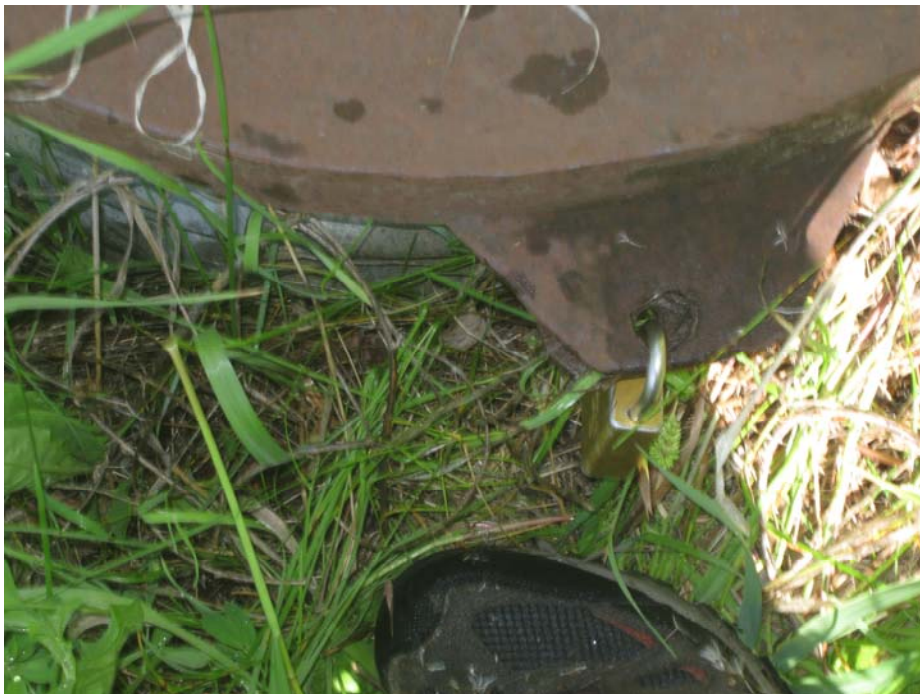
Photo #10 Looking at MH#2 cover; the manhole was locked by others which made it inaccessible for inspection
