NORTH CENTRAL REGION (ATHABASCA AREA)
- 2013 GEOHAZARD ASSESSMENT

NC14: HWY 661:02 FORT ASSINIBOINE (km 1.8)
SITE PLAN SHOWING EXISTING FEATURES

**NC14: HWY 661: 02 FORT ASSINIBOINE (km 1.8)
 SITE PLAN SHOWING MID-HILL SLIDE AREA**

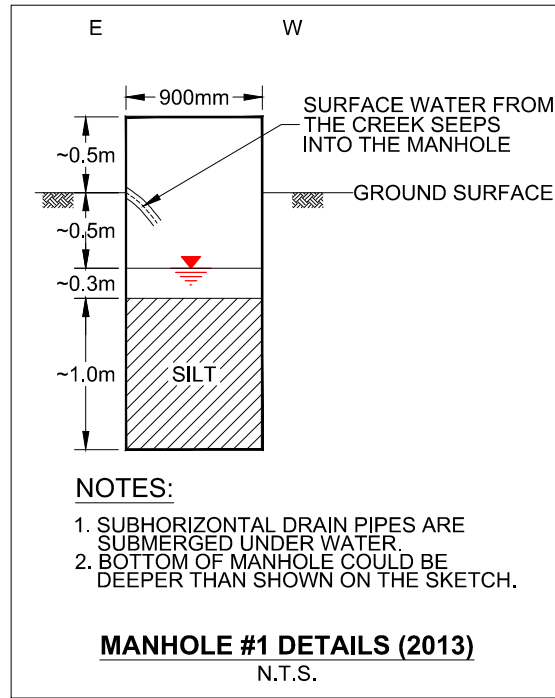
- NOTES:**
1. SUBHORIZONTAL DRAIN PIPES ARE SUBMERGED UNDER WATER.
 2. BOTTOM OF MANHOLE COULD BE DEEPER THAN SHOWN ON THE SKETCH.
