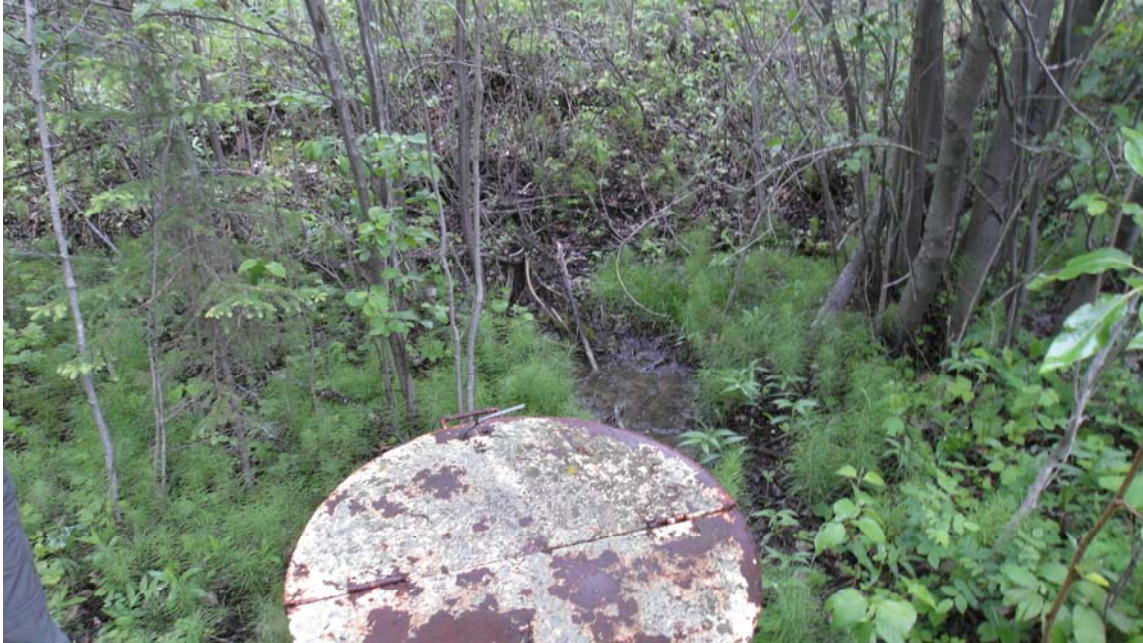
**Photo #1** Looking at natural gully located upslope of drainage collection manhole #1

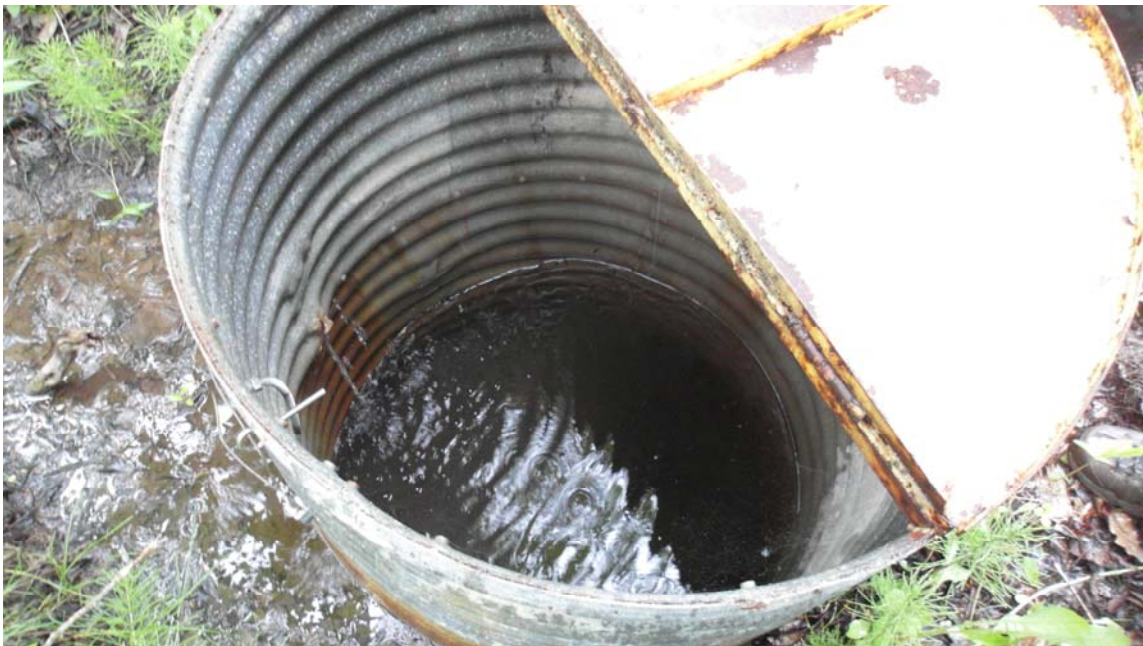
**Photo #2** Standing water inside MH#1; note that the drain outlets are completely submerged under water

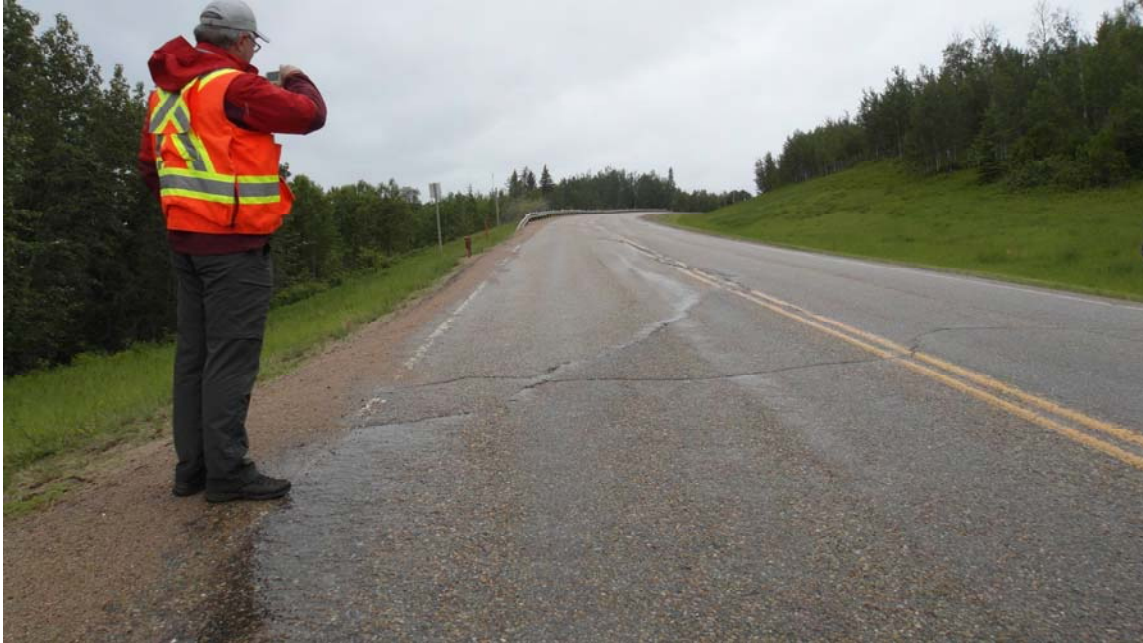
**Photo #3** Open diagonal crack at the southern limit of Mid-Hill slope section (looking north)

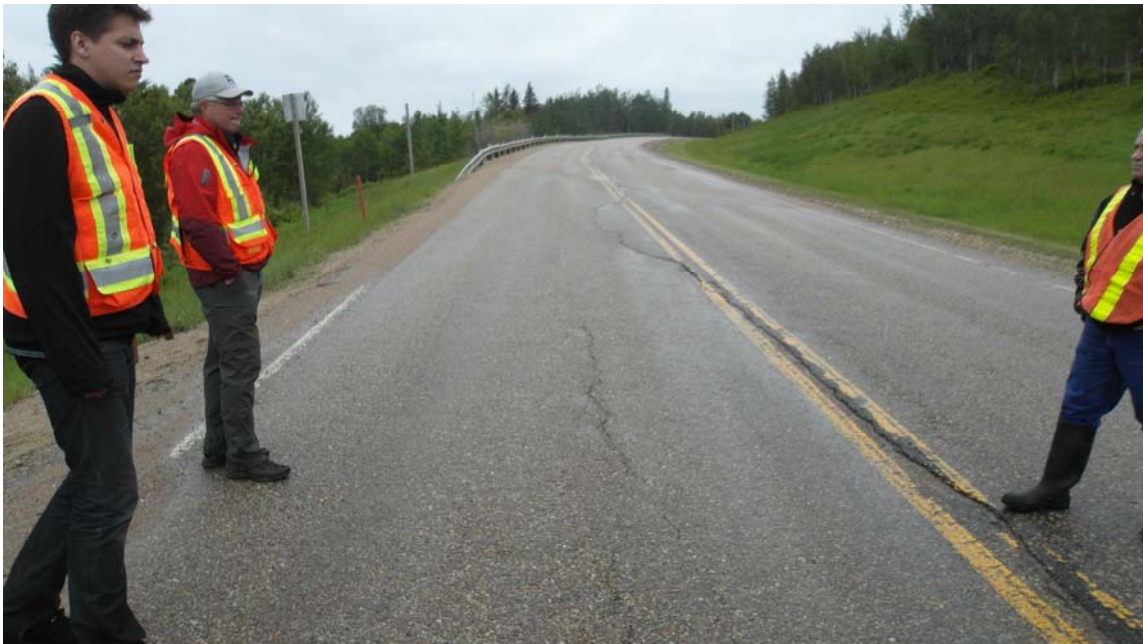
**Photo #4** Open longitudinal crack within the Mid-Hill slope section (looking north)

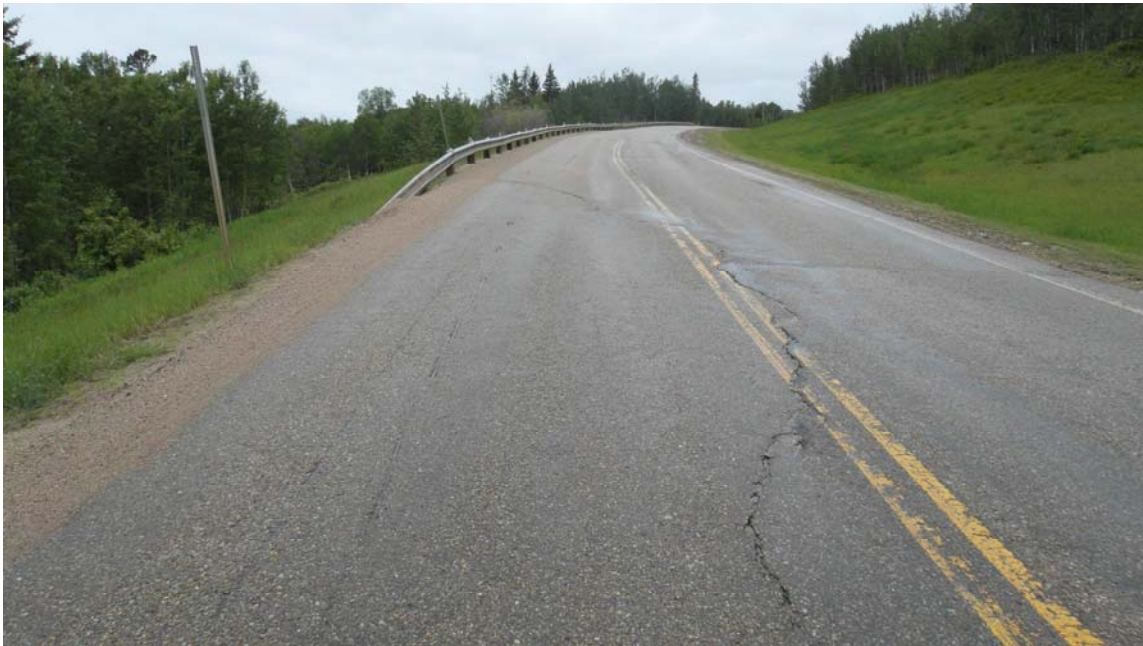
**Photo #5** Open arc-shaped crack at the northern limit of Mid-Hill slope section (looking north)

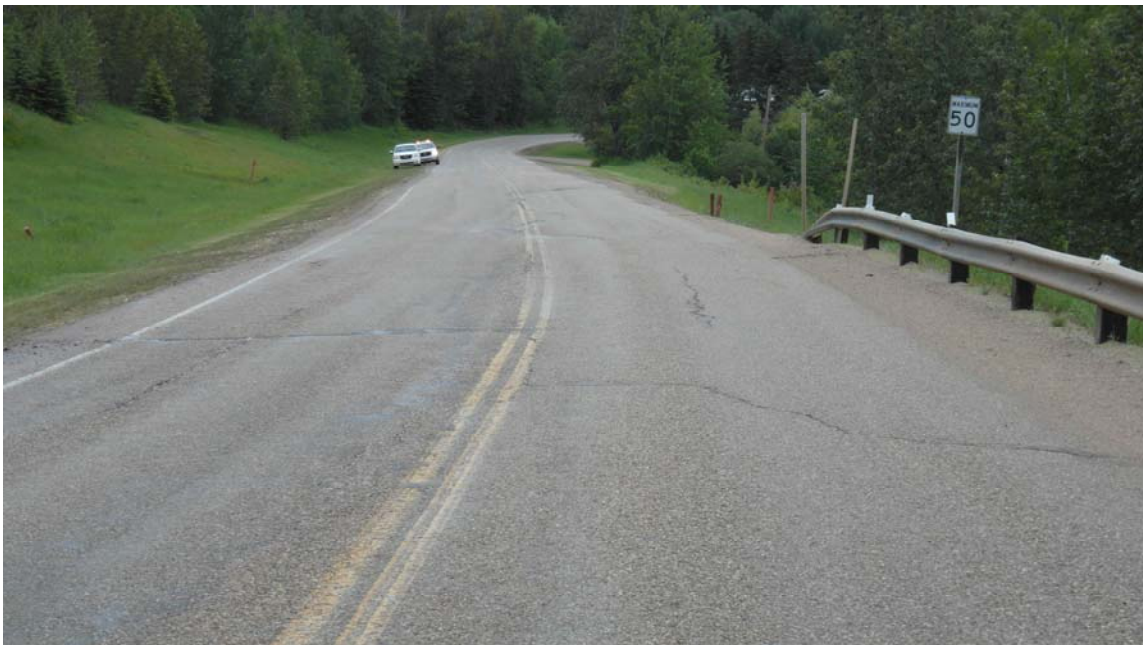
**Photo #6** Looking south at the dip bounded by the cracks to the south of the speed sign on the highway Mid-Hill slope section

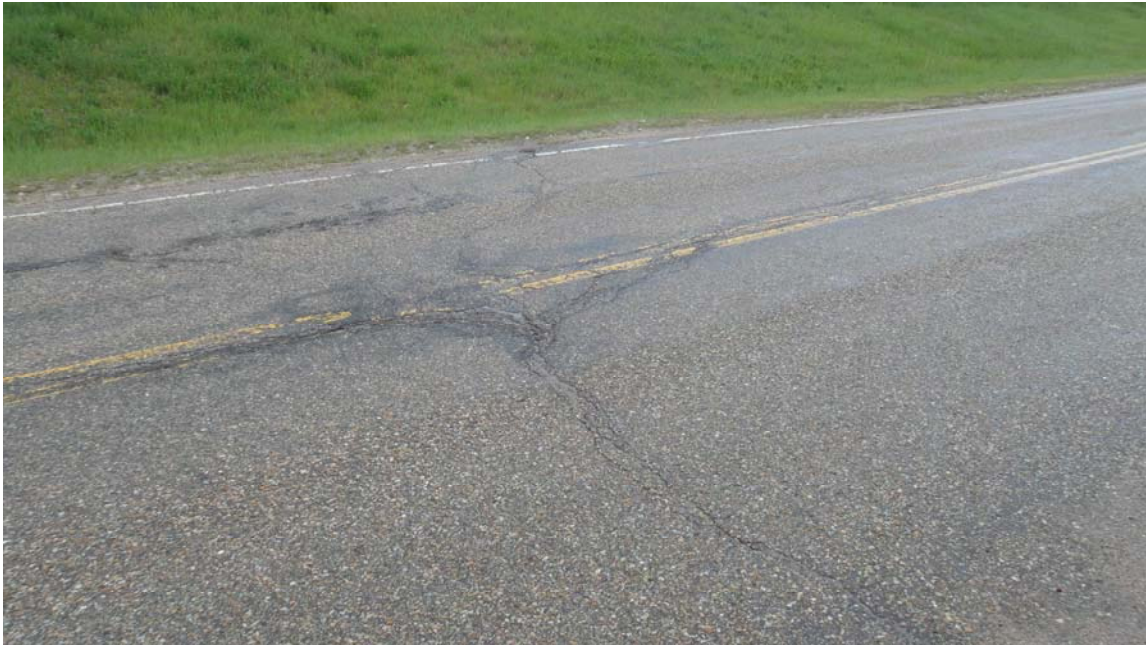
**Photo #7** Diagonal open crack on the northern limit of highway uphill section, looking south
