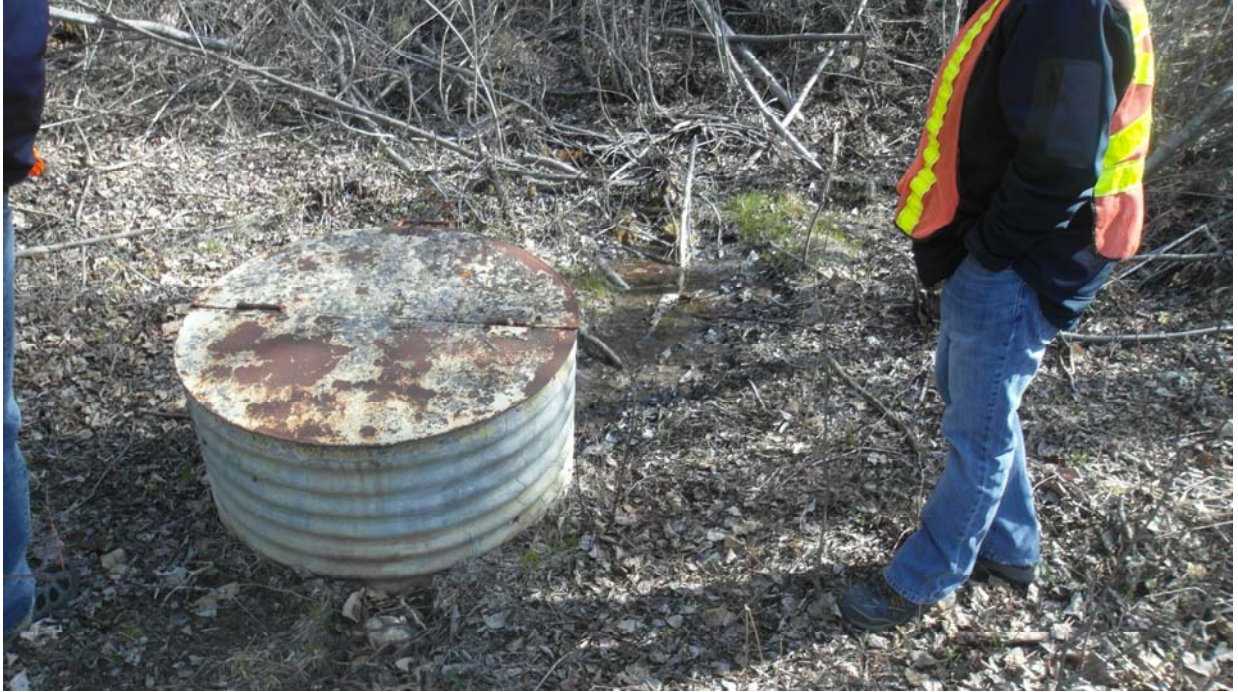
Photo #1 Looking at natural gully located upslope of drainage collection manhole #1

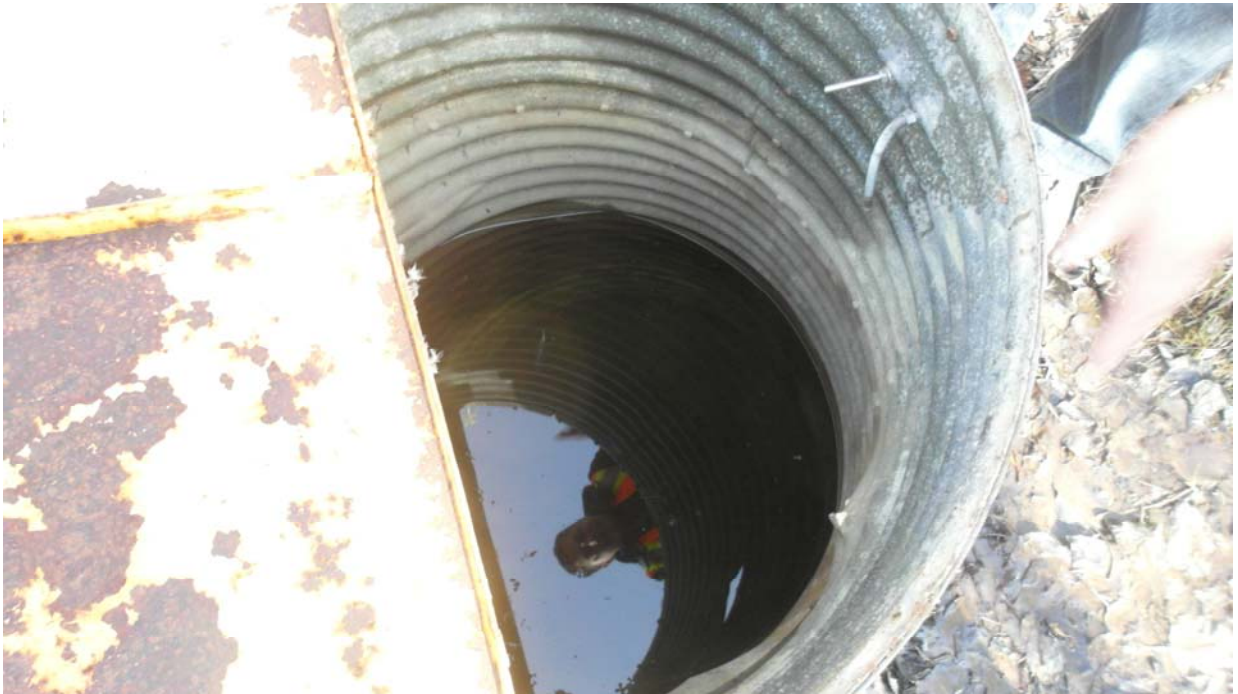
Photo #2 Standing water inside MH#1

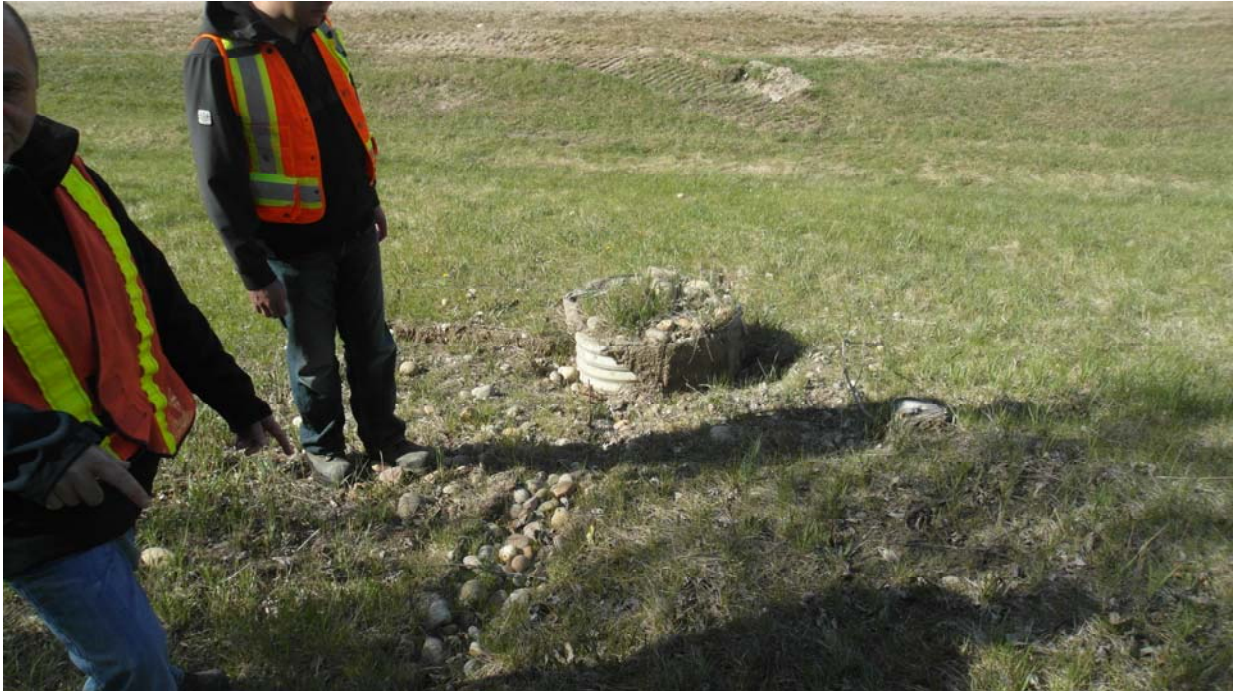
Photo #3 Looking at the manhole filled with cobbles located downslope of MH#1; note the rock filled trench by the manhole.

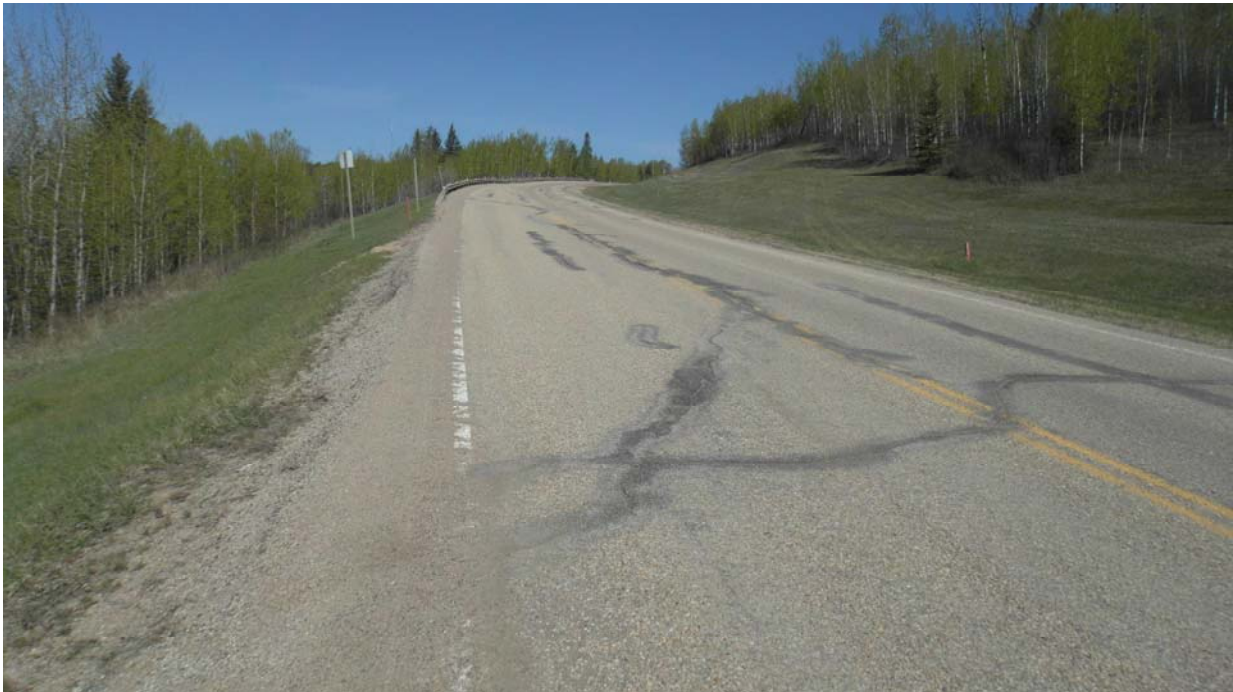
Photo #4 Open diagonal crack at the southern limit of Mid-Hill slope section (Looking northwest)

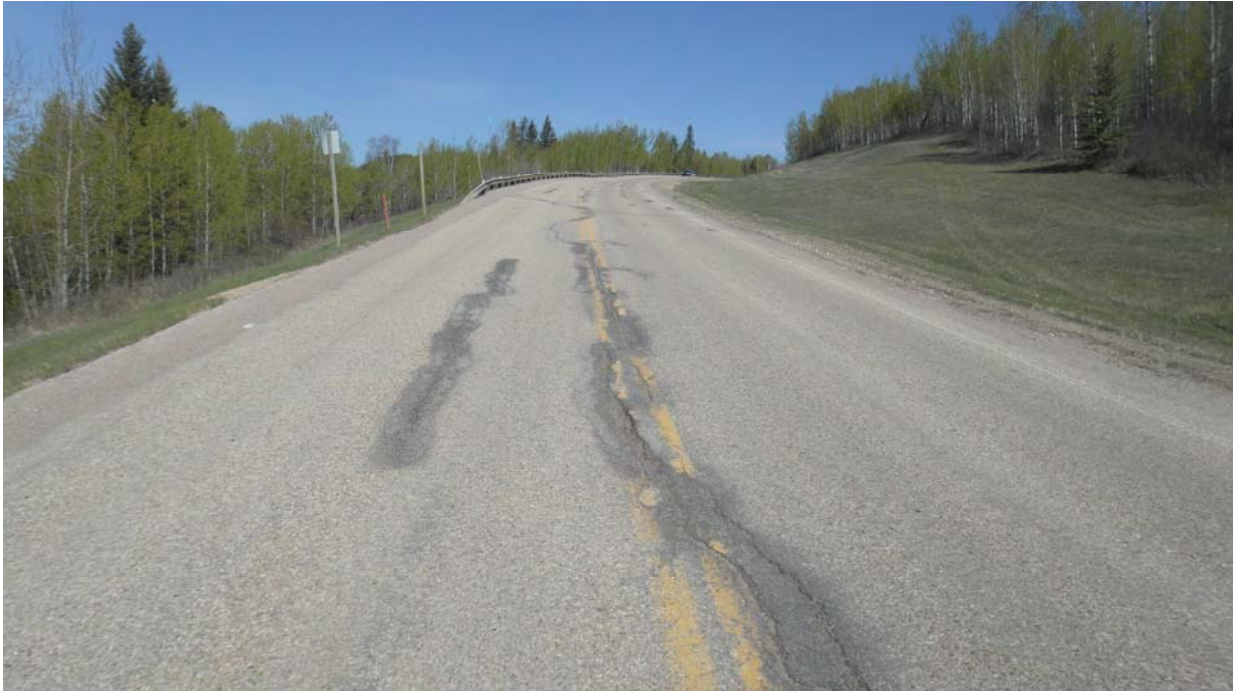
Photo #5 Open longitudinal crack within the Mid-Hill slope section
(Looking northwest)

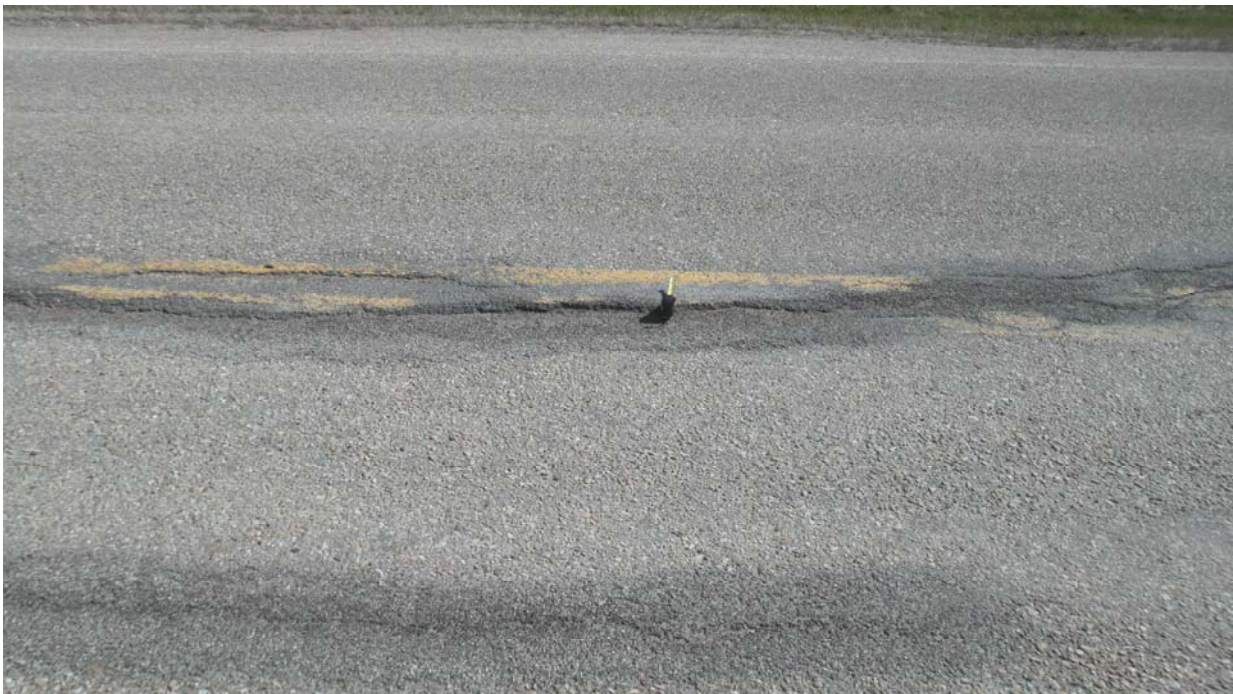
Photo #6 Open longitudinal crack within the Mid-Hill slope section; note the drop across the crack surface (Looking northeast)

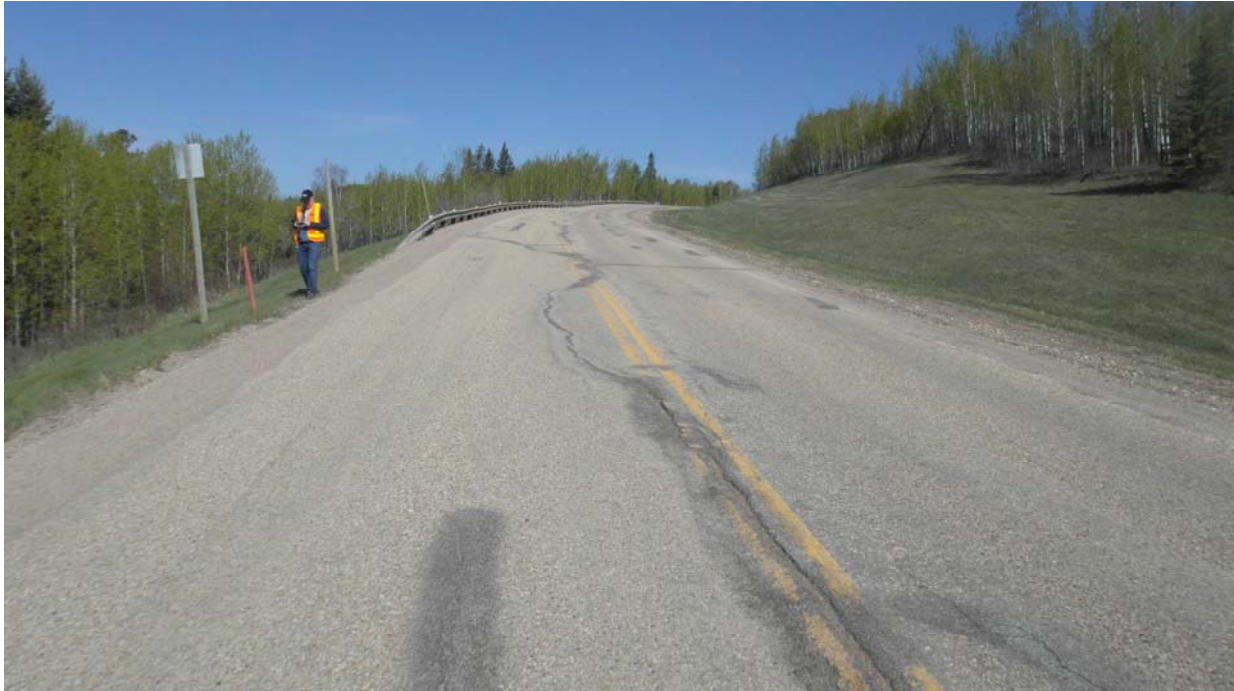
Photo #7 Open arc-shaped crack at the northern limit of Mid-Hill slope section
(Looking northwest)

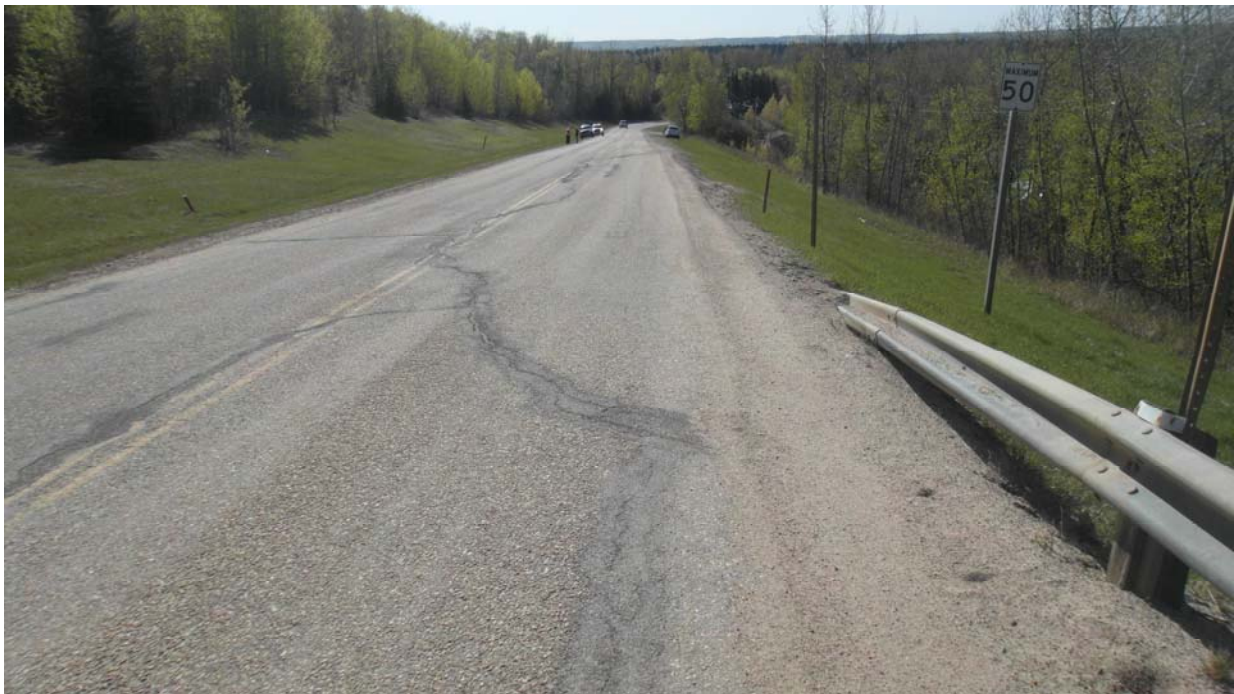
Photo #8 Looking southeast at the dip bounded by the cracks to the south of the speed sign
on the highway Mid-Hill slope section

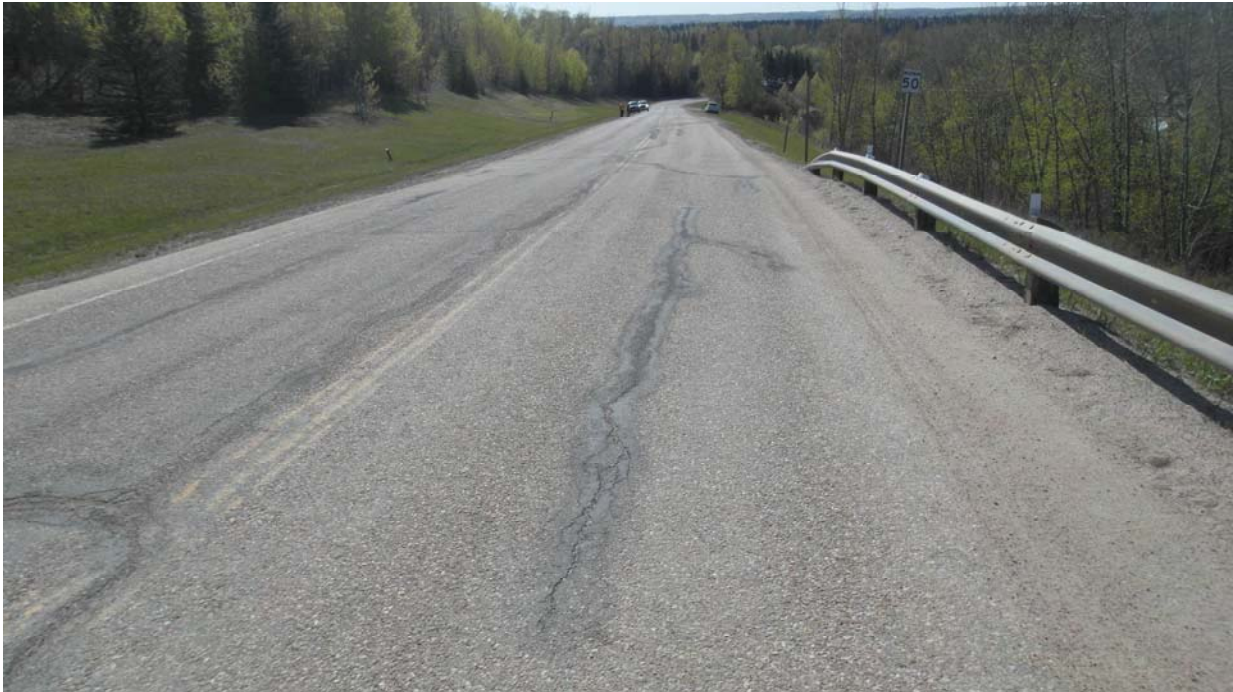
Photo #9 Looking southeast at a longitudinal crack northwest of the Mid-Hill slope section

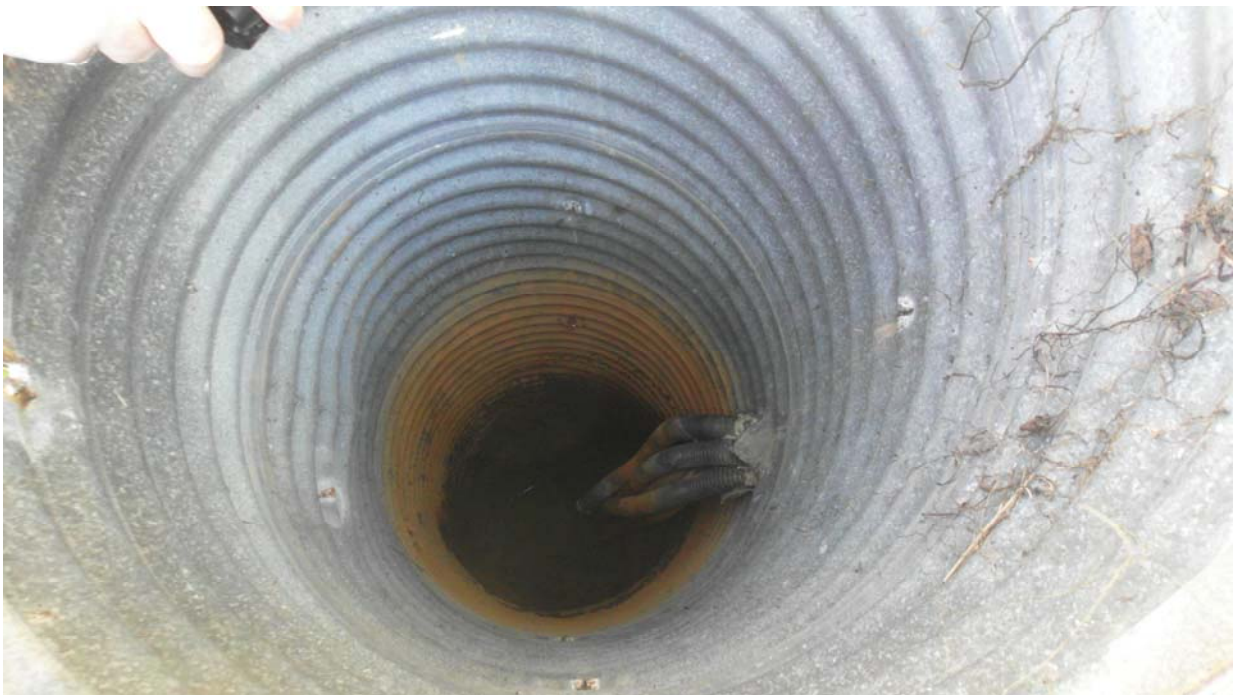
Photo #10 Looking inside MH#2
