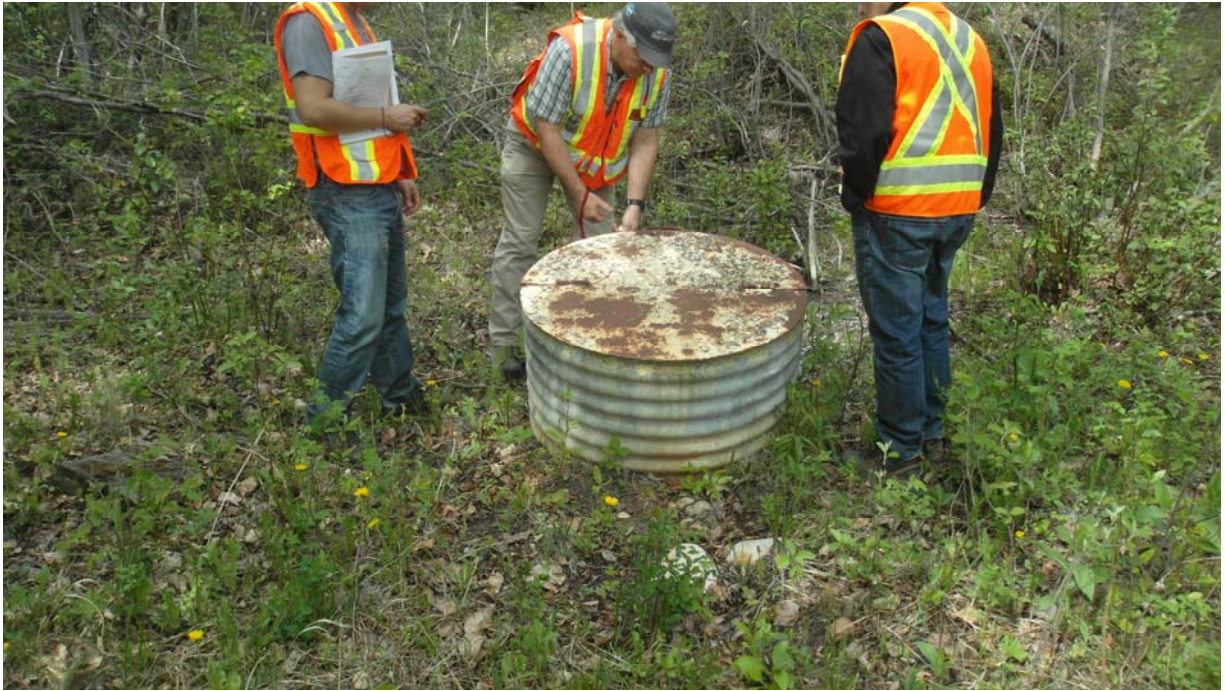
**Photo #1** Looking at the area located upslope of drainage collection manhole #1

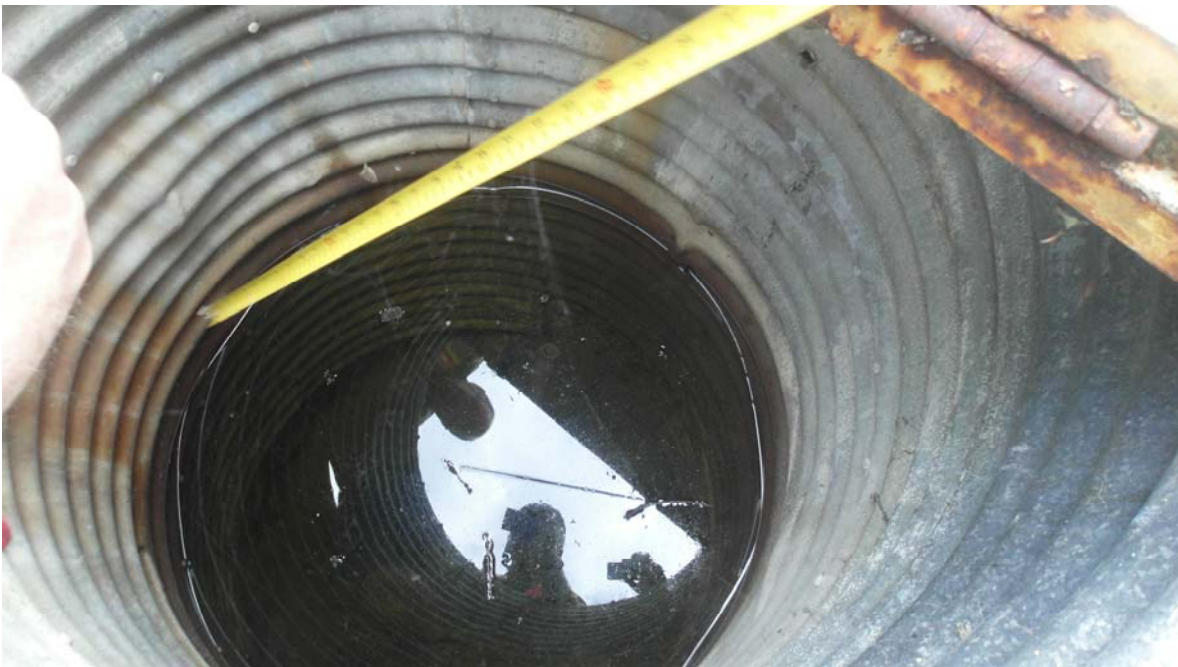
**Photo #2** Standing clear water inside MH#1

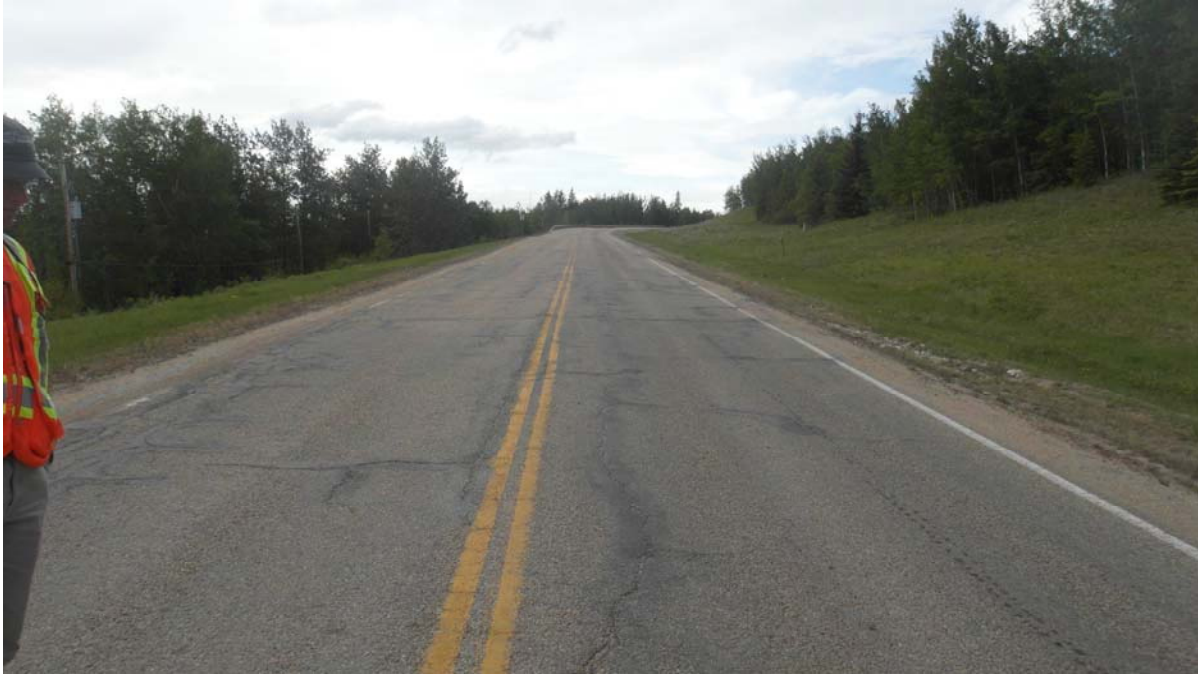
**Photo #3** Looking north at multiple open longitudinal cracks in the highway surface between the southern limit of the Mid-Hill slope section and MH#1 location.

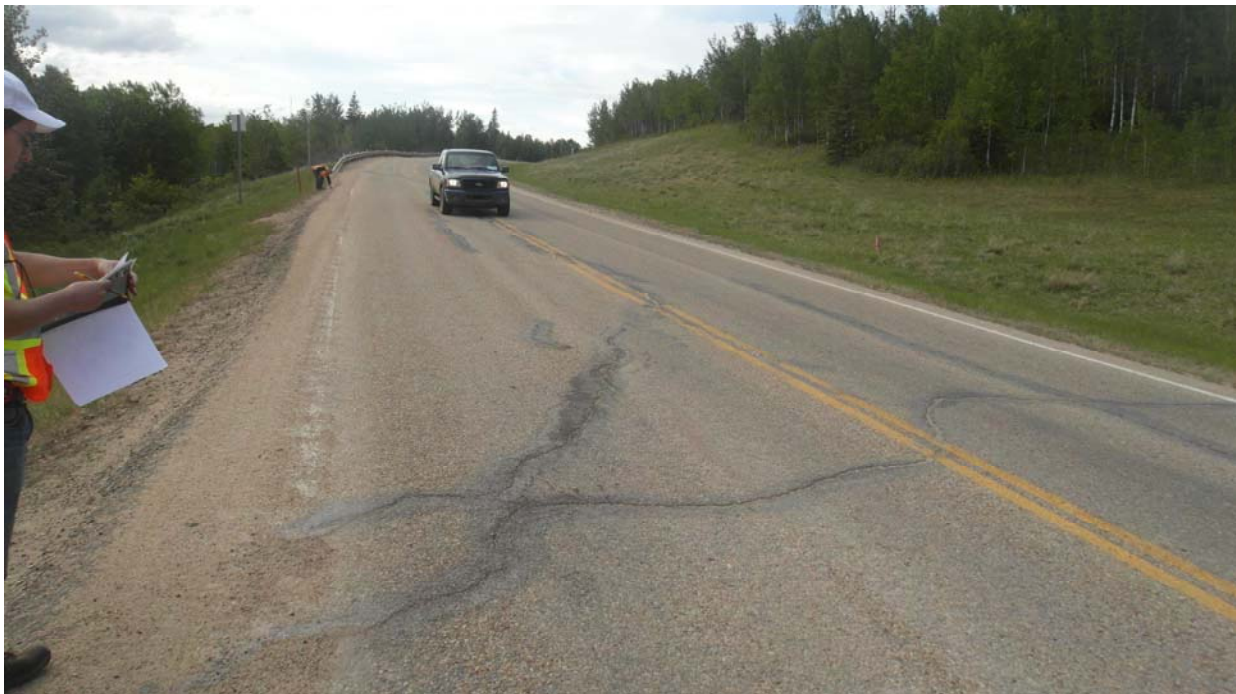
**Photo #4** Open diagonal crack at the southern limit of Mid-Hill slope section  
(Looking northwest)

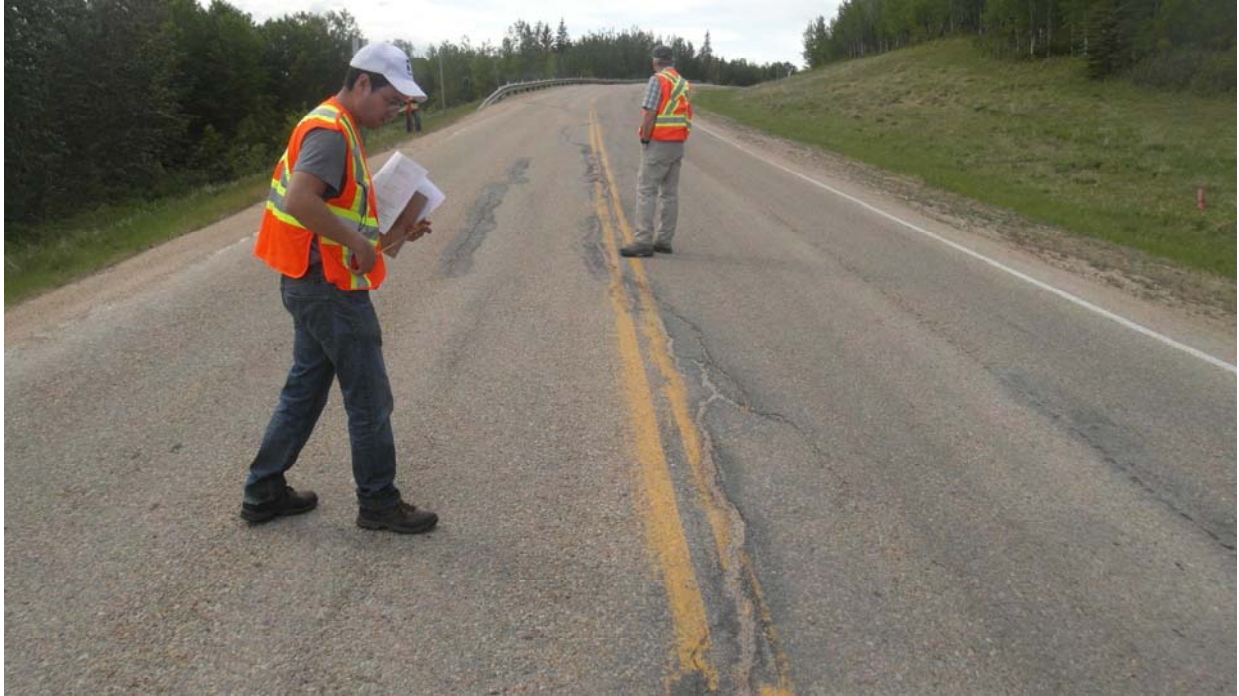
**Photo #5** Open longitudinal crack within the Mid-Hill slope section  
(Looking northwest)

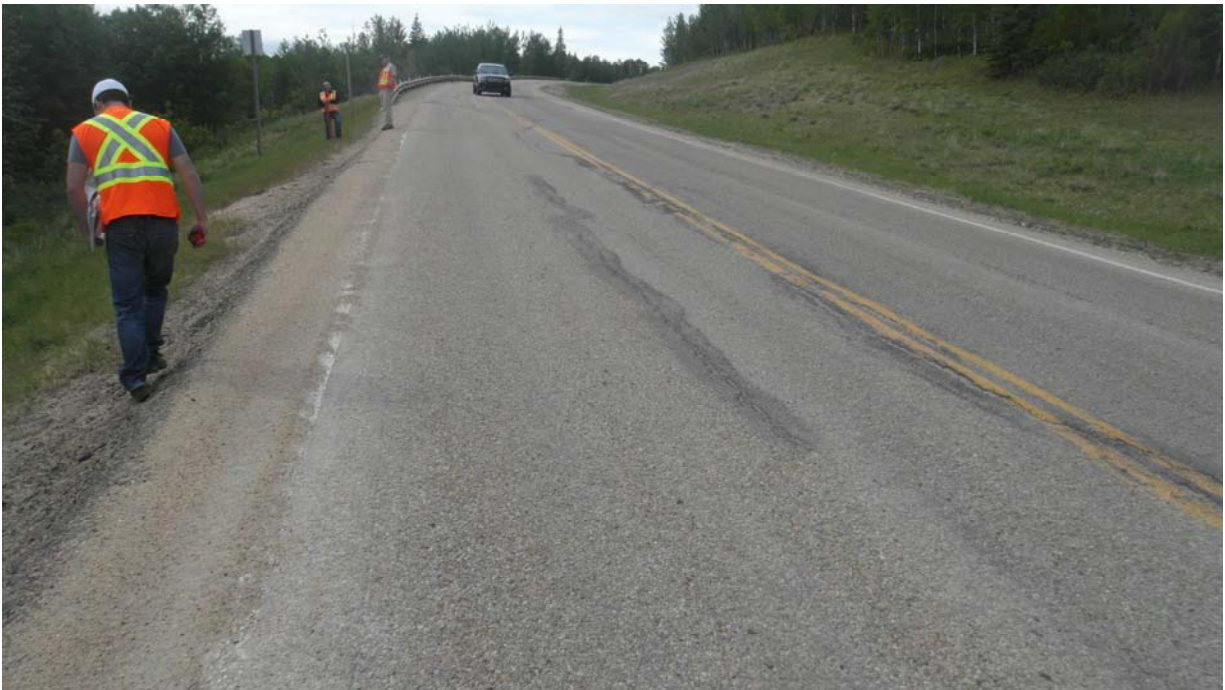
**Photo #6** Open longitudinal crack within the Mid-Hill slope section (Looking northeast)

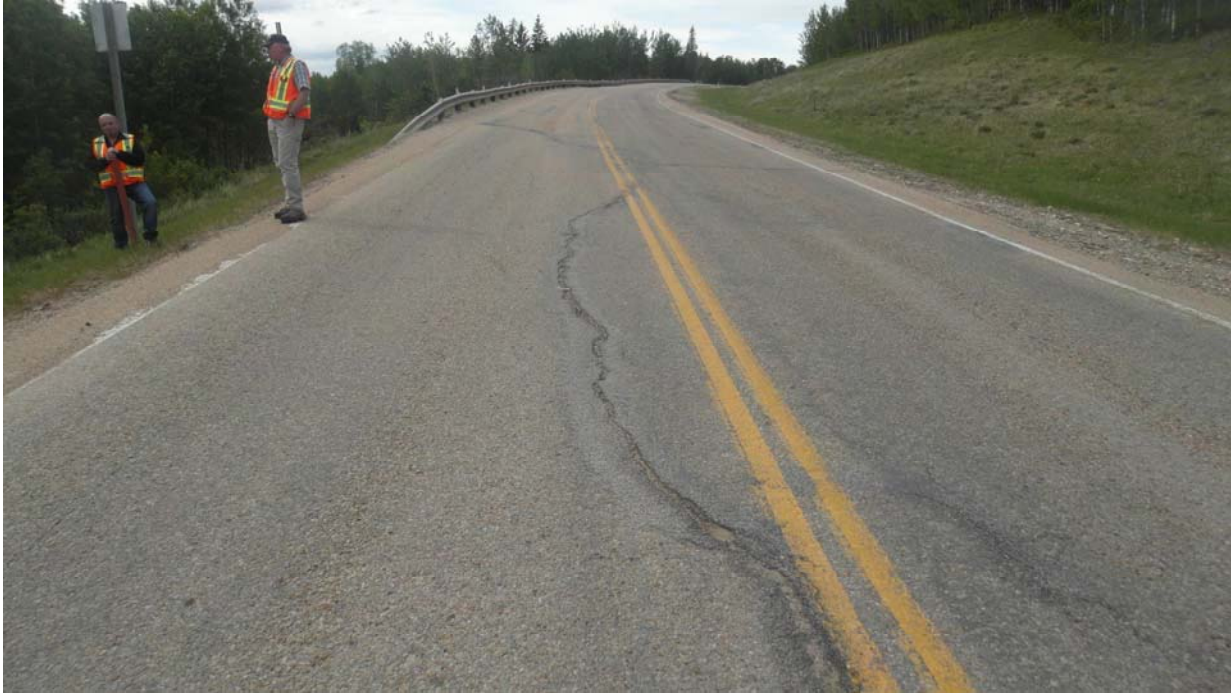
**Photo #7** Open semi-longitudinal crack with the middle of the of Mid-Hill slope section  
(Looking northwest)

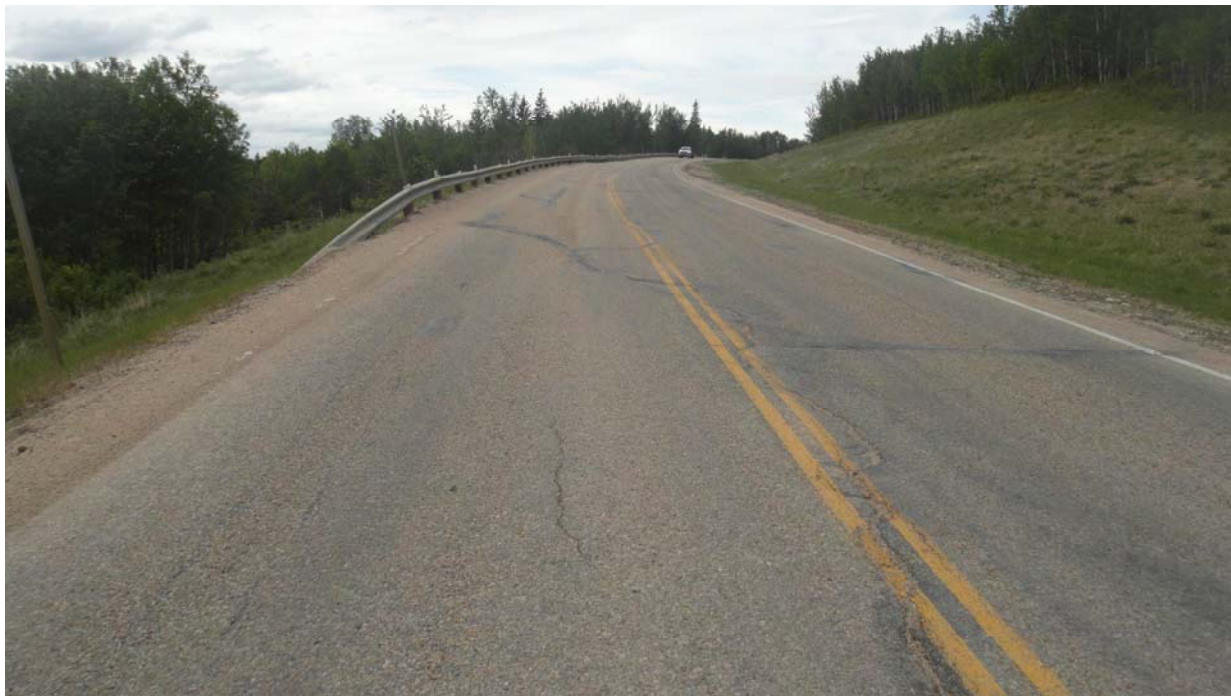
**Photo #8** Open arc-shaped crack at the northern limit of Mid-Hill slope section  
(Looking northwest)

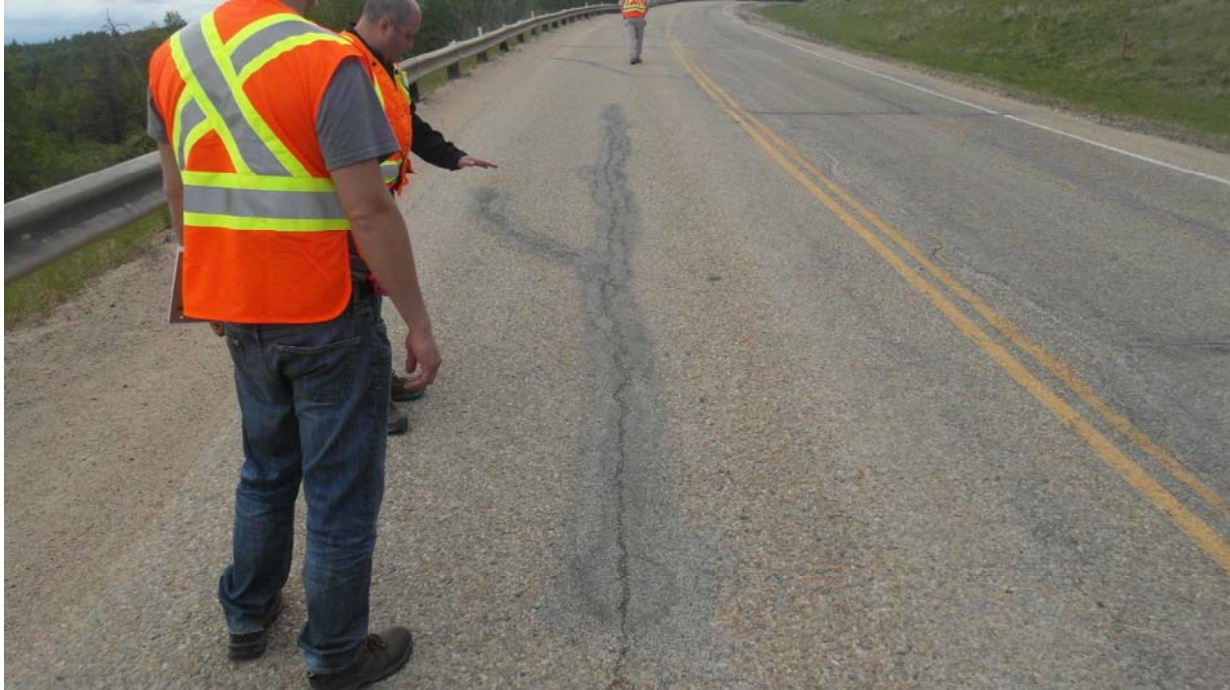
**Photo #9** Looking northwest at a longitudinal crack - Mid-Hill slope section

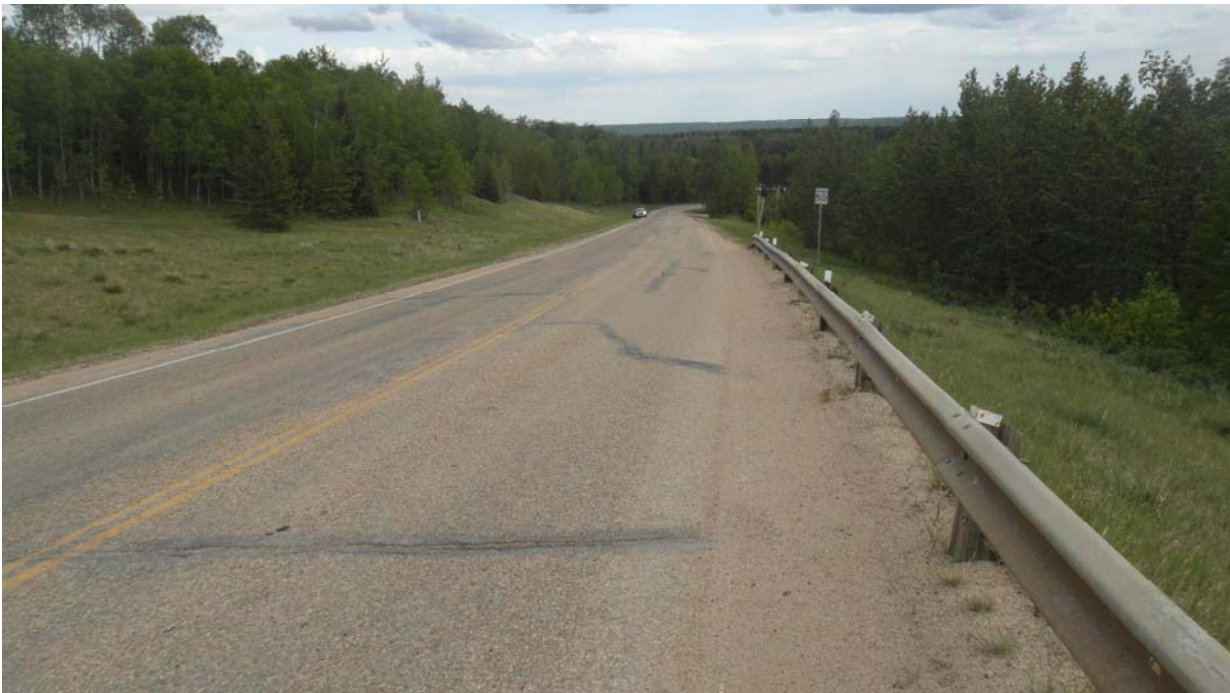
**Photo #10** Looking southeast at the dip developed within the Mid-Hill slope section; the southern limit of the Mid-Hill slope section is near the 50 km/h sign

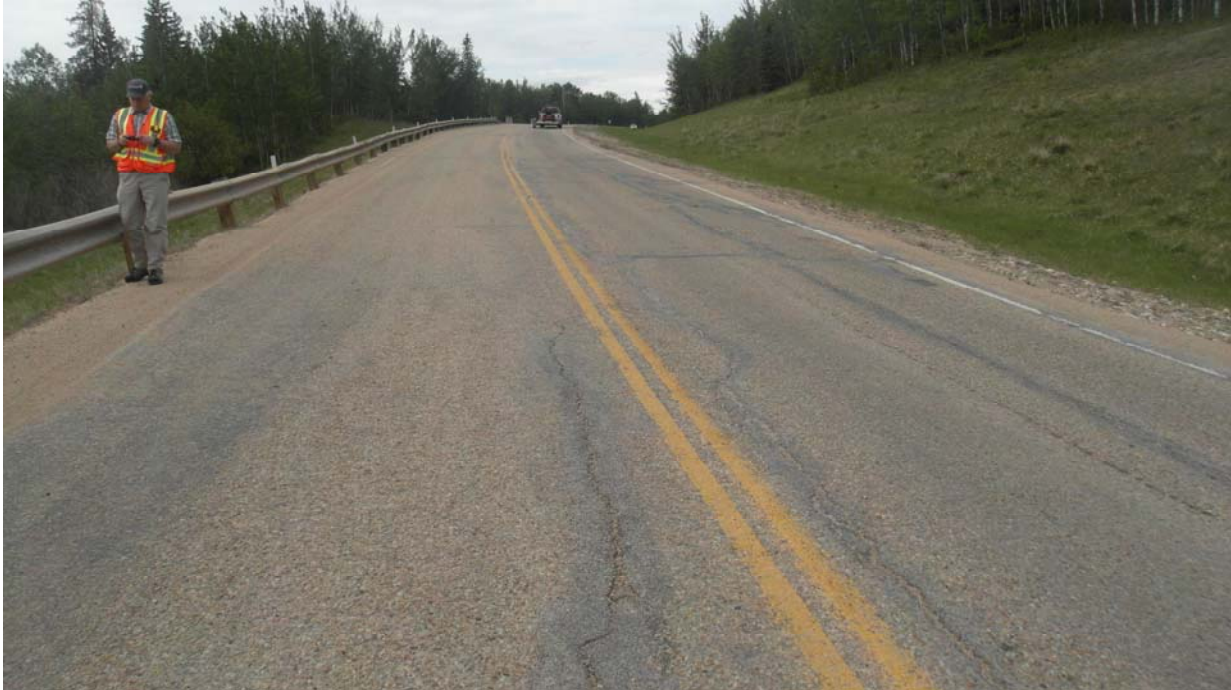
**Photo #11** Looking northwest at multiple open cracks to the north of the Mid-Hill slope section

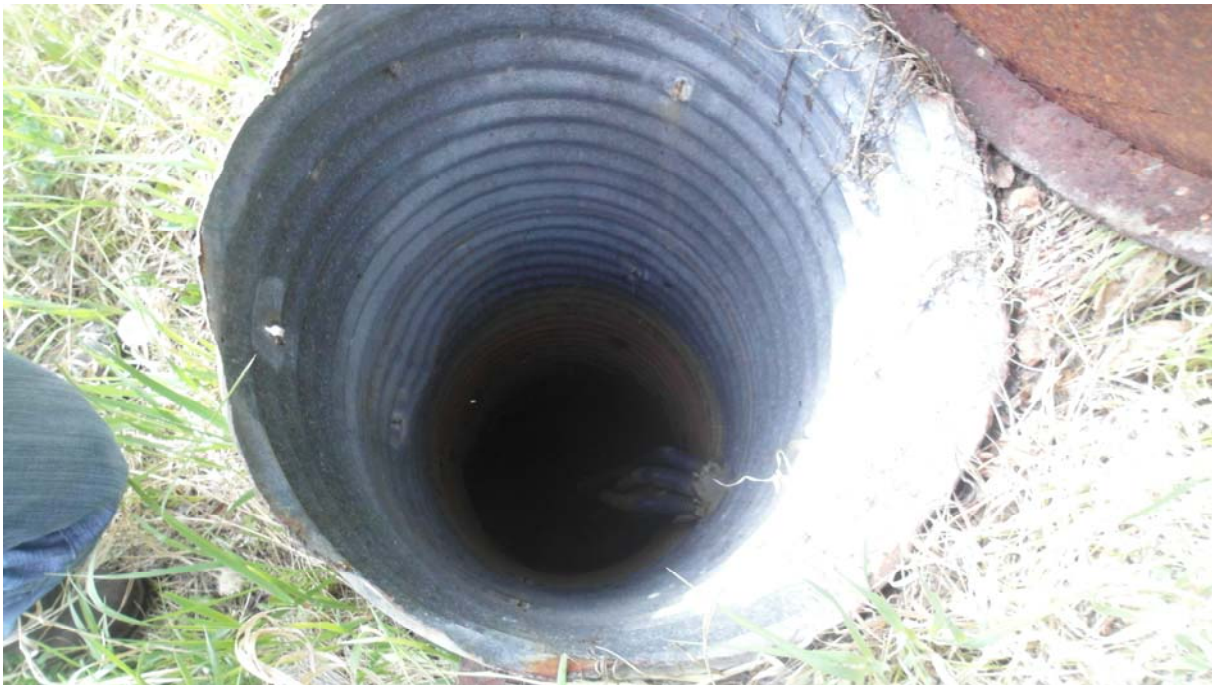
**Photo #12** Looking inside MH#2
