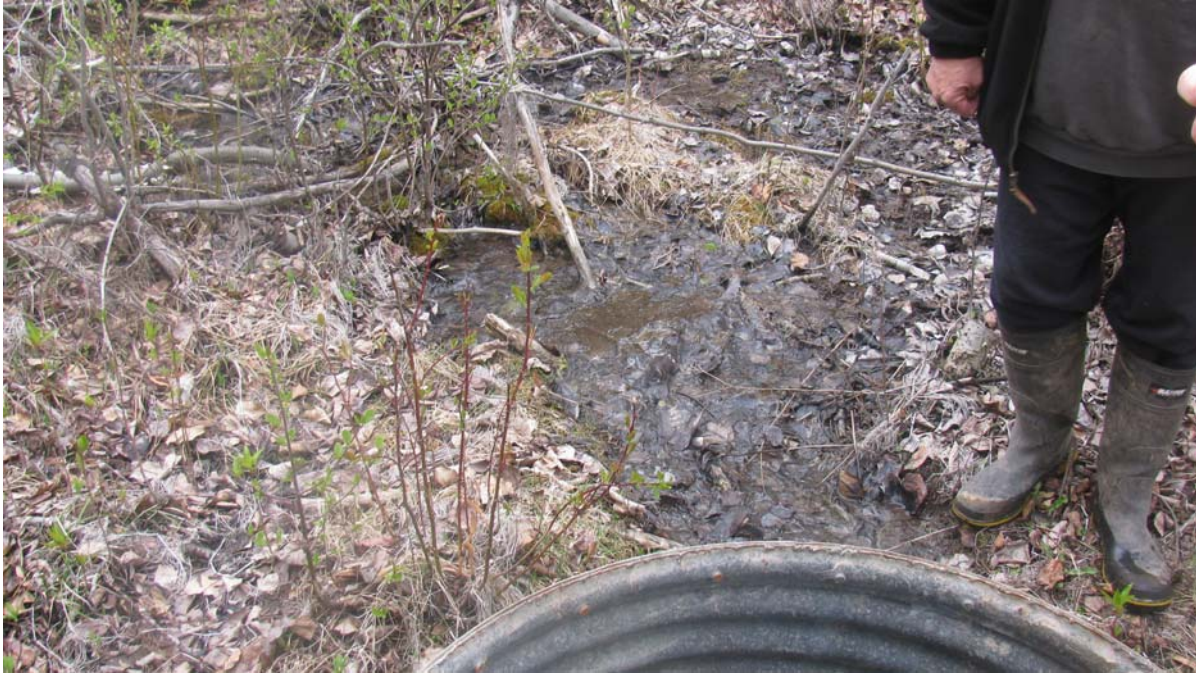
Photo #1 Looking at the area located upslope of drainage collection manhole #1.
Note the presence of seepage from the hill side

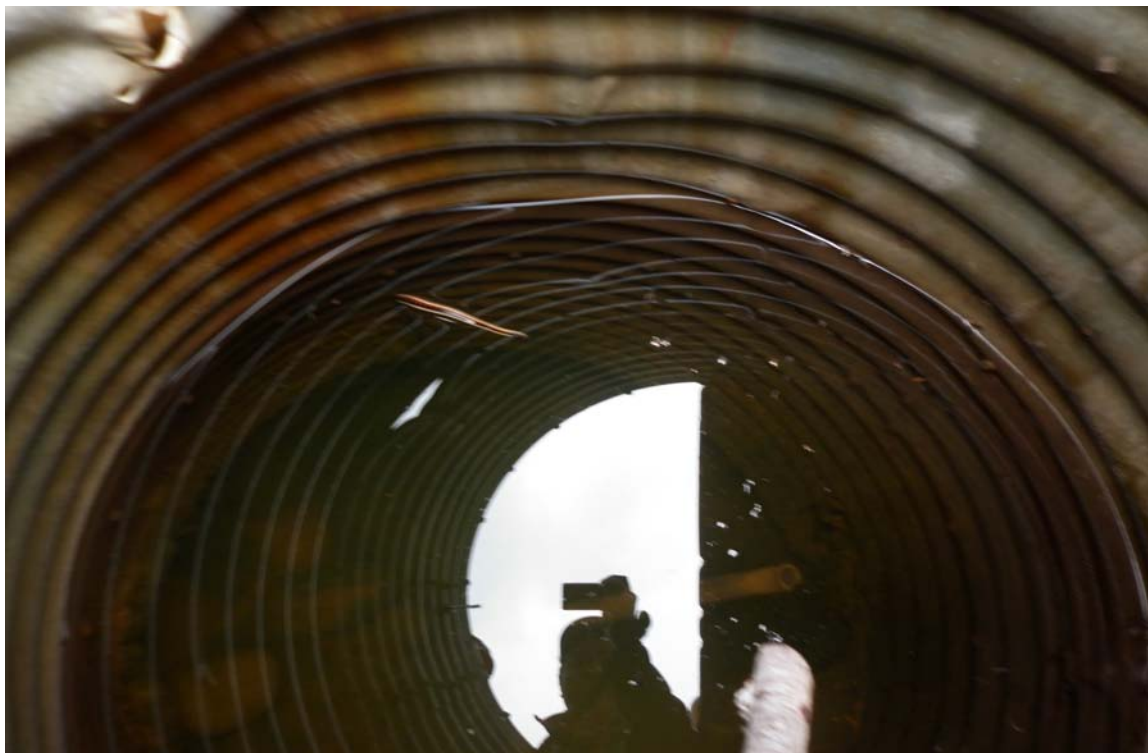
Photo #2 Standing clear water inside MH#1

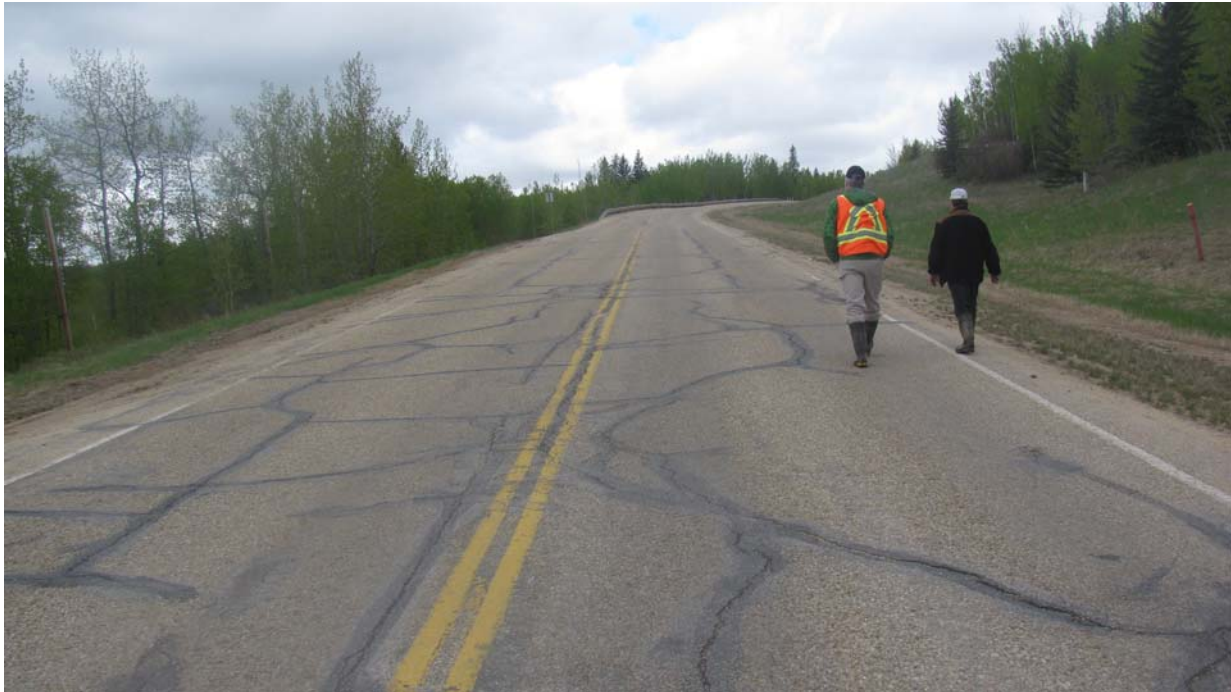
Photo #3 Looking north at multiple open longitudinal cracks in the highway surface between the southern limit of the Mid-Hill slope section and MH#1 location.

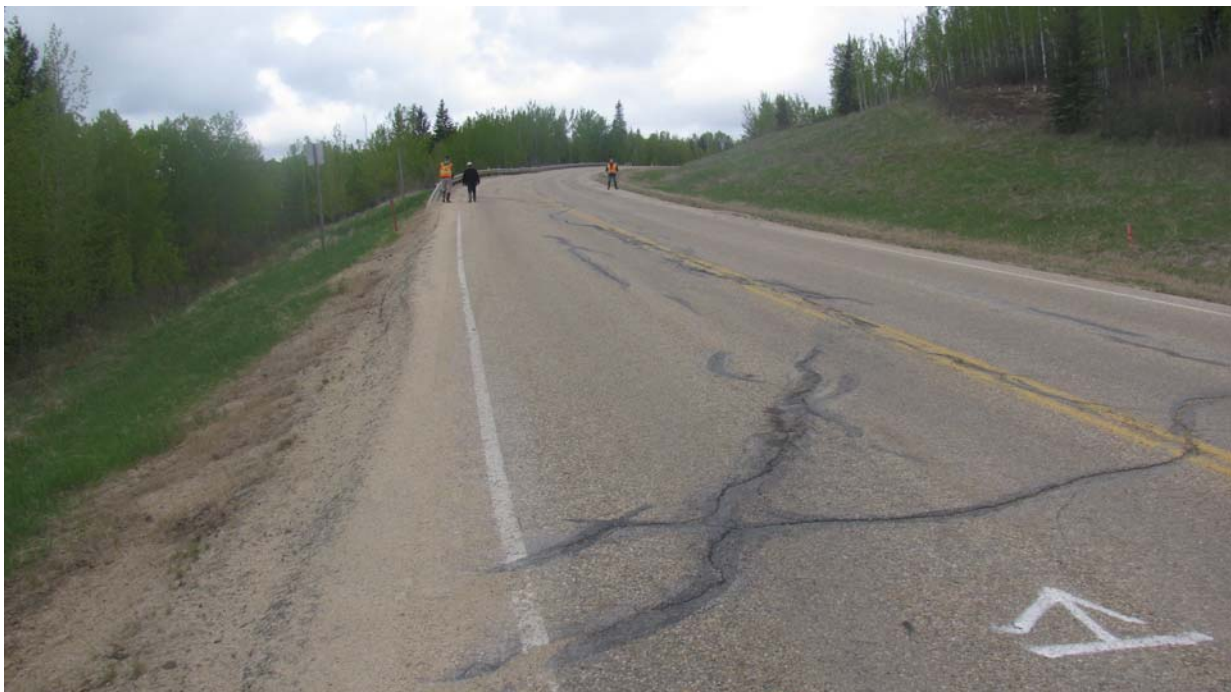
Photo #4 Open diagonal crack at the southern limit of Mid-Hill slope section (Looking northwest)

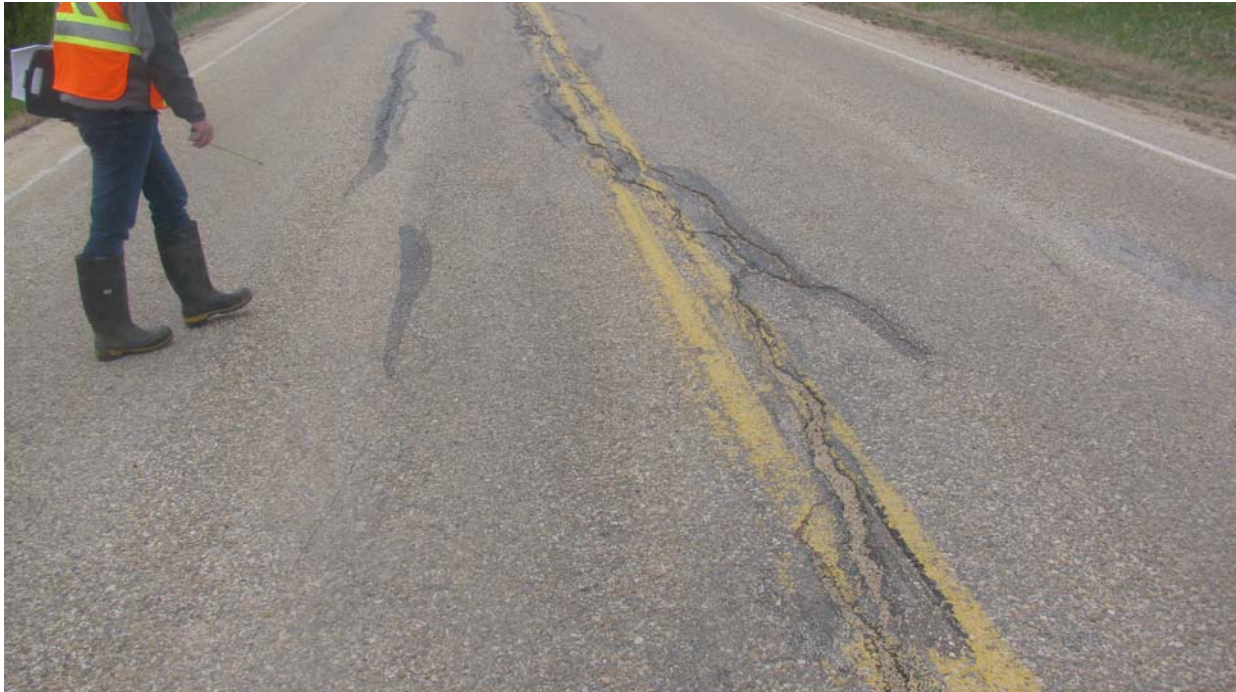
Photo #5 Open longitudinal crack within the Mid-Hill slope section (Looking northwest)

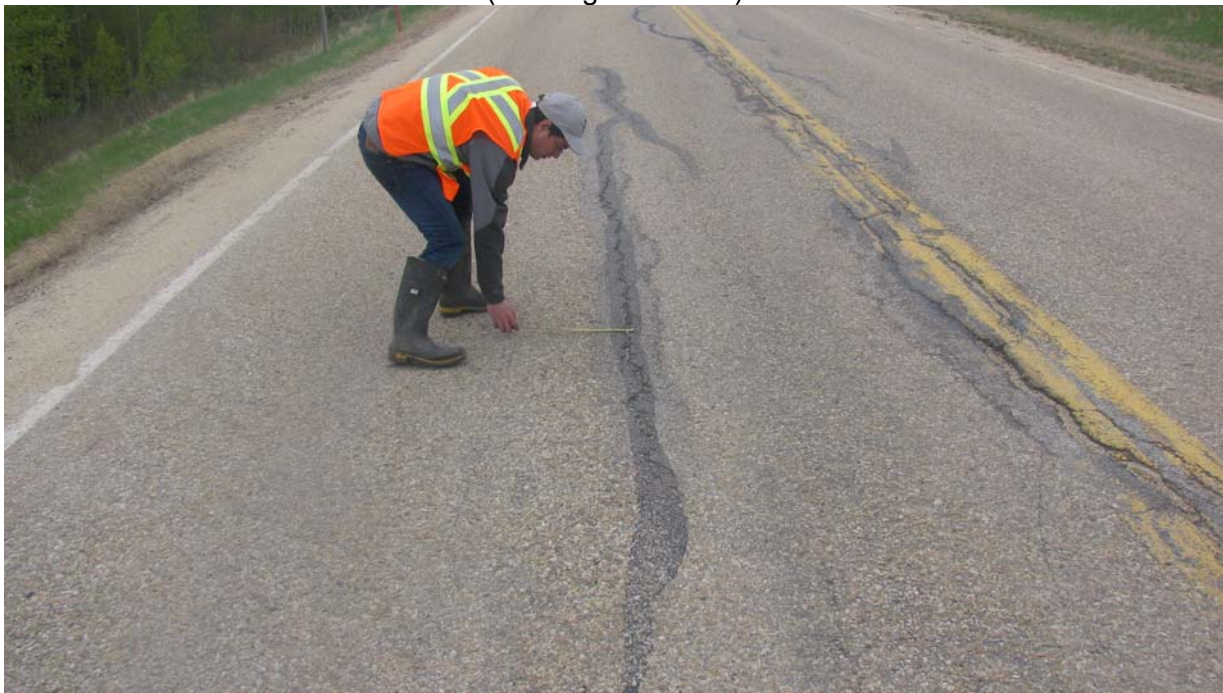
Photo #6 Open longitudinal crack within the Mid-Hill slope section (Looking Northwest)

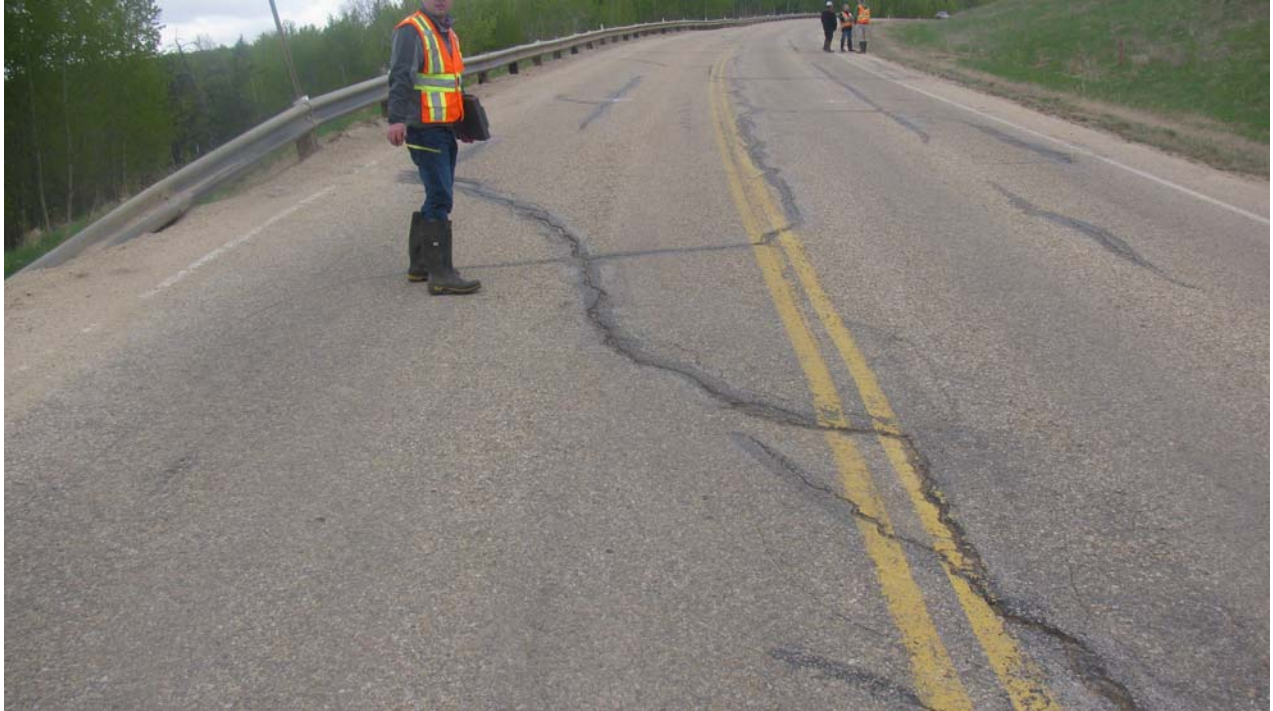
Photo #7 Open arc-shaped crack at the northern limit of Mid-Hill slope section
(Looking northwest)

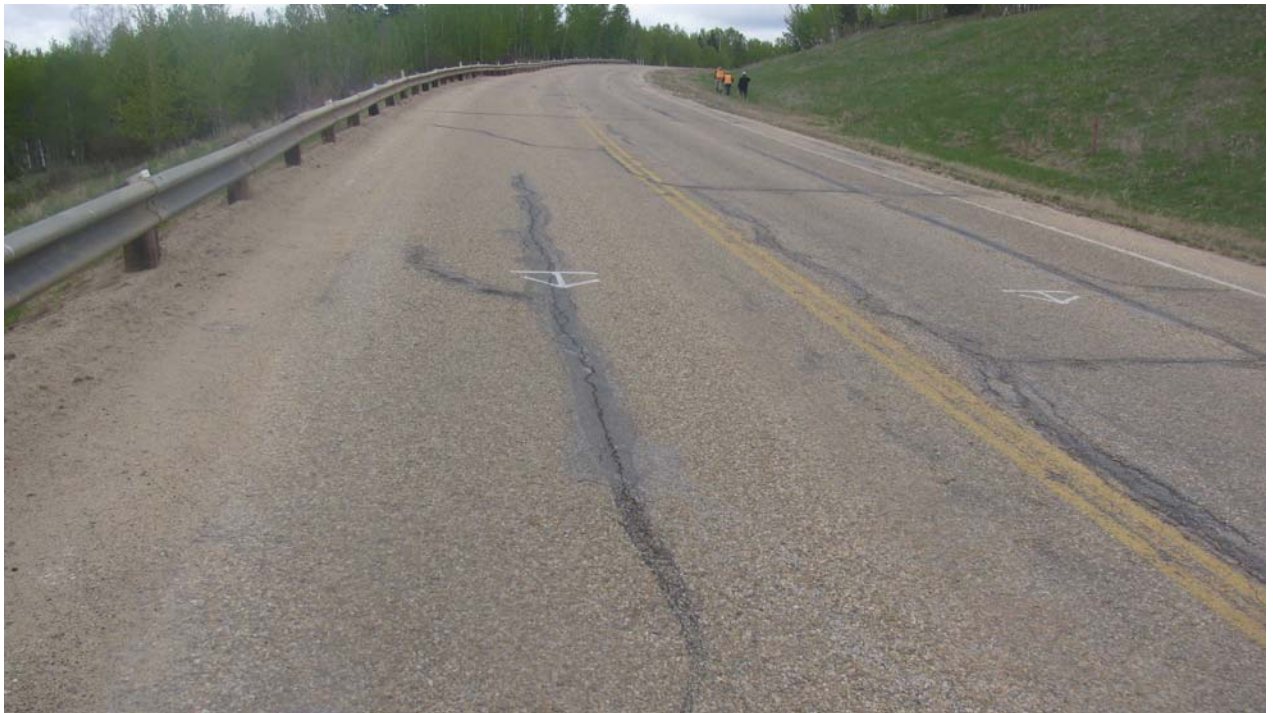
Photo #8 Looking northwest at a longitudinal crack - Mid-Hill slope section

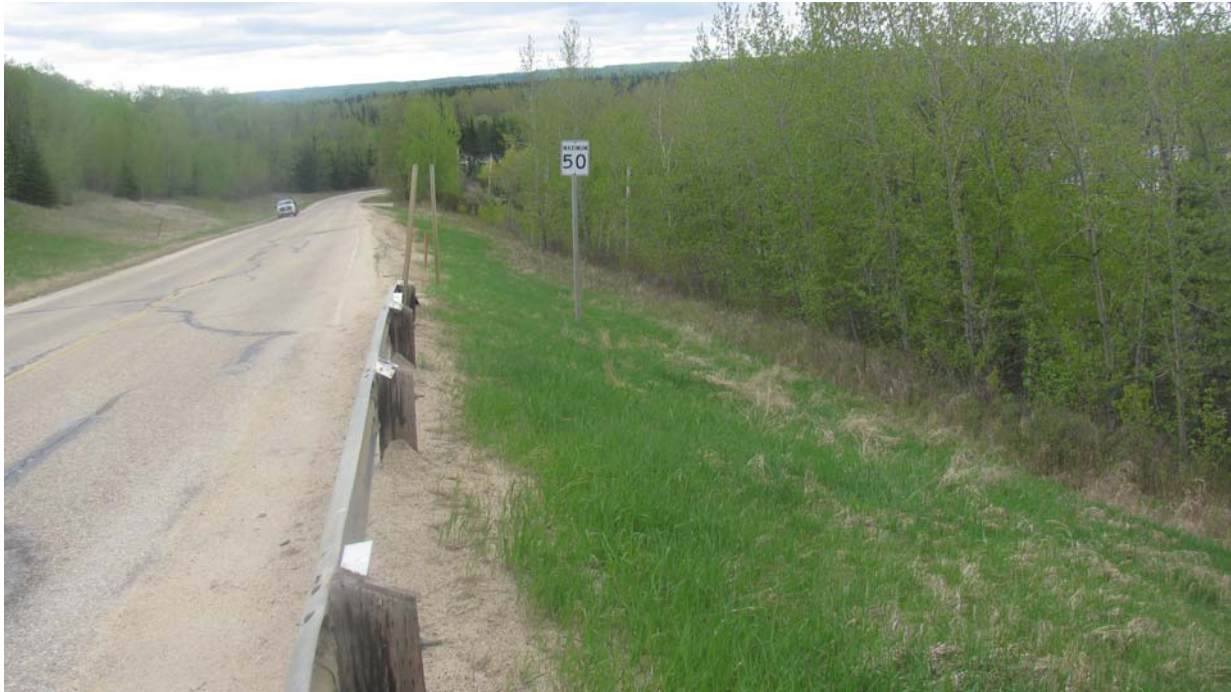
Photo #9 Looking southeast at the dip developed within the Mid-Hill slope section; the southern limit of the Mid-Hill slope section is near the 50 km/h sign

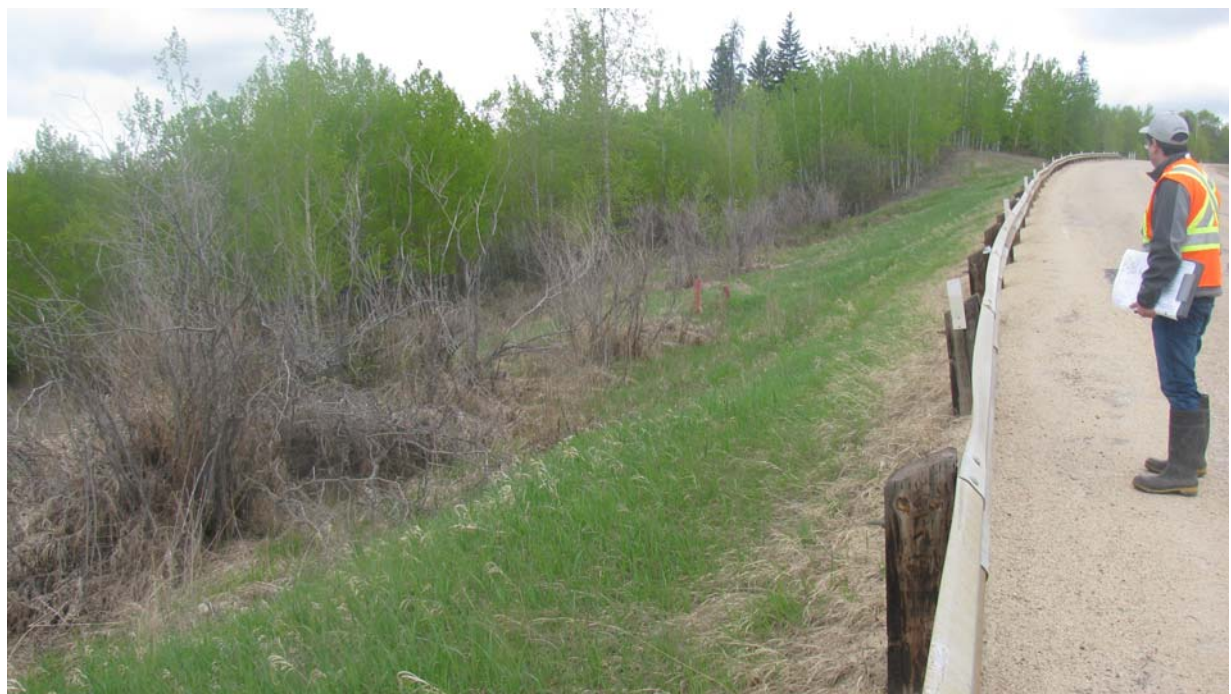
Photo #9a Looking northwest at an old graben feature of a dormant landslide location downslope of the highway to the north of the Mid-Hill slope section

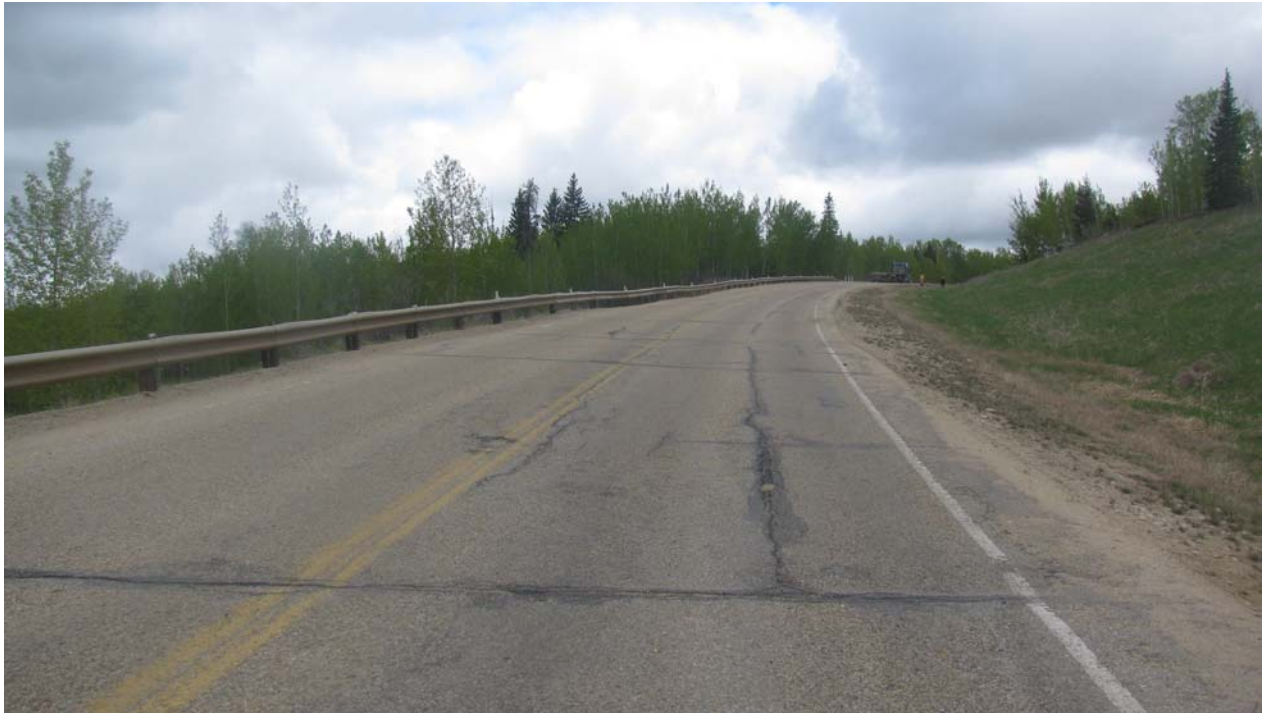
Photo #10 Looking northwest at multiple open cracks to the north of the Mid-Hill slope section; A sag in the guardrail and a dip in the highway SBL were noted above the dormant landslide located to the north of the Mid-Hill slope section

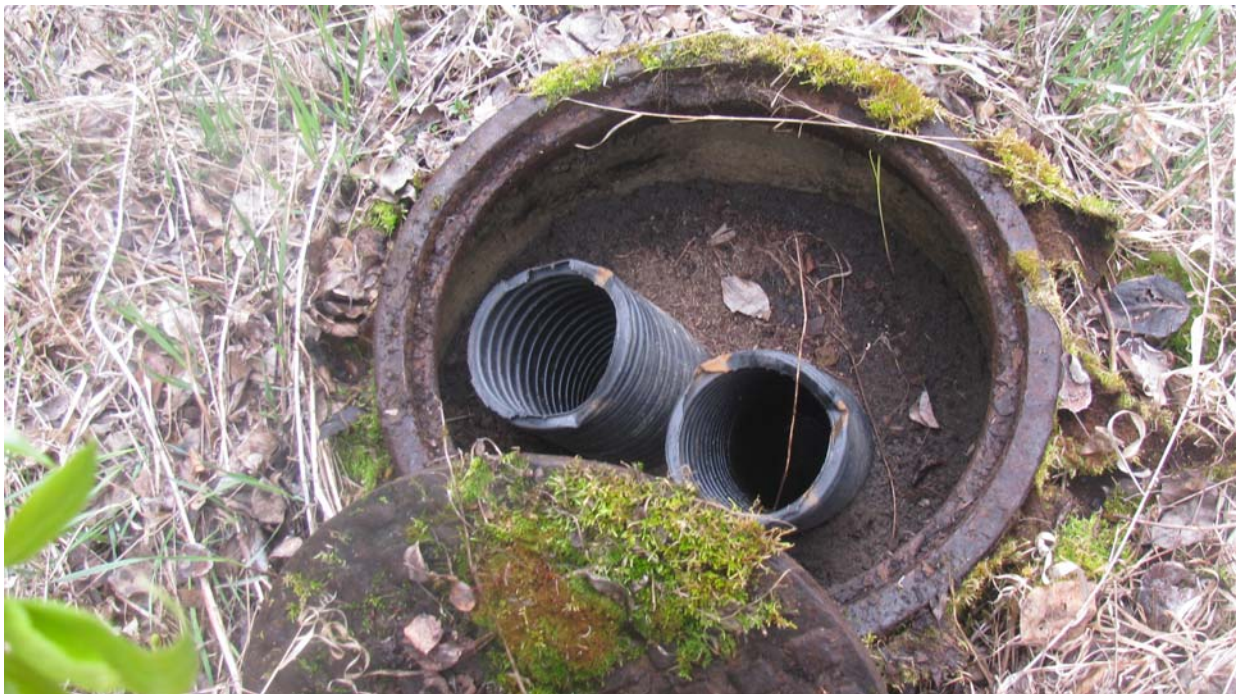
Photo # 11 Subdrain Manhole MH5. Two 150 mm diameter HDPE pipes

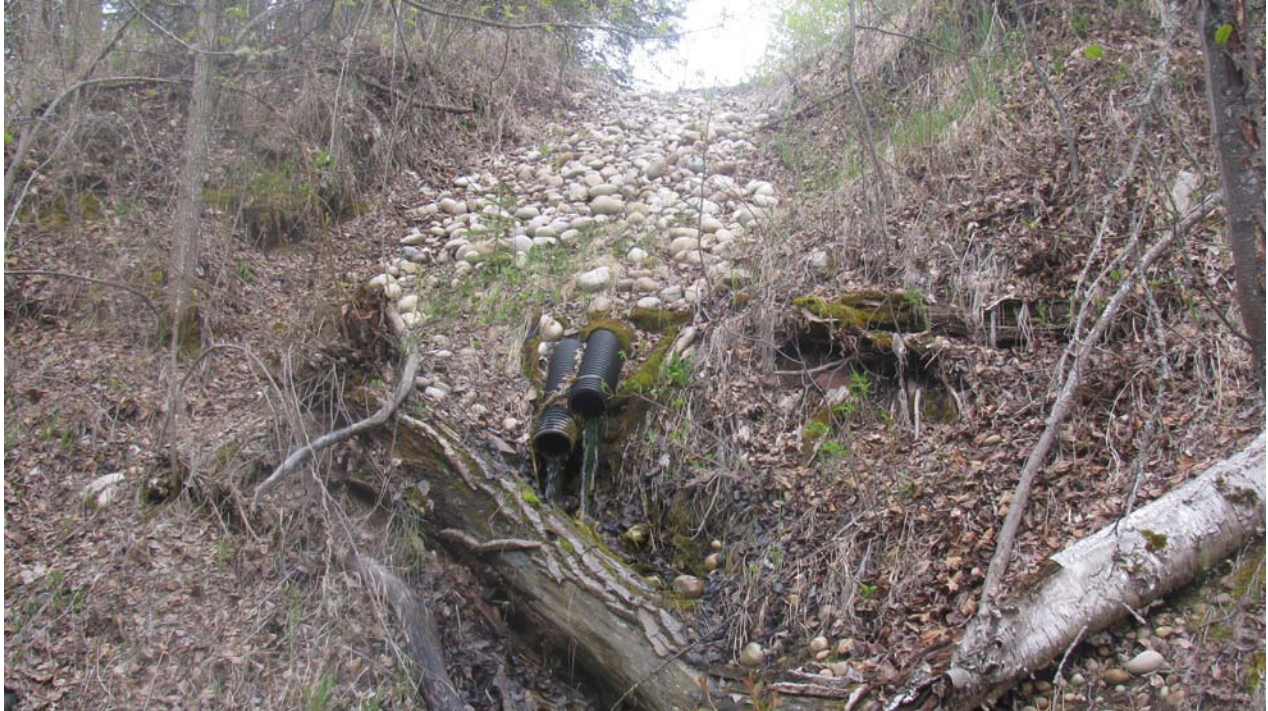
Photo #12 Subdrain Outlets. Note heavy flow from the HDPE pipes

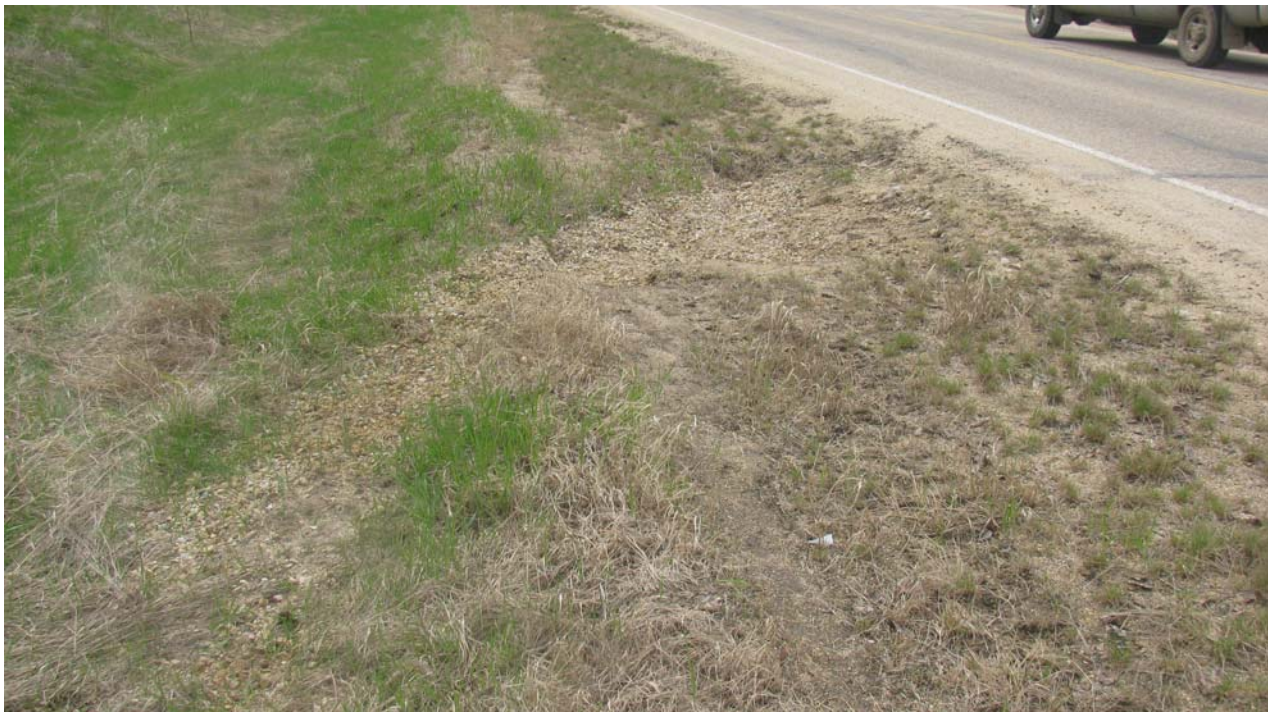
Photo #13 Looking at the slight drop/settlement development near the edge of the road.
