**NORTH CENTRAL REGION (ATHABASCA AREA)
- 2018 GEOHAZARD ASSESSMENT**

**NC014-1: HWY 661: 02 FORT ASSINIBOINE (km 1.8)
SITE PLAN SHOWING MID-HILL SLIDE AREA**

DWG NO. NC014-1-2

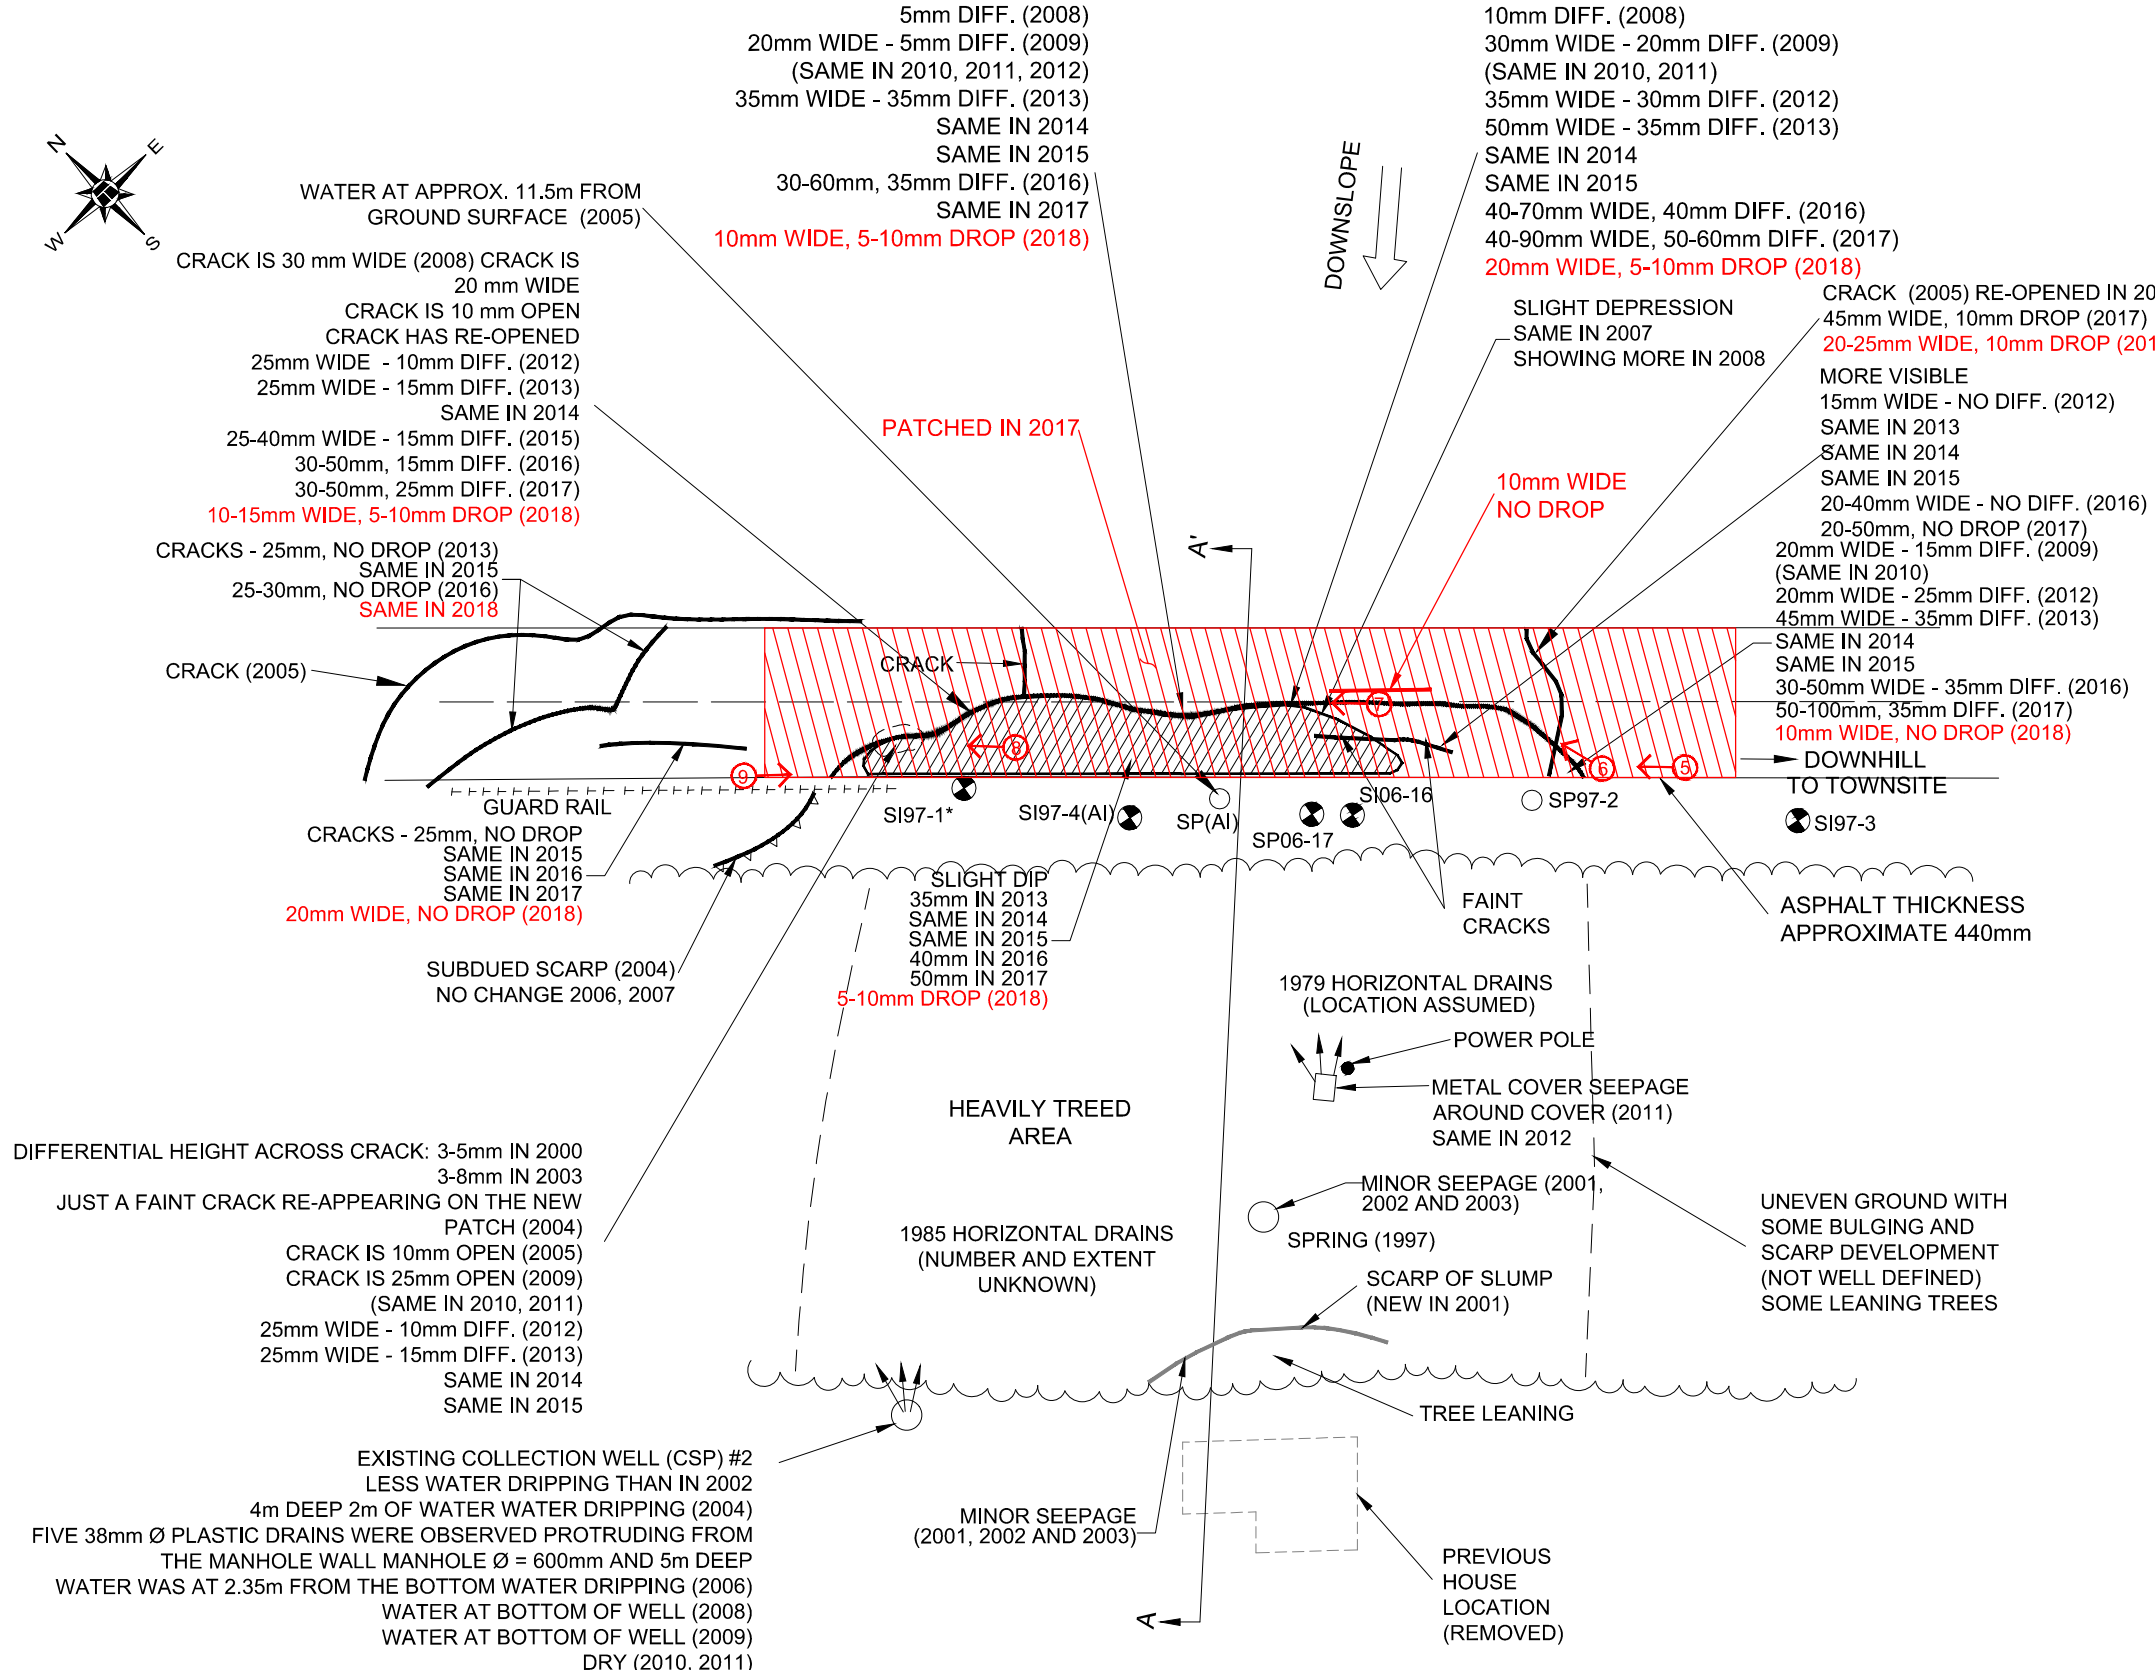
- NOTE:**
1. MANHOLE COVER WAS LOCKED BY OTHERS AND COULD NOT BE OPENED FOR INSPECTION IN 2012, 2013, AND 2014
 2. MH #2 HAS NO OUTFLOW PIPE - WATER IS LIKELY PERCOLATING INTO GROUND. (2015)
 3. MINOR FLOW FROM ONE OF SUBHORIZONTAL DRAINS IN 2016.
 4. ONE OF THE SUBHORIZONTAL DRAINS IS DRIPPING WATER.
 5. **ONE OF THE DRAINS IS FLOWING. MORE WATER NOTED IN 2018**

DIFFERENTIAL HEIGHT ACROSS CRACK: 3-5mm IN 2000
3-8mm IN 2003
JUST A FAINT CRACK RE-APPEARING ON THE NEW PATCH (2004)
CRACK IS 10mm OPEN (2005)
CRACK IS 25mm OPEN (2009)
(SAME IN 2010, 2011)
25mm WIDE - 10mm DIFF. (2012)
25mm WIDE - 15mm DIFF. (2013)
SAME IN 2014
SAME IN 2015

EXISTING COLLECTION WELL (CSP) #2
LESS WATER DRIPPING THAN IN 2002
4m DEEP 2m OF WATER WATER DRIPPING (2004)
FIVE 38mm Ø PLASTIC DRAINS WERE OBSERVED PROTRUDING FROM THE MANHOLE WALL MANHOLE Ø = 600mm AND 5m DEEP WATER WAS AT 2.35m FROM THE BOTTOM WATER DRIPPING (2006)
WATER AT BOTTOM OF WELL (2008)
WATER AT BOTTOM OF WELL (2009)
DRY (2010, 2011)
