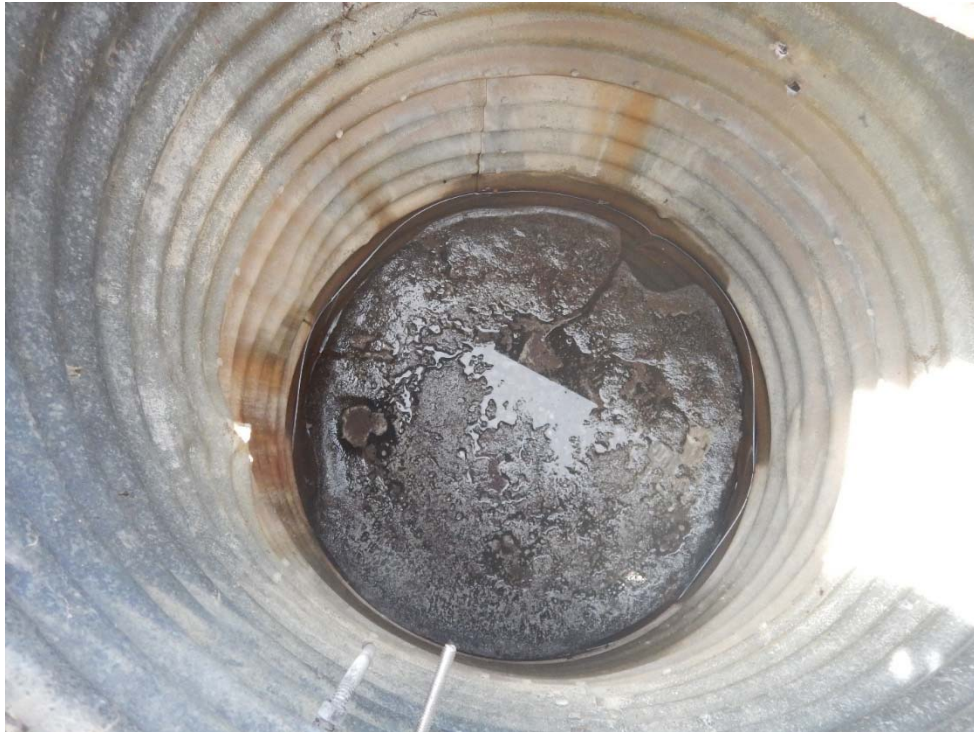
Photo No. 1 – Standing water and ice inside MH#1

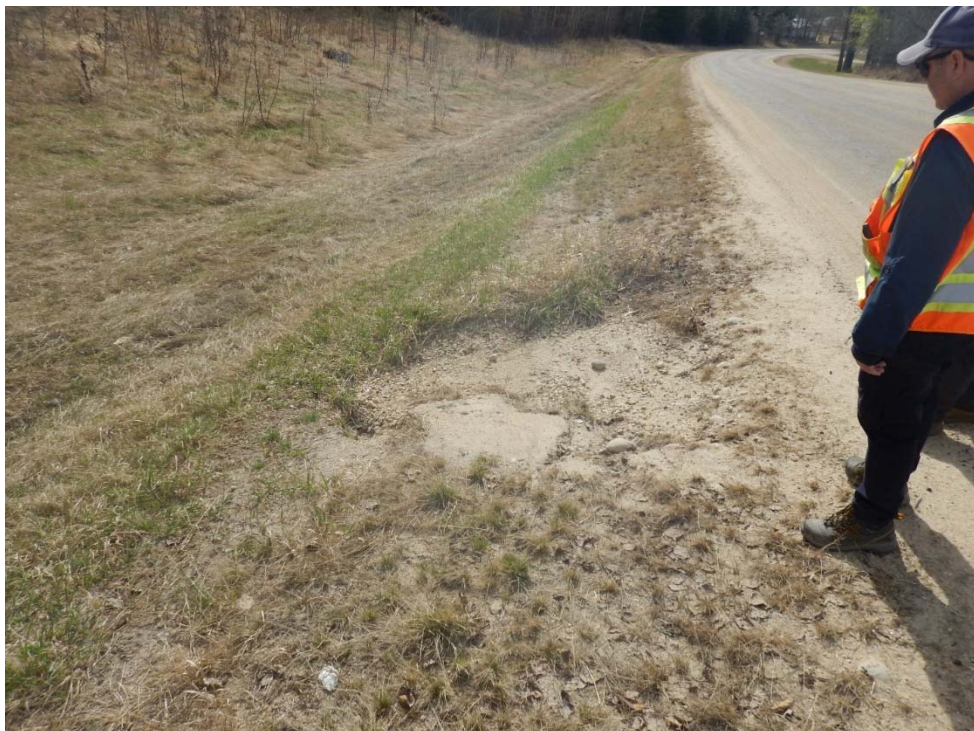
Photo No. 2 – Looking at the slight drop/settlement development near the edge of the road

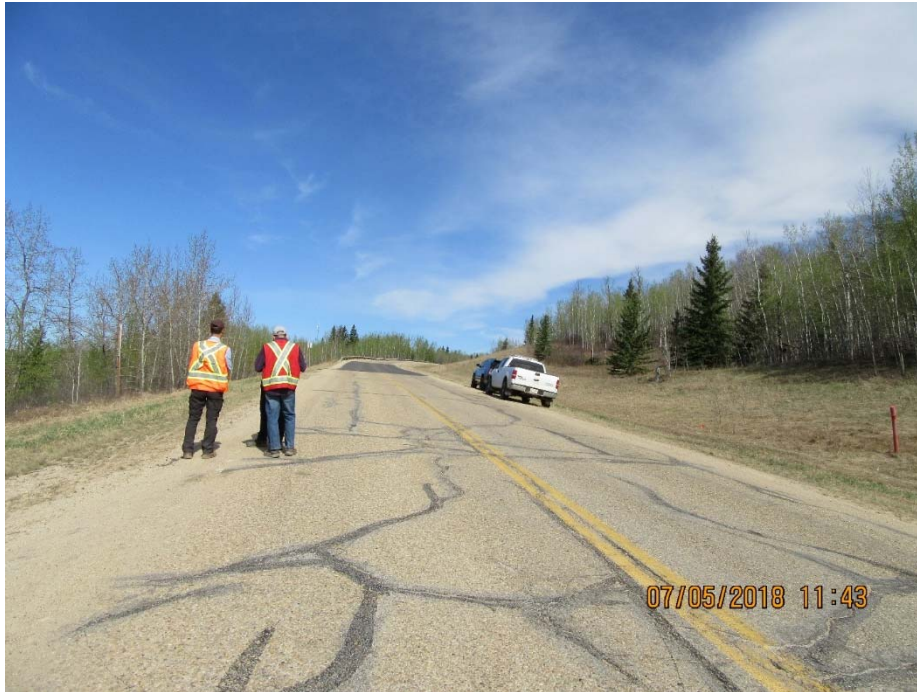
Photo No. 3 – Looking north at multiple open longitudinal cracks in the highway surface between the MH#1 location and the Mid-Hill slope section

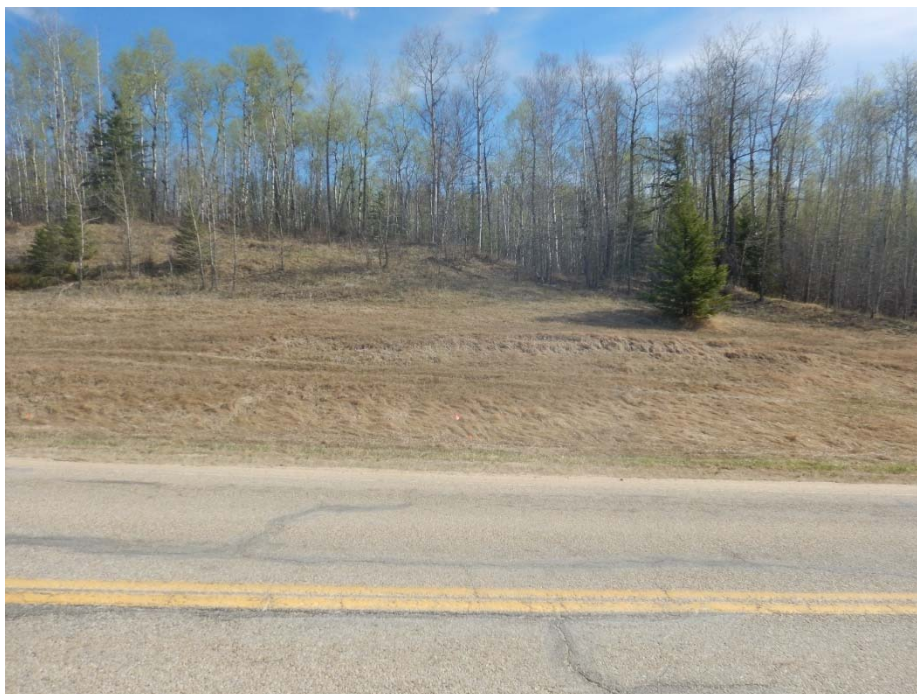
Photo No. 4 – Looking east at a vegetated scarp crack of a dormant slump within the highway backslope between the Mid-Hill and bottom of the hill slope sections

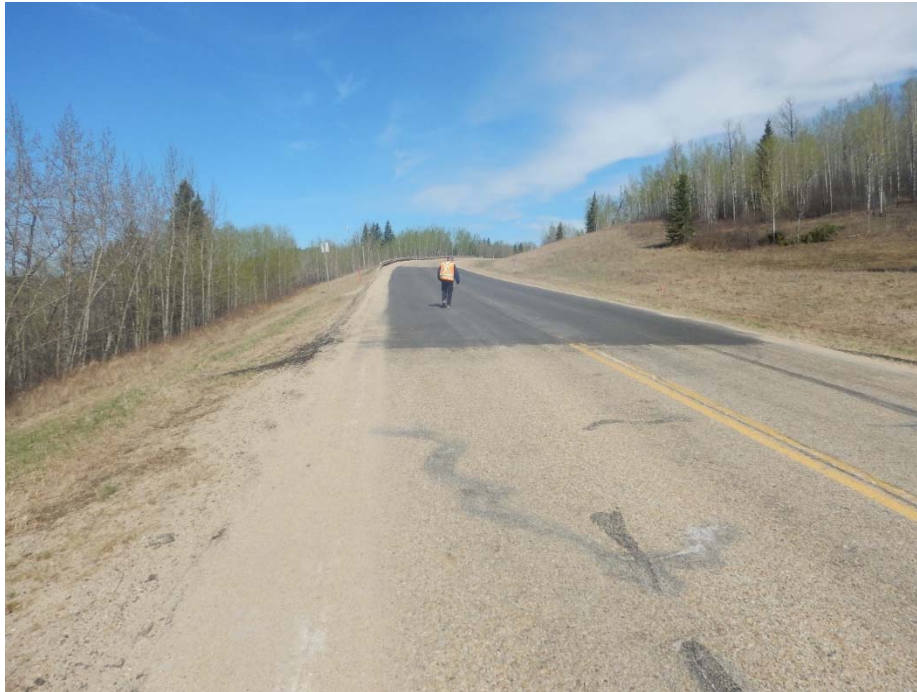
Photo No. 5 - Looking North at 2017 ACP Patch placed over the Mid-Hill Slope Section

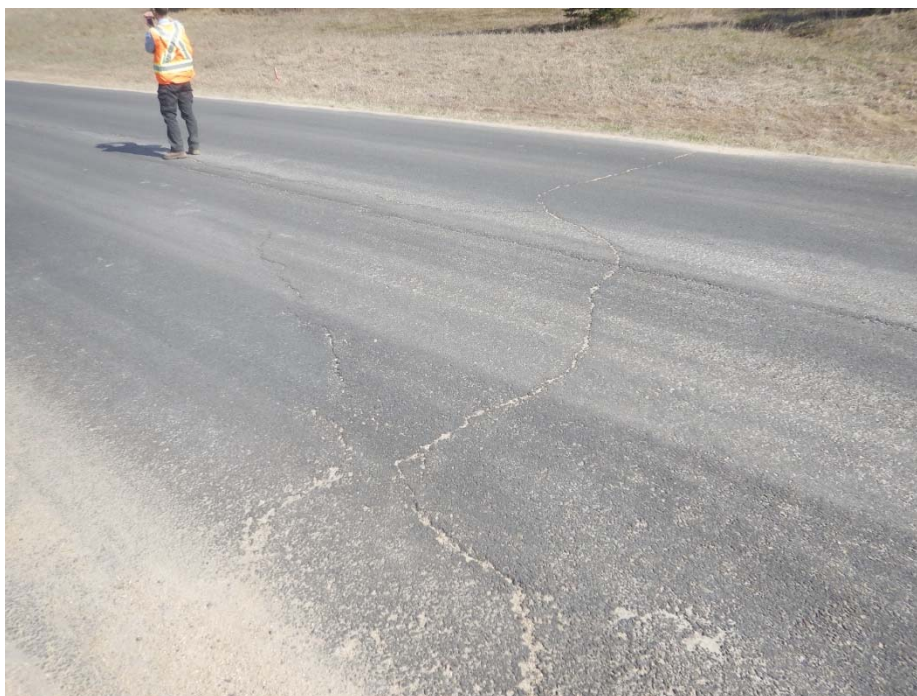
Photo No. 6 – Reflective diagonal crack after 2017 ACP patch at the southern limit of Mid-Hill Slope Section (looking northeast)

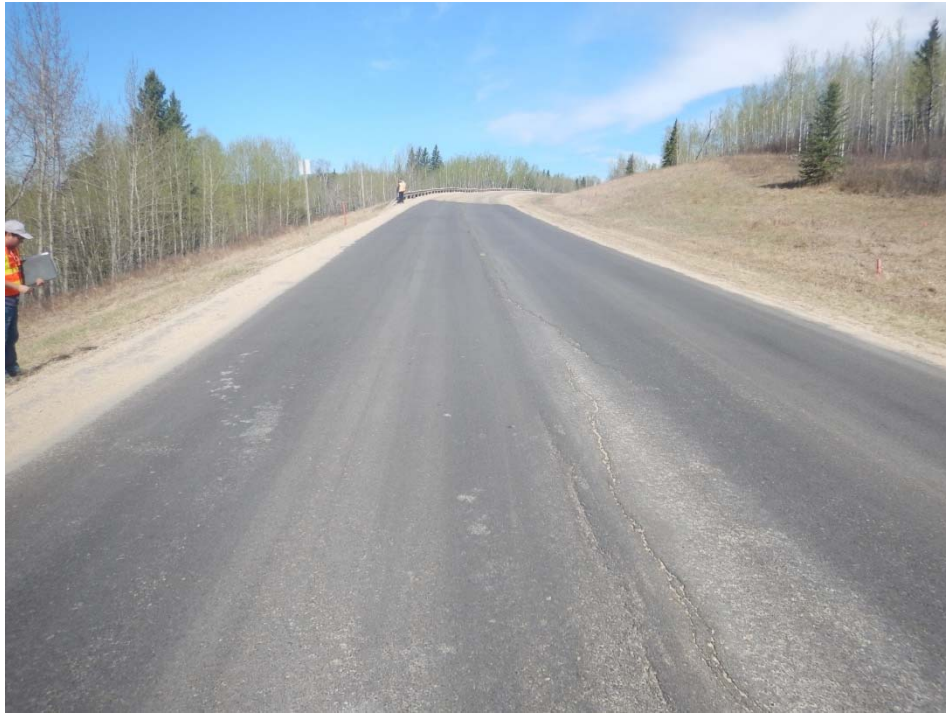
Photo No. 7 – Reflective Longitudinal Cracks at the Mid-Hill Slope Section (looking north)

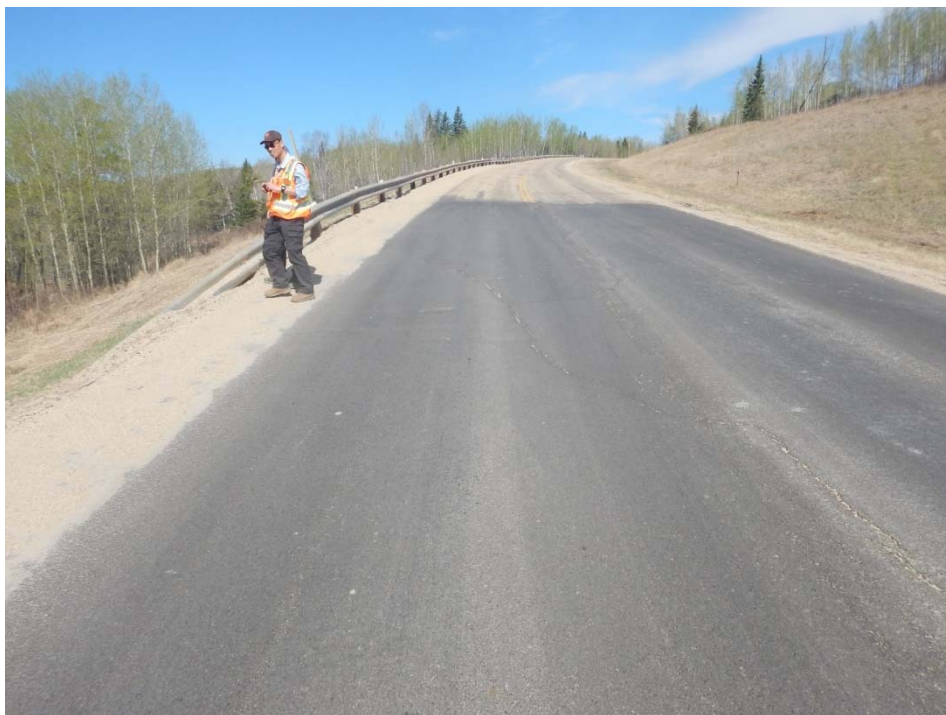
Photo No. 8 – Reflective Diagonal Crack at the north end of the Mid-Hill Slope Section

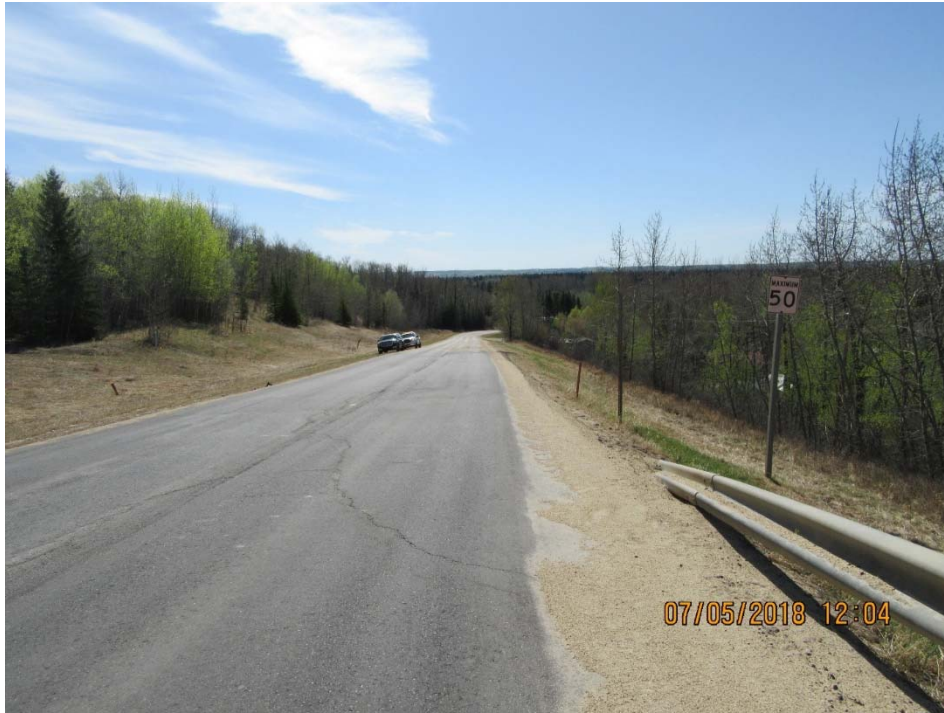
Photo No. 9 – Looking south at the patch from the northern limit of the Mid-Hill Slope Section
