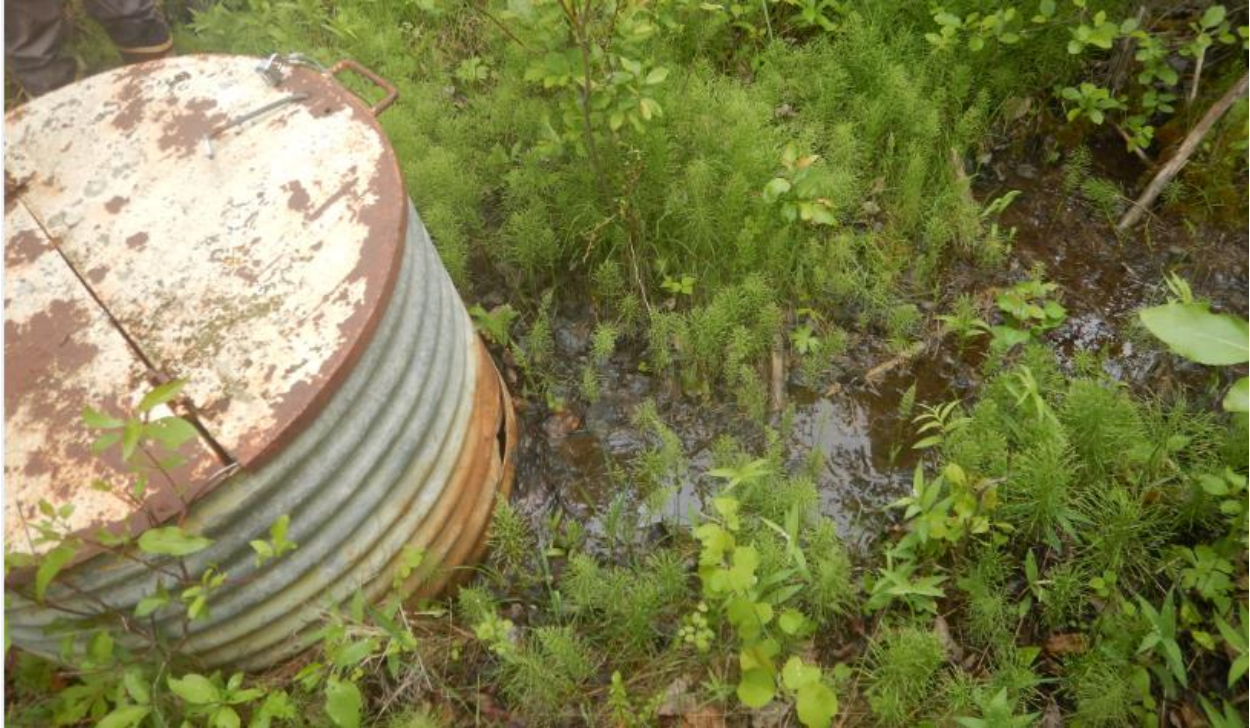
Photo No. 1 – Seepage and standing water near MH#1

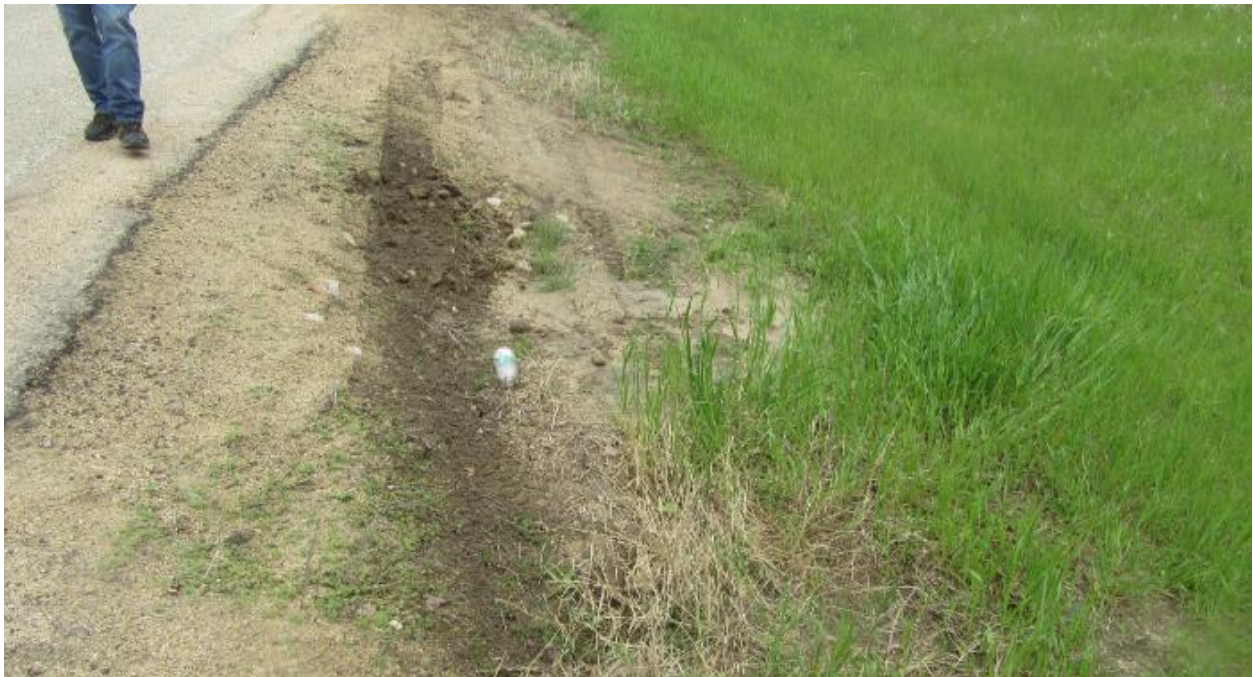
Photo No. 2 – Looking at the slight drop/settlement development near the edge of the road

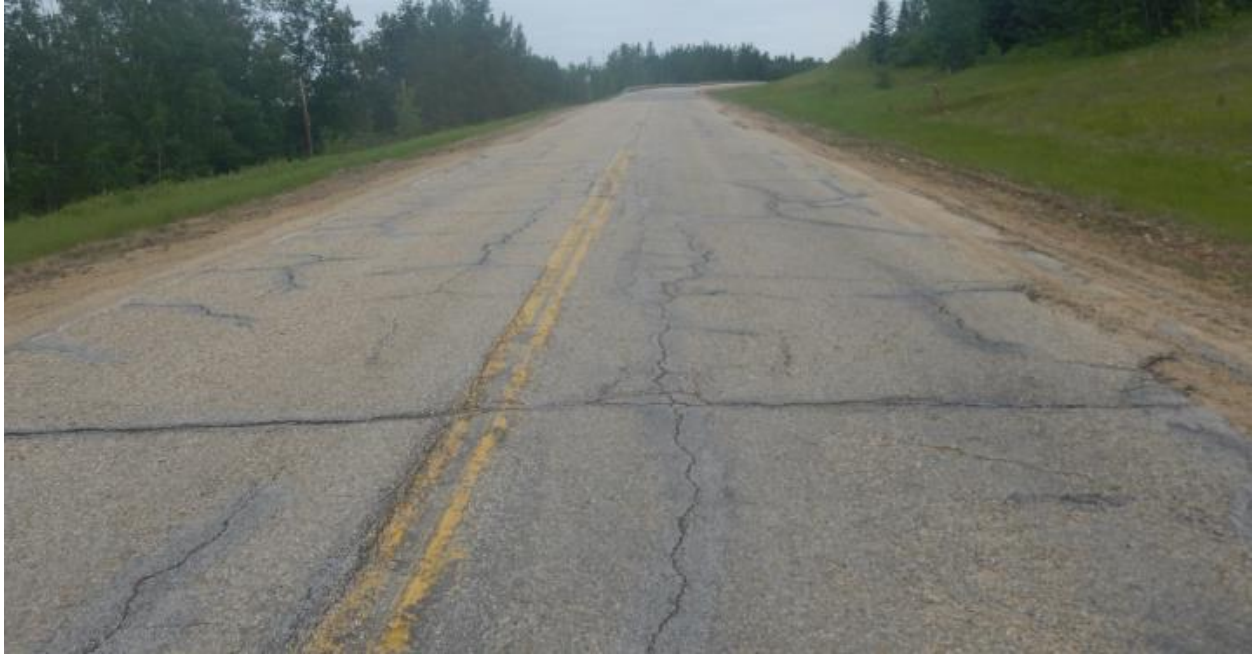
Photo No. 3 – Looking north at multiple open longitudinal cracks in the highway surface between the MH#1 location and the Mid-Hill slope section

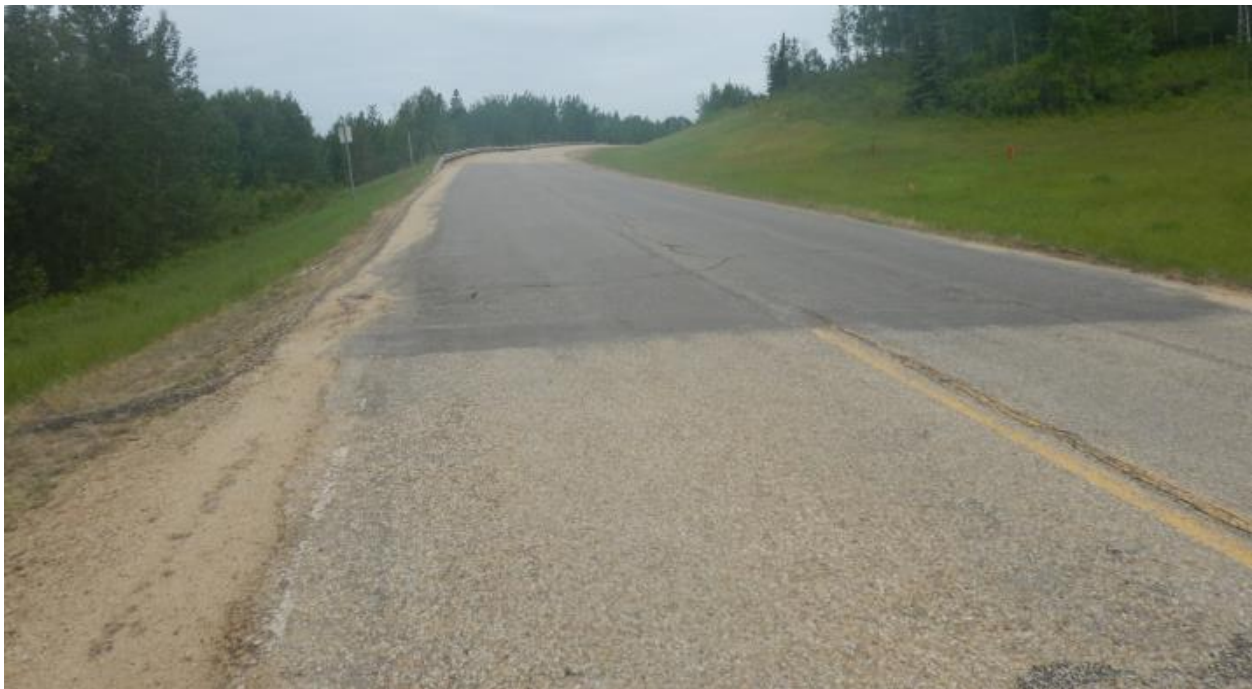
Photo No. 4 - Looking North at 2017 ACP Patch placed over the Mid-Hill Slope Section

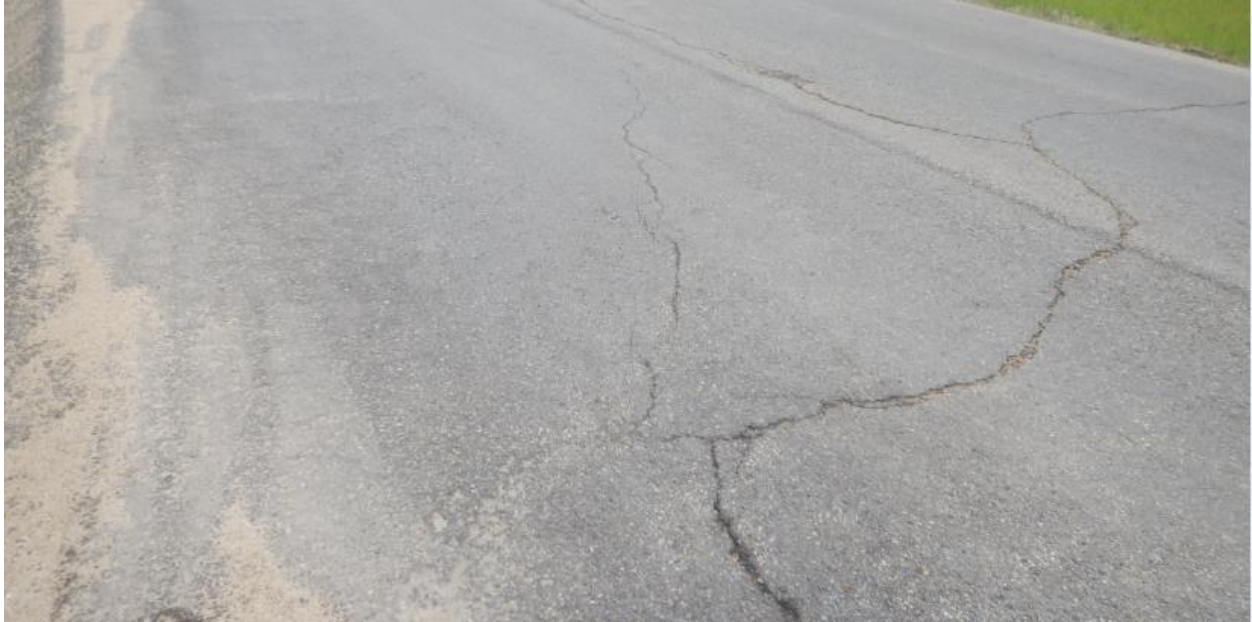
Photo No. 5 – Reflective diagonal crack at the southern limit of Mid-Hill Slope Section (looking northeast)

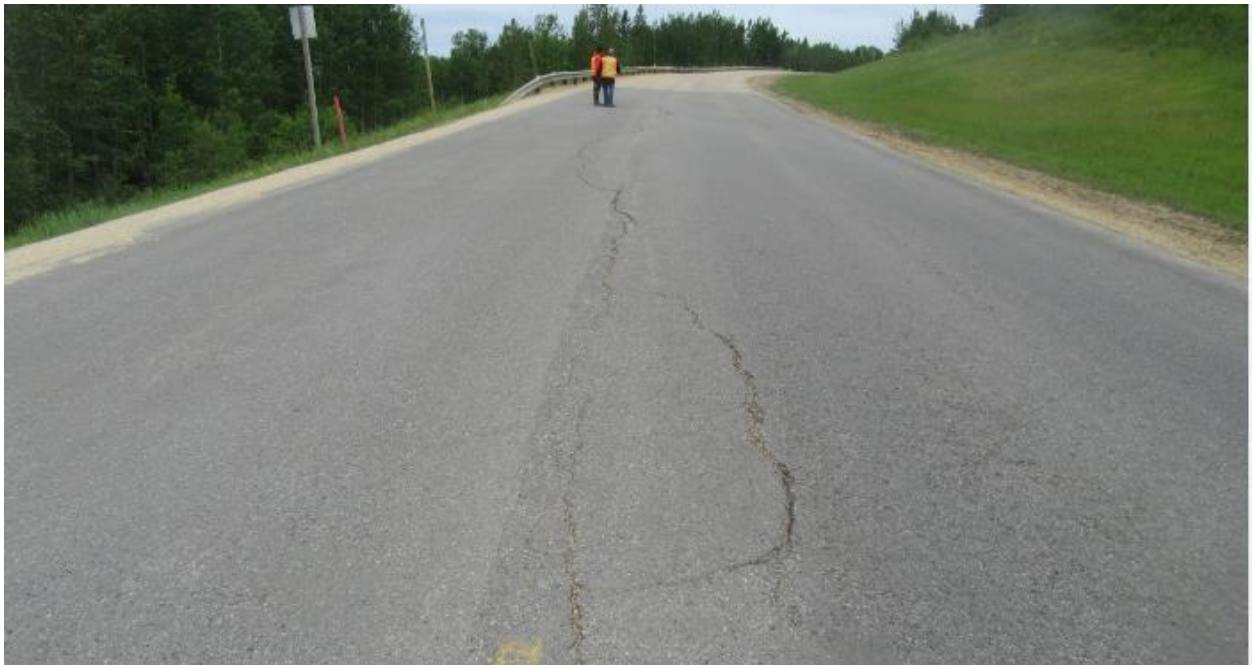
Photo No. 6 – Reflective Longitudinal Cracks at the Mid-Hill Slope Section (looking north)

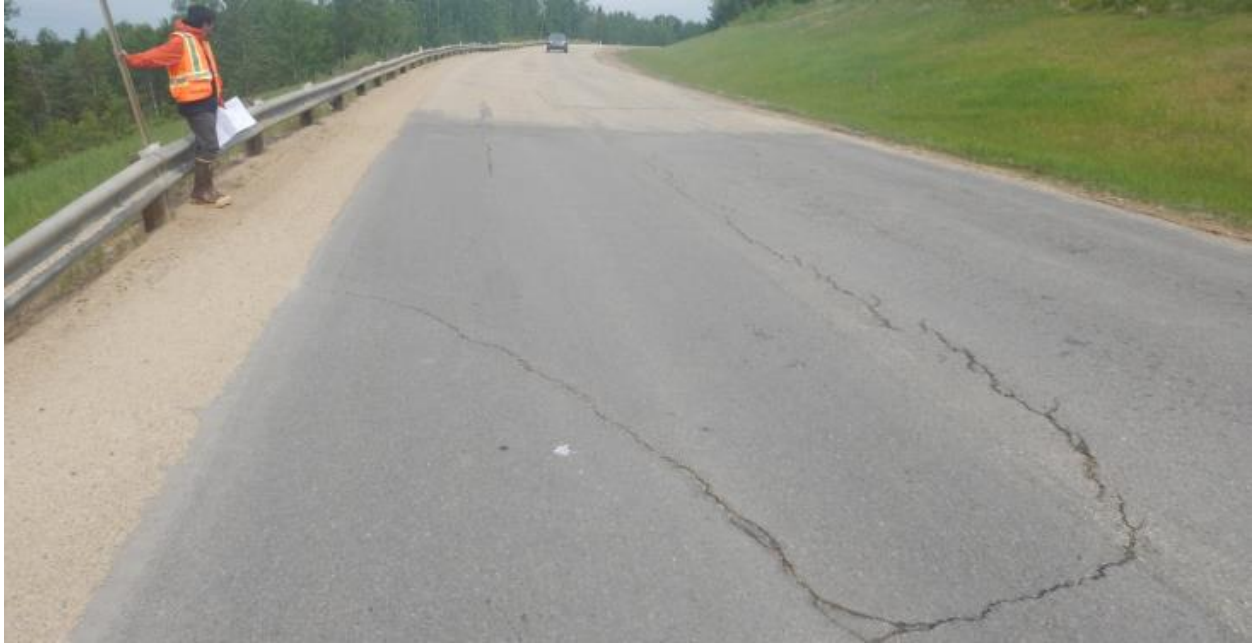
Photo No. 7 – Reflective Diagonal Crack at the north end of the Mid-Hill Slope Section

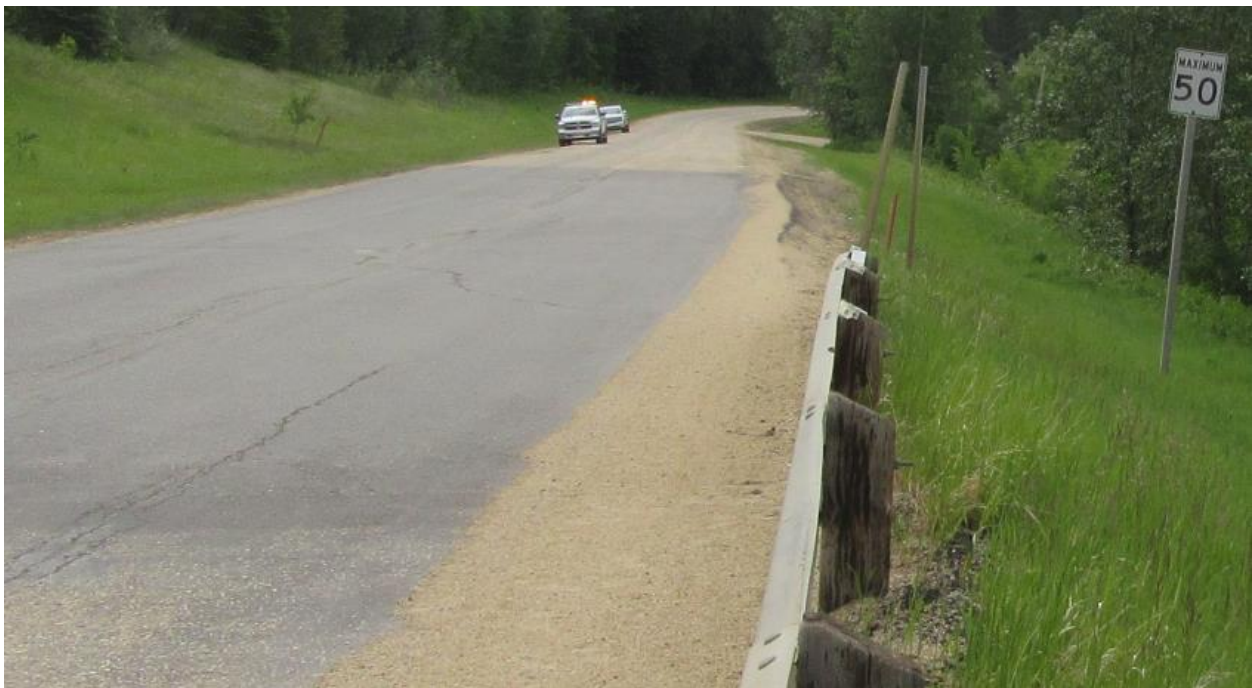
Photo No. 8 – Looking south at the SBL dip from the northern limit of the Mid-Hill Slope Section

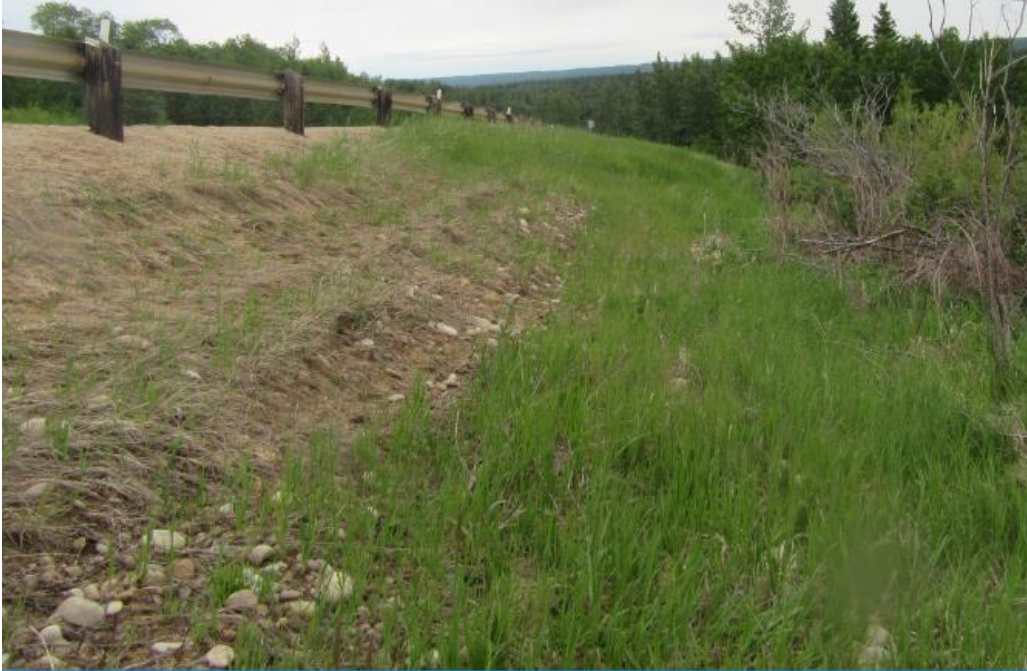
Photo No. 9 – Looking south at graben back scarp
