**ALBERTA INFRASTRUCTURE  
LANDSLIDE RISK ASSESSMENT**

**SITE NC14: SH661:02**

**NORTH CENTRAL REGION LANDSLIDE ASSESSMENT  
SH 661:02 NEAR NORTHEAST BOUNDARY OF  
TOWN OF FT. ASSINIBOINE (NC14)  
2000 ANNUAL INSPECTION REPORT**

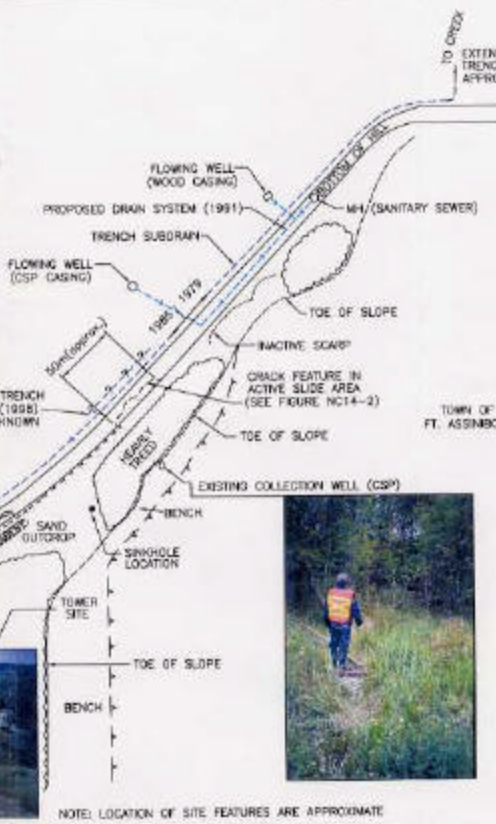
OWNER (UL)	ALBERTA INFRASTRUCTURE
DRAWN (SH)	<b>SITE PLAN</b>
DATE NOV 2000	
APPROVED	
SCALE 1:3000 (APPROX)	
NORTH CENTRAL LANDSLIDE ASSESSMENT N. OF

- A 15 m long shallow dip in the roadway shoulder and guard rail (down slope side) was noted at a location approximately 100 m uphill from the active slide feature. Some minor cracking was noted in the pavement surface in this area with no significant differential height noted across the cracks. No signs of recent instability were noted in the side slope below the dip feature.

- A possible graben feature was noted on the upper side slope adjacent to and further uphill from the dip feature, located approximately as shown on the site plan. This feature appears inactive at this time. This feature could also be a result of slope grading at the time of construction or later. The upslope side of the roadway has been patched in the recent past at this location.

- A sinkhole was noted in the side slope approximately half way down the slope, located approximately as shown on the site plan. The sinkhole was approximately 600 mm deep and 3 m in diameter. There was no evidence of seepage or piping discharge from the sinkhole feature.

- An inactive scarp area was noted in the lower portion of the slope. This feature does not appear to be impacting the roadway at this time.
- The house where distress to the walls was noted in the 1999 AGRA letter had been removed from the property below the failed slope at the time of the site reconnaissance in June, 2000.

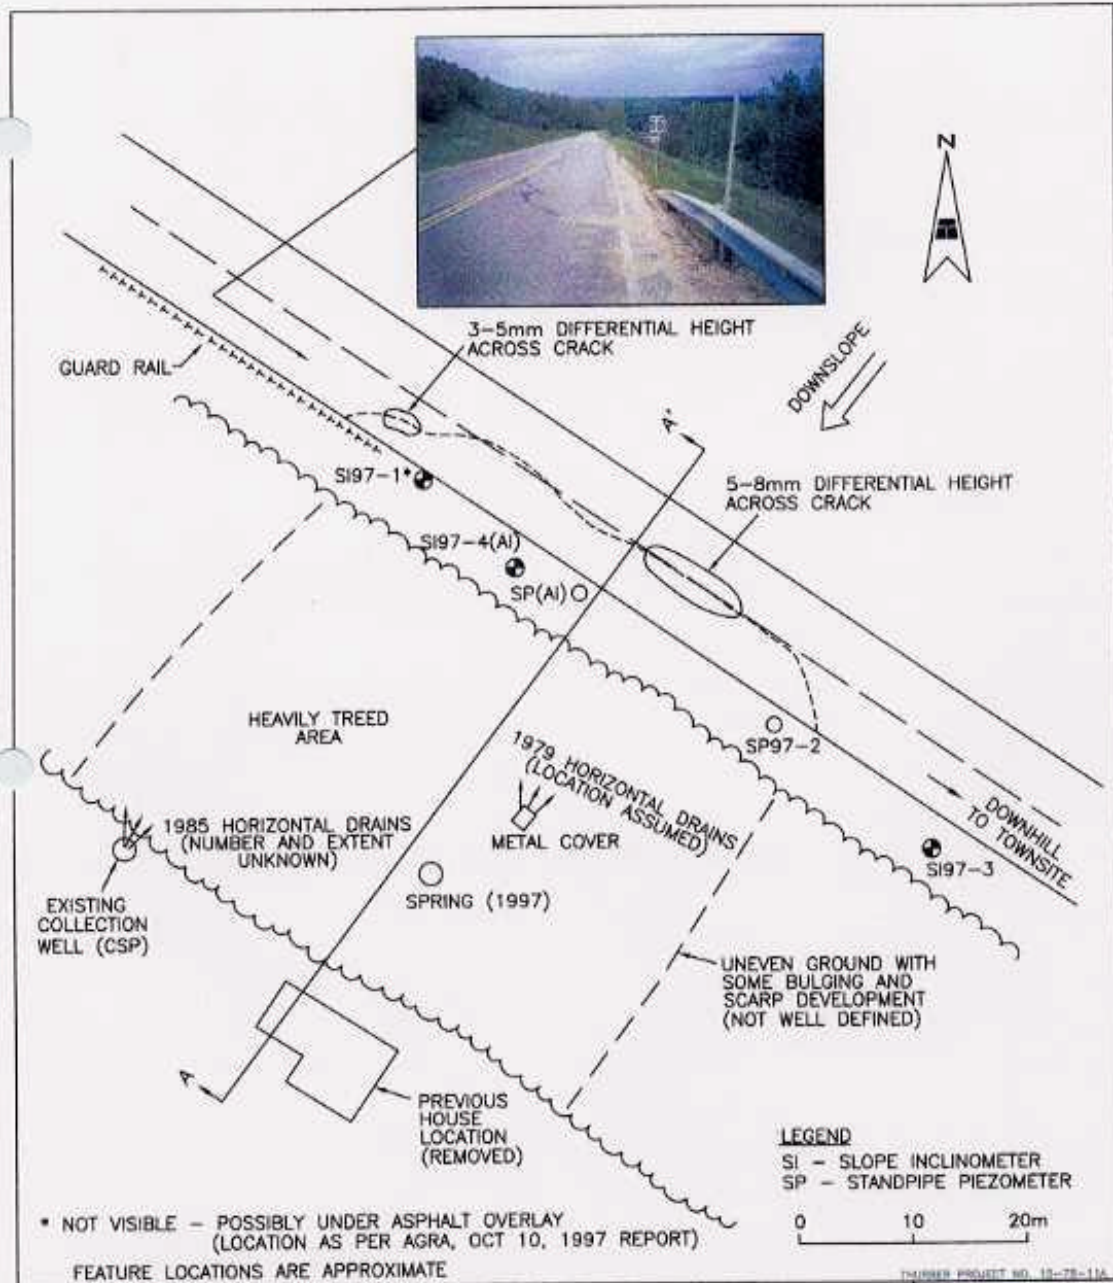
<b>THURBER</b>
DRAWN	VH	<h3>ACTIVE SLIDE AREA</h3>		
DATE	NOV 2000			
APPROVED				
SCALE	1:500 (APPROX.)			
		NORTH CENTRAL LANDSLIDE ASSESSMENT	SH661:02 N. OF FT. ASSINIBOINE	FIGURE NC14-2

- A 50 m section of roadway is presently impacted by the active slide feature. This area is shown in detail on Figure NC14-2, and includes the approximate location of the instrumentation. The side slope at this location averages approximately 24° (2.2H:1V) over an 18 m height. The crack pattern indicates that only the down slope lane (i.e. right hand lane as you travel down hill) is substantially affected by the slope movements at this location at this time.
- No signs of seepage or active slope movement were noted in the side slope and back slope in the vicinity of the roadway distress. Some bulging and uneven ground was evident within the treed area near the toe of the slope below the area of roadway distress, however the toe of the slide was not well defined at the time of the site reconnaissance. In addition, the trees were not leaning significantly in this area.

- Crack filling had been undertaken in the recent past. Differential heights across the crack feature of up to about 8 mm and crack widths of up to about 6 mm were noted.

Consideration should be given to a toe berm below the active slide area. A berm in the order of 6 m high and 20 m wide may be appropriate. A detailed design should be undertaken, including stability analyses using existing stratigraphic information. However it is recommended to install a piezometer nest in the slide area to determine appropriate pore pressures for the analyses and to assist in estimating the approximate flow rate of groundwater from the slope. Control of water through the base of the berm would need to be incorporated into the design.

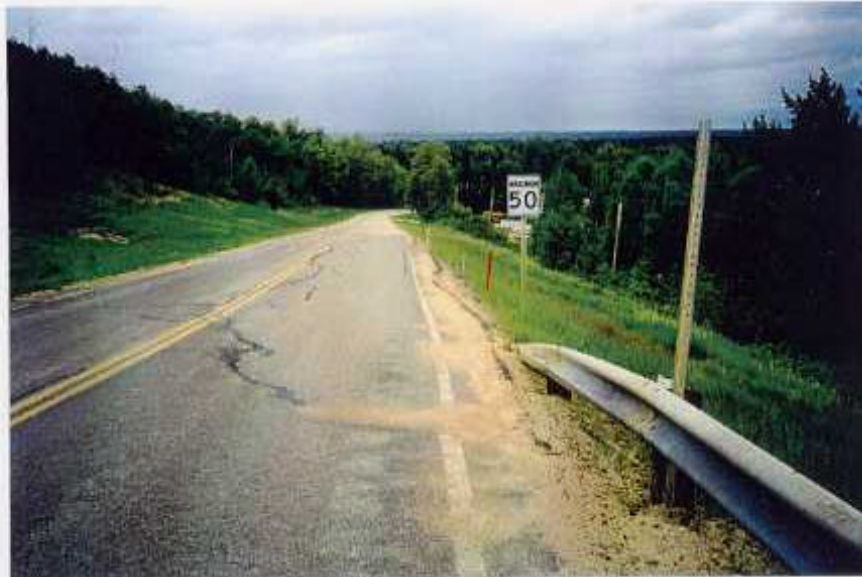
PHOTO NC14-1    LOOKING SOUTHEAST (DOWNSLOPE) AT  
ROADWAY DISTRESS AND INSTRUMENTATION.

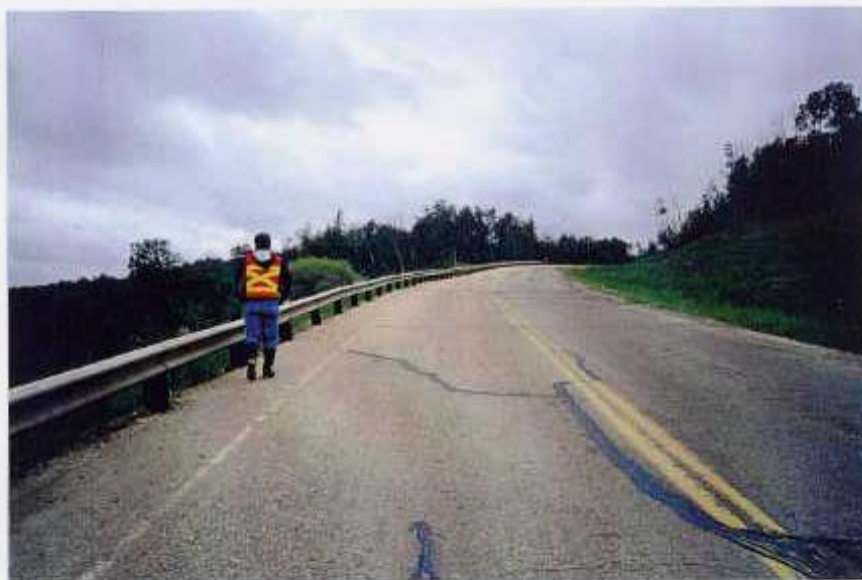
The distress (patch, cracking and dip in roadway shoulder) noted 100 m uphill from the active slide area may be indicative of slope movements developing at this location. Ongoing movements may cause further distress at this location.

PHOTO NC14-2    LOOKING NORTHWEST (UPSLOPE)  
AT DIP IN SHOULDER.

Slope inclinometers and a piezometer nest are recommended in the patched area located 100 m uphill from the active slide area to monitor potential slope movements and measure pore pressures. Consideration should be given to placing one SI in the roadway and one on the possible graben feature below the roadway. If movements are determined, a survey of the area is recommended to determine the slope profile for stability analyses.

As a minimum this area should be monitored visually by the MCI and if any further distress is noted, reassessment should be undertaken by a geotechnical engineer.

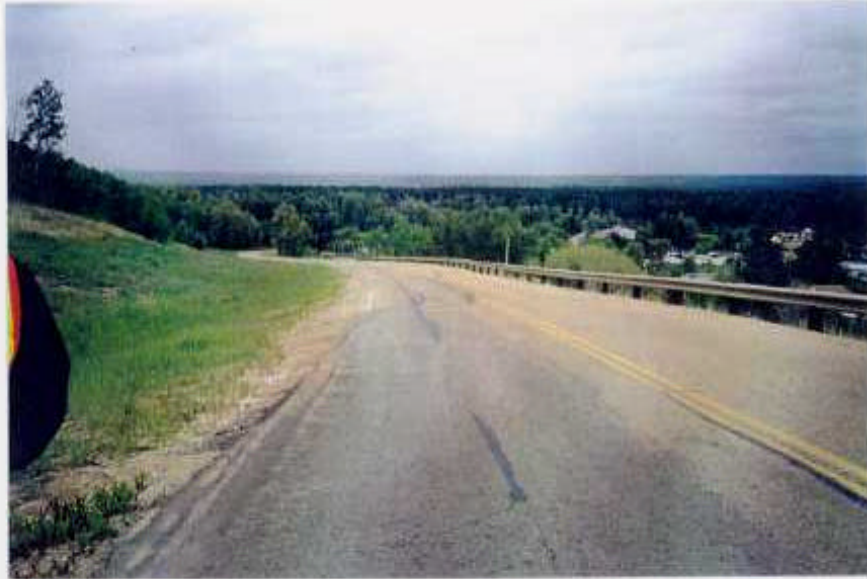
PHOTO NC14-3    LOOKING SOUTHEAST AT PATCH IN  
ROADWAY (UPPER SLOPE).

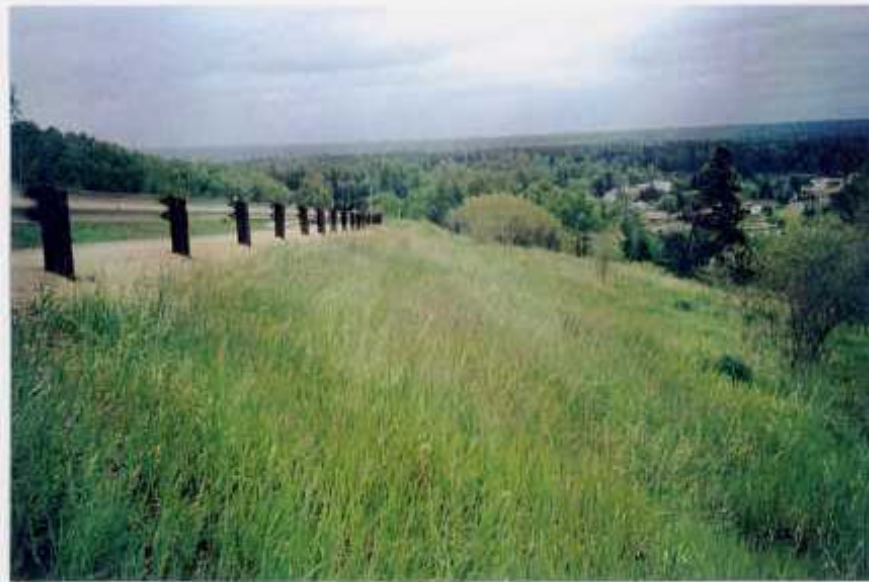
PHOTO NC14-4    LOOKING SOUTHEAST AT POSSIBLE  
GRABEN AREA IN UPPER SLOPE.

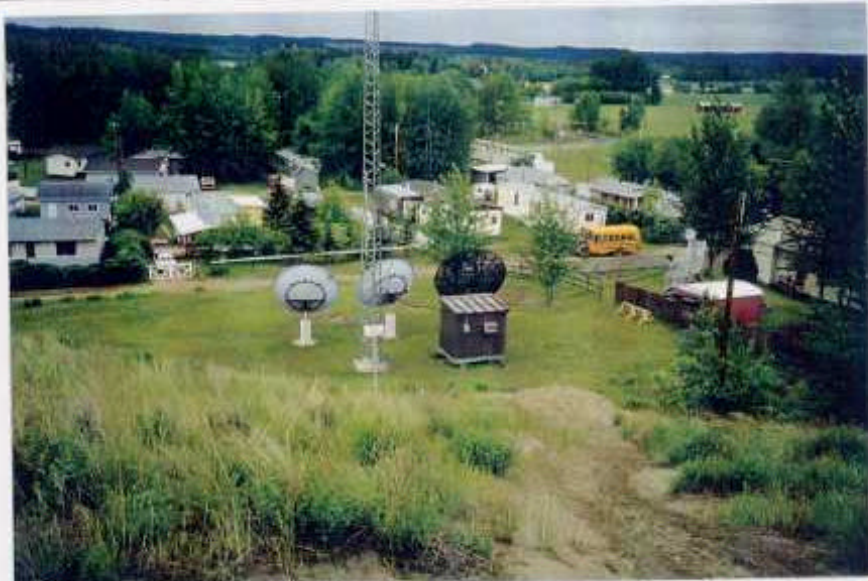
PHOTO NC14-5 LOOKING SOUTH AT TOWER SITE,  
(SAND OUTCROP IN FOREGROUND).

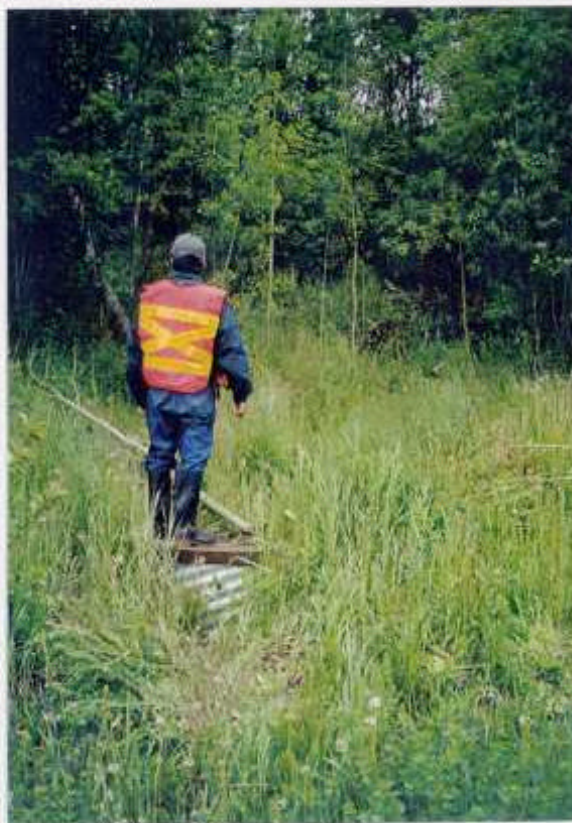
PHOTO NC14-6  
LOOKING NORTHEAST AT  
COLLECTION WELL AT  
TOE OF SLOPE.
