**ALBERTA TRANSPORTATION  
GEOHAZARD ASSESSMENT PROGRAM  
NORTH CENTRAL REGION – ATHABASCA &  
FORT MCMURRAY DISTRICTS  
2021 SITE INSPECTION**

Site Number	Location	Name	Hwy	km
NC071	1 km east of Colinton	Little Pine Creek Slide	663:04	6.98
Legal Description		UTM Co-ordinates (NAD 83)		
S.E.15&S.W.14& N.E.10-65-22-W4M		12 N 6054582	E 355785

**NC071: HWY 663:04 LITTLE PINE CREEK SLIDE (km 6.98)**

**DWG NO. 32122-NC071-1**

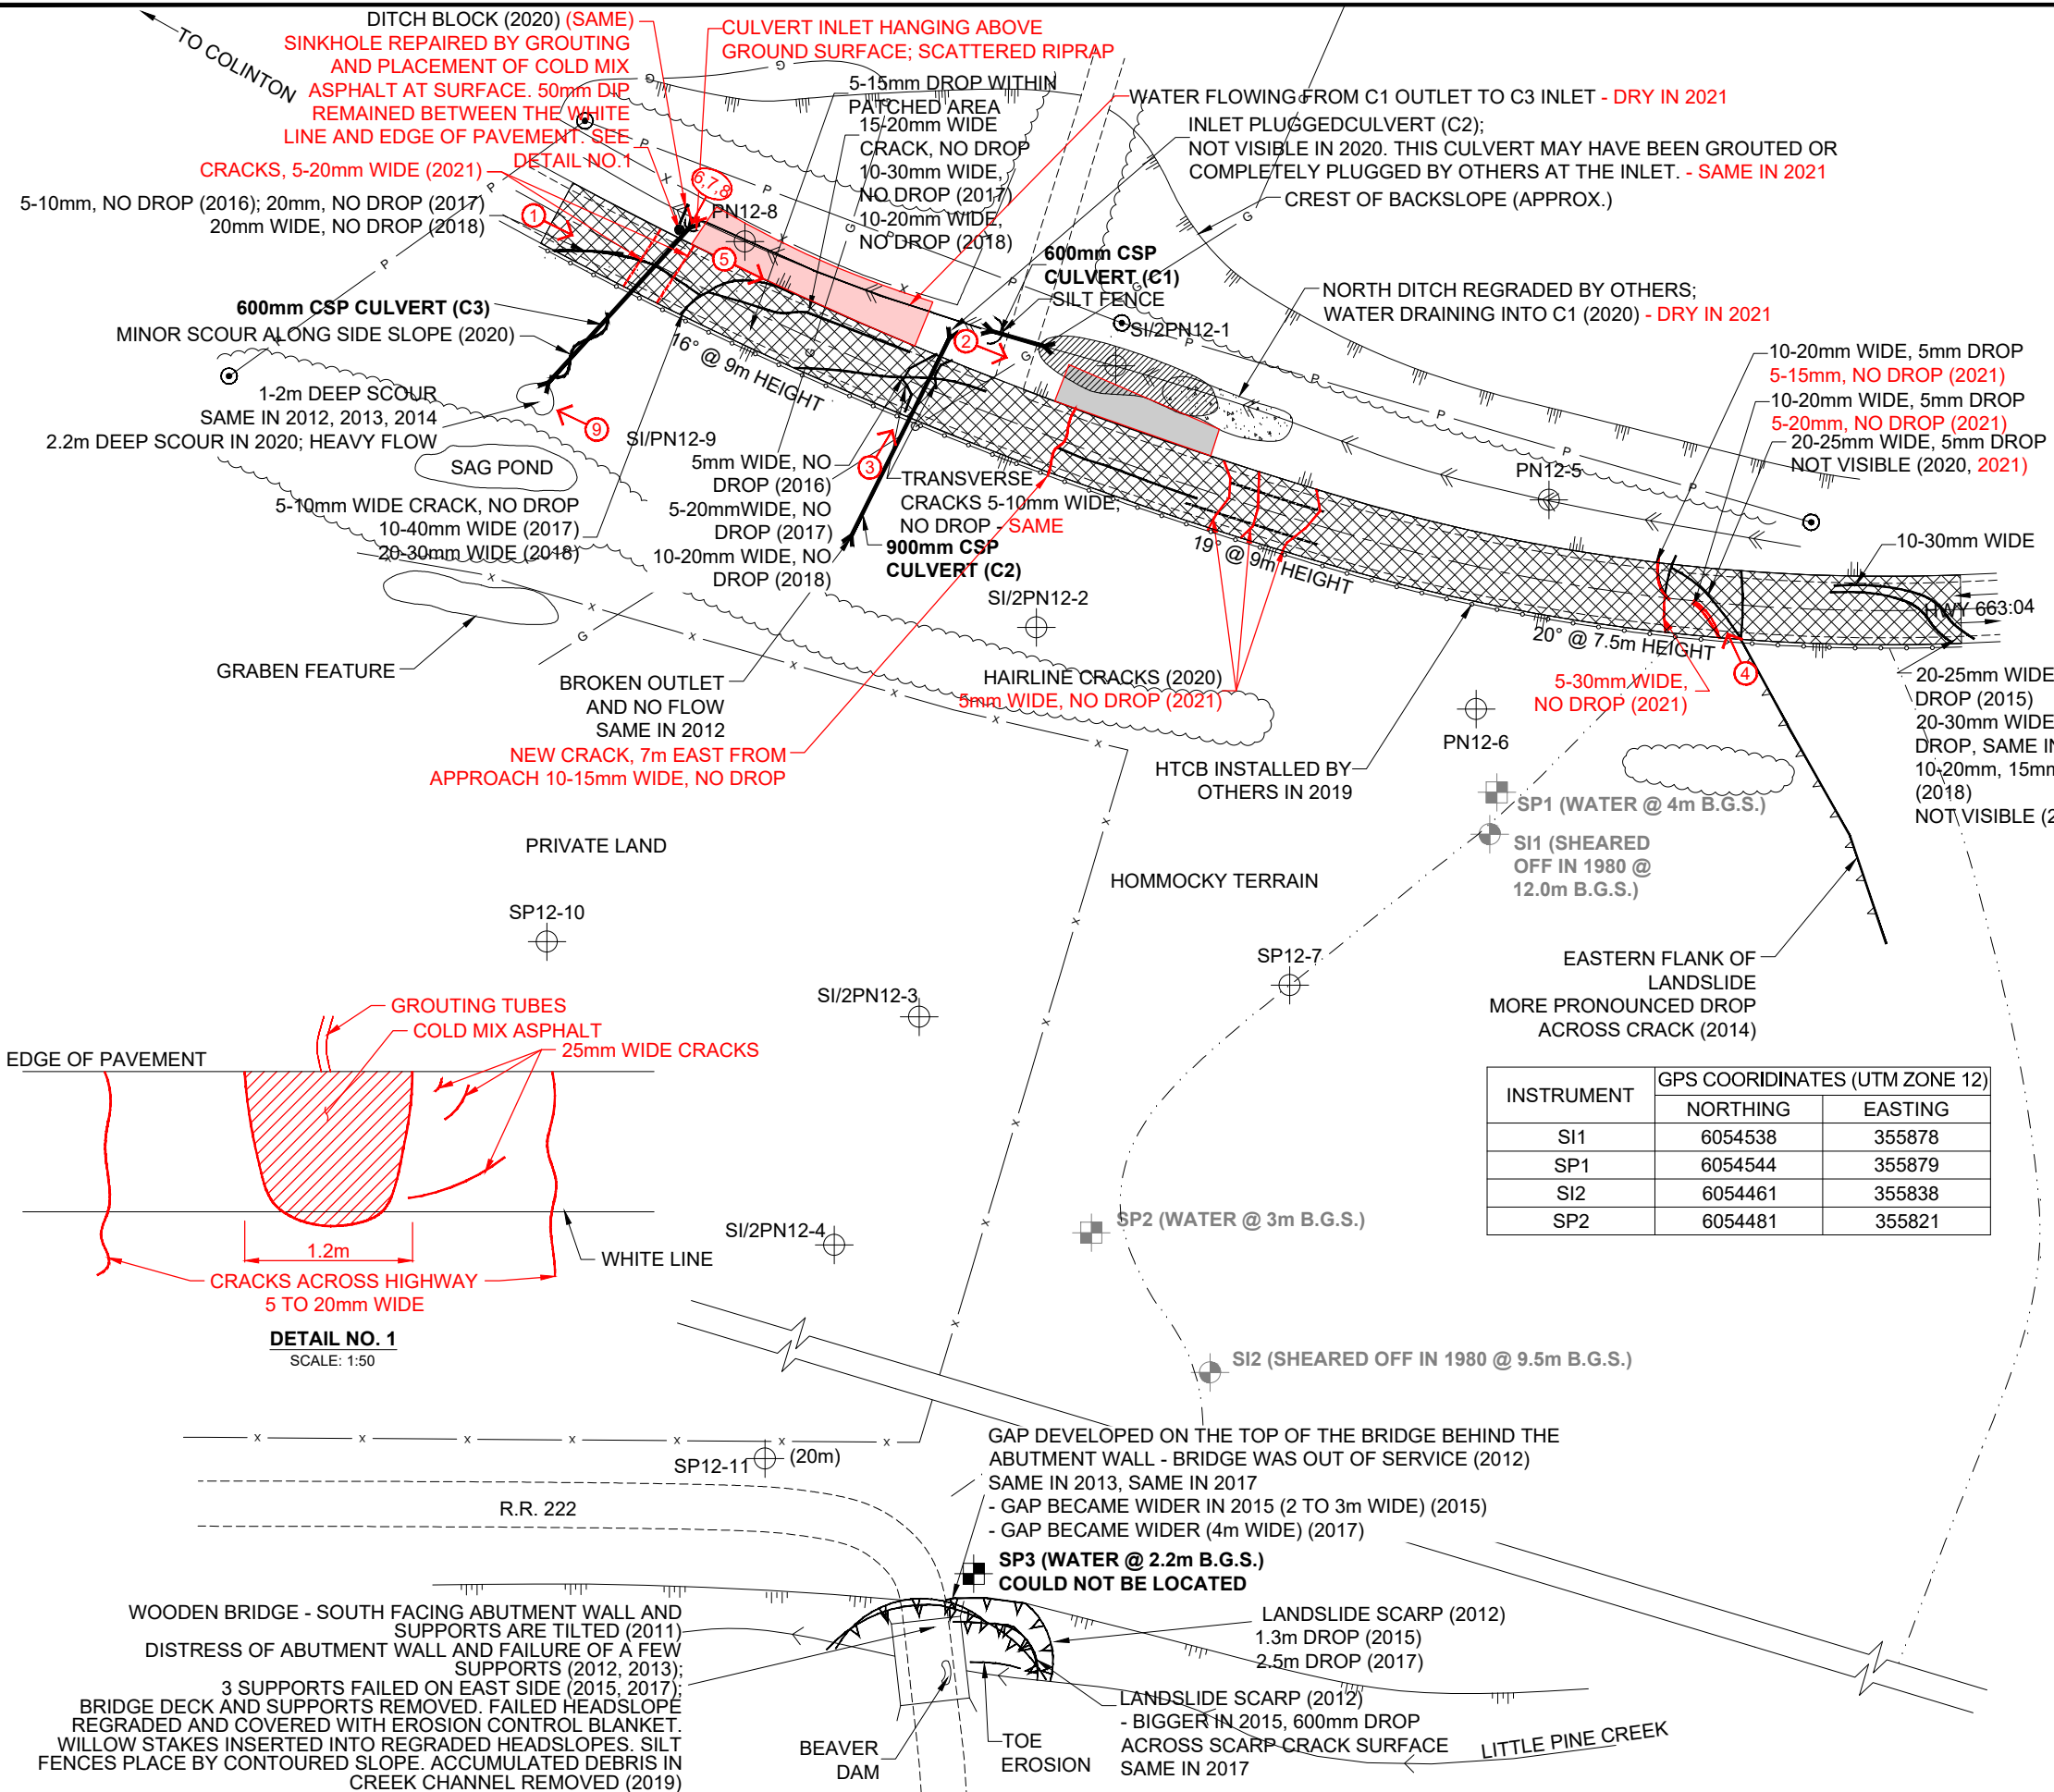
The site conditions did not change significantly since last year with the exception of the ongoing issue with the highway sinkhole at culvert C3 location.

The 2019 pavement overlay masked the majority of the landslide features and created a smooth ride along the highway surface.

The landslide is currently moving at a slow rate, but landslide cracks will keep reflecting through the highway surface with time. Despite moving at a slow rate, the landslide will likely cause progressive deterioration to the highway condition with time. The deterioration may take place quickly between the spring and the fall seasons since the landslide tends to be at high rates within this period based on historical data.

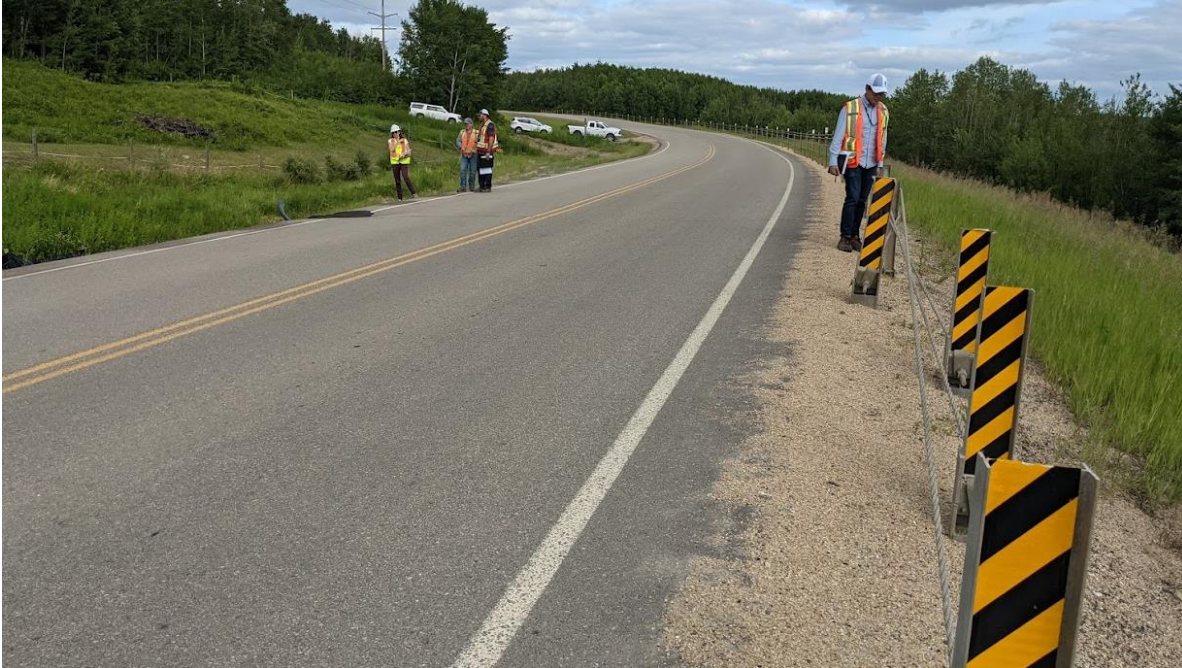
Photo No. 1 – Looking at the highway surface from the western limit of the site

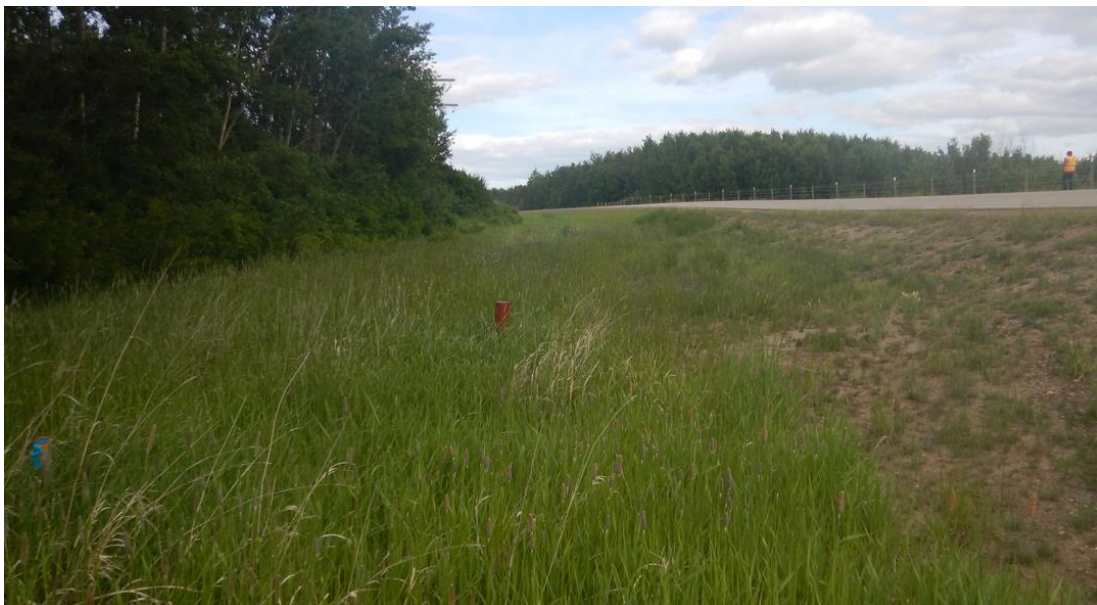
The absence of vegetation on the highway north side slope and a few spots of the ditch may result in future erosion issues within the ditch bottom and instability of the north side slope.

Photo No. 2 – Looking east at highway north ditch to the east of the approach; scarce vegetation on the highway side slope

The local MCI should continue to monitor the site (particularly between the spring and the fall seasons) and seal any open cracks to reduce surface water infiltration into the highway fill, and clean or undertake minor grading to the north ditch (when required) to improve its drainage characteristics. Topsoil and seeding of areas bare of vegetation within the highway north side slope and ditch is encouraged to promote vegetation growth and reduce erosion potential.

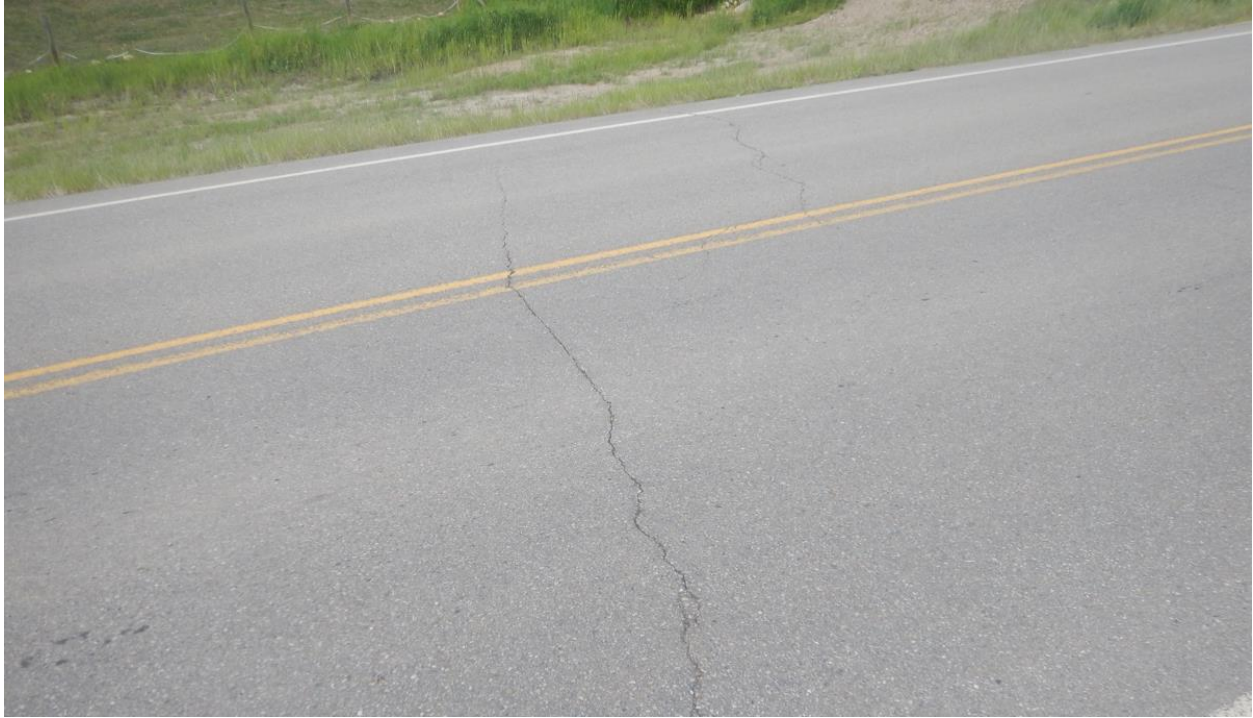
Photo No. 3 – Looking north at a transverse crack (5 to 10 mm wide with no drop)

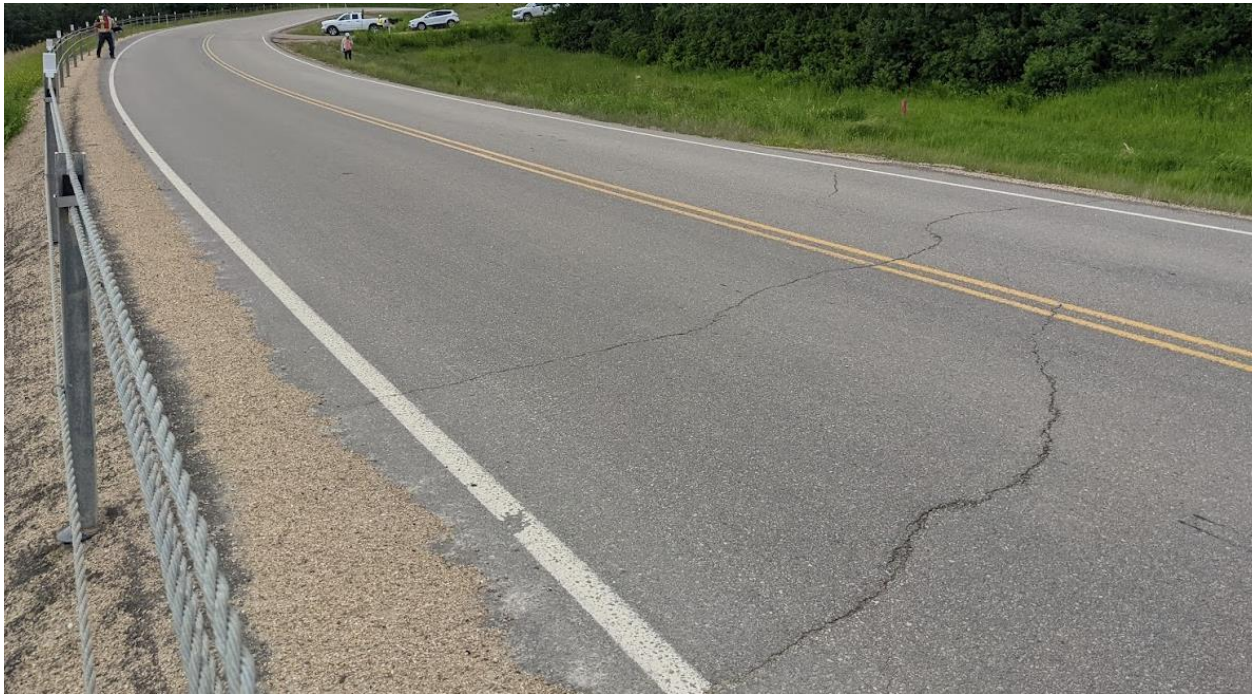
Photo No. 4 – Looking northwest at the eastern flank reflective diagonal cracks (5 – 20 mm wide with no drop)

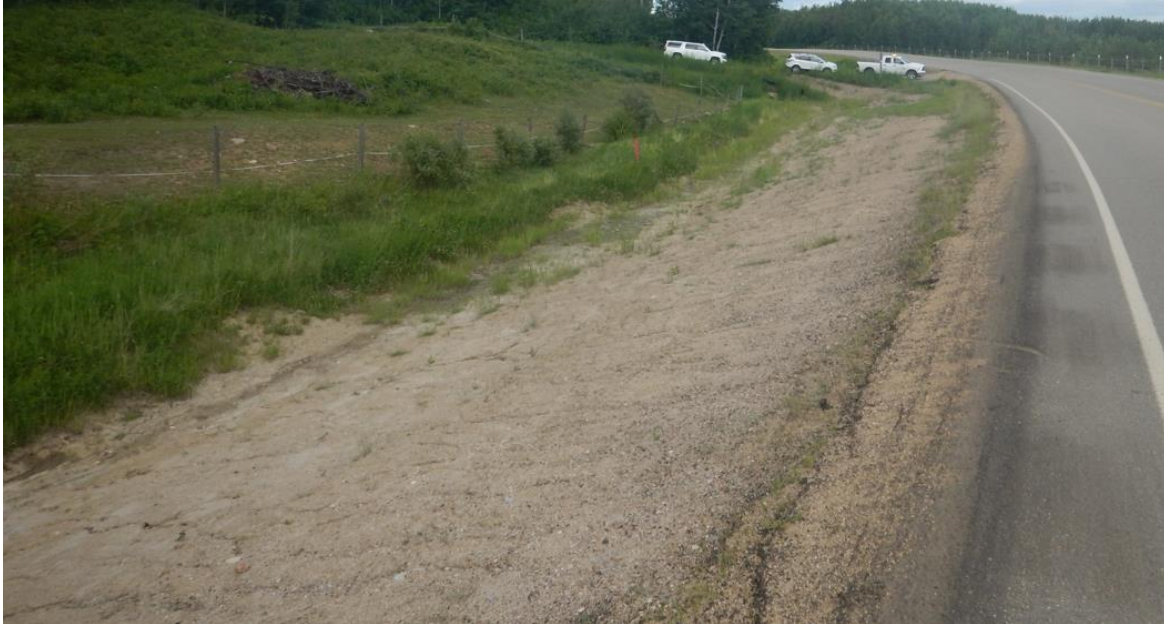
Photo No. 5 – Looking east at ditch regraded in 2019 by WSP; the north ditch has been regraded from culvert C1 outlet to culvert C3 inlet; culvert C2 appears to have been abandoned; side slopes and sections of the ditch are bare of vegetation

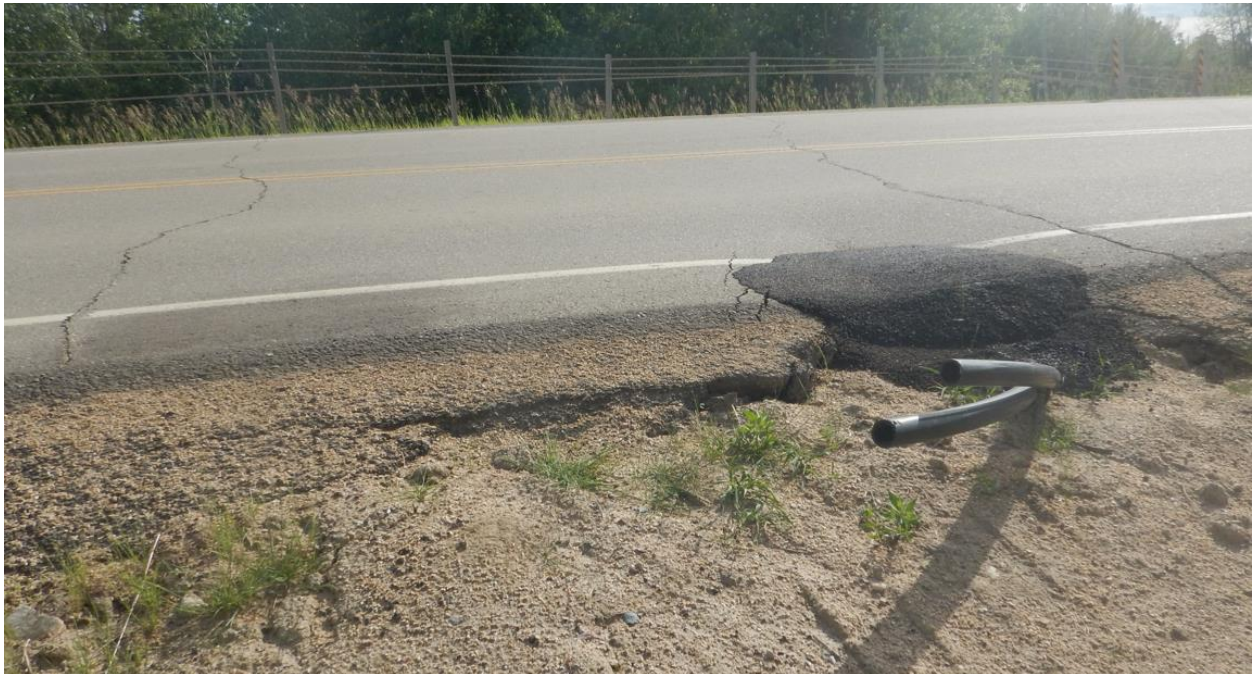
The separation of culvert C3 near its inlet location, and the presence of a dip within the patched area above the previously noted sinkhole in 2020 indicate that the repairs (completed by others in late 2020) are not adequate. This issue, unless dealt with in a timely manner, can result in stability/settlement issues of the highway embankment at this location. In addition, the culvert inlet is higher in elevation than the ditch bottom, and hence the ditch flow will either seep under the culvert floor or pond at the culvert inlet location and saturate/erode the highway embankment fill.

Photo No. 6 – Sinkhole developed above culvert C3 near the north edge of pavement appears to have been fixed in 2020 by grouting the void and placing cold mix patch at the surface; there is a 50 mm dip within the patched surface of the original sinkhole and cracks are developing around the patched area

The ongoing issue at culvert C3 inlet location should be investigated and repaired. The repairs will likely require: (a) excavating the north side slope to remove the separated section of the culvert (including the sinkhole area on the highway WBL), (b) installing a new pipe section and backfilling the highway side slope, (c) re-surfacing the excavated section of the highway between the white line and edge of pavement, (d) topsoiling and seeding the re-constructed highway side slope and placement of salvaged riprap at the inlet of the new pipe.

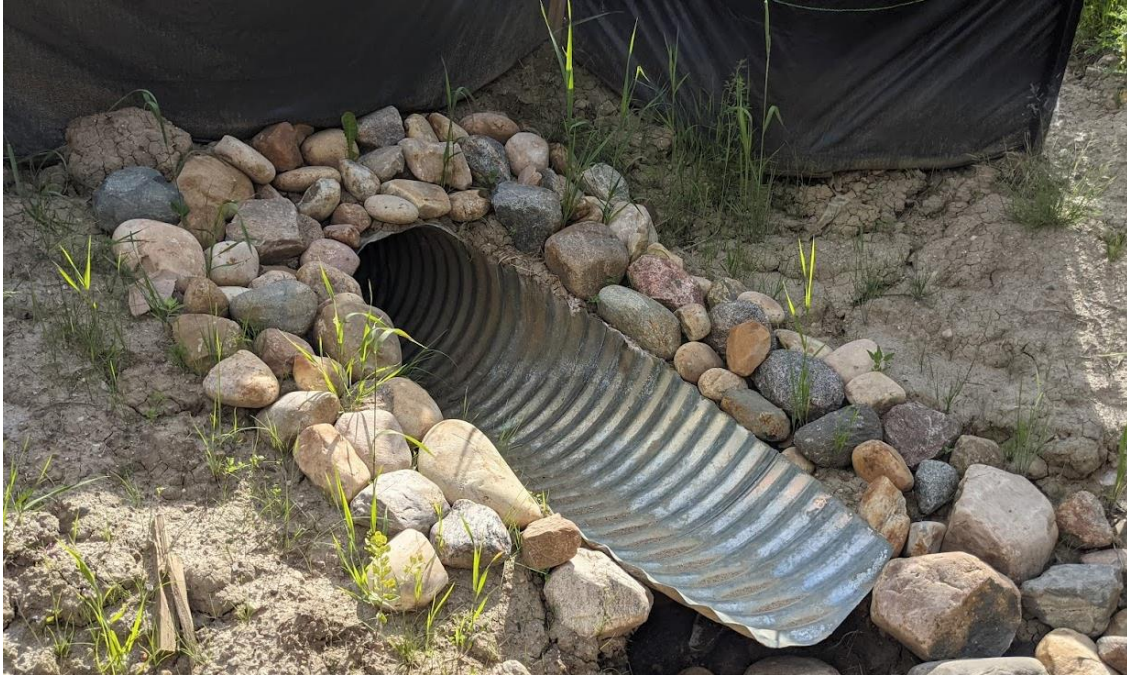
Photo No. 7 – Looking south at culvert C3 inlet; note that the inlet invert is hanging above ground and the presence of a scattered riprap

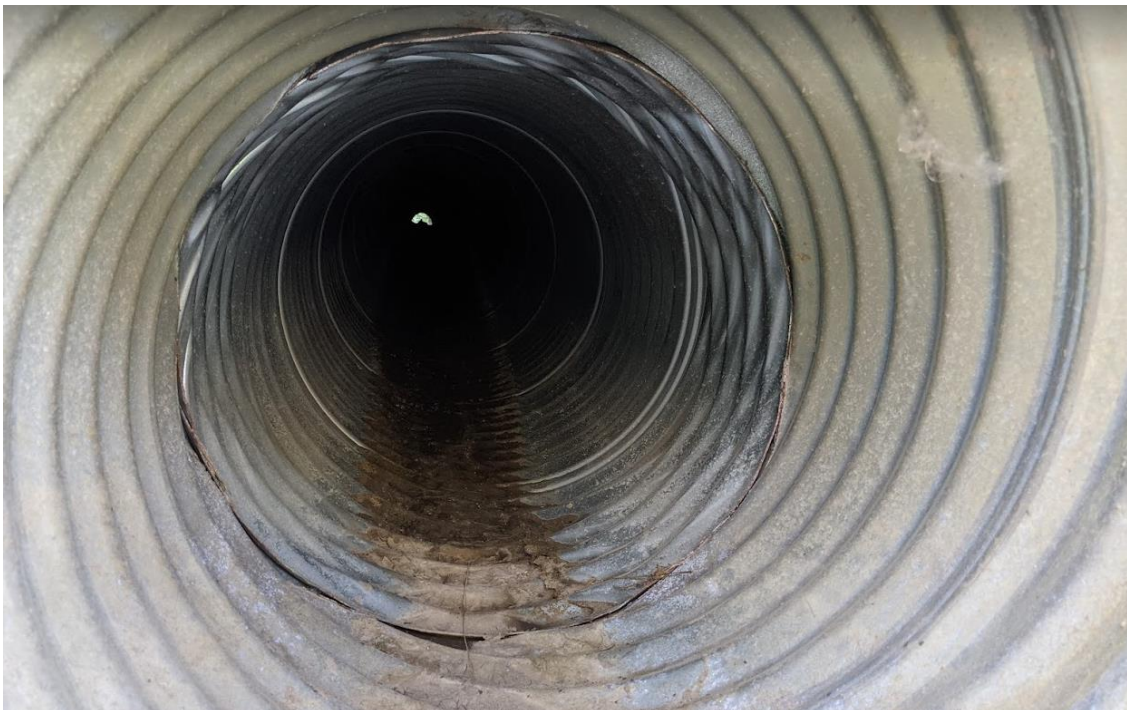
Photo No.8 – Looking inside culvert C3 inlet; note culvert separation and rusting at the base

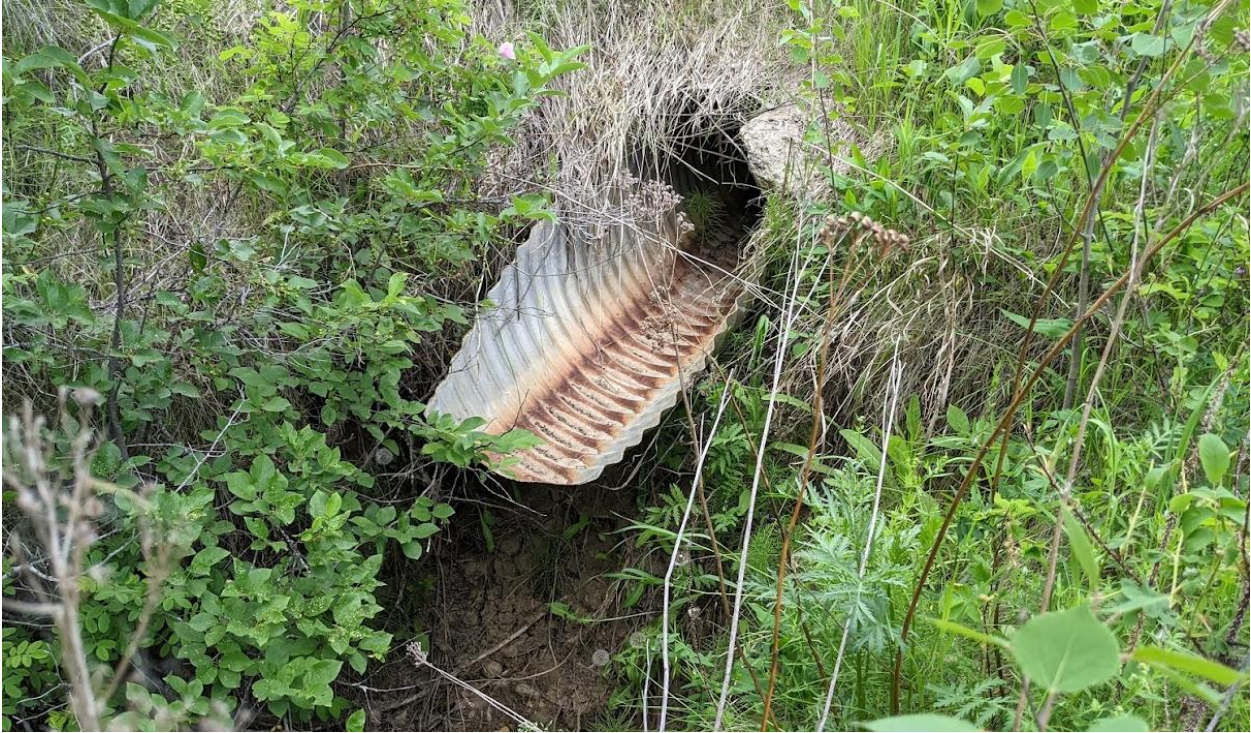
Photo No. 9 – Looking west at culvert C3 outlet; note 2.2 m deep scour at the culvert outlet

Consideration should also be given to repairing previously noted erosion at the C3 culvert outlet location. This may require excavating and backfilling the eroded area with clay and placing a Class 1 heavy rock riprap (underlain by non-woven geotextile Type C) at the outlet location to prevent further erosion issues. It is unknown though whether the recommended erosion repair is within AT ROW, and this should be checked prior to planning the work.
