**ALBERTA TRANSPORTATION
GEOHAZARD ASSESSMENT PROGRAM
NORTH CENTRAL REGION – ATHABASCA &
FORT MCMURRAY DISTRICTS
2022 SITE INSPECTION**

Site Number	Location	Name	Hwy	km
NC071	1 km east of Colinton	Little Pine Creek Slide	663:04	6.98
Legal Description		UTM Co-ordinates (NAD 83)		
S.E.15&S.W.14& N.E.10-65-22-W4M		12 N 6054582	E 355785

**NORTH CENTRAL REGION
(ATHABASCA AND FORT McMURRAY DISTRICTS)
2022 GEOHAZARD ASSESSMENT**

NC071: HWY 663:04 LITTLE PINE CREEK SLIDE (km 6.98)

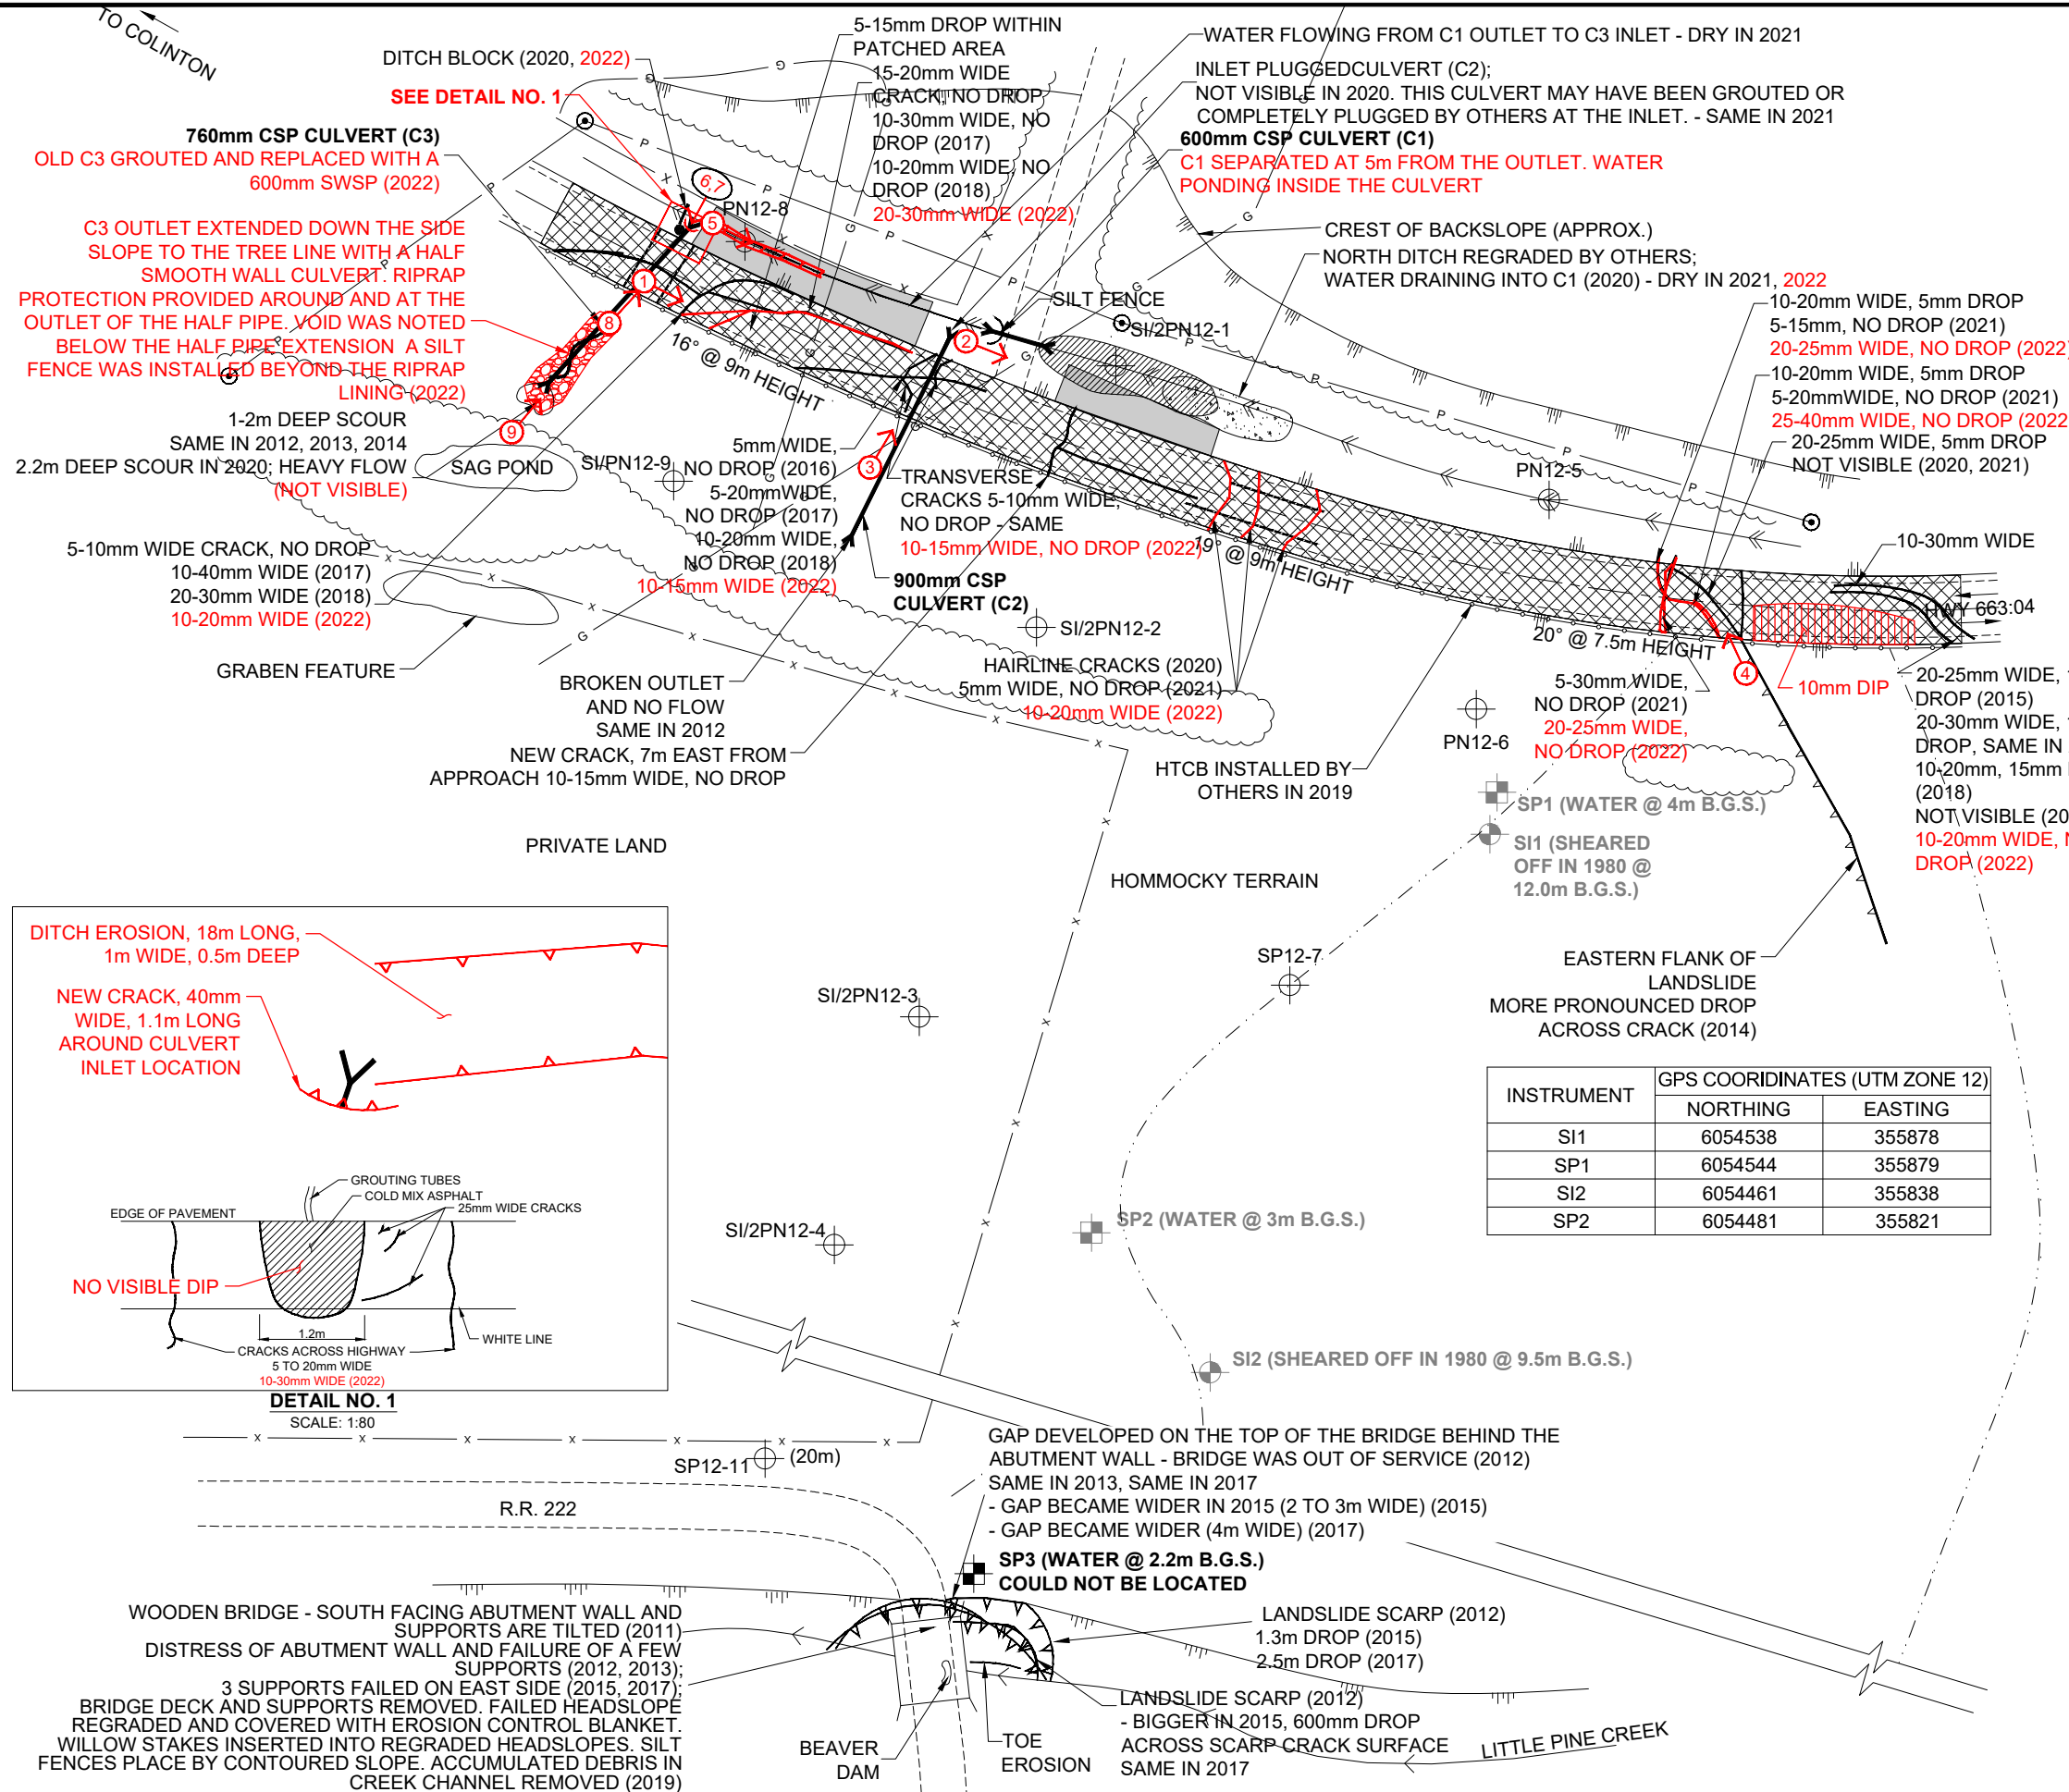
DWG NO. 32122-NC071-1

Primary Site Issue:	Slowly creeping deep-seated translational landslide, resulting in diagonal cracks and slight depression along both highway lanes; depression is more pronounced along the flanks of the slide.	
Dimensions:	Approximately 150 m wide (parallel to highway) by approximately 300 m long to the south of the highway.	
Site history:	The highway was constructed as a side-hill cut and fill section at this location; the road section was upgraded in the 70's and raised by 2 m; original landslide occurred prior to 1978 and extended from the uphill ditch of the highway to the existing bridge over the Little Pine Creek located approximately 300 m to the south of the highway; test holes (completed with 2 slope inclinometers and 3 standpipe piezometers) were drilled downslope of the highway prior to 1978; Drainage pipes were installed on May 12, 1980 to reduce ground water levels; slope inclinometers were sheared off in December 1980; slope inclinometers and piezometers were installed by Thurber in 2012.

Further opening/re-appearance of cracks on the highway surface and the instrumentation readings indicate that the landslide is more active than 2021. Despite moving at a relatively slow rate, the landslide will continue to cause progressive deterioration to the highway condition with time. The deterioration may take place quickly between the spring and the fall seasons since the landslide tends to be at high rates within this period based on historical data.

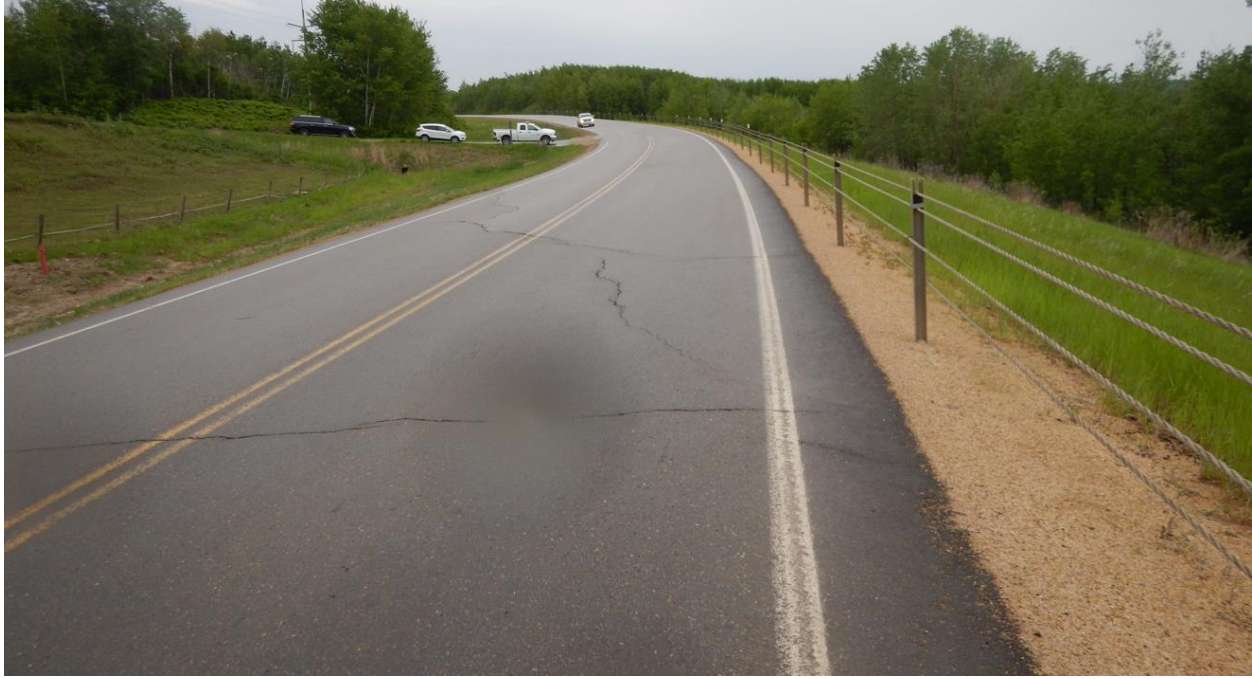
The existing twist on the highway surface near the flanks of the landslide creates a rough ride to motorists.

Photo No. 1 – Looking at reflective diagonal cracks on the highway surface from the western limit of the site

The local MCI should continue to monitor the site (particularly between the spring and the fall seasons) and seal any open cracks to reduce surface water infiltration into the highway fill. Consideration should be given in the future to placing an ACP patch near the flanks of the landslide to provide a smooth ride to motorists.

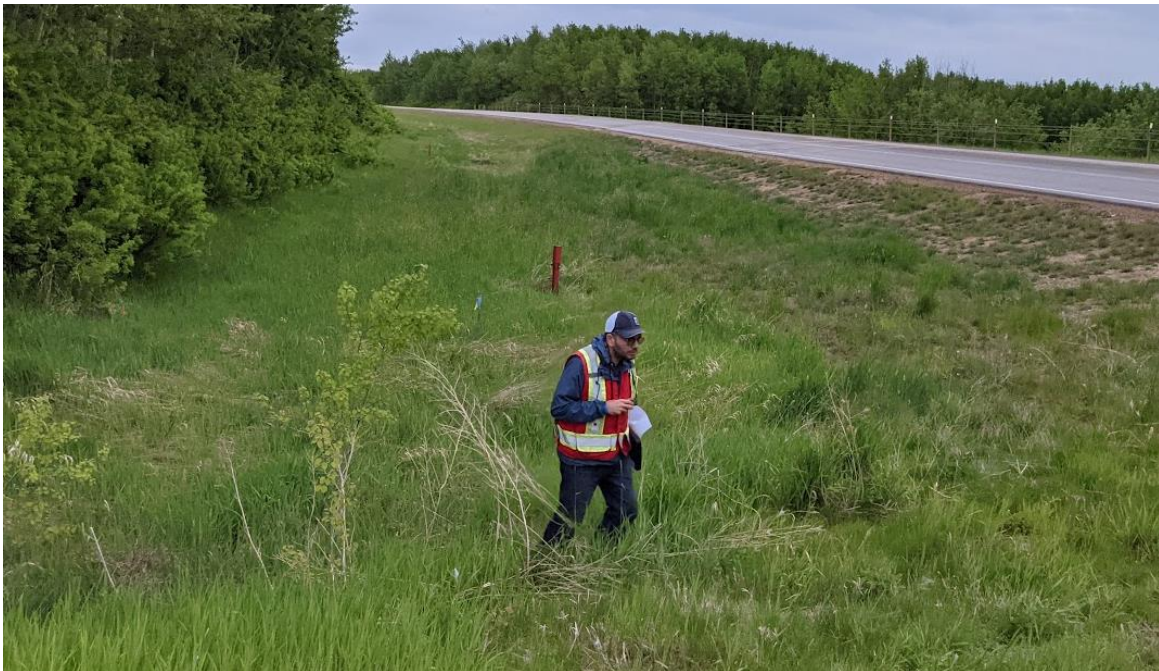
The absence of vegetation in the highway north side slope and ditches, to the west of the access road, has resulted in the development of a severe erosion gully around and upstream of Culvert C3 inlet location.

Photo No. 2 – Looking at highway north ditch to the east of the approach; scarce vegetation on the highway side slope

- The north ditch to the west of the access road should be properly graded to eliminate the gully located upstream of Culvert C3 inlet. The area around Culvert C3 inlet should also be scarified, repacked, and contoured to eliminate existing crack/depression. After ditch/side slope repairs are completed, all disturbed areas within the north ditch should be topsoiled and seeded. The ditch bottom should be covered with Type C TRM to reduce erosion potential.
- Culvert C1 should also be replaced to reduce the amount of ponding water within the highway ditch
- The void below the half pipe culvert should be filled with grout.

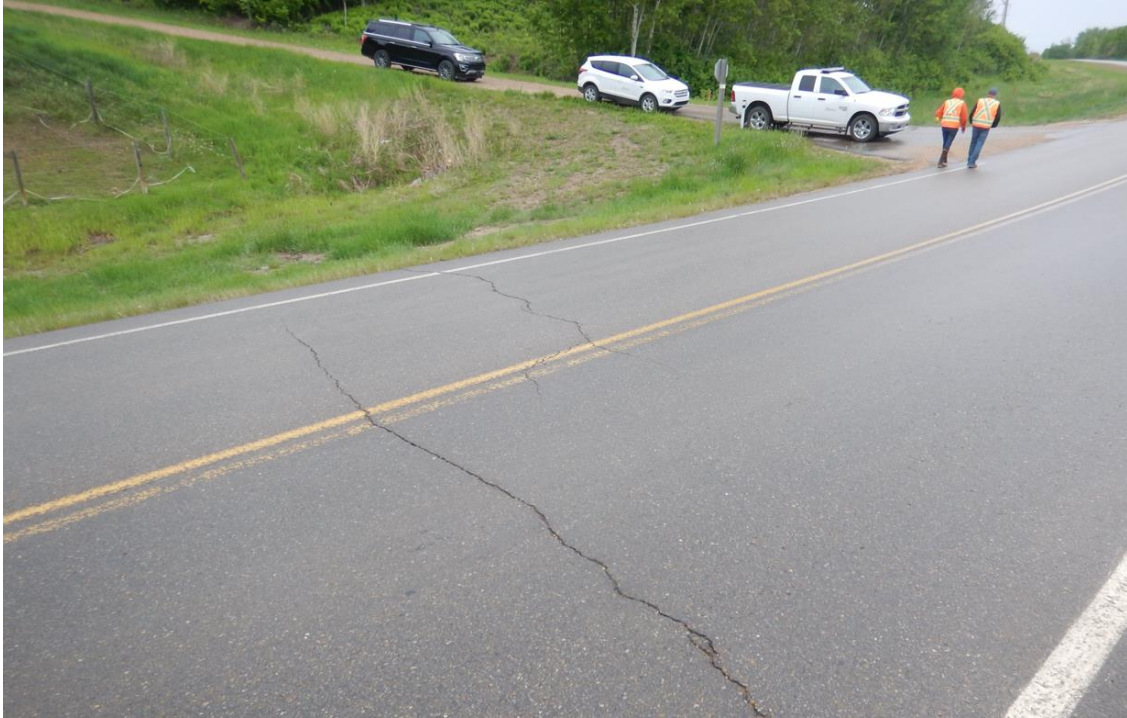
Photo No. 3 – Looking north at a transverse crack (10 to 15 mm wide with no drop)

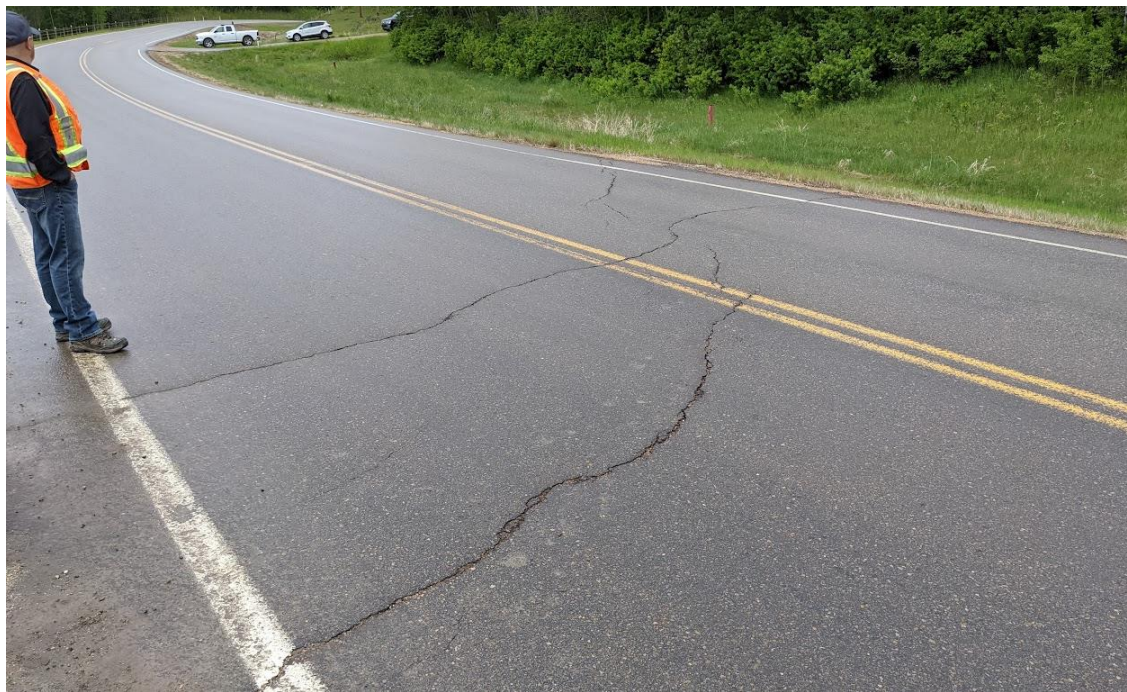
Photo No. 4 – Looking northwest at the eastern flank reflective diagonal cracks (20 – 40 mm wide with no drop)

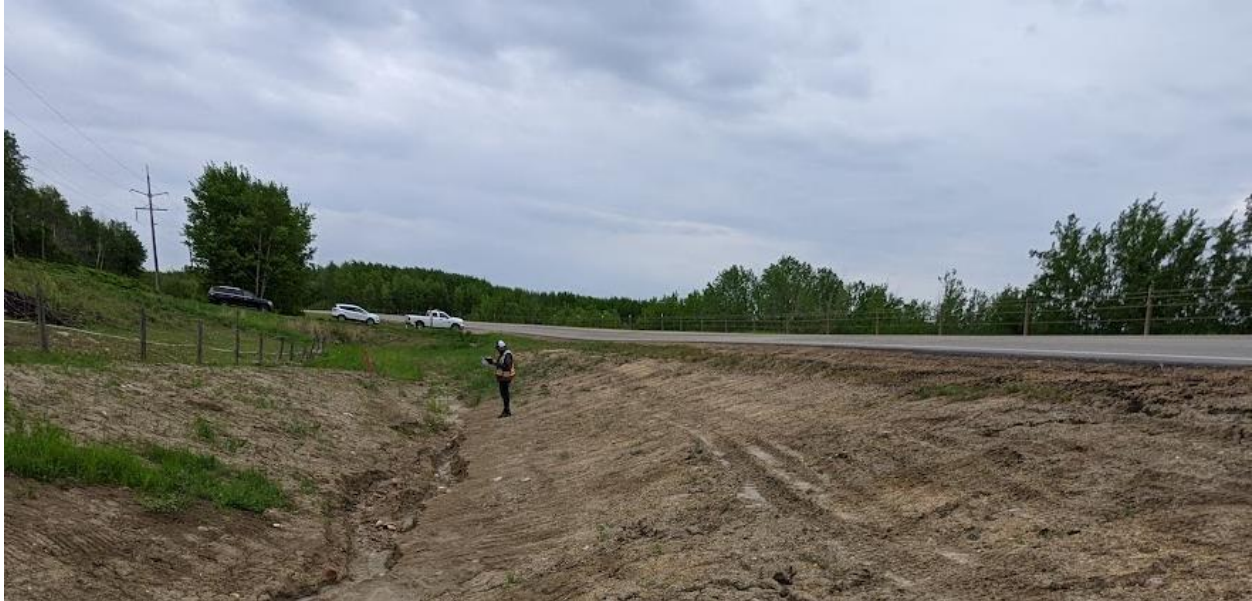
Culvert C1, located under the access road, is separated and hence this will likely impede the surface drainage within the north ditch, resulting in elevated groundwater levels within the landslide mass.

Photo No. 5 – Looking east at ditch regraded in 2019 by WSP; the north ditch has been regraded from culvert C1 outlet to culvert C3 inlet; culvert C2 appears to have been abandoned; side slopes and sections of the ditch bottom are bare of vegetation; erosion developed within the ditch

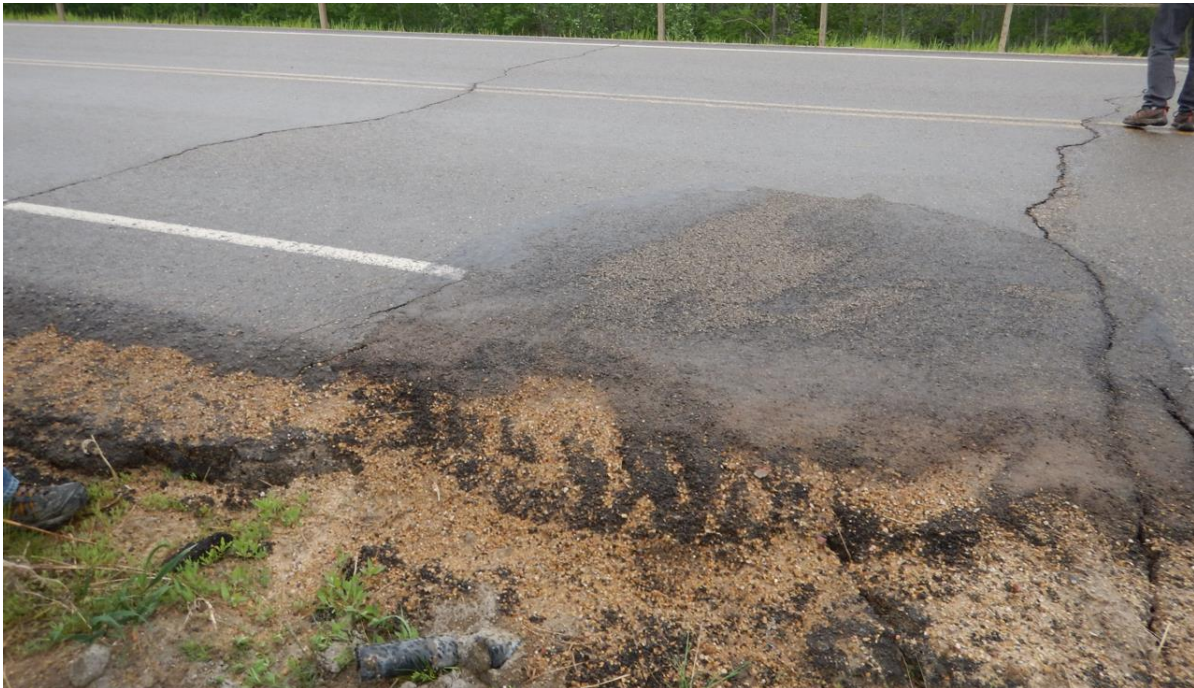
Photo No. 6 – Sinkhole previously developed within the northern edge of pavement of the highway above the original 600 mm diameter culvert (C3) ; Original pipe was grouted and a new 760 mm diameter SWSP was auger bored in 2021; cold mix patch placed on the highway surface but cracks are still visible around the patched area

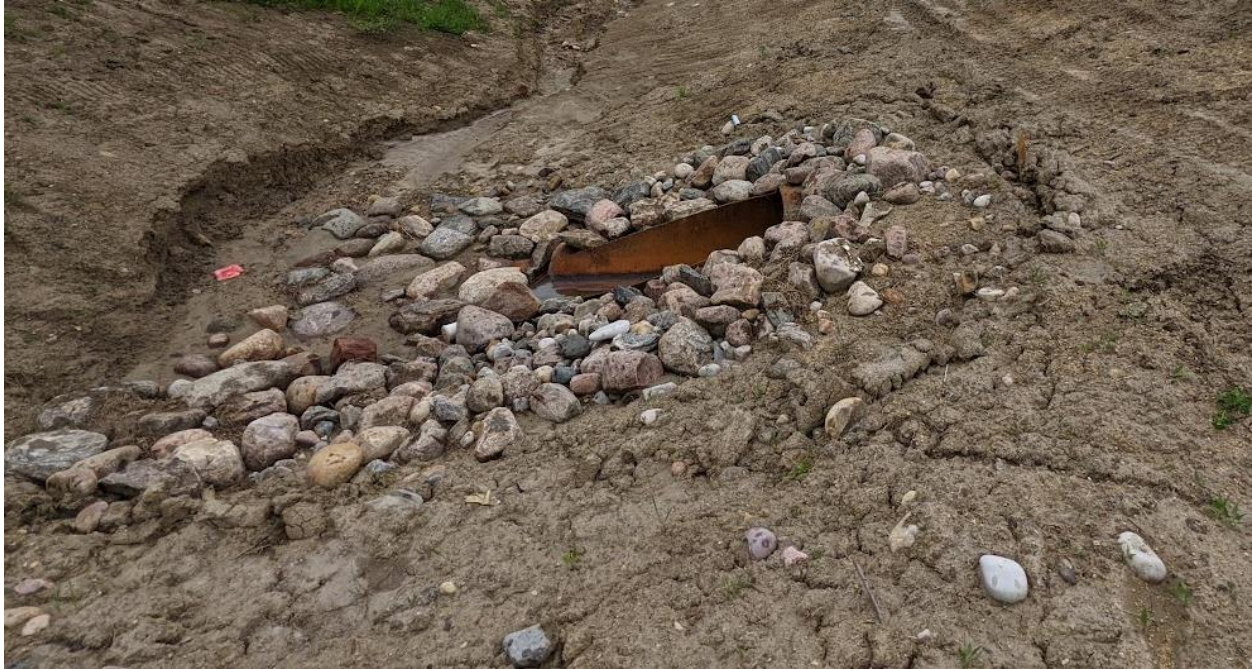
It is likely that the crack developed above the inlet of Culvert C3 replacement pipe reflects poor compaction of the reception pit, and this may result in stability issues of the slope and impact the performance of the new pipe.

Photo No. 7 – Looking south at new culvert C3 inlet; note bare vegetation, crack around culvert inlet and erosion developing upstream of the inlet within the ditch

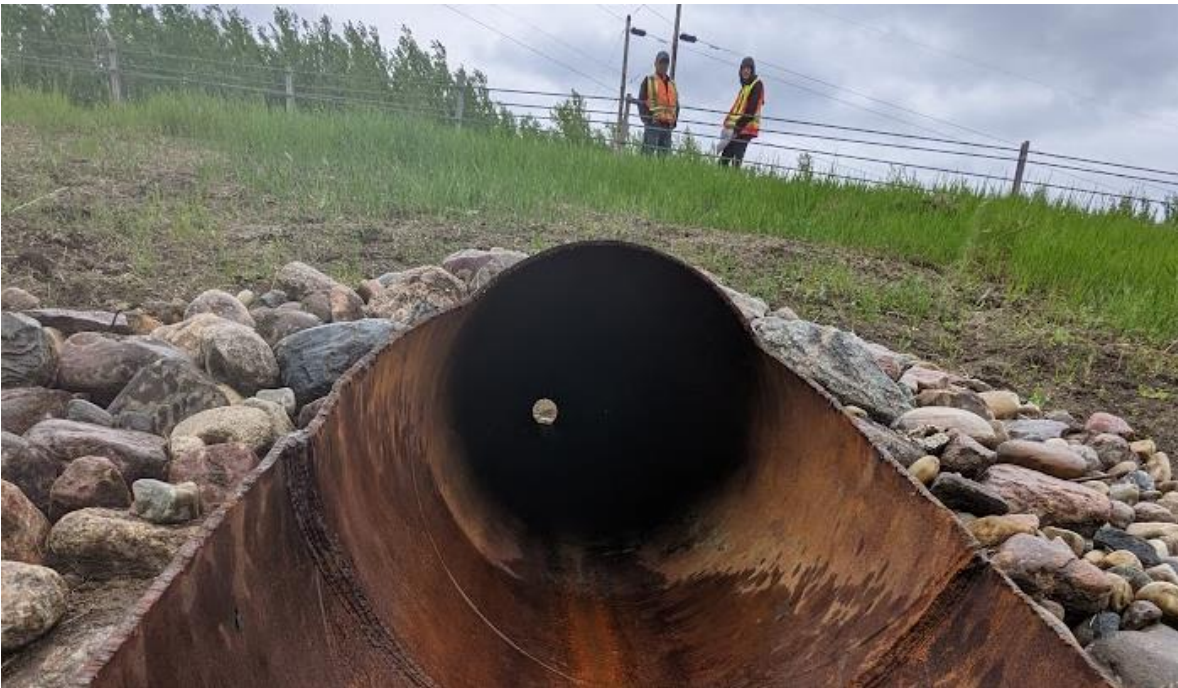
Photo No.8 – Looking inside new culvert C3 outlet.

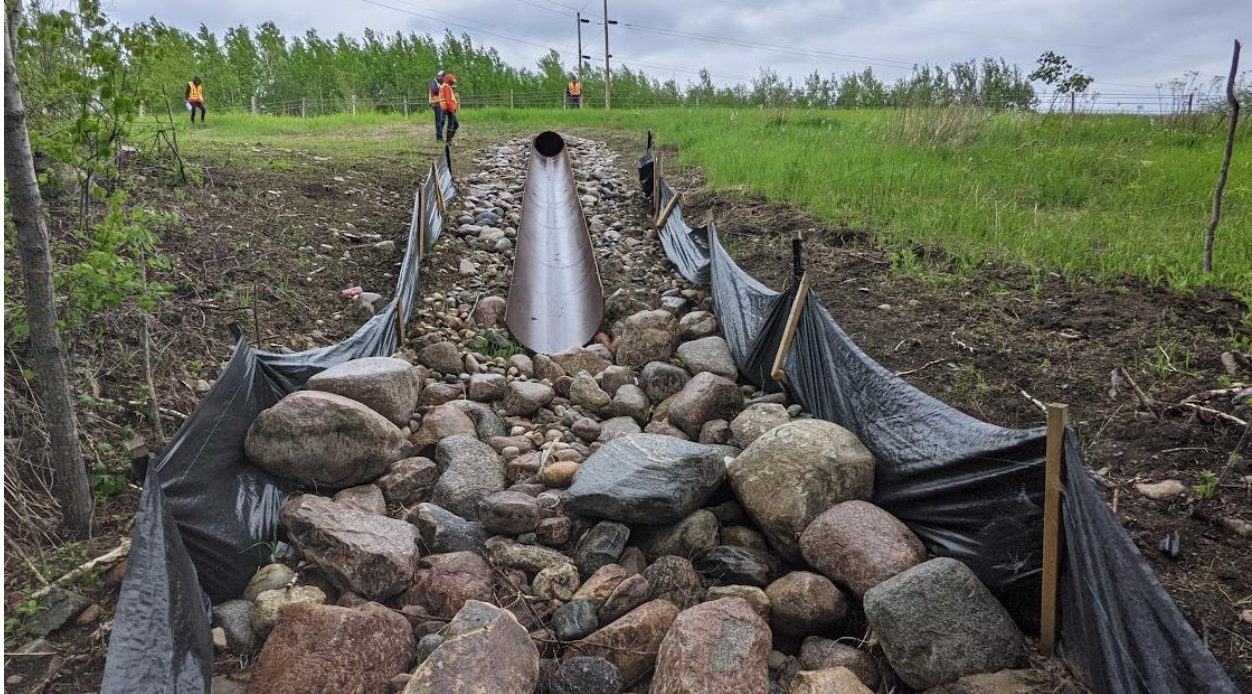
The void below the half pipe is due to improper subgrade preparation. The surface flow around the pipe may undermine the subgrade, potentially resulting in the development of a severe erosion gully below and around the extension pipe.

Photo No. 9 – Looking north at the outlet of culvert C3, installed in 2021. There is a void below the half pipe extension piece.
