**ALBERTA TRANSPORTATION AND ECONOMIC CORRIDORS
GEOHAZARD ASSESSMENT PROGRAM
NORTH CENTRAL REGION – ATHABASCA &
FORT MCMURRAY DISTRICTS
2023 SITE INSPECTION**

Site Number	Location	Name	Hwy	km
NC071	1 km east of Colinton	Little Pine Creek Slide	663:04	6.98
Legal Description		UTM Co-ordinates (NAD 83)		
S.E.15&S.W.14& N.E.10-65-22-W4M		12 N 6054582	E 355785

NC071: HWY 663:04 LITTLE PINE CREEK SLIDE (km 6.98)

DWG NO. 32122-NC071-1

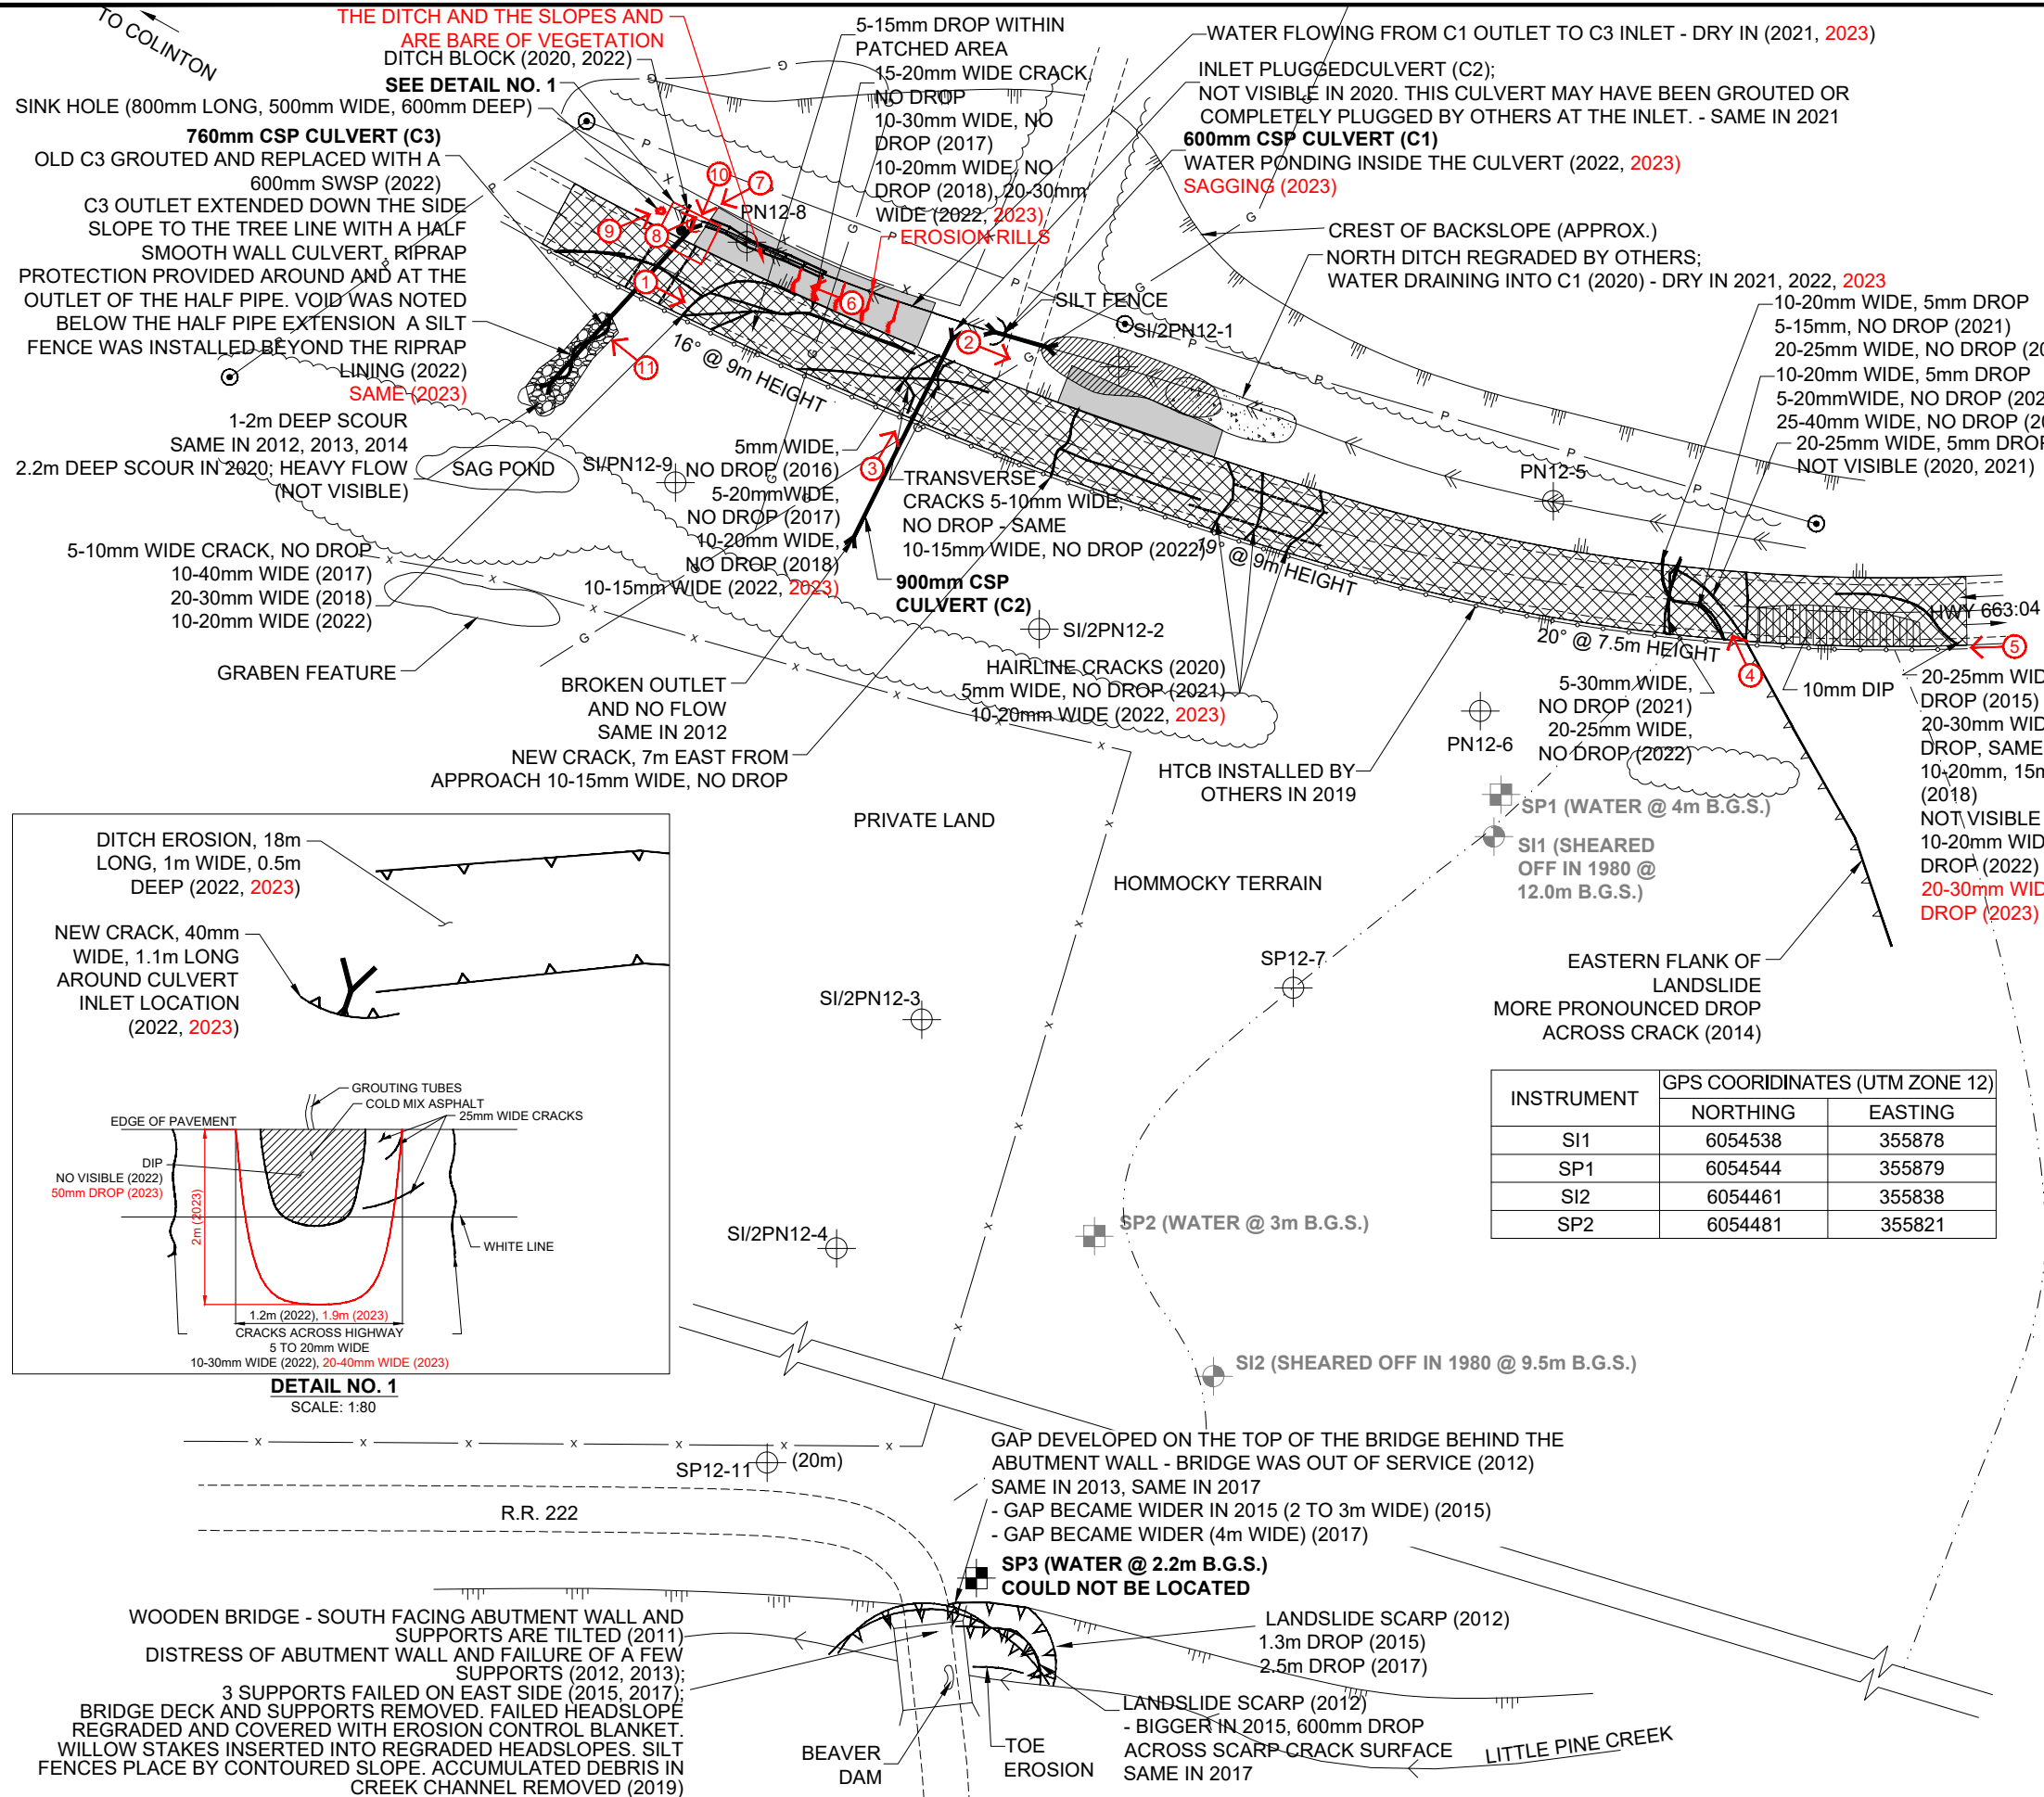
- NOTES**
1. WATER LEVELS IN STANDPIPE PIEZOMETERS ARE BASED ON THE AVAILABLE INFORMATION PROVIDED BY TRANS
 2. MAY 16, 2023 SITE OBSERVATIONS ARE SHOWN IN RED.

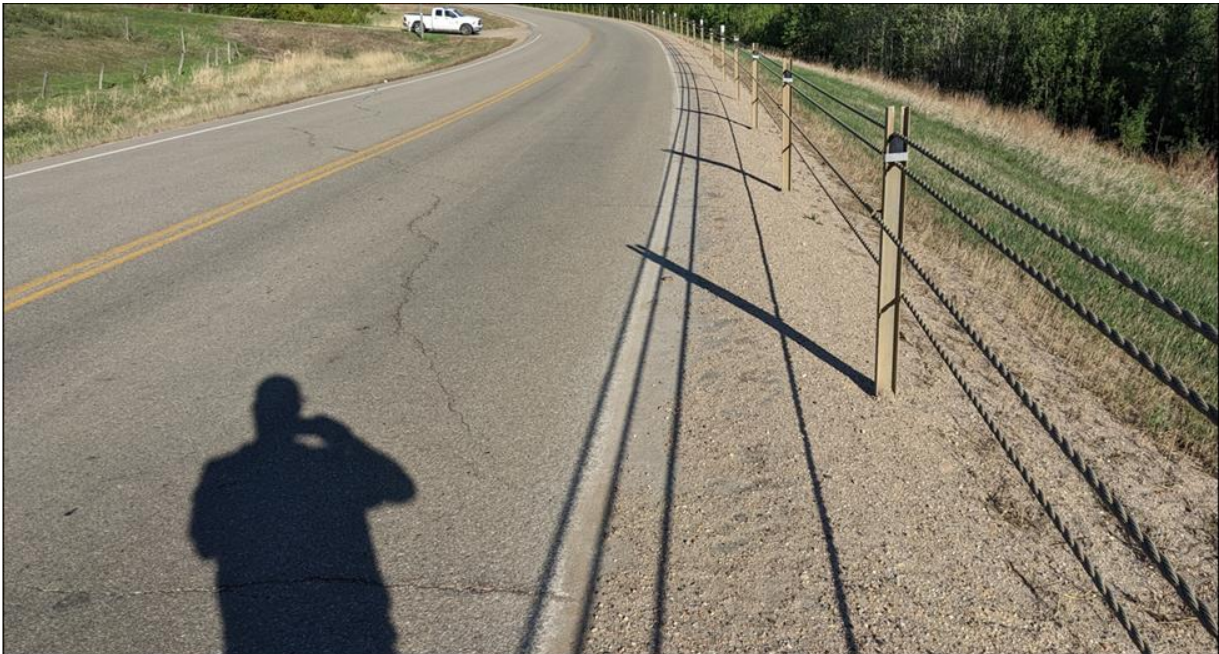
Photo 1. Looking at reflective diagonal cracks on the highway surface from the western limit of the site.

The local MCI should continue to monitor the site (particularly between the spring and the fall seasons) and seal any open cracks to reduce surface water infiltration into the highway fill. Consideration should be given in the future to placing an ACP patch near the flanks of the landslide to provide a smooth ride to motorists.

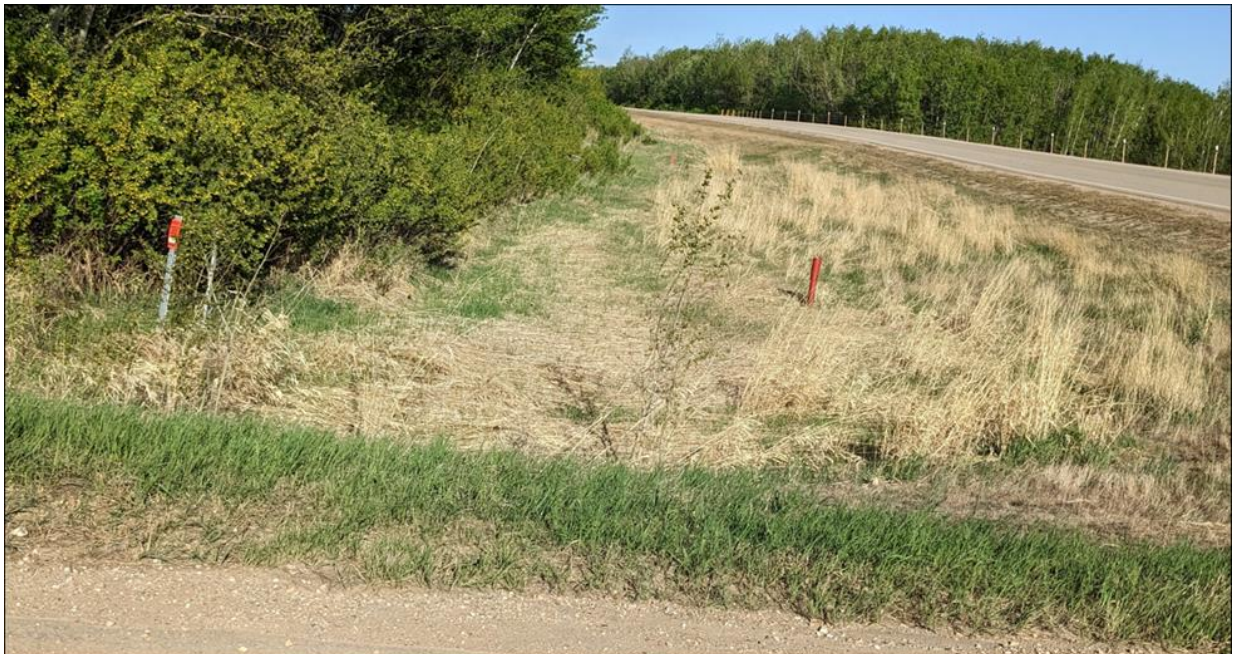
Photo 2. Highway's north ditch to the east of the approach.

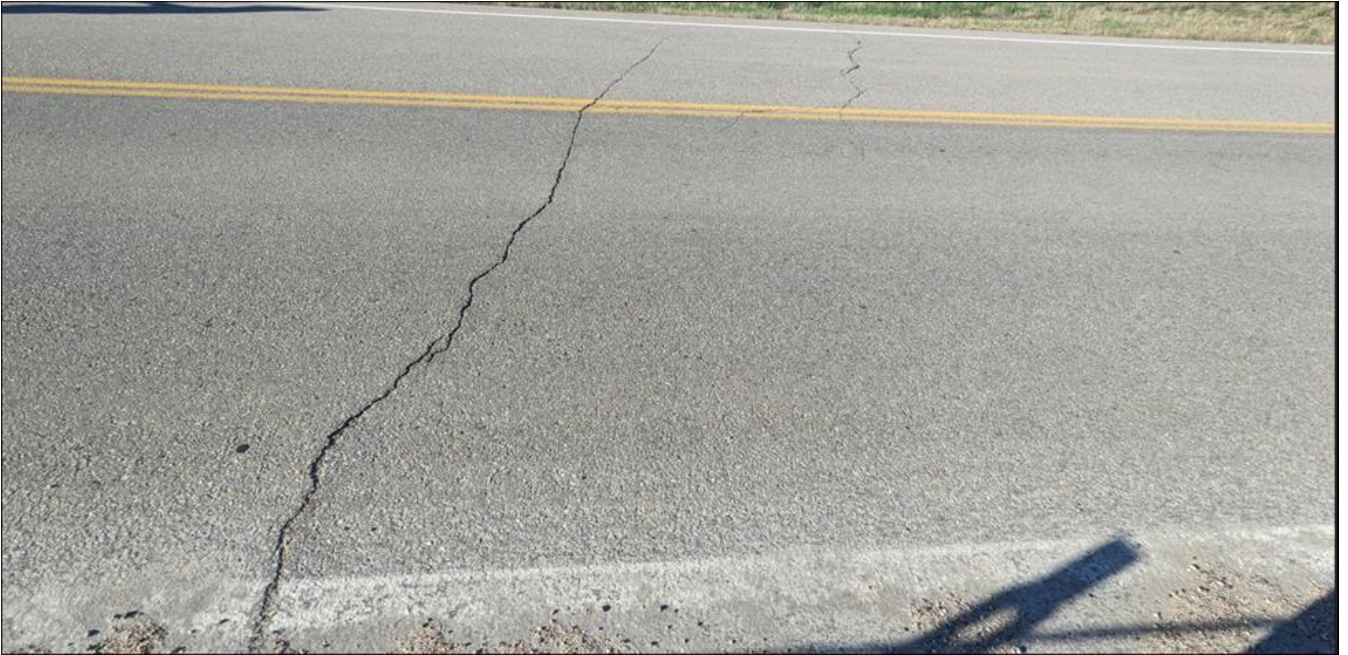
Photo 3. Looking north at a transverse crack (10 to 15 mm wide with no drop)

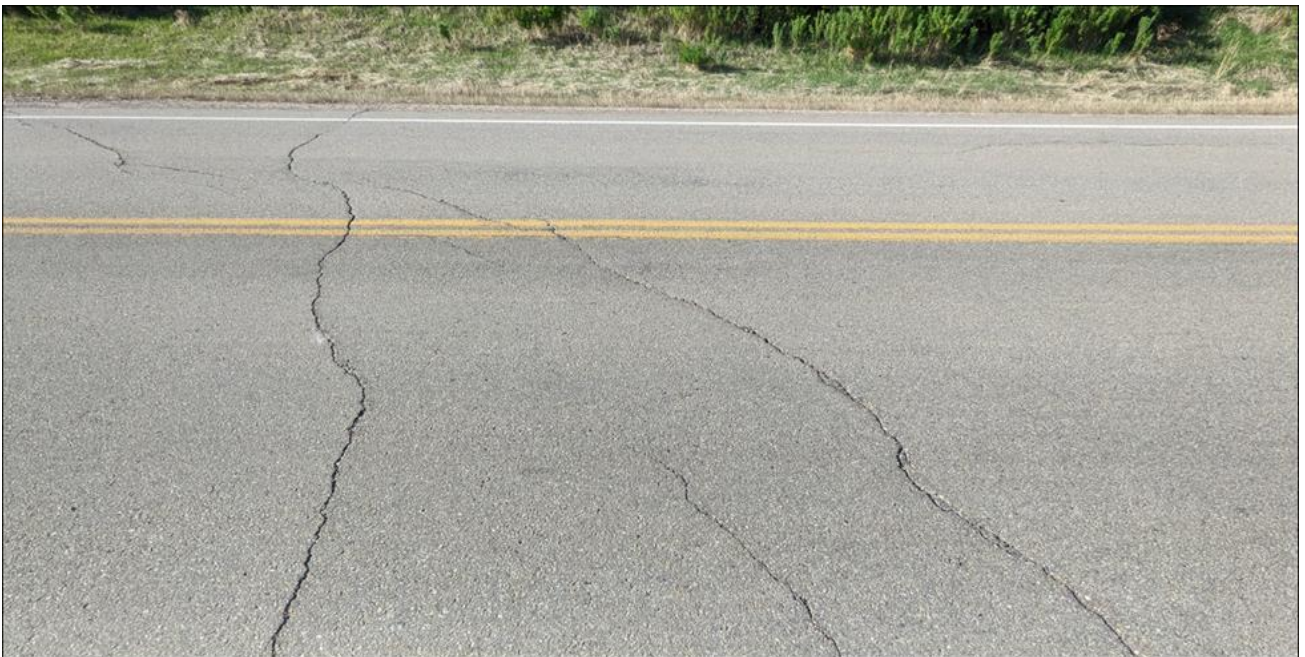
Photo 4. Looking northwest at the eastern flank reflective diagonal cracks (20 -25 mm wide with no drop).

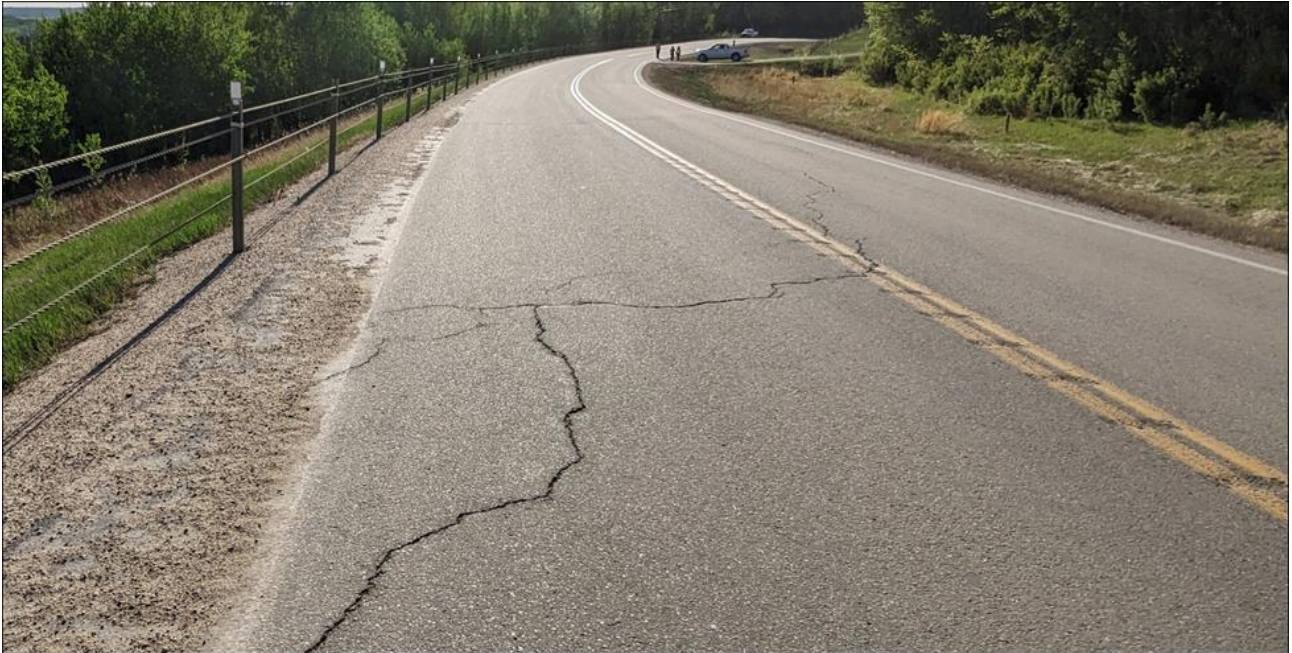
Photo 5 Diagonal cracks located about 15 m east of the landslide western flank; 20mm – 30 mm wide with no drop.

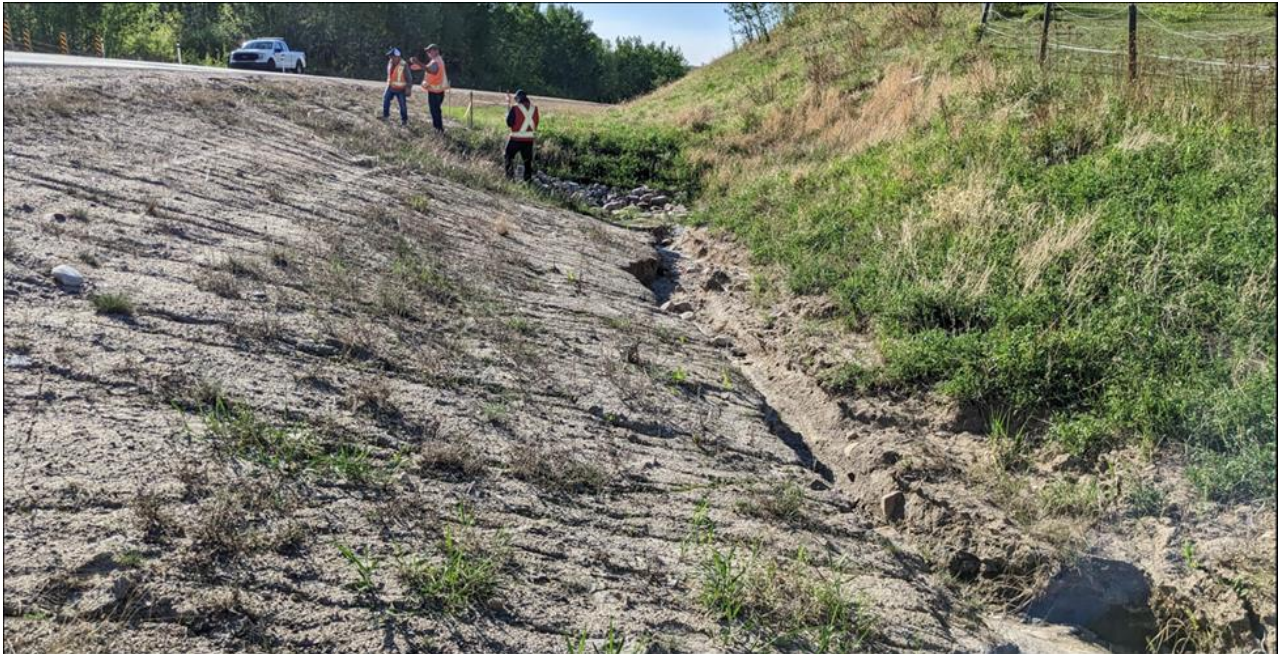
Photo 6. Looking west at the regraded section of the ditch in 2019; side slopes and sections of the ditch bottom are bare of vegetation; note the presence of erosion rills along the side slope and a deep erosion gully in the ditch.

- The north ditch to the west of the access road should be properly graded to eliminate gully erosion gully. The side slope should also be track-packed to fill erosion rills. After the ditch/side slope repairs are completed, all disturbed areas within the north ditch should be topsoiled and seeded. The ditch bottom should be covered with Type C TRM to reduce erosion potential.

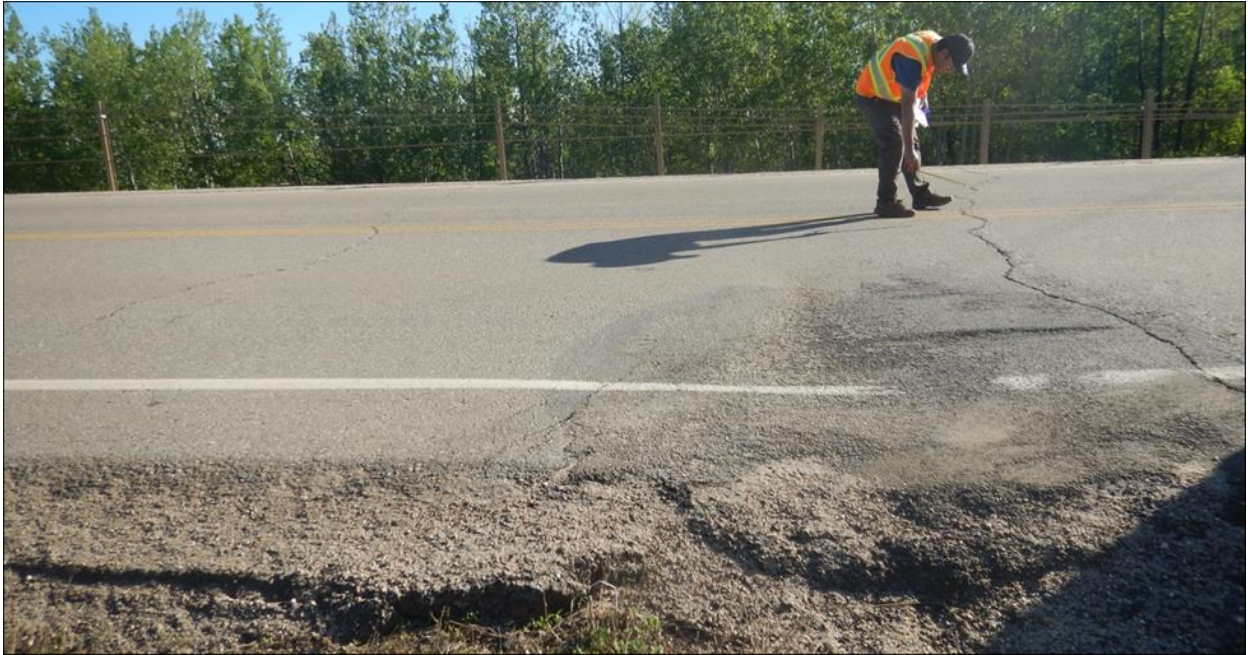
Photo 7. Looking southwest at the sinkhole previously developed within the northern edge of pavement of the highway above the original 600 mm diameter culvert (C3); Original pipe was grouted and a new 760 mm diameter SWSP was auger bored in 2021; cold mix patch placed on the highway surface, but cracks are still visible around the patched area; there is a 50 mm dip within the previously patched area.

- Culvert C1 should also be replaced to reduce the amount of ponding water within the highway ditch.
- The dip developed on the highway WBL surface upslope of culvert C3 inlet location should be patched to eliminate existing hazard and provide a smooth ride to motorists. However, frequent patching of the highway should be anticipated to eliminate future dips. It is highly recommended that the distressed area be excavated, without damaging the new culvert, to locate the existing void. An excavator with a ripper tooth attachment may be needed to complete the excavation. Once the void is located, the base of the excavation should be inspected to remove damaged/collapsed section of the old pipe, debris, and soft /loose materials. Attempts should be made to re-grout the old pipe if the inspection reveals that the exposed section of the pipe has not been filled with grout. The excavation should then be backfilled with compacted crushed gravel to ground surface to re-build the highway surface and the side slope. The side slope should be capped with at least 300 mm of clay at ground surface. The closure of the highway WBL will likely be required to complete this repair.

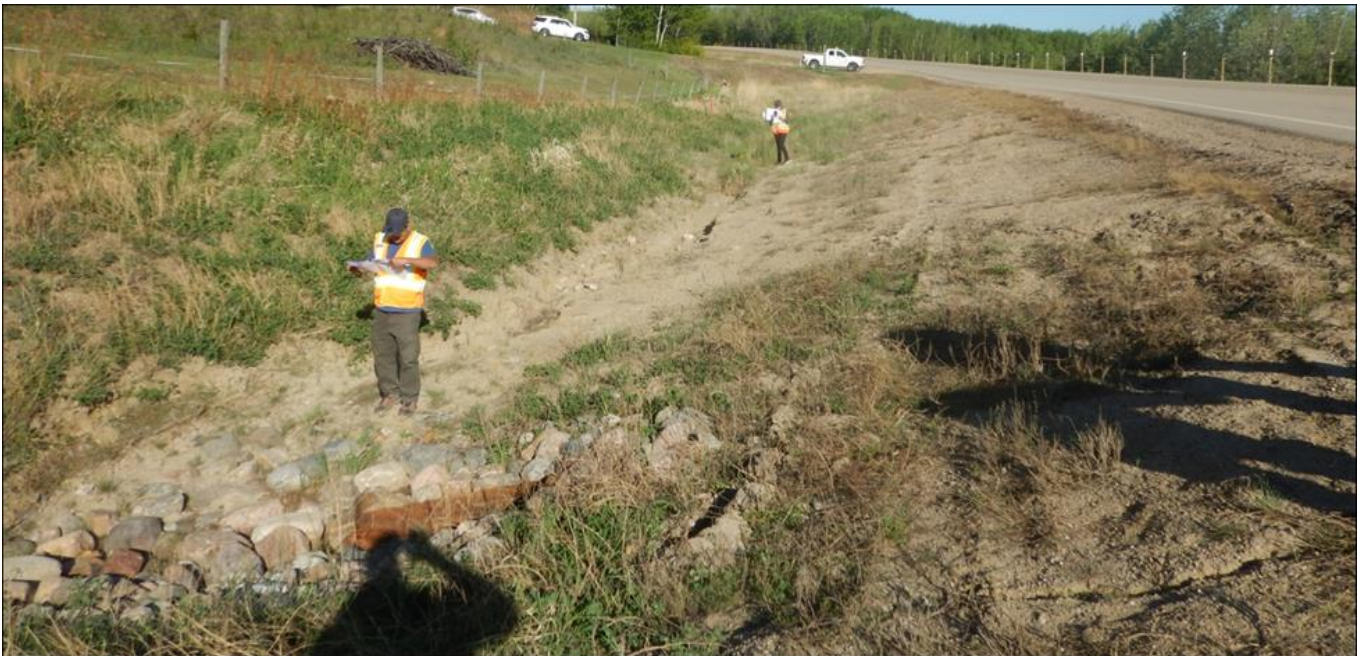
Photo 8. C3 inlet; side slope is bare of vegetation; open crack around culvert inlet and erosion developing upstream of the inlet within the ditch.

- The area around Culvert C3 inlet should also be scarified, repacked, and contoured to eliminate the existing crack, and the sinkhole to the west of the culvert should be backfilled with compacted fill.

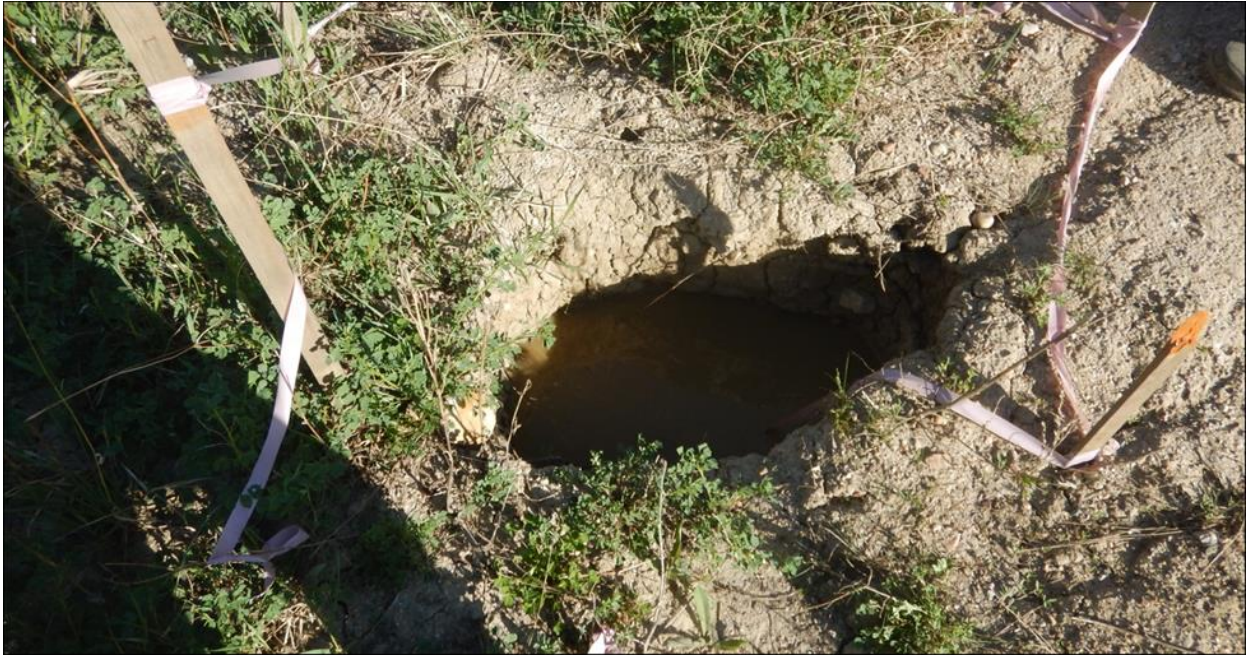
Photo 9. A sink hole (800 mm long x 500 mm wide x 600 mm deep) developed to the west of C3 culvert inlet.

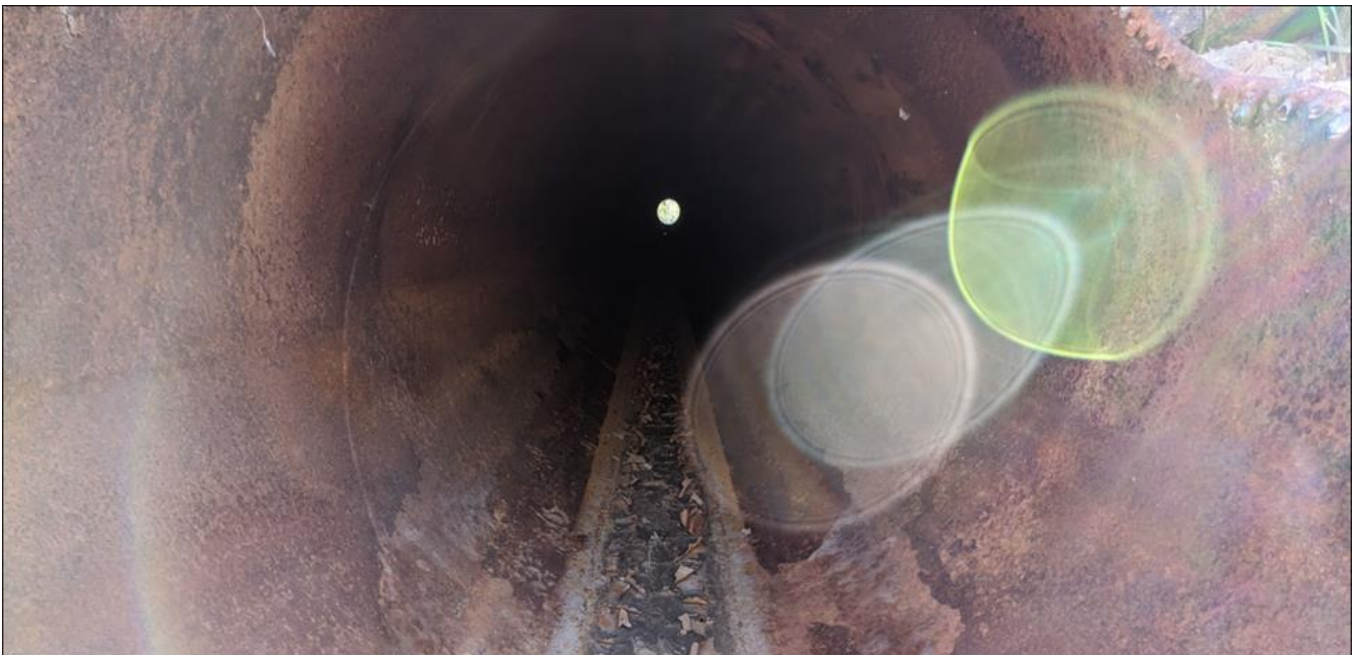
Photo 10. Looking inside culvert C3 outlet.

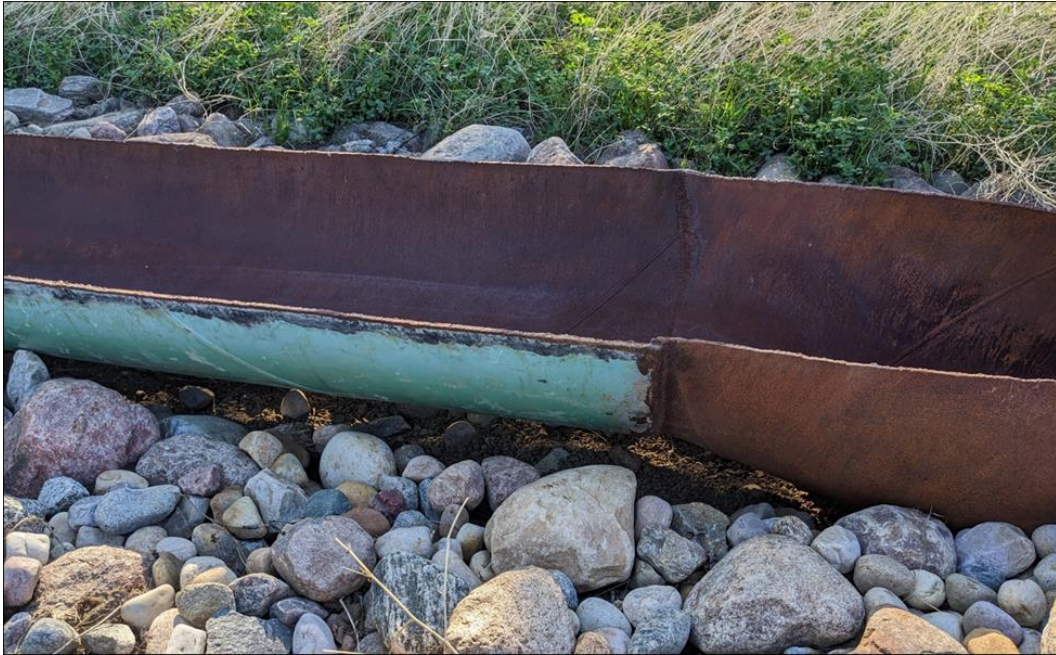
Photo 11. Outlet of culvert C3, installed in 2021. There is a void below the half pipe extension piece.

- The void below the half pipe culvert, downstream of the outlet of the C3 culvert, should be filled with fillcrete.
