ALBERTA TRANSPORTATION AND
ECONOMIC CORRIDORS GRMP
NORTH CENTRAL (ATHABASCA AND FORT
MCMURRAY DISTRICTS)
2024 SITE INSPECTION

Site Number	Location	Name	Hwy	km
NC071	1 km east of Colinton	Little Pine Creek Slide	663:04	6.98
Legal Description		UTM Co-ordinates (NAD 83)		
S.E.15&S.W.14& N.E.10-65-22-W4M		12 N 6054582	E 355785

**NORTH CENTRAL REGION
(ATHABASCA AND FORT McMURRAY DISTRICTS)
2024 GEOHAZARD ASSESSMENT**

NC071: HWY 663:04 LITTLE PINE CREEK SLIDE (km 6.98)

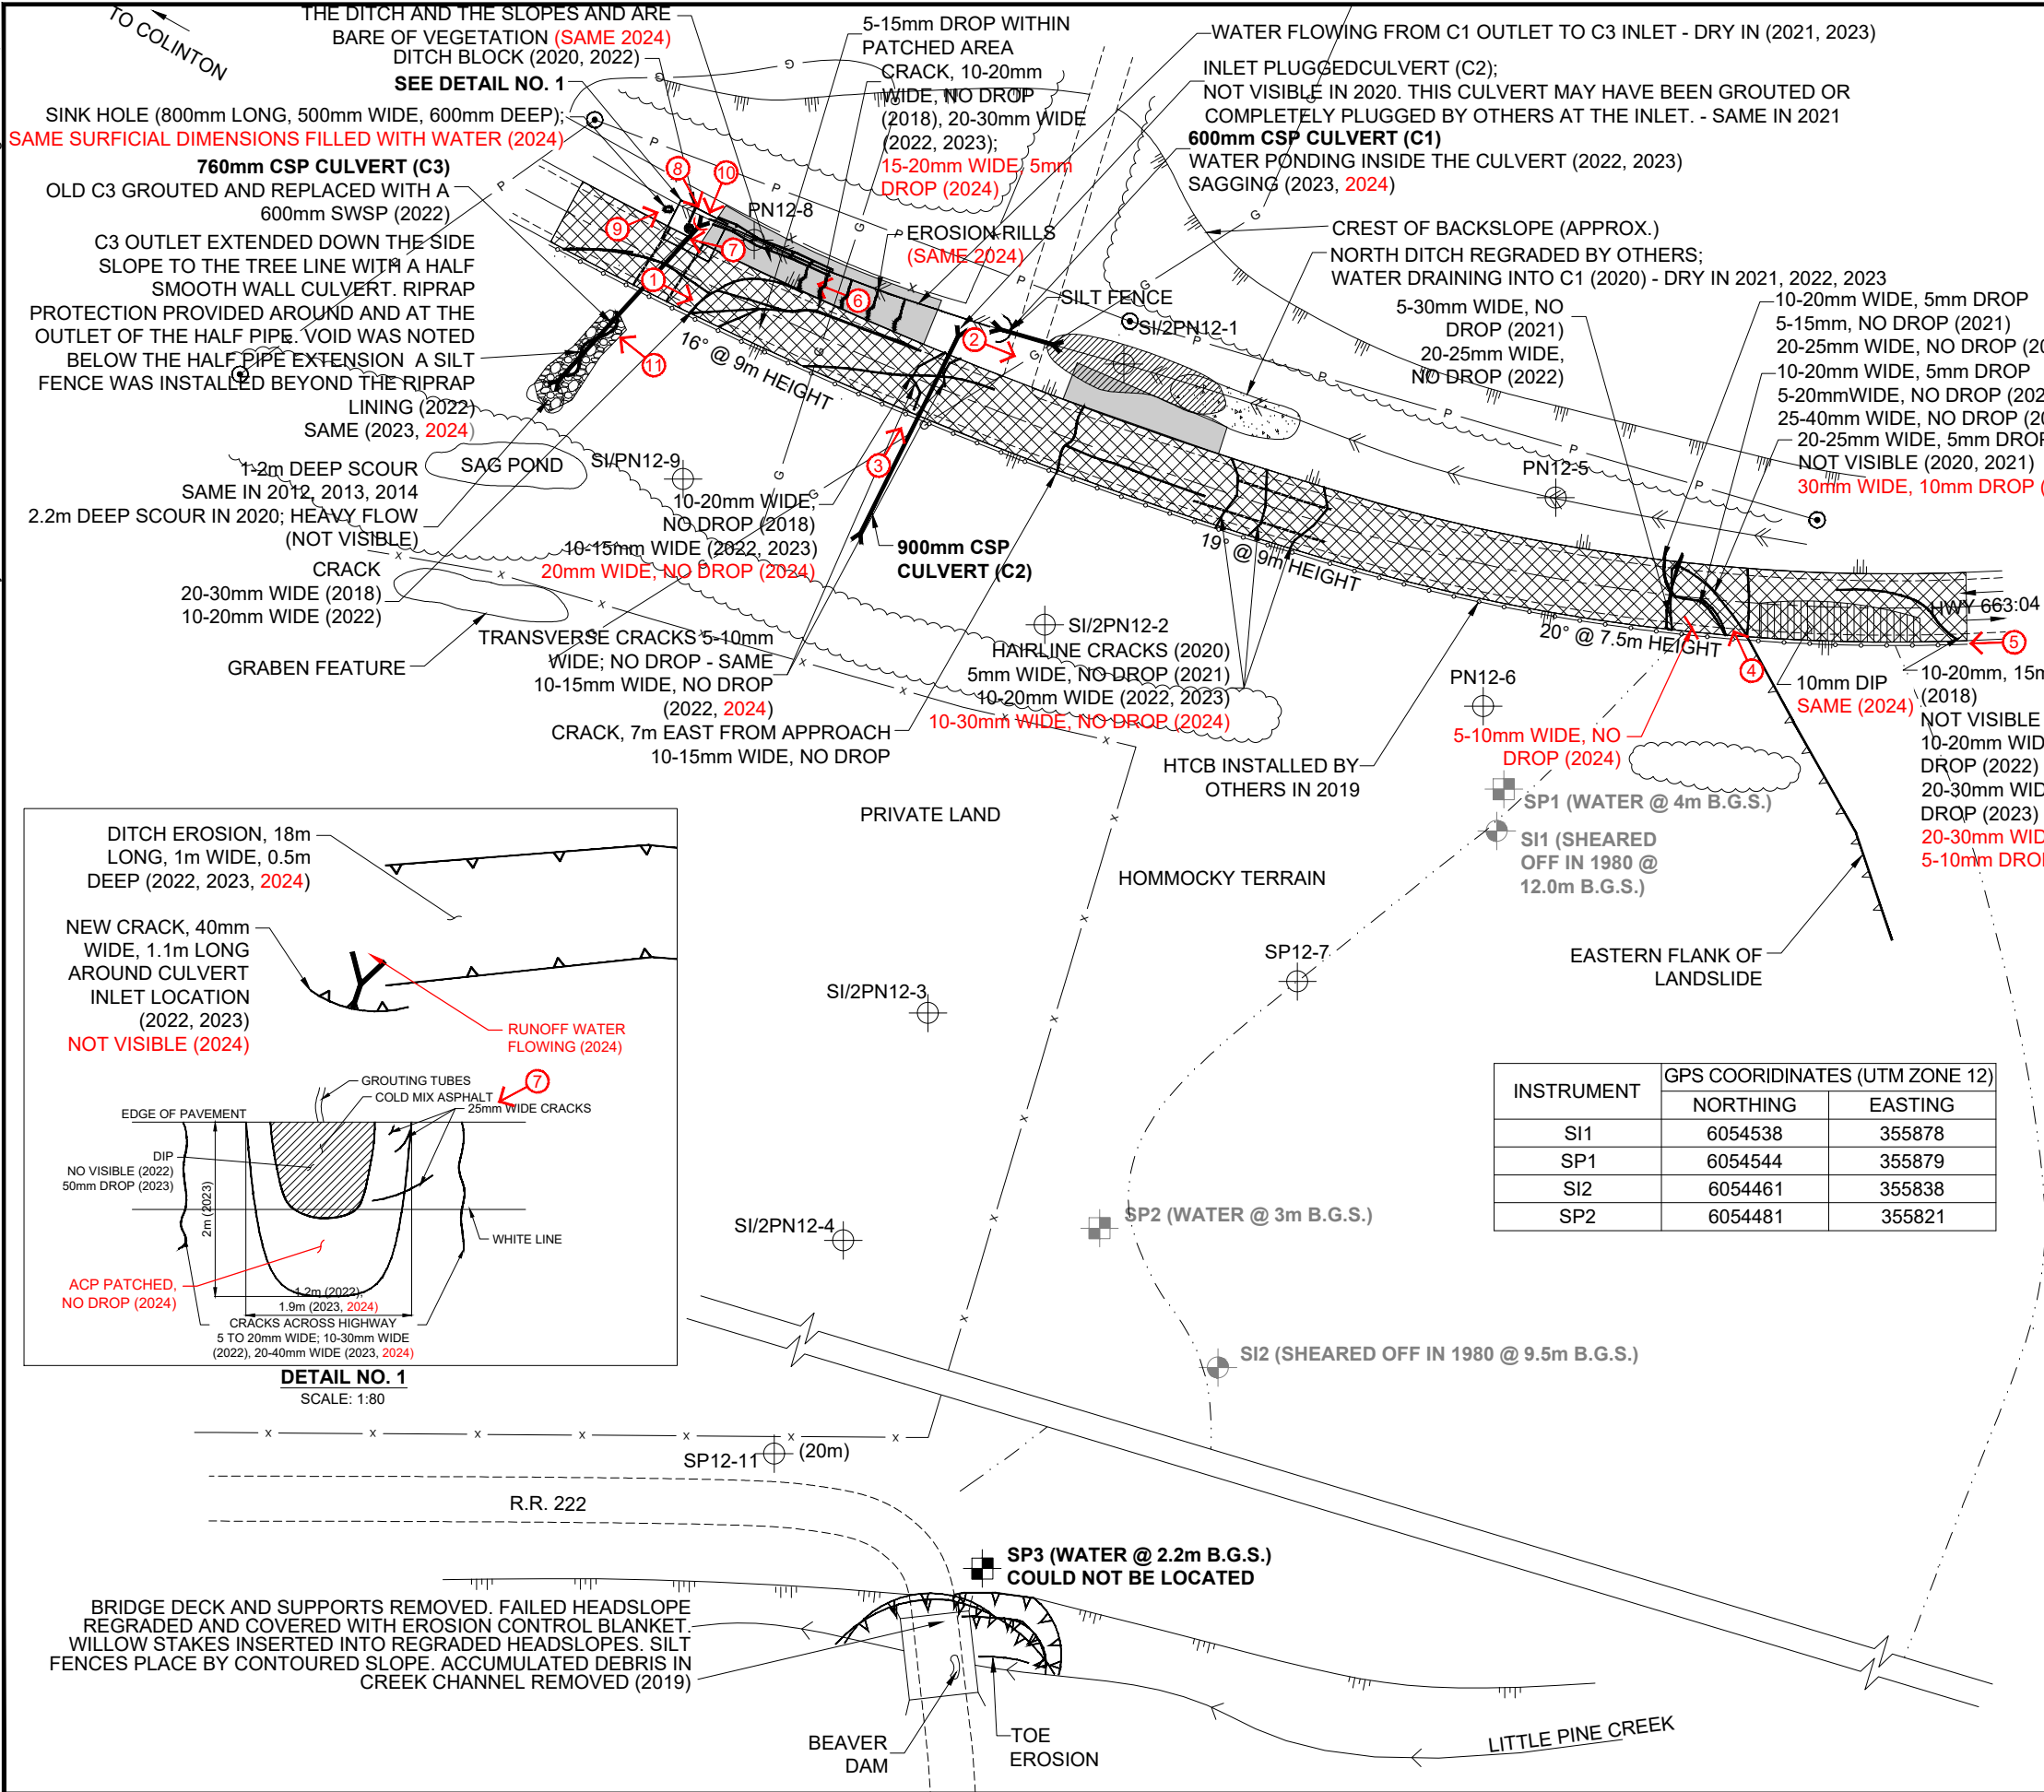
DWG NO. 32122-NC071-1

- NOTES**
1. WATER LEVELS IN STANDPIPE PIEZOMETERS ARE BASED ON THE AVAILABLE INFORMATION PROVIDED BY TRANS
 2. JUNE 3, 2024 SITE OBSERVATIONS ARE SHOWN IN RED.

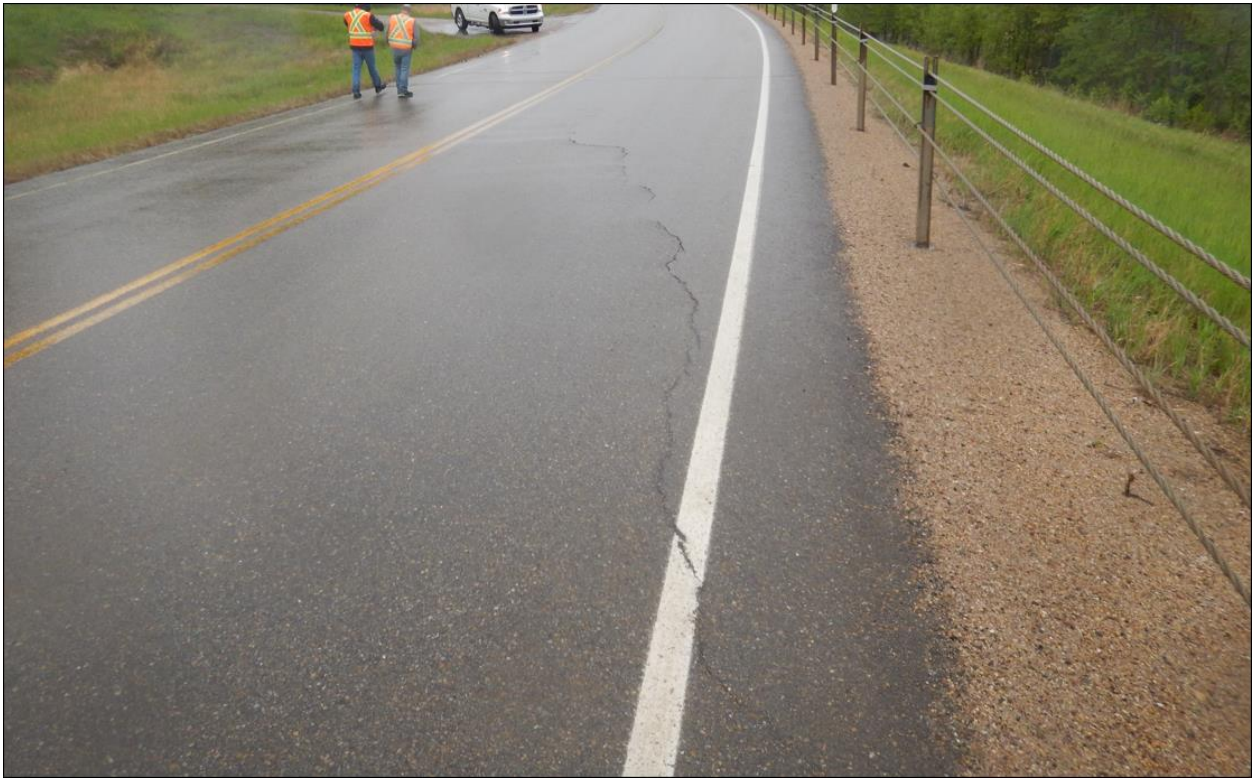
<input checked="" type="checkbox"/> Slope Movement	Western flank crack is showing reflective cracks 15 to 20 mm wide, 5 mm drop; 10 to 30 mm wide cracks within the	<input checked="" type="checkbox"/>

Photo 1. Looking at (15-20 mm wide, 5 mm drop) diagonal crack on the highway surface from the western limit of the site.

The local MCI should continue to monitor the site (particularly between the spring and the fall seasons) and seal any open cracks to reduce surface water infiltration into the highway fill. Consideration should be given in the future to placing an ACP patch near the flanks of the landslide to provide a smooth ride to motorists.

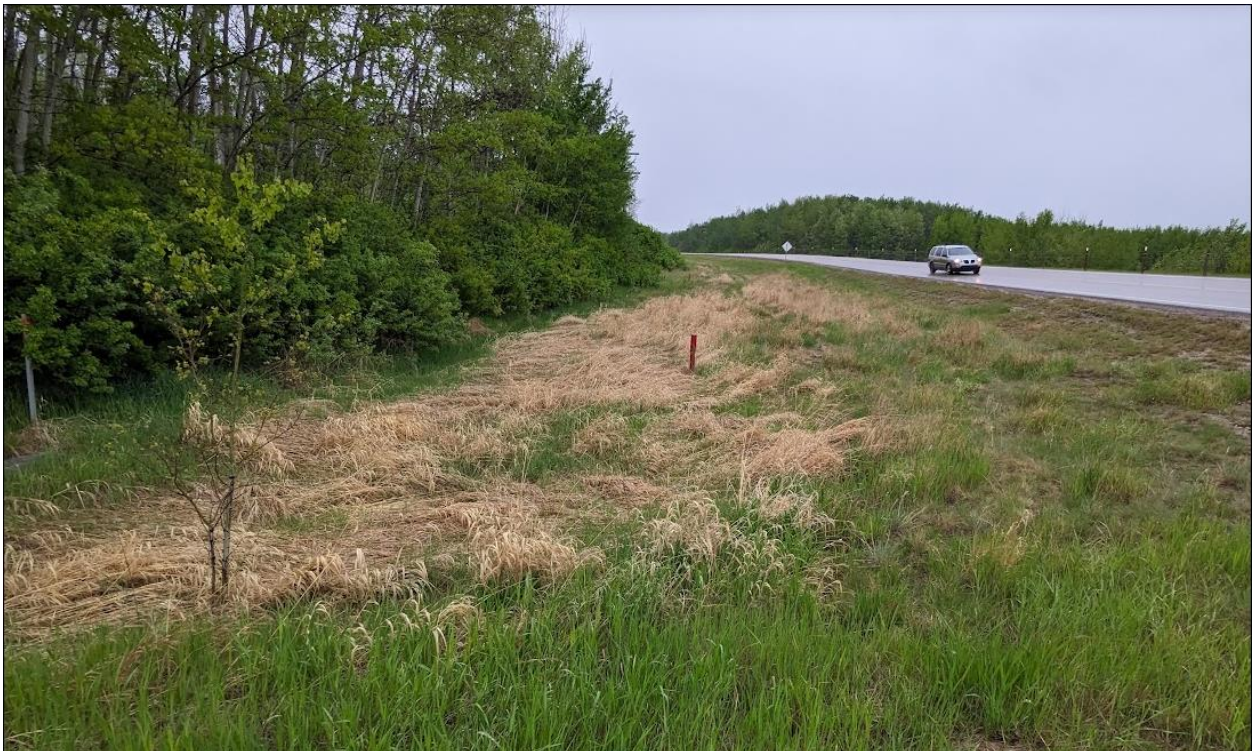
Photo 2. Highway's north ditch to the east of the approach.

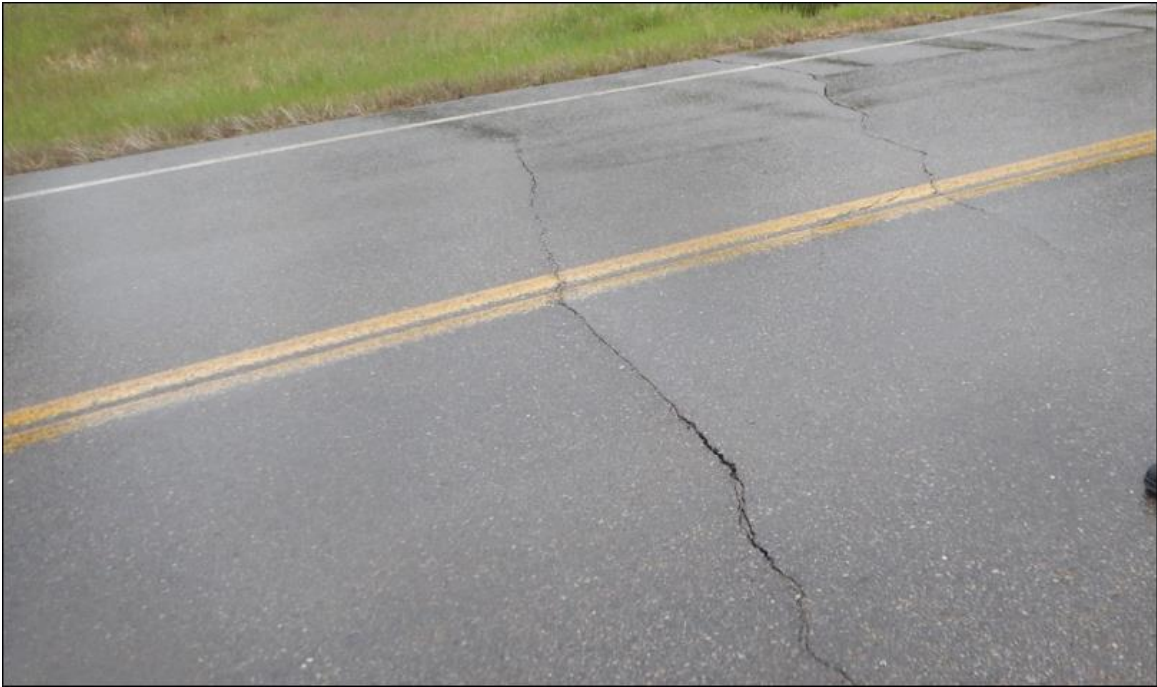
Photo 3. Looking north at a transverse crack (10 - 15 mm wide with no drop).

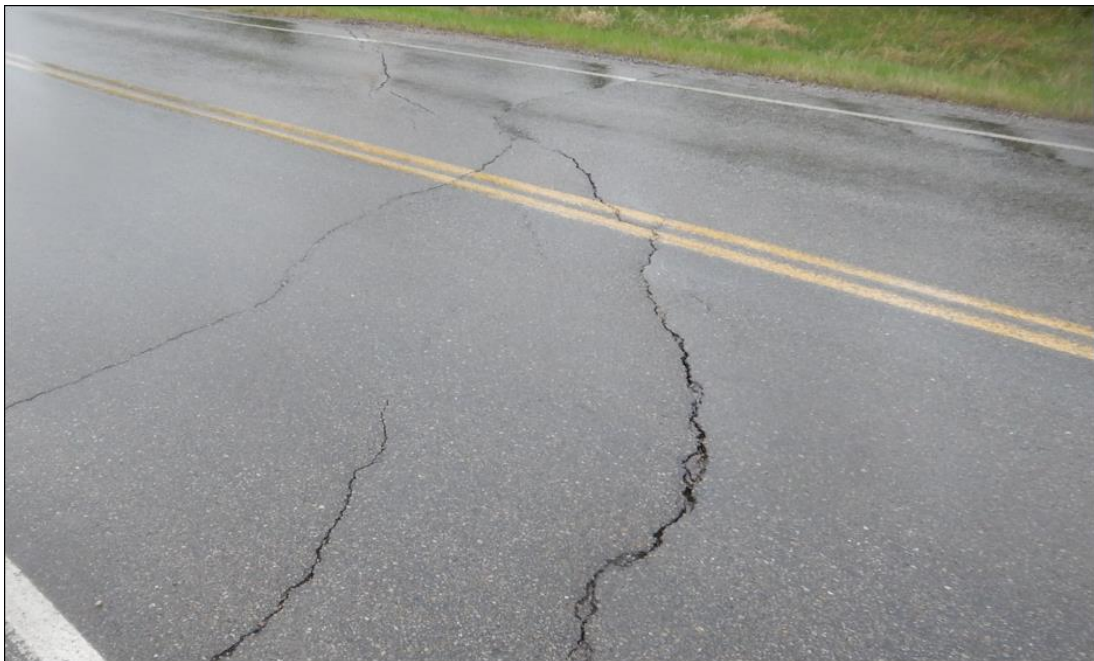
middle section of the landslide; eastern flank cracks are 30 mm wide with 10 mm drop.	
<input checked="" type="checkbox"/> Erosion	Erosion gully (18 m long x 1 m wide x 0.5 m deep) developed in 2022 within the north ditch upstream of culvert C3 remains unchanged; erosion rills along the highway side slope to the west of the access road; sink hole (800 mm long x 500 mm wide x 600 mm deep) to the west of C3 inlet location was filled with water.	<input type="checkbox"/>
<input type="checkbox"/> Seepage		<input type="checkbox"/>
<input checked="" type="checkbox"/> Bridge/Culvert Distress	A void was noted under the half pipe extension of C3 outlet location; Culvert C1 is sagging, and water is ponding inside the culvert;	<input type="checkbox"/>
<input checked="" type="checkbox"/> Other	Highway north ditch: the highway side slope and the ditch to the west of the access road are bare of vegetation	<input type="checkbox"/>

Photo 4. Looking northwest at the eastern flank reflective diagonal cracks

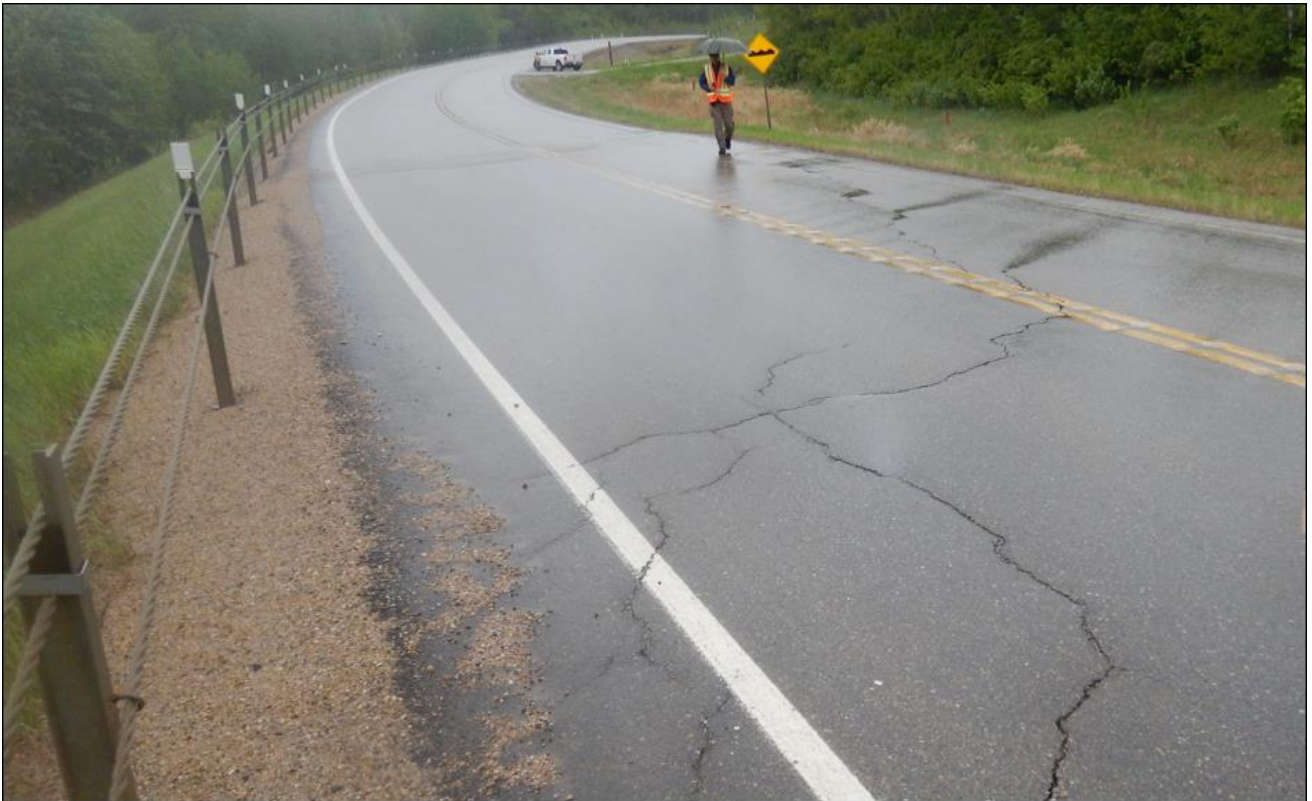
Photo 5 Diagonal cracks located about 15 m east of the landslide western flank

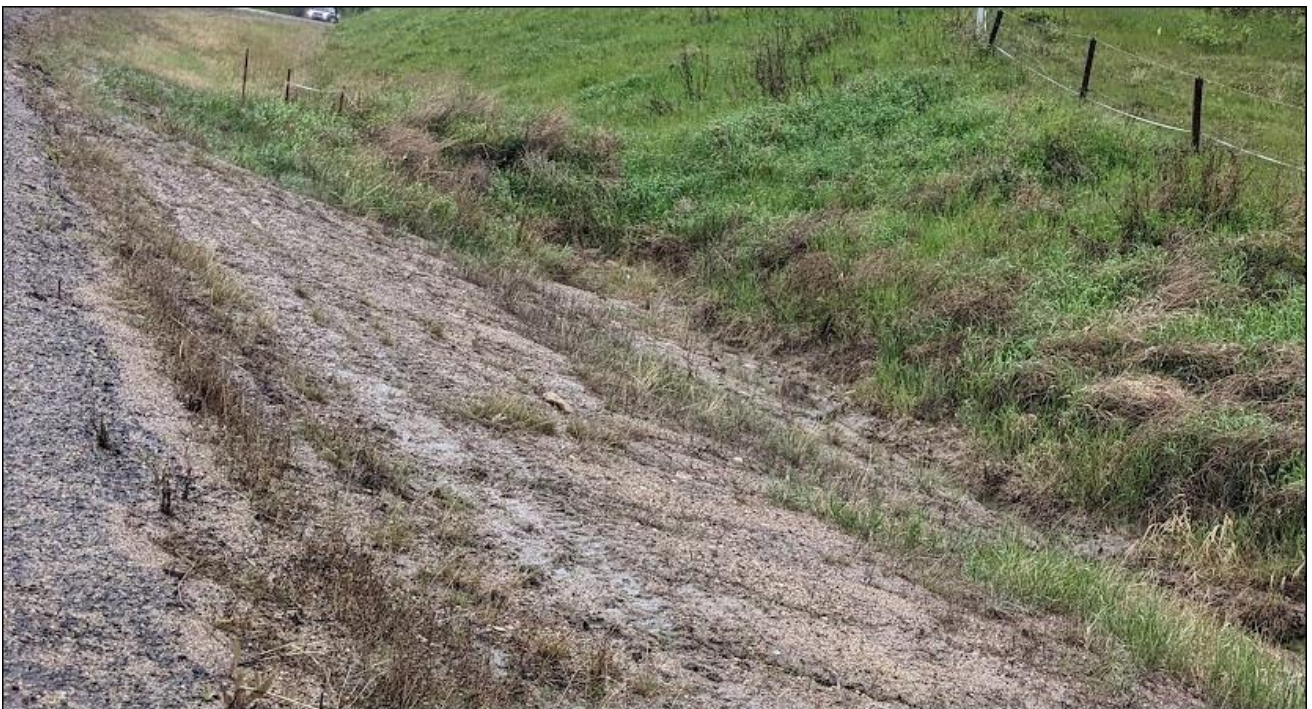
Photo 6. Looking west at the regraded section of the ditch in 2019; side slopes and sections of the ditch bottom are still bare of vegetation; note the presence of erosion rills along the side slope and a deep erosion gully in the ditch.

- The north ditch to the west of the access road should be properly graded to eliminate gully erosion gully. The side slope should also be track-packed to fill erosion rills. After the ditch/side slope repairs are completed, all disturbed areas within the north ditch should be topsoiled and seeded. The ditch bottom and side slopes should be covered with Type C TRM to reduce future erosion potential.

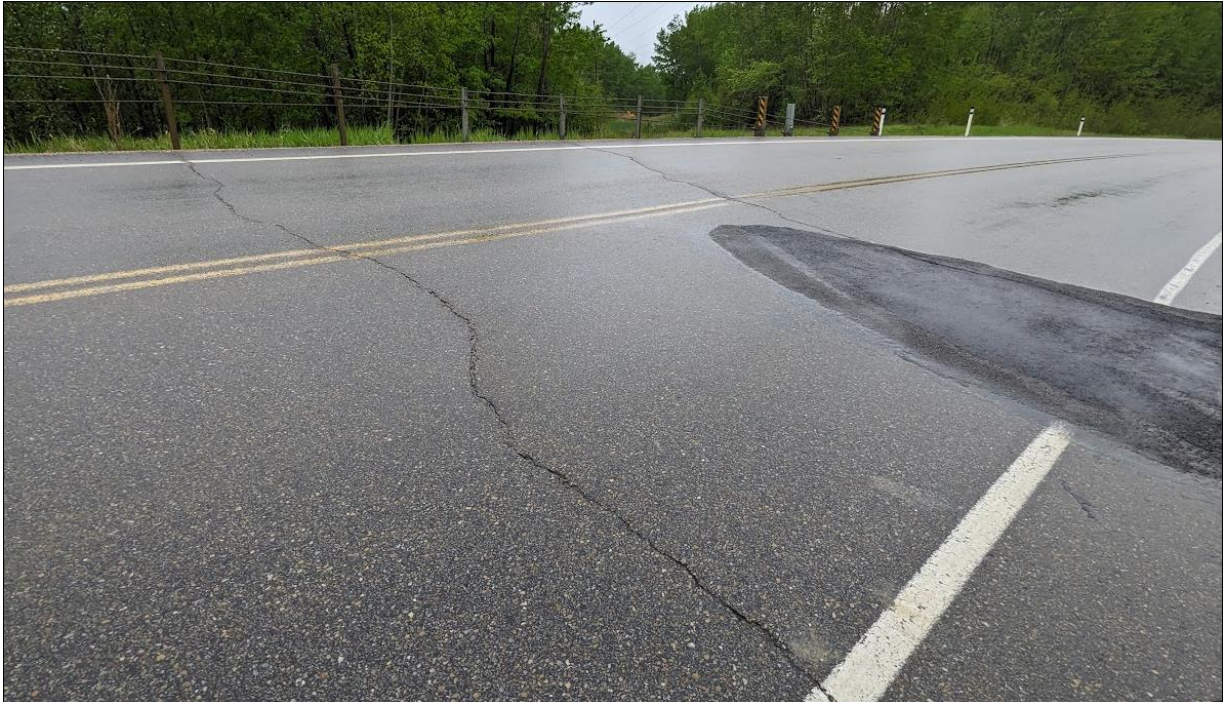
Photo 7. Looking southwest at the sinkhole previously developed within the northern edge of pavement of the highway above the original 600 mm diameter culvert (C3); Original pipe was grouted and a new 760 mm diameter SWSP was auger bored in 2021; cold mix patch placed on the highway surface (2022), larger ACP patch was noted in 2024.

- The distressed area above C3 culvert should be excavated to properly fill the existing void in this area. Care should be taken during the excavation to avoid damaging the new culvert. An excavator with a ripper tooth attachment may be needed to complete the excavation. Once the void is located, the base of the excavation should be inspected to remove damaged/collapsed section of the old pipe, debris, and soft /loose materials. Attempts should be made to re-grout the old pipe if the inspection reveals that the exposed section of the pipe has not been filled with grout. The excavation should then be backfilled with compacted crushed gravel to ground surface to re-build the highway surface and the side slope. The side slope should be capped with at least 300 mm of clay at ground surface. The closure of the highway WBL will likely be required to complete this repair.

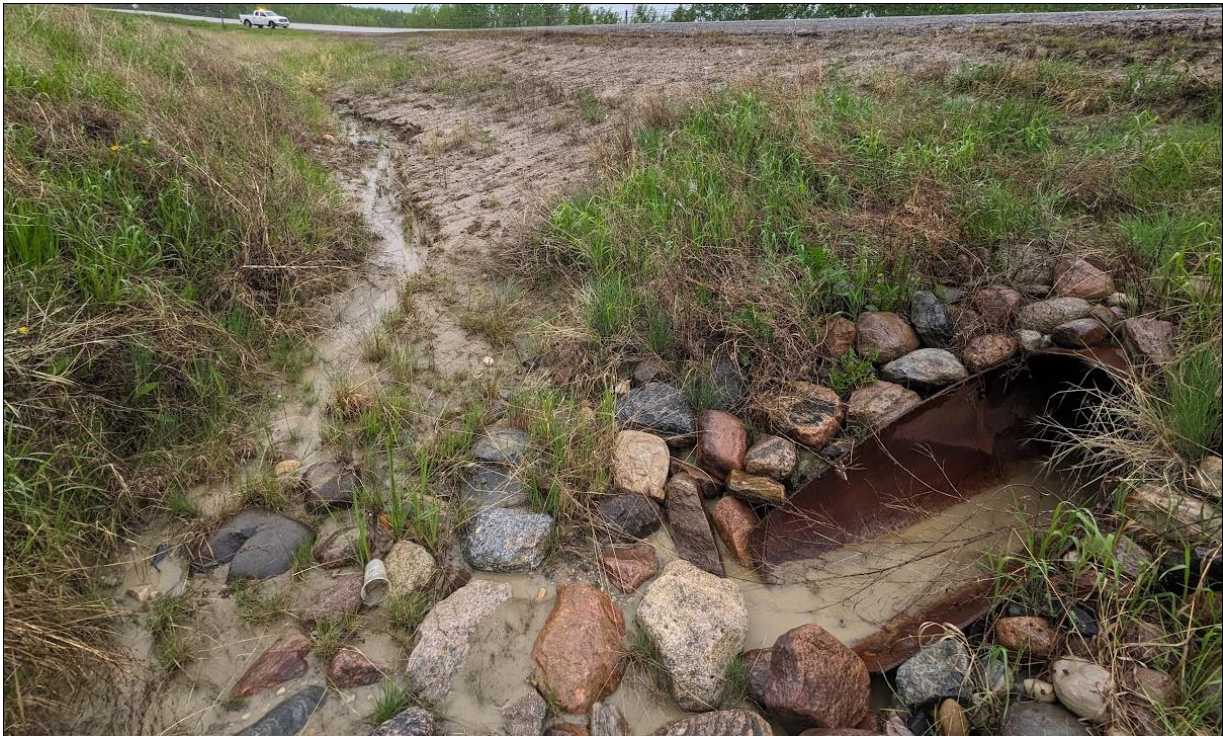
Photo 8. C3 inlet; Water flowing; side slope is bare of vegetation; erosion developing upstream of the inlet within the ditch.

- The area around Culvert C3 inlet should also be scarified, repacked, and contoured to eliminate the existing crack, and the sinkhole to the west of the culvert should be backfilled with compacted fill.

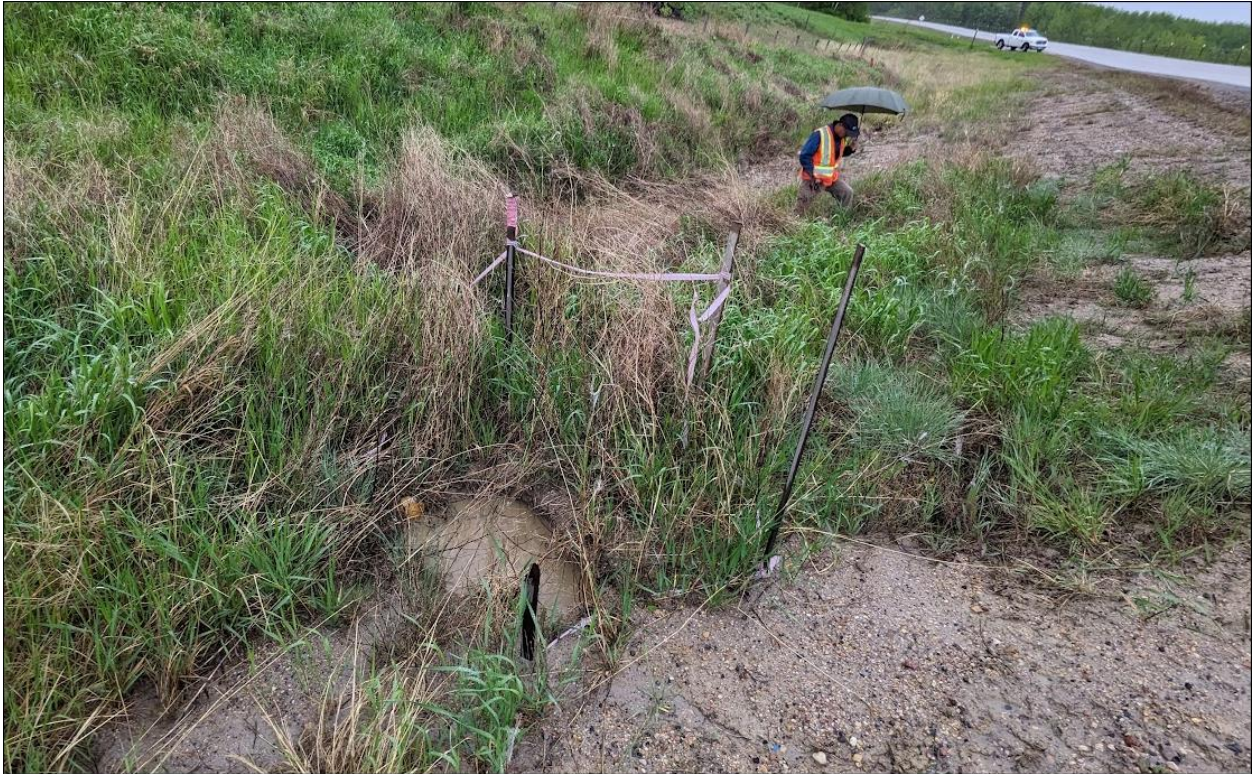
Photo 9. A sink hole (800 mm long x 500 mm wide x 600 mm deep) developed to the west of C3 culvert inlet.

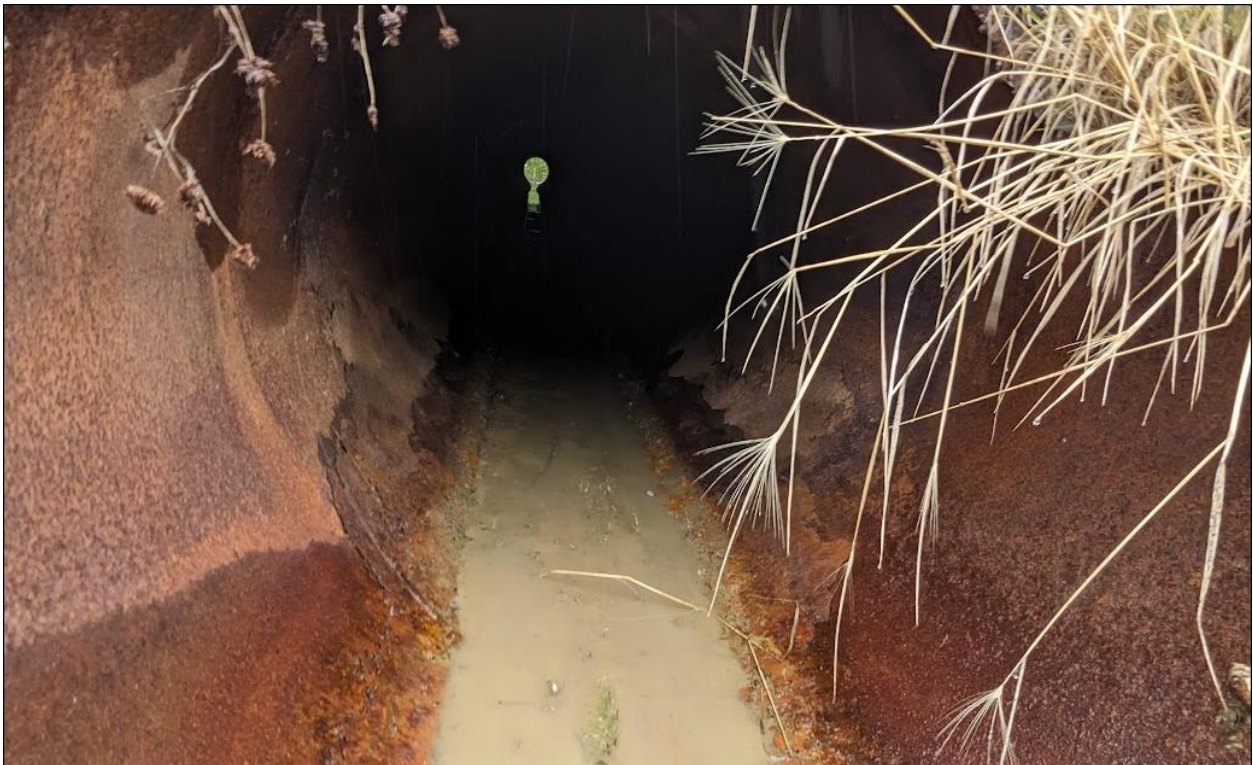
Photo 10. Looking inside culvert C3 outlet.

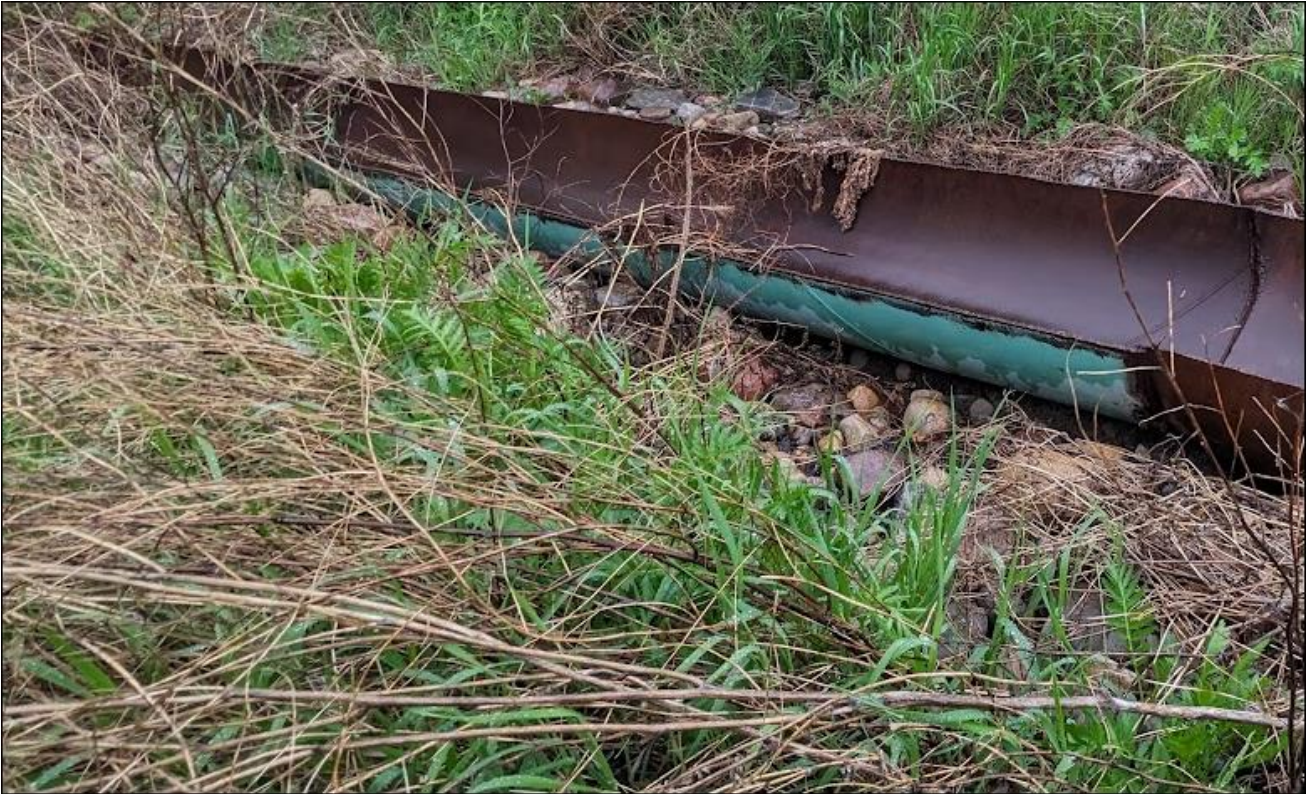
Photo 11. Outlet of culvert C3, installed in 2021. There is a void below the half pipe extension piece.

- Culvert C1 should also be replaced to reduce the amount of ponding water within the highway ditch.
- The void below the half pipe culvert, downstream of the outlet of the C3 culvert, should be filled with fillcrete.
