**ALBERTA TRANSPORTATION  
GEOHAZARD ASSESSMENT PROGRAM  
NORTH CENTRAL REGION – ATHABASCA DISTRICT  
2020 INSPECTION**

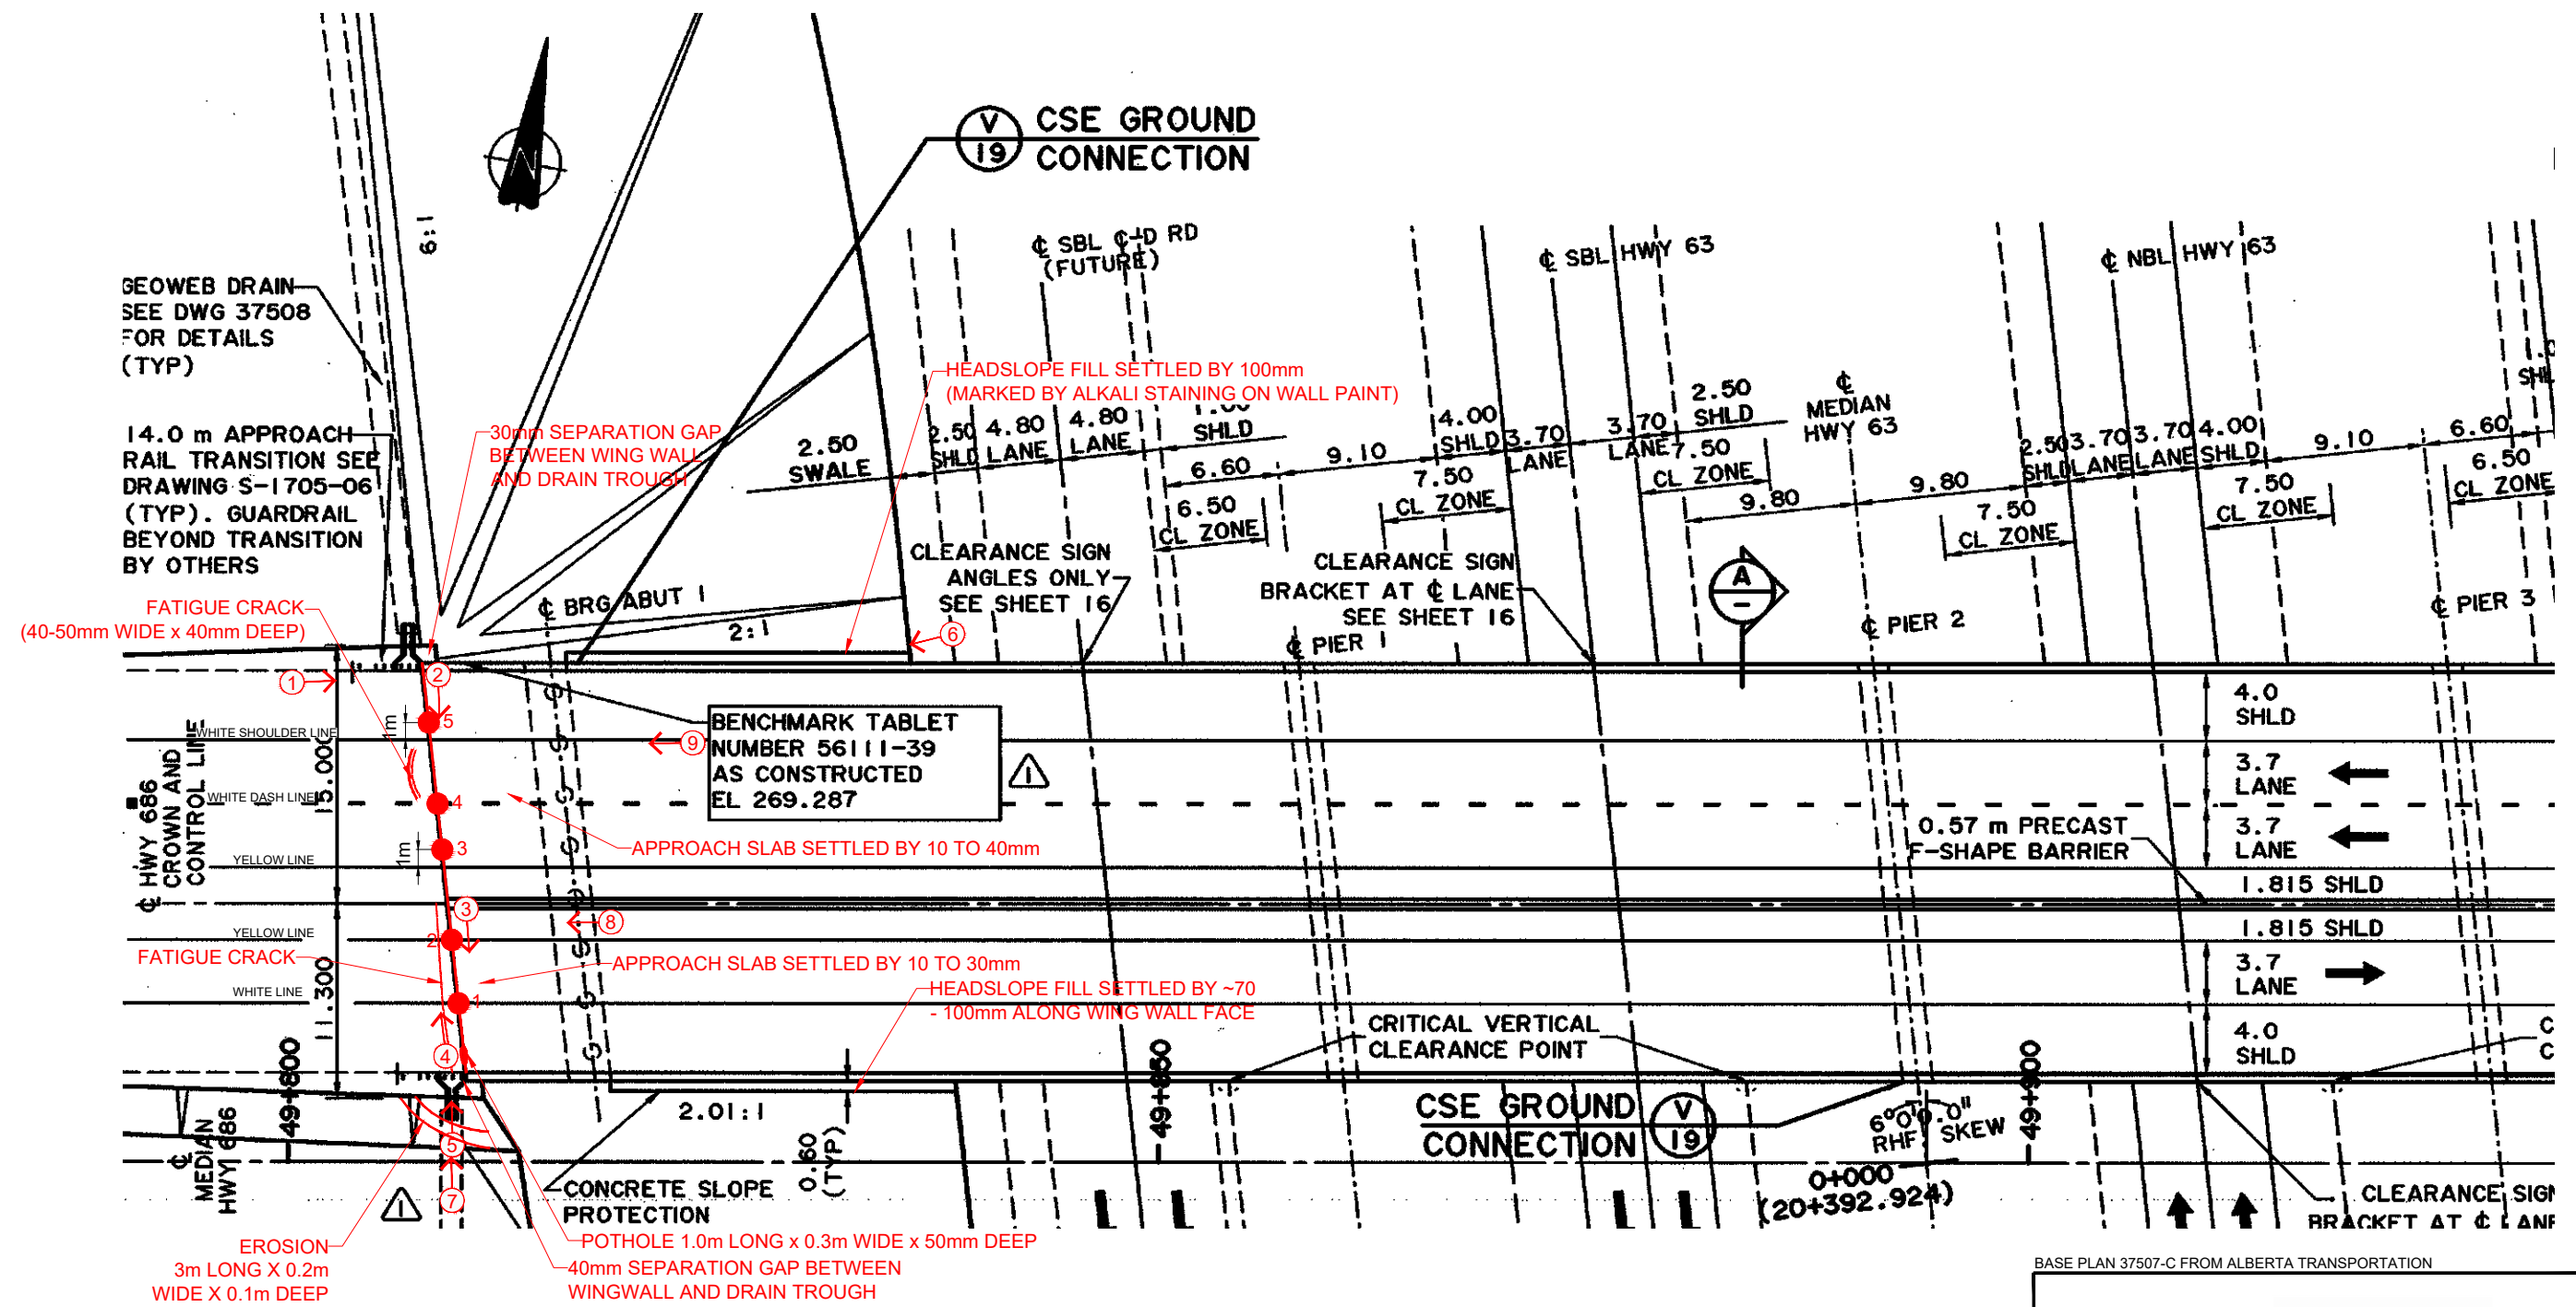
- LEGEND**
- CRACK MEASUREMENT LOCATION
  - CRACK LOCATION
  - ① PHOTOGRAPH NUMBER, AND APPROXIMATE DIRECTION AND LOCATION

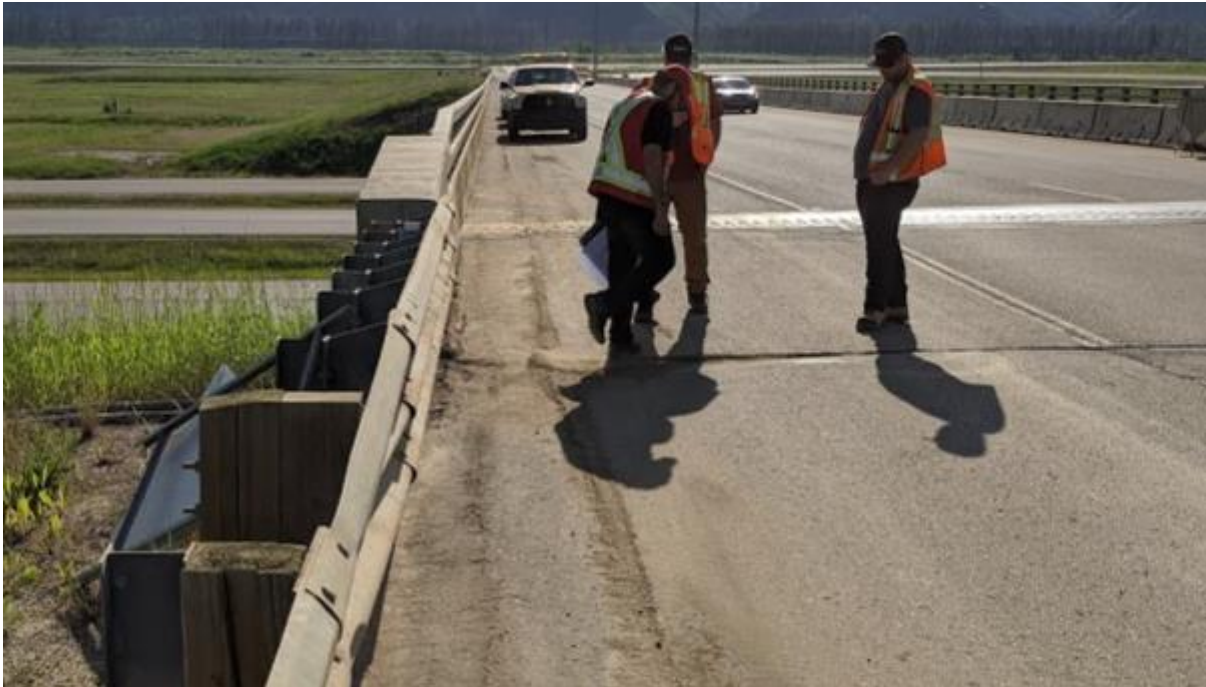
Photo 1 – Looking east at the bridge westbound lanes. The crack is across both traffic lane directions and has formed between the approach slab and the pavement, about 6 m west of the west abutment fingerplate.

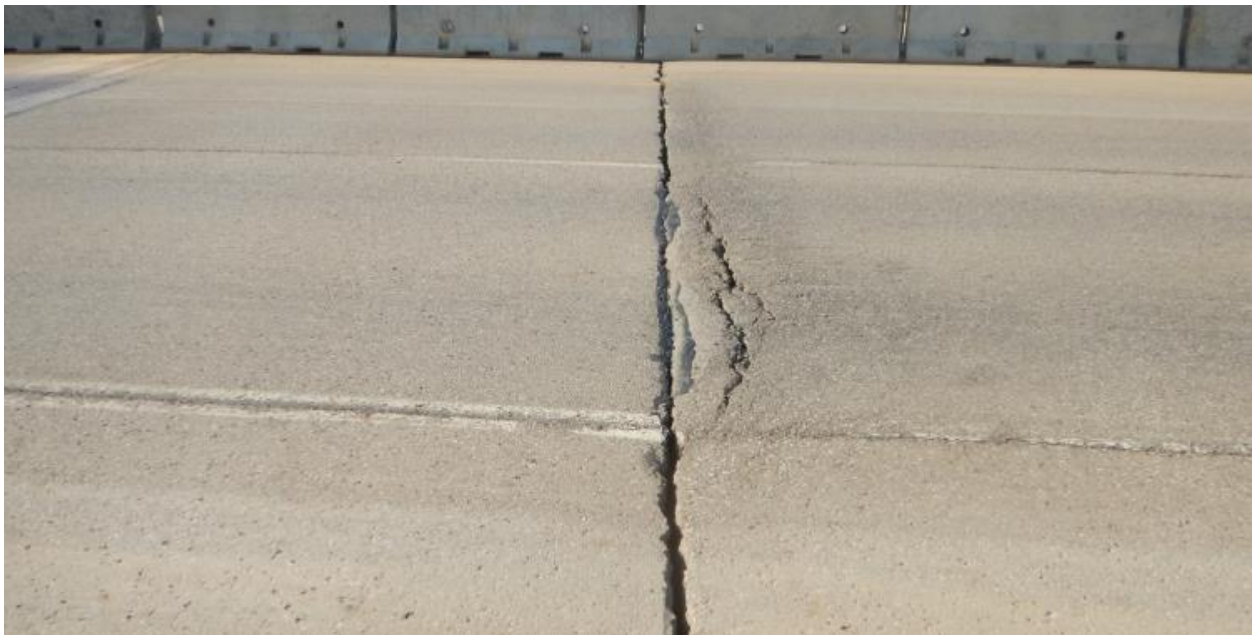
Photo 2 – Looking south at the crack across the westbound lanes towards the median. Note the ~0.3 m wide fatigue cracking on the west (higher) side of the crack. The crack is 40 to 50 mm wide x 40 m deep.

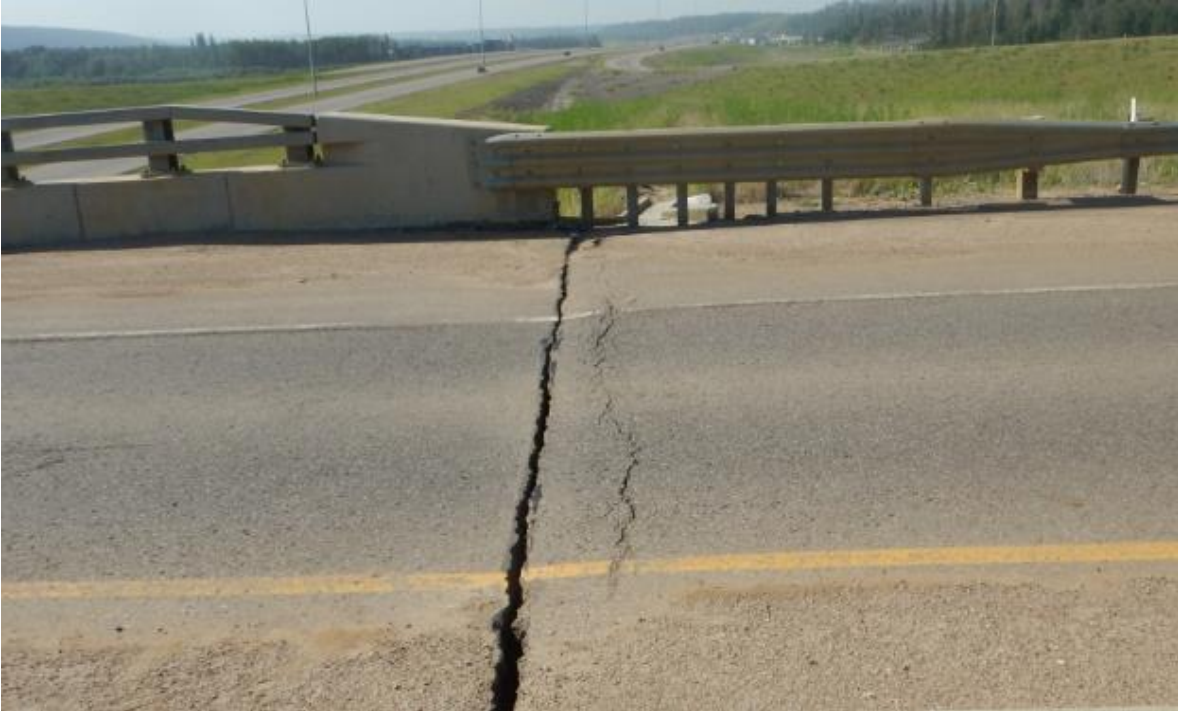
Photo 3 – Looking south across the eastbound lanes. Note the fatigue cracks along the west (higher) side of the main crack.

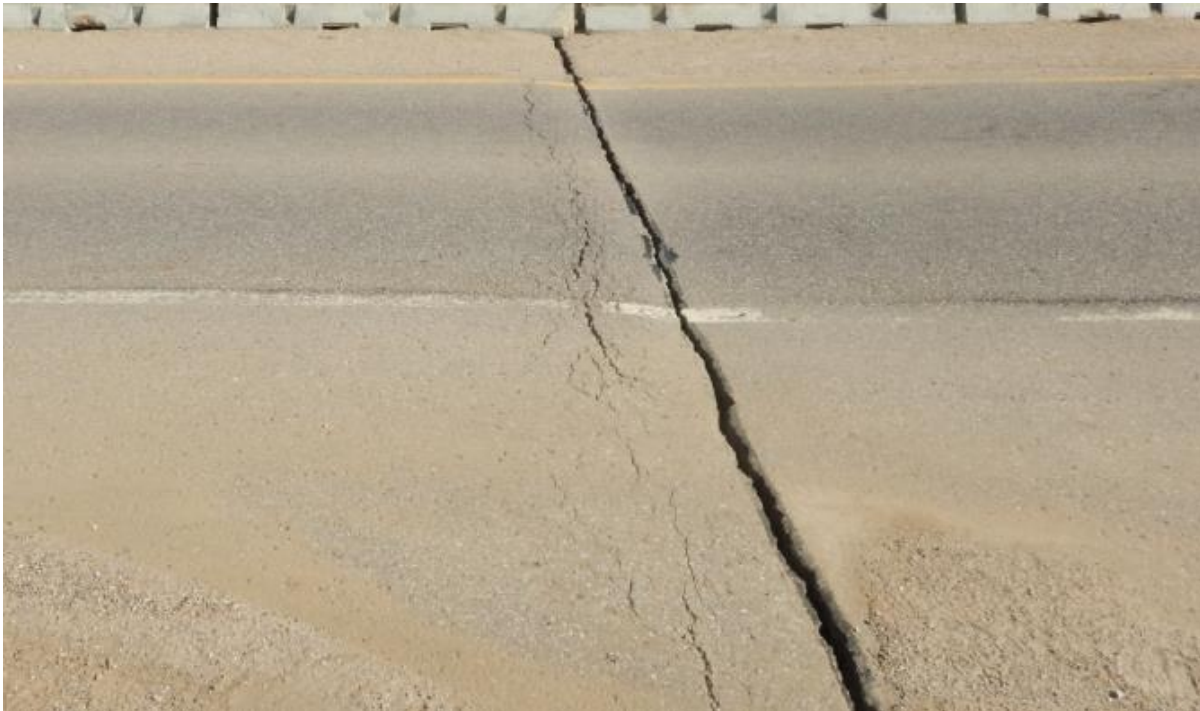
Photo 4 – Looking north across the eastbound lanes.

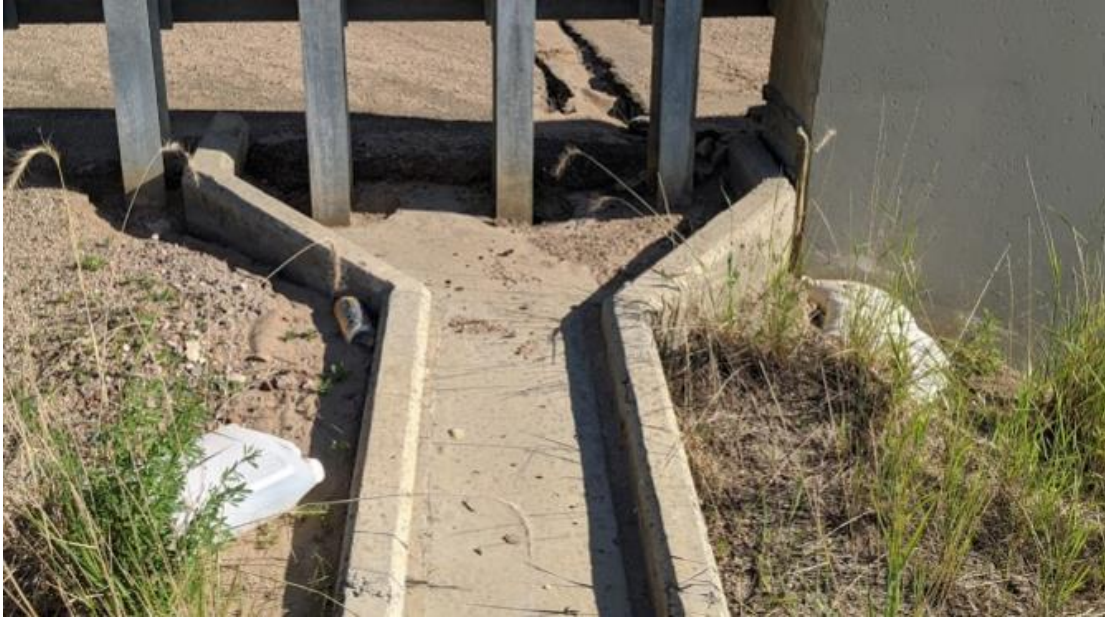
Photo 5 – Looking at the south drain trough. Note the cracking between the drain trough and concrete wingwall.

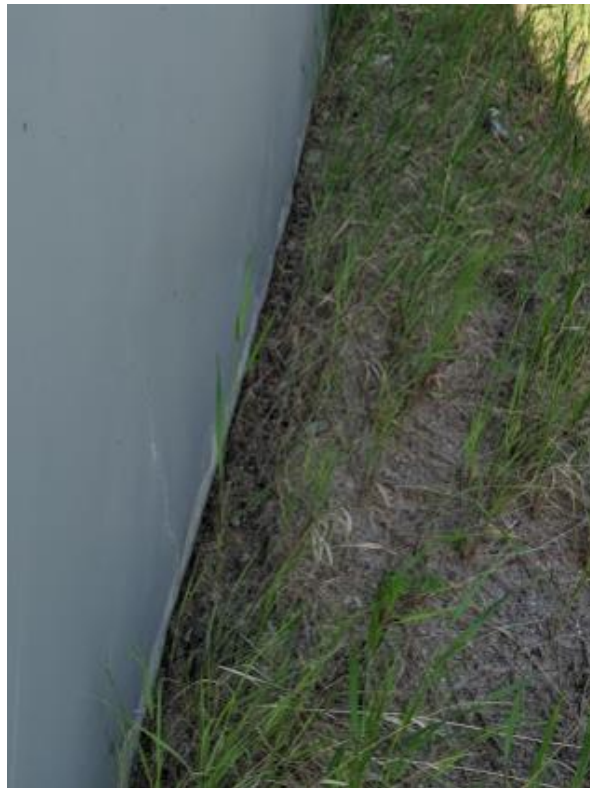
Photo 6 – Looking at the north face of the north wingwall and side slope above the west abutment. Note the fill settlement averages ~100 mm marked by the alkali staining on the paint.

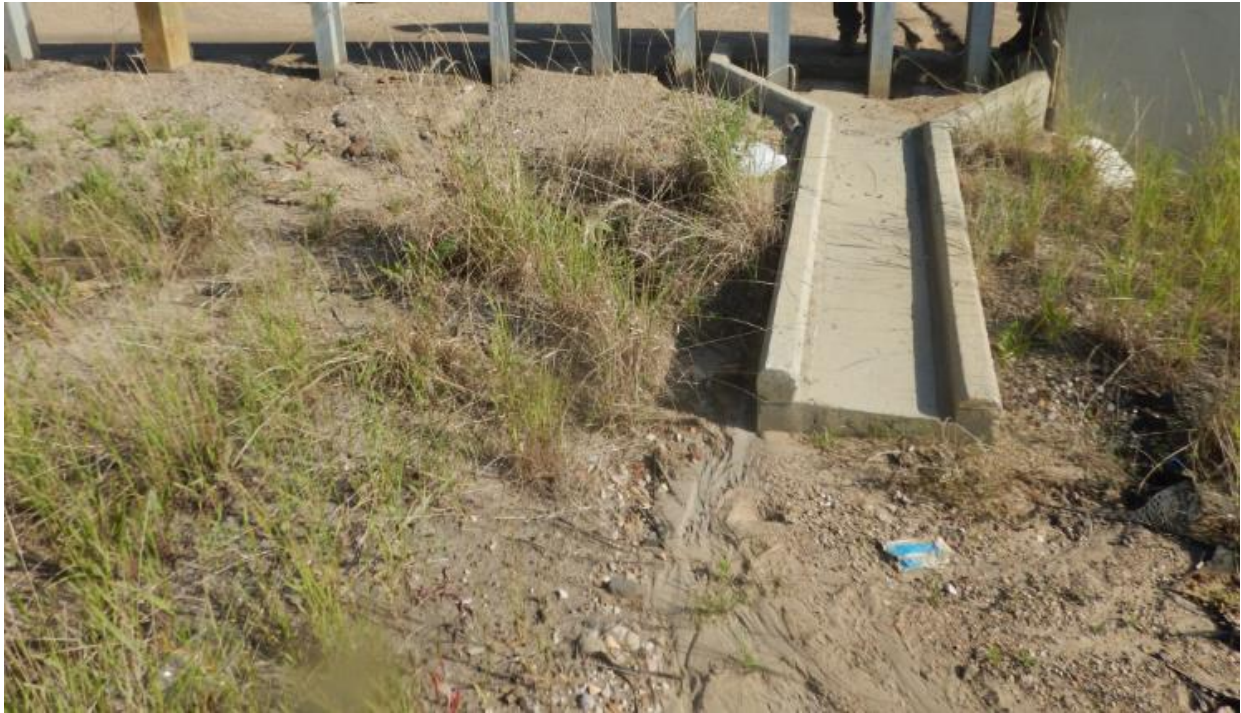
Photo 7 – Looking north at the erosion formed along the south wingwall and side slope at drain trough location
