**ALBERTA TRANSPORTATION
GEOHAZARD ASSESSMENT PROGRAM
NORTH CENTRAL REGION – ATHABASCA &
FORT MCMURRAY DISTRICTS
2021 SITE INSPECTION**

Site Number	Location	Name	Hwy	km
NC097	Fort McMurray	Parsons Road Overpass/Hwy 63	686:20	
Legal Description		UTM Co-ordinates (NAD 83)		
SW7-90-9-W4		12V N 6,293,600	E 473,700

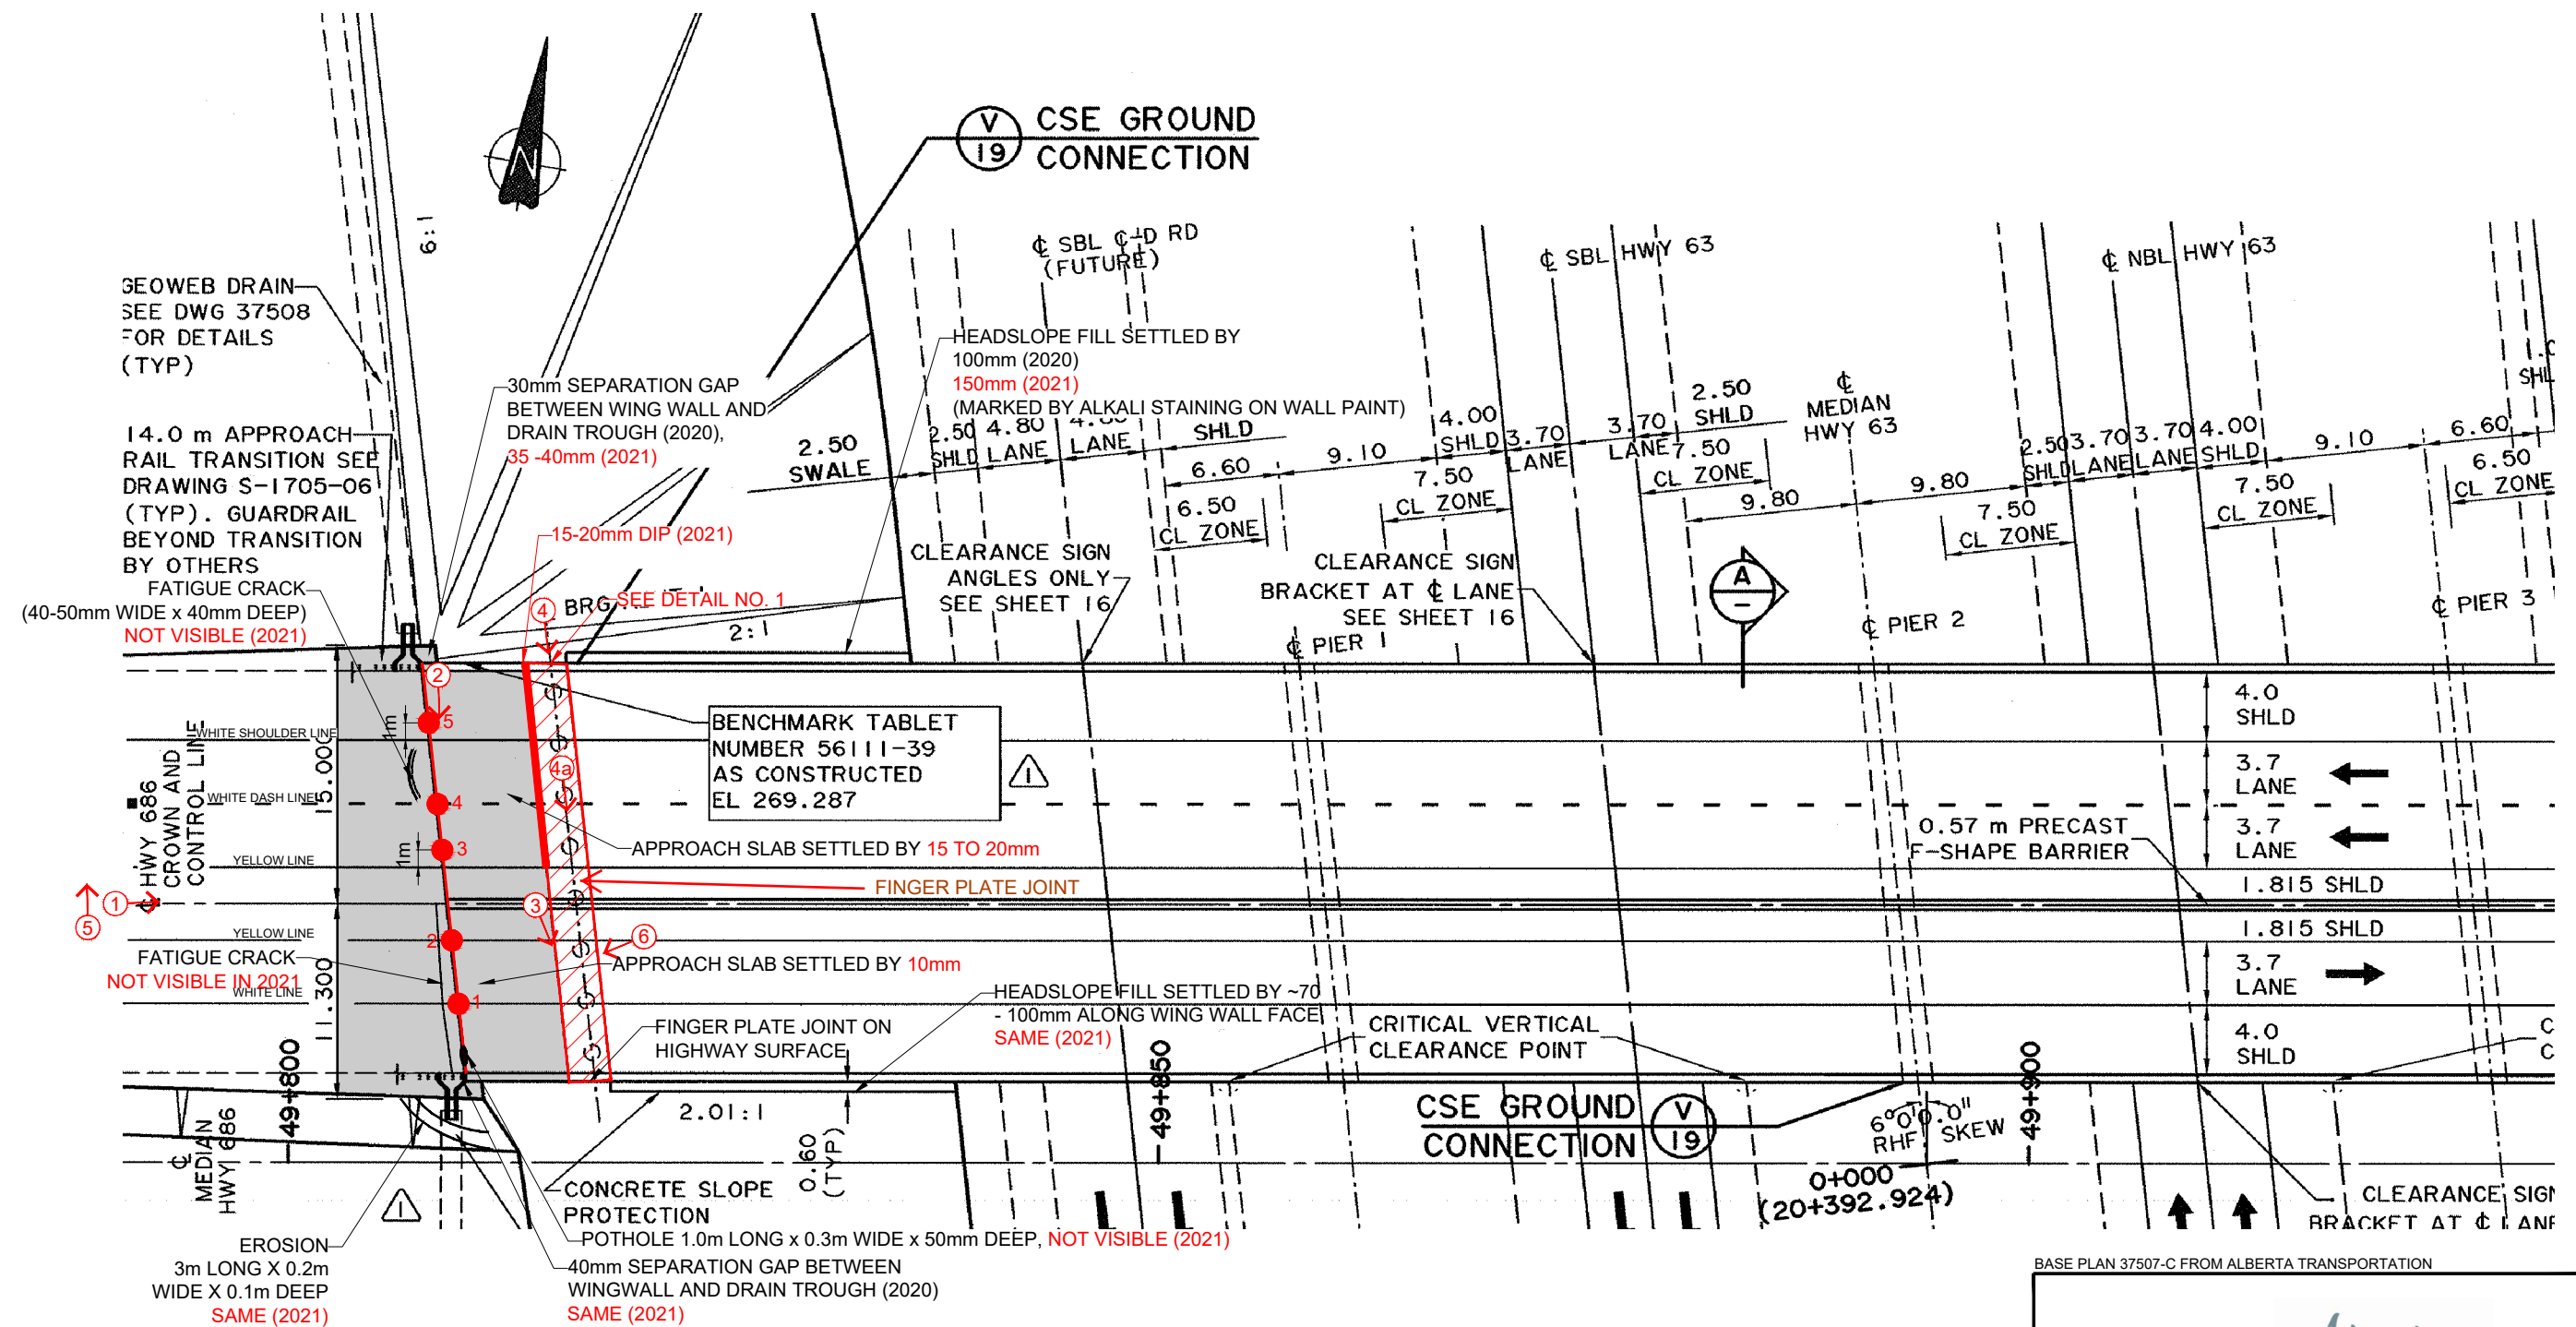
- LEGEND**
- CRACK MEASUREMENT LOCATION
 - CRACK LOCATION
 - ① PHOTOGRAPH NUMBER, AND APPROXIMATE DIRECTION AND LOCATION
 - ACP PATCH PLACED IN 2020 EXTENDS 12m TO THE WEST OF THE CONSTRUCTION JOINTS

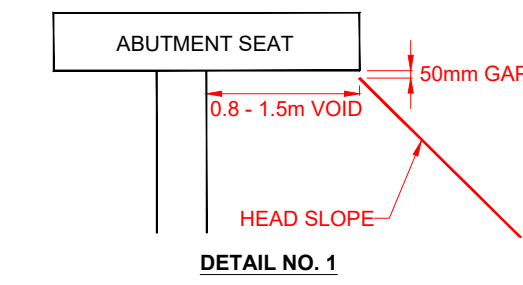
BASE PLAN 37507-C FROM ALBERTA TRANSPORTATION

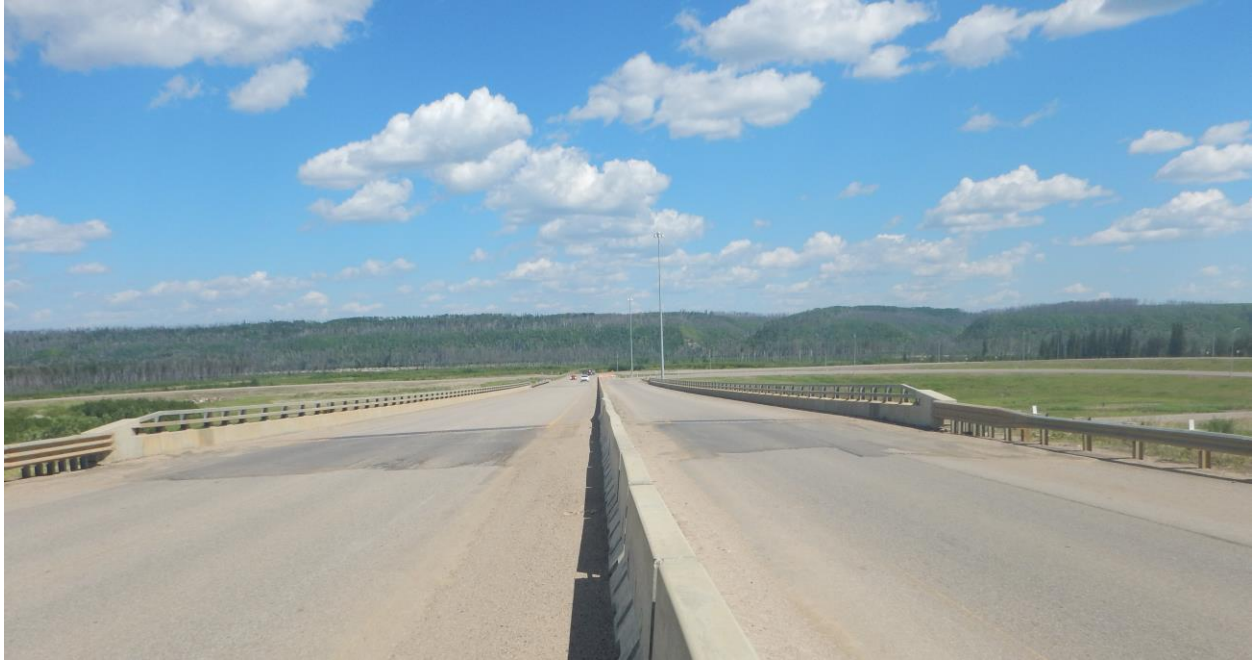
Photo No. 1 – Looking east at the bridge eastbound and westbound lanes. The cracks are across both traffic lane directions and has formed between the approach slab and the pavement, about 6 m west of the west abutment fingerplate; note ACP patch placed in 2020 and the dip to the west of the expansion joint

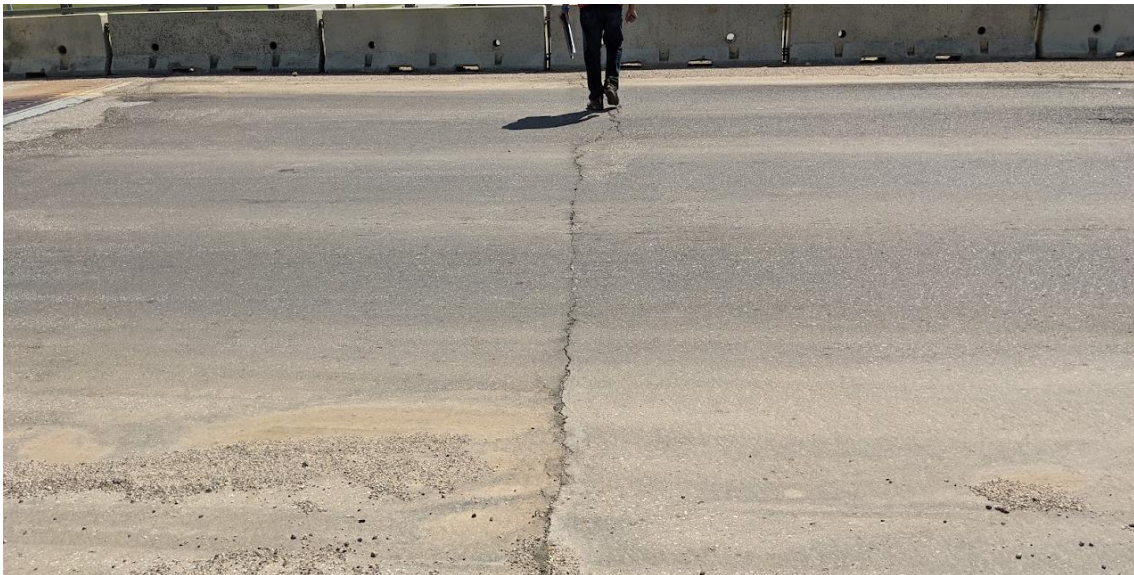
Photo No. 2 – Looking south at the crack across the westbound lanes towards the median. The crack is 5 to 20 mm wide x 5 to 15 mm deep

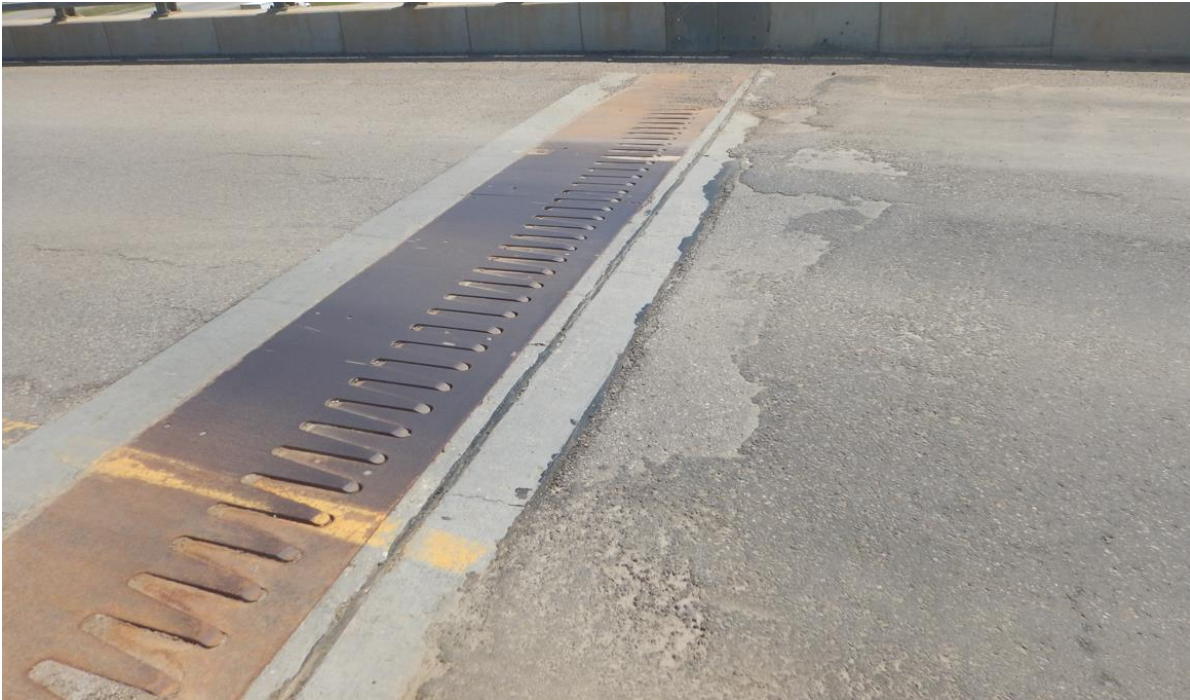
Photo No. 3 – Looking south across the eastbound lanes; there is almost no gap at the joint to accommodate any further movement

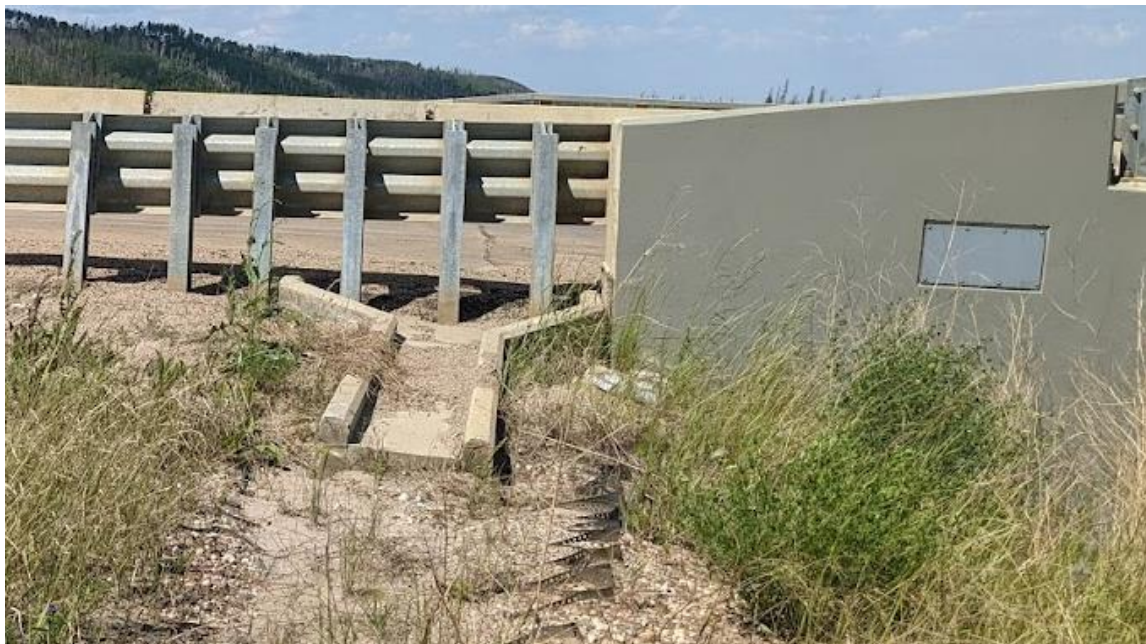
Photo 5 – Looking at the north drain trough. Note the cracking between the drain trough and wingwall.

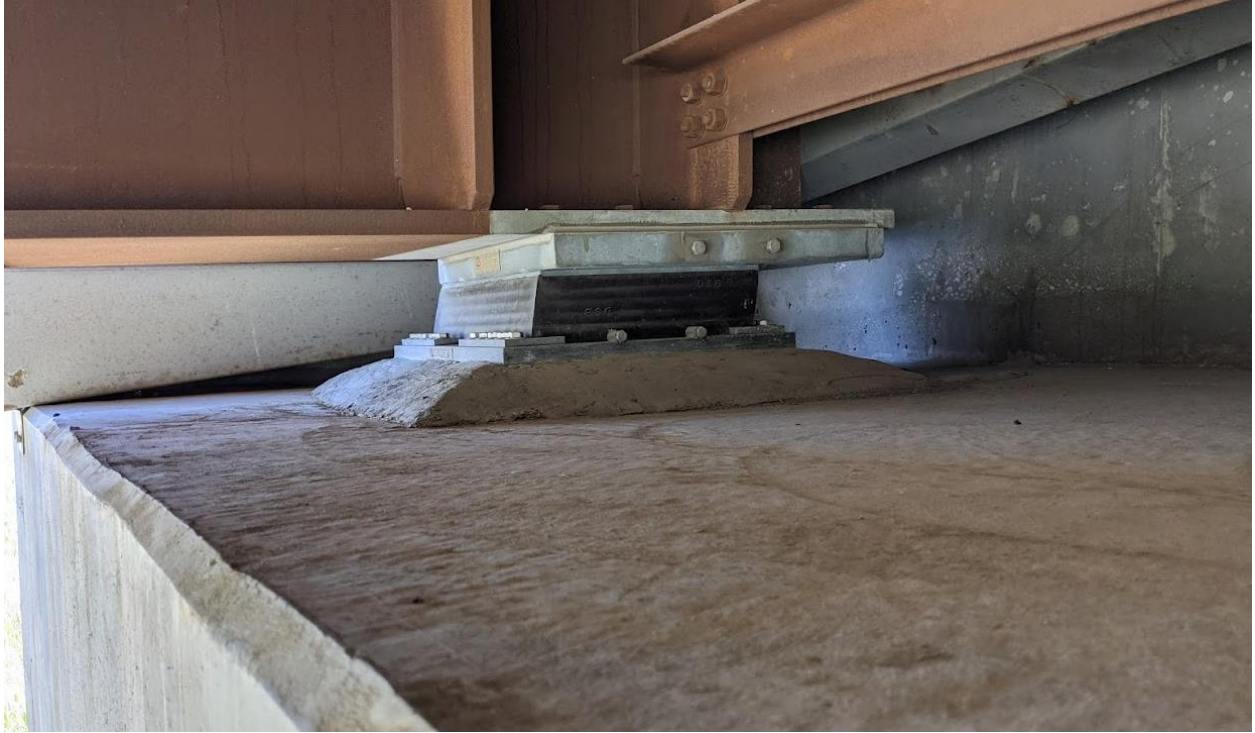
Photo 6 – Bridge bearing position appears be in conformance with design drawings
