THURBER ENGINEERING LTD.

**ALBERTA TRANSPORTATION GRMP (CON0022163)
NORTH CENTRAL (ATHABASCA AND FORT McMURRAY DISTRICTS)
INSTRUMENTATION MONITORING RESULTS – SPRING 2022**

SITE NC097: HWY 63:12 PARSONS CREEK INTERCHANGE

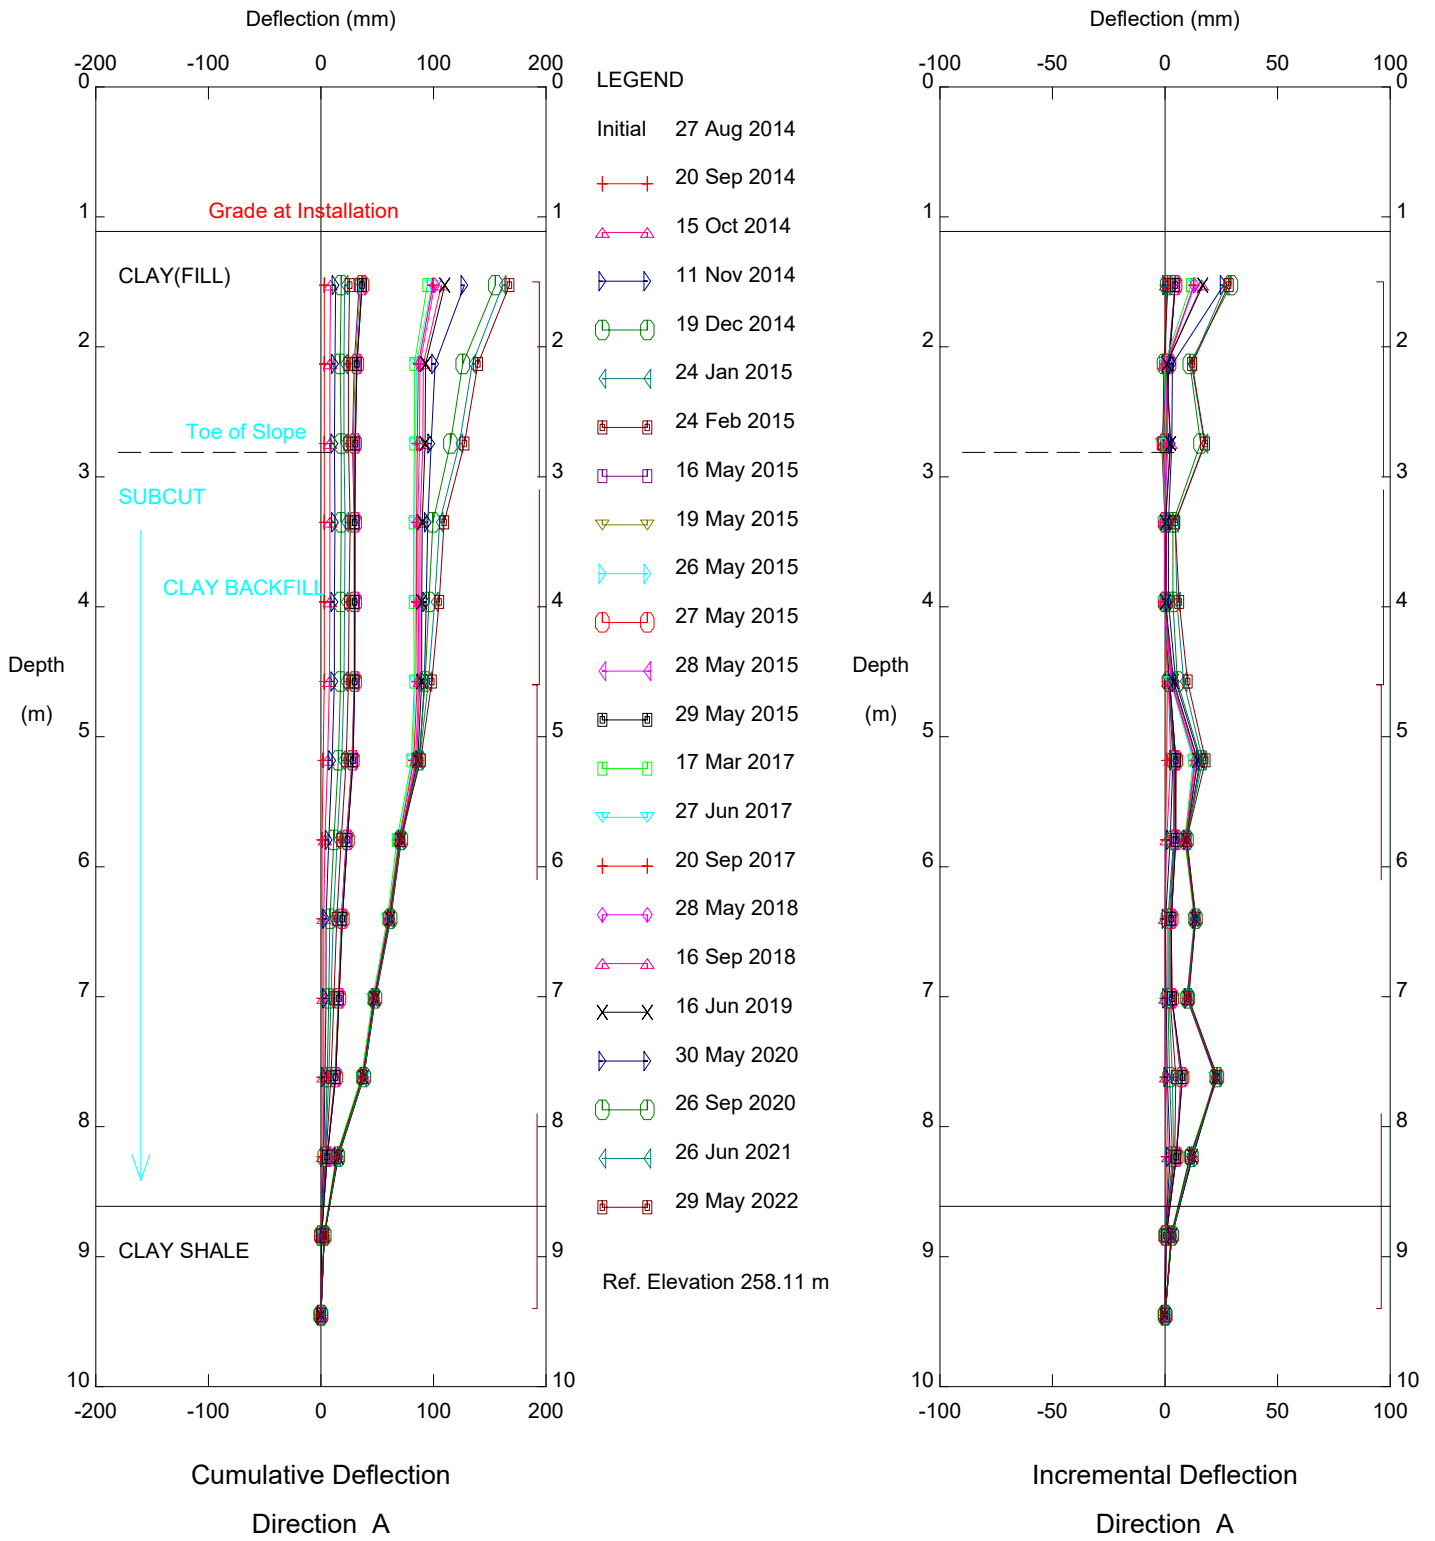
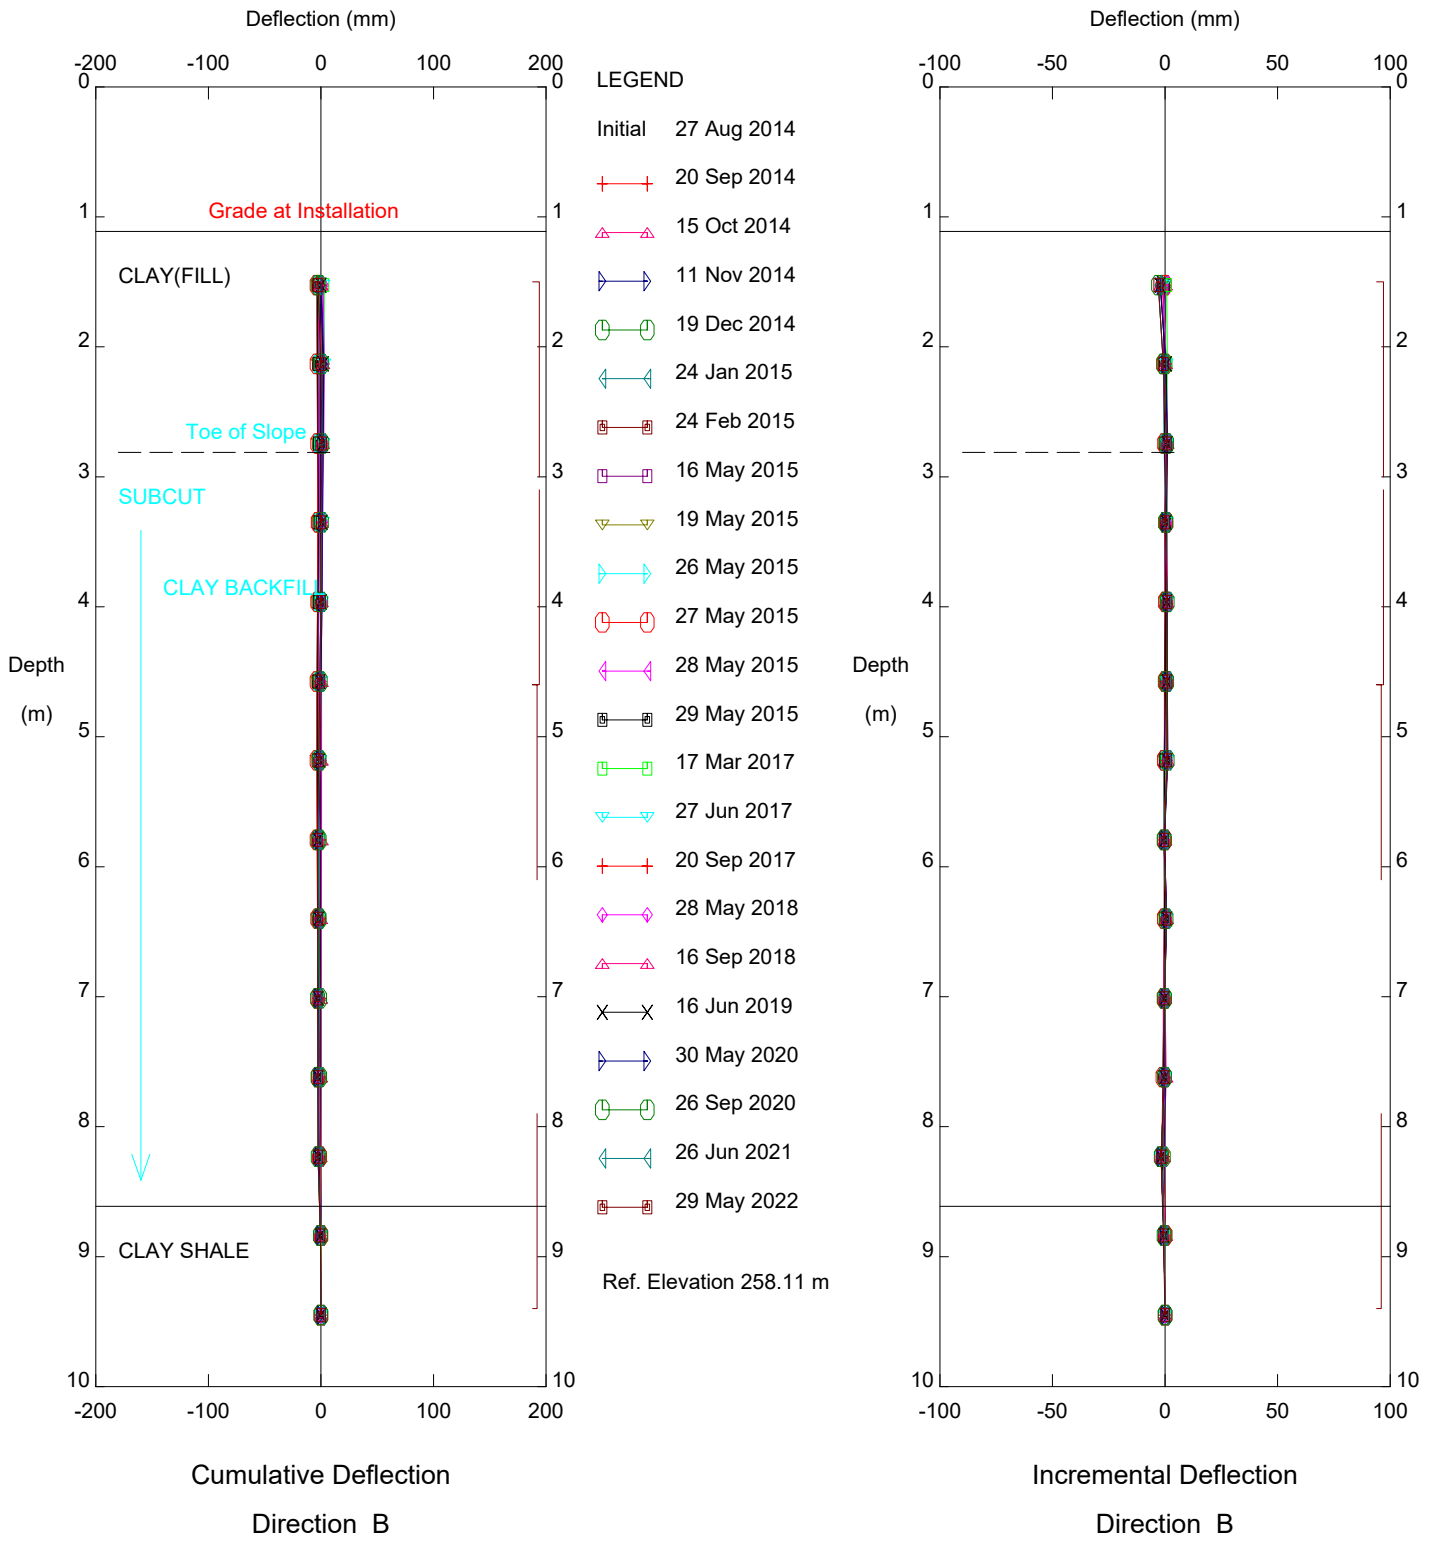
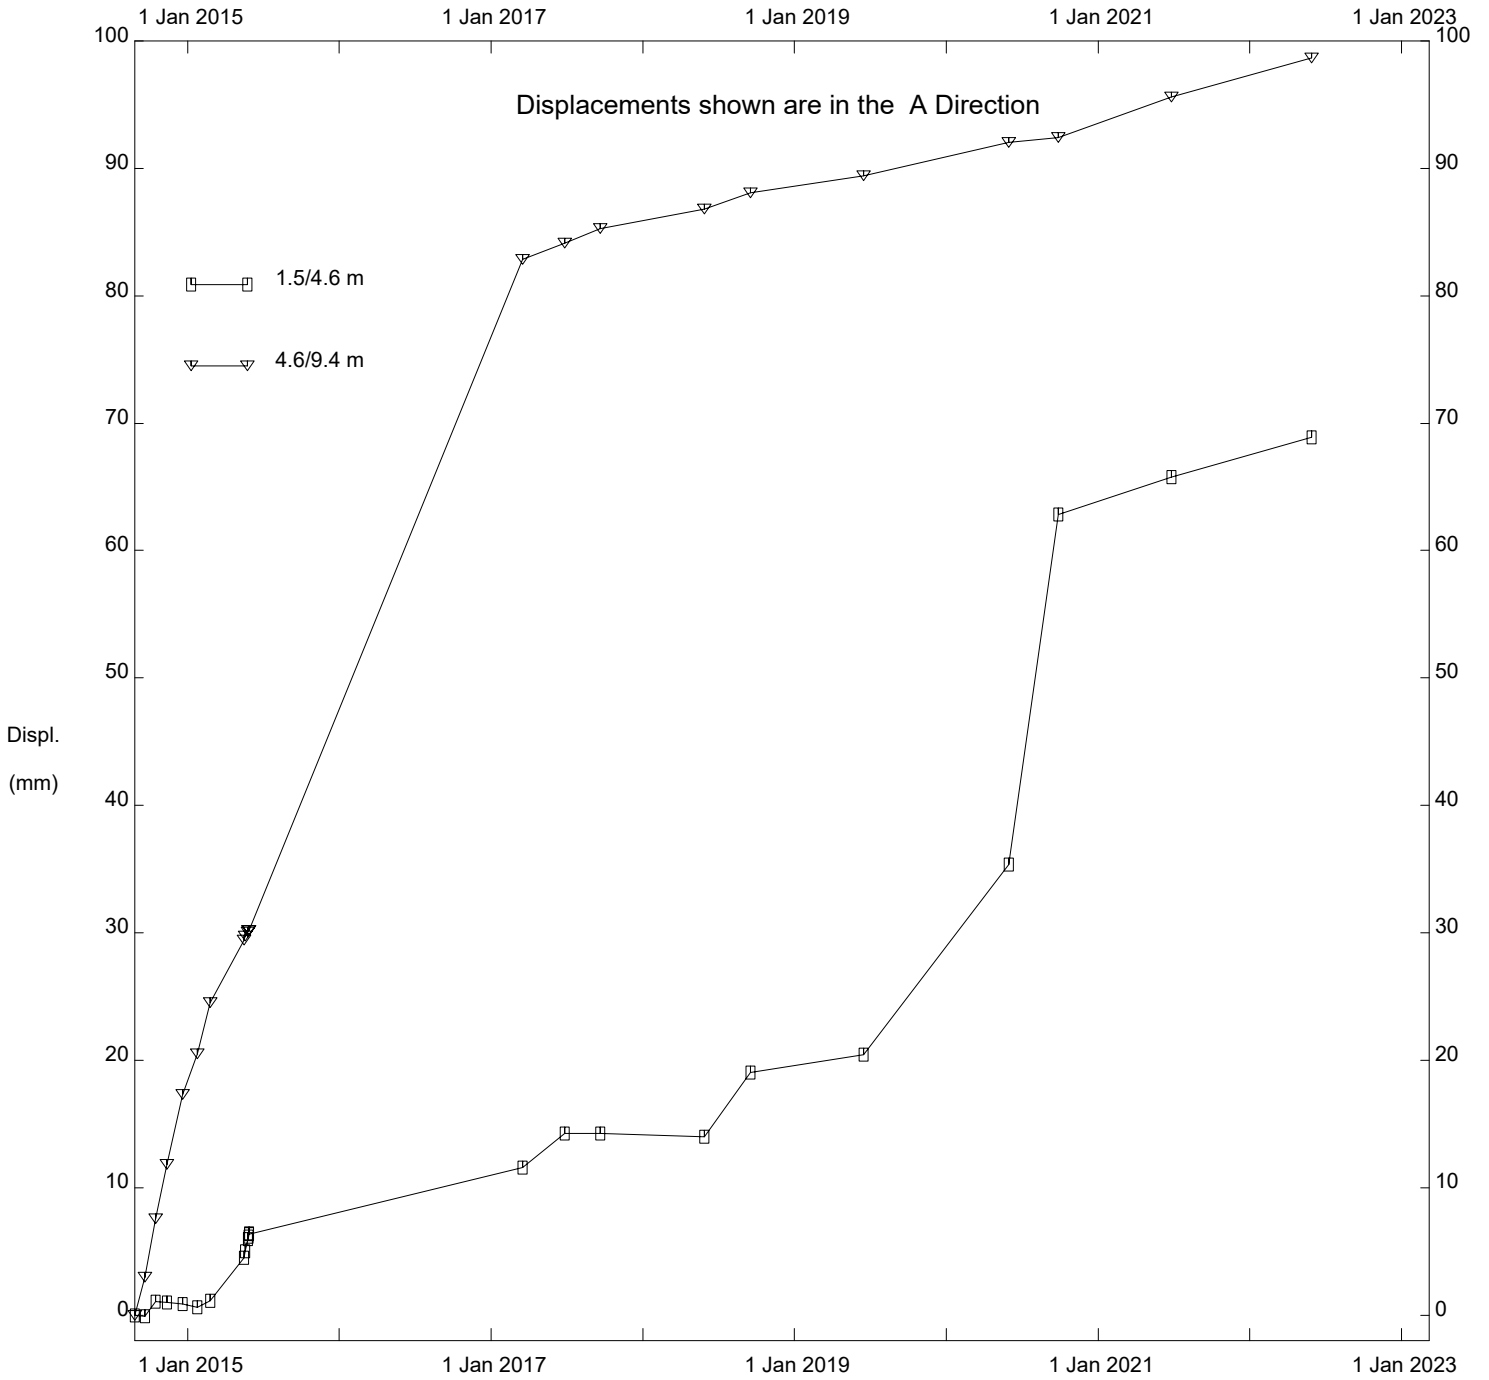
Hwy 686, 49+833.7 o/s +6.6m, Inclinometer SI14-05

Slope inclinometer SI14-05 showed rates of movement of 3.4 mm/yr and 3.3 mm/yr over 1.5 m to 4.6 m depth and 4.6 m to 9.4 m depth, respectively, since the spring of 2021 readings. SI15-14 showed a rate of movement of 2.4 mm/yr over 3.4 m to 12.5 m depth since the spring of 2021 readings.

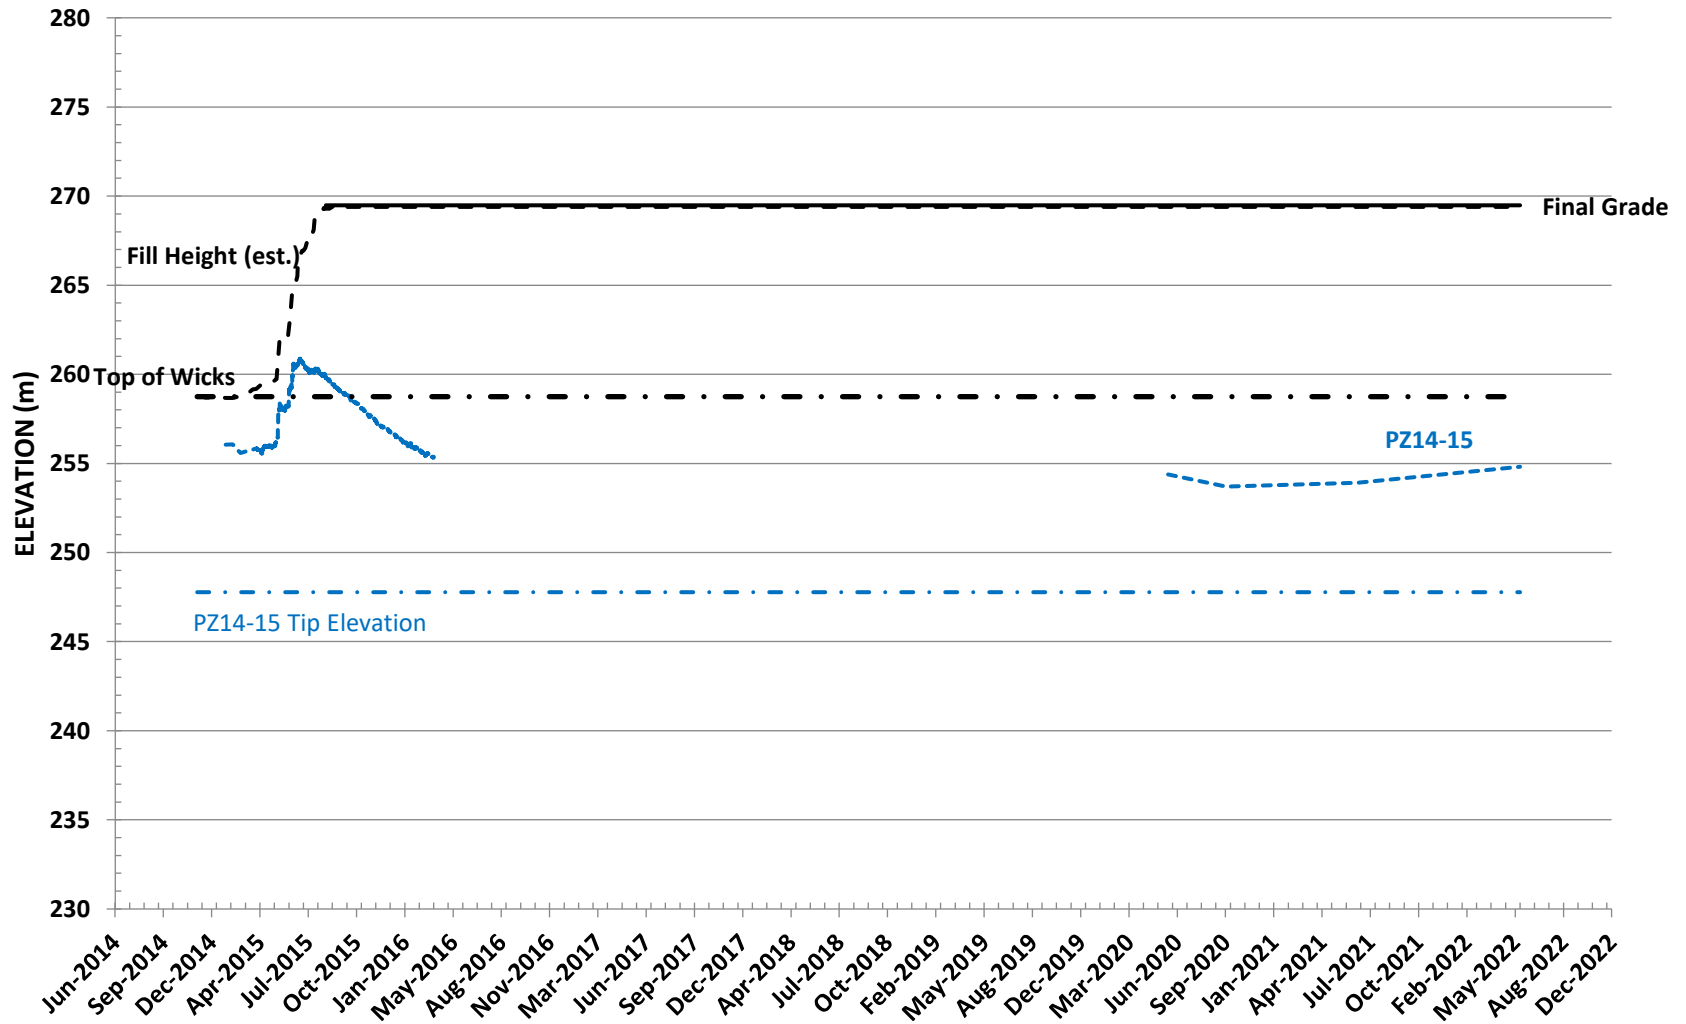
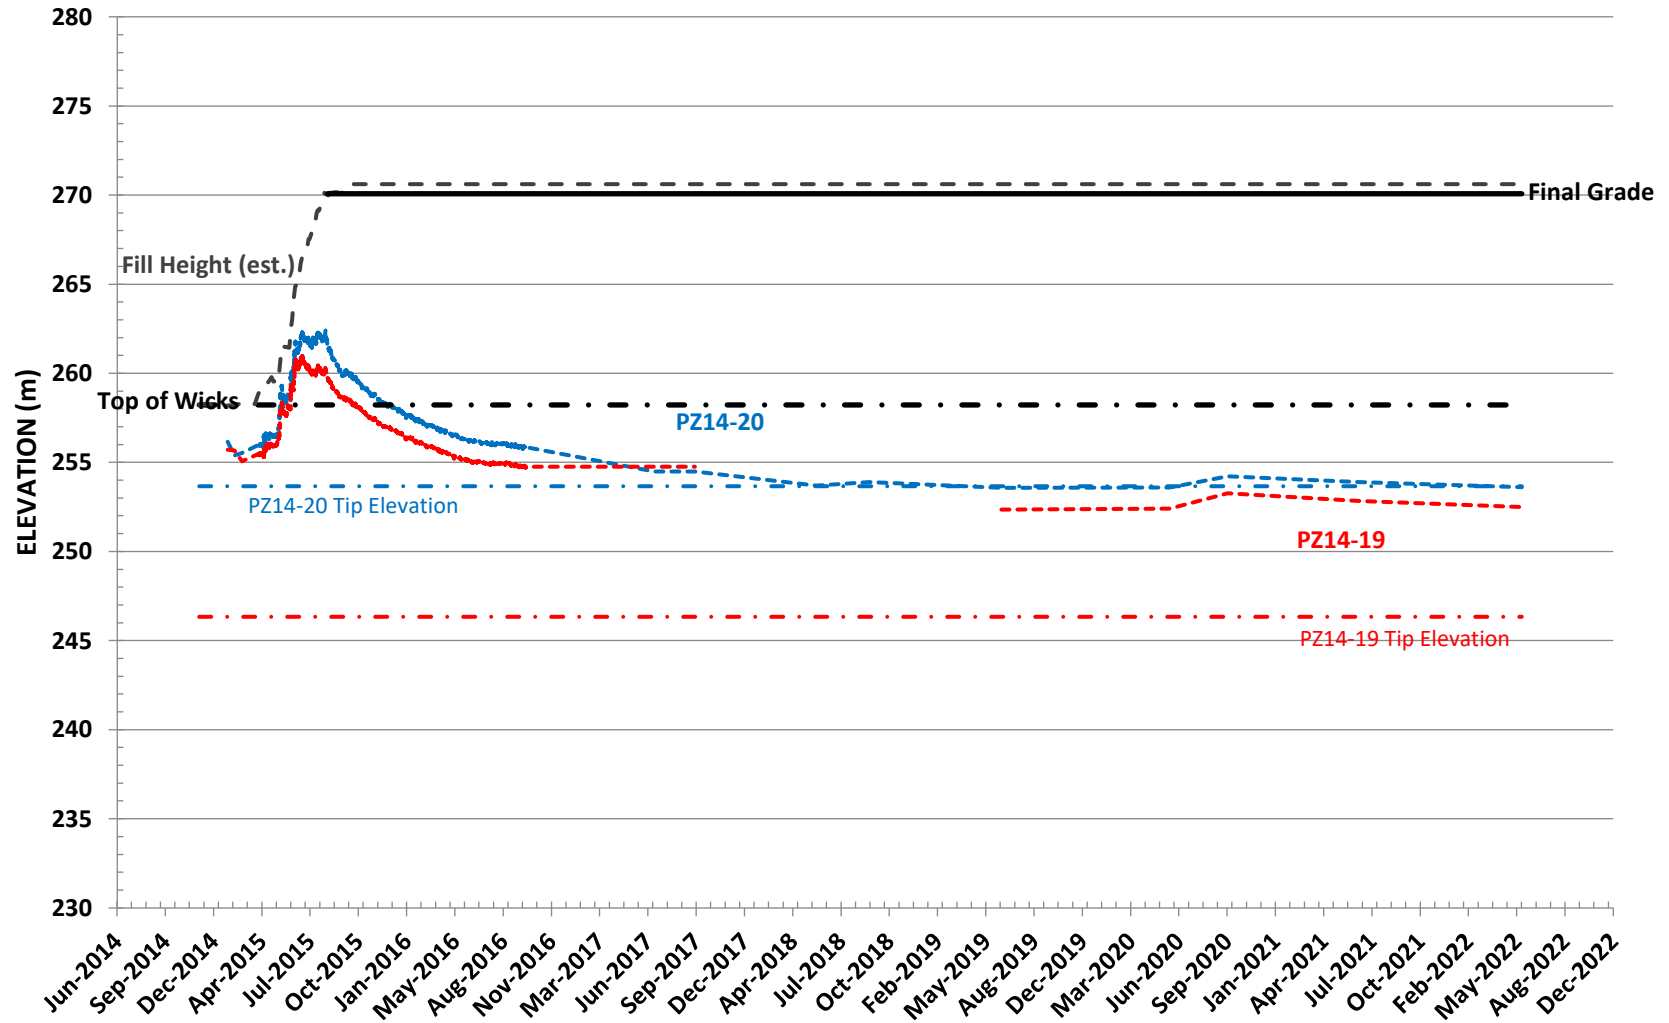
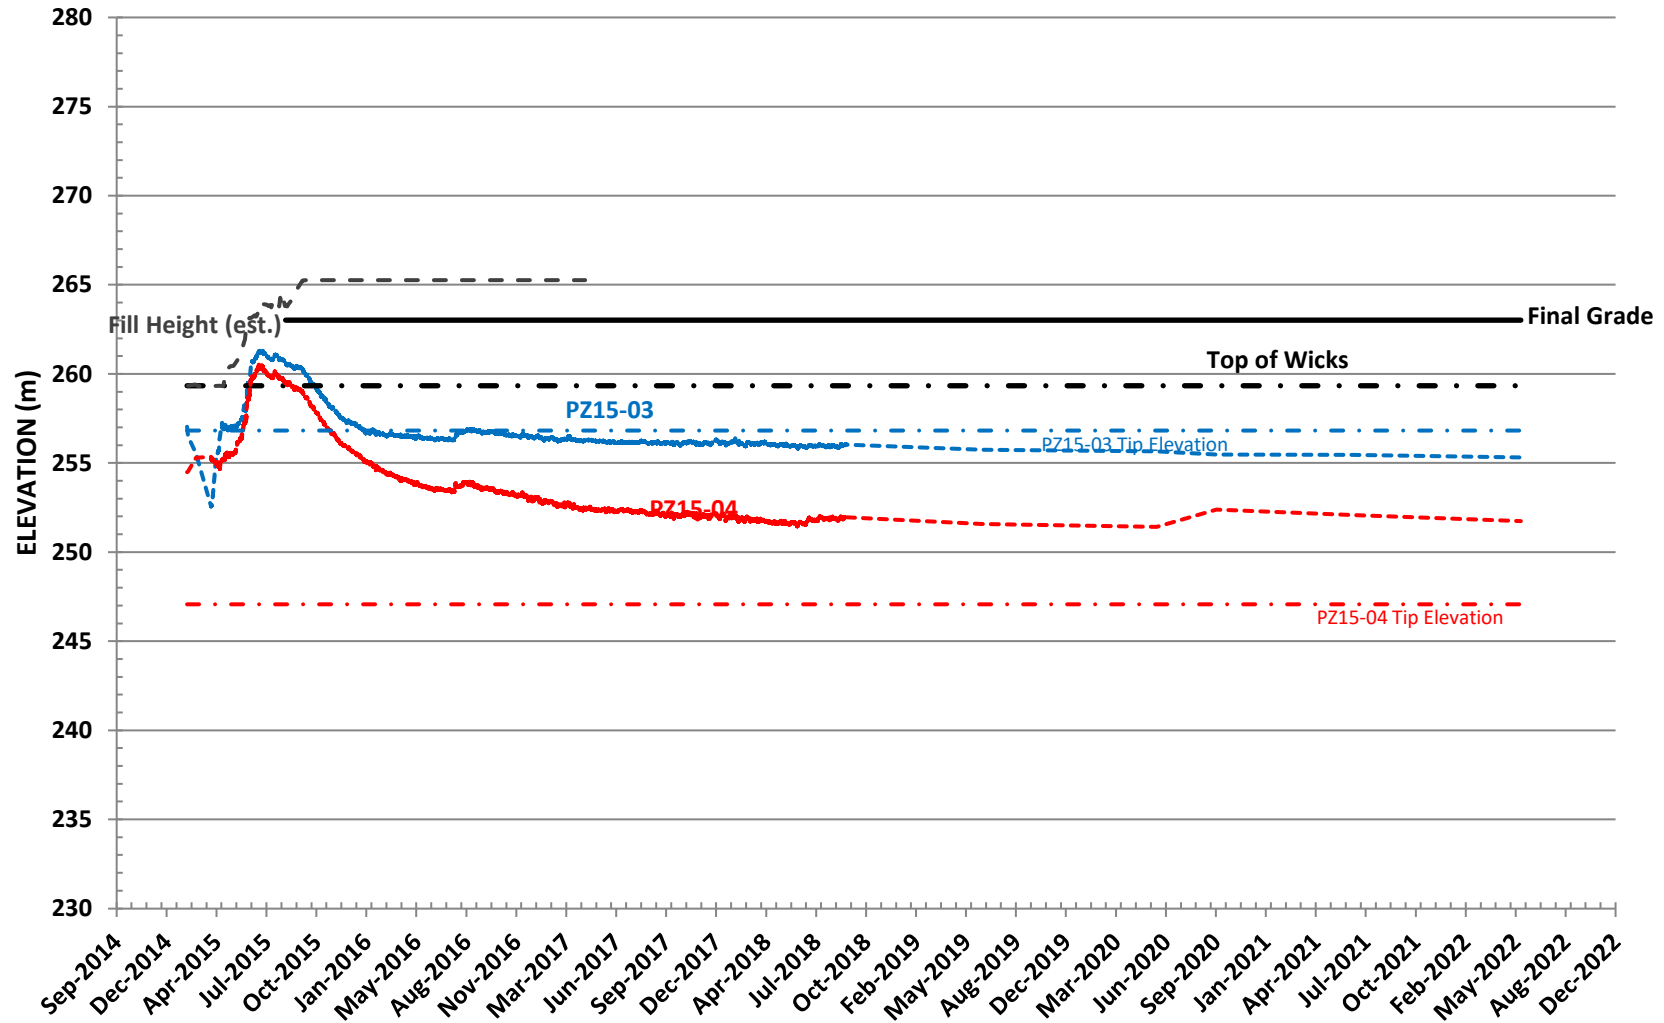
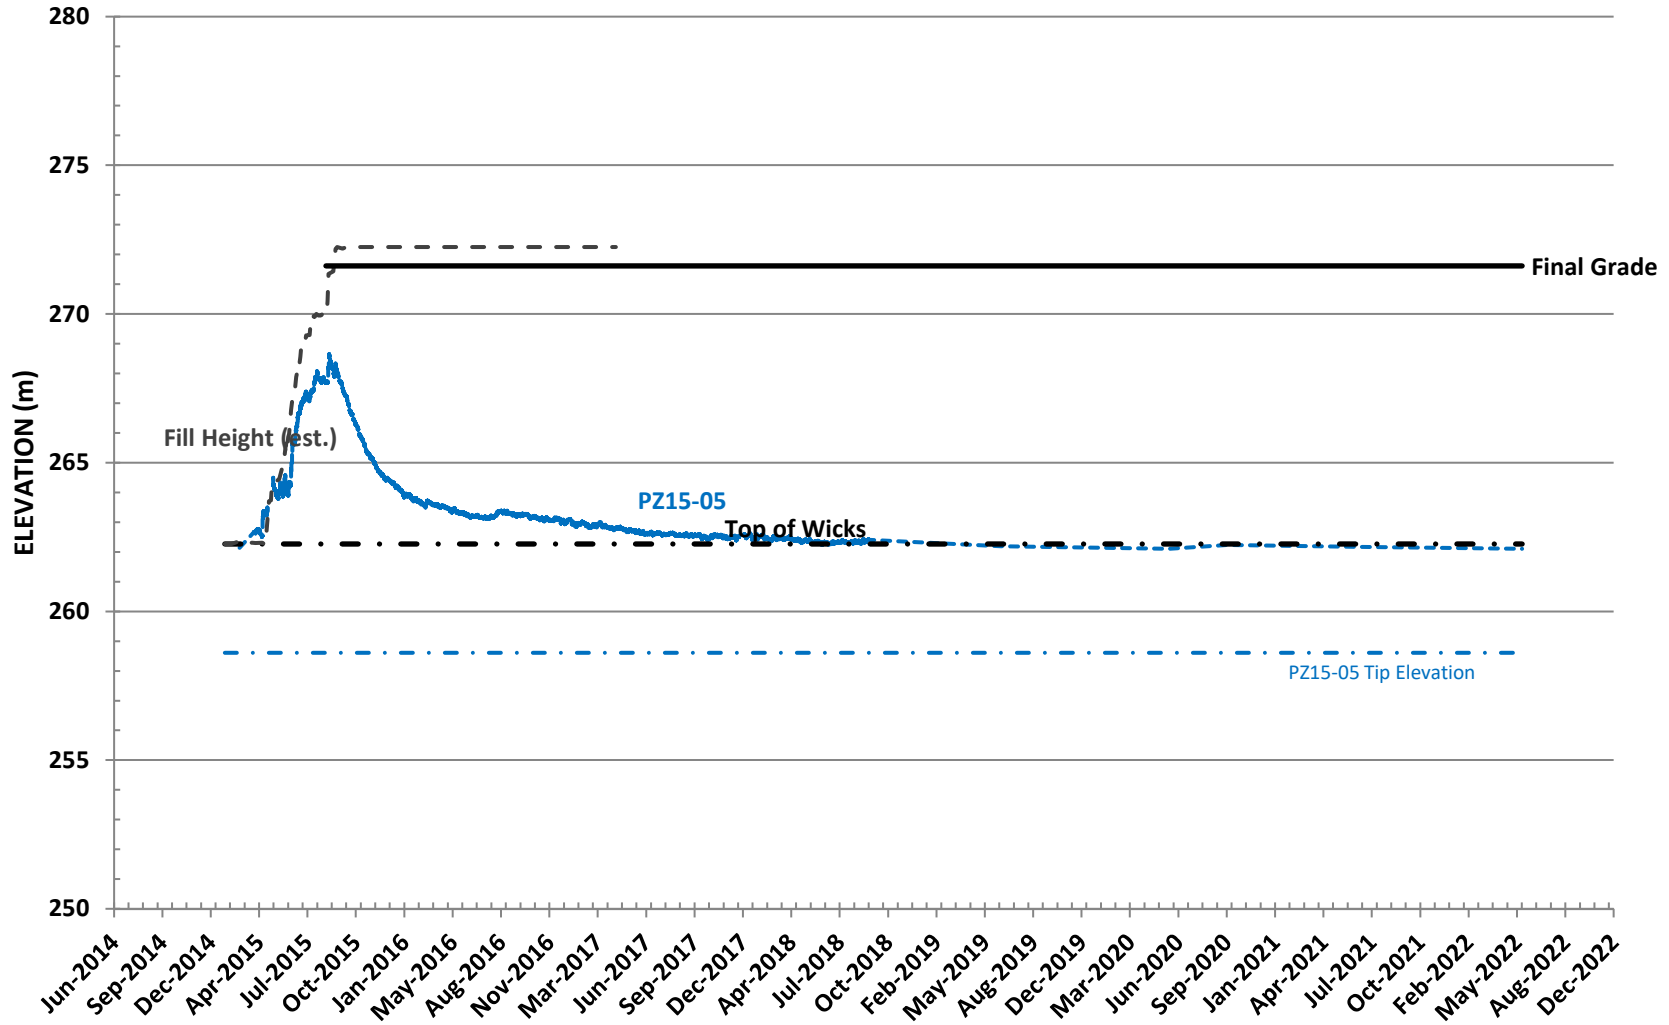
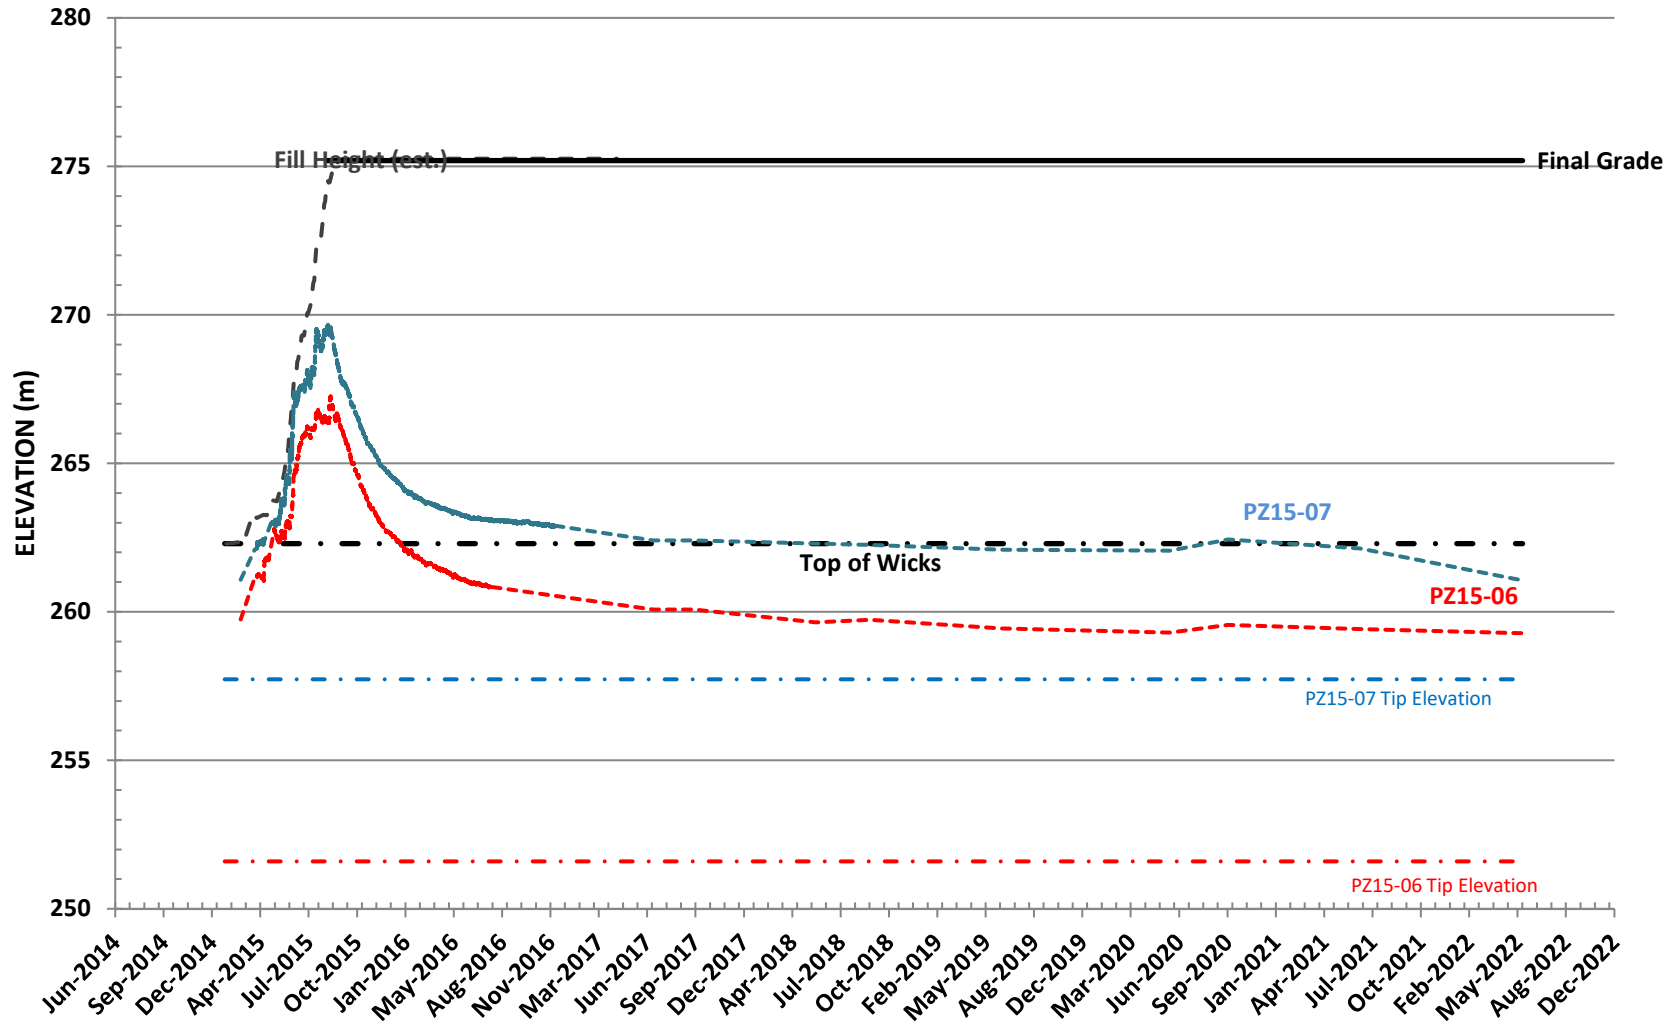
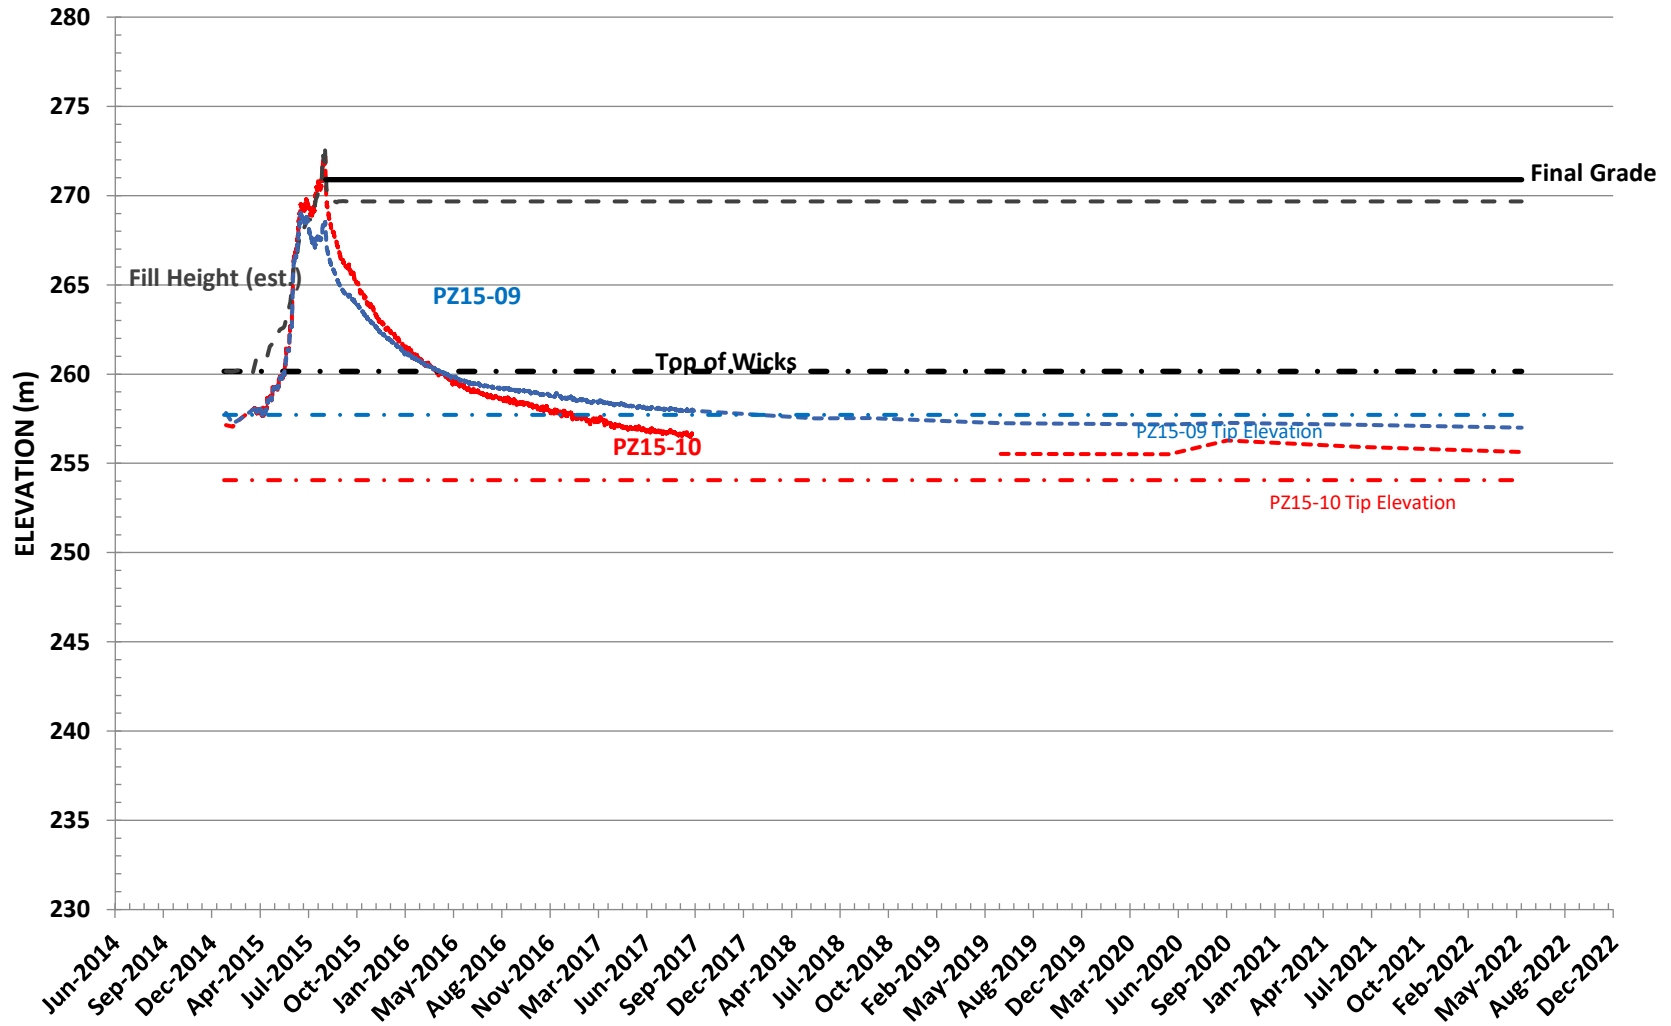
The groundwater levels decreased in the majority in the vibrating wire piezometers installed within the Parsons Creek Interchange compared to the spring of 2021 readings. The groundwater level decreases ranged from of 0.07 m in PZ15-05 to a decrease of 1.07 m in PZ15-07. The groundwater level in piezometer PZ14-15 showed an increase of 0.89 m since the spring of 2021 readings. Piezometers PZ15-03 and PZ15-09 continued to be dry. The vibrating wire piezometer readings are summarized in Table NC097-2 and are plotted on Figures PZ1 through PZ6 in Appendix A.
