THURBER ENGINEERING LTD.

**ALBERTA TRANSPORTATION GRMP (CON0022163)
NORTH CENTRAL (ATHABASCA AND FORT McMURRAY DISTRICTS)
INSTRUMENTATION MONITORING RESULTS – SPRING 2022**

SITE NC097: HWY 63:12 PARSONS CREEK INTERCHANGE

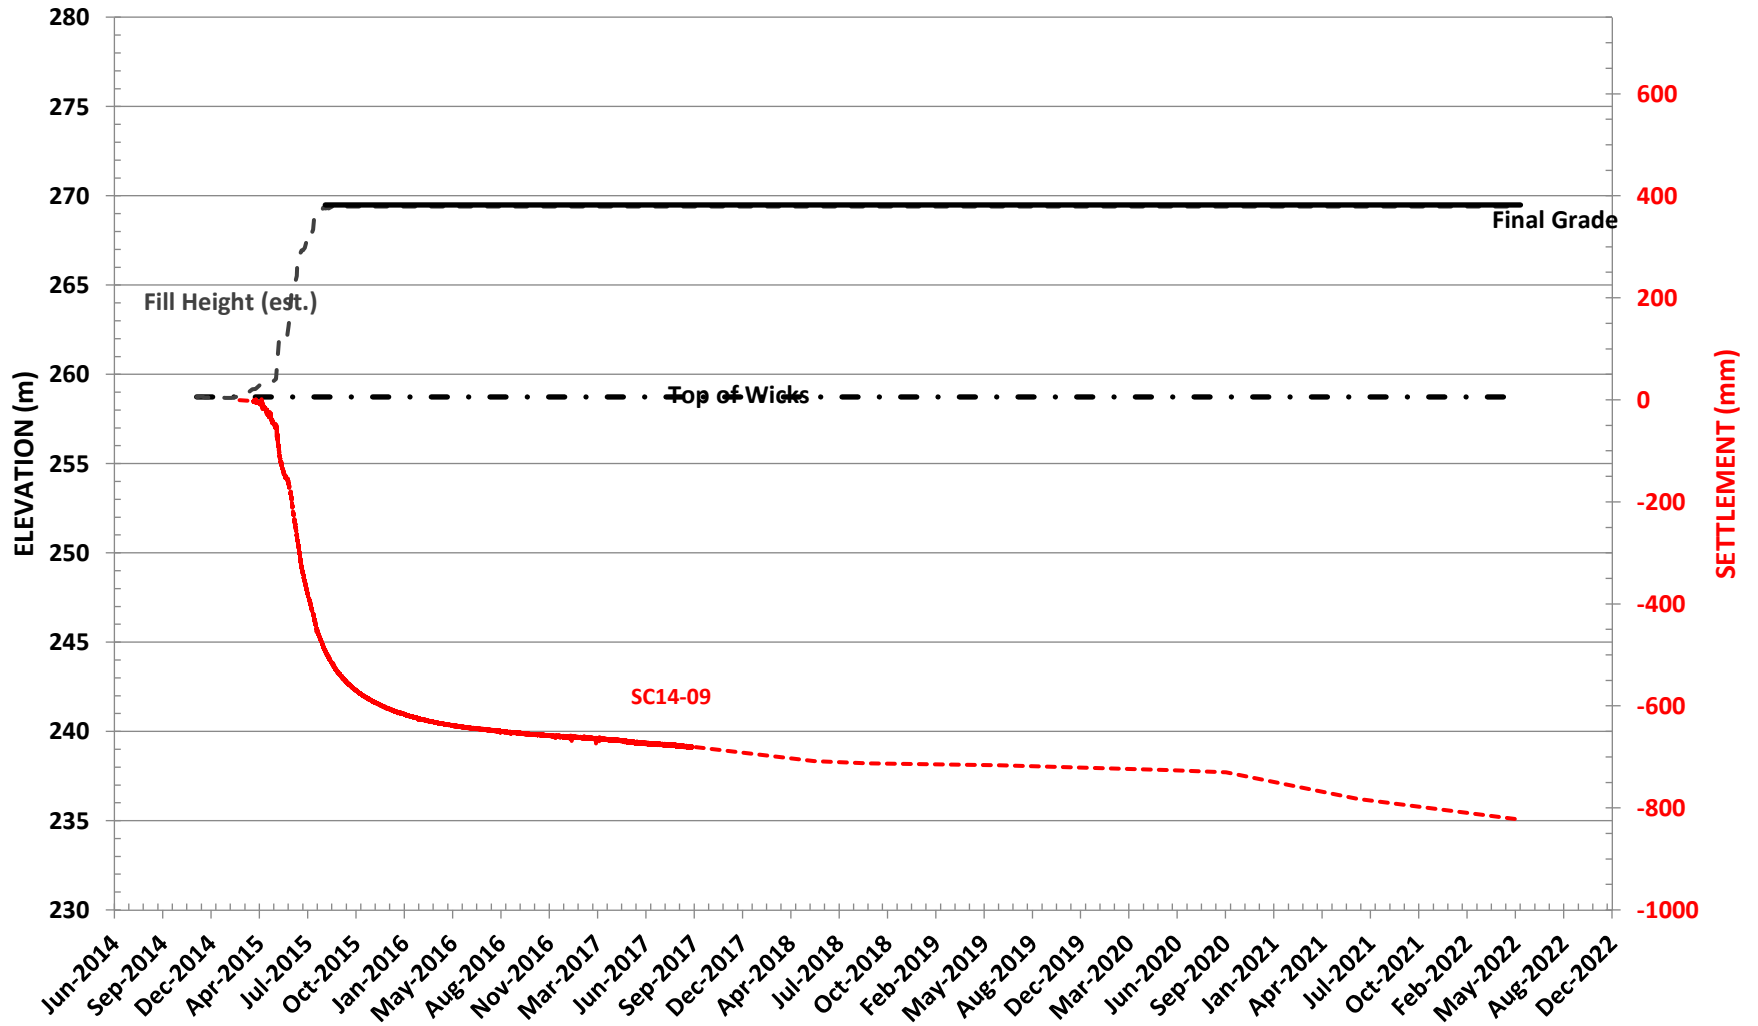
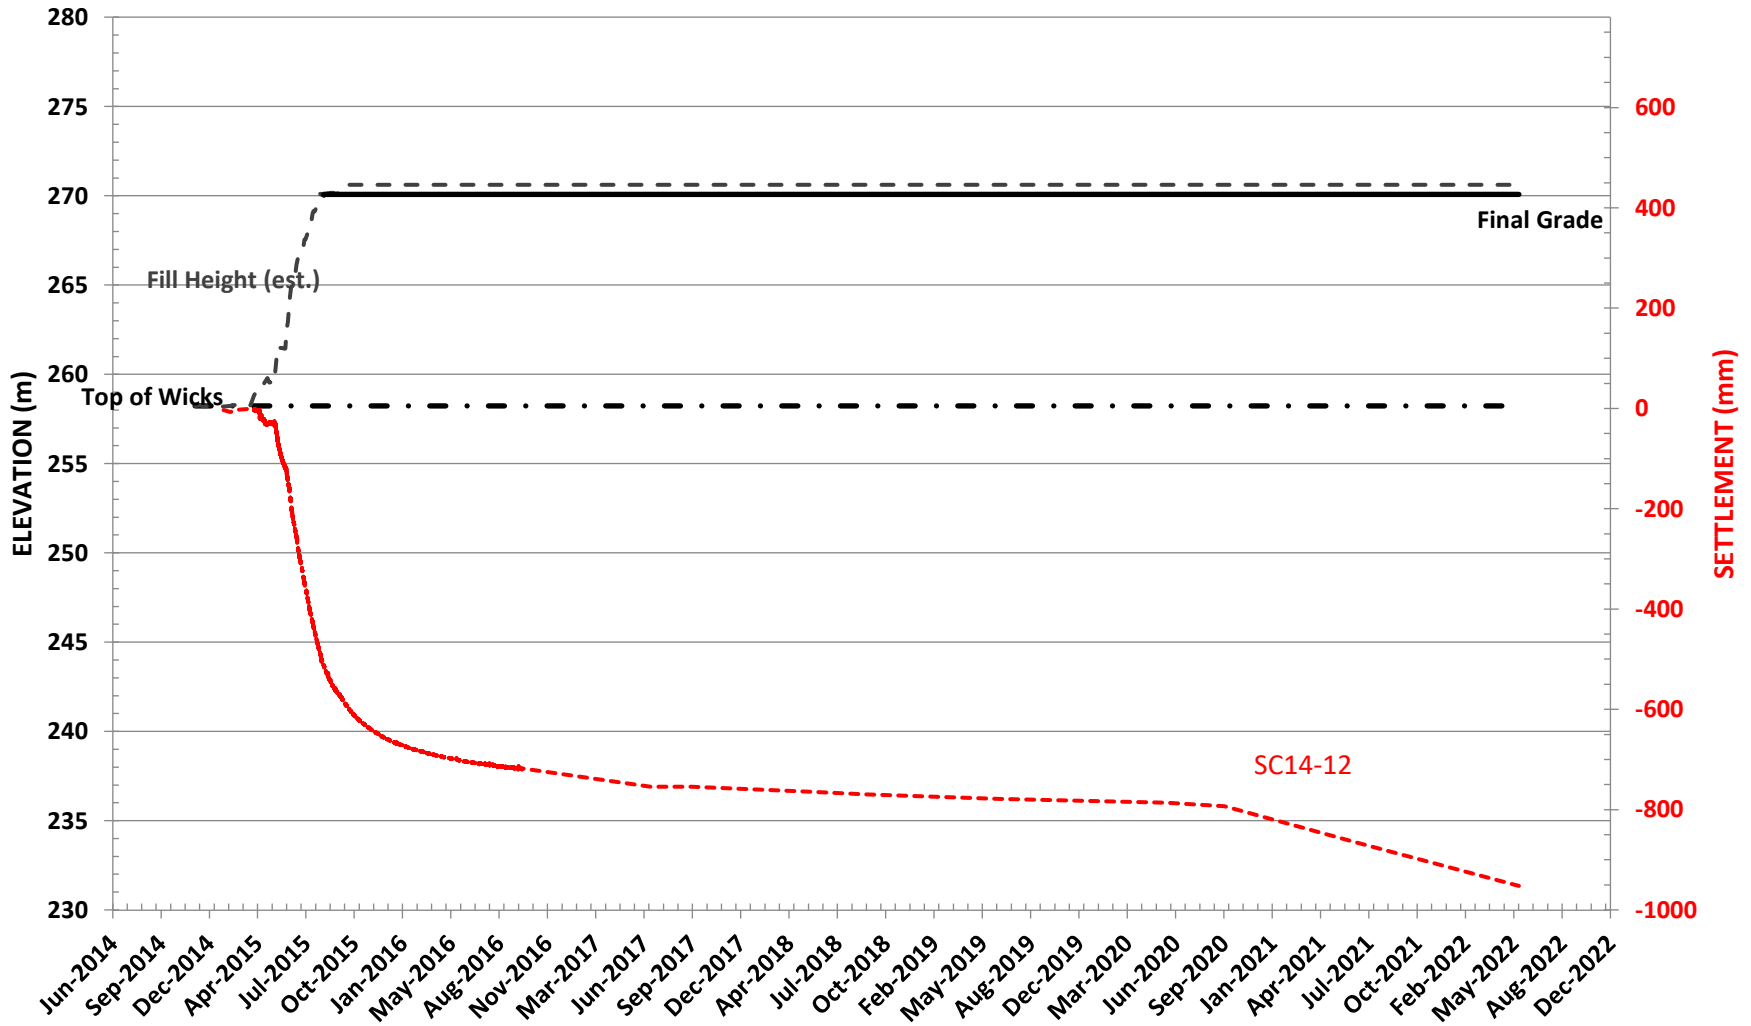
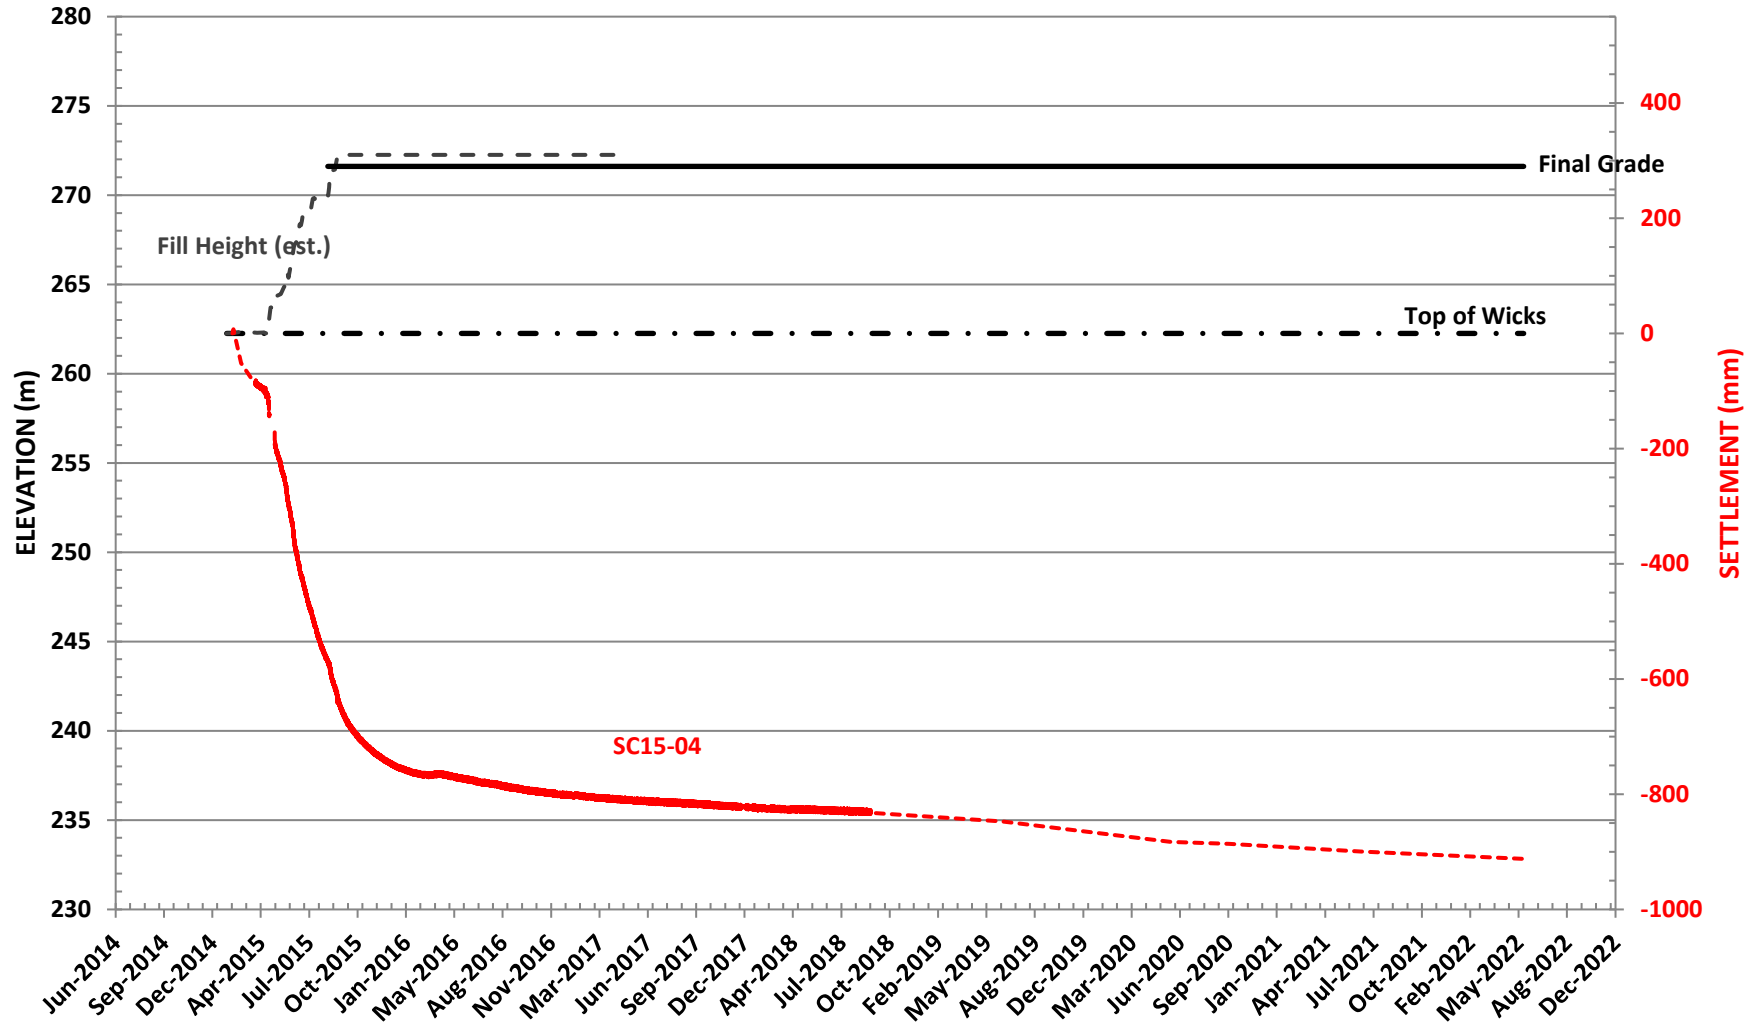
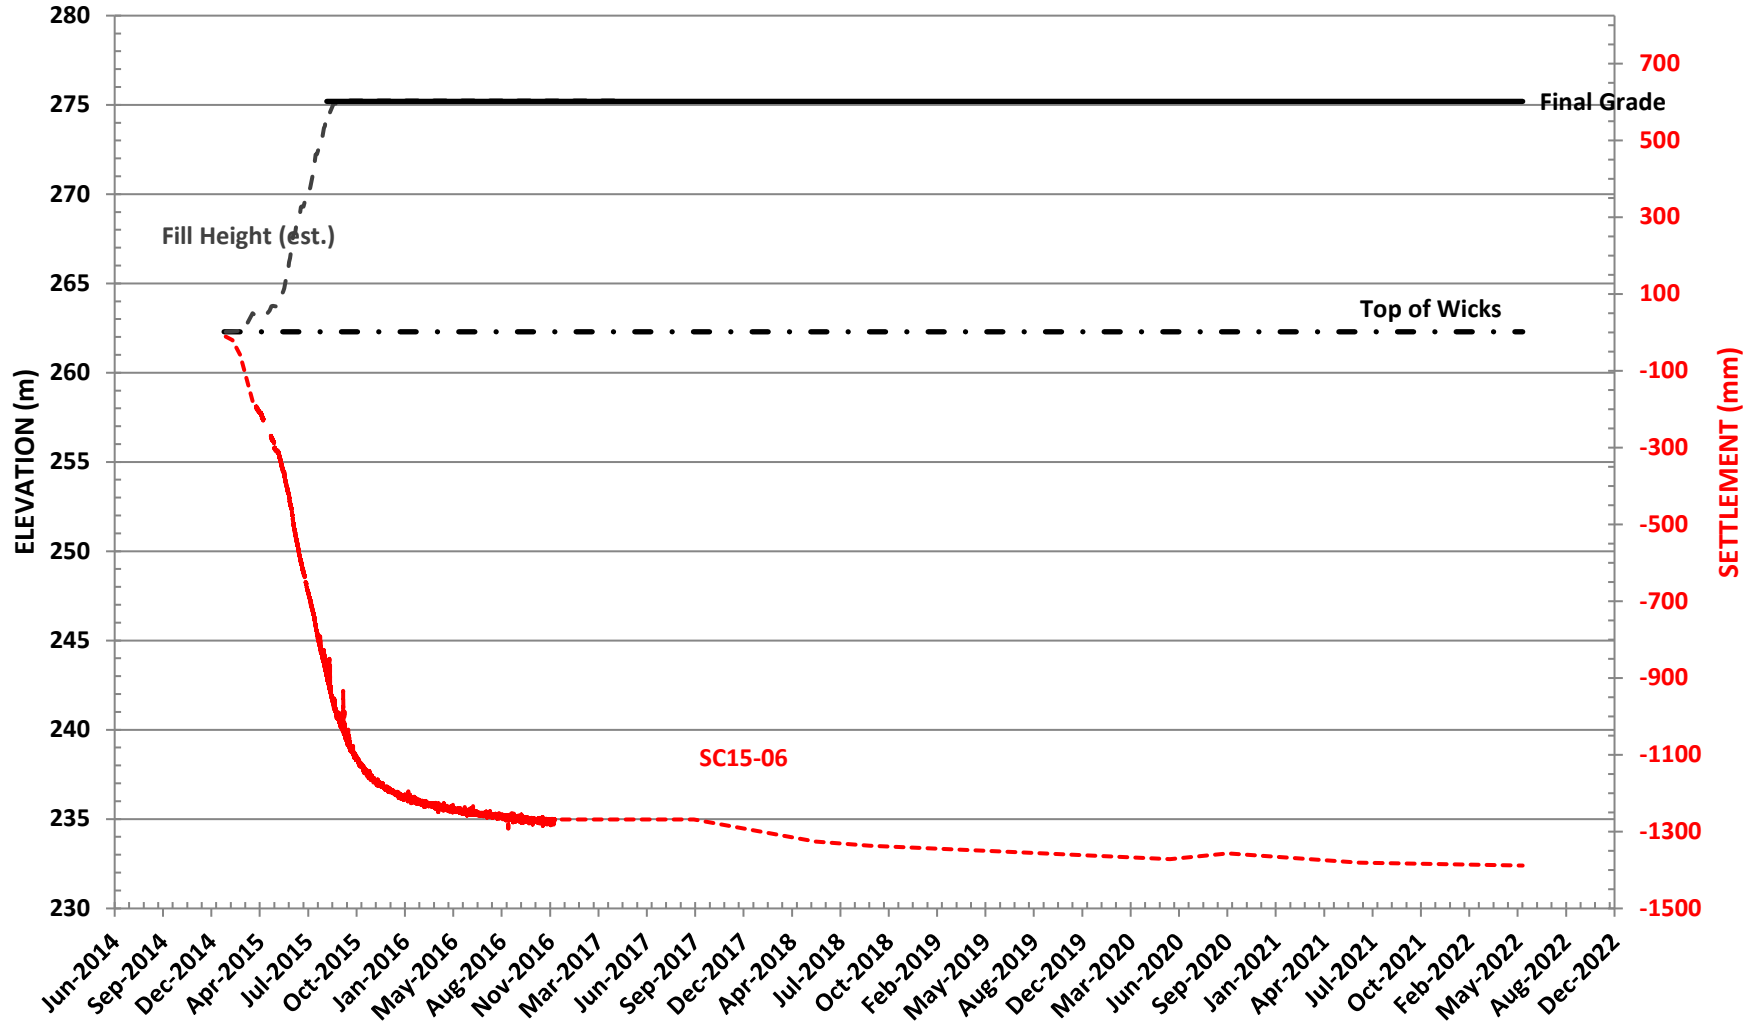
The settlement cells all showed increases in settlement compared to the spring of 2021 readings. The increases in settlement ranged from 8.04 mm in SC15-06 to 86.48 mm in SC14-12. The settlement cells are summarized in Table NC097-3 above and are plotted on Figures SC1 through SC4 in Appendix A.

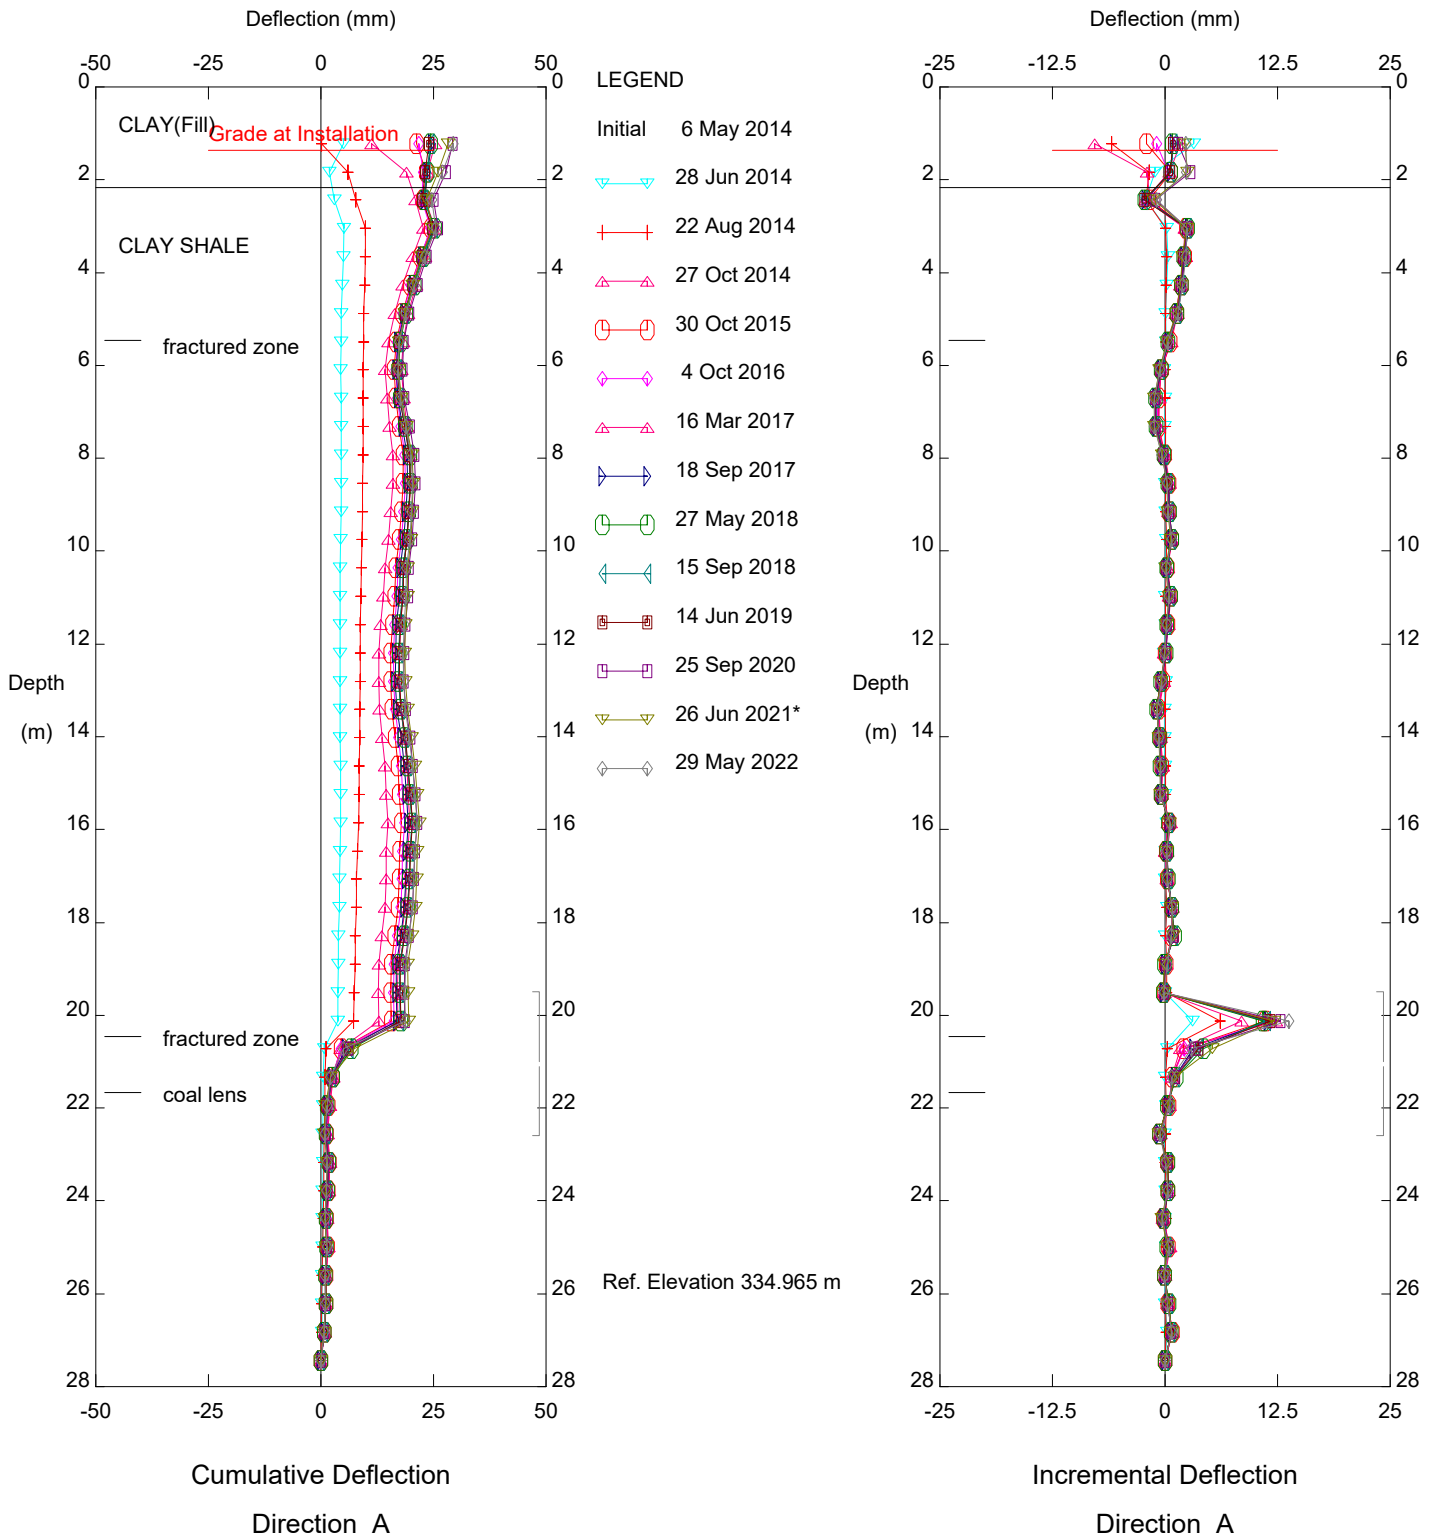
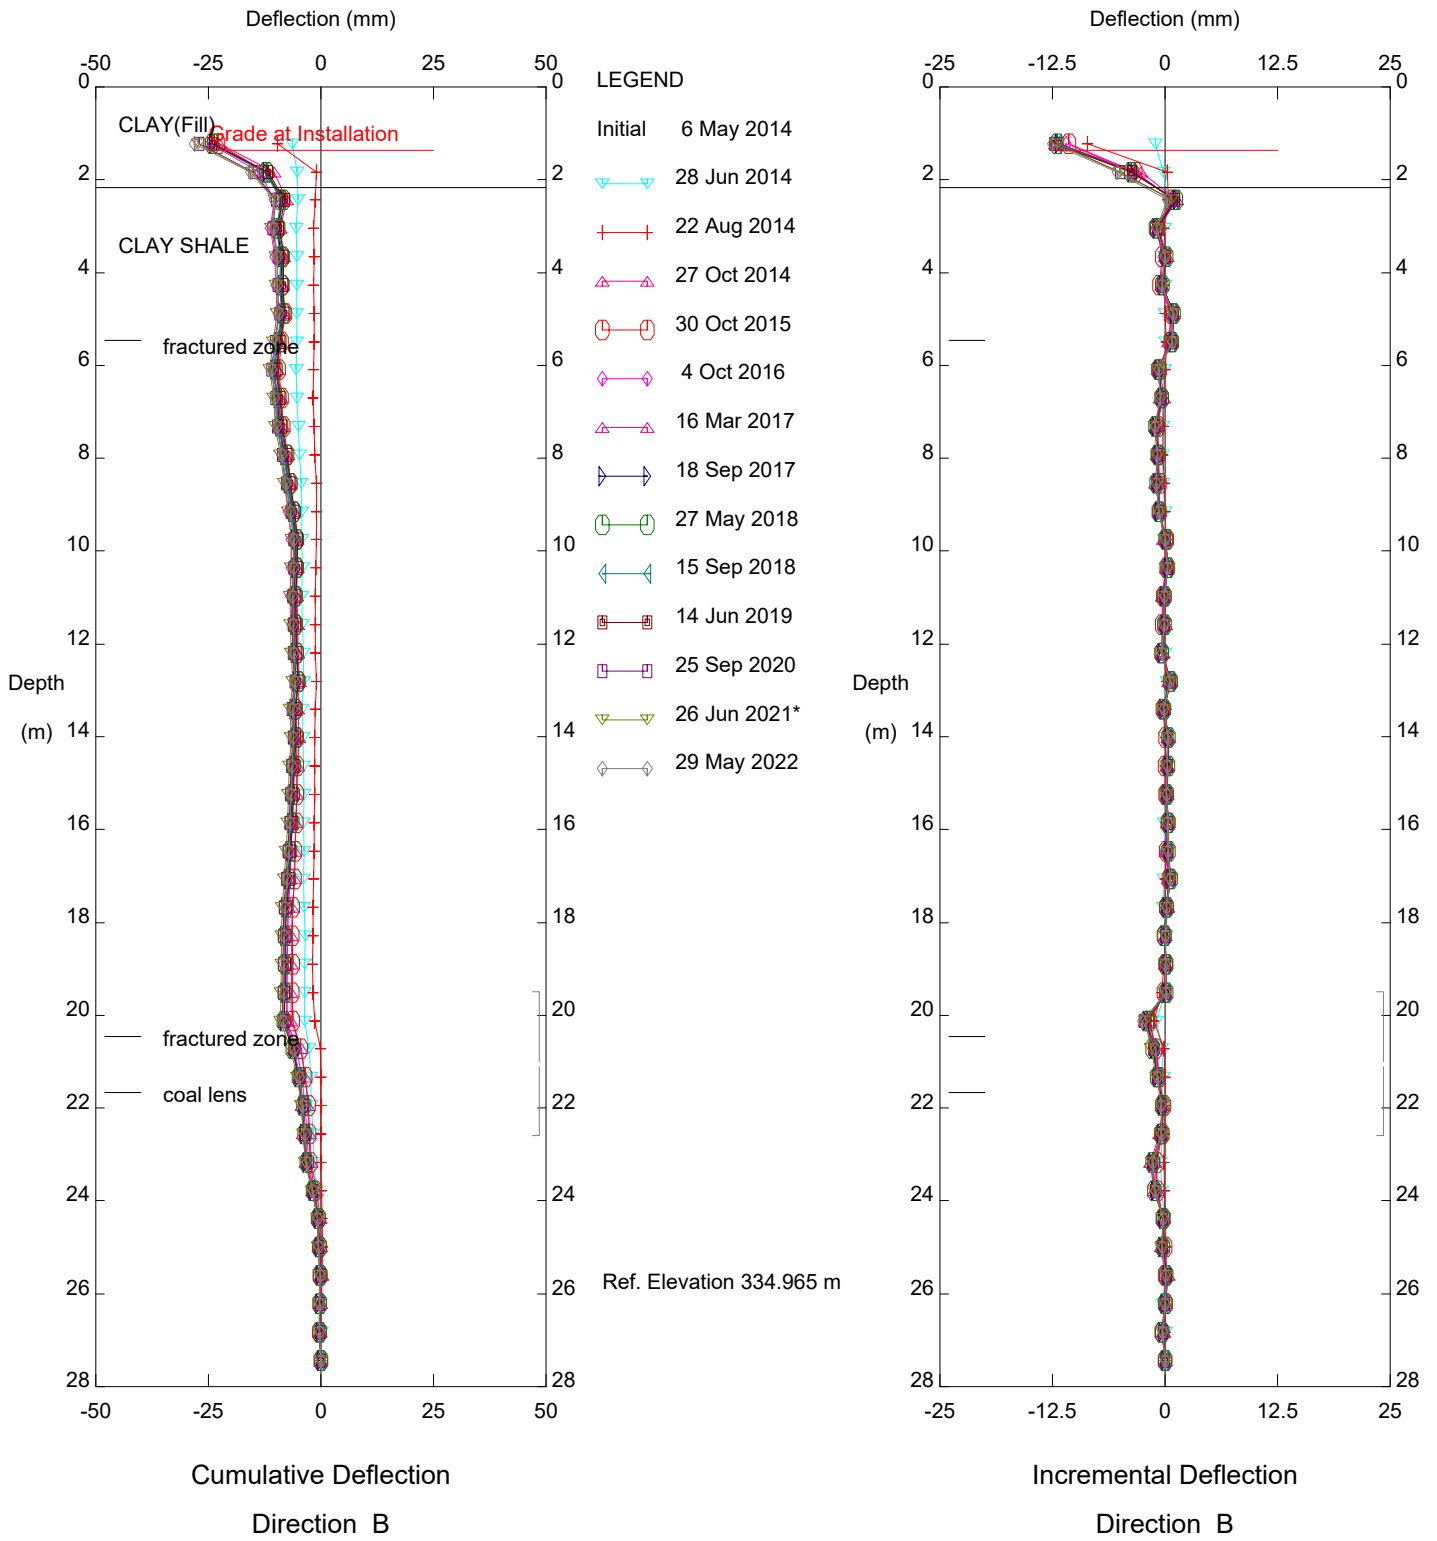
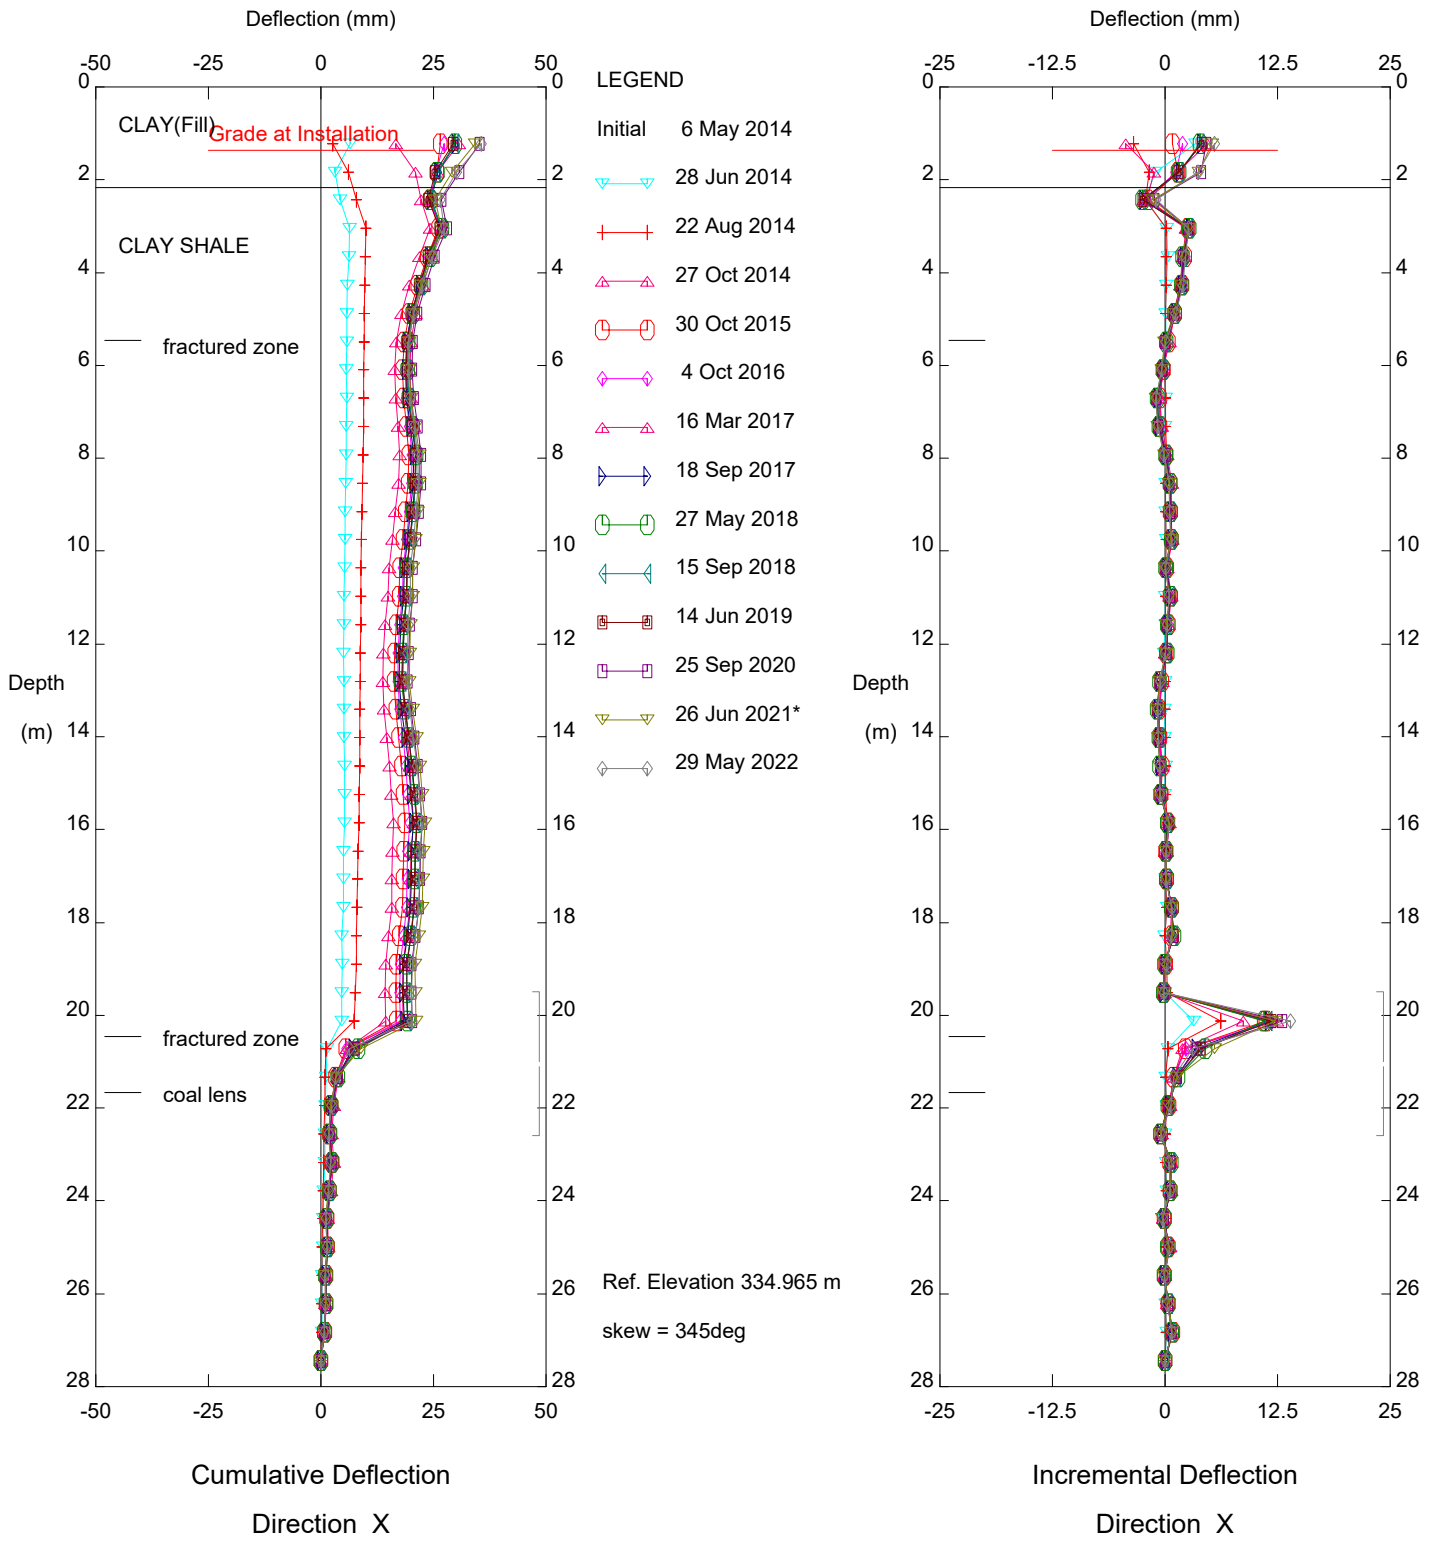
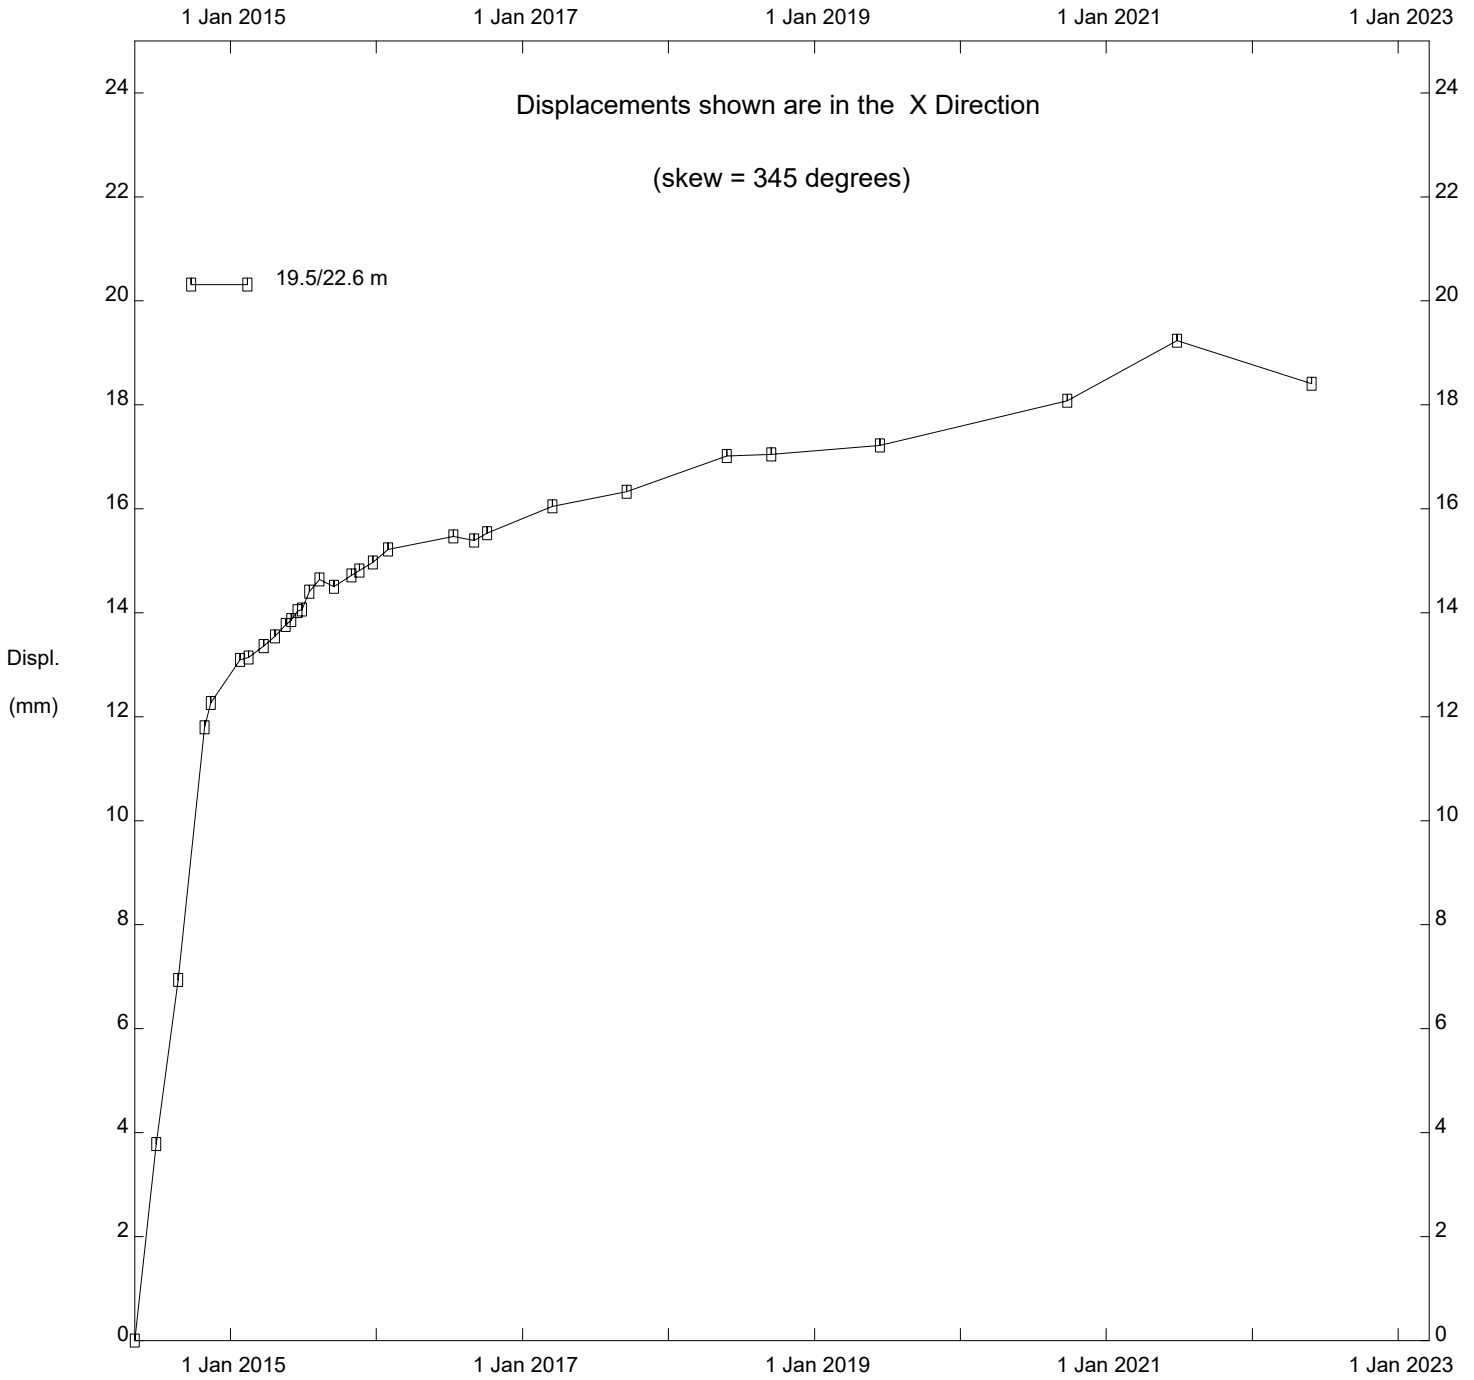
HWY 686, 48+973 o/s -173m, Inclinometer SI14-09A

SI14-09A showed no discernible movement over 19.5 m to 22.6 m depth since the spring of 2021 readings. SI14-13 showed a rate of movement of 3.7 mm/yr over 10.1 m to 11.3 m depth since the spring of 2021 readings. SI14-14 showed rates of movement of 5.0 mm/yr and 1.6 mm/yr over 4.0 m to 5.8 m depth and 9.4 m to 11.3 m depth, respectively, since the spring of 2021 readings. SI14-19 showed a rate of movement of 5.3 mm/yr over 5.8 m to 7.6 m depth since the spring of 2021 readings.
