THURBER ENGINEERING LTD.

**ALBERTA TRANSPORTATION GRMP (CON0022163)
NORTH CENTRAL (ATHABASCA AND FORT McMURRAY DISTRICTS)
INSTRUMENTATION MONITORING RESULTS – SPRING 2022**

SITE NC097: HWY 63:12 PARSONS CREEK INTERCHANGE

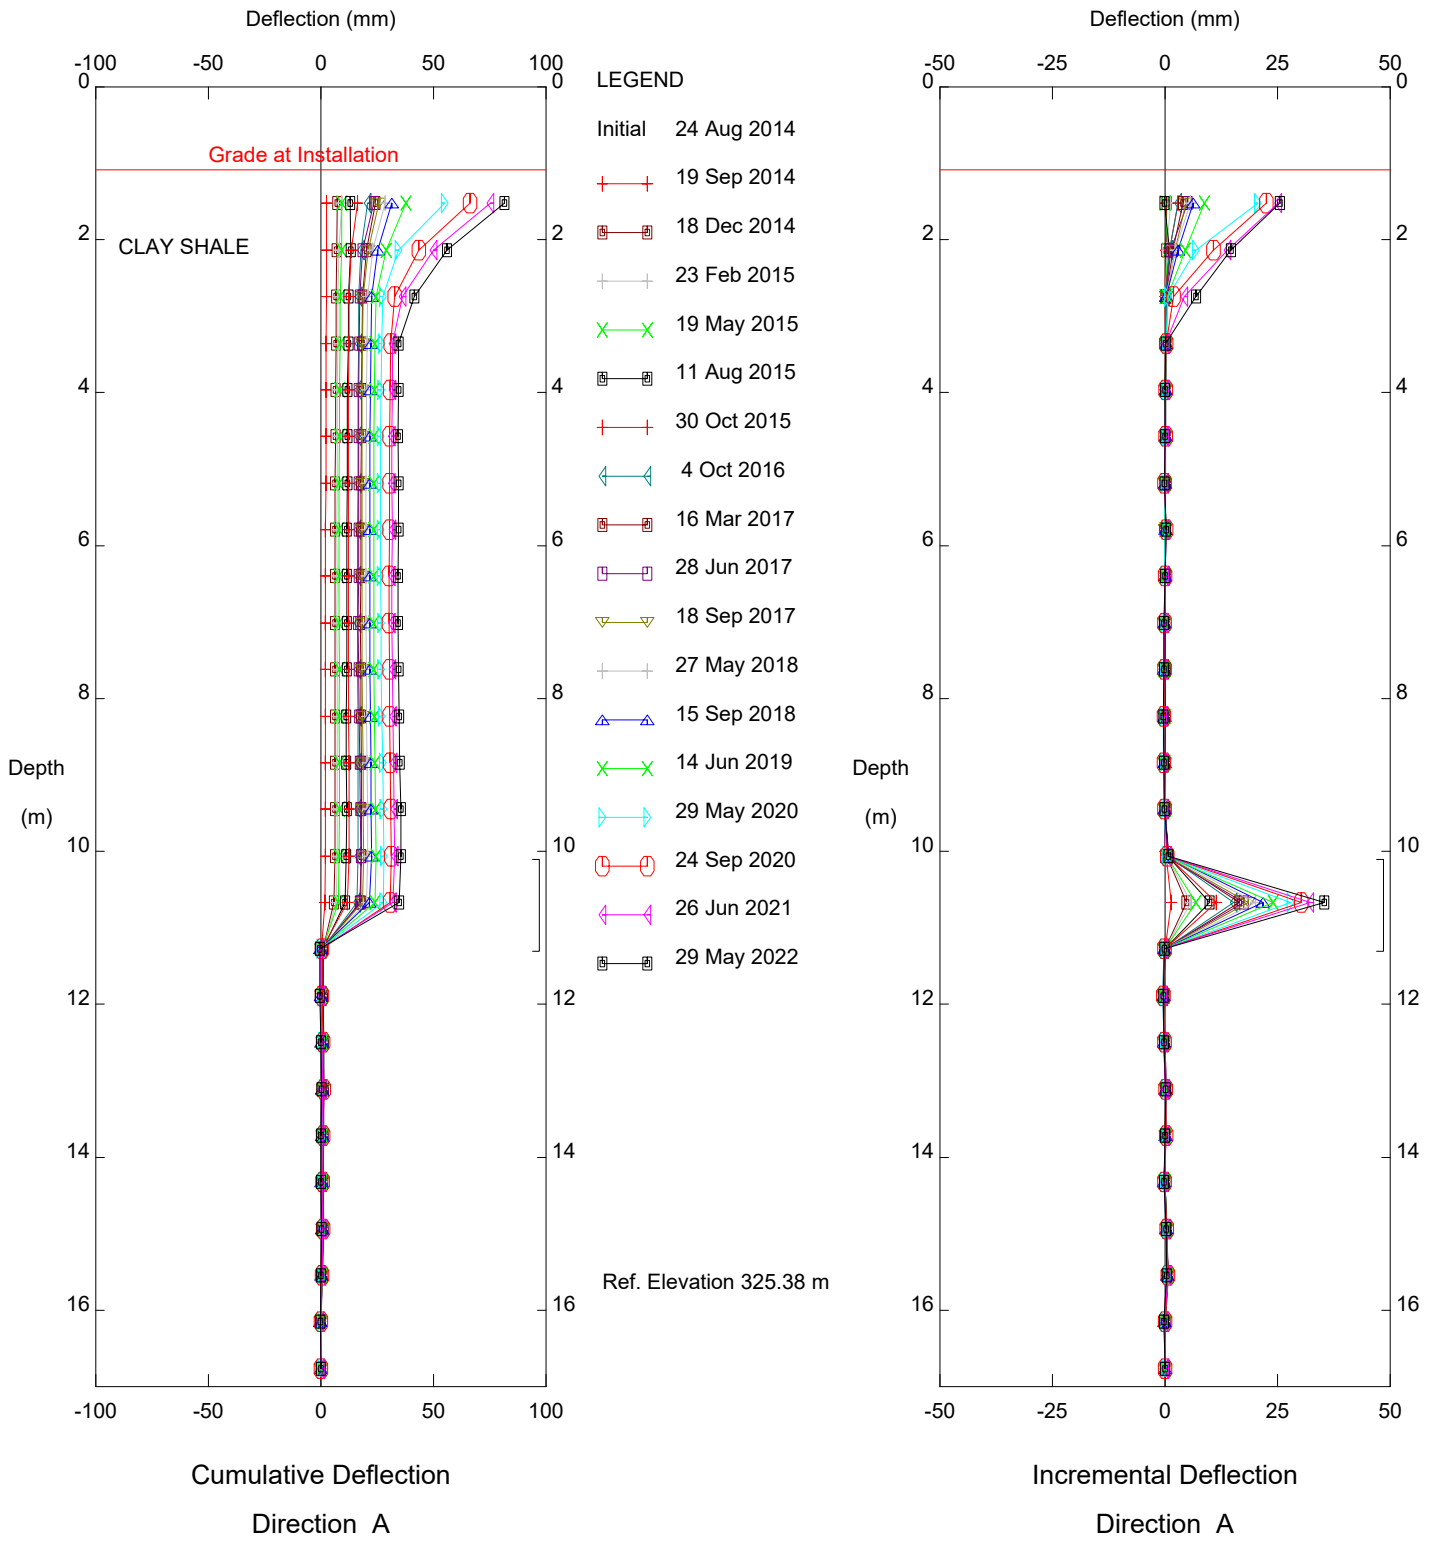
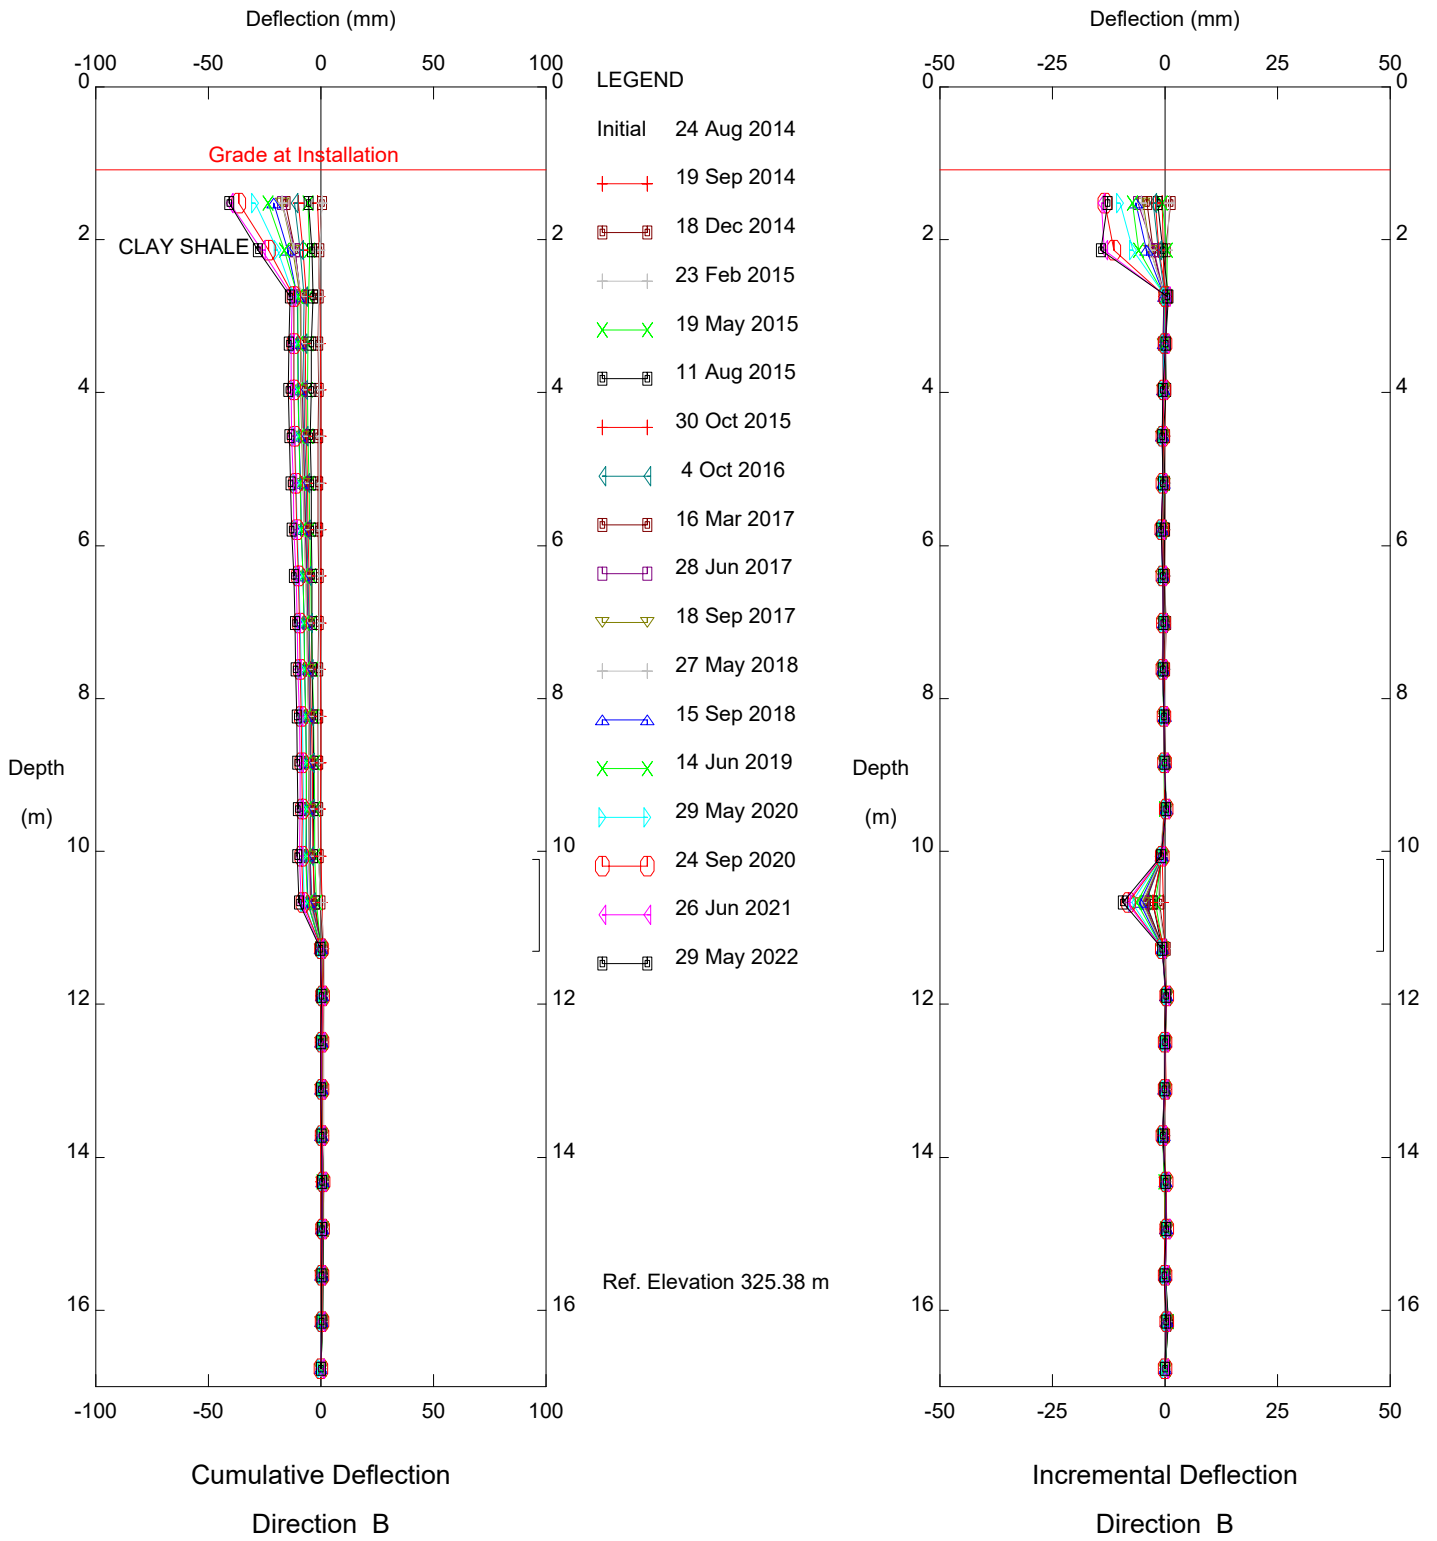
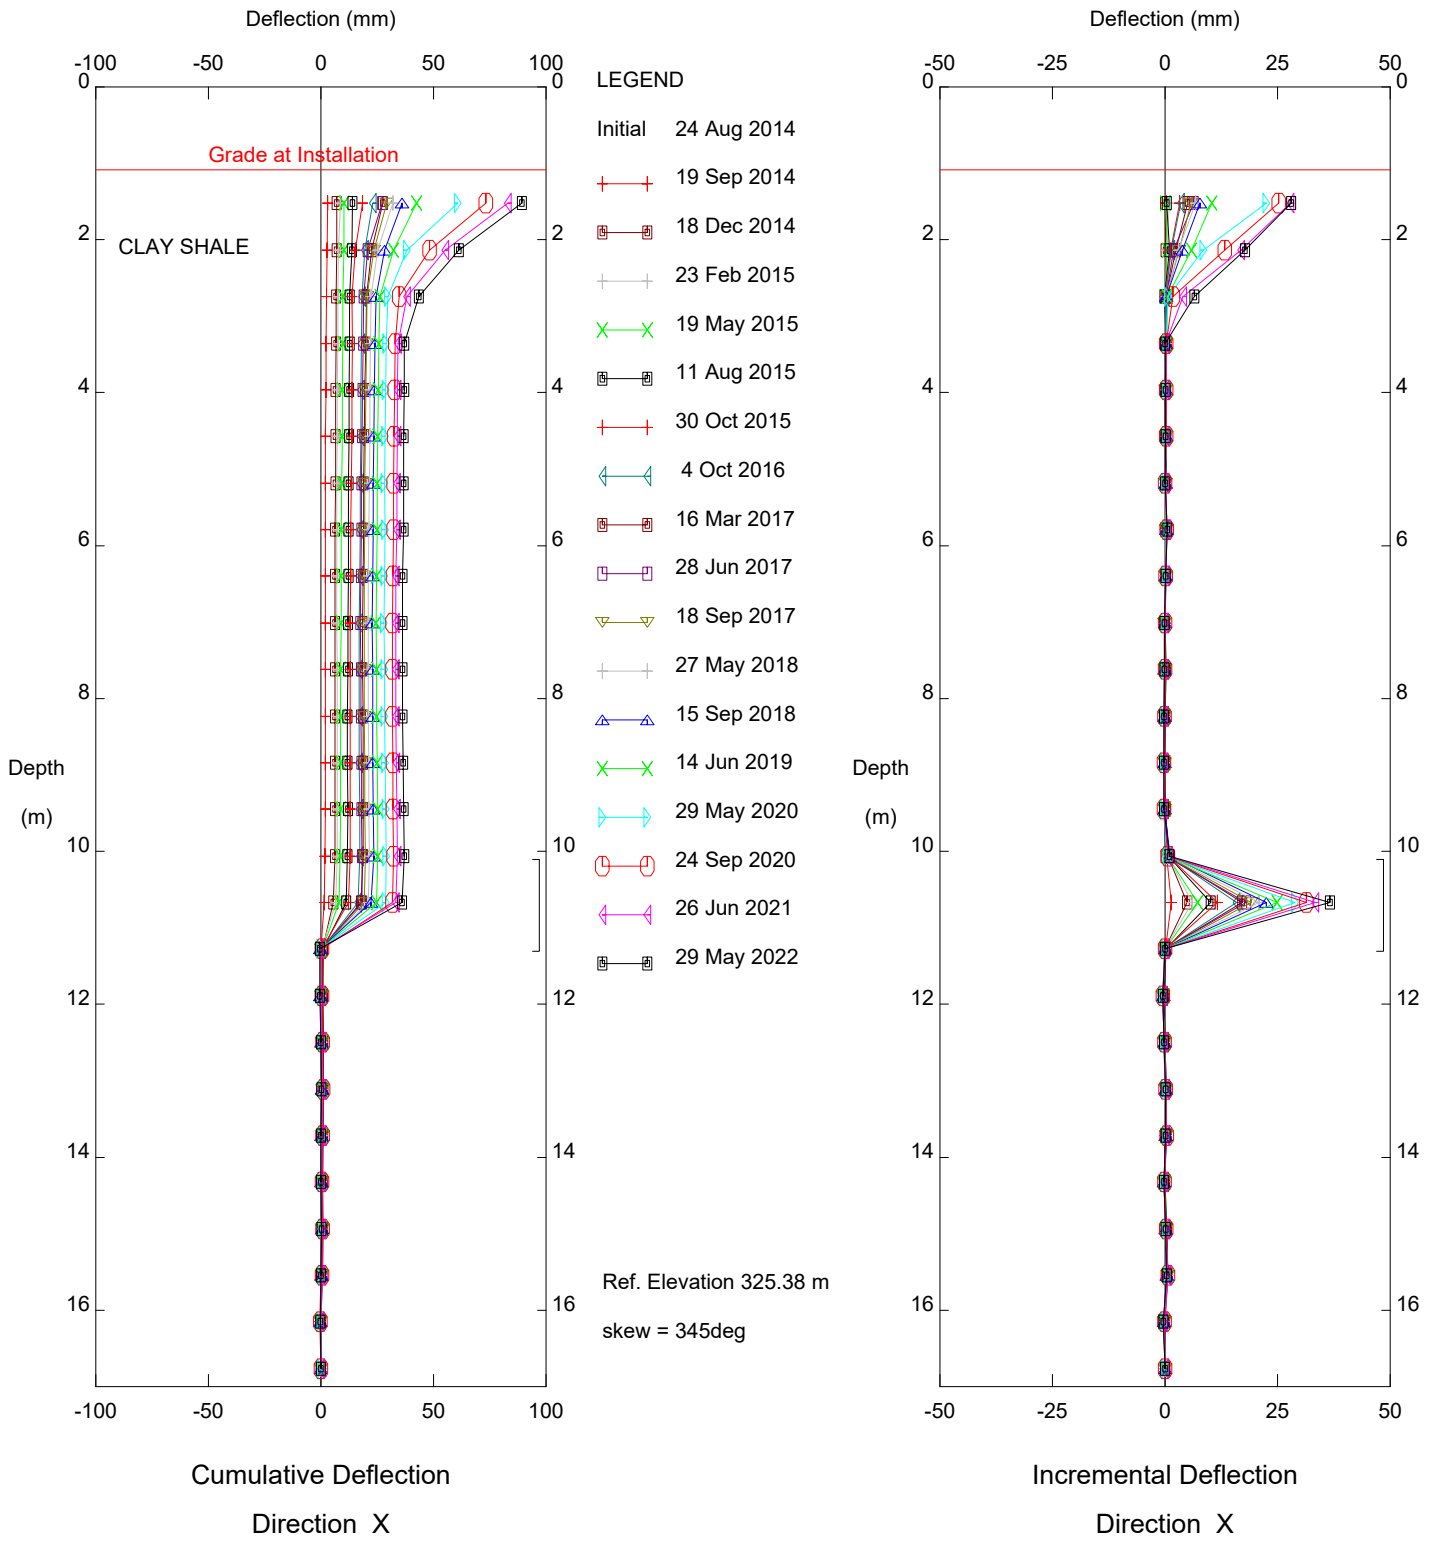
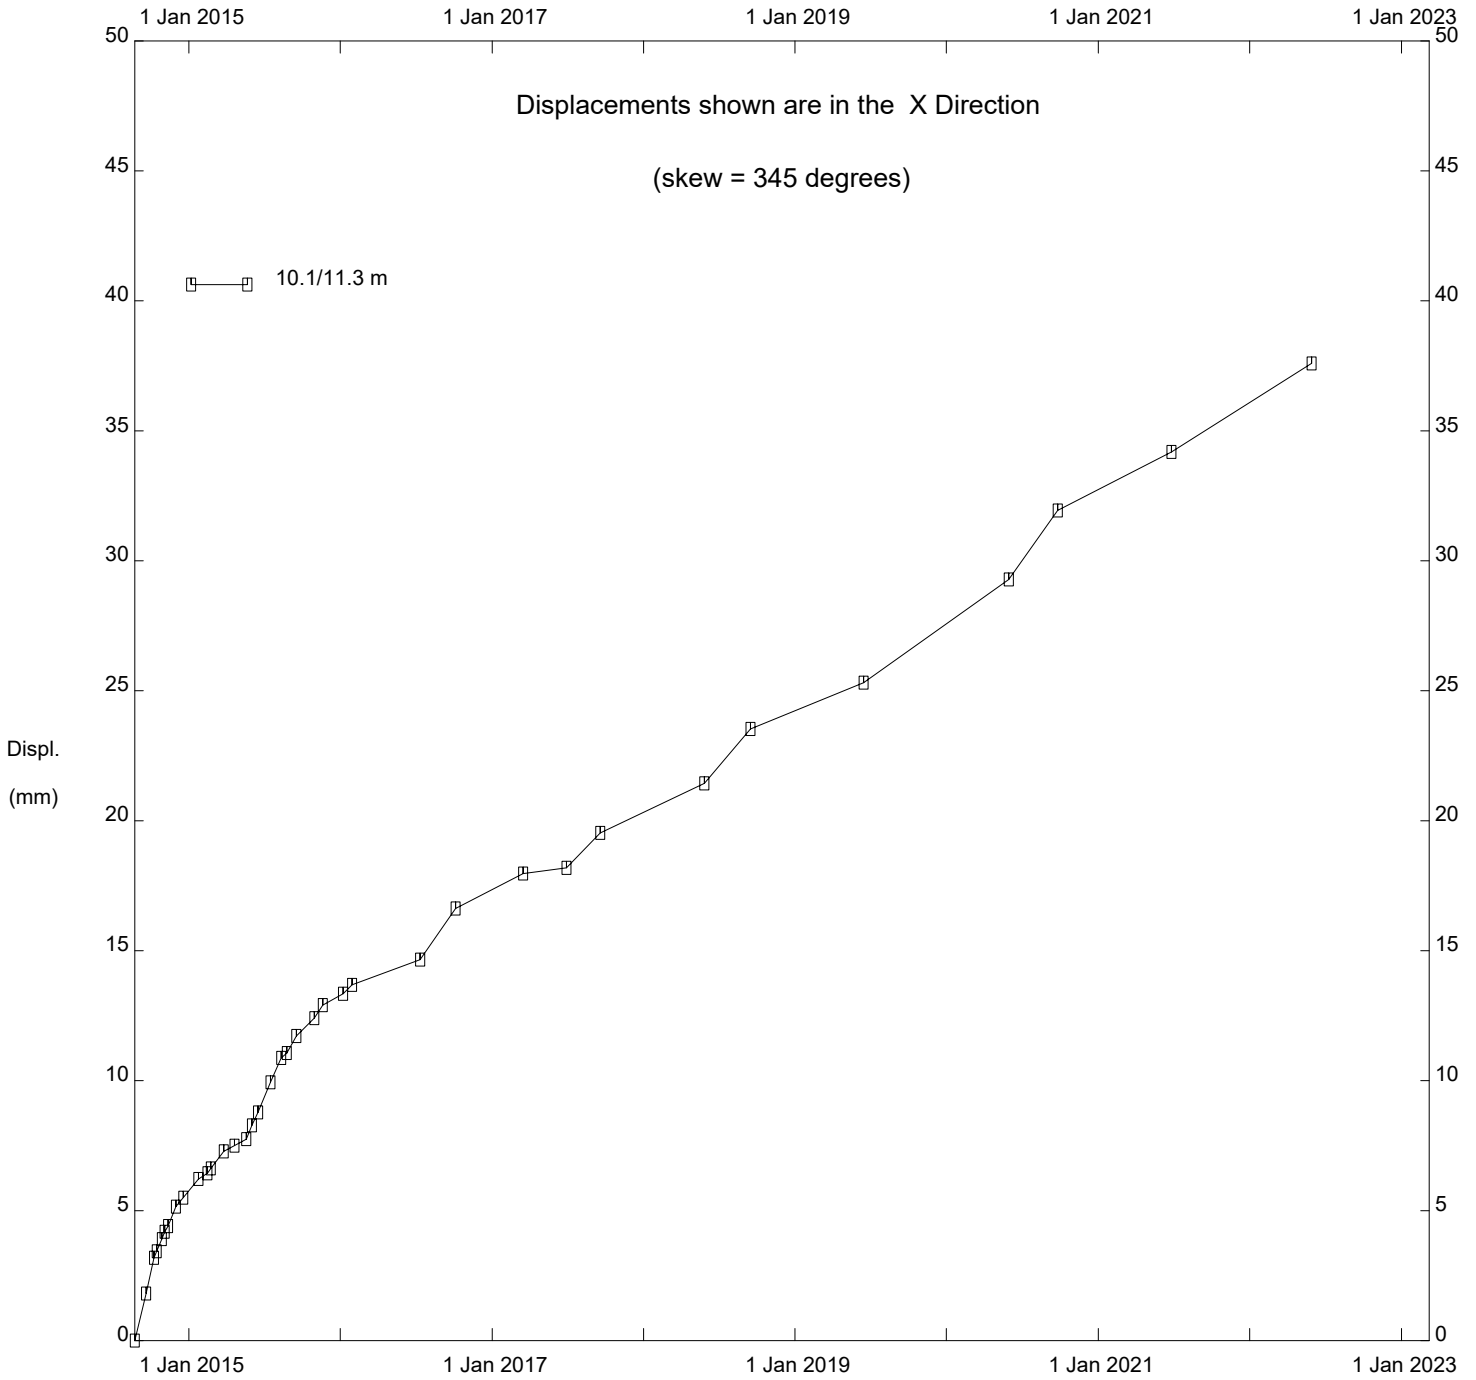
Hwy 686, 49+000 o/s +90.8m, Inclinometer SI14-13

SI14-09A showed no discernible movement over 19.5 m to 22.6 m depth since the spring of 2021 readings. SI14-13 showed a rate of movement of 3.7 mm/yr over 10.1 m to 11.3 m depth since the spring of 2021 readings. SI14-14 showed rates of movement of 5.0 mm/yr and 1.6 mm/yr over 4.0 m to 5.8 m depth and 9.4 m to 11.3 m depth, respectively, since the spring of 2021 readings. SI14-19 showed a rate of movement of 5.3 mm/yr over 5.8 m to 7.6 m depth since the spring of 2021 readings.
