**ALBERTA TRANSPORTATION AND ECONOMIC CORRIDORS
GEOHAZARD ASSESSMENT PROGRAM
NORTH CENTRAL REGION – ATHABASCA &
FORT MCMURRAY DISTRICTS
2023 SITE INSPECTION**

Site Number	Location	Name	Hwy	km
NC097	Fort McMurray	Parsons Road Overpass/Hwy 63	686:20	
Legal Description		UTM Co-ordinates (NAD 83)		
SW7-90-9-W4		12V N 6,293,600	E 473,700

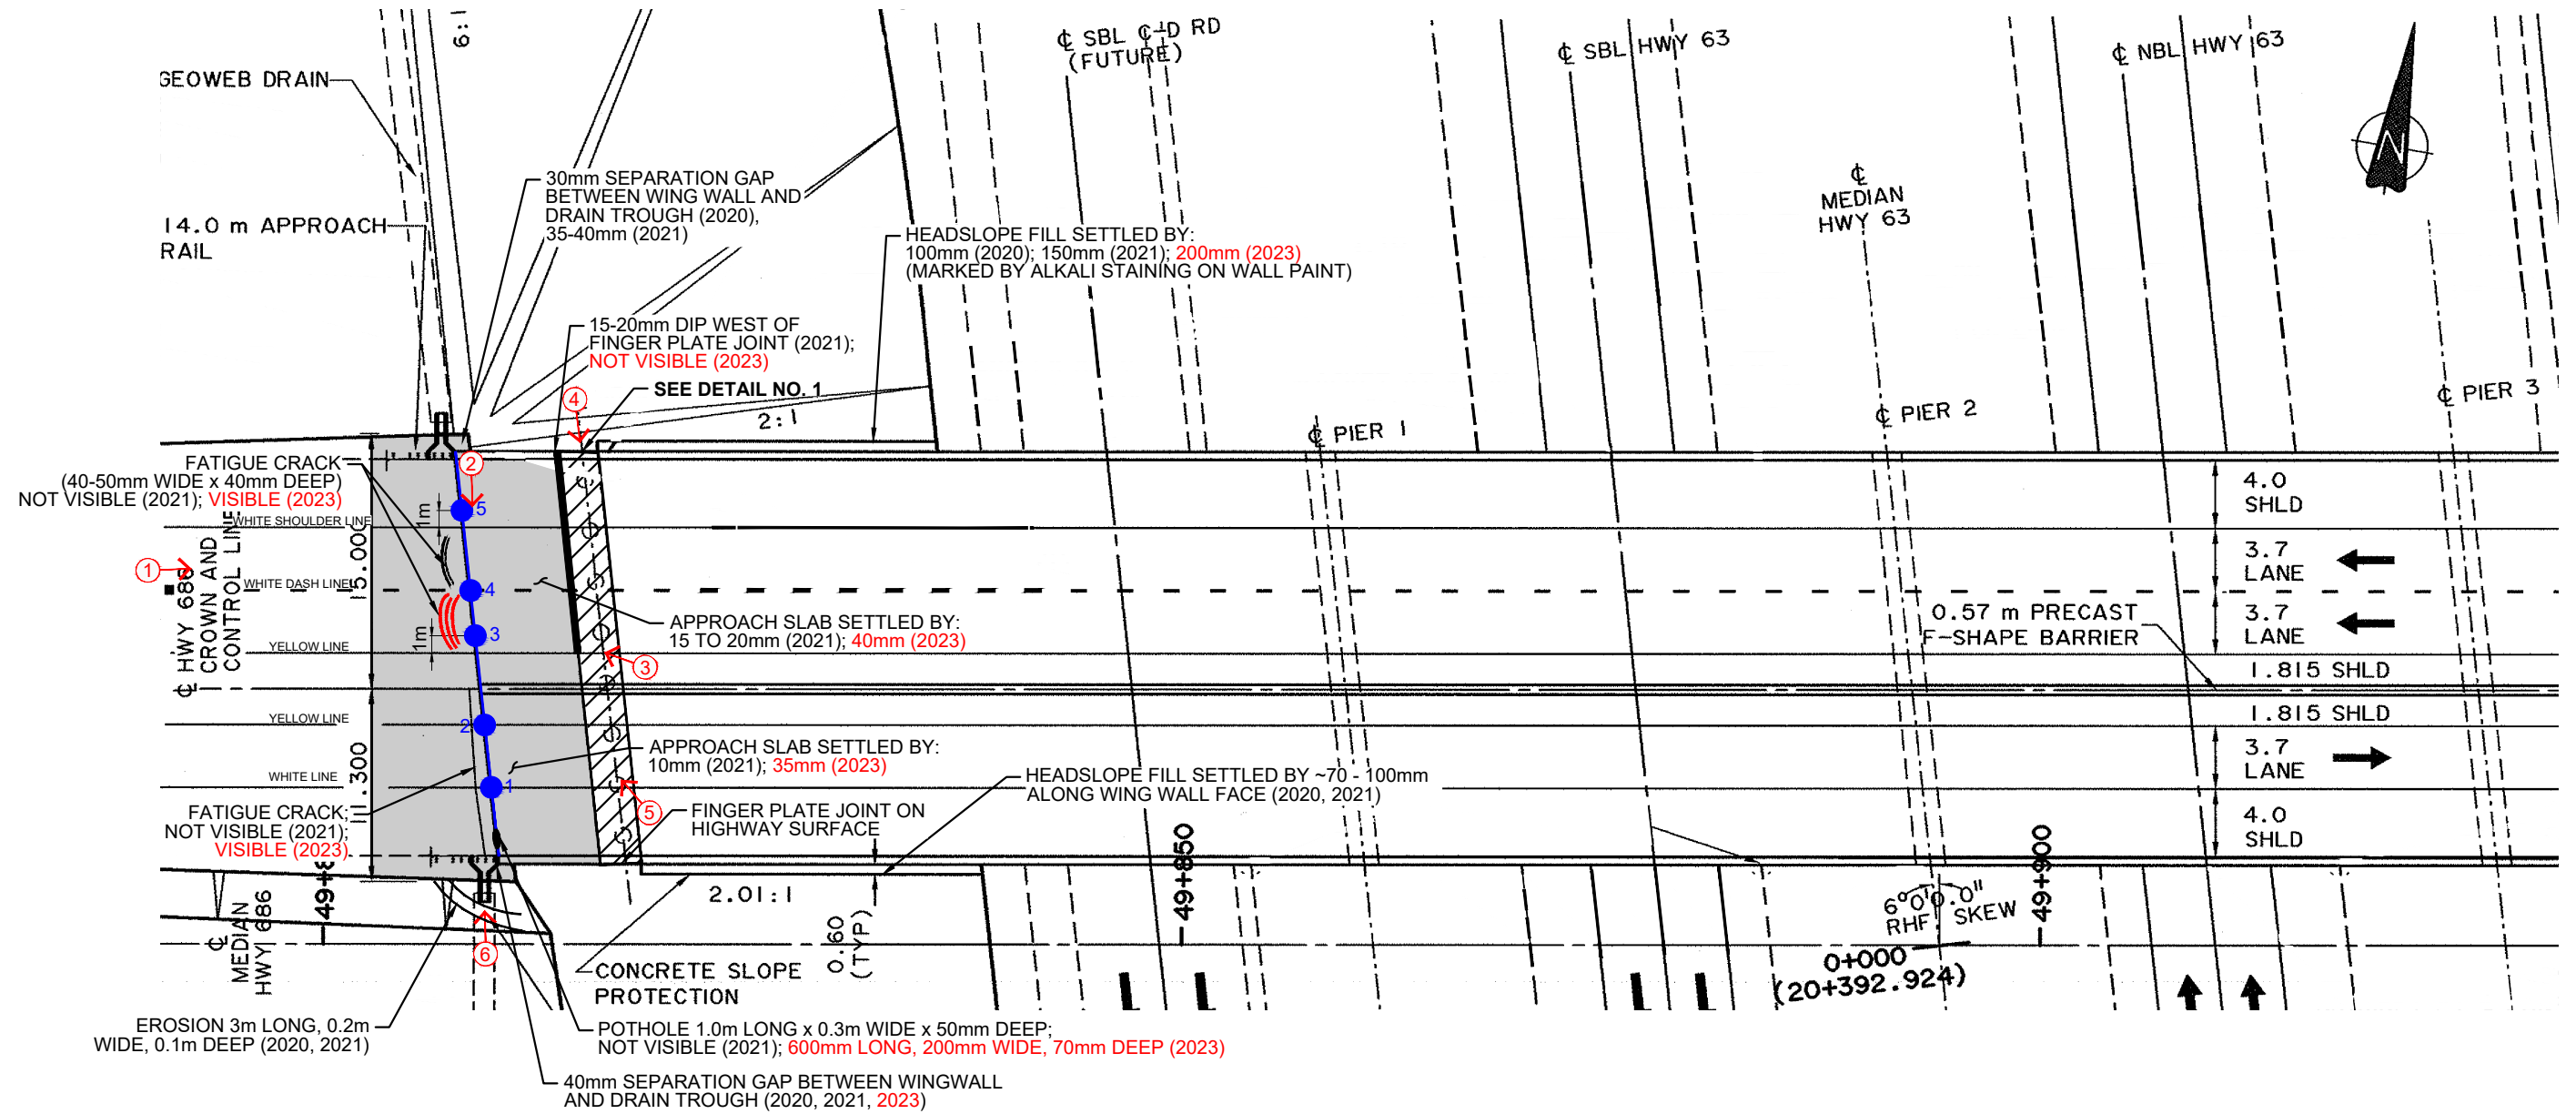
H:\32000\32122 AT GRMP Athabasca and Fort McMurray Districts 2021-2025\CAD\2023 GEO HAZARD\GP\32122 NC097-1.dwg - 1 - Jun. 29, 2023

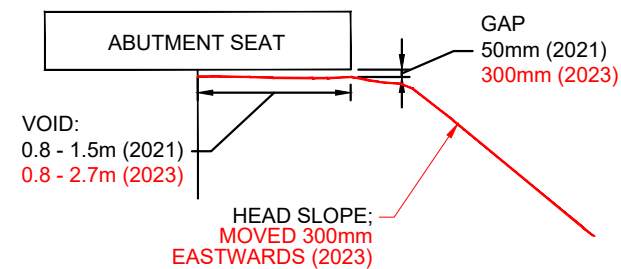
* SAND AND SALT WERE NOTED WITHIN BOTTOM OF CRACK.

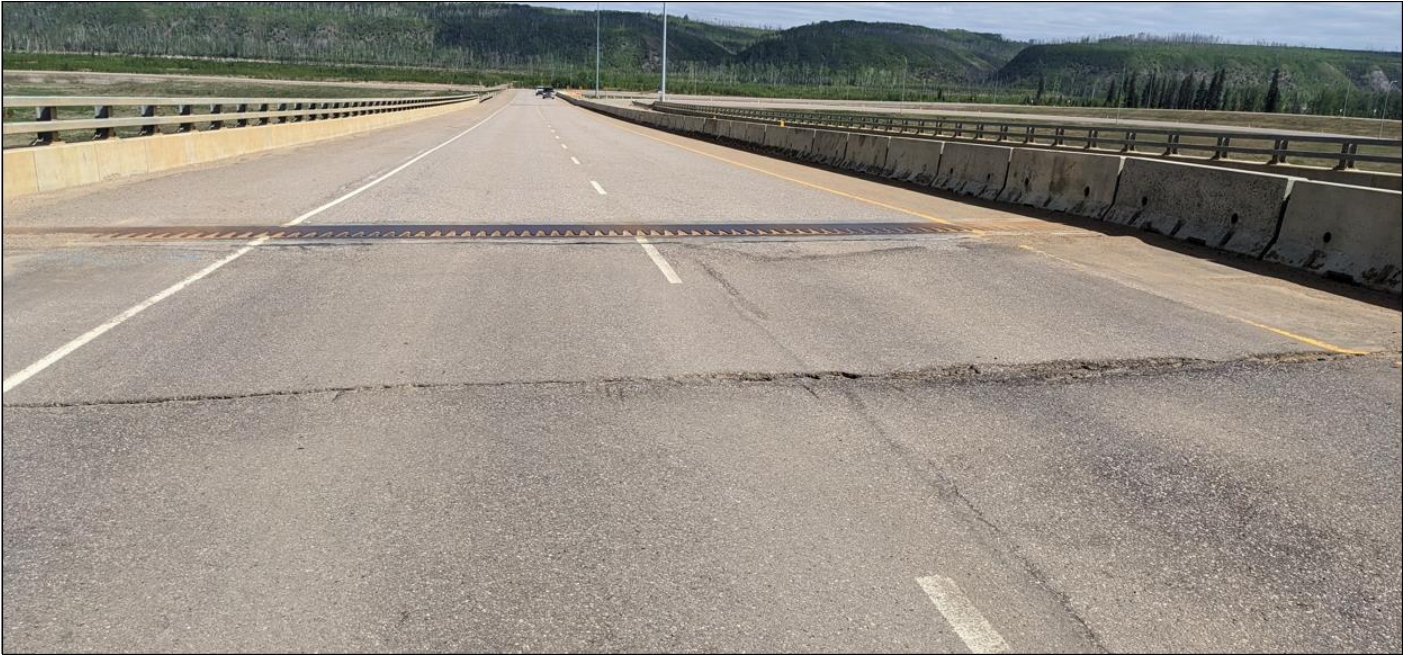
Photo No. 1 – Looking east at the bridge westbound lanes. The cracks are across both traffic lane directions and has formed between the approach slab and the pavement, about 6 m west of the west abutment fingerplate; note ACP patch placed in 2022 and the dip to the west of the expansion joint.

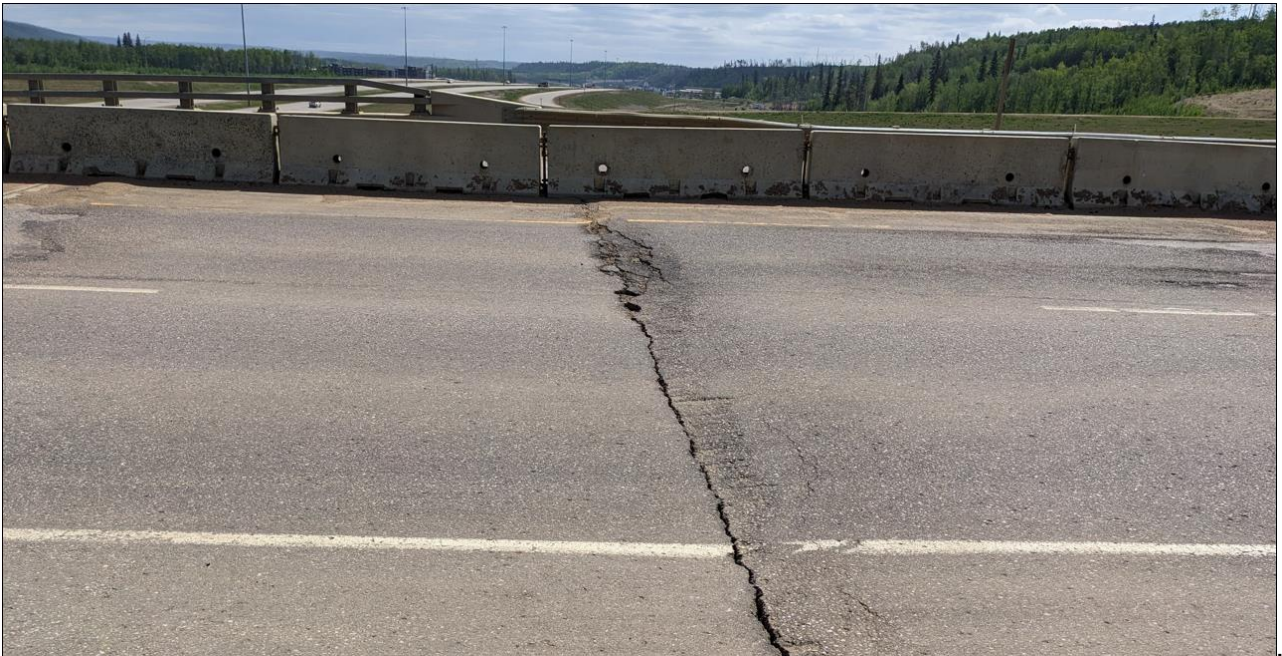
Photo No. 2 – Looking south at the crack developed across the westbound lanes towards the median. The main crack is 30 to 100 mm wide x 70 to 100 mm deep.

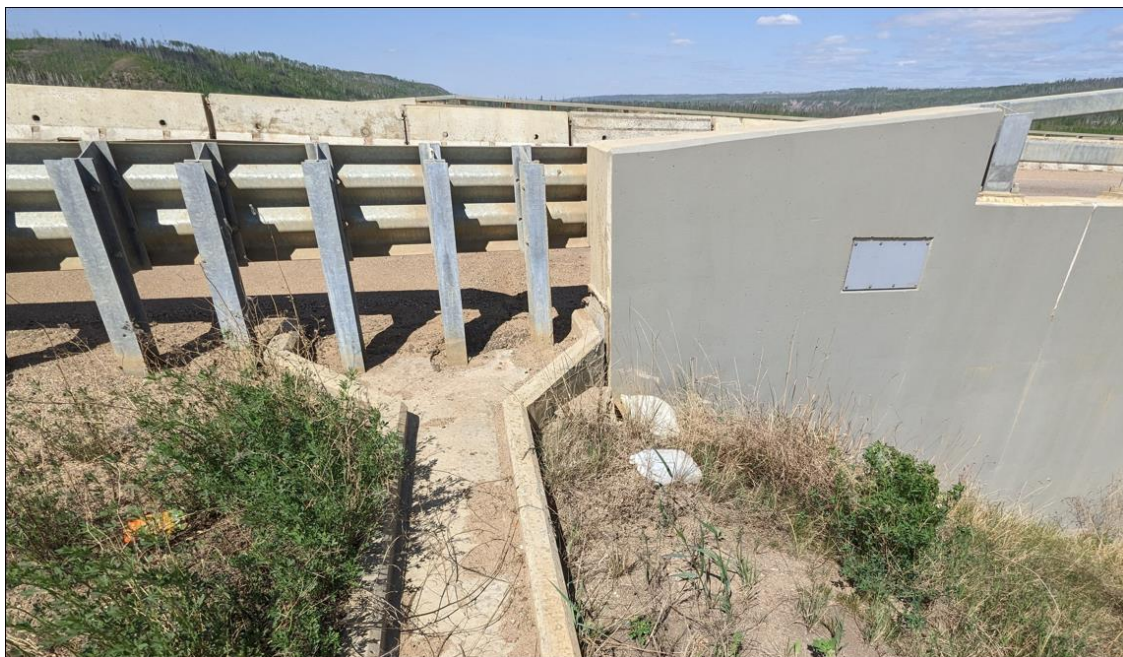
Photo 6 – Drain trough. Note the cracking between the drain trough and wingwall.
