**ECONOMIC CORRIDORS GRMP
NORTH CENTRAL (ATHABASCA AND FORT
McMURRAY DISTRICTS)
INSTRUMENTATION MONITORING- SPRING 2024**

Site Number	Location	Name	Hwy	km
NC097	HWY 63:12 L1 0.093	Parsons Creek Interchange	63:12	Km 0.09
Legal Description: 12-5-87-10 W6		UTM Co-ordinates		
		12V E 473714	N	6293608

Current Monitoring:	9-June-2024	Previous Monitoring	Between 28-May-2023 and 04-Oct-2023
Instruments Read By:	Mr. Niraj Regmi, G.I.T and Mr. Nixson Mationg, of Thurber

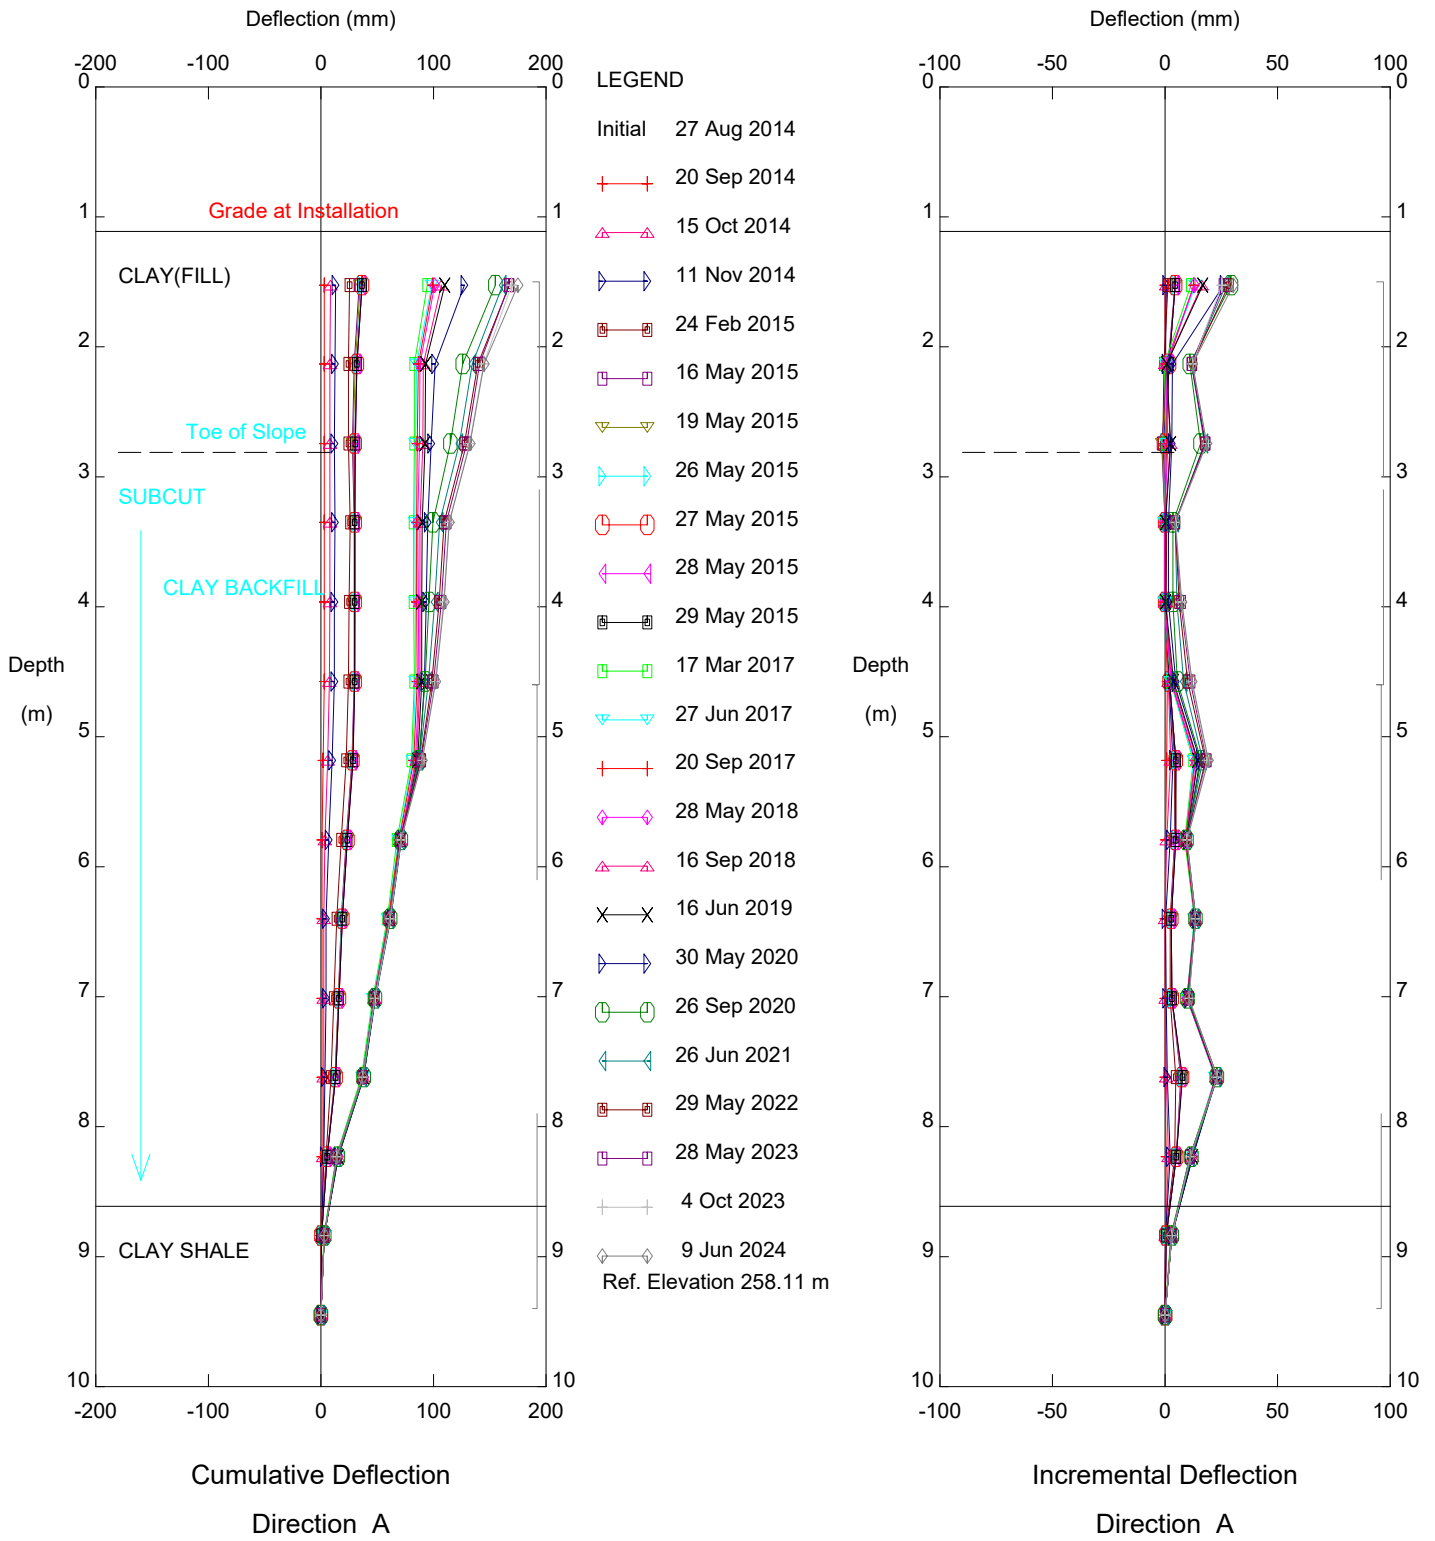
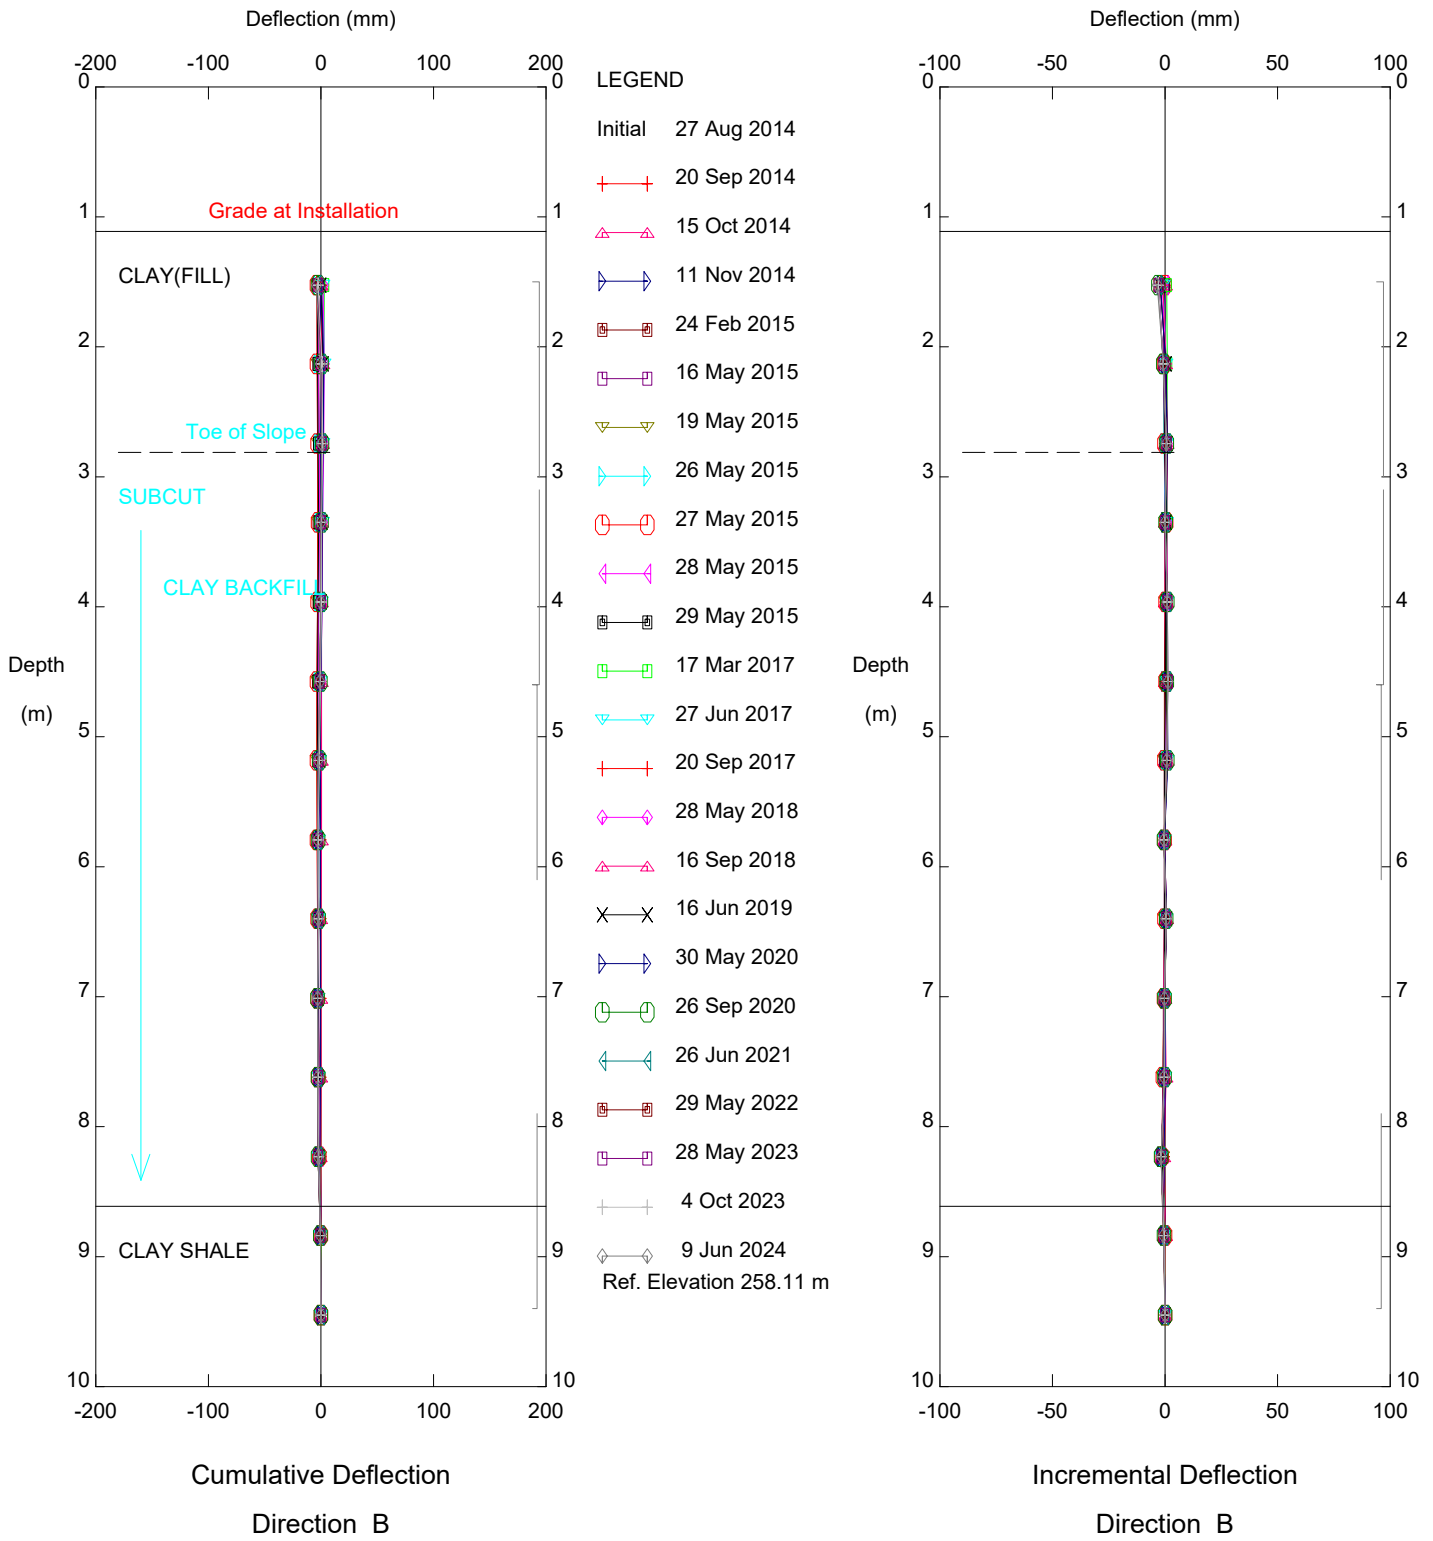
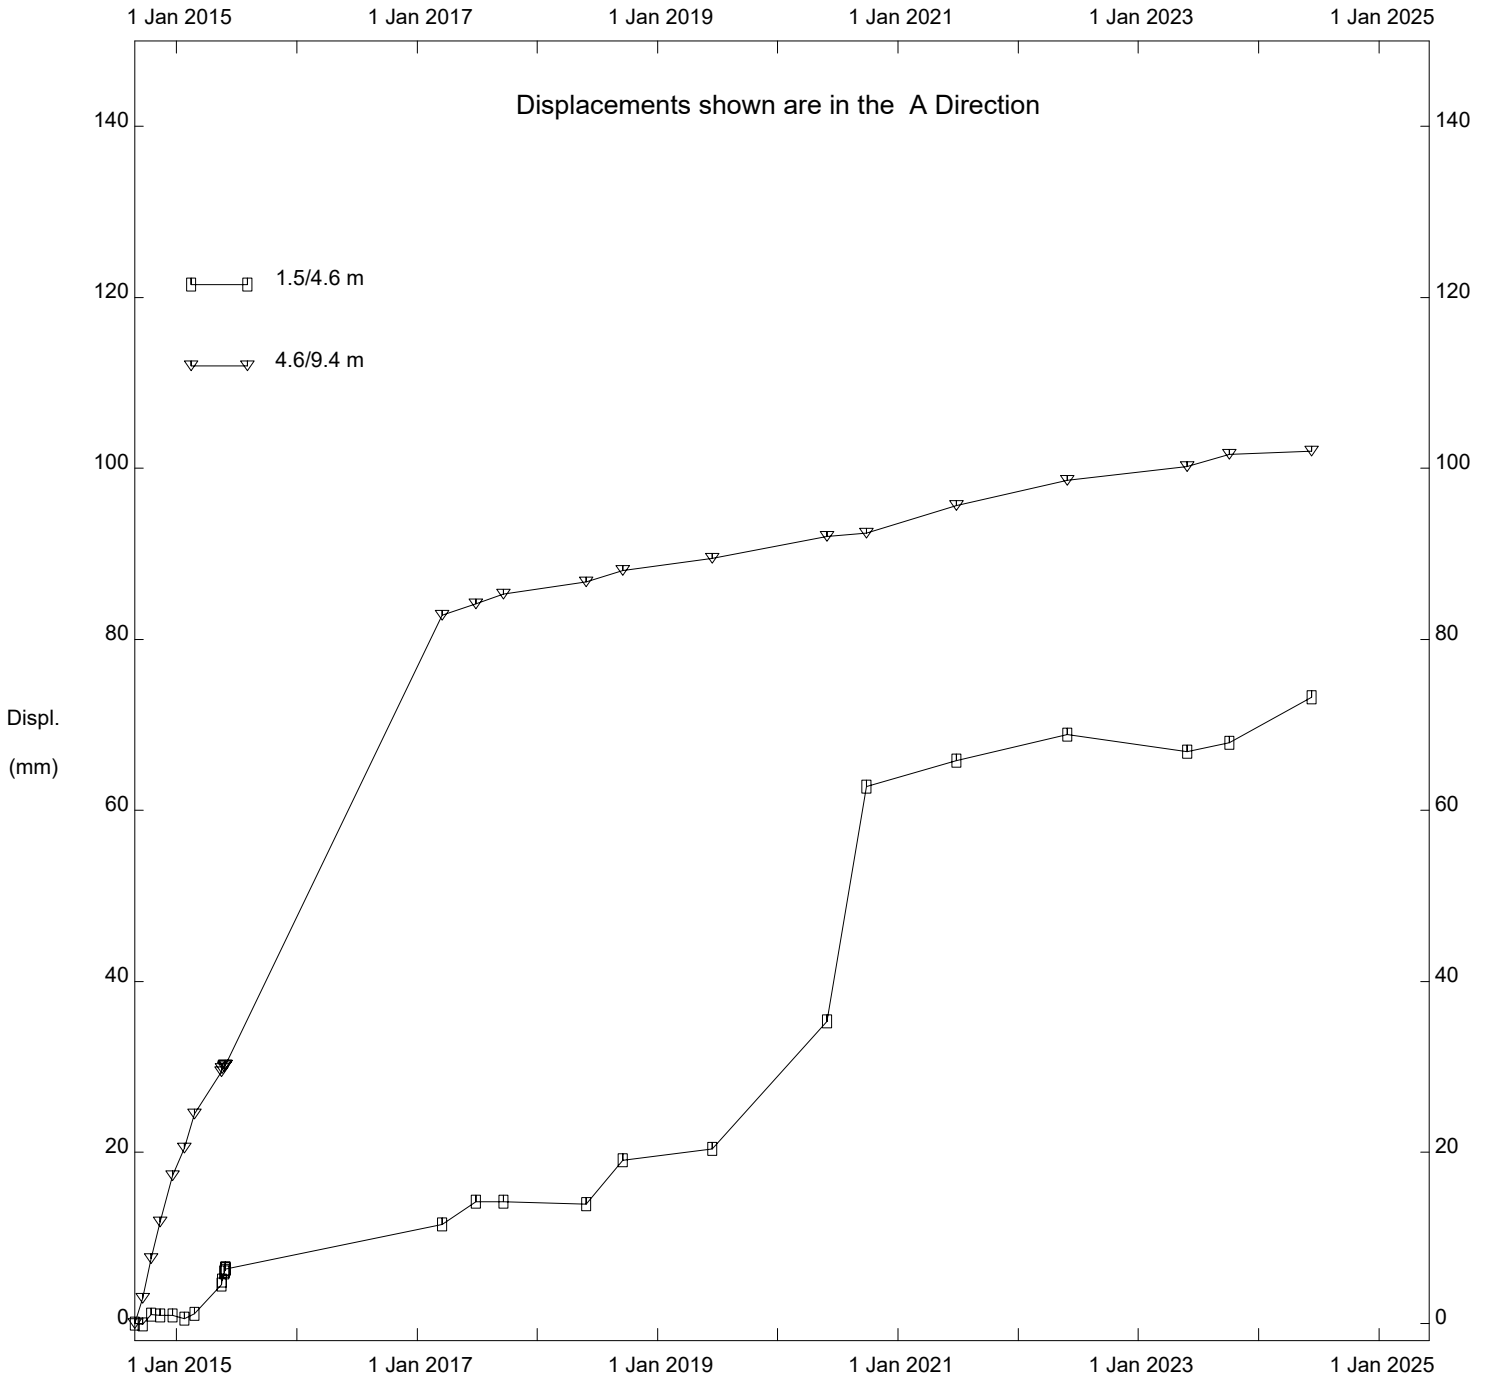
Hwy 686, 49+833.7 o/s +6.6m, Inclinometer SI14-05

Zones of New Movement:	None
Interpretation of Monitoring Results:	<p><u>Parsons Interchange:</u></p> <p>Slope inclinometer SI14-05, installed near the west headslope of the bridge, showed a rate of movement of 7.7 mm/yr over 1.5 m to 4.6 m depth and a rate of movement of 0.5 mm/yr over 4.6 m to 9.4 m depth since the fall of 2023 readings. SI15-14 showed a rate of movement of 5.9 mm/yr since it was last read in the spring of 2023 readings.</p> <p>PZ14-15, PZ14-19, and PZ15-10 showed increases in groundwater level of 0.16 m, 0.49 m, and 0.67 m, respectively, since the fall of 2023 readings. PZ15-04, PZ15-05, PZ15-06 and PZ15-07 showed increases in groundwater level of 0.70 m, 0.08 m, 0.06 m and 0.14 m, respectively, since the spring of 2023 readings. PZ15-03 and PZ15-09 were dry during the current readings.</p> <p>Settlement cell SC14-09 showed a decrease in settlement of 24.96 mm compared to the fall of 2023 readings. Settlement cell SC14-12 showed an increase in settlement of 21.62 mm since the fall of 2023 readings. SC14-12 continues to show a trend of settlement increase since January 2021. SC15-04 and SC15-06, which were previously read in the spring of 2023, showed increases in settlement of 10.94 mm and 6.70 mm, respectively.</p> <p><u>Hwy 686 Cut Slope:</u></p> <p>SI14-09A showed a rate of movement of 0.8 mm/yr over 19.5 m to 22.6 m depth since the spring of 2023 readings. SI14-13 showed a rate of movement of 4.6 mm/yr over 10.1 m to 11.3 m depth. SI14-14 showed rates of movement of 6.9 mm/yr and 2.2 mm/yr over 4.0 m to 5.8 m and 9.4 m to 11.3 m depth, respectively. SI14-19 showed no discernible movement since the spring of 2023 readings.</p> <p>PZ14-28a, PZ14-29a, PZ14-30a, PZ14-33, PZ14-34, PZ14-37, PZ14-38, PN14-40 and PZ14-41 showed increases in groundwater level of 0.13 m, 0.44 m, 0.01 m, 1.16 m, 0.1 m, 0.16 m, 0.16 m, 4.51 m and 0.02 m, respectively, since the spring of 2023 readings. The current readings in PN14-30a, PN14-33, and PN14-40 are the highest recorded in these instruments since they were initialized. PZ14-35, PZ14-36, and PZ14-39 showed decreases in groundwater level of 3.47 m, 3.32 m, and 0.02 m, respectively, since the spring of 2023 readings. PZ14-47 showed no change in groundwater level compared to the spring of 2023 readings. PZ14-42, PZ14-43 and PZ14-50 were all dry. PZ14-46, PZ14-48 and PZ14-49 were all previously dry in the spring of 2023 but showed current groundwater levels above their tips of 0.42 m, 0.22 m and 0.13 m, respectively.</p>

Future Work:	<p>The operational instruments at this site should be read again in the spring of 2024.</p> <p>Due to the movement noted within the west headslope of the bridge, it is also recommended that SI14-5, SC14-12, SC14-09, PZ14-19, PZ14-20, PZ14-15, located in the vicinity of the bridge west headslope, be read in the upcoming fall seasons until the end of the GRMP's Contract. During the coming fall visit, another attempt should be made to read PZ14-20 to see if it is malfunctioning.</p>
Instrumentation Repairs:	No instrument repairs are required at this time.
Additional Comments:
