**ALBERTA TRANSPORTATION AND
ECONOMIC CORRIDORS GRMP
NORTH CENTRAL (ATHABASCA AND FORT
McMURRAY DISTRICTS)
2024 SITE INSPECTION**

Site Number	Location	Name	Hwy	km
NC097	Fort McMurray	Parsons Road Overpass/Hwy 63	686:20	
Legal Description		UTM Co-ordinates (NAD 83)		
SW7-90-9-W4		12V N 6,293,600	E 473,700

**NC097: HWY 686 (PARSONS ROAD OVERPASS) / HWY 63
SITE INSPECTION PLAN**

FIGURE 1

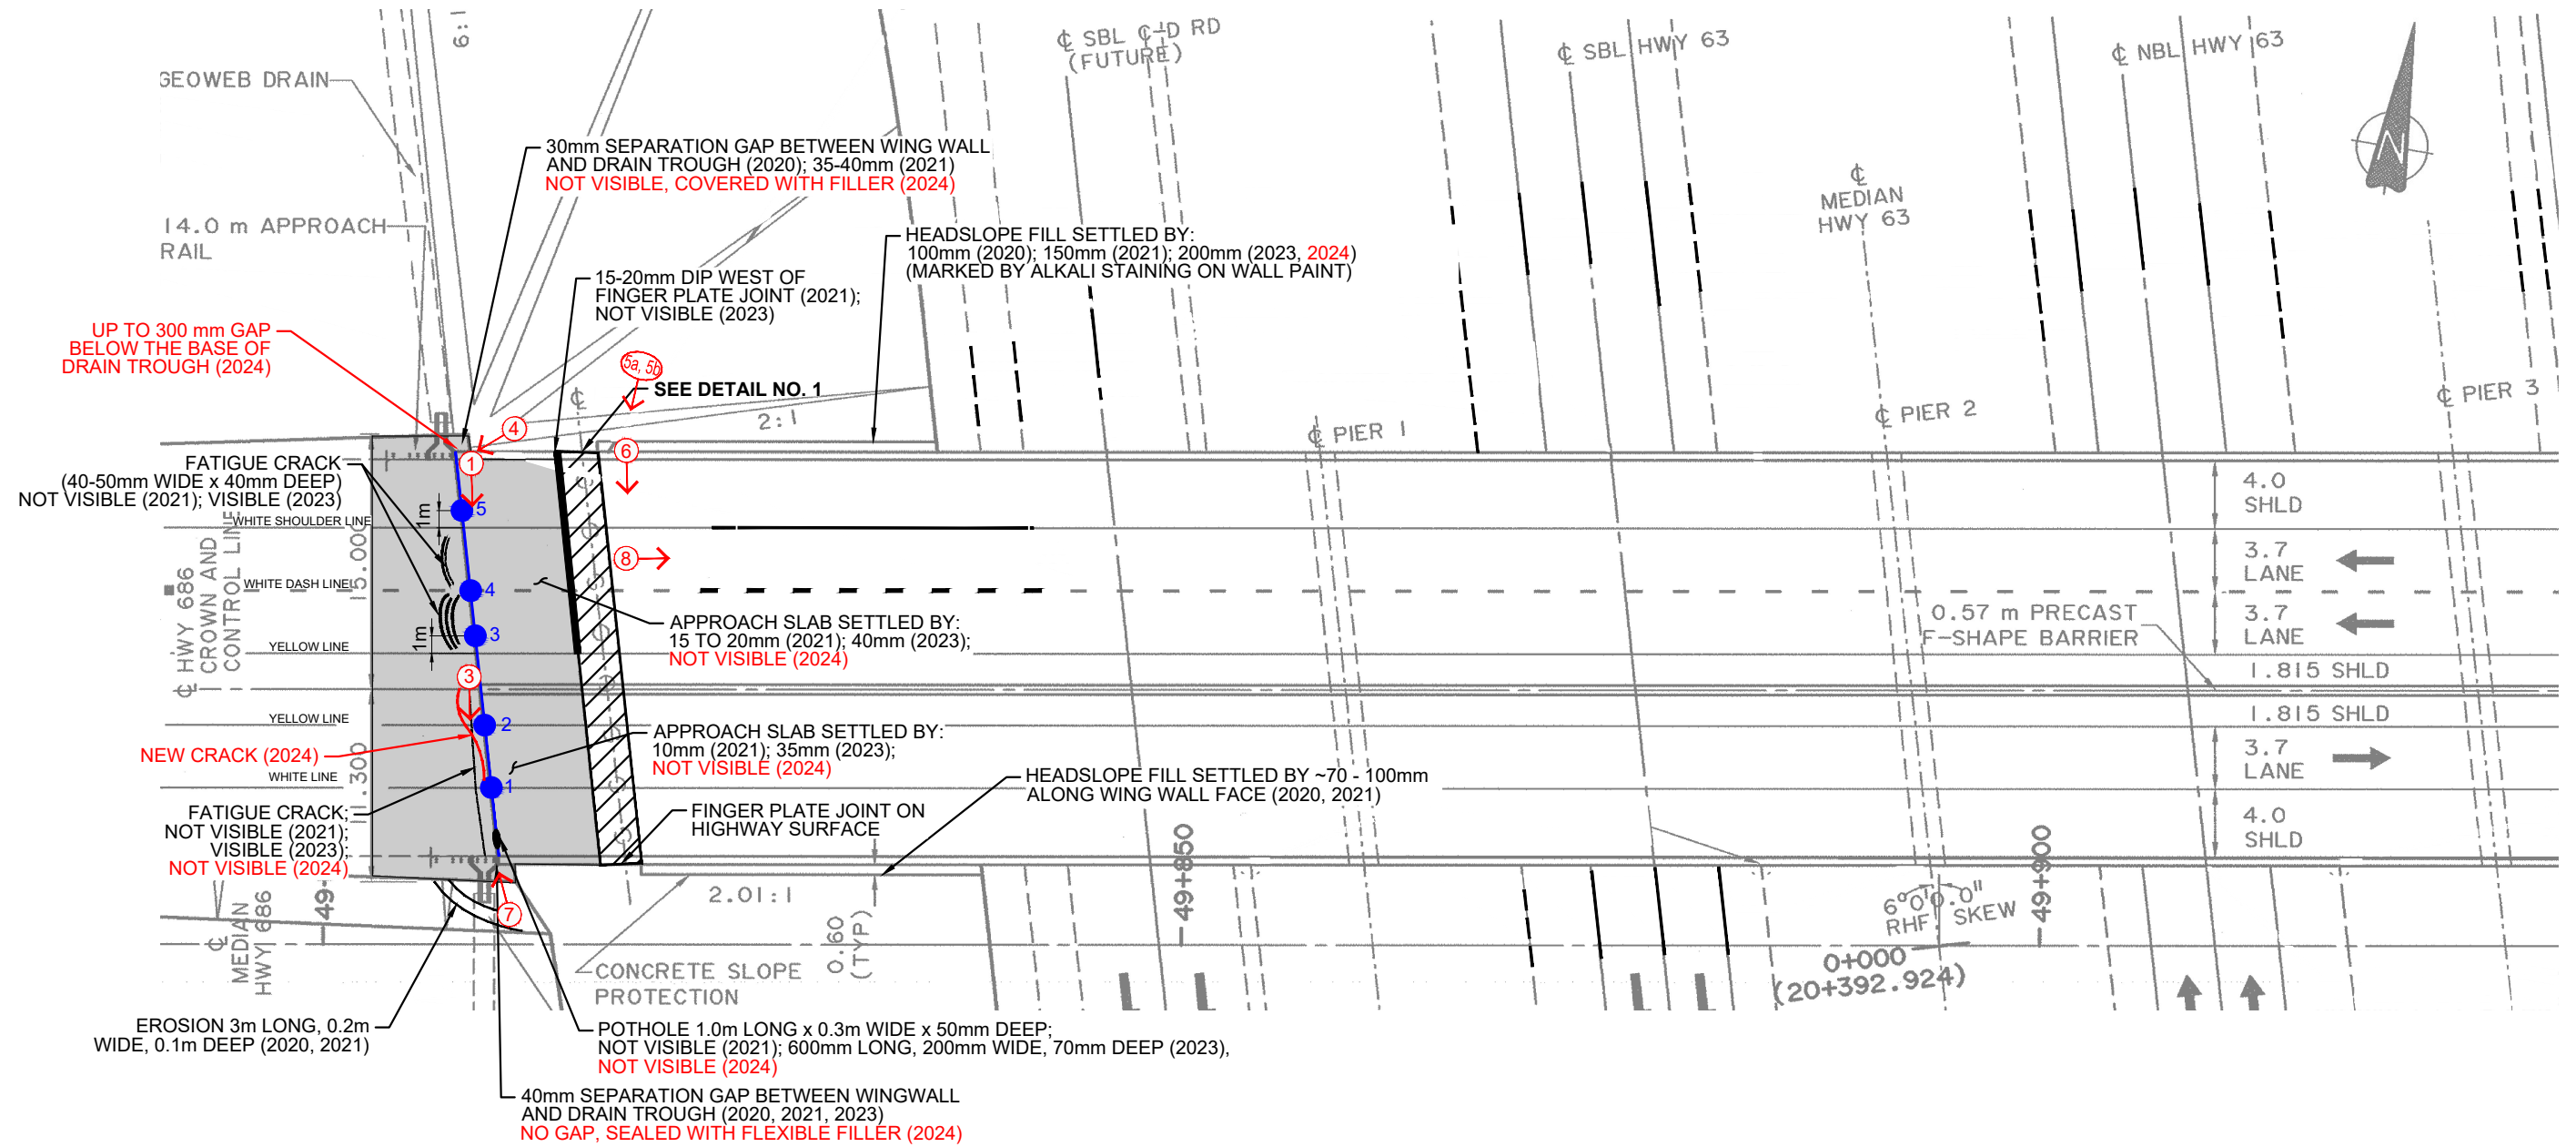
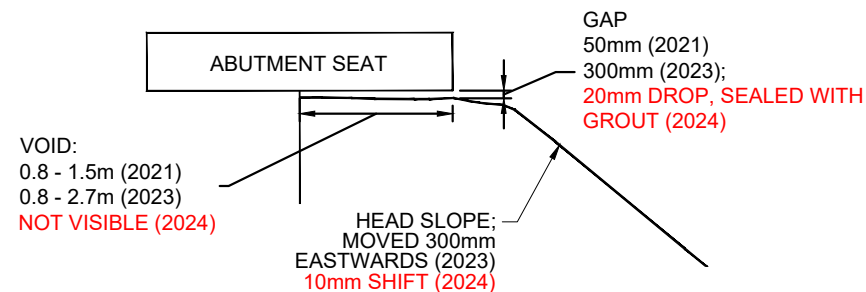
- CRACK MEASUREMENT LOCATION
- CRACK LOCATION
- ① PHOTOGRAPH NUMBER, AND APPROXIMATE DIRECTION AND LOCATION
- ACP PATCH PLACED IN 2022

JUNE 5, 2024 SITE OBSERVATIONS ARE SHOWN IN RED.

CRACK LOCATION	MAY 17, 2023			JUNE 5, 2024		
	WIDTH (mm)	DEPTH * (mm)	DROP (mm)	WIDTH (mm)	DEPTH * (mm)	DROP (mm)
1	30	70	20	60	90	0
2	140	150	40	60	90	0
3	40	100	30	20	10	0
4	100	100	20	40	40	0
5	30	70	20	30	20	0

* SAND AND SALT WERE NOTED WITHIN BOTTOM OF CRACK.

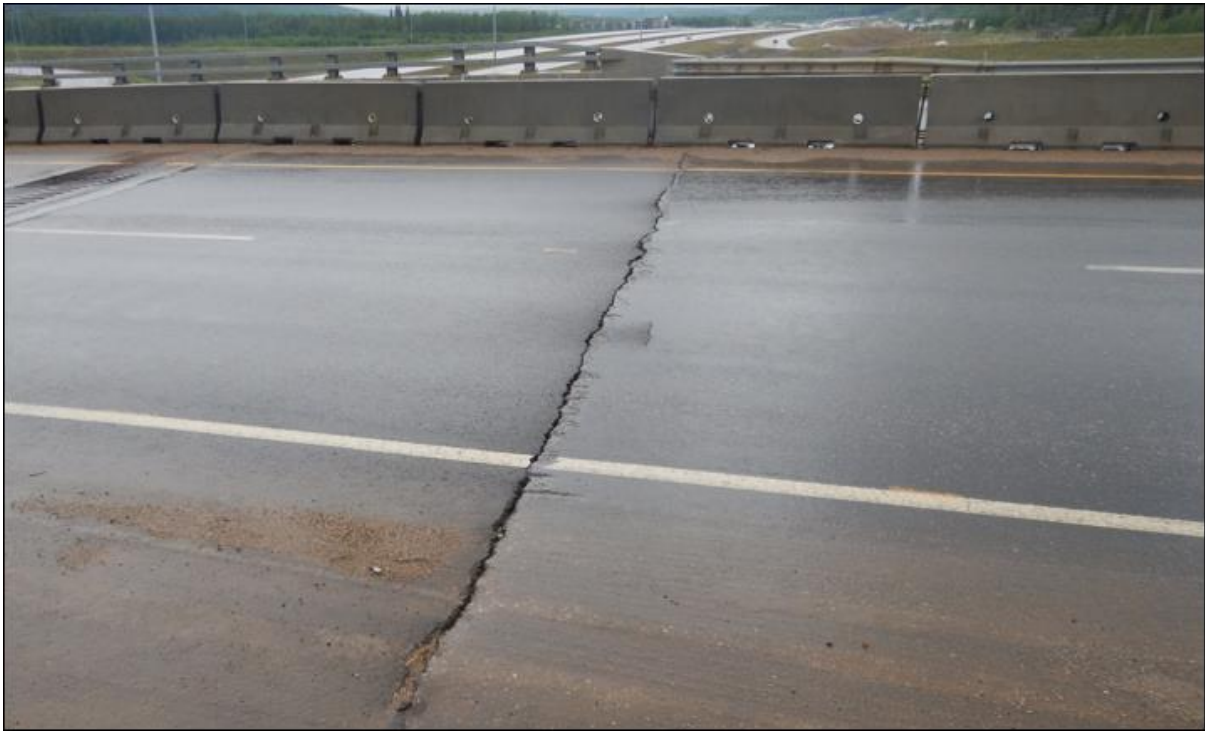
The site observations and instrumentation monitoring results indicate “excessive” vertical and lateral movements of the west approach fill. The cracks and the dips noted on the driving lanes are reflections of the ongoing slope movement of the approach fill. The movement of the fill appears to have created voids below the approach slab.

Photo No. 1 – Looking south at the crack developed across the westbound lanes towards the median. The main crack is 20 to 40 mm wide x 10 to 40 mm deep. The cracks are across both traffic lane directions and have formed between the approach slab and the pavement, about 6 m west of the west abutment fingerplate; a new ACP patch was noted in 2024.

The cracks on the highway should be sealed, and ACP patch should also be placed if a significant dip occurs on the highway surface. As recommended in the past it is ideal to drill holes within the slab to and inject grout in the holes to fill any voids below the slab. This may lessen the frequency of milling and patching on the highway.

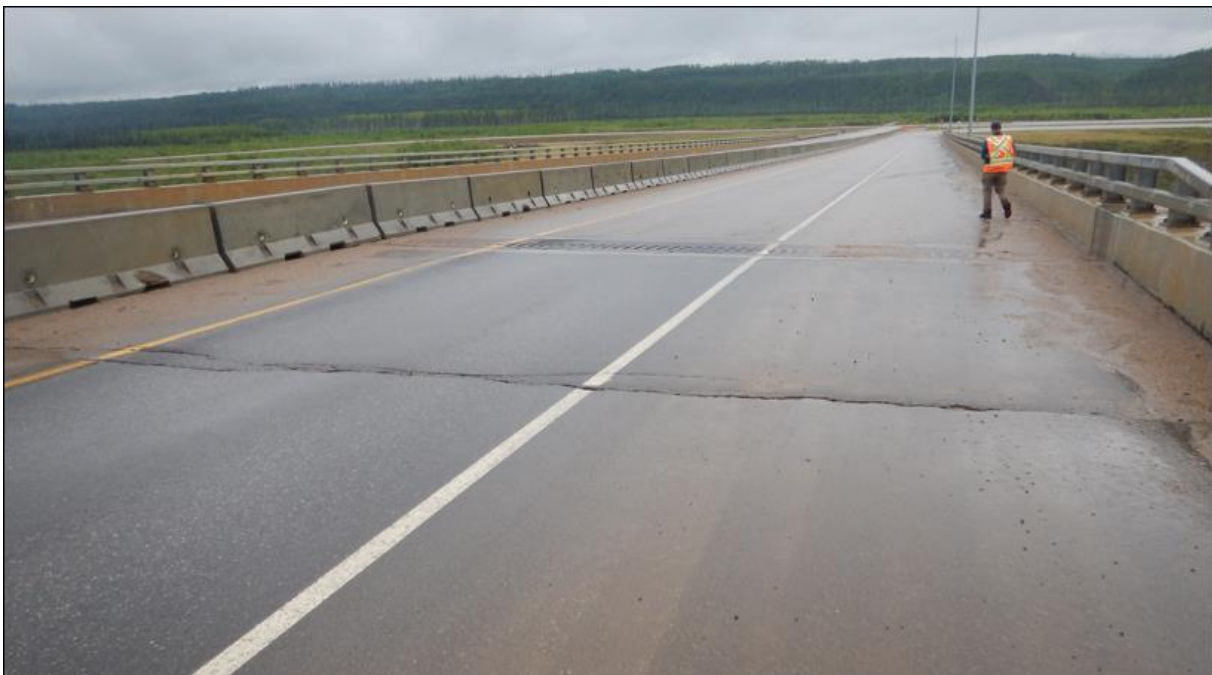
Photo No. 2 – Looking east at east bound lane. Cracks up to 60 mm wide and 90 mm deep

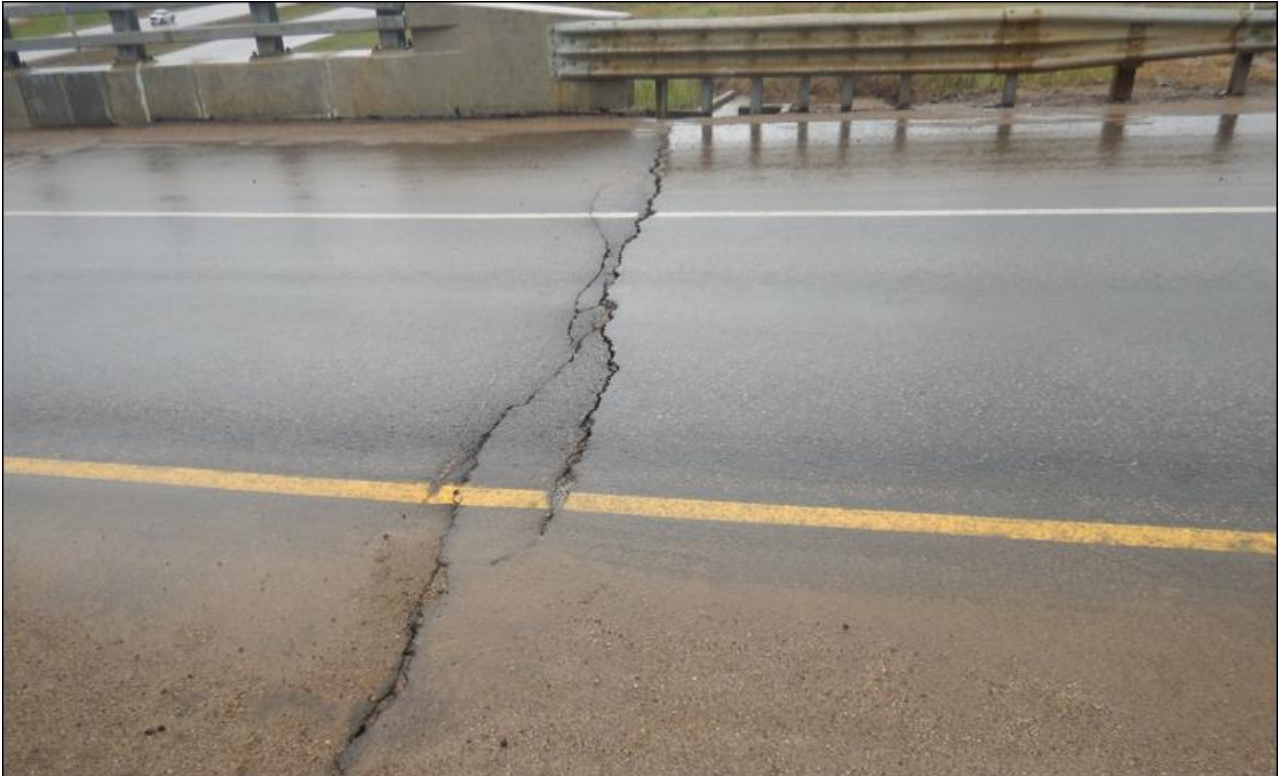
Photo No. 3 – Looking south at east bound lane. Cracks up to 60 mm wide and 90 mm deep

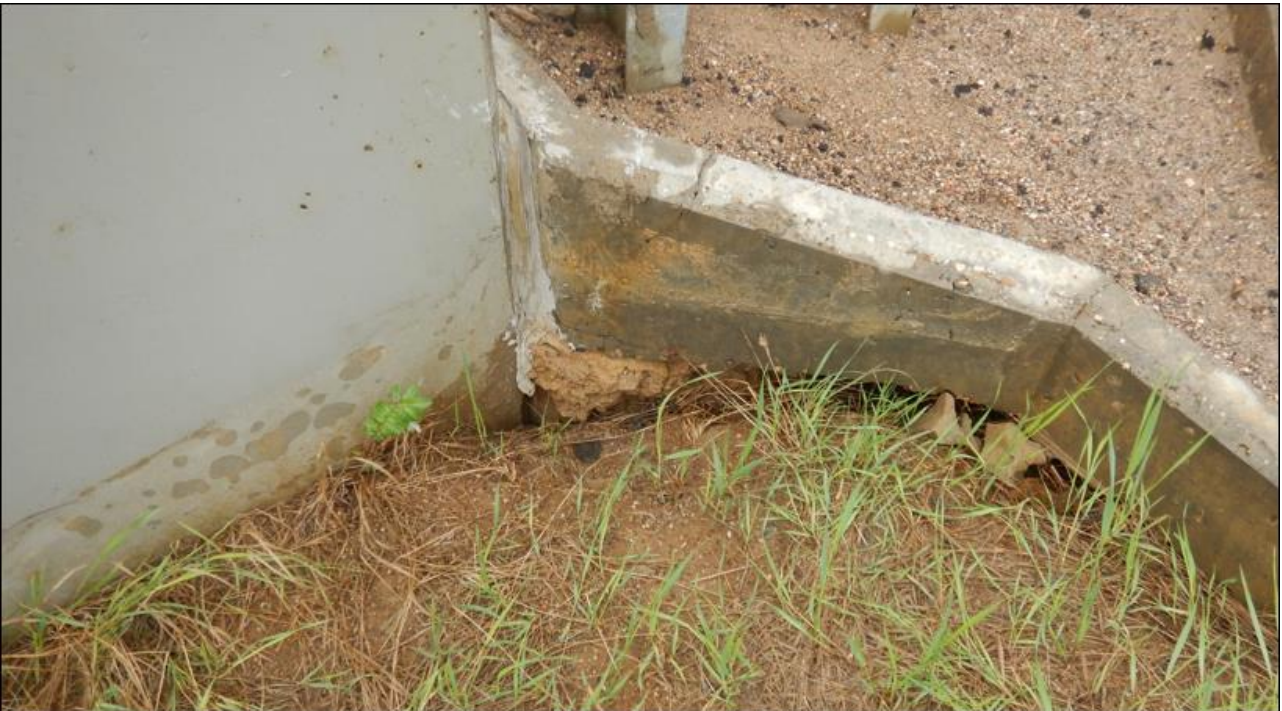
Photo No. 4 – A Flexible filler placed in 2024 to seal the 50 mm wide separation gap between the northwest wing wall and the drain trough. However, up to 300 mm deep gap was noted below the drain trough in response to fill settlement

Existing and future gaps (if developed) under drain troughs, between drain troughs and wingwalls, and below the abutment seat under the bridge should be filled with low strength fillcrete.

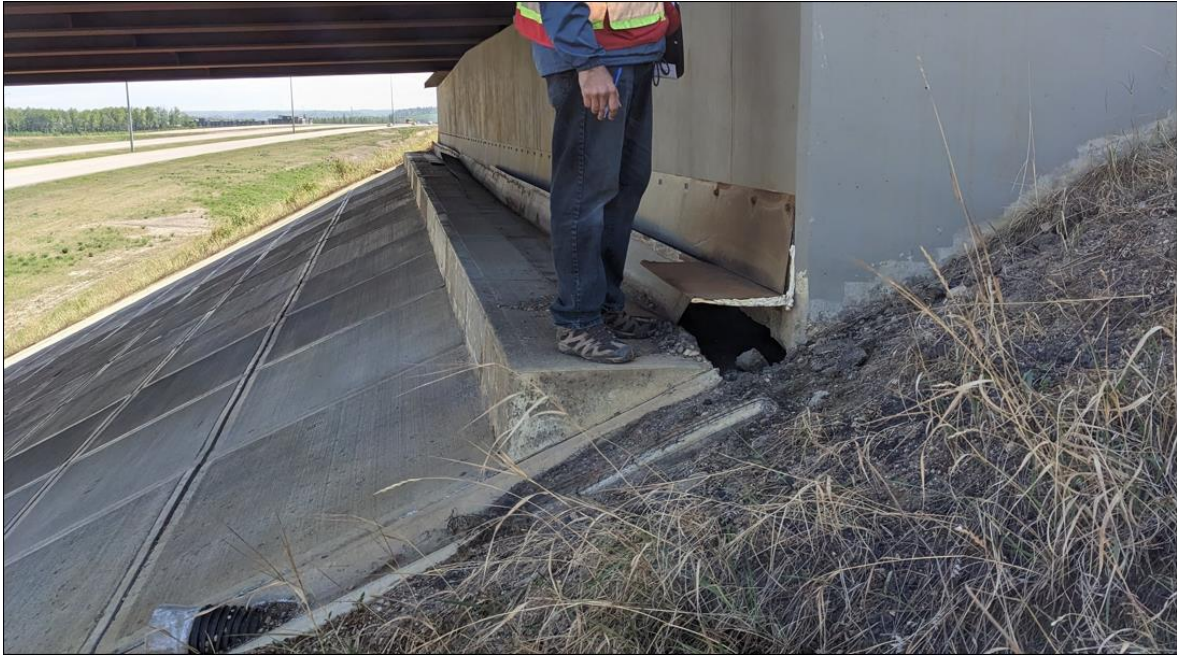
Photo No. 5a – (Taken in Spring of 2023) Looking south at head slope movement (300 mm vertical drop x 300 mm lateral shift towards east); Void under abutment seat ranges from 0.8 m to 2.7 m.

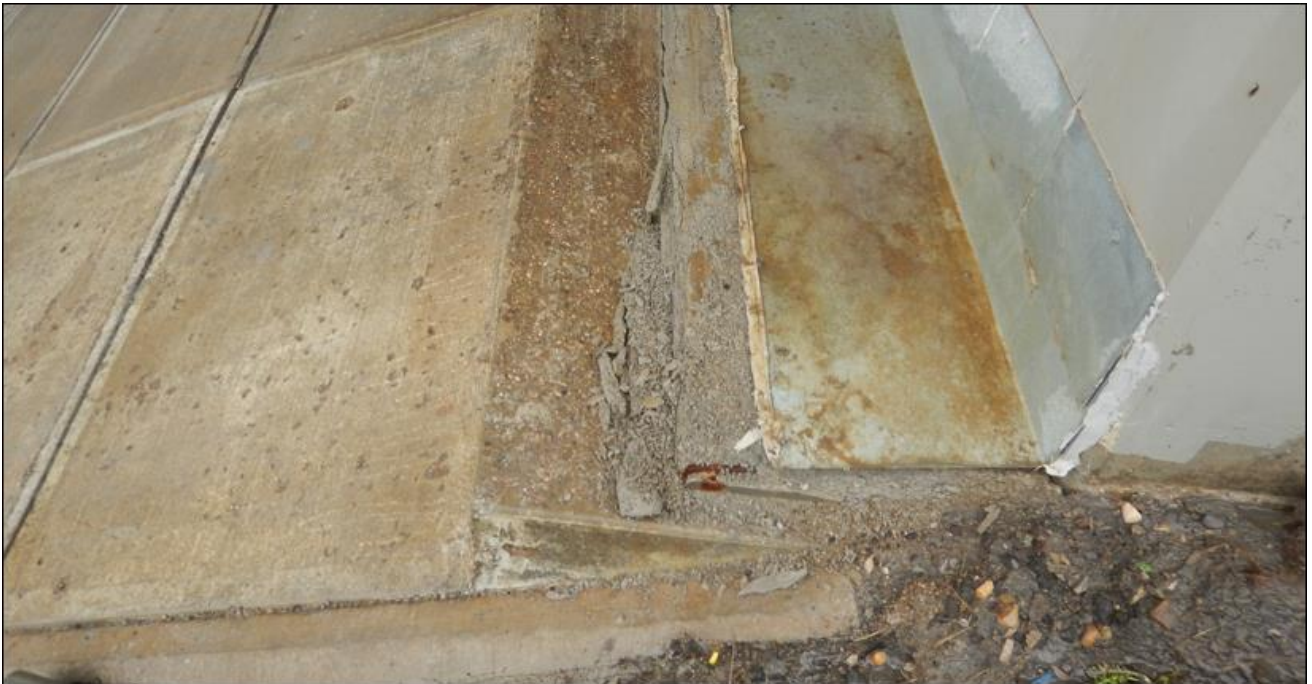
Photo No. 5b – (Taken in Spring of 2024) Void under the abutment seat shown in photo 5a was filled with grout; However, ground appears to have dropped by 20 mm and displaced laterally by 10 mm at this location

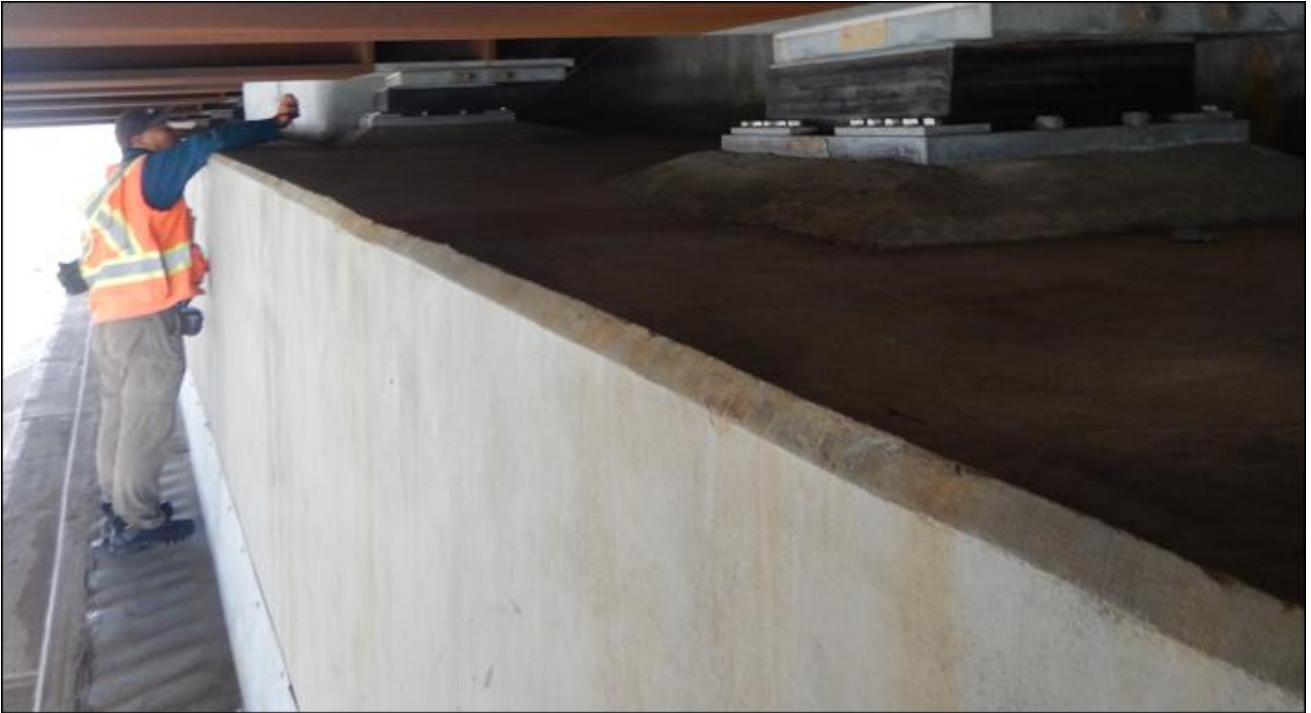
<input checked="" type="checkbox"/> Bridge/Culvert Distress	200 to 300 mm of head slope movement; no visible cracks on abutment walls, wing walls, and abutment slope concrete facing; bridge bearing plates movement maxed out	<input checked="" type="checkbox"/>
<input type="checkbox"/> Other		<input type="checkbox"/>

Photo No. 6 – Bridge bearings appear to have maxed out.

A structural engineer should be consulted in the near future to (a) examine the condition of the bridge and assess whether the structure is performing as per the original design, and (b) provide recommendations for rehabilitation/repairs (if needed) and instrumentation monitoring of structural elements (if required).

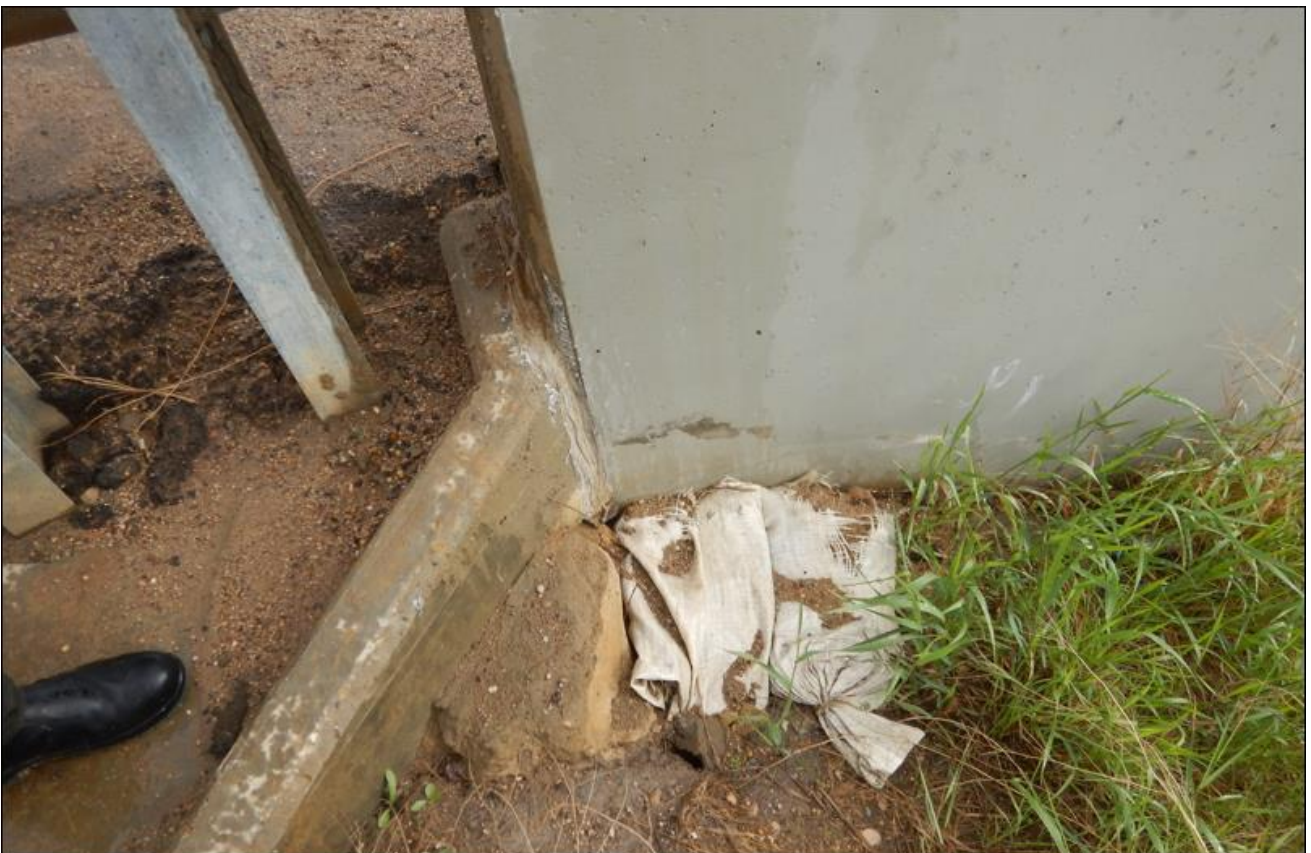
Photo 7 – South drain trough. The gap between the drain trough and wingwall was sealed with a flexible filler.

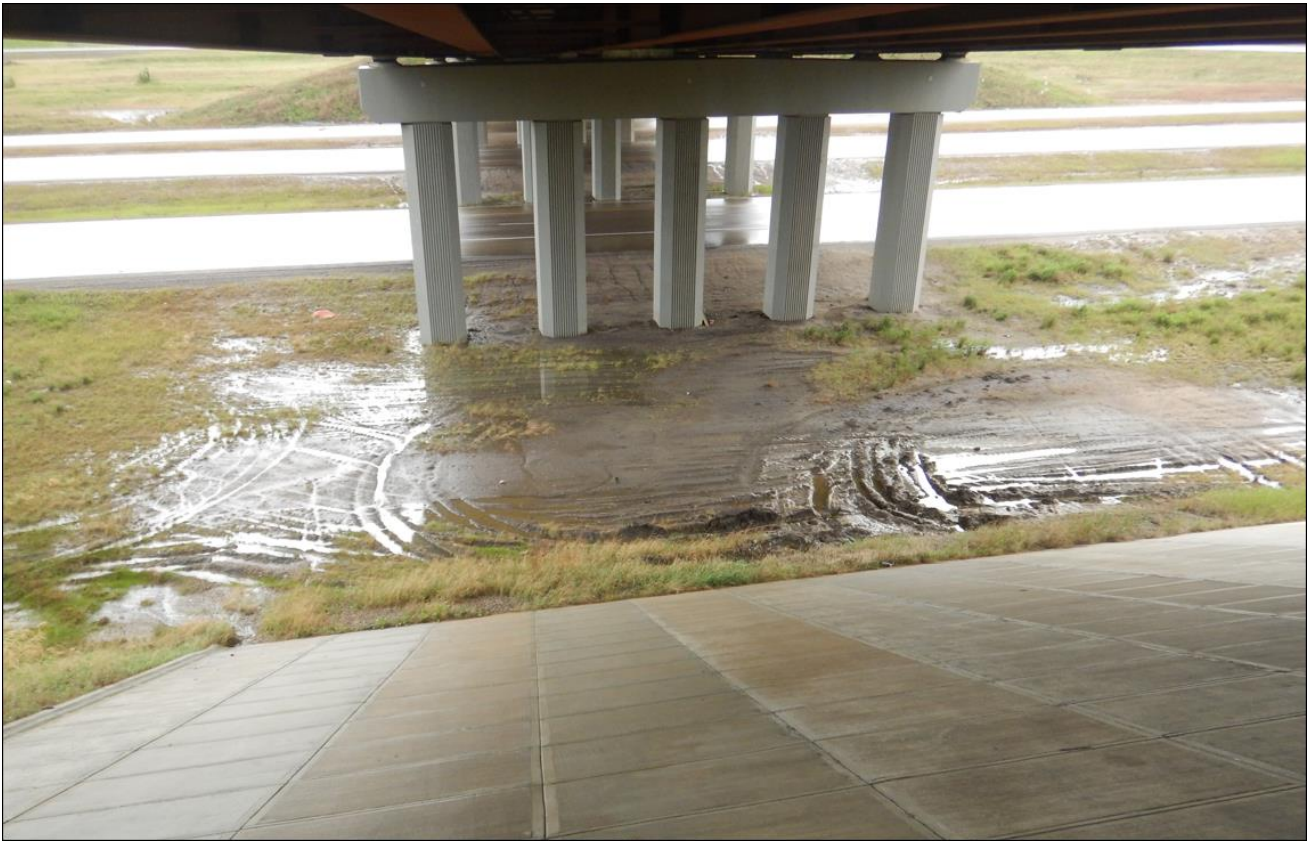
The accumulated water at the bottom of the west headslope is likely a reflection of poor surface drainage in this area. The toe is also bare of vegetation and the water accumulating at the toe has created a soft zone with multiple rutting as a result of off terrain vehicle traffic in this area.

Photo 8 – Water ponding and rutting at the toe of the bridge west headslope

The ground surface at the toe the headslope should be slightly regraded to avoid ponding of water and the re-graded surface should be topsoiled, seeded, and covered with a heavy-duty erosion control product.
