THURBER ENGINEERING LTD.

September 14, 2023

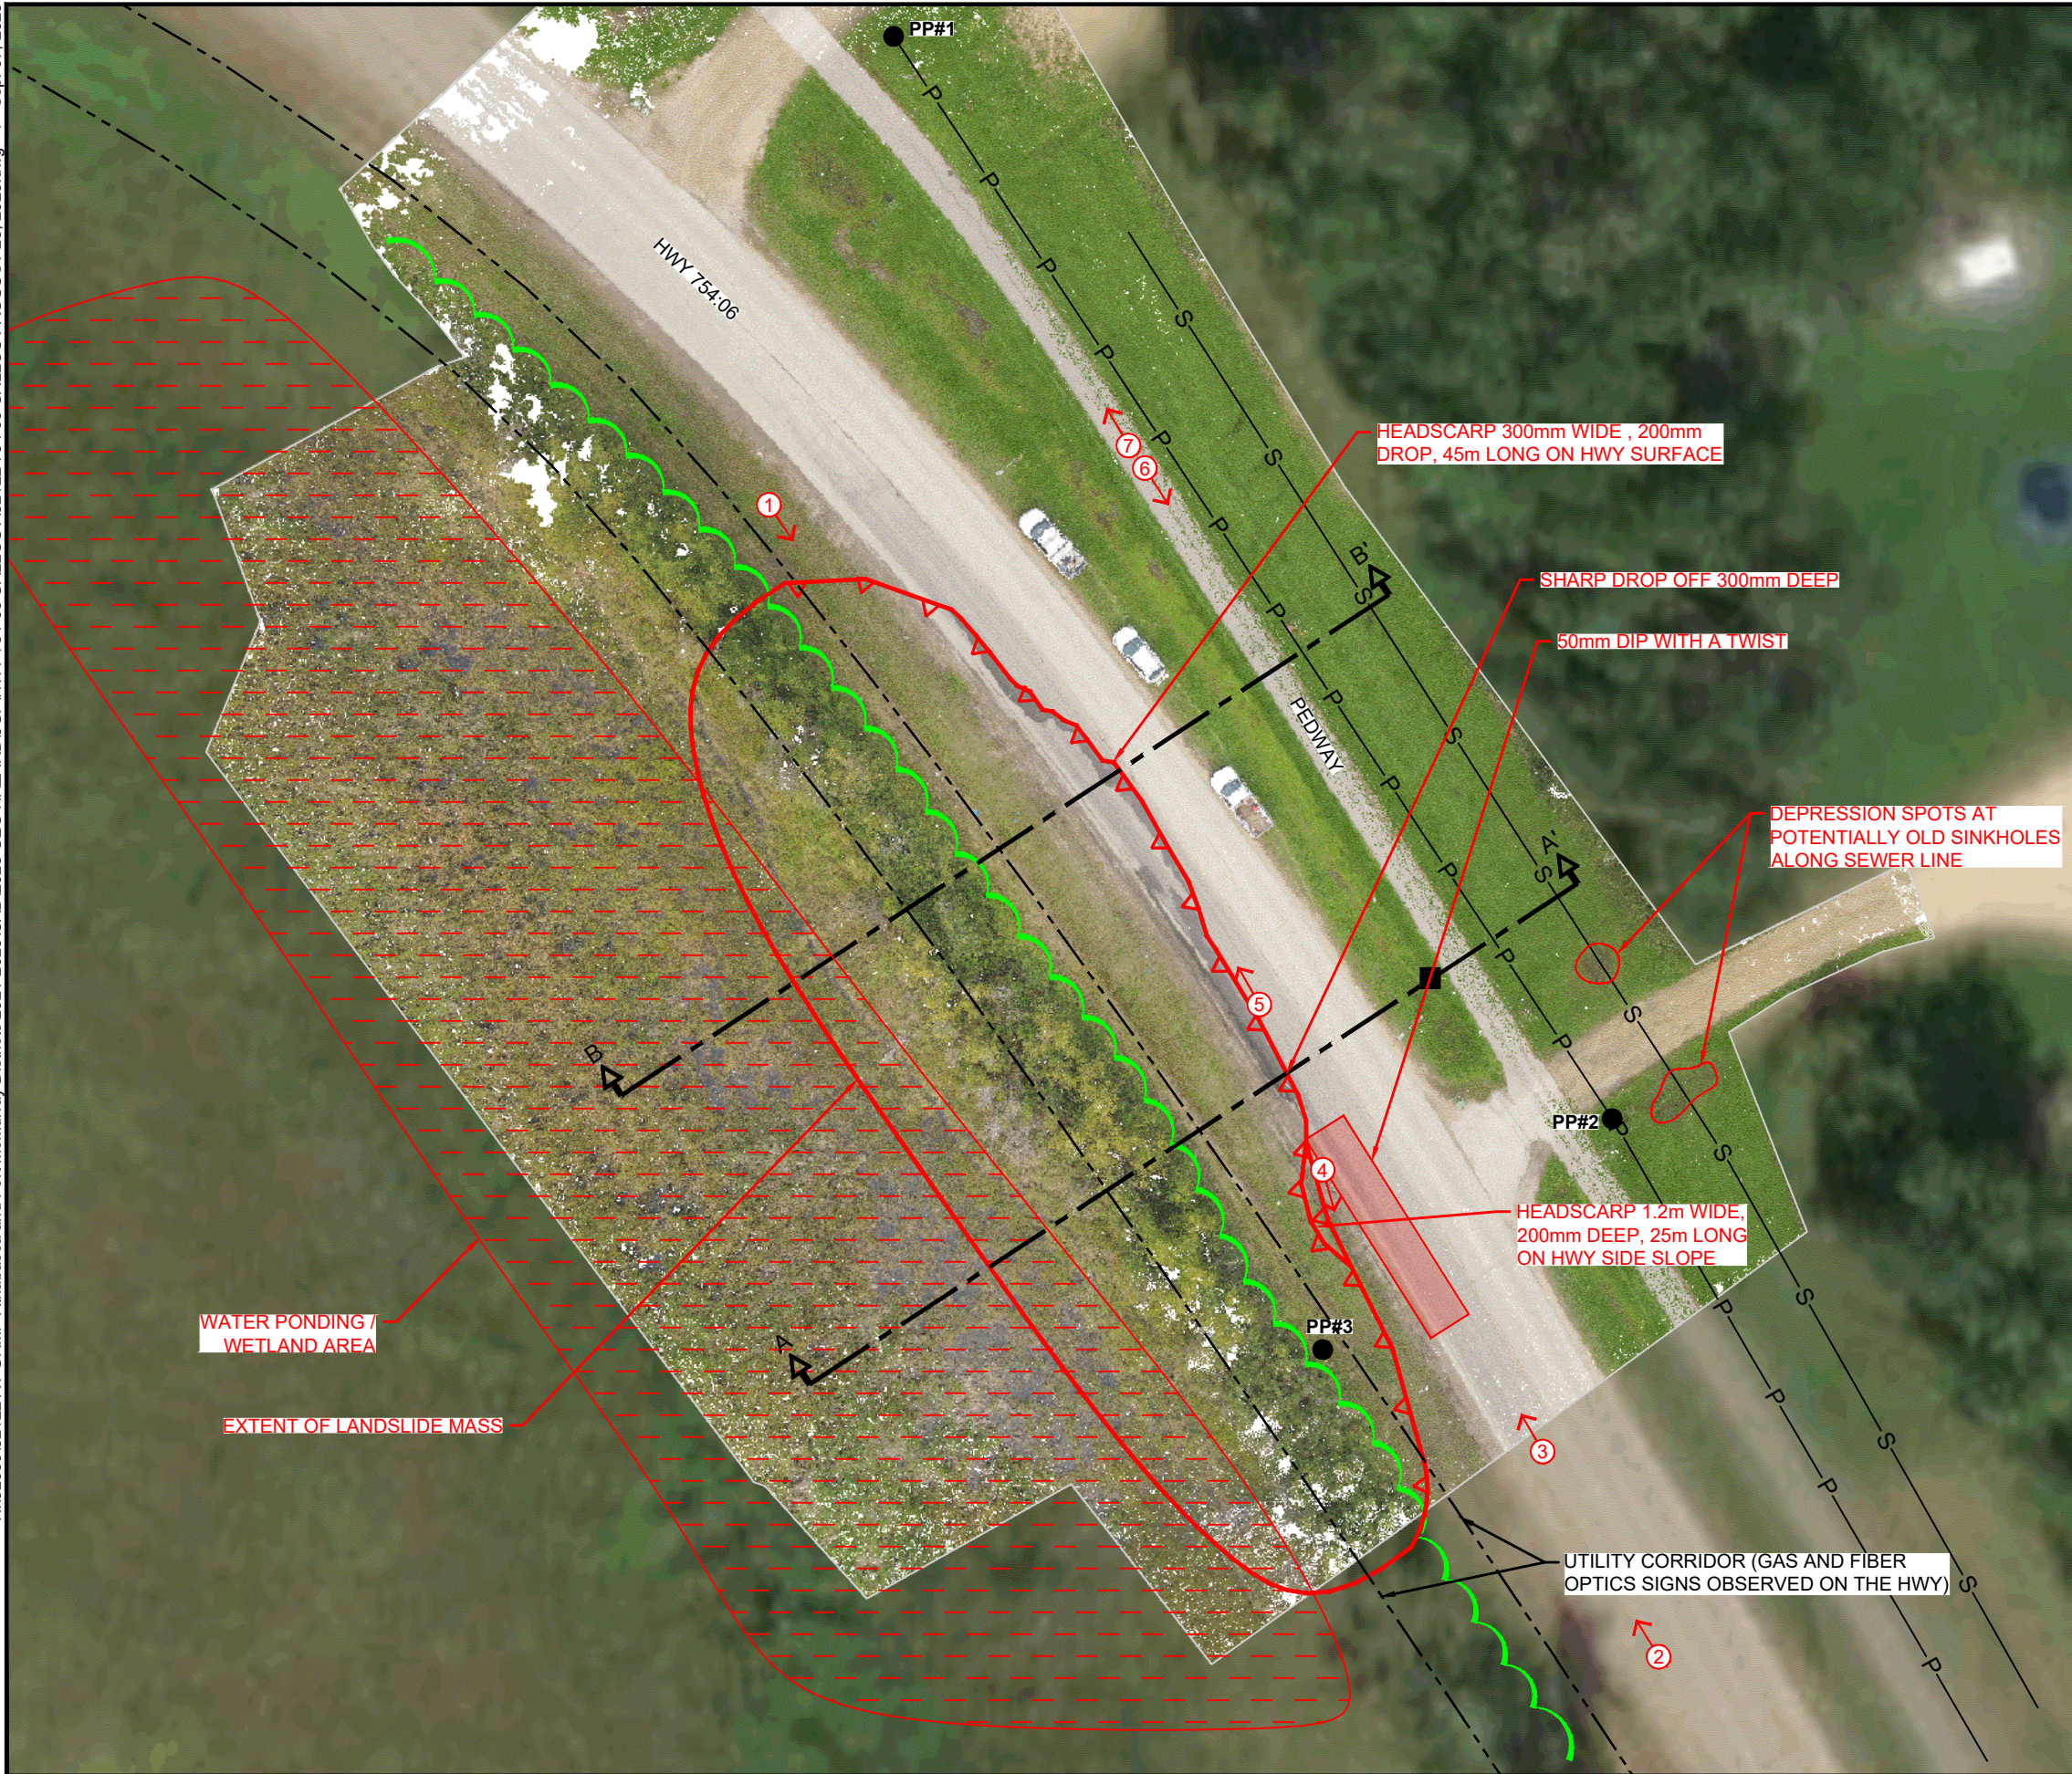
H:\32000\32122 AT GRMP Athabasca and Fort McMurray Districts 2021-2025\CAD\2023 GEO HAZARD\GPHHWY 754-06 CALLOUT\32122 754 06 CALLOUT AUGUST 29, 2023.dwg - 1 - Sep. 07, 2023

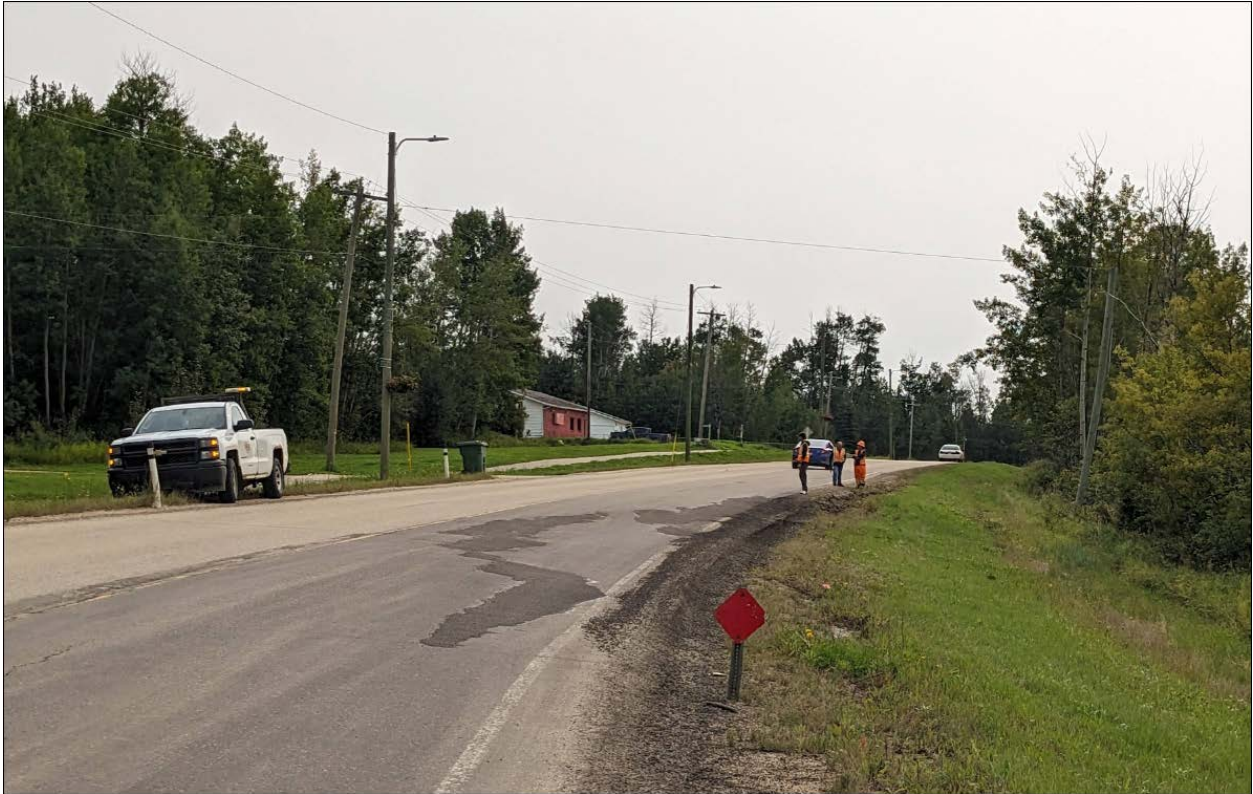
Photo 1. Northern flank of landslide. Head scarp crack was patched a few days before August 24, 2023 site visit. Note the sharp drop off on the highway shoulder (approximately 300 mm drop).

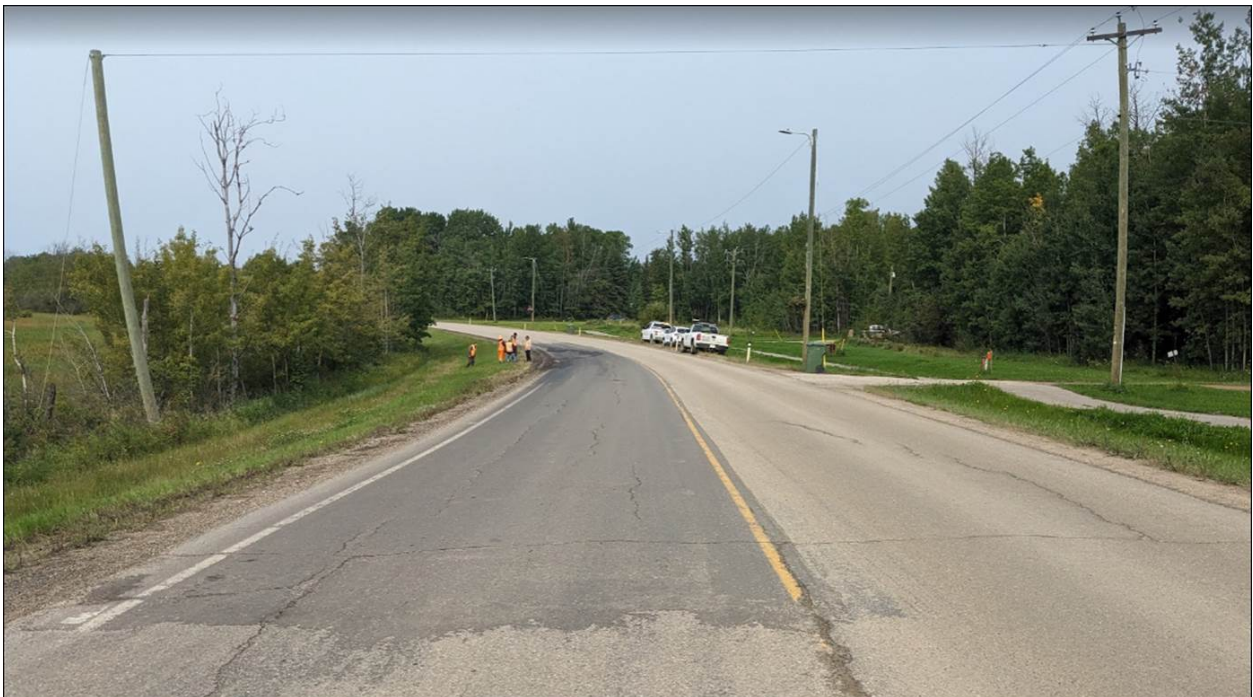
Photo 2. Looking north at the landslide area. Anchor Power Pole No. 3 on the LHS and the Power Pole No. 2 on the RHS of the photo are bent due to the high tension in the overhead cable.

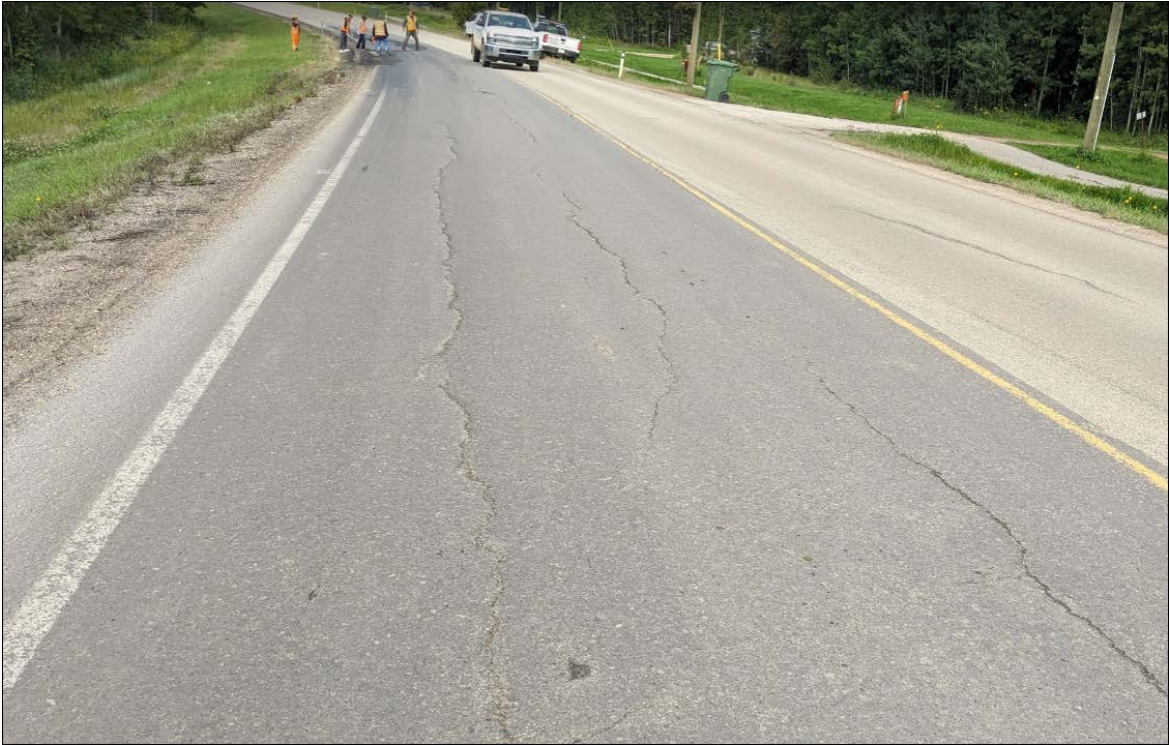
Photo 3. Longitudinal cracks (30 mm wide by 30 mm deep) within the previously patched area. There is a 50 mm dip with a twist on the southern portion of the site.

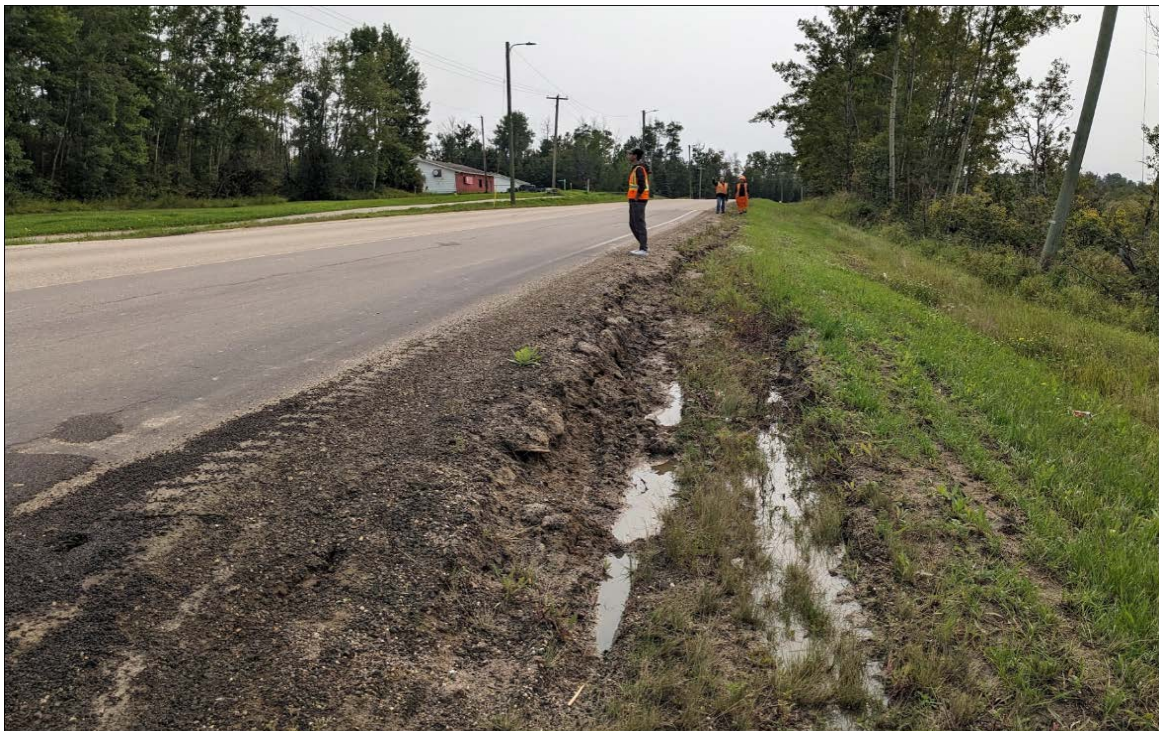
Photo 4. Southern flank of the landslide (looking south); 1.2 m wide x 0.2 m deep landslide crack on the highway west side slope.

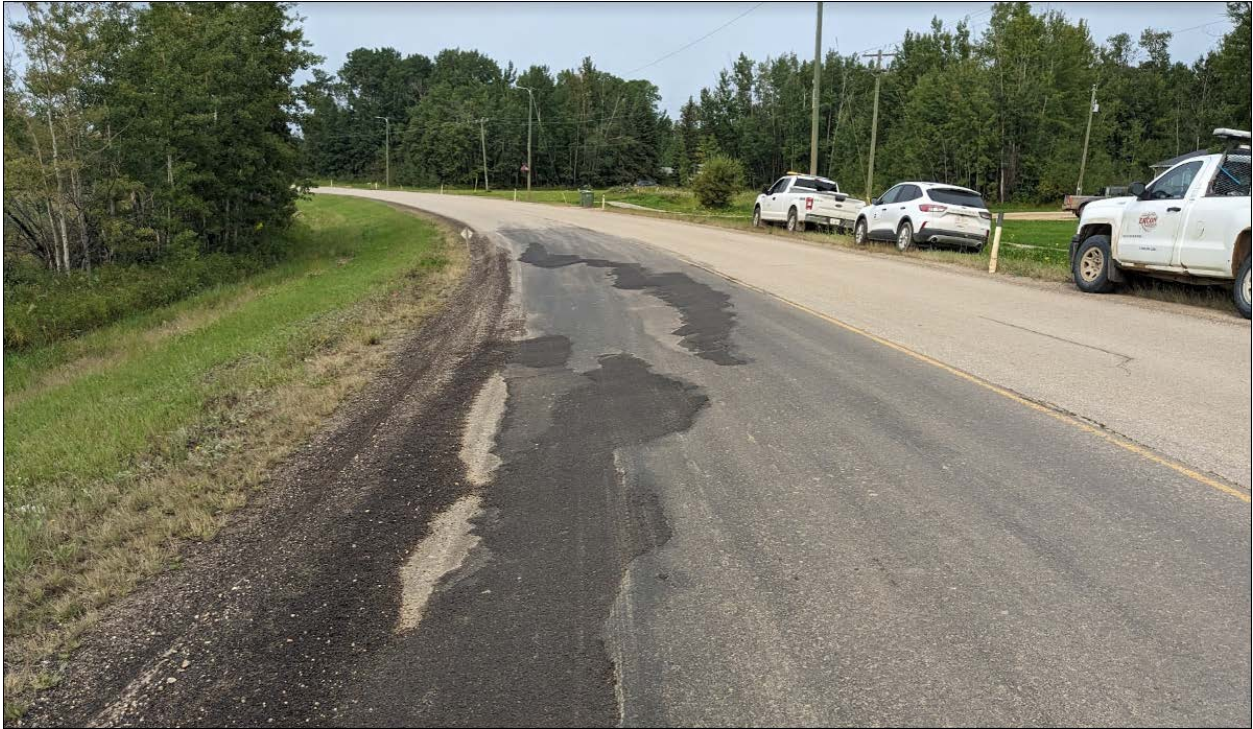
Photo 5. Looking north at the severely impacted section of the highway by the landslide movement. Head scarp crack at this section (near the northern flank of the landslide) is 300 mm wide with up to 200 mm drop.

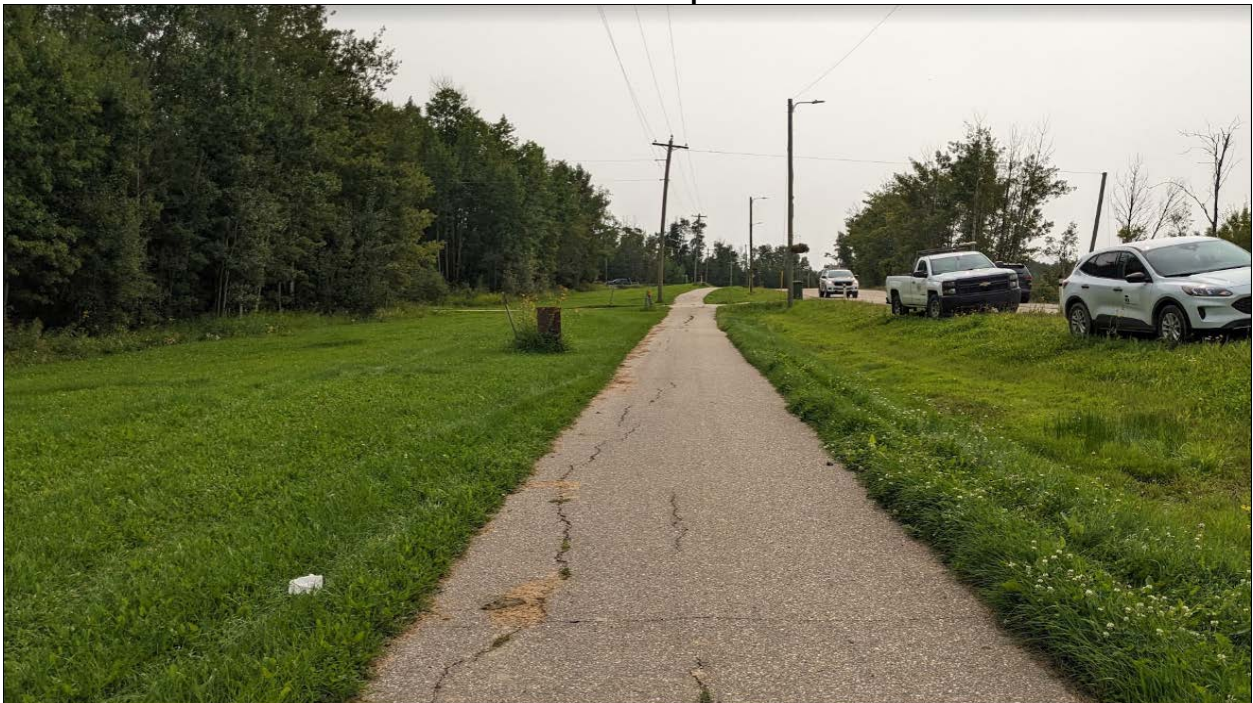
Photo 6. Pedway on the east side of the highway. Note Power Pole No. 2 and Anchor Pole No. 3 tilting due to the landslide movement.
