**ALBERTA TRANSPORTATION AND
ECONOMIC CORRIDORS GRMP
NORTH CENTRAL (ATHABASCA AND
FORT MCMURRAY DISTRICTS)
2024 SITE INSPECTION**

**NORTH CENTRAL REGION
(ATHABASCA AND FORT MCMURRAY DISTRICTS)
2024 GEOHAZARD ASSESSMENT
NC110 - WABASCA LAKE SLIP 'N SLIDE
HWY 754:06 km 30.9
SITE PLAN SHOWING APPROXIMATE SITE FEATURES**

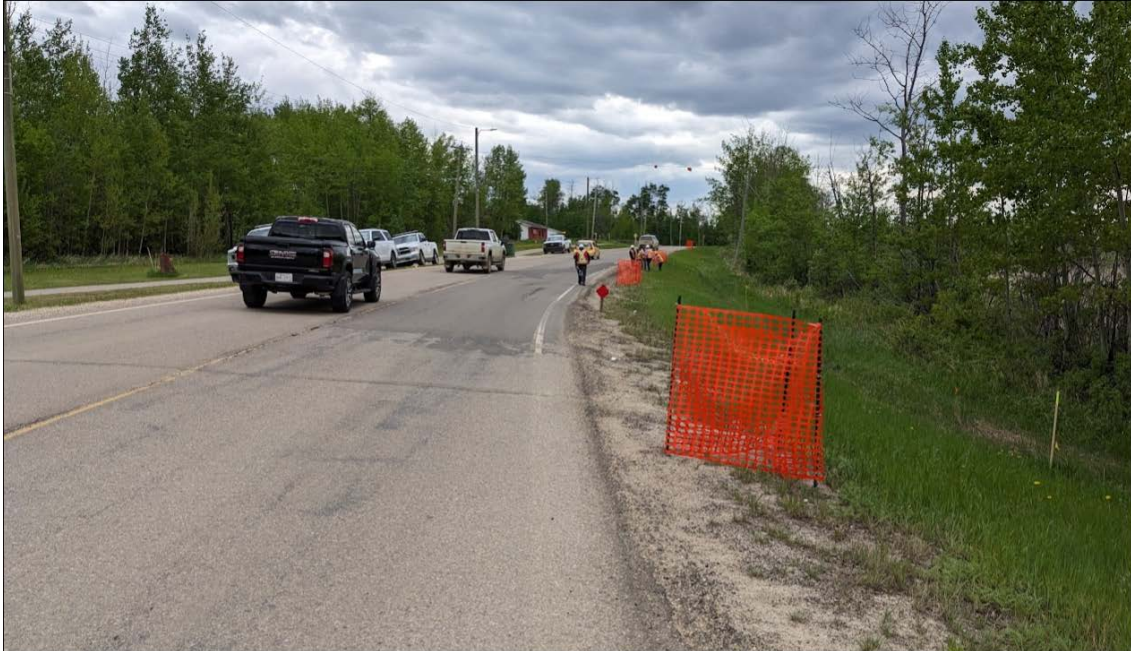
The existing 300 mm drop on the highway surface within the northern limit of the landslide is a serious hazard and constitutes a major safety concern to motorists.

Photo 1. Northern flank of landslide. Head scarp open cracks were filled with ACP in early Spring 2024. Note the significant dip on the highway surface (approximately 300 mm drop).

- The MCI should monitor the highway condition on a regular basis and seal all open cracks as they re-appear on the highway surface.
- ACP patch should be placed on the highway SBL, where the severe distress was noted, to eliminate existing hazard and provide a smooth ride to the motorists.
- A landslide warning sign should be placed off the highway surface to warn motorists of the existing hazard.
- TEC should contact the owners of utility lines and notify them of the existing hazard,

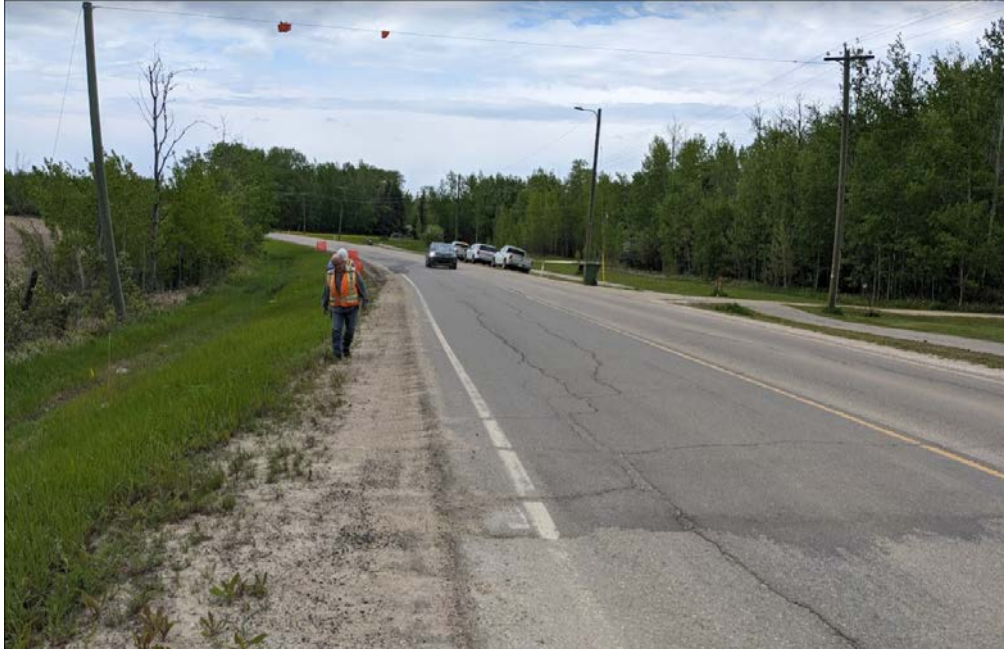
Photo 2. Looking north at the landslide area. Anchor Power Pole No. 3 on the LHS and the Power Pole No. 2 on the RHS of the photo are bent due to the high tension in the overhead cable.

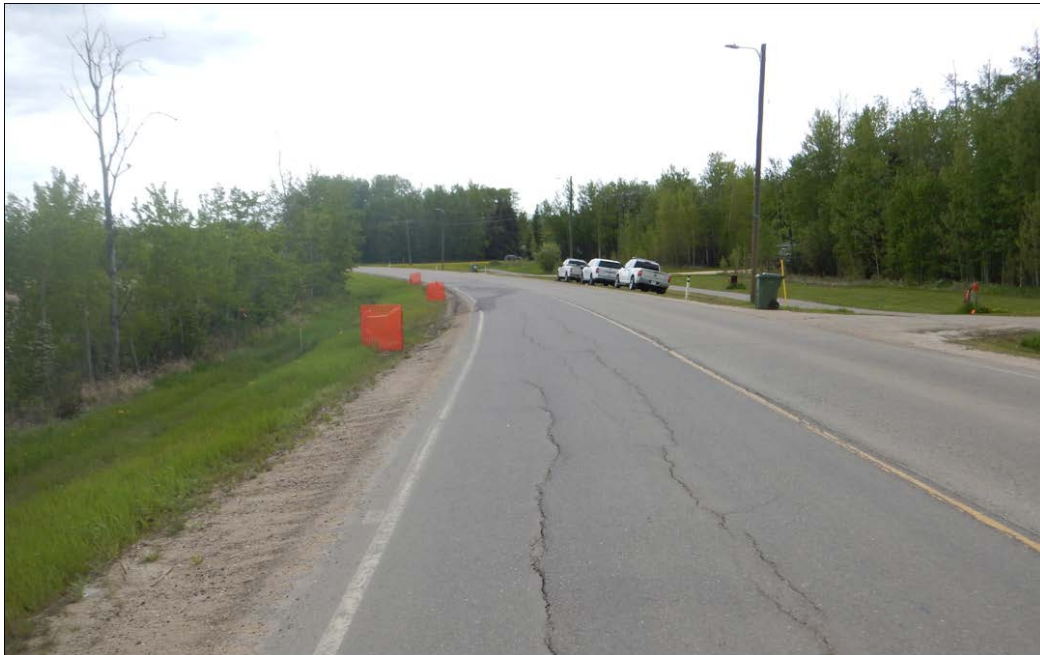
Photo 3. Longitudinal cracks (15-20 mm wide, 20 mm drop) within the previously patched area. There is a 50 mm dip with a twist on the southern portion of the site.

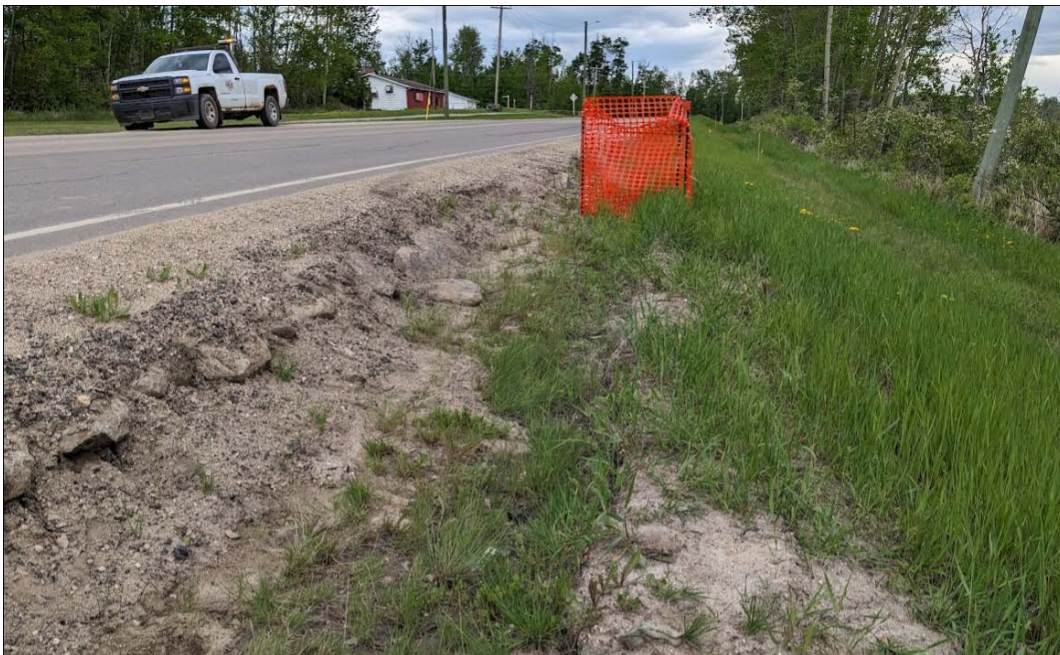
Photo 4. Southern flank of the landslide (looking south); 1.2 m wide x 0.2 m deep landslide crack on the highway west side slope.

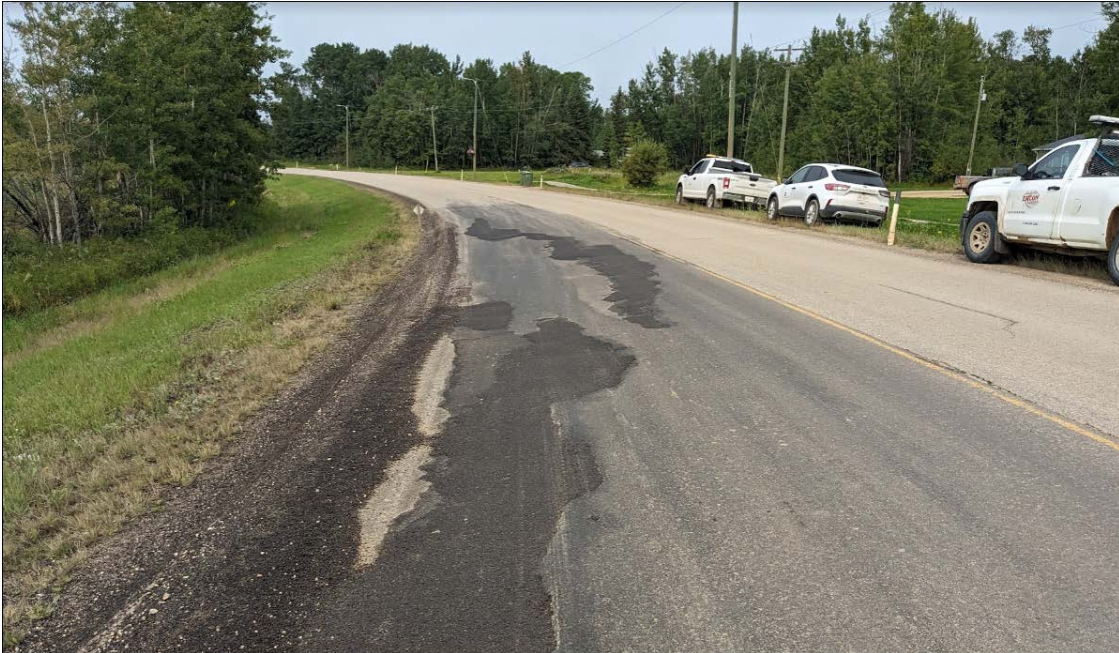
Photo 5 A. (2023) – Headscarp Crack 45 m long, 300 mm wide with 200 mm drop

Photo 5. Looking north at the severely impacted section of the highway by the landslide movement. Photo 5 A and 5 B were taken in 2023 and 2024, respectively

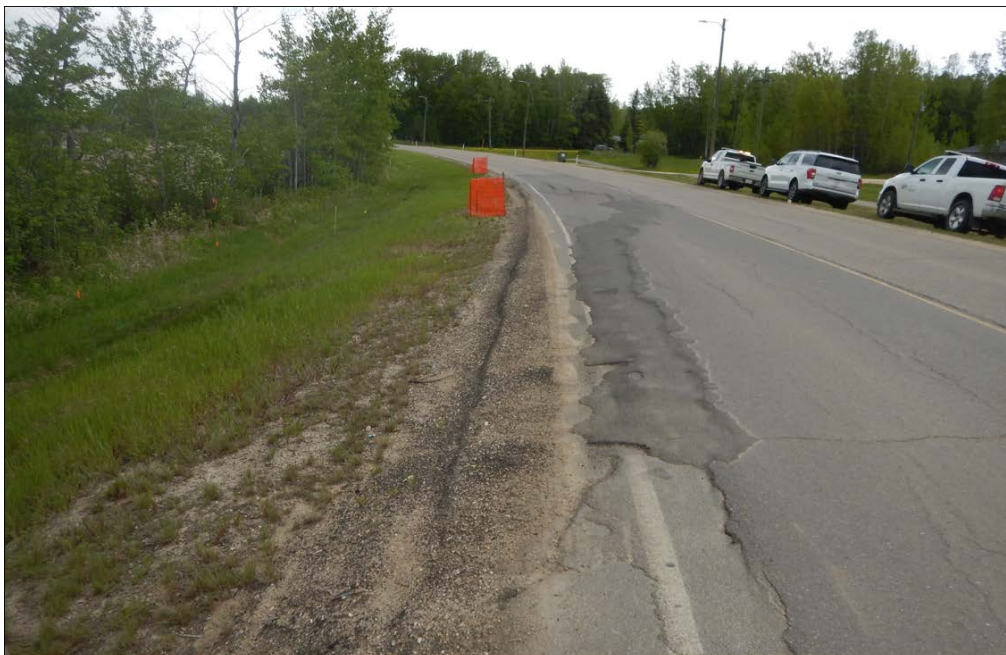
Photo 5 B. (2024) – Headscarp Crack 50 m long, 300 mm wide, 300 mm drop

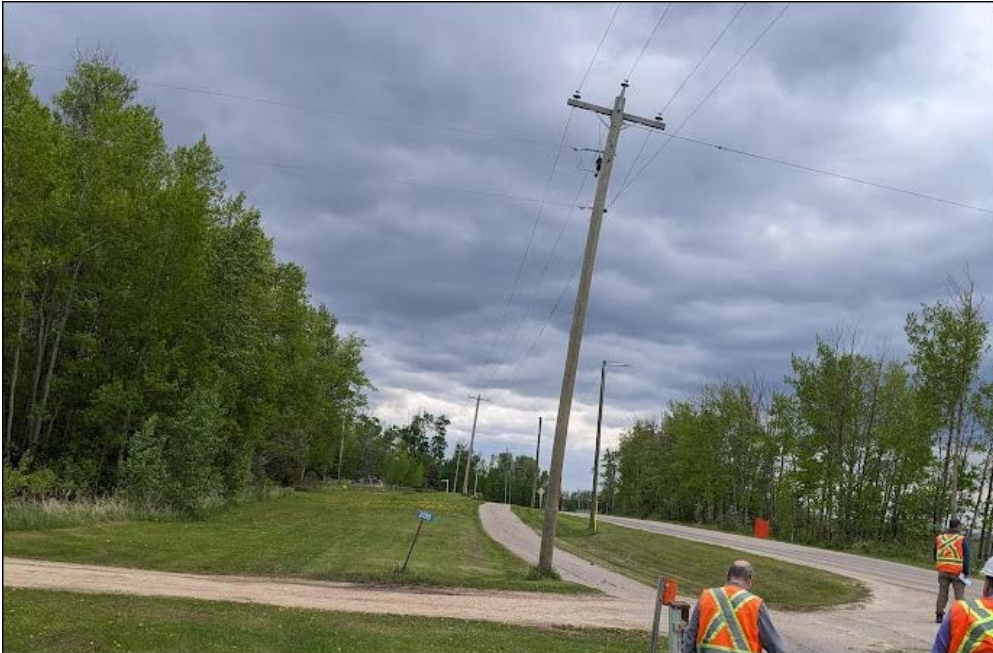
Photo 6. Looking south from the east side of the highway at Power Pole No. 2, which appeared to have tilted more between 2023 and 2024
