**ALBERTA TRANSPORTATION AND  
ECONOMIC CORRIDORS GRMP  
NORTH CENTRAL (ATHABASCA AND FORT  
McMURRAY DISTRICTS)  
INSTRUMENTATION MONITORING- FALL 2024**

Site Number	Location	Name	Hwy	km
NC110	HWY 754:06 C1 32.94	Wabasca Lake Slip 'n Slide	754:06	km 32.94
<b>Legal Description:</b> NW-27-80-25 W4		<b>UTM Co-ordinates</b>		
		12U E 321468	N	6207205

<b>Current Monitoring:</b>	17-Sep-2024	<b>Previous Monitoring</b>	13-Jun-2024
<b>Instruments Read By:</b>	Mr. Niraj Regmi, G.I.T and Mr. Nixon Mationg, of Thurber

**NC110 - WABASCA LAKE SLIP N' SLIDE  
HWY 754:06 WABASCA, ALBERTA  
SITE PLAN**

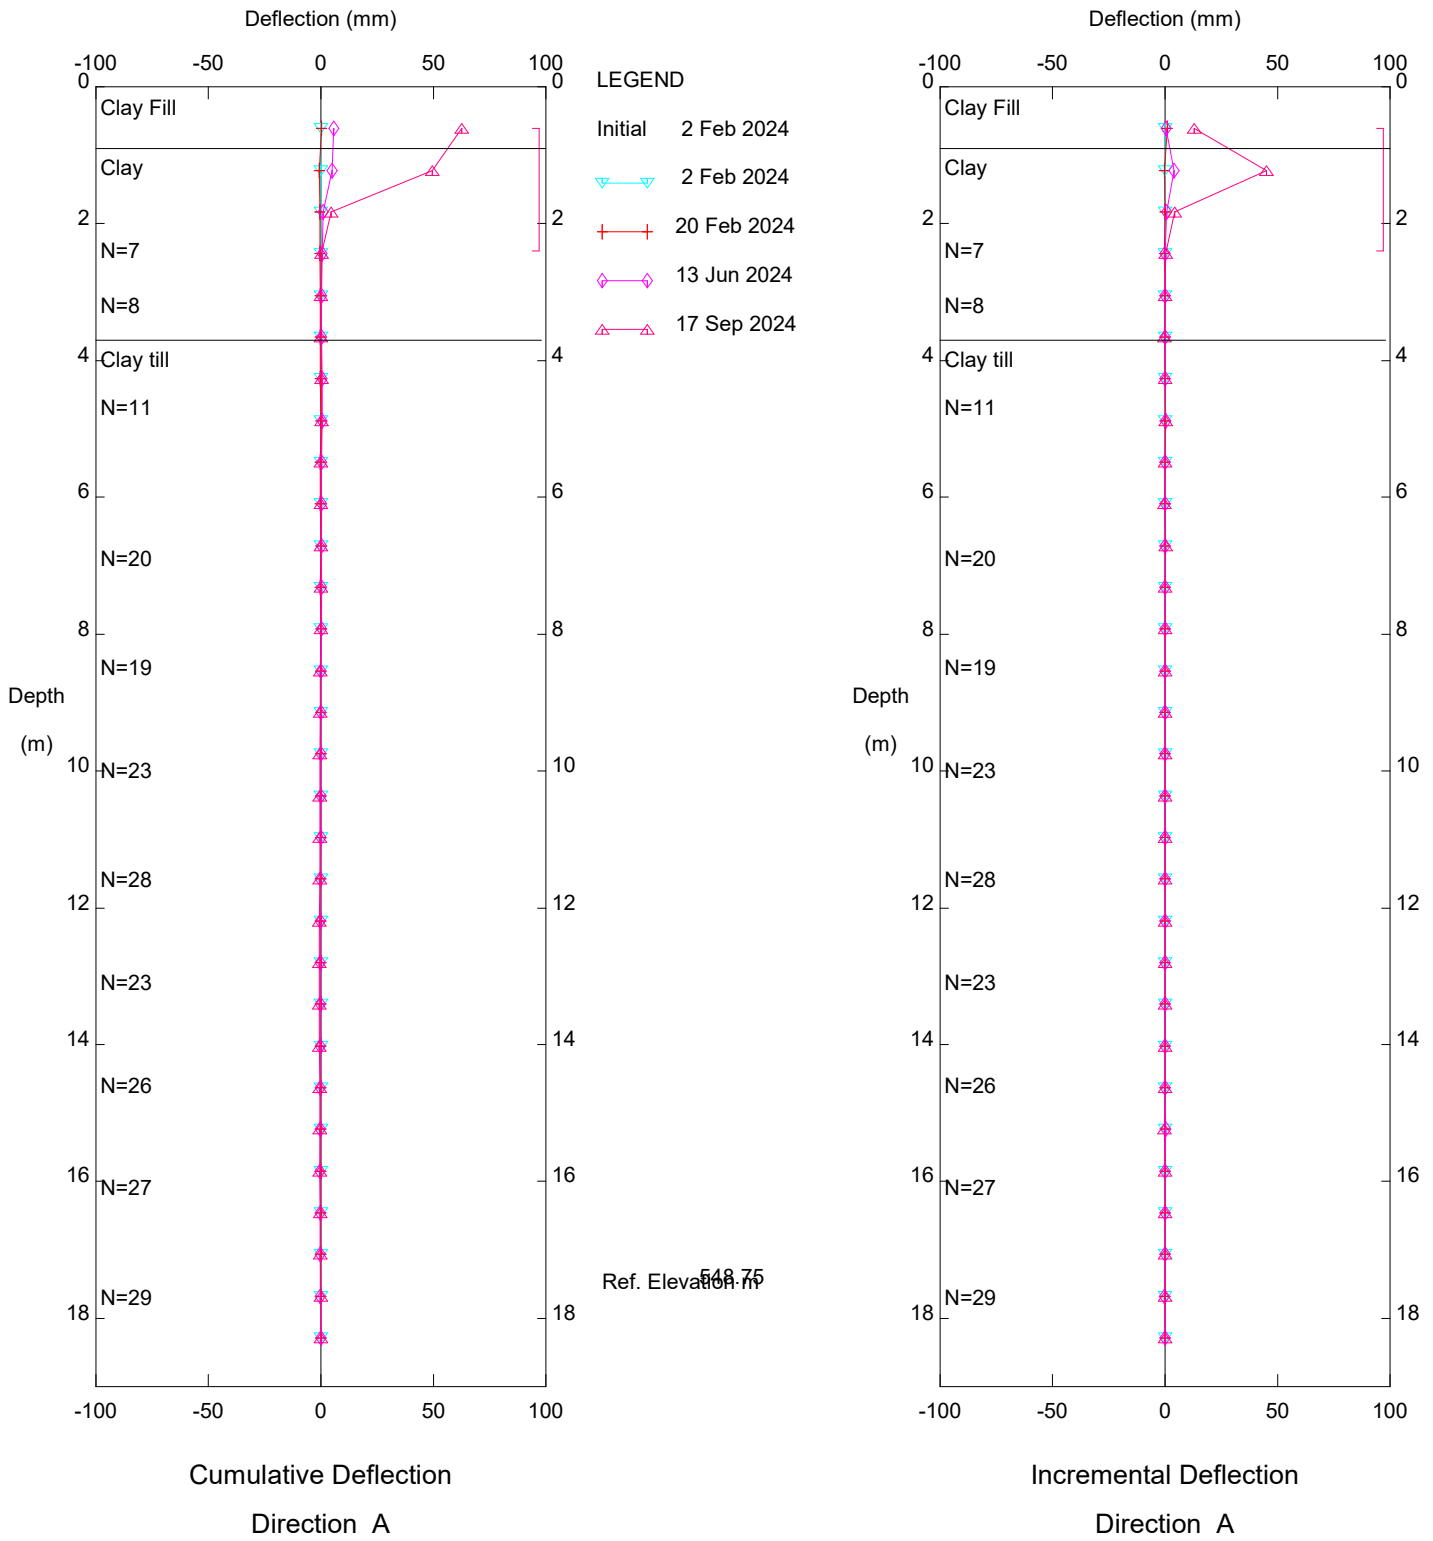
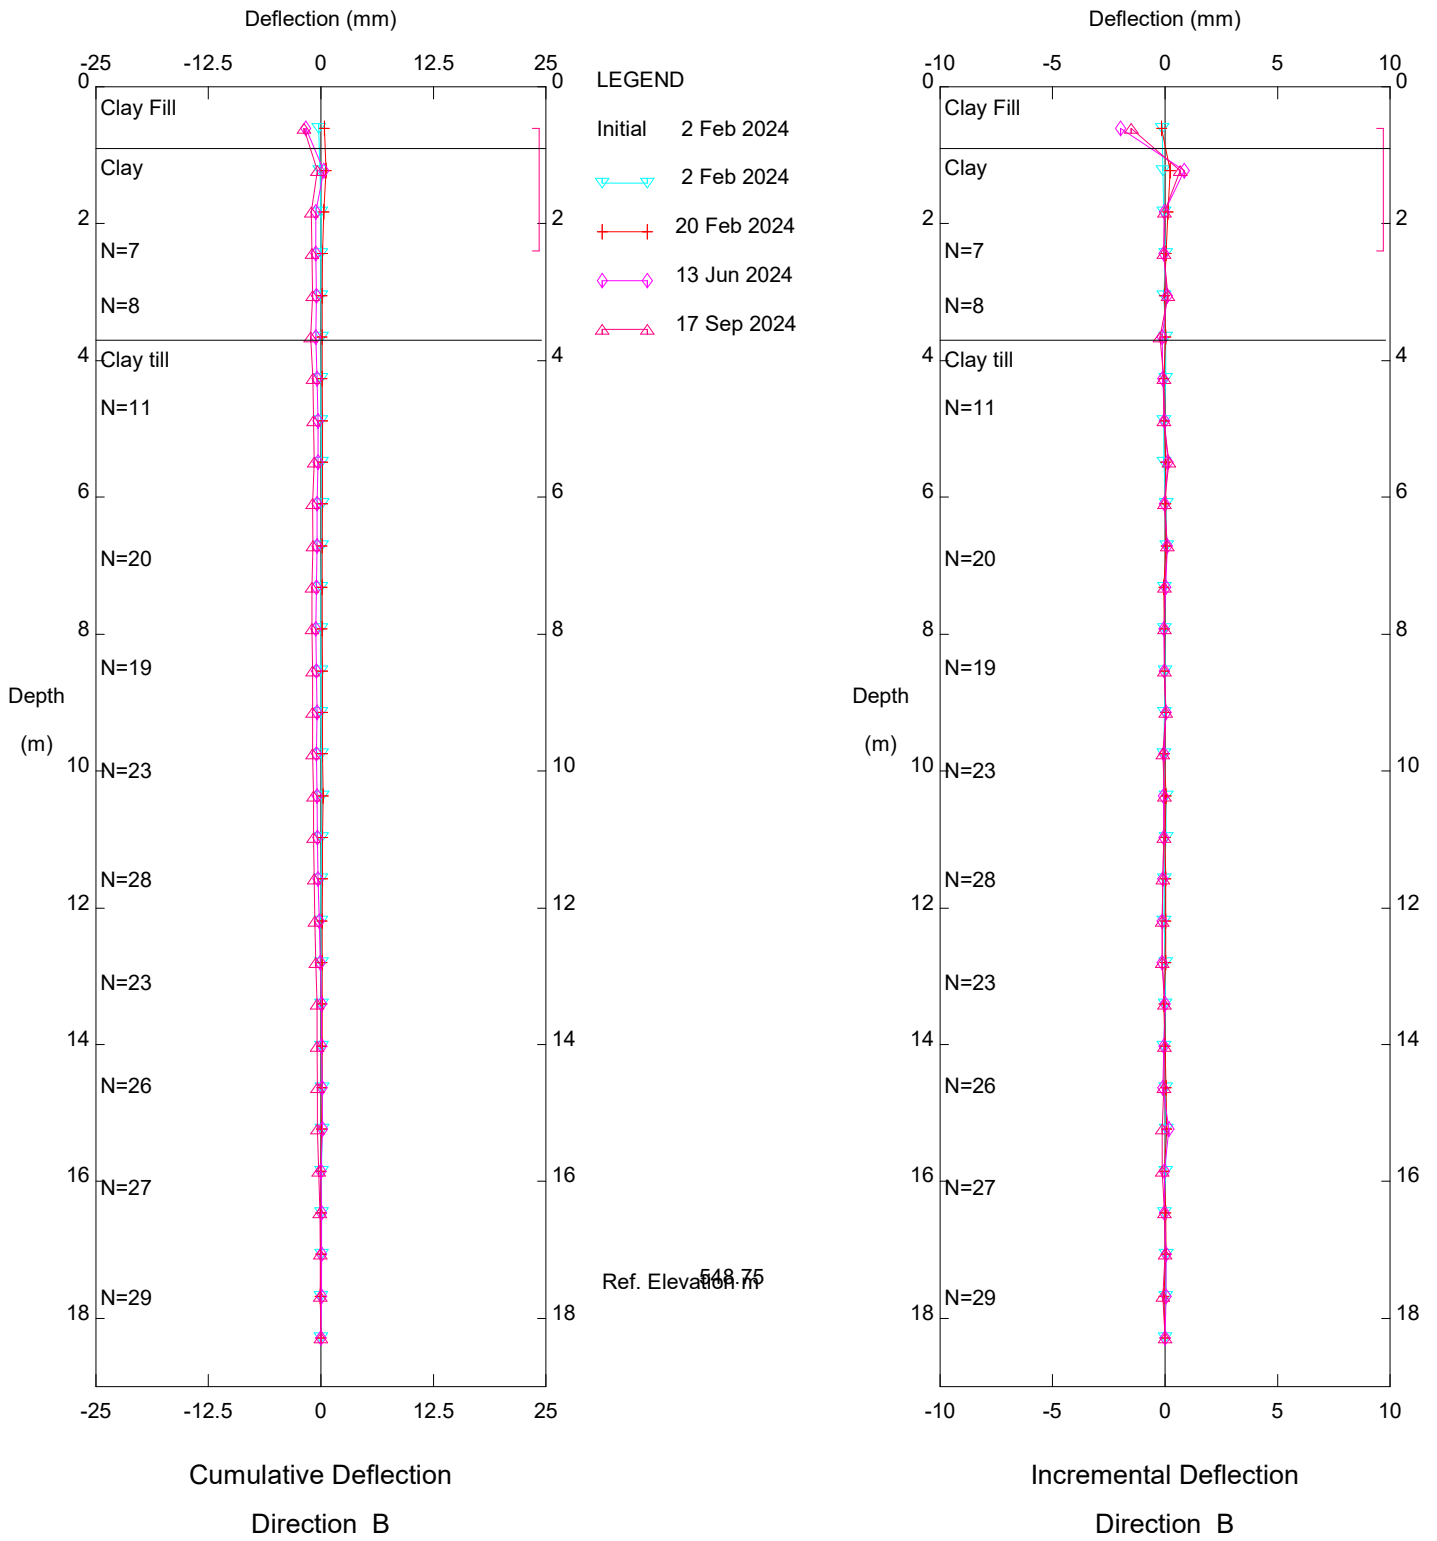
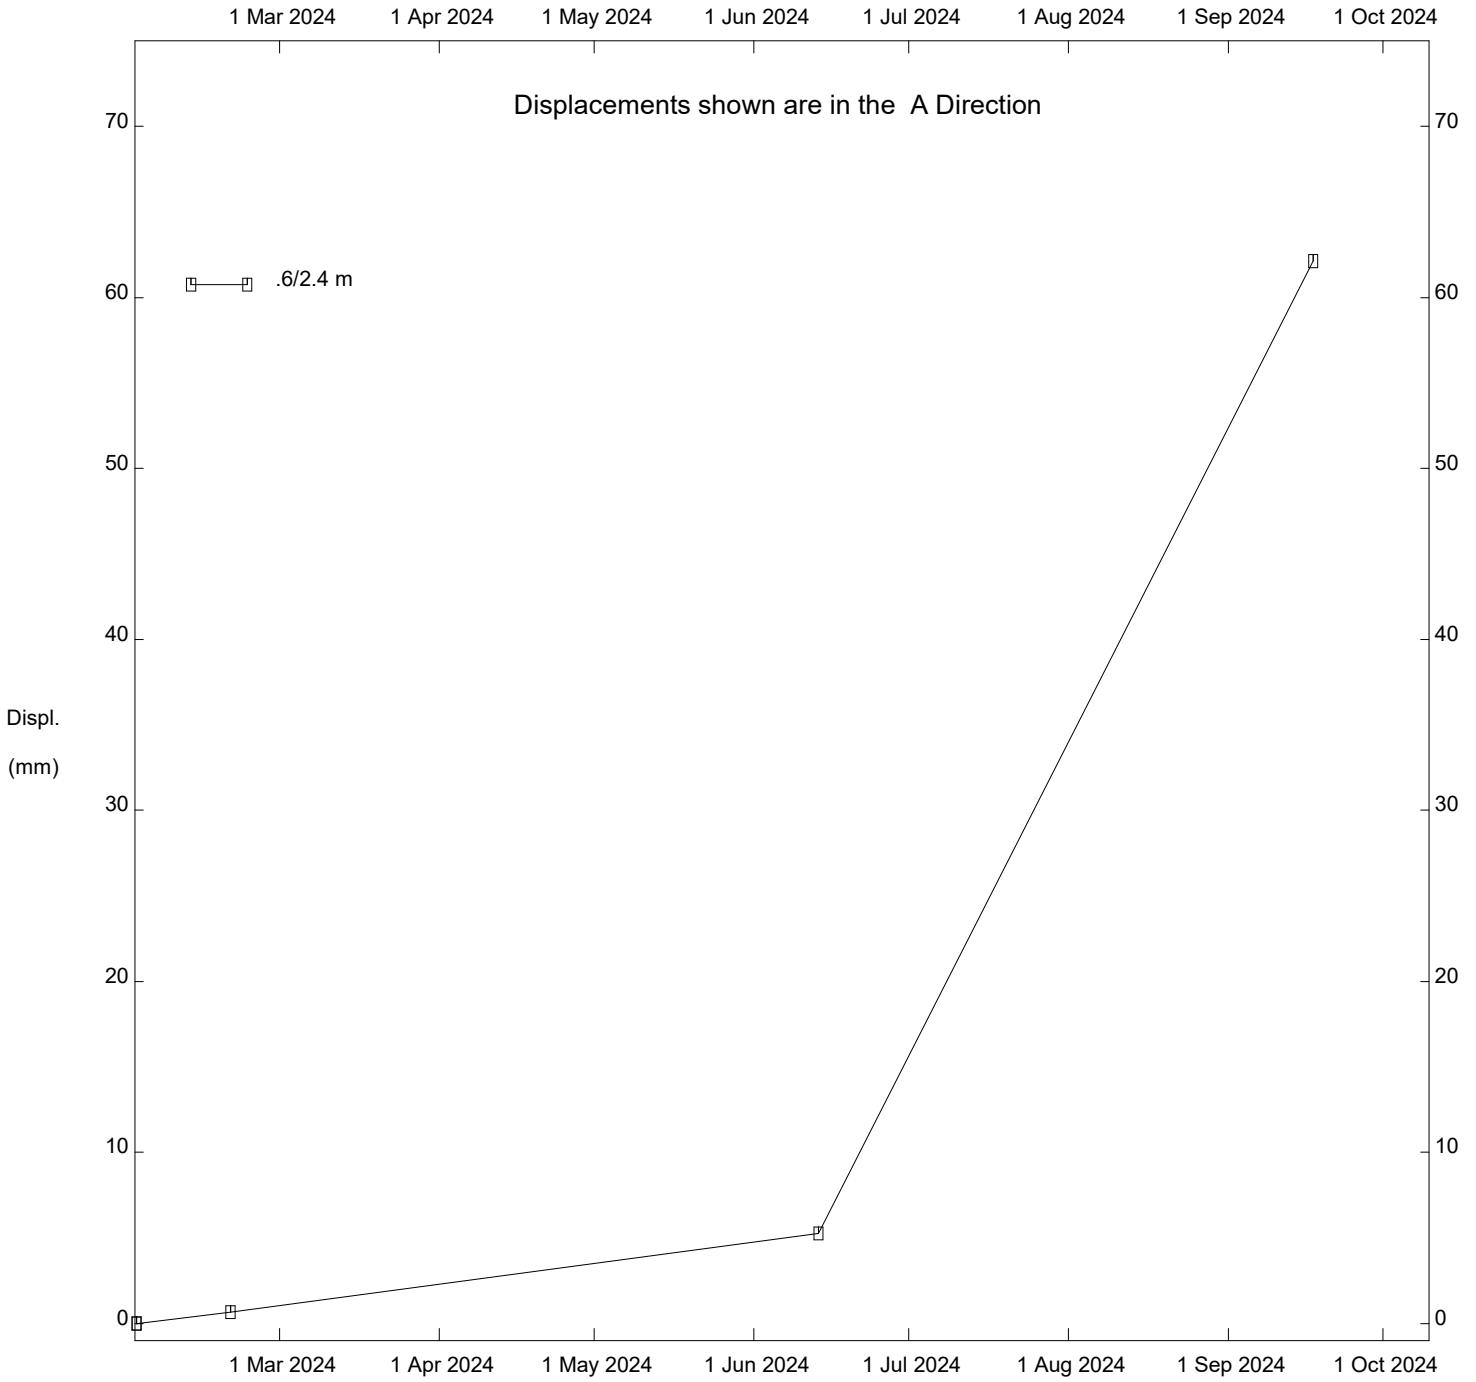
SI24-3, NC110 Wabasca Lake, Inclinometer 24-3

Discussion	
<b>Zones of New Movement:</b>	None
<b>Interpretation of Monitoring Results:</b>	<p>SI24-3 showed a rate of movement of 216.5 mm/yr over 0.6 m to 3.7 m depth since the spring 2024 readings. This corresponds to an increase in the rate of movement by 201.7 mm/yr.</p> <p>Standpipe piezometer SP24-1 showed an increase in groundwater level of 0.17 m since the spring 2024 readings. The current groundwater level of 1.67 m below ground surface is the highest measured since the instrument was initialized. SP24-4 showed a decrease in groundwater level of 1.61 m since the spring 2024 readings.</p> <p>Vibrating wire piezometers VW24-2B and VW24-3A showed decreases in groundwater level of 0.03 m and 0.13 m, respectively, since the spring 2024 readings. VW24-2B showed an increase in groundwater level of 0.38 m since the spring 2024 readings. The groundwater level recorded in VW24-3B during this monitoring event is the highest measured since it was initialized.</p>
