**ALBERTA TRANSPORTATION AND  
ECONOMIC CORRIDORS GRMP  
NORTH CENTRAL (ATHABASCA AND FORT  
McMURRAY DISTRICTS)  
INSTRUMENTATION MONITORING- SPRING 2024**

Site Number	Location	Name	Hwy	km
NC110	HWY 754:06 C1 32.94	Wabasca Lake Slip 'n Slide	754:06	Km 32.94
<b>Legal Description:</b> NW-27-80-25 W4		<b>UTM Co-ordinates</b>		
		12U E 321468	N	6207205

<b>Current Monitoring:</b>	13-Jun-2024	<b>Previous Monitoring</b>	01-May-2024
<b>Instruments Read By:</b>	Mr. Niraj Regmi, G.I.T and Mr. Nixson Mationg, of Thurber

**SITE NC110: HWY 754:06 WABASCA LAKE SLIP N' SLIDE**

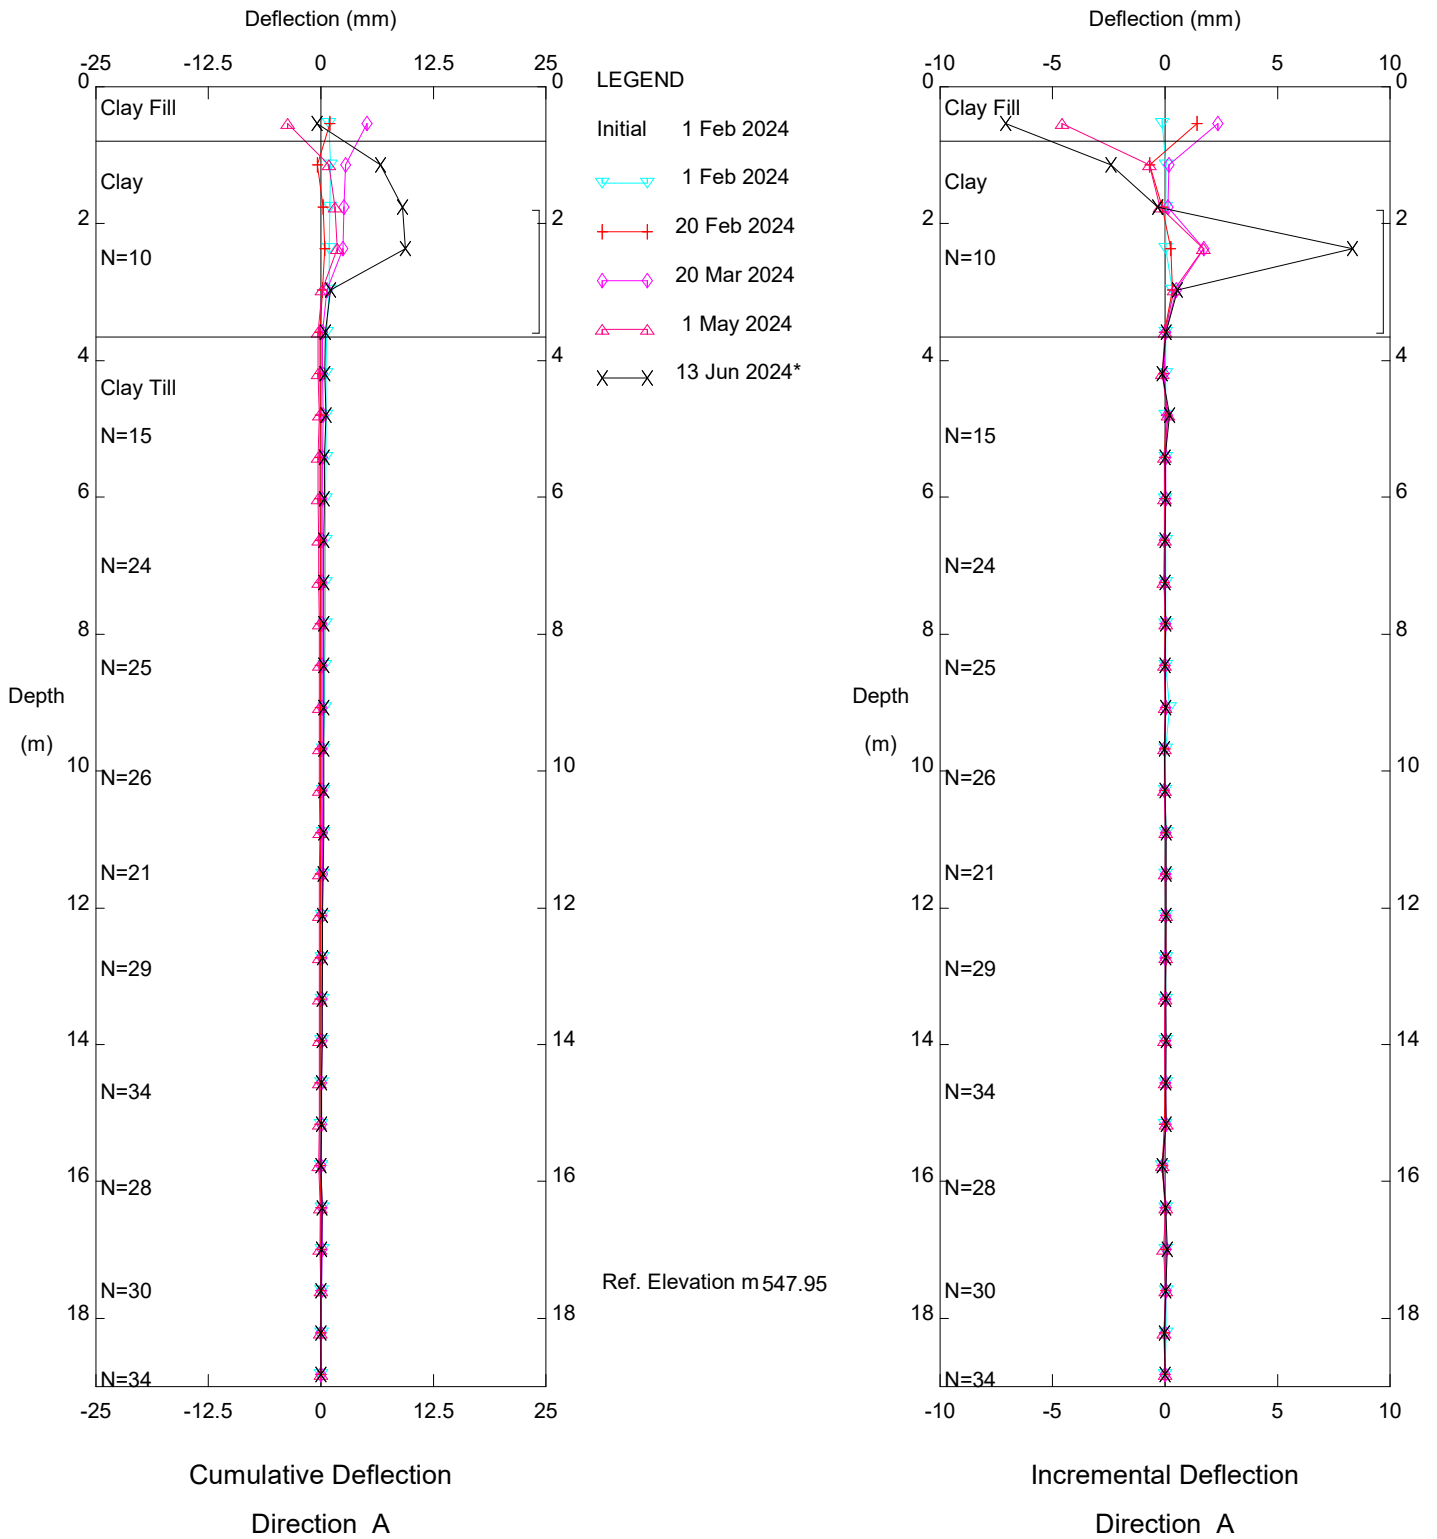
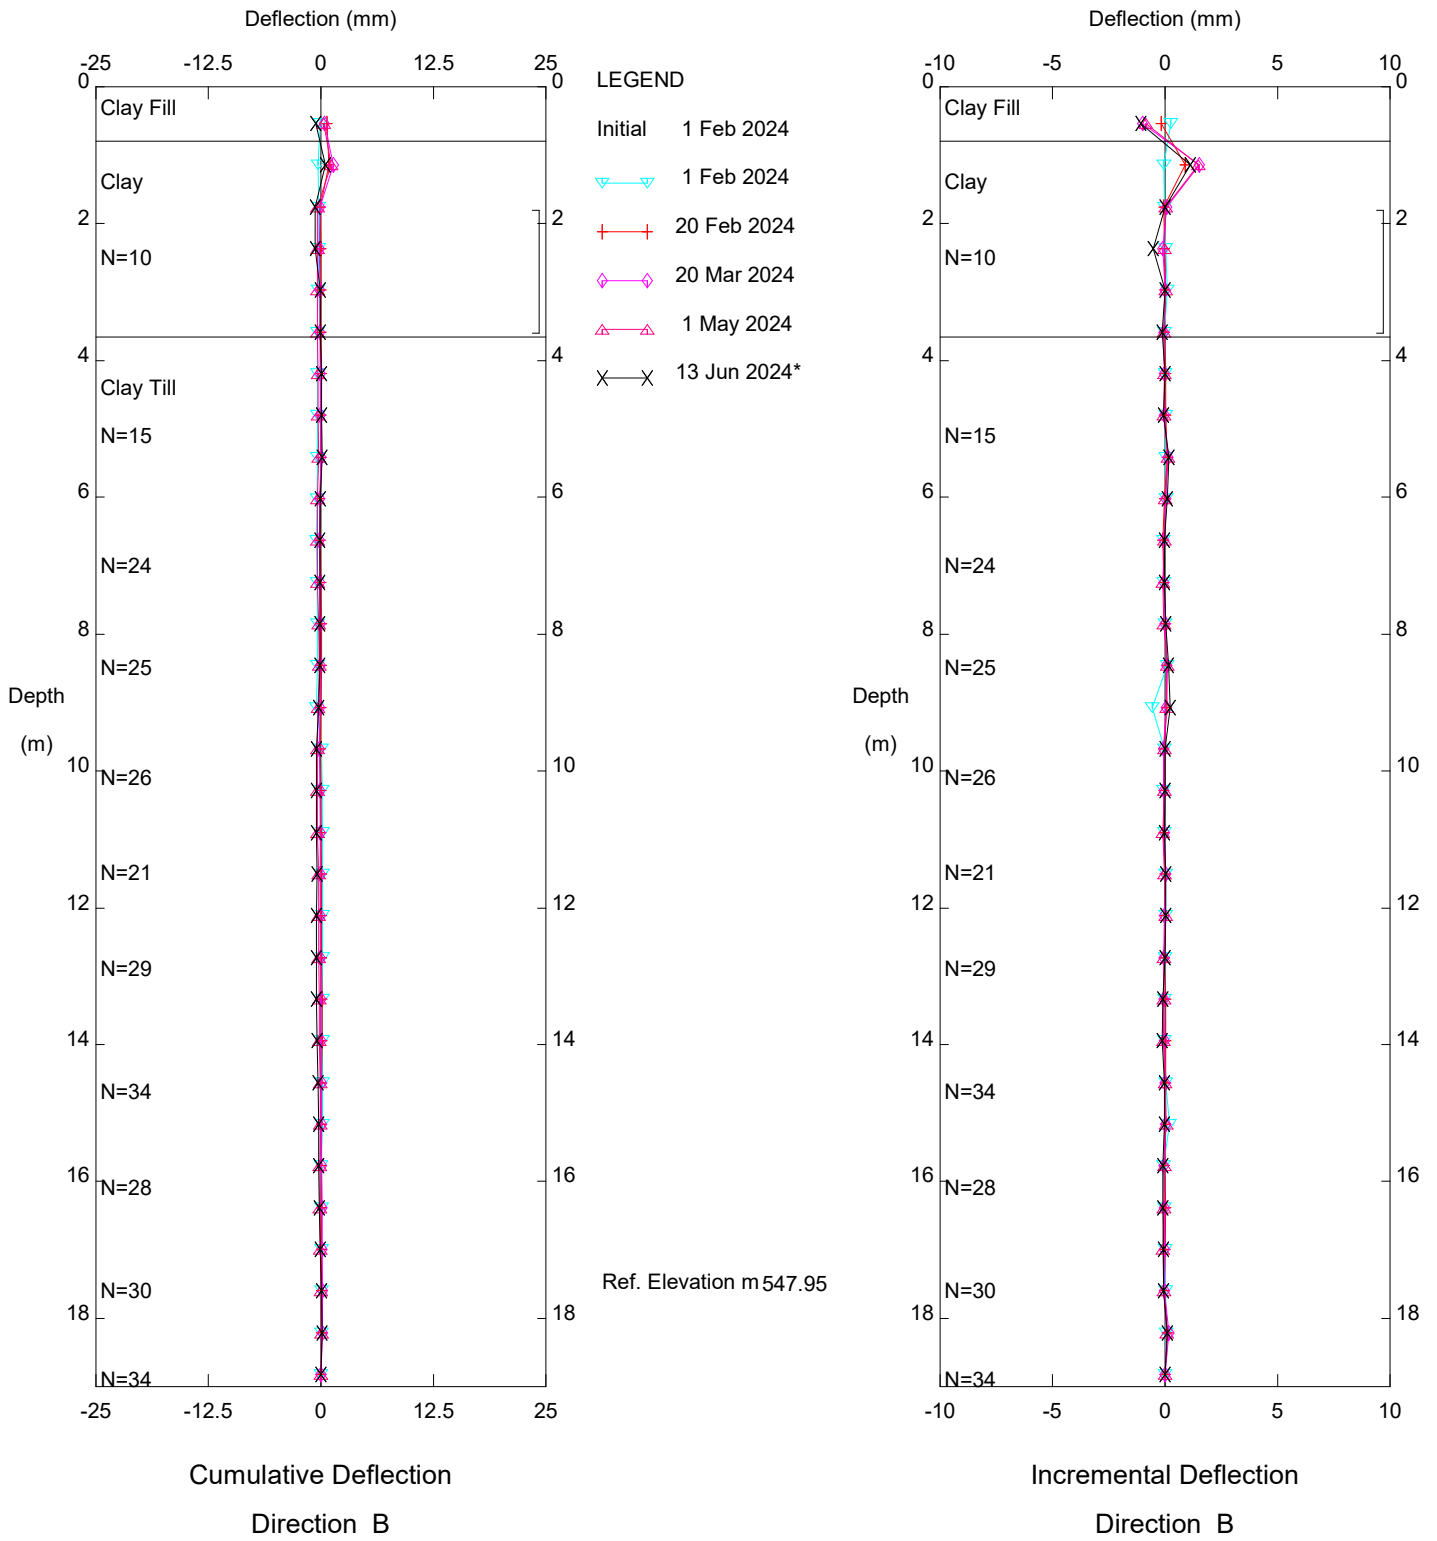
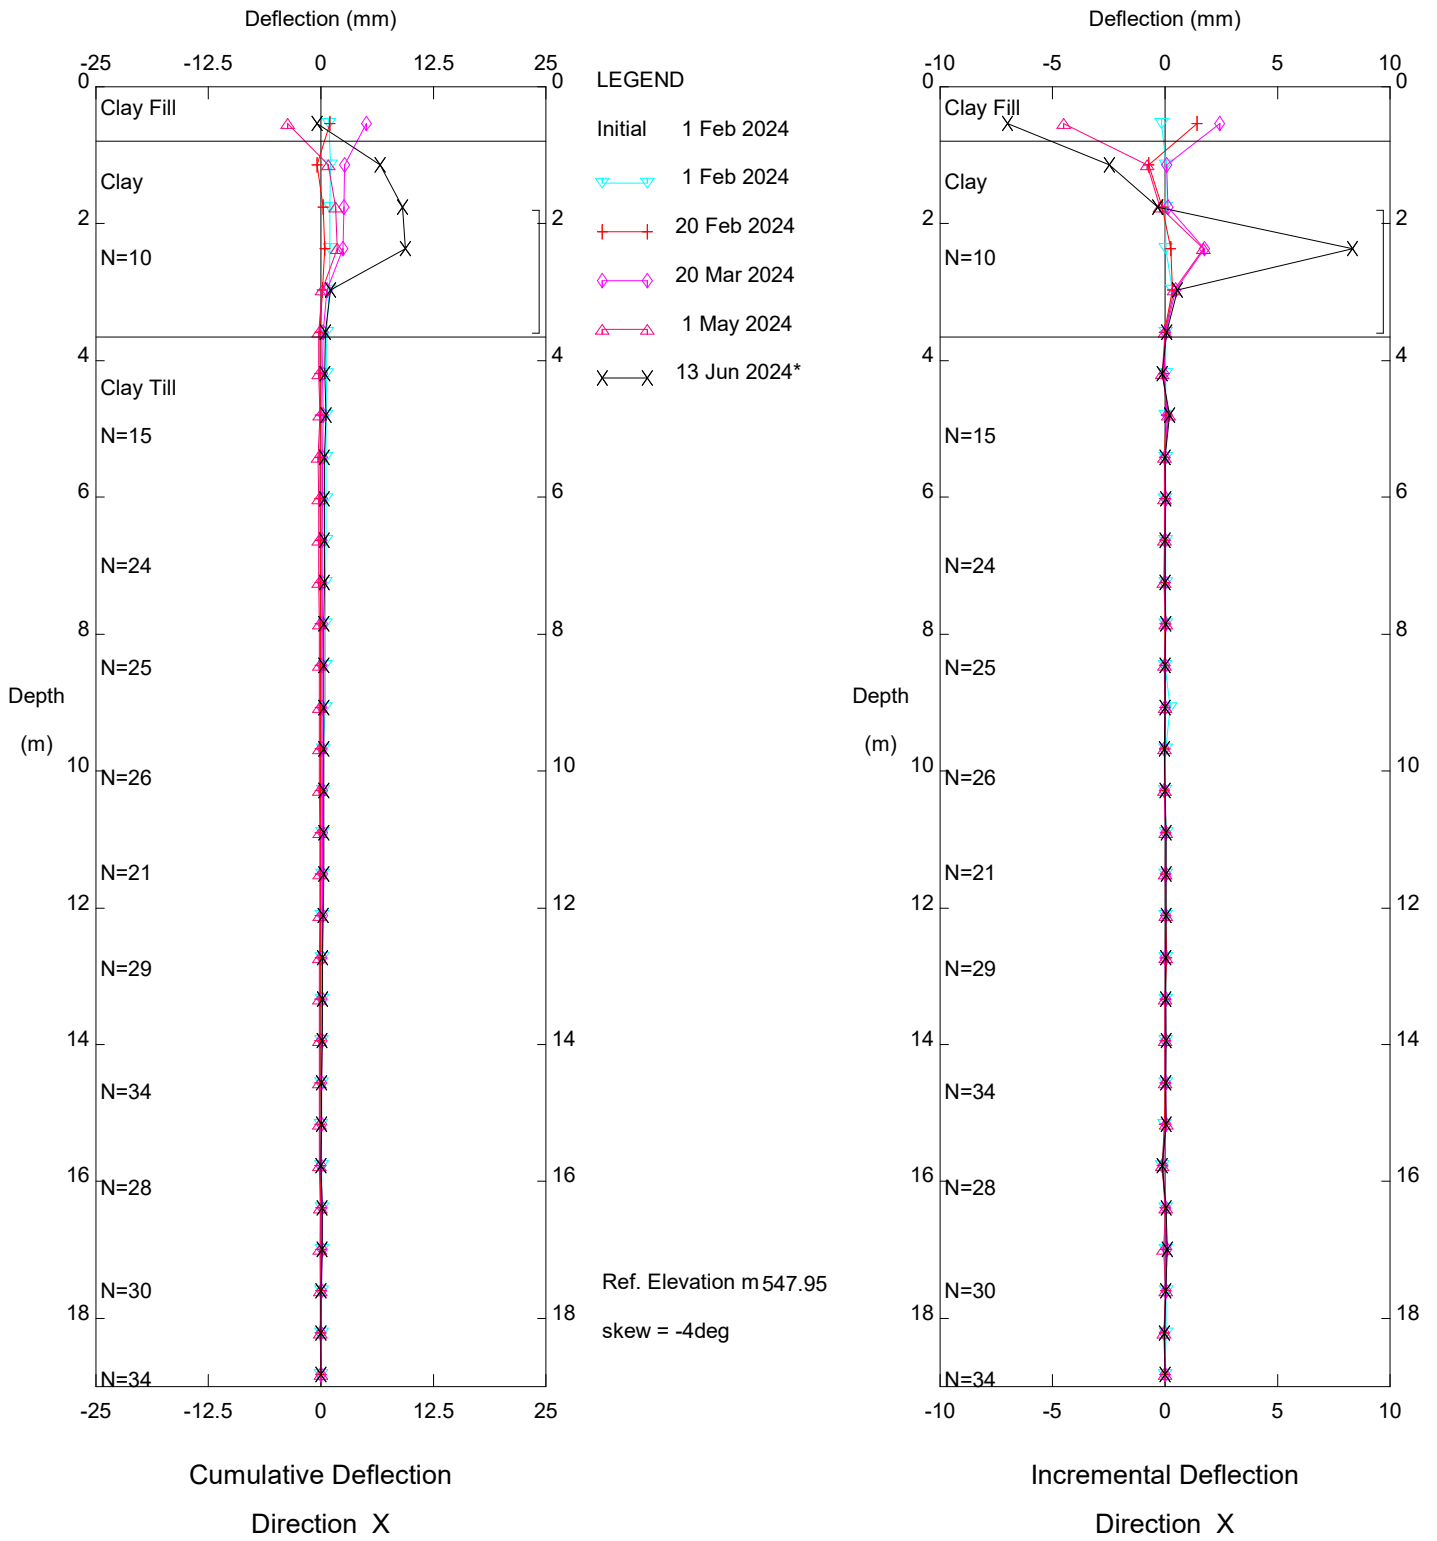
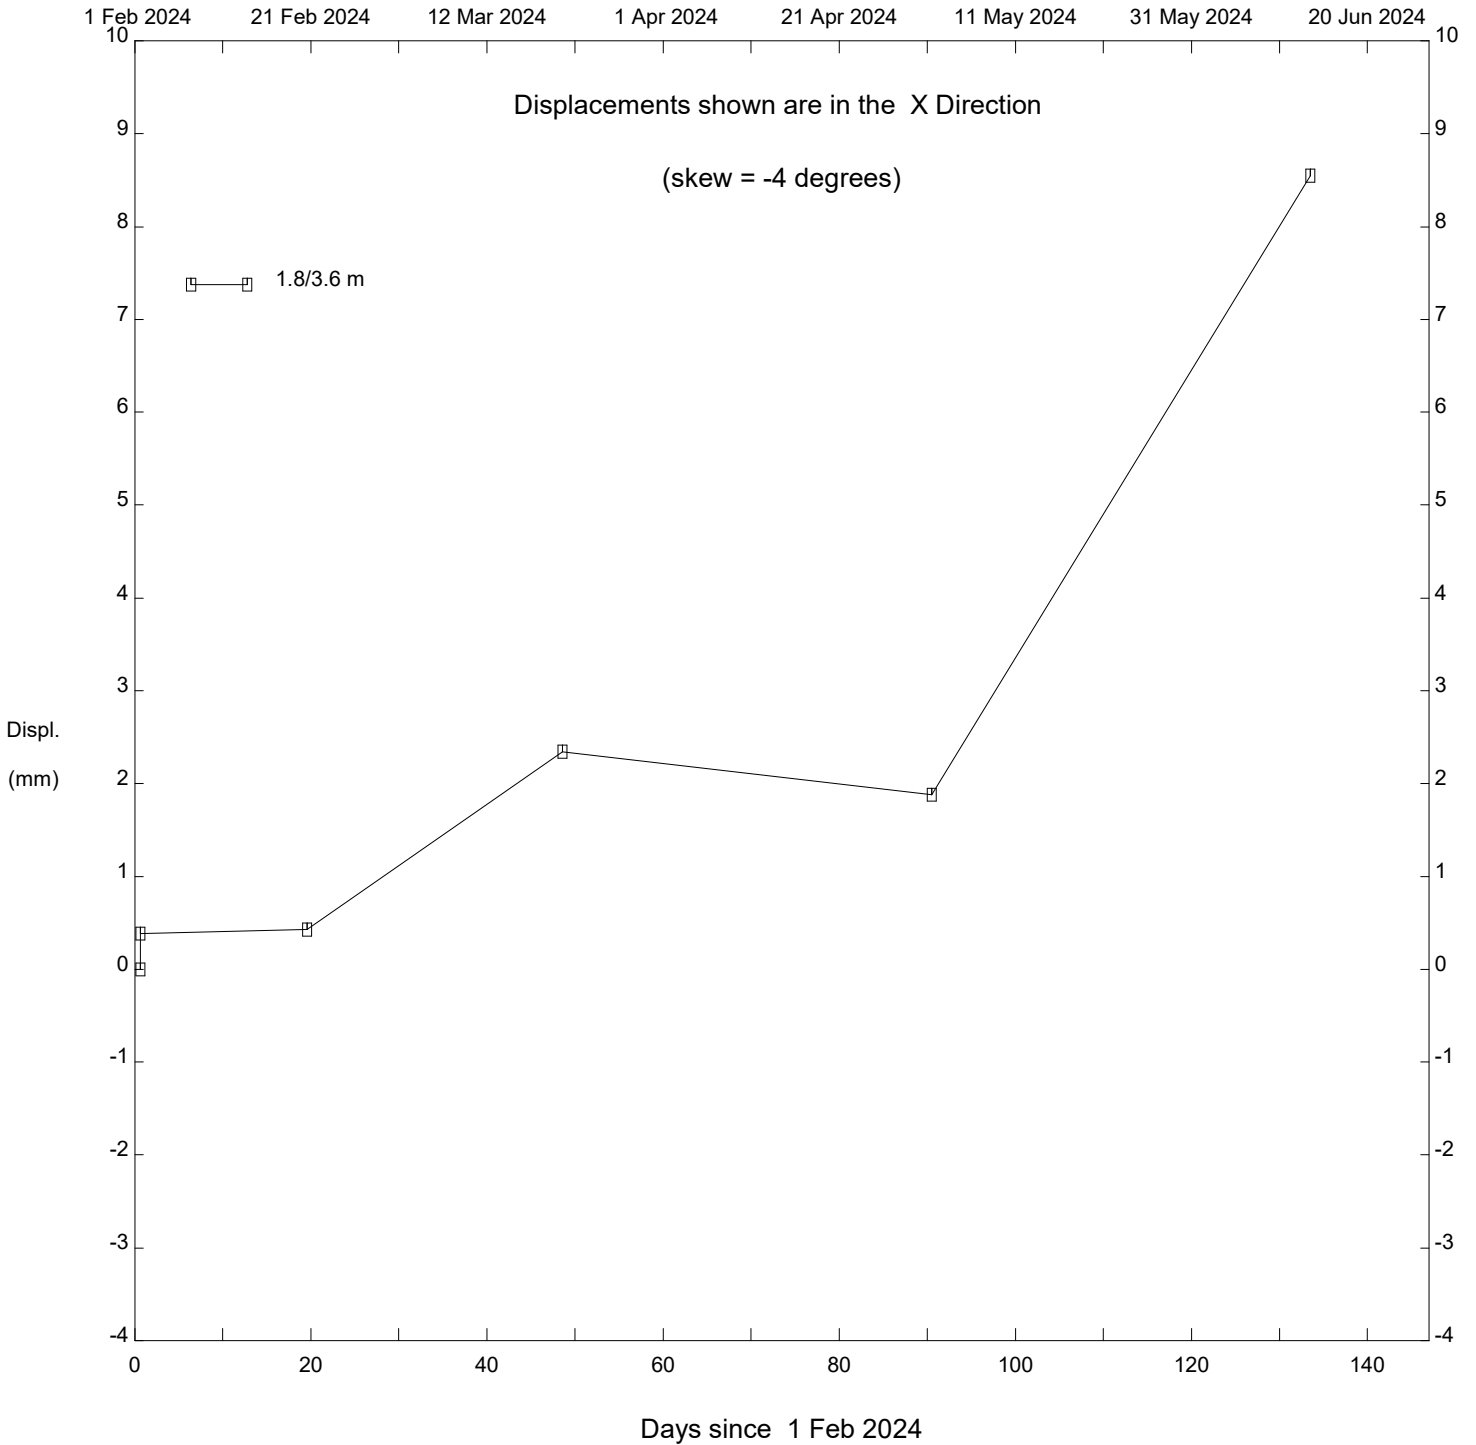
SI24-2, NC110 Wabasca Lake, Inclinator 24-2

Discussion	
<b>Zones of New Movement:</b>	A zone of movement was observed in slope Inclinator SI24-3, over 0.6 to 3.7 m depth.
<b>Interpretation of Monitoring Results:</b>	<p>SI24-2 showed a rate of movement of 56.6 mm/yr over 1.8 m to 3.6 m since the previous readings on May 1, 2024. This corresponds to an increase in rate of movement of 60.6 mm/yr.</p> <p>SI24-3 showed a rate of movement of 16.5 mm/yr over 0.6 m to 3.7 m depth since the last readings on February 20, 2024. This corresponds to an increase in the rate of movement by 10.0 mm/yr. The movement zones in both SIs are within the native high plastic clay below the highway embankment fill.</p> <p>Standpipe piezometer SP24-1 and SP24-4 showed increases in groundwater level of 0.86 m and 0.35 m, respectively compared to the last reading on May 1, 2024. The groundwater level in both instruments is the highest since they were initialized.</p>

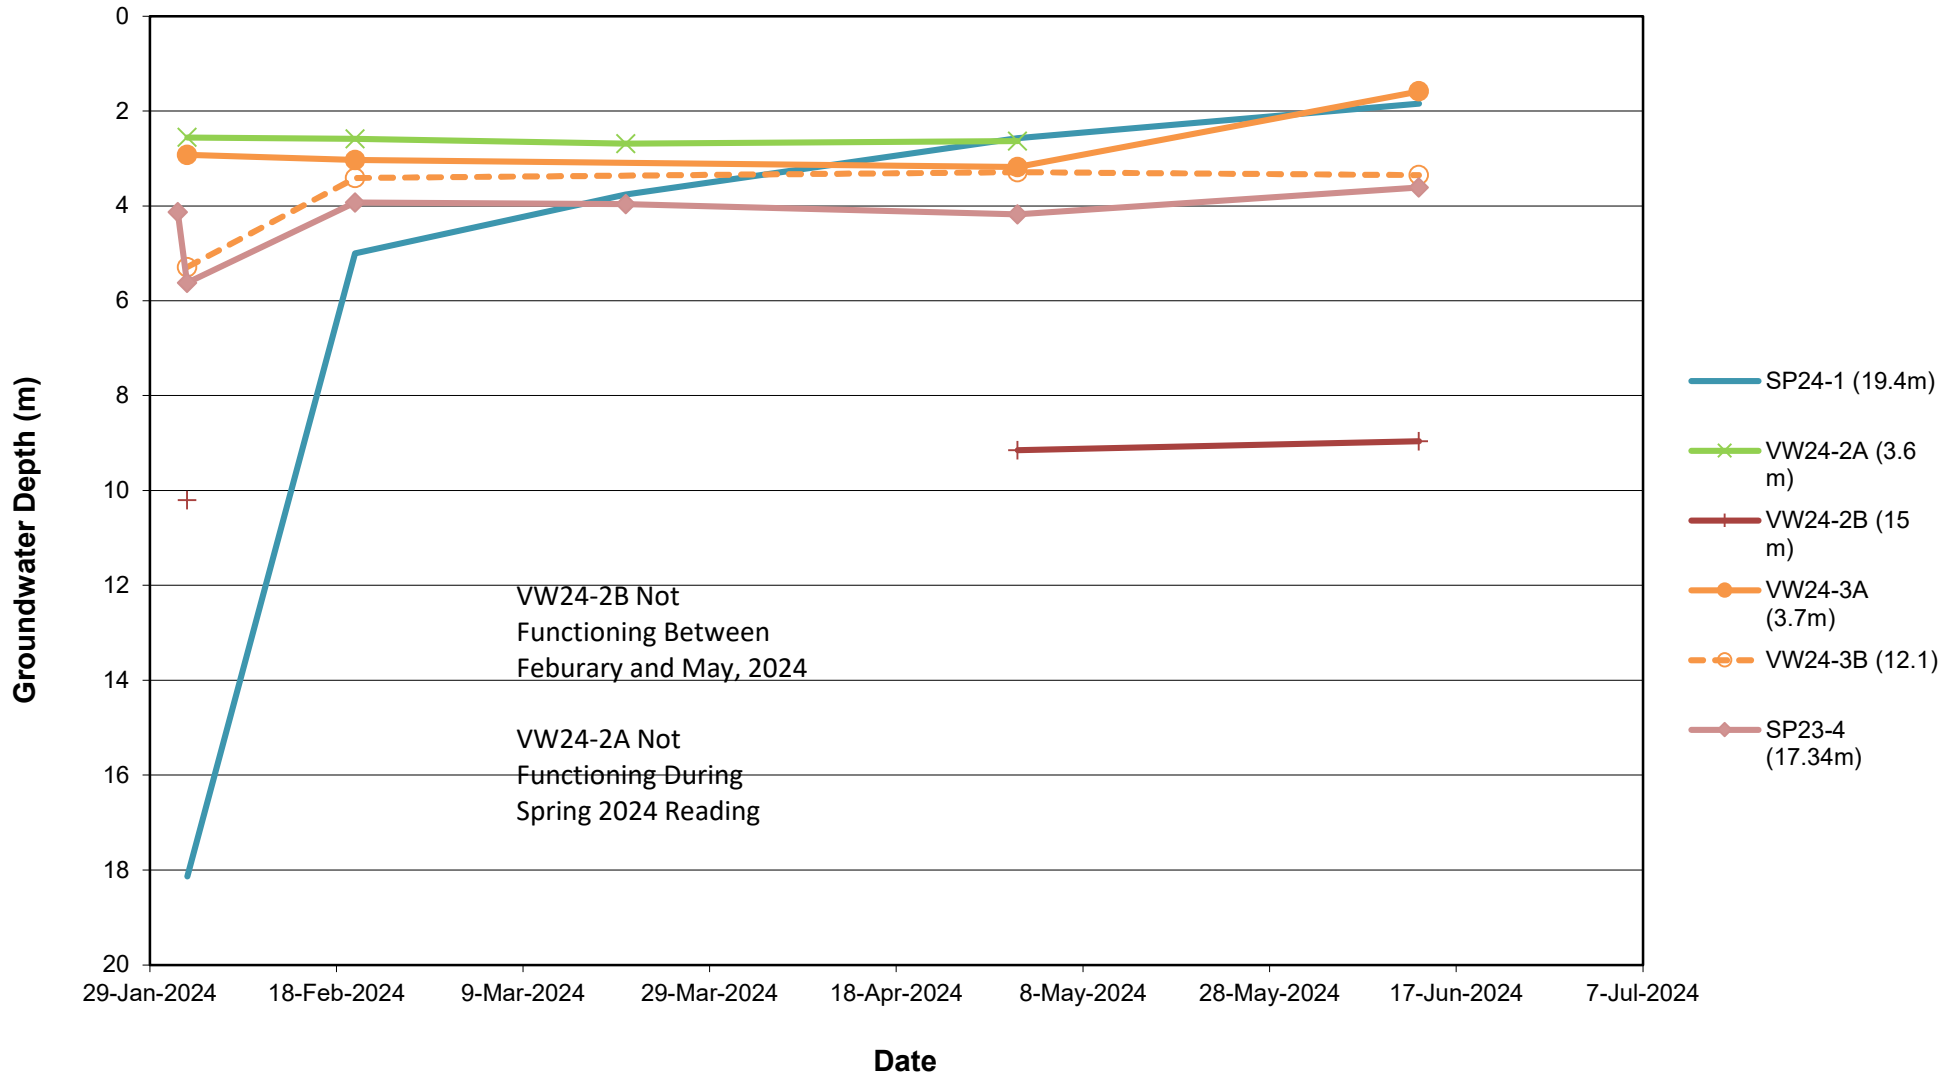
**FIGURE NC110 -1  
HWY 754:06 (NC110) - WABASCA LAKE PIEZOMETER DEPTHS**

<p>Vibrating wire piezometer VW24-2A was found to be malfunctioning during the spring 2024 readings.</p> <p>Vibrating wire piezometers VW24-2B and VW24-3A showed increases in groundwater level of 0.19 m and 1.60 m, respectively, since they were last read on May 1, 2024. The groundwater level recorded in both instruments is the highest since they were initialized. VW24-2B showed a decrease in groundwater level of 0.06 m since the last reading on May 1, 2024.</p>
<b>Future Work:</b>	The instruments should be read again in the fall of 2024.
<b>Instrumentation Repairs:</b>	Vibrating Wire Piezometer VW24-2A should be read again to confirm if it is still malfunctioning. If it continues to malfunction, it should be removed from future readings.
<b>Additional Comments:</b>
