**ALBERTA TRANSPORTATION  
GEOHAZARD ASSESSMENT PROGRAM  
NORTH CENTRAL REGION – ATHABASCA &  
FORT MCMURRAY DISTRICTS  
2021 SITE INSPECTION**

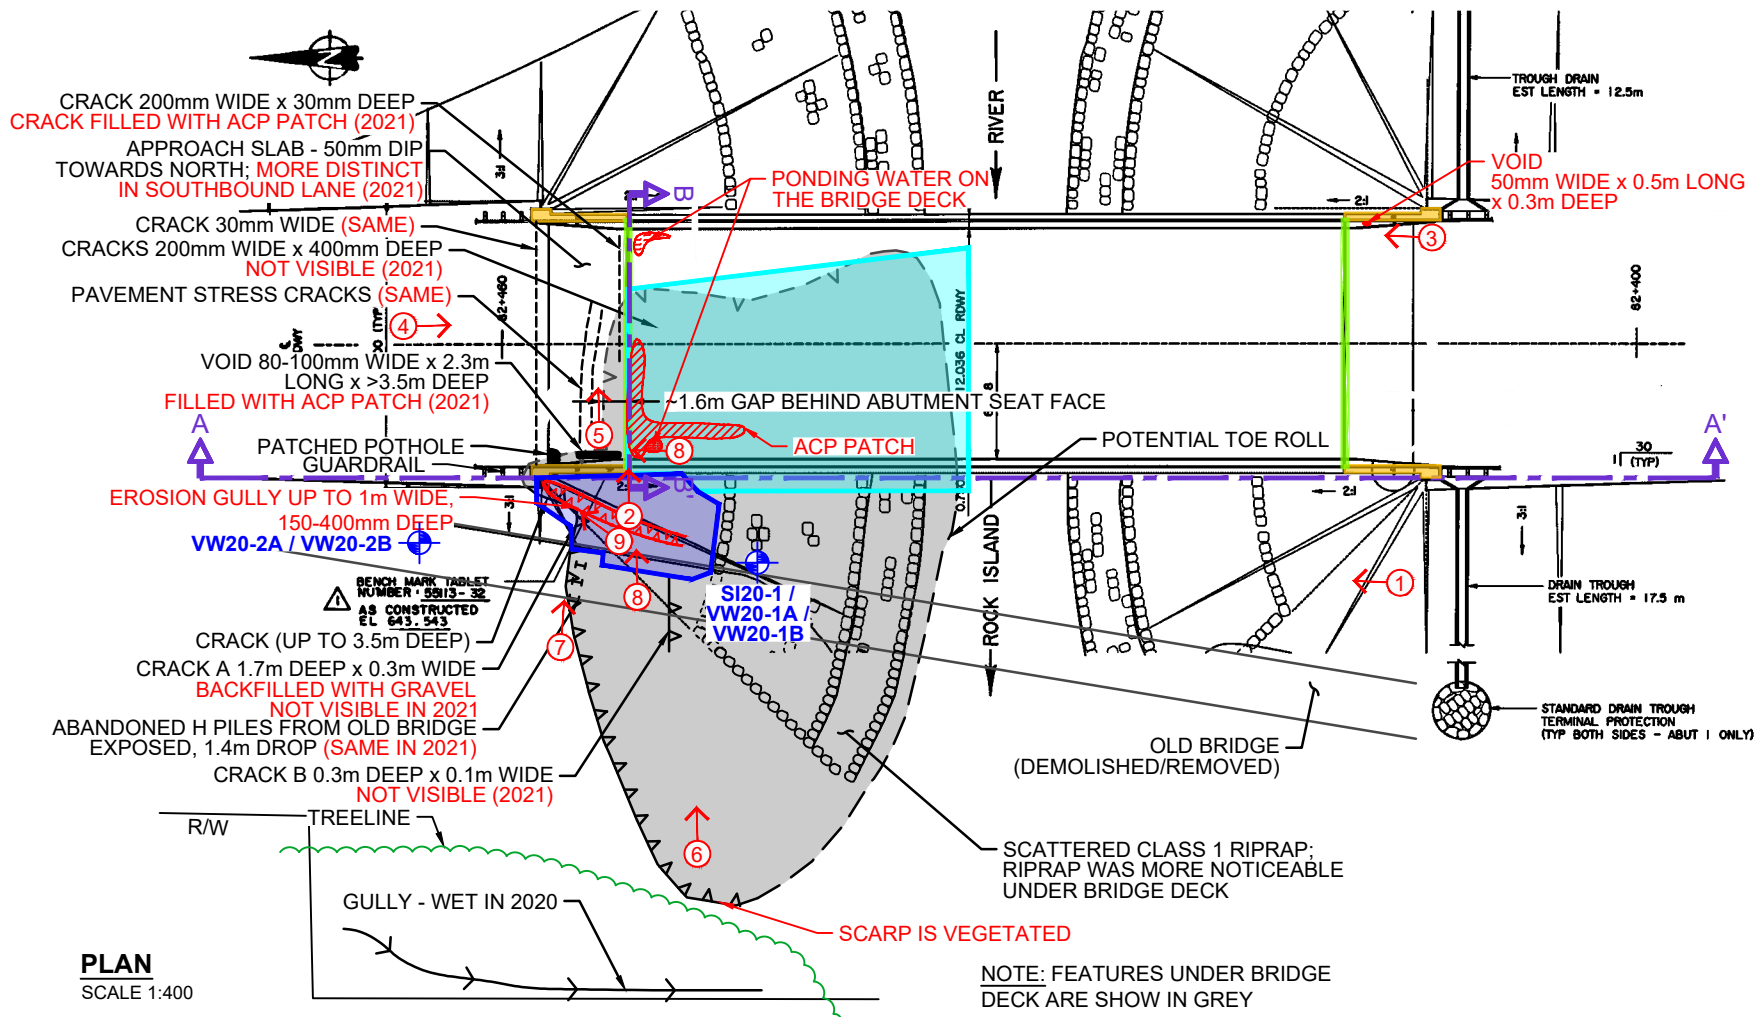
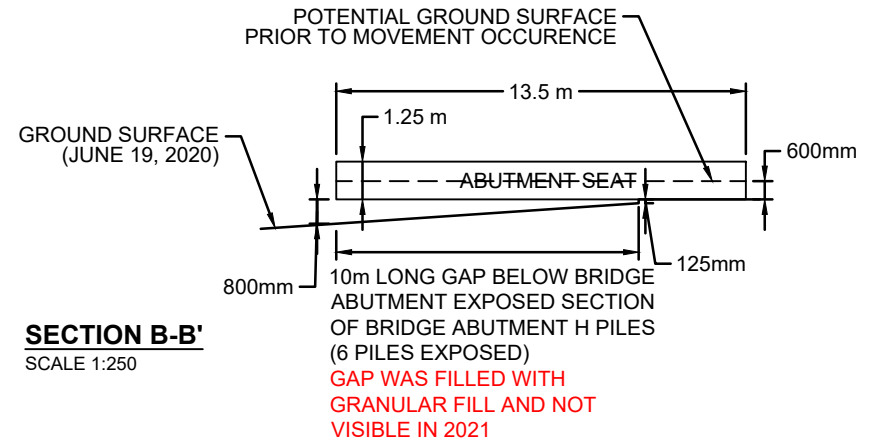
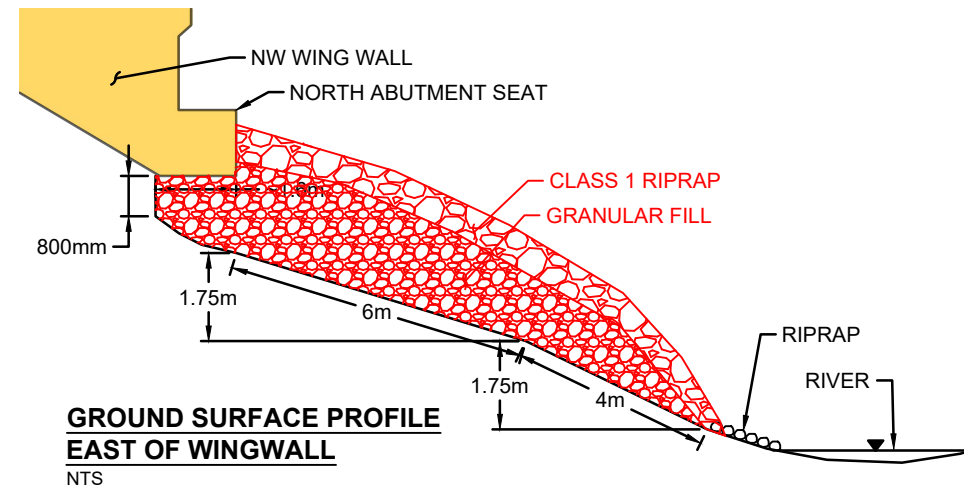
- NOTES:
- JUNE 23, 2021 OBSERVATIONS ARE SHOWN IN RED.
  - IN 2020, ALBERTA TRANSPORTATION PLACED GRAVEL AGAINST THE NW WING WALL AND UNDER THE BRIDGE AGAINST THE NORTH BRIDGE ABUTMENT.

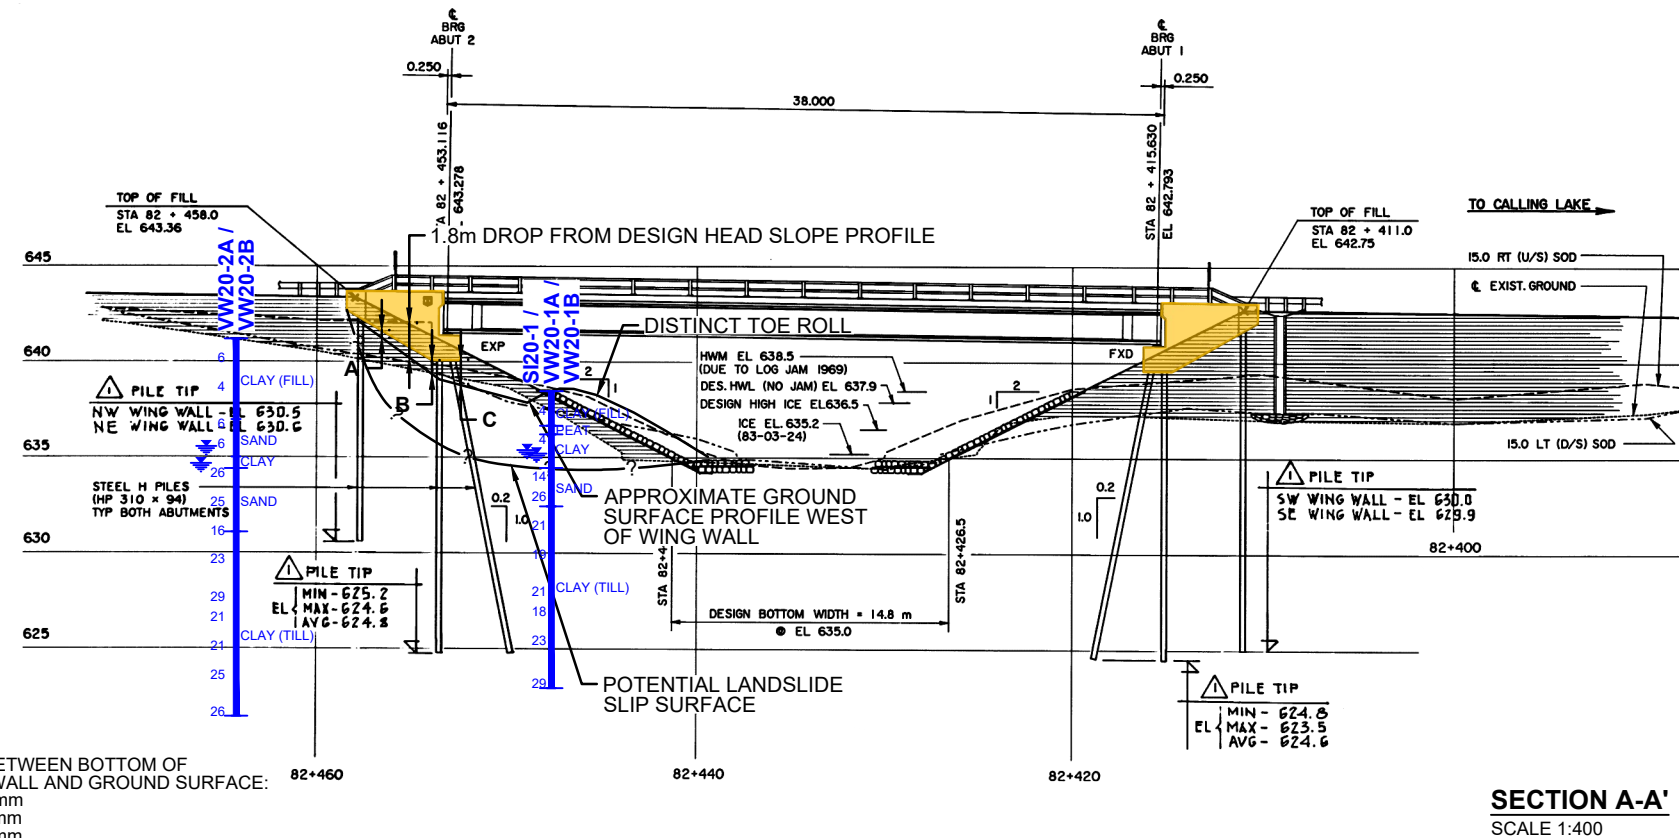
GAP BETWEEN BOTTOM OF WINGWALL AND GROUND SURFACE:

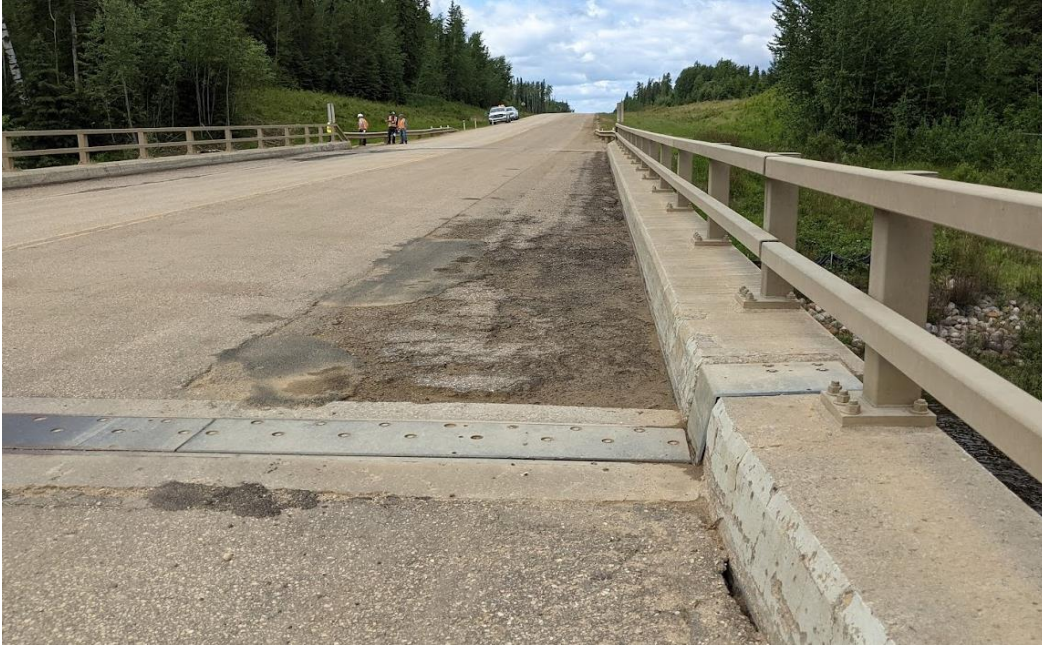
Photo No. 3 – Bridge deck and highway surface condition (Looking north at the south expansion joint). Note 50 mm gap between the pavement and wing wall

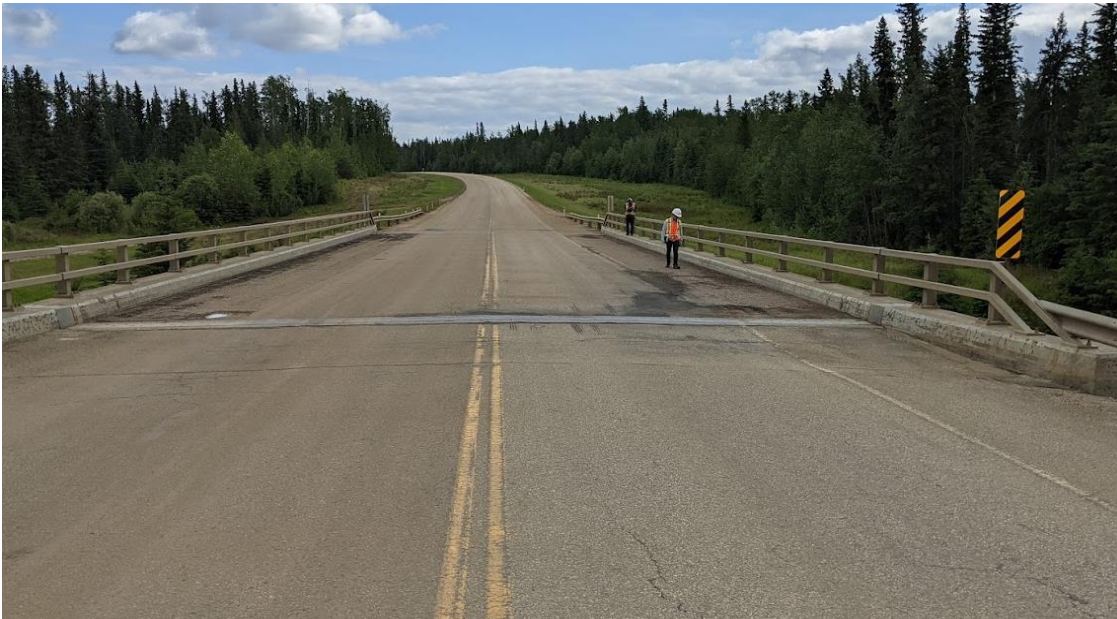
Photo No. 4 – Bridge deck and highway surface condition (Looking south at north expansion joint). Note water ponding on the northeast and northwest corners of the bridge deck, poor condition of bridge deck wearing surface, and existing dip within the highway SBL by the NW wingwall

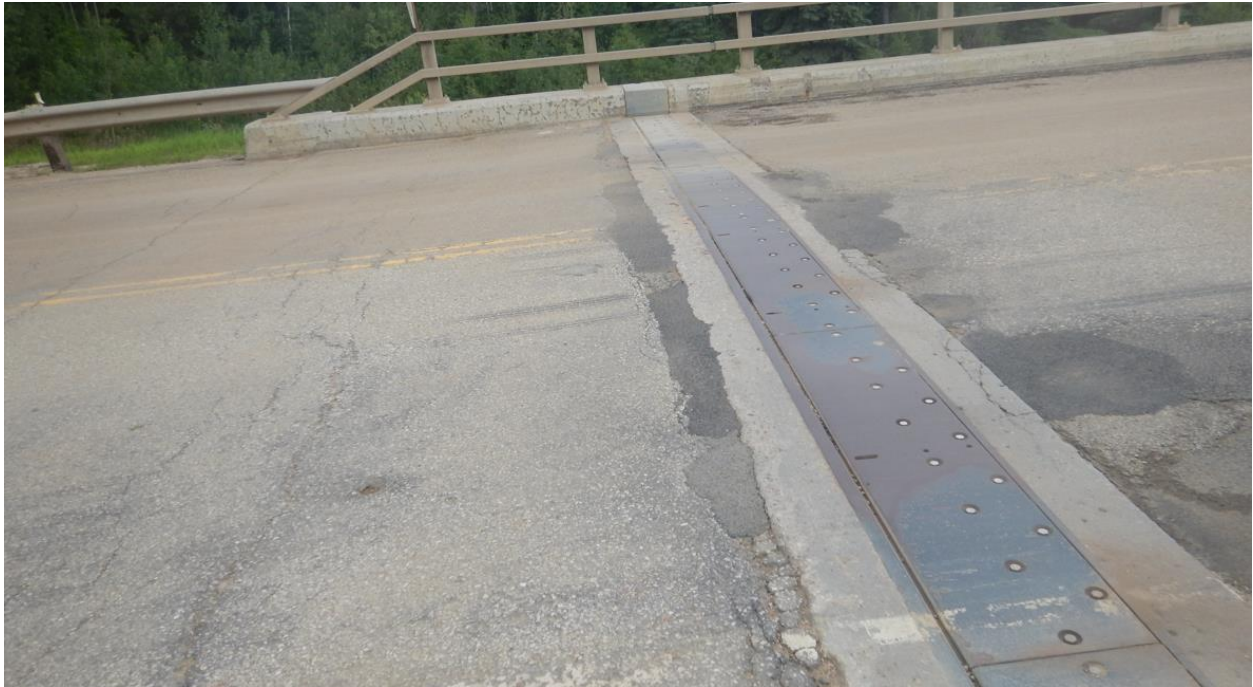
Photo No. 5 – Cracks along north expansion joint filled with instant Patch (Looking east); note cracks within the approach slab

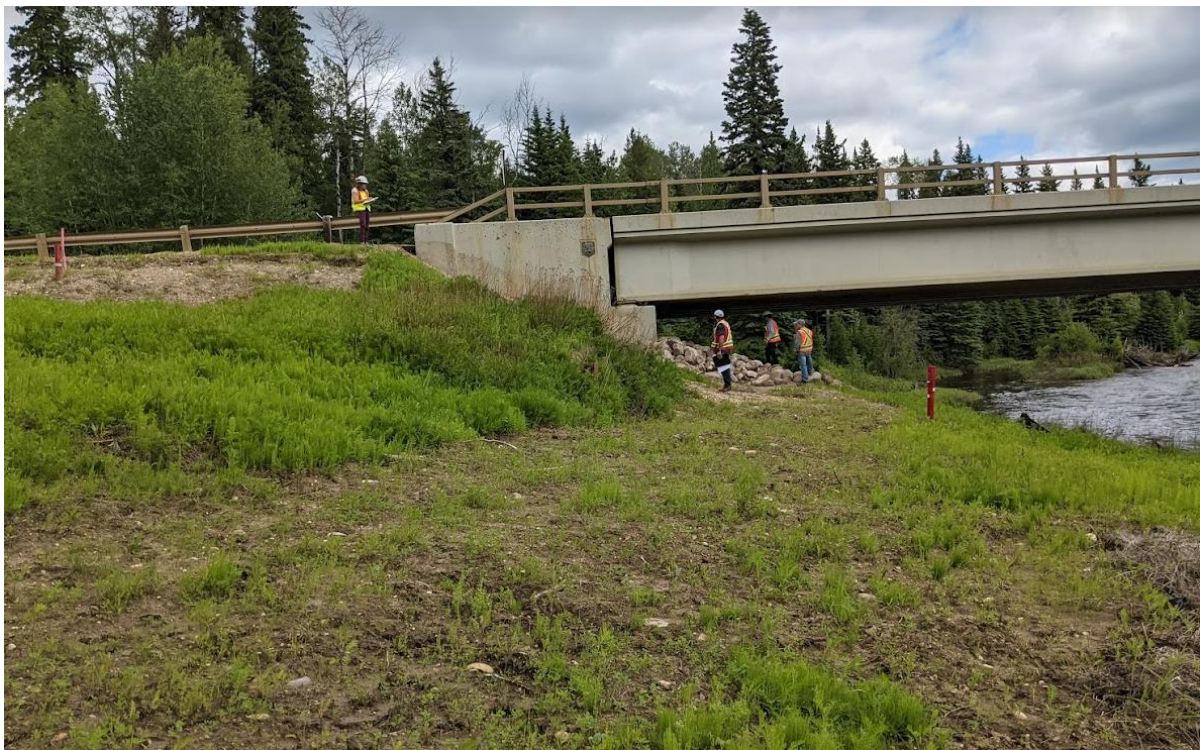
Photon No. 6 –Looking east at the NW approach fill headslope

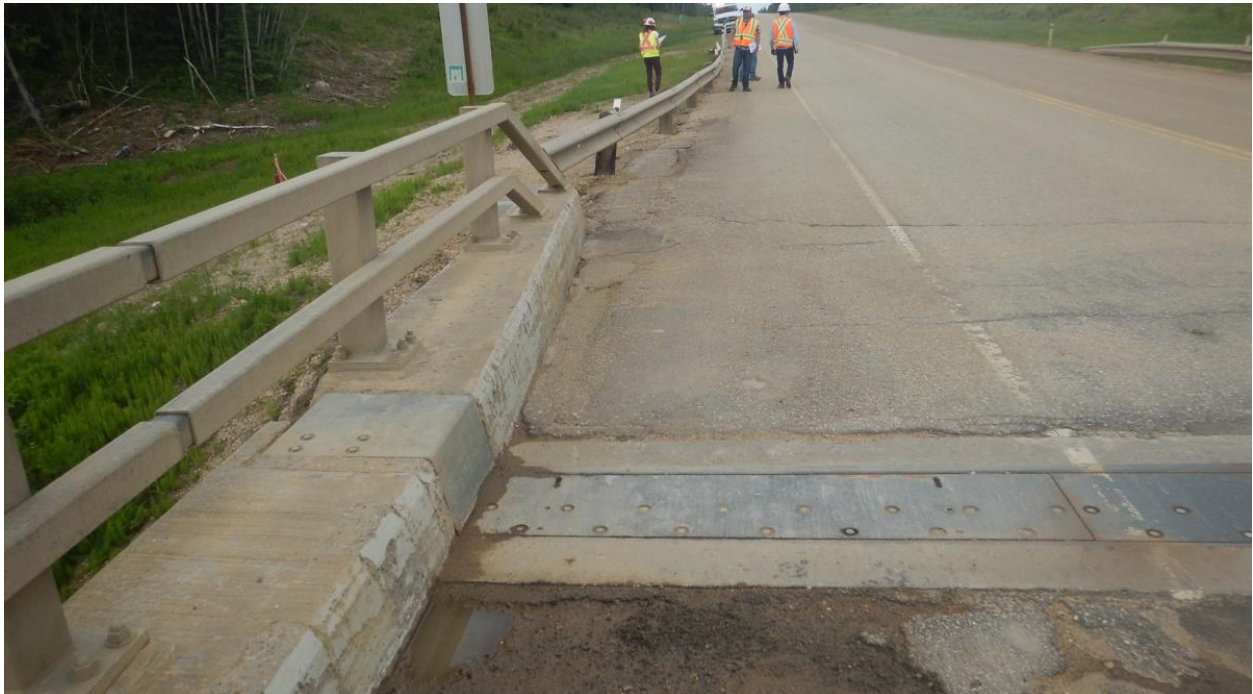
Photo No. 8 – Voids, noted in 2020, between the concrete curb and the asphalt above the NW wing wall (80 to 100 mm wide, 2.3 m long, > 3.5 m deep) filled with instant patch

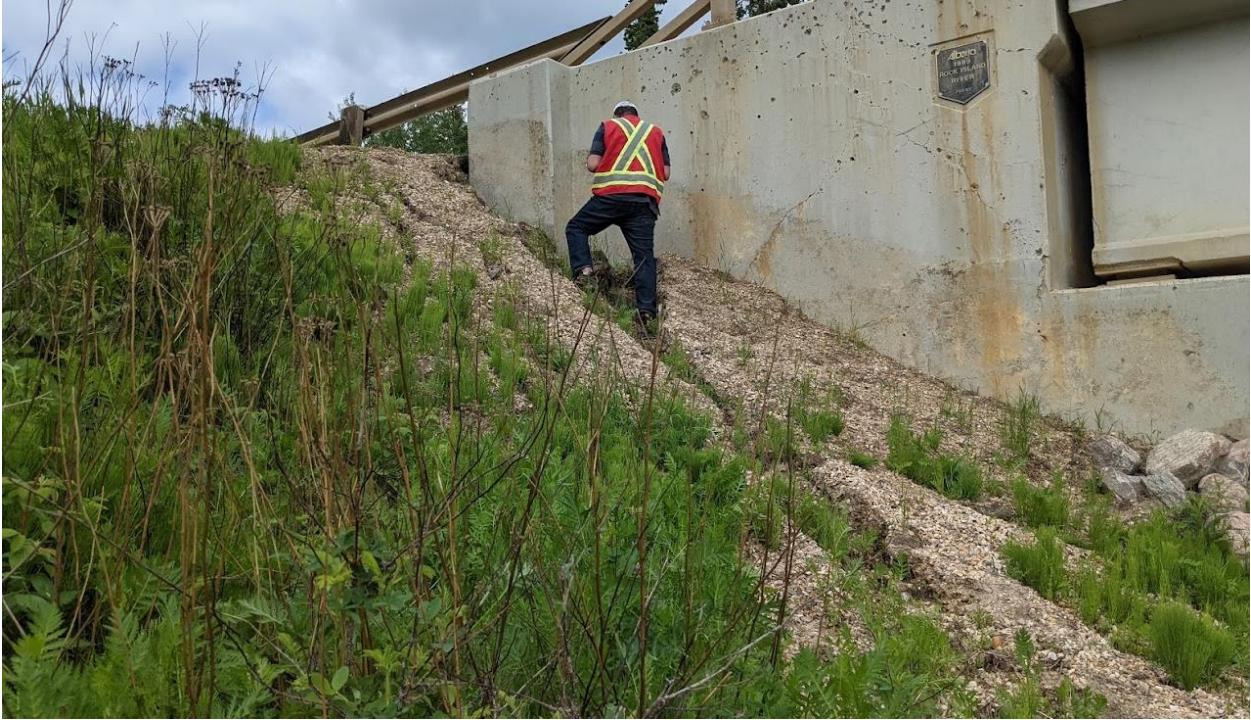
Photo No. 9 – Northwest wingwall. Previous soil staining on the concrete showing up to 1.8 m drop along the design head slopes was backfilled with approximately 1 m of gravel. Gap between bottom of wing wall / abutment seat and ground surface is not visible due to granular fill placed in this area. Note erosion developed on the steeply inclined gravel wedge placed adjacent to the wingwall
