October 26, 2022

**ALBERTA TRANSPORTATION GRMP (CON0022163)  
NORTH CENTRAL (ATHABASCA AND FORT McMURRAY DISTRICTS)  
INSTRUMENTATION MONITORING RESULTS – FALL 2022**

**SECTION C**

**SITE NC093: HWY 813 ROCK ISLAND RIVER BRIDGE NW APPROACH FILL LANDSLIDE  
(BF79692)**

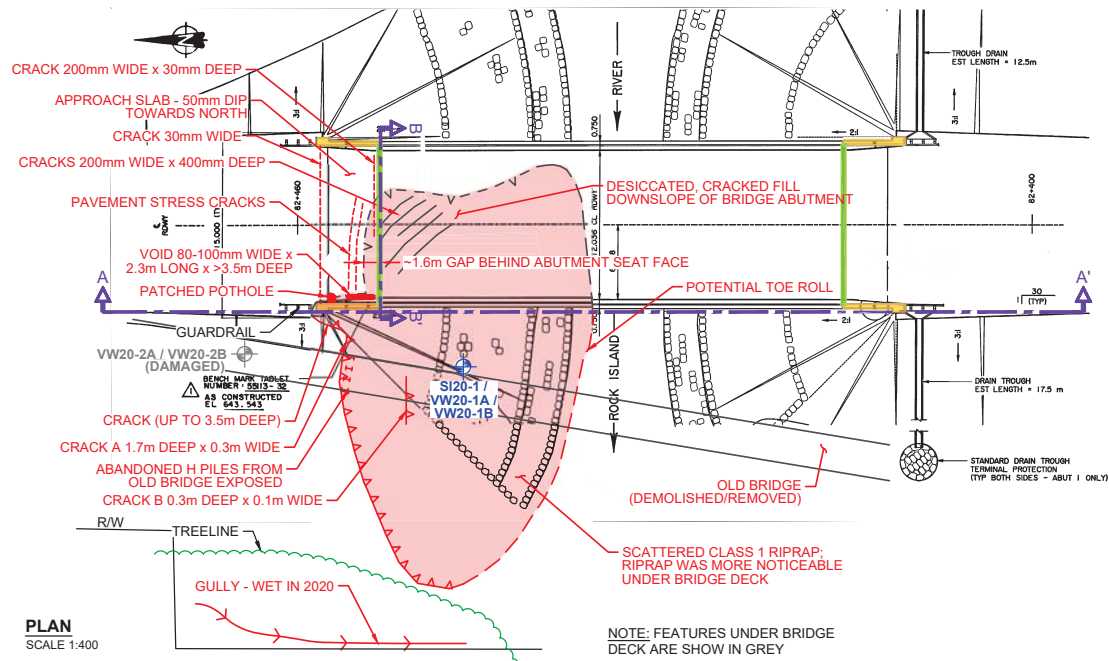
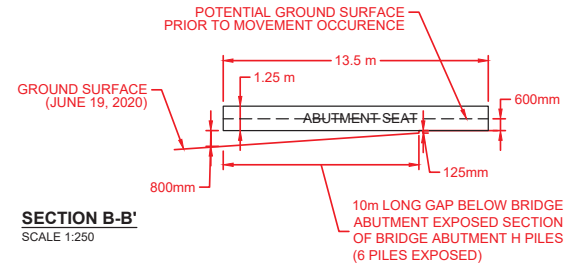
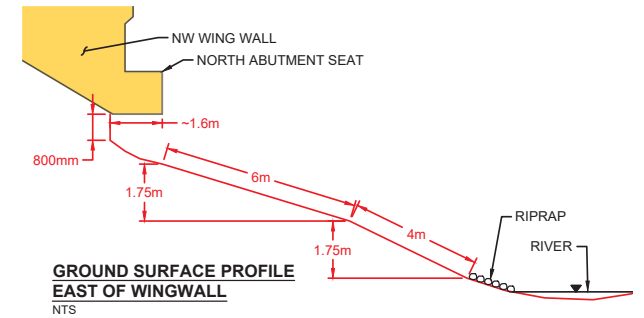
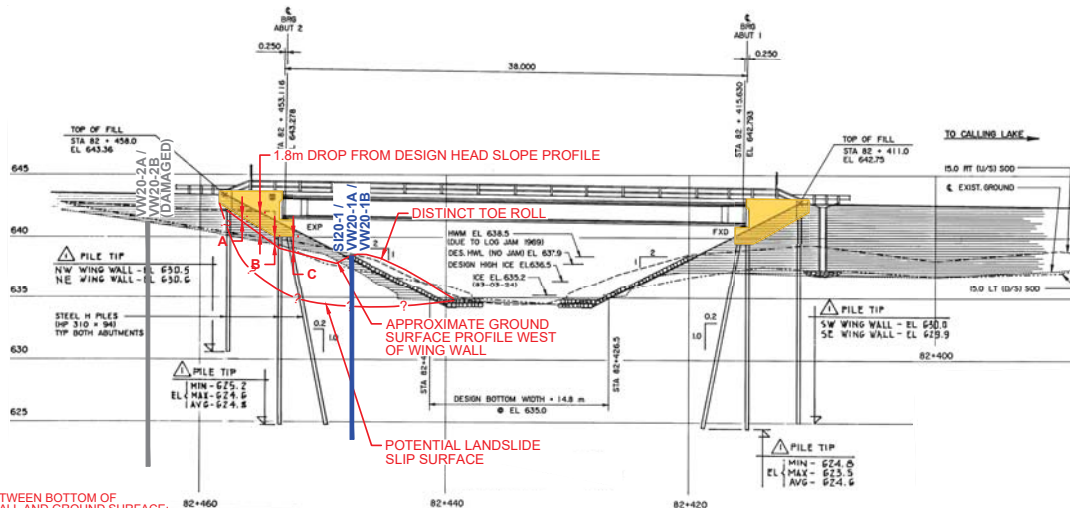
**NORTH CENTRAL  
(ATHABASCA AND FORT MCMURRAY DISTRICTS)  
NC093 HWY 813 ROCK ISLAND RIVER  
BRIDGE NW APPROACH FILL  
SITE PLAN SHOWING APPROXIMATE  
INSTRUMENT LOCATIONS  
DWG NO. 32122-NC093**

Vibrating wire piezometers VW20-2A and VW20-2B are damaged and could not be read or repaired during this reading event.

Site is KM marker 70 on Hwy 813
VW20-2A and VW20-2B damaged by lawn mower. If repair needed, have to dig down where the wire is cut off, make splice and restore stickup protector.

It is recommended to repair VW20-2A and VW20-2B. A small backhoe or a hydrovac excavation unit will be needed to repair these instruments.

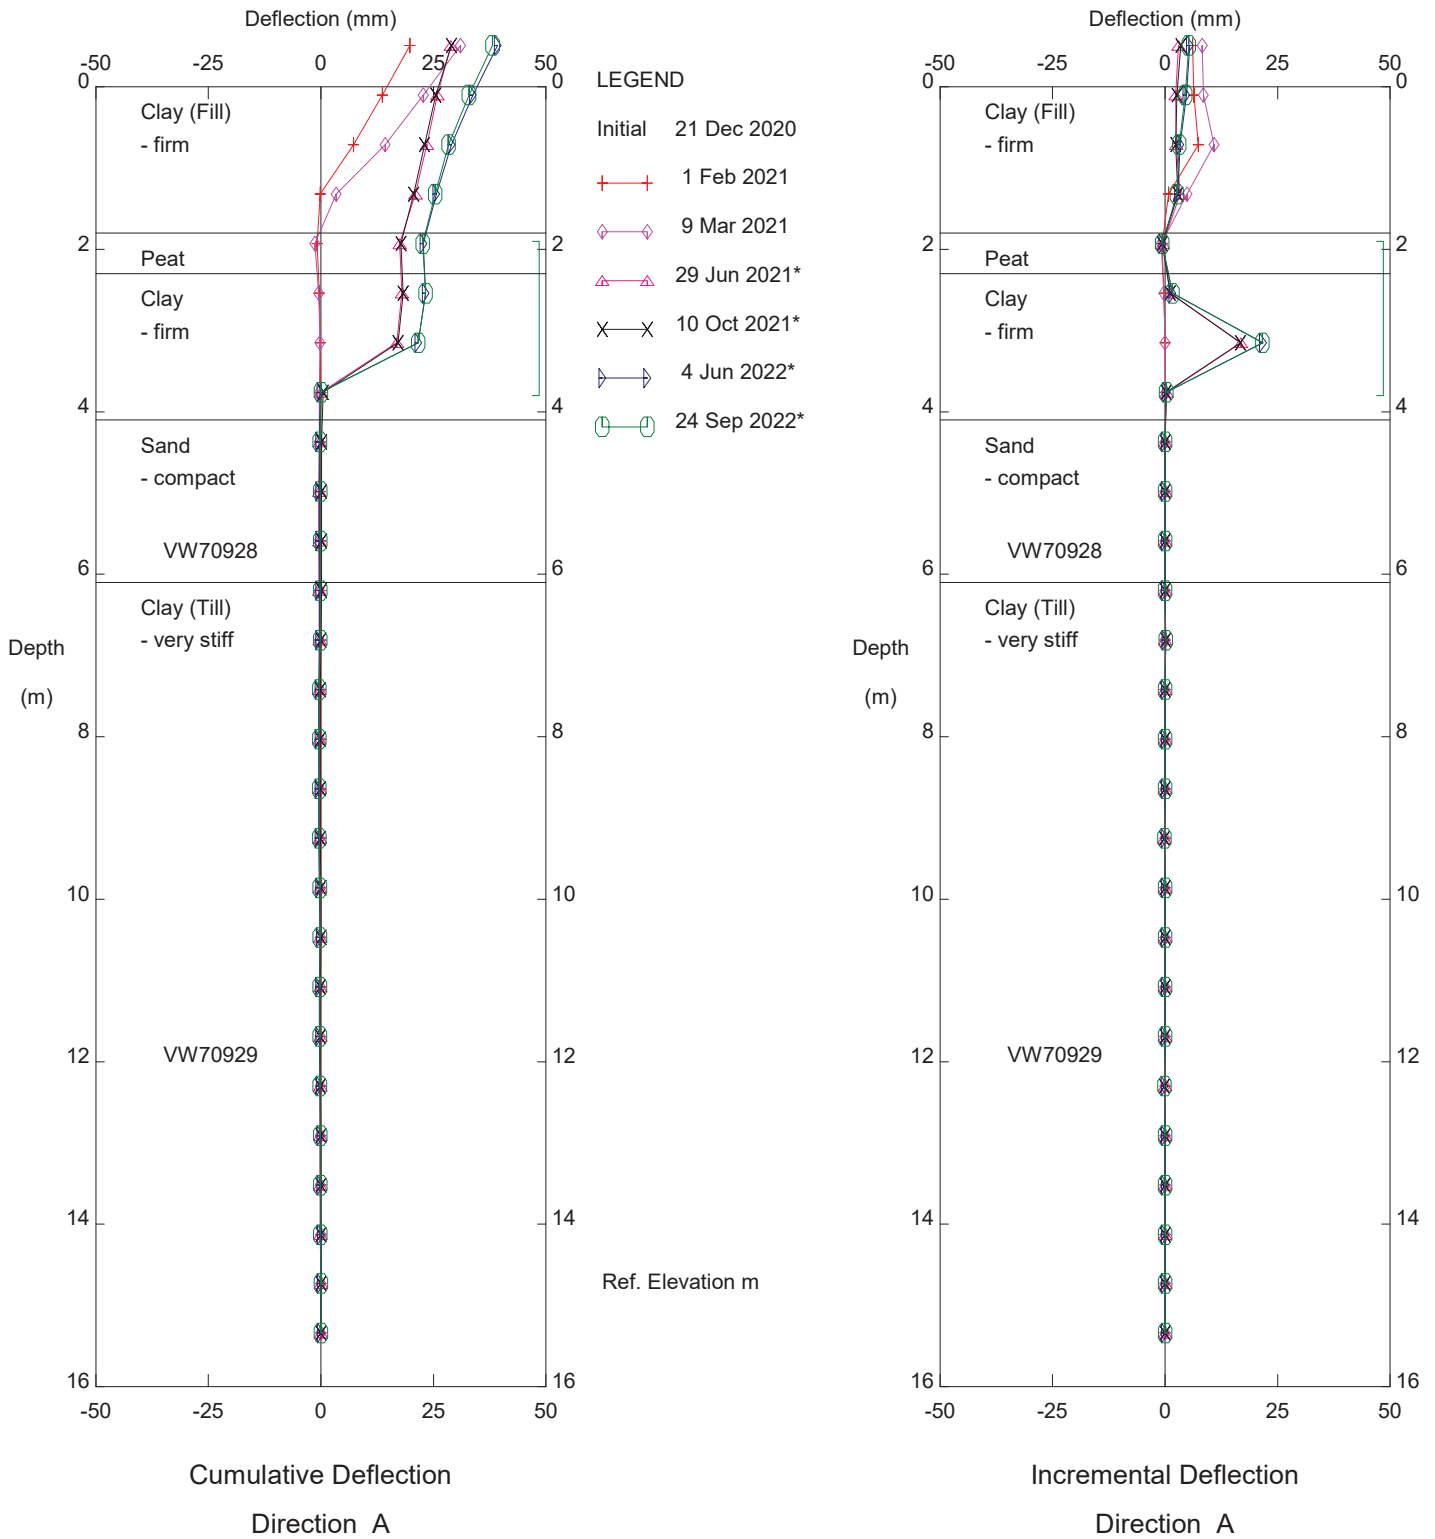
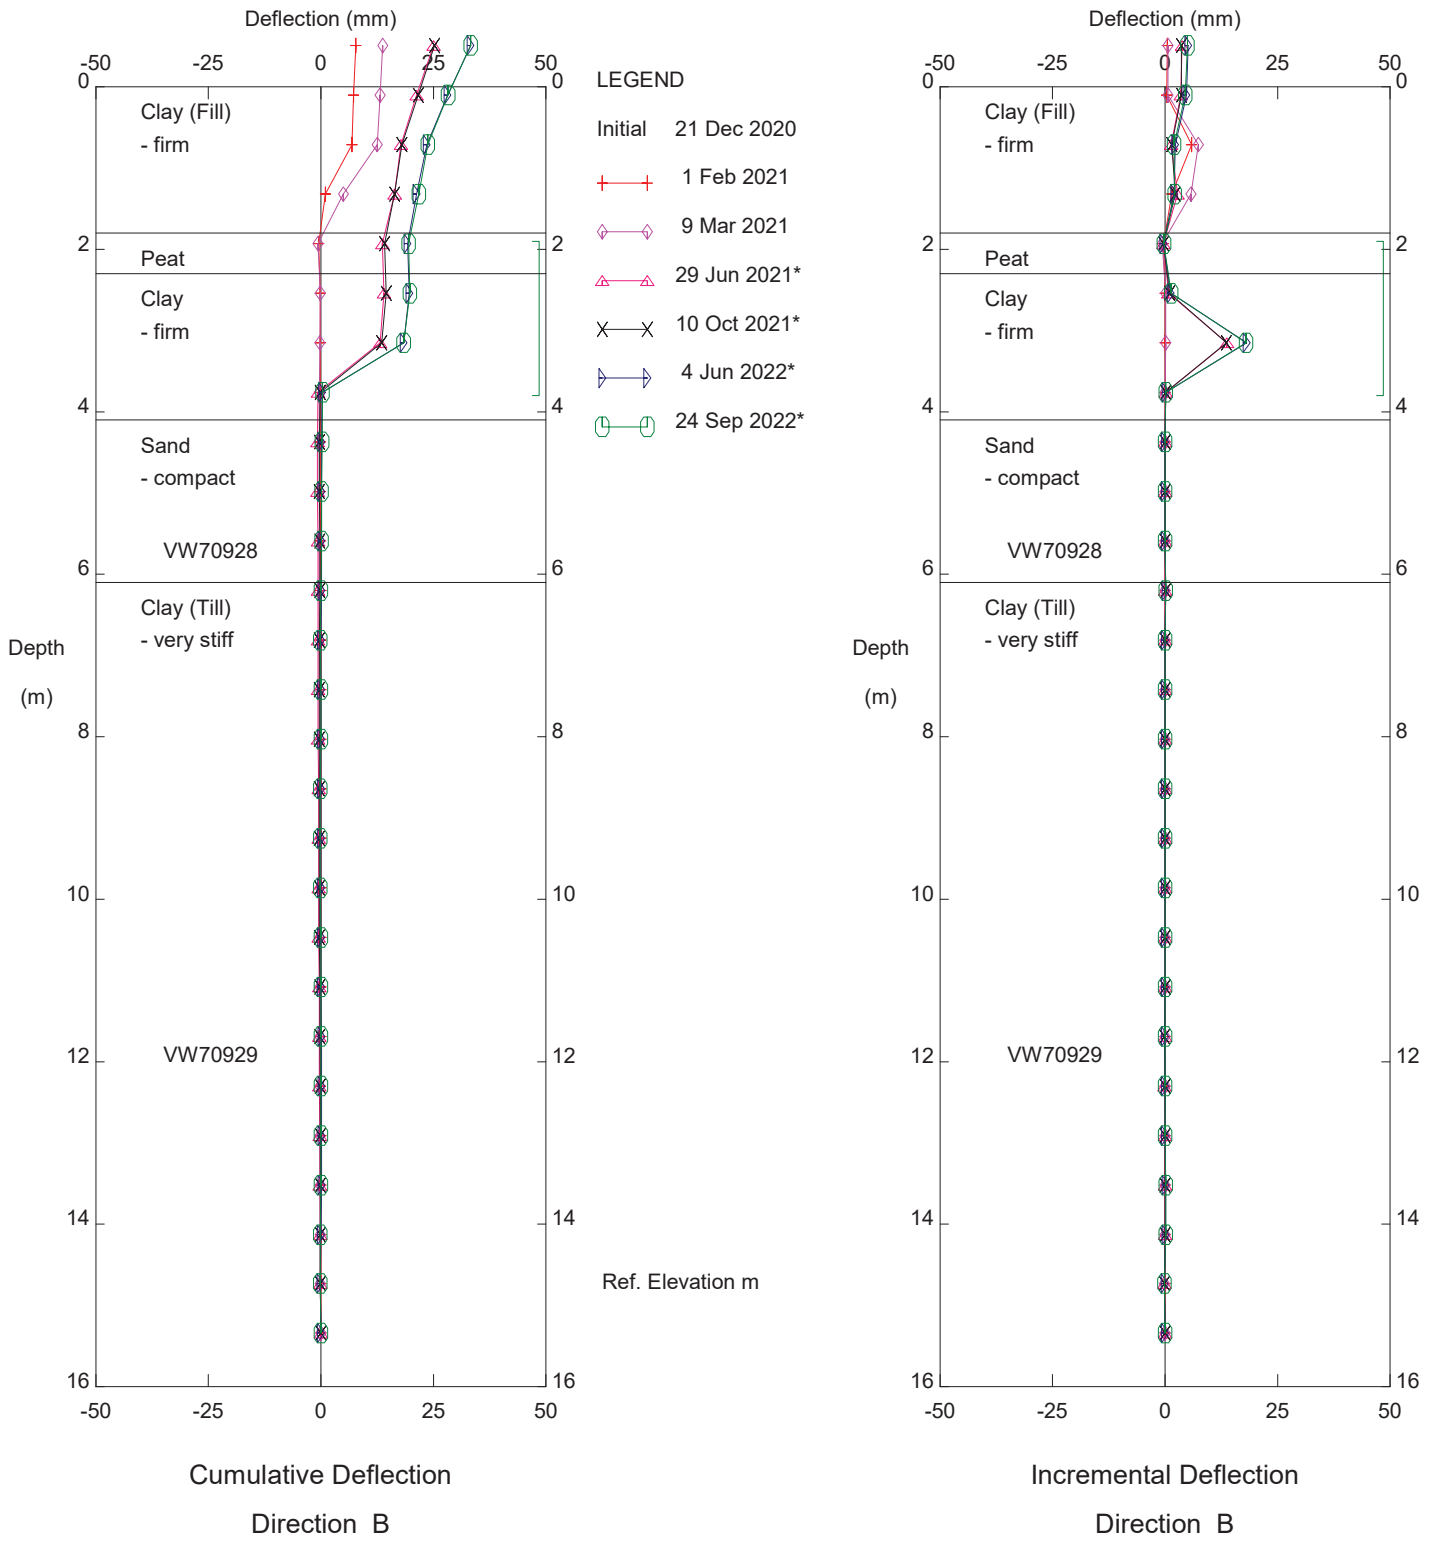
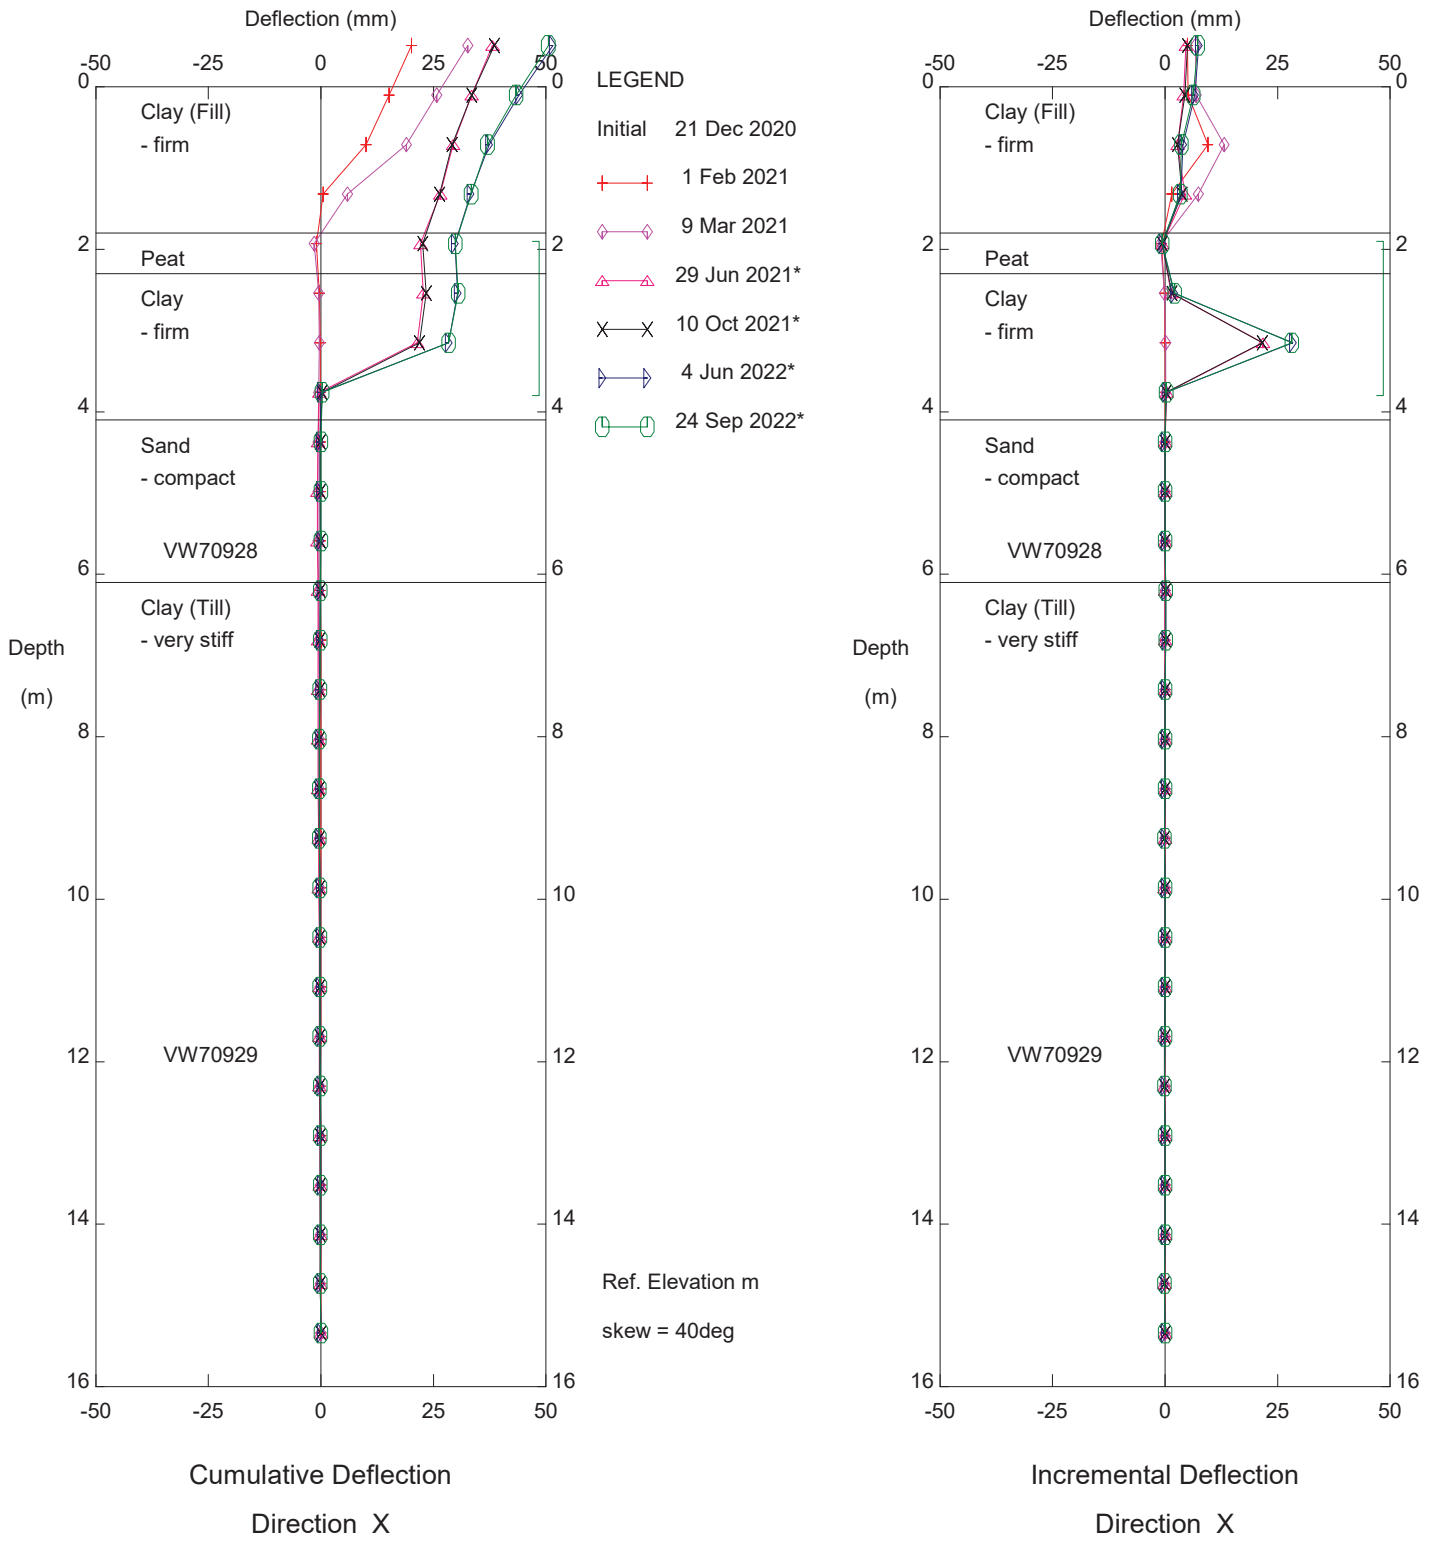
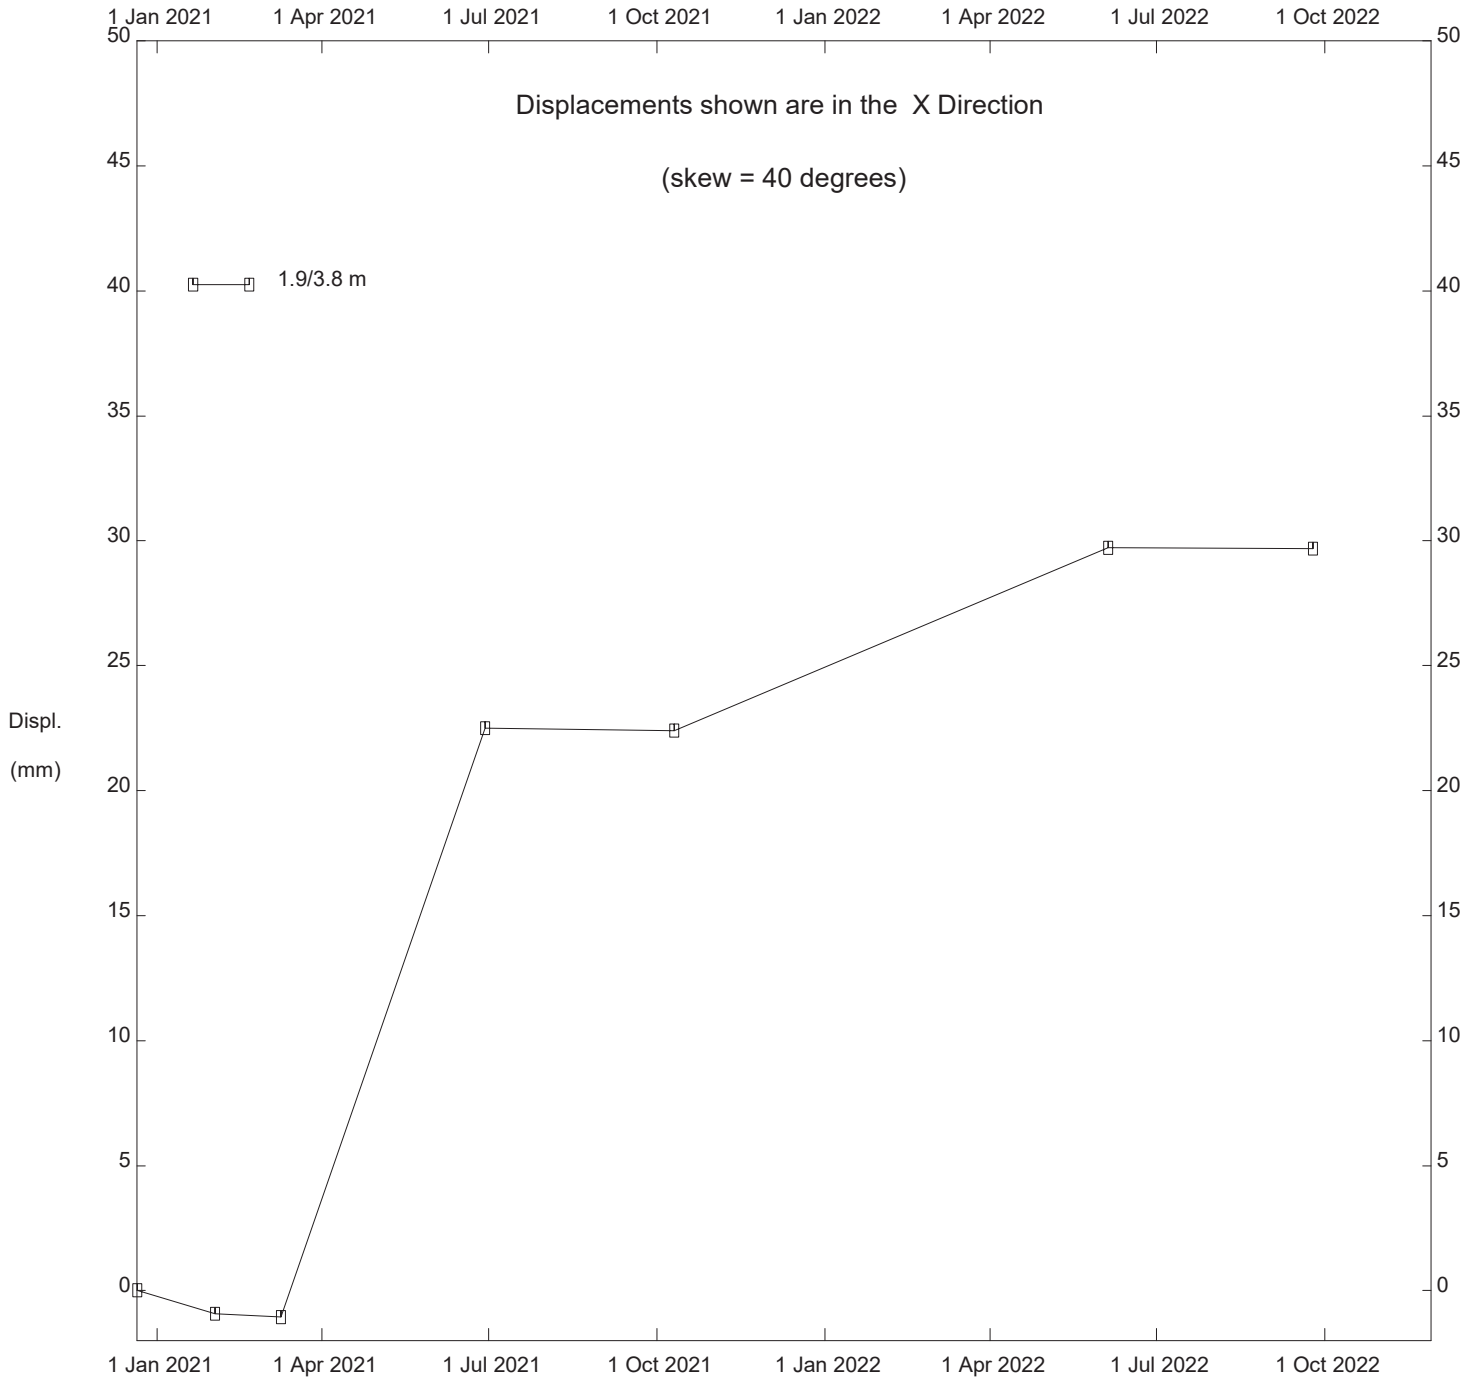
Hwy 813 NC93 Rock Island River Bridge, Inclinometer SI20-1

No zones of new movement were identified in SI20-1 since the previous readings in the spring of 2022.

SI20-1 showed no discernible movement over 1.9 m to 3.8 m depth since the spring of 2022 readings. The rate of movement has decreased by 11.4 mm/yr since the spring of 2022 readings.

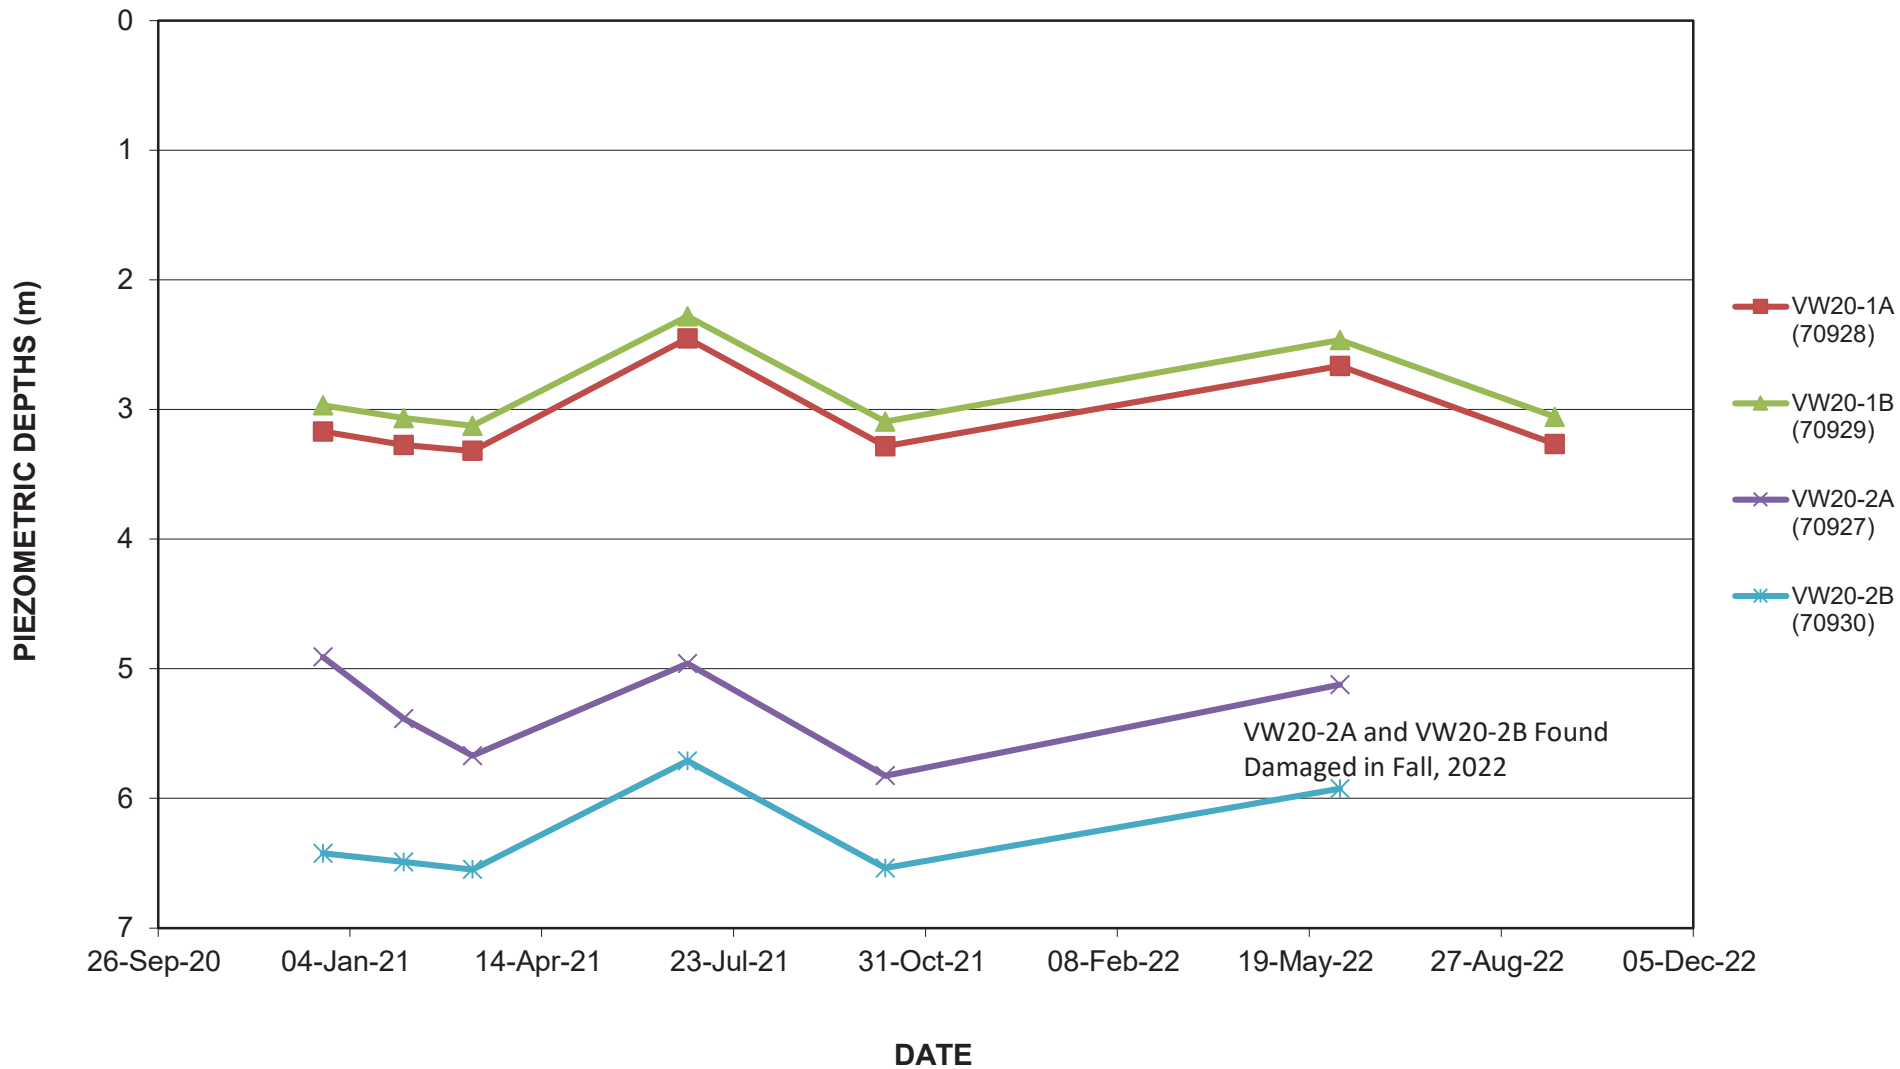
**FIGURE NC093-1  
HWY 813 ROCK ISLAND RIVER BRIDGE (BF79692)  
VIBRATING WIRE PIEZOMETER DATA**

Vibrating wire piezometers VW20-1A and VW20-1B showed decreases in groundwater level of 0.60 m and 0.59 m, respectively, since the spring of 2022 readings. The vibrating wire piezometer readings are summarized in Table NC093-2 above, and are plotted on Figure NC093-1 in Appendix A.
