**ALBERTA TRANSPORTATION
GEOHAZARD ASSESSMENT PROGRAM
NORTH CENTRAL REGION – ATHABASCA &
FORT MCMURRAY DISTRICTS
2022 SITE INSPECTION**

Site Number	Location	Name	Hwy	km
NC093	22 Km north of Calling Lake	Rock Island Bridge (79692) Landslide	813:06	4.70
Legal Description		UTM Co-ordinates (NAD 83)		
NE 5-74-22-W4		12	6139937.91	E 351682.46

Date	PF	CF	Total
Previous Inspection:	June 23, 2021	10	6	60
Current Inspection	June 6, 2022	10	6	60
Road AADT:	480	Year:		2021
Inspected By:	José Pineda, Tarek Abdelaziz (Thurber) Arthur Kavulok, Rishi Adhikari, Amy Driessen (Alberta Transportation)			
Report Attachments:	<input checked="" type="checkbox"/> Photographs <input checked="" type="checkbox"/> Plans <input type="checkbox"/> Maintenance Items

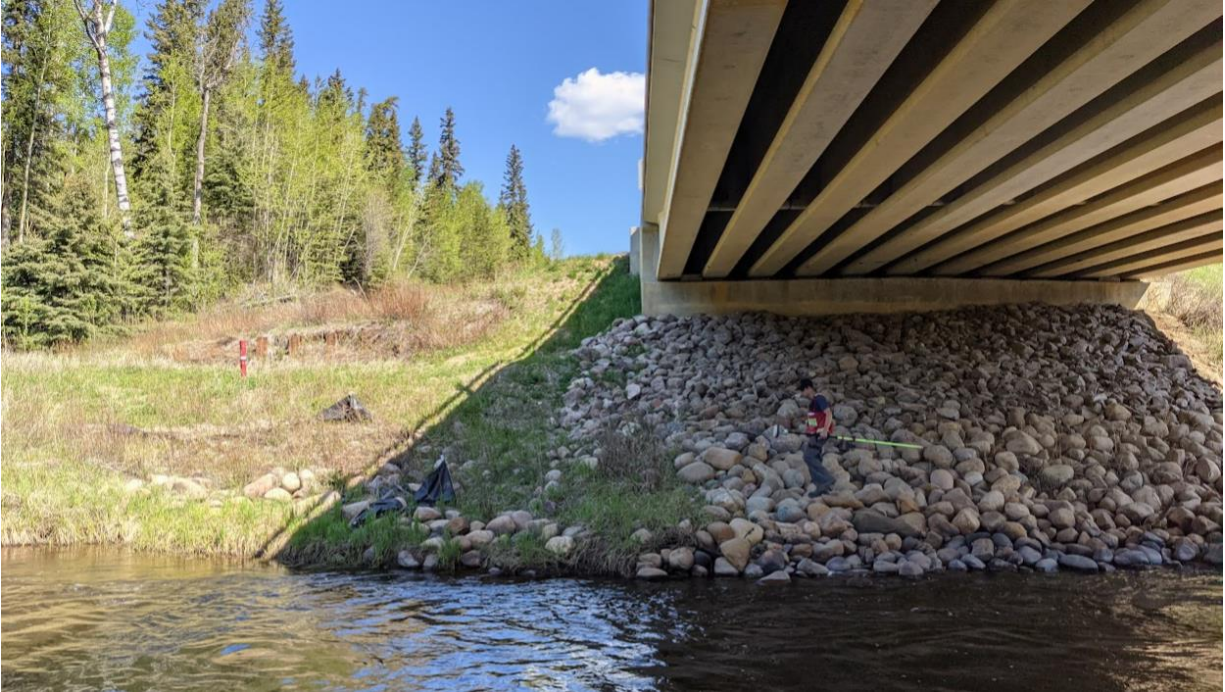
Photo No. 1 – Landslide Area (Looking North)

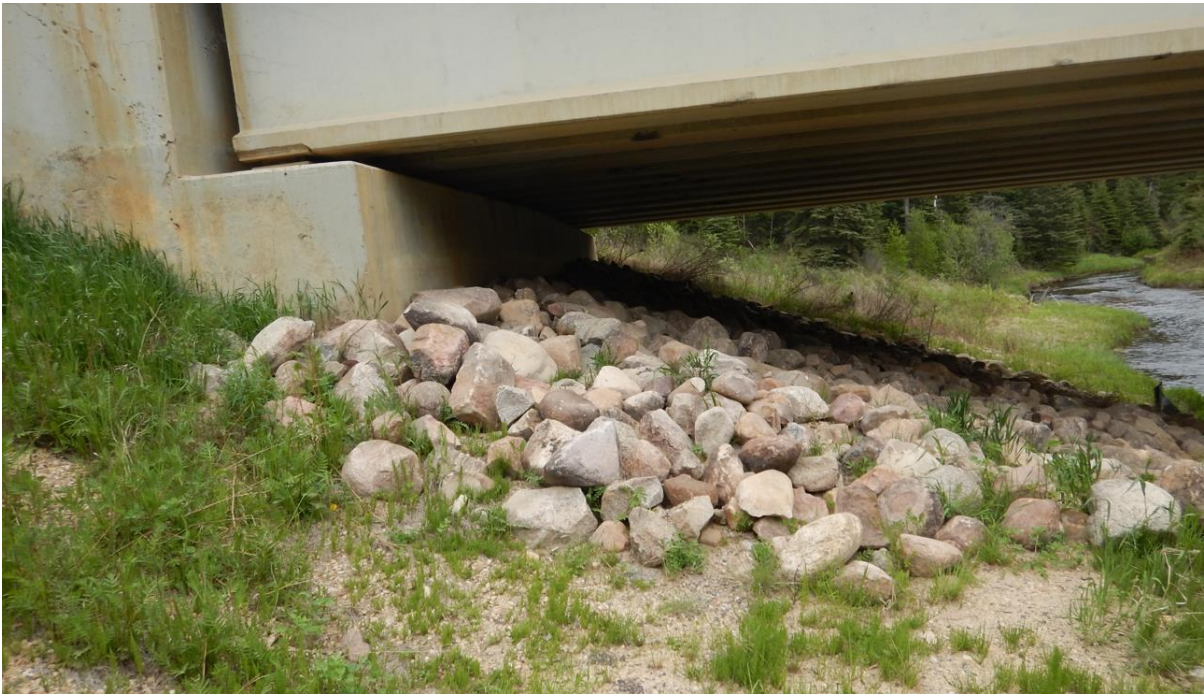
Photo No. 2 – North Abutment (Looking East) showing riprap placed by AT in 2021

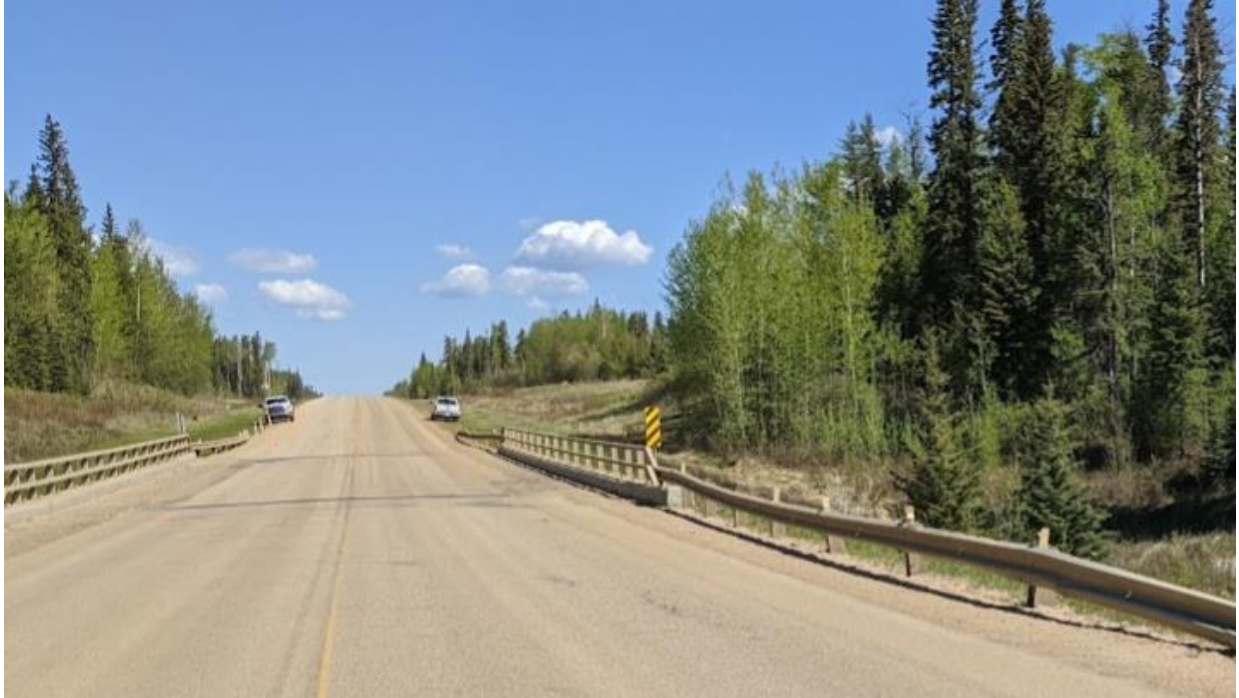
Photo No. 3 – Bridge deck and highway surface condition (Looking north at the south expansion joint).

The surface condition of the bridge deck is very poor, and this needs to be addressed by AT's bridge group in the near future.

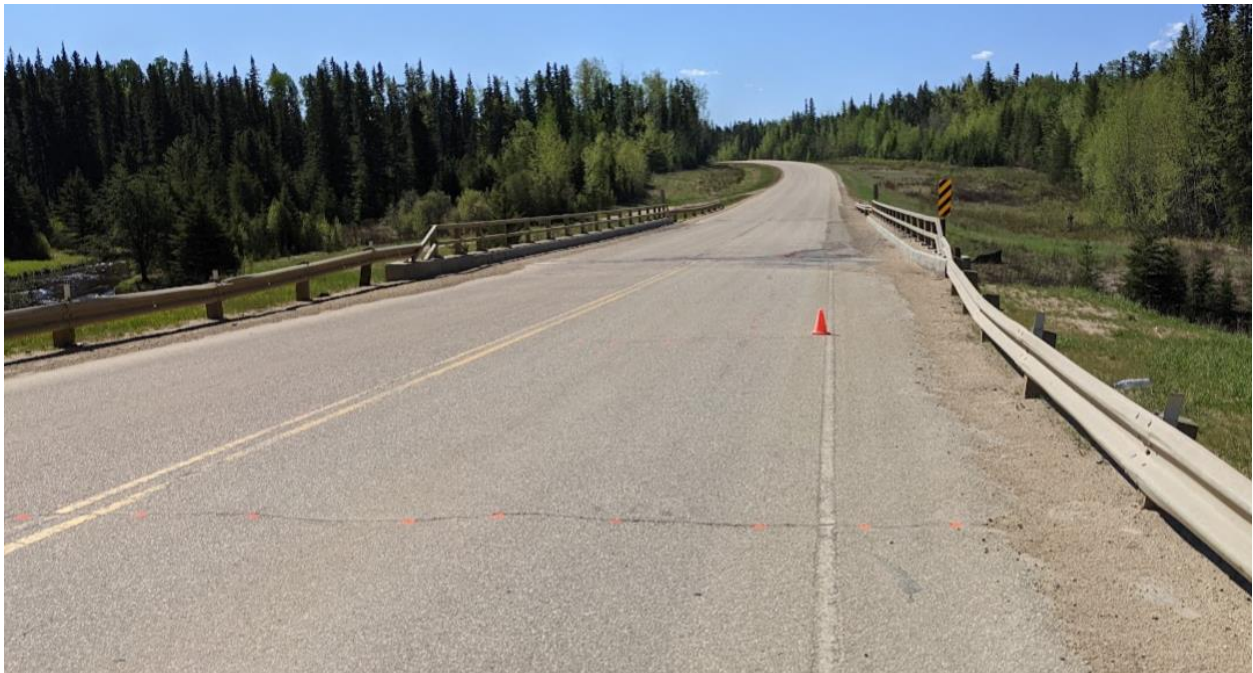
The settlement of the approach slab created a low spot at the north edge of the NW wing wall (on highway side) and hence surface drainage from the highway is currently directed towards the NW approach fill side slope rather than to the south side of the bridge as per the original design. The erosion gully developed within the recently placed gravel fill is a direct consequence of concentrated surface water runoff along the face of the NW wing wall. The erosion gully will likely continue to grow bigger in size, and this may result in future exposure of the underside of the wing wall.

Photo No. 4 – Bridge deck and highway surface condition (Looking south at north expansion joint). Note poor condition of bridge deck wearing surface, and existing dip within the highway SBL by the NW wingwall

- Place an ACP patch on the north side of the bridge. The patch should be designed to eliminate the dip on the highway, provide a smooth ride to motorists, eliminate existing low spot near the northern edge of the NW concrete curb, and divert highway runoff away from the wing wall and landslide area; consider placing sandbags or extending the NW concrete curb further north to ensure that runoff is diverted away from the landslide area. Consideration may also be given to installing a half CSP pipe along the highway NW side slope to direct surface water away from the landslide area and the northern edge of the wingwall.
- Add granular fill to backfill the erosion gully developed near the NW wing wall.
- Place riprap within recently noted eroded areas at the toe of the slope.

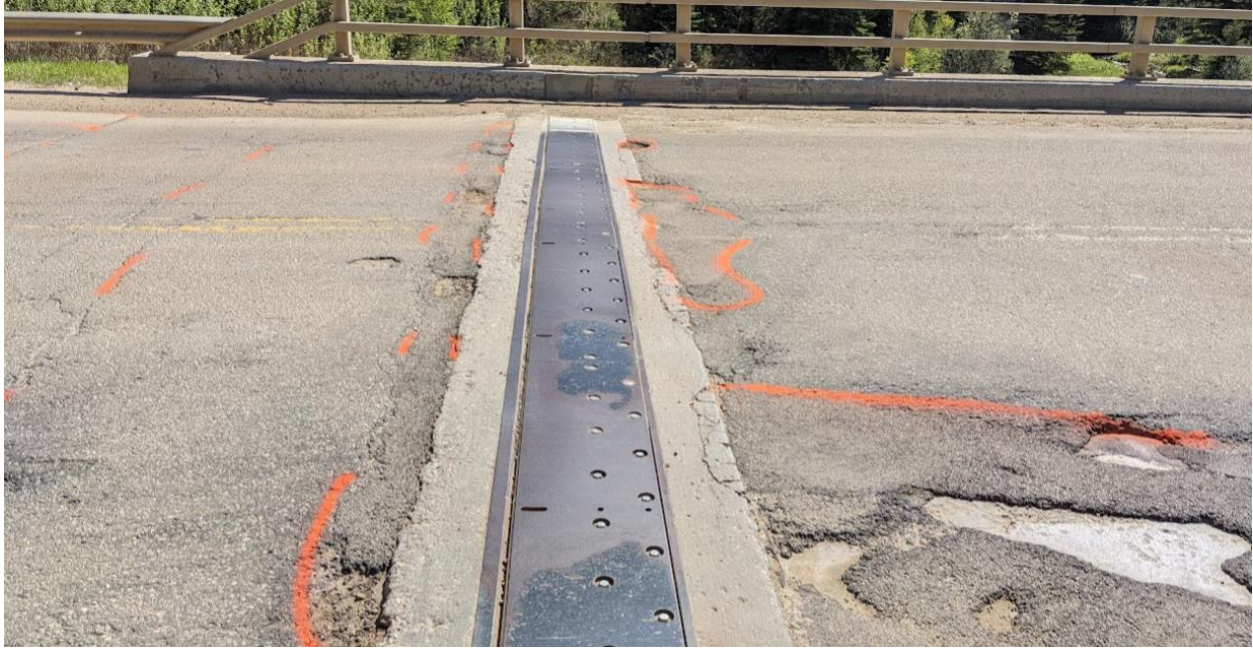
Photo No. 5 – Cracks along north expansion (Looking east)

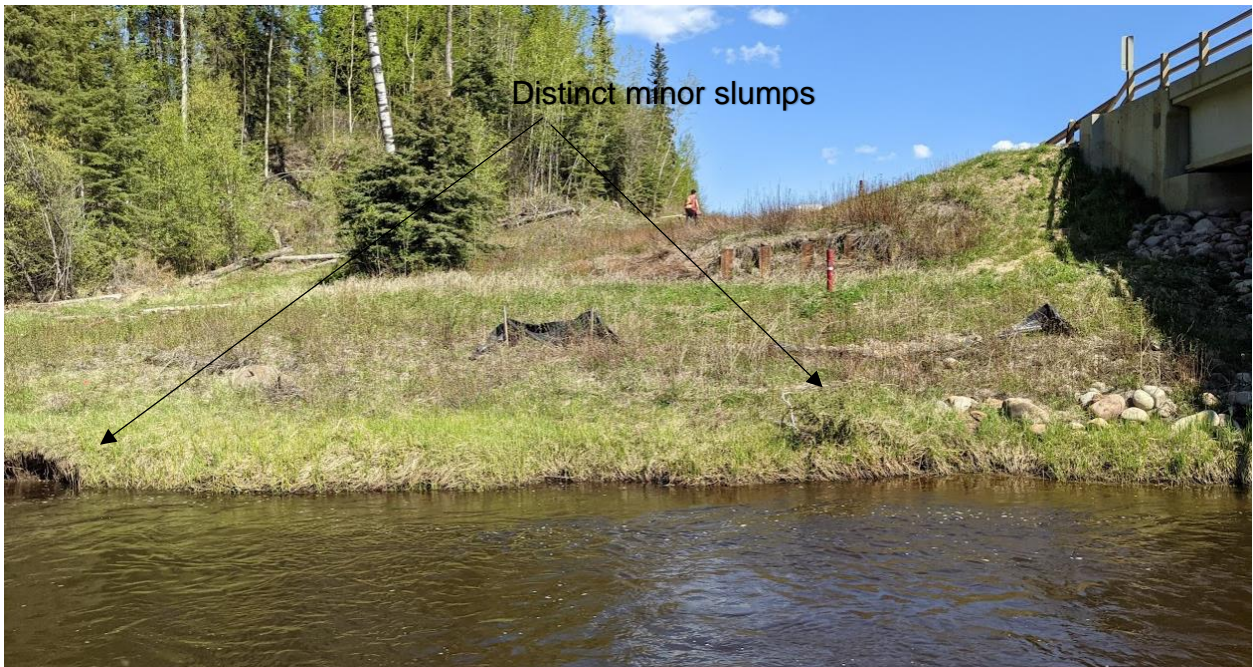
Ongoing toe erosion by the river resulted in the development of two distinct minor slumps immediately above the stream level. These slumps may get bigger in size and result in a significant loss of toe support at the base of the slope and hence an accelerated movement of the landslide.

Photo No. 6 – Looking north at the NW approach fill headslope; note two distinct slumps just above the stream

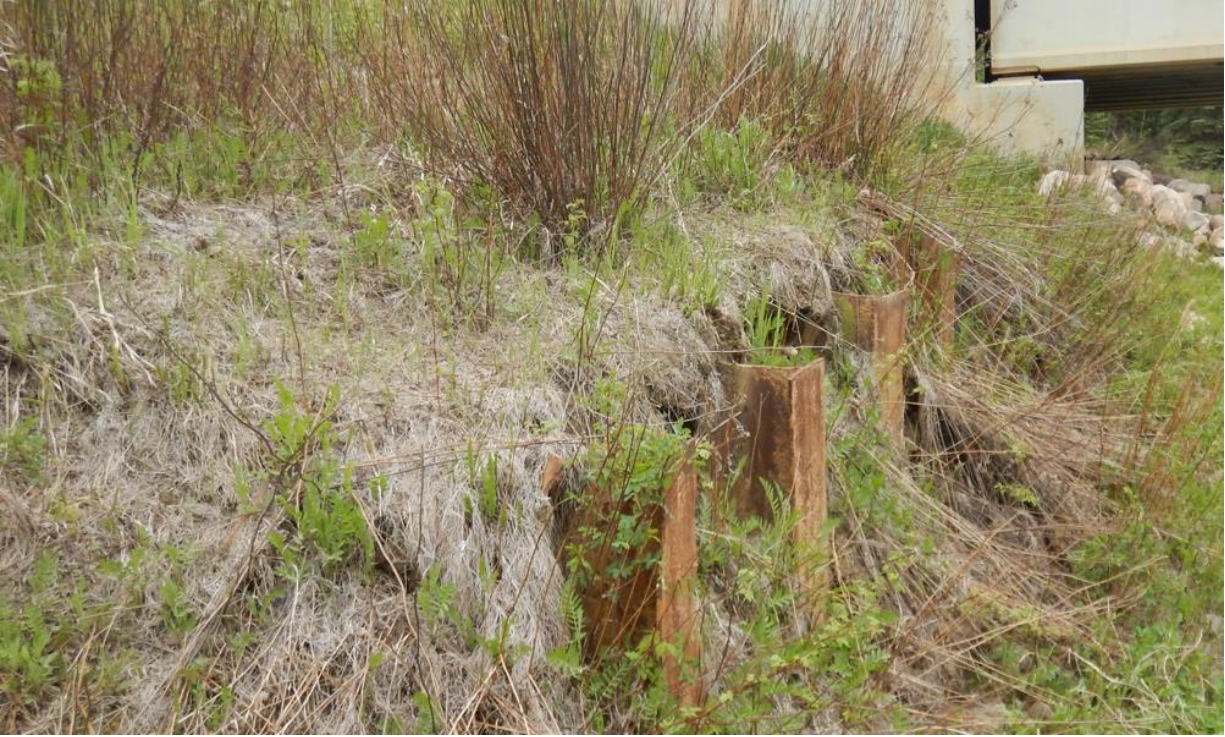
Photo No. 7 – Old bridge H piles showing 1.4 m drop by landslide (Looking East)

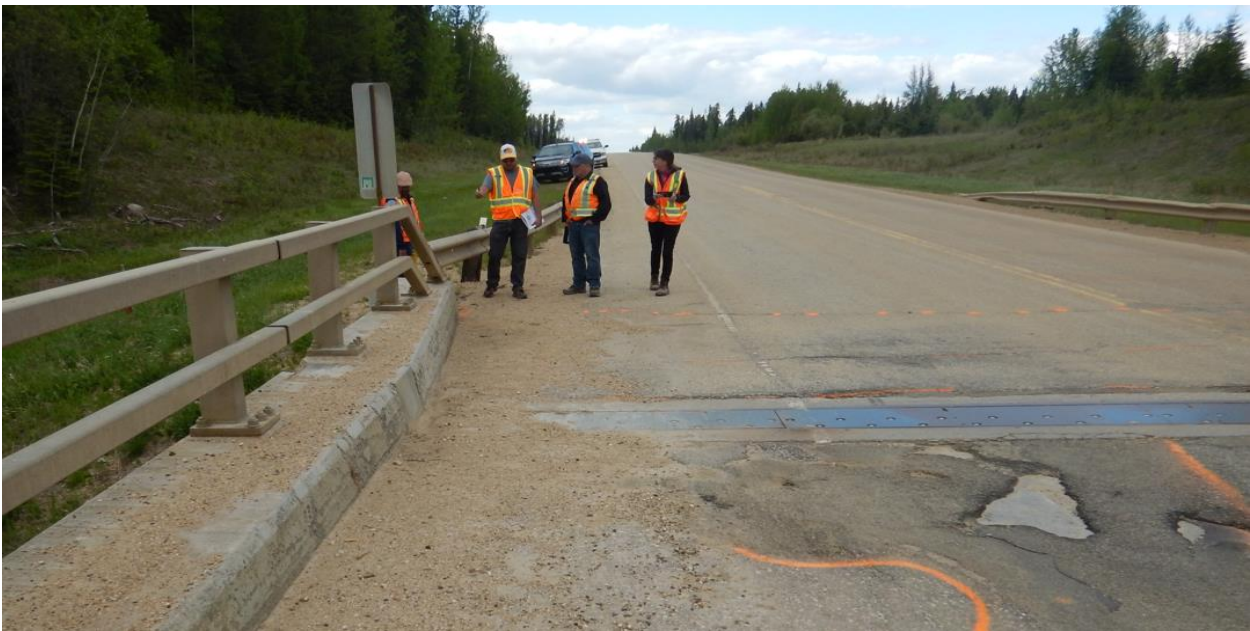
Photo No. 8 –Previous voids, formed behind the wing wall on the highway side and filled with instant patch in 2020 did not open again

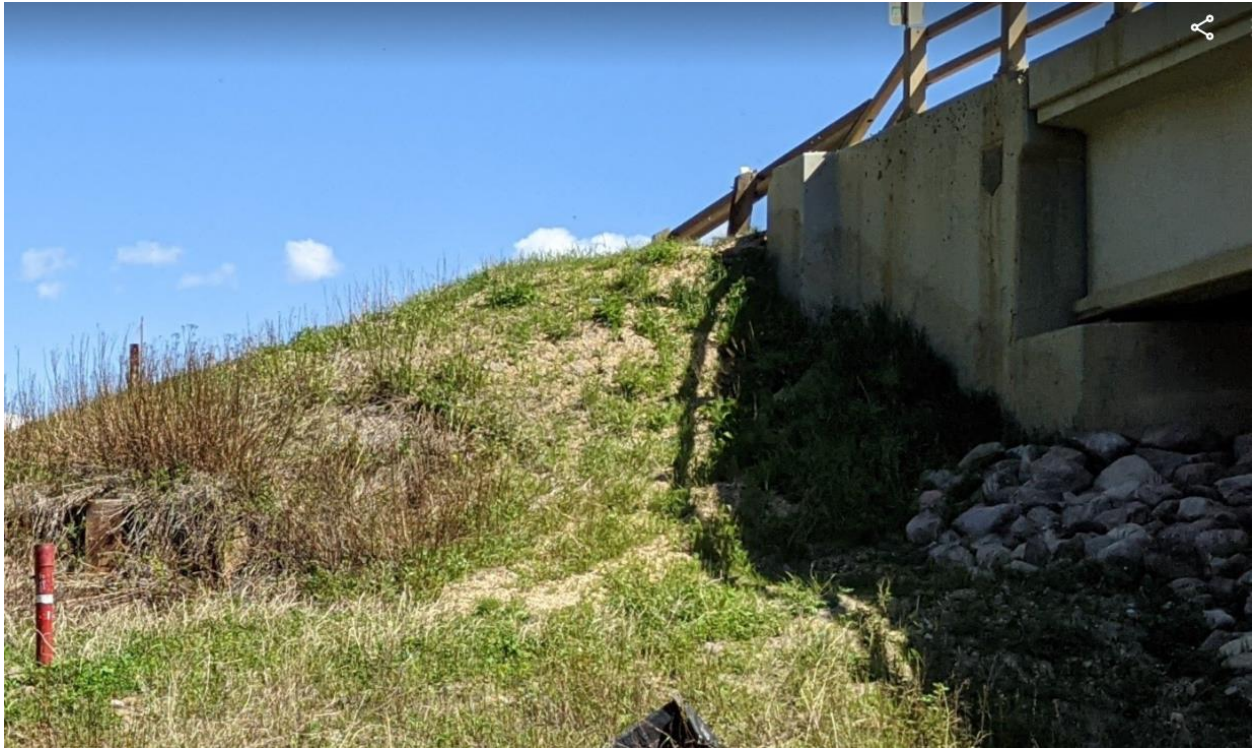
Photo No. 9 –Northwest wingwall: soil staining on the wall face shows original design elevation of fill; approximately 1 m of gravel was placed in 2020 to buttress/cover the gap formed below the wing wall; vegetation has grown within the backfilled area since 2020; slight erosion developed within new fill placed against the wing wall.
