**ALBERTA TRANSPORTATION AND ECONOMIC CORRIDORS  
GEOHAZARD ASSESSMENT PROGRAM  
NORTH CENTRAL REGION – ATHABASCA &  
FORT MCMURRAY DISTRICTS  
2023 SITE INSPECTION**

**THURBER ENGINEERING LTD.**

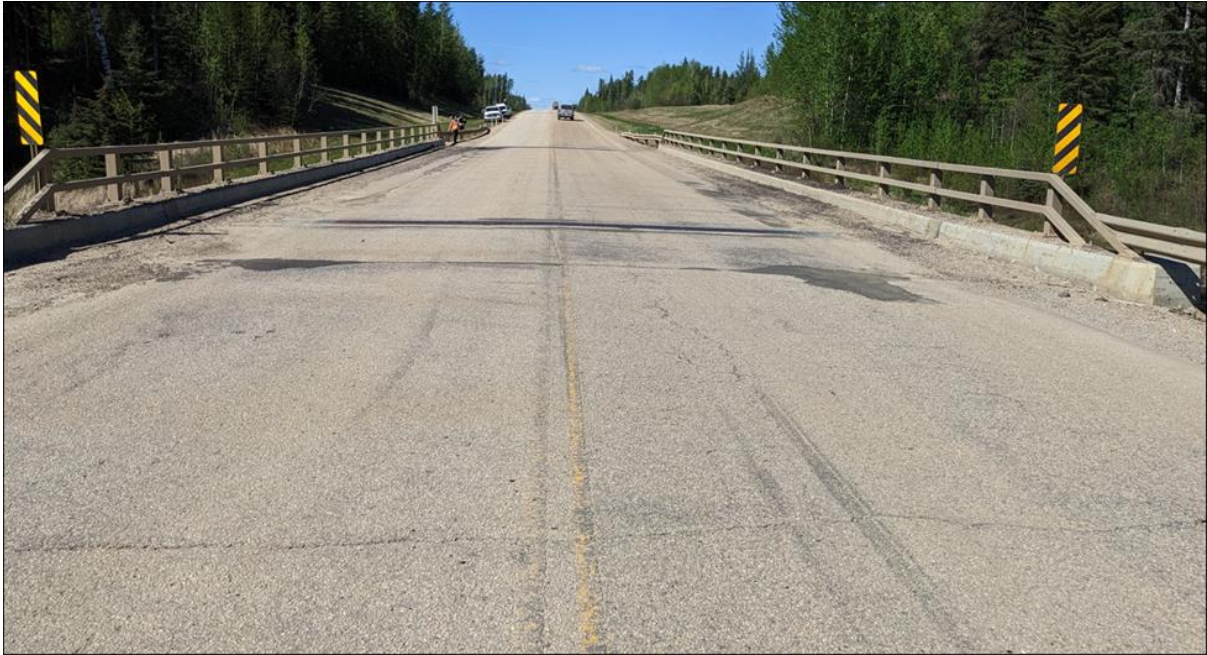
**Photo 3. Bridge deck and highway surface condition (Looking north at the south expansion joint). ACP patch placed in 2022 to seal cracks and potholes at the joints and on the bridge deck.**

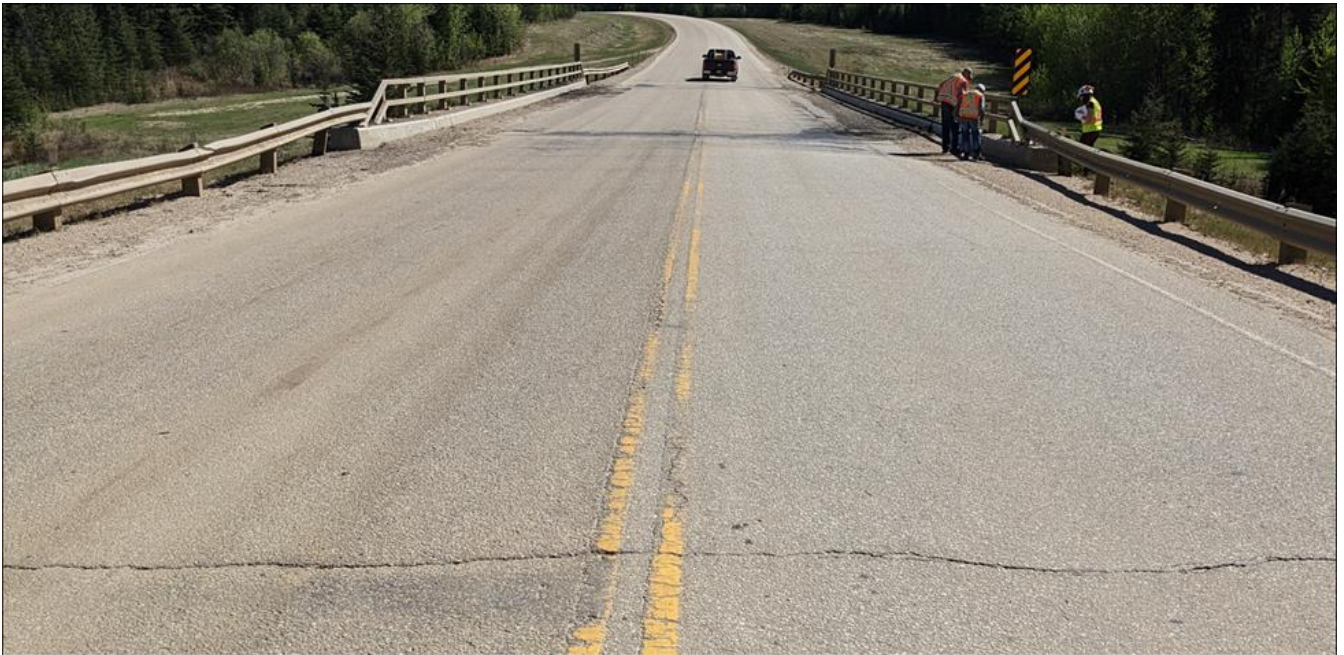
**Photo 4. Bridge deck and highway surface condition (Looking south at north expansion joint). The approach slab dip by the NW wingwall was noted to be worse than the dip noted in 2022.**

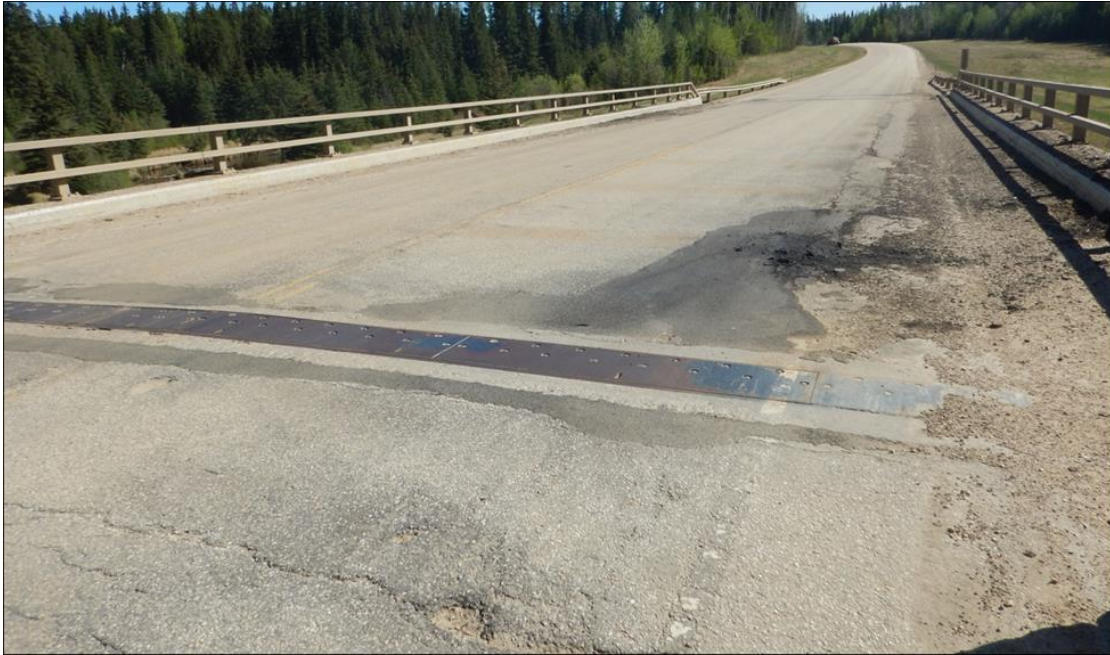
**Photo 5. Sealed Cracks along north expansion joint (Looking east). ACP patch placed on the bridge deck in 2022 is failing.**

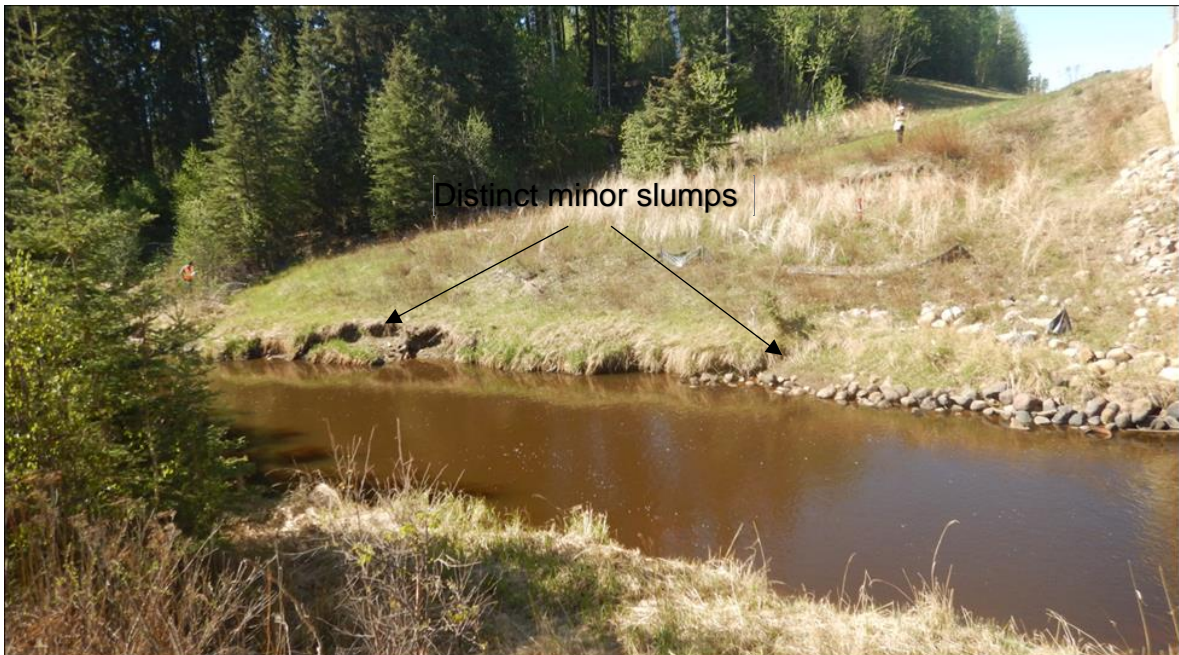
**Photo 6. NW approach fill headslope; note two distinct slumps just above the stream level.**

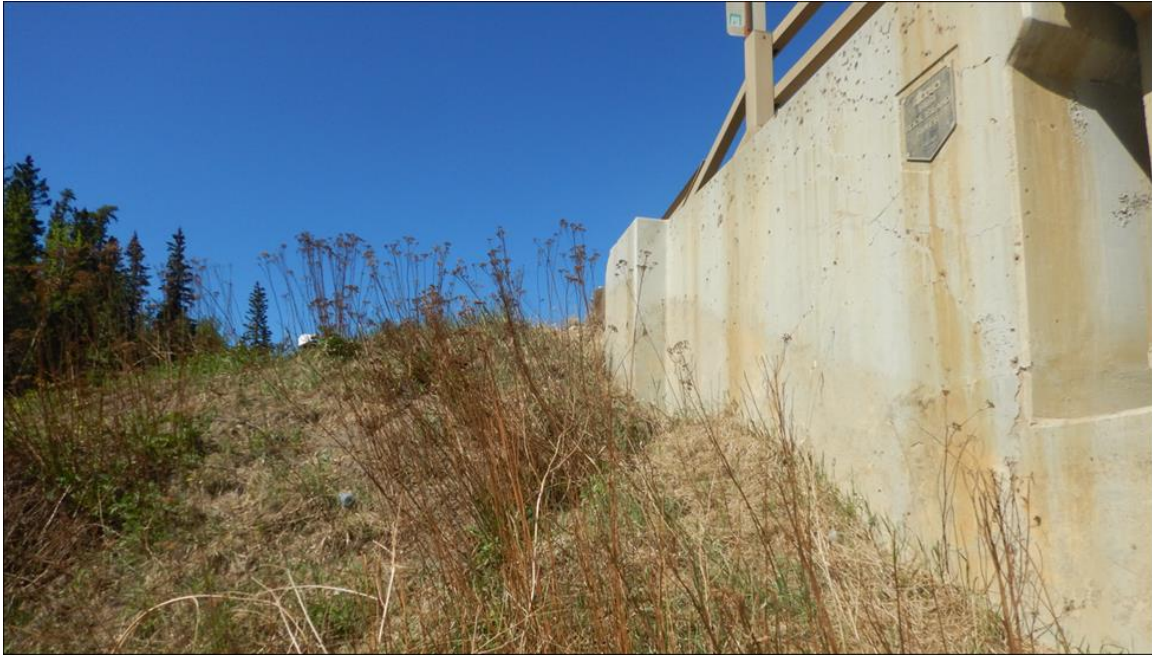
**Photo 9. Northwest wingwall: soil staining on the wall face shows original design elevation of fill; approximately 1 m of gravel was placed in 2020 to buttress/cover the gap formed below the wing wall; vegetation has grown within the backfilled area since 2020; erosion up to 500 mm at the top developed within new fill placed against the wing wall. |**
