**ALBERTA TRANSPORTATION AND
ECONOMIC CORRIDORS GRMP
NORTH CENTRAL (ATHABASCA AND FORT
McMURRAY DISTRICTS)
INSTRUMENTATION MONITORING- FALL 2024**

Site Number	Location	Name	Hwy	km
NC093	HWY 813:06, C1 4.631	Rock Island Bridge	813:06	km 4.6
Legal Description: 9-5-74-22 W4		UTM Co-ordinates		
		12U E 351689	N	6139948

**SITE NC093: HWY 813 ROCK ISLAND RIVER BRIDGE NW APPROACH FILL LANDSLIDE
(BF79692)**

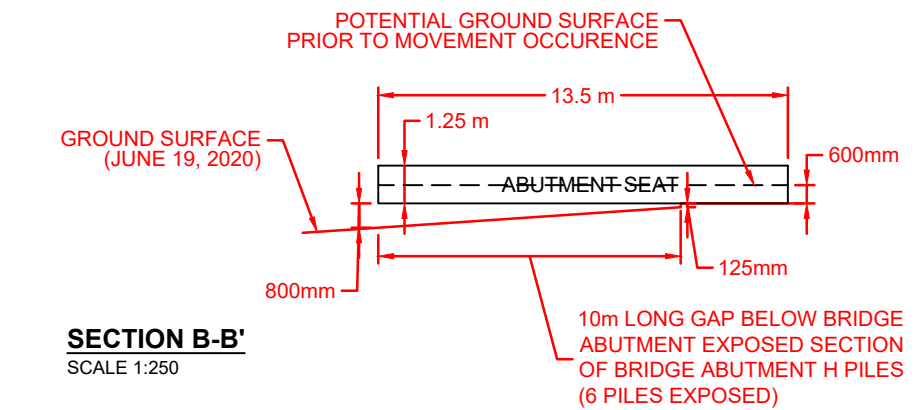
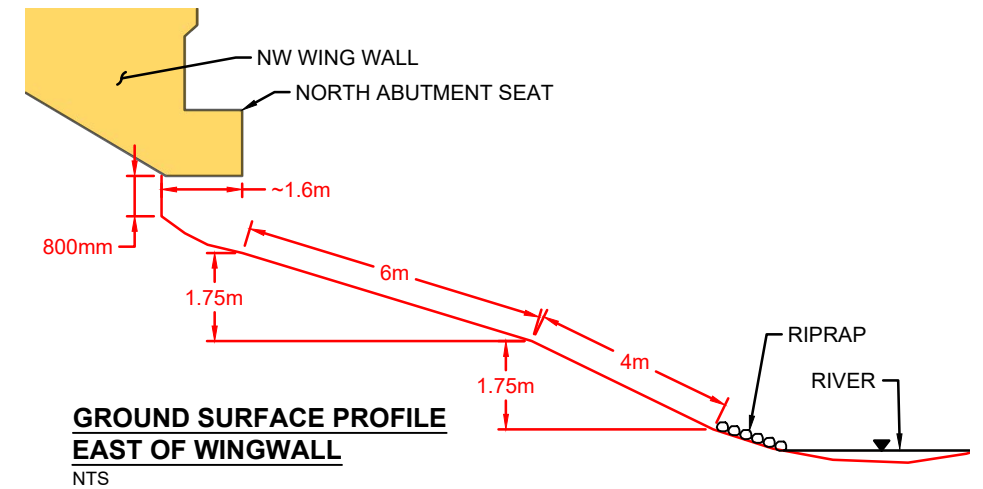
**NORTH CENTRAL
(ATHABASCA AND FORT McMURRAY DISTRICTS)**
NC093 HWY 813 ROCK ISLAND RIVER
BRIDGE NW APPROACH FILL
SITE PLAN SHOWING APPROXIMATE
INSTRUMENT LOCATIONS
DWG NO. 32122-NC093

GAP BETWEEN BOTTOM OF WINGWALL AND GROUND SURFACE:
A: 300mm
B: 200mm
C: 800mm

Site is KM marker 70 on Hwy 813
VW20-2A & VW20-2B attempted to repair need mechanical excavator if repair needed, skip reading for Fall 2024.

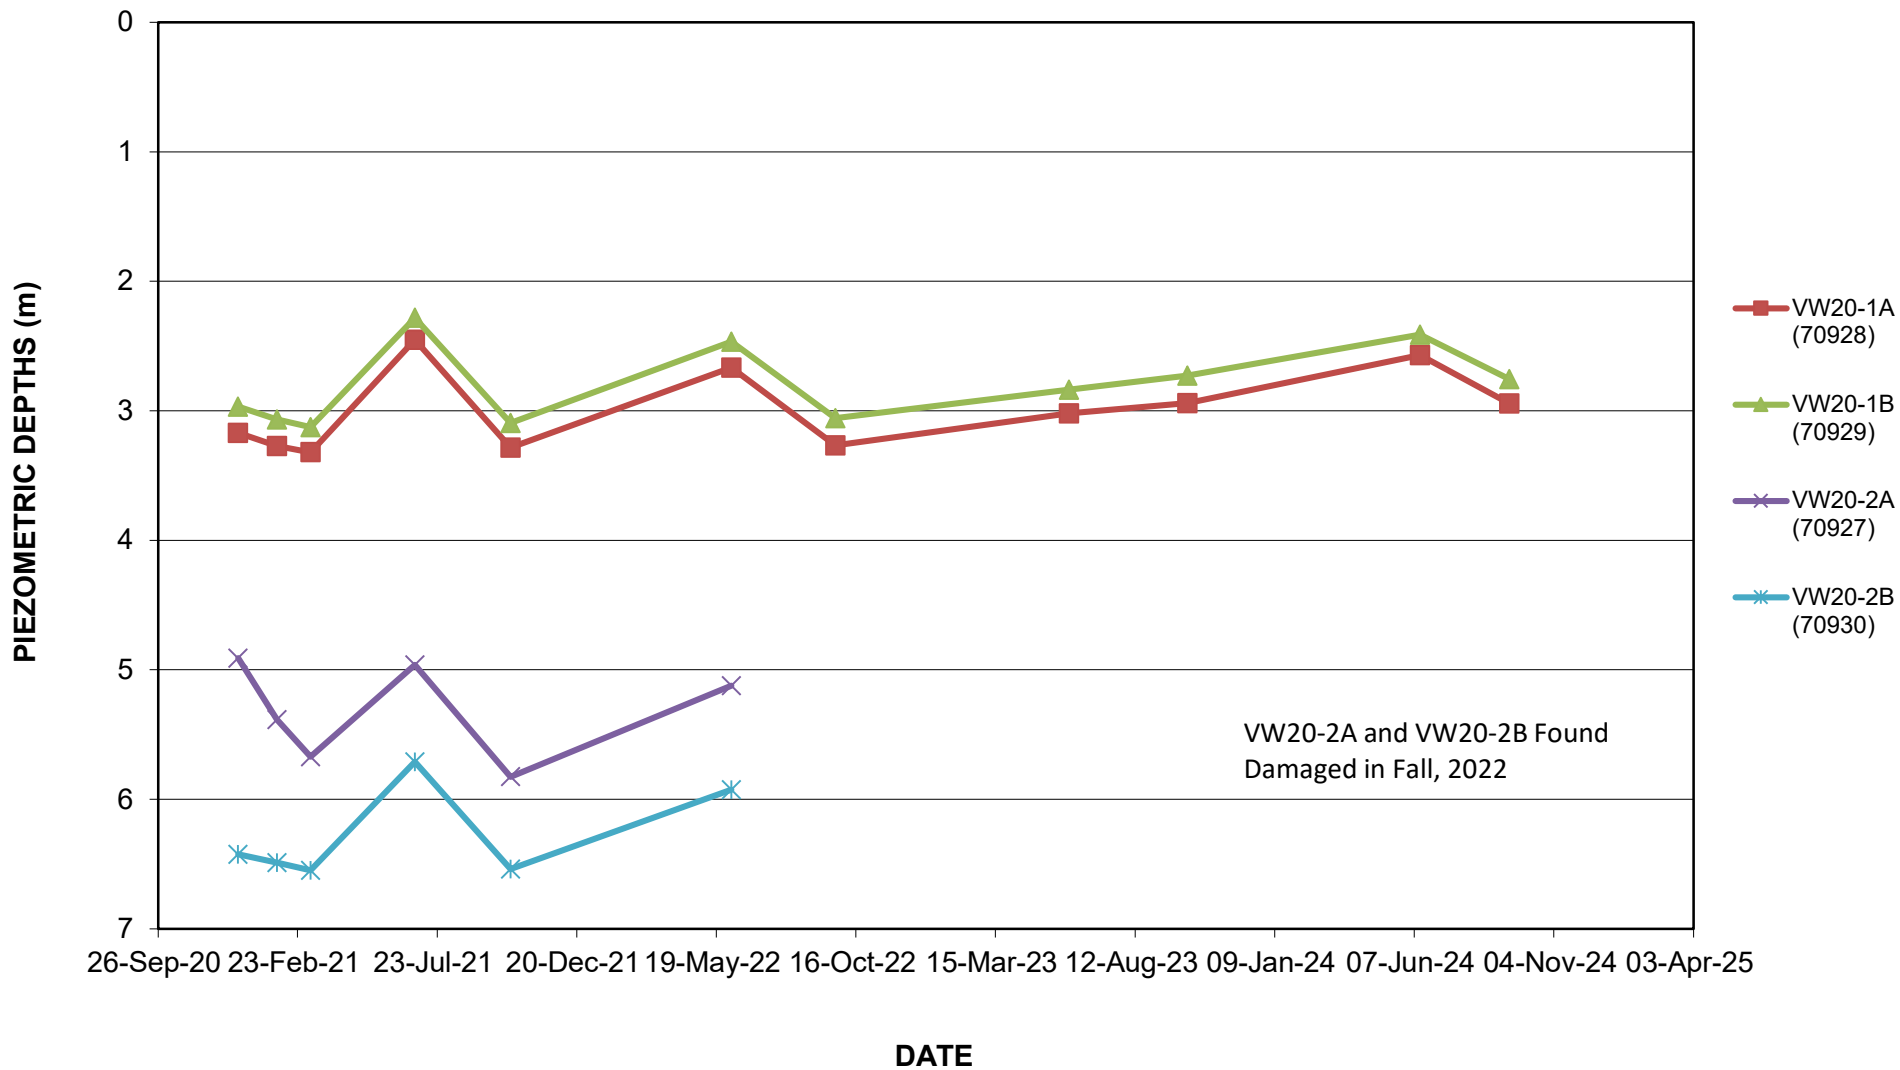
**FIGURE NC093-1
 HWY 813 ROCK ISLAND RIVER BRIDGE (BF79692)
 VIBRATING WIRE PIEZOMETER DATA**

Discussion	
Zones of New Movement:	None
Interpretation of Monitoring Results:	Vibrating wire piezometers VW20-1A and VW20-1B showed decreases in groundwater level of 0.37 m and 0.34 m, respectively, since the spring of 2024 readings. The current groundwater levels are within the historical levels.
Future Work:	The instruments should be read again in the spring of 2025.
Instrumentation Repairs:	Consideration should be given to repairing SI20-1 to continue monitoring the landslide movement rate at this site. A mechanical or hydrovac excavation will be required to repair the SI.
Additional Comments:
